**2004 Operations, Maintenance,
and Monitoring Report**

**Cheniere Au Tigre Shoreline
Demonstration**

State Project Number TV-16
Priority Project List 2

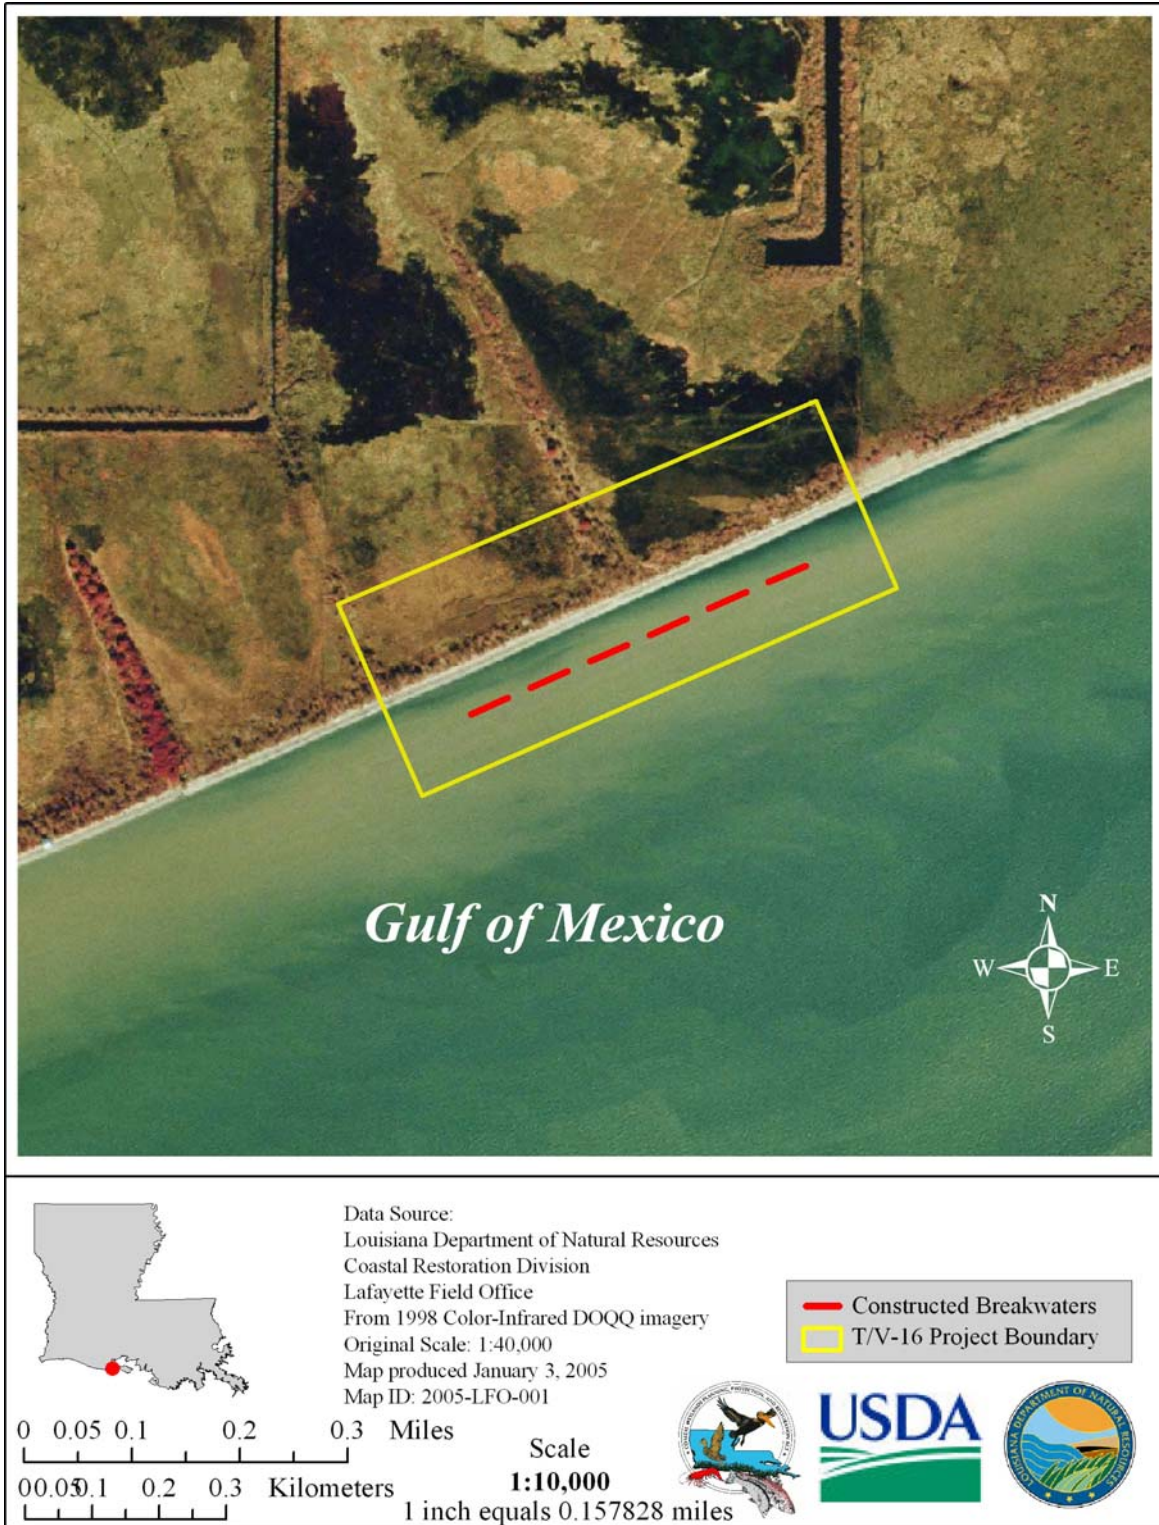
Figure 1. Location of the Cheniere au Tigre (TV-16) shoreline protection project and the locations of the constructed rock breakwaters.

The project design involved the construction of 6 rock rip-rap breakwater segments, each 200 ft (61 m) long, with a 120 ft (36 m) gap between segments. Breakwater segments were constructed parallel to the shoreline at a distance of 200 ft (61 m) offshore. Settled elevation of the rock segments was 3.5 ft (1 m) (North American Vertical Datum [NAVD] of 1988). The project design utilized results from a previous breakwater project employed at nearby Holly Beach, Louisiana (Underwood et al. 1999). Specifically, the current project used longer breakwaters with smaller gaps between breakwaters, set at a distance as much as 300 ft closer to the shore than those constructed for the Holly Beach project, in order to further reduce wave energies and allow sufficient sediment availability for the westernmost areas of the project. The actual number of breakwater segments constructed was dependent on the costs of the rock rip-rap and construction, and resulted in a total of 6 breakwater segments. Construction was initiated in July 2001 and completed in September 2001.

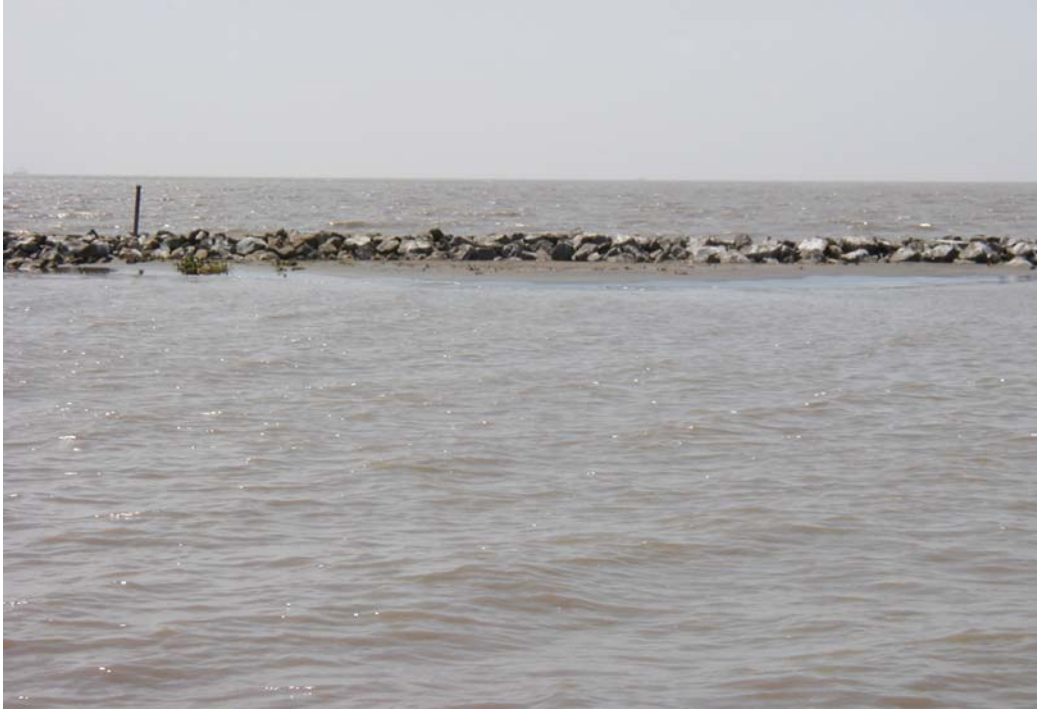
As-built shoreline position was documented in 2002 (figure 3) and although no subsequent shoreline information has been collected, qualitative observations indicate that the shoreline is prograding and sediment is accumulating both along the shoreline and immediately shoreward of the breakwater segments (figures 4 and 5). Similar responses have been observed at the Holly Beach Breakwaters (CS-01) and Raccoon Island (TE-29) projects.

Figure 4. Segmented rock breakwater showing foreshore accreted sand approximately 6 mo. following construction.

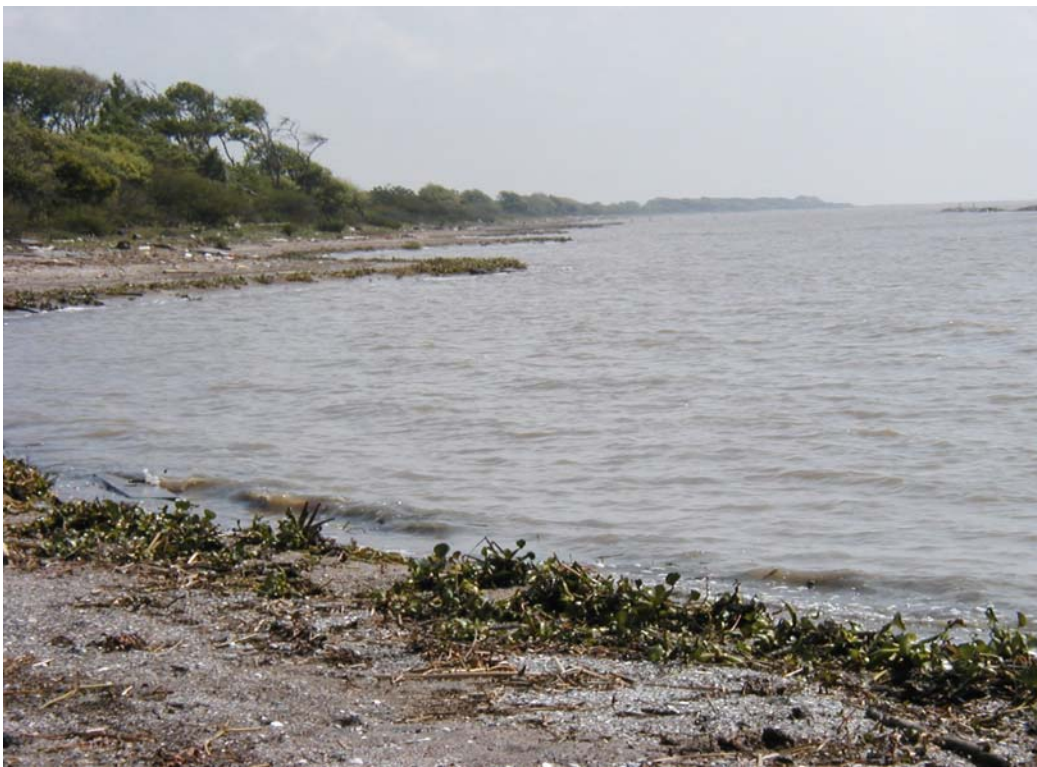
Figure 5. Shoreline of Cheniere au Tigre.
