VEGETATIVE DELINEATION REPORT

**GIWW TO CLOVELLY WETLAND**

Allan B. Ensminger  
Wetlands and Wildlife Mang. Co.

Chris Simon  
Geoscience Specialist II  
Louisiana Department of Natural Resources  
Coastal Restoration Division

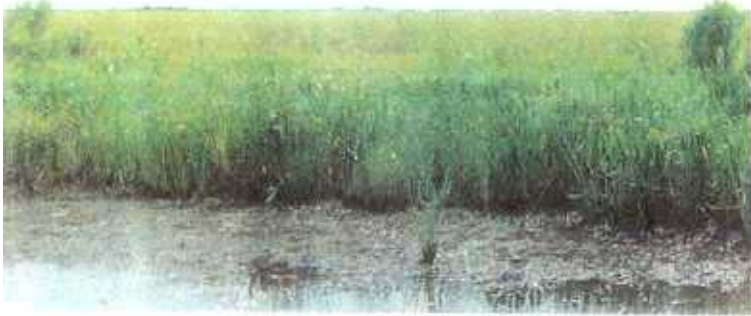
Figure 4

| <u>Figure</u> | | <u>Page</u> |
|---|---|---|
| 4. | Station 2 is located north of a Exxon pipeline along a ditch running north. This is a brackish marsh with 85% marshhay cordgrass, 10% bulltongue and 5% three-cornered grass. Photo is to the north . . . | |

Station 2 is located along a small ditch running north off of an east-west Exxon pipeline and is approximately at the point where Chabreck and Linscombe established the brackish/intermediate marsh boundary in 1988. The marsh was composed of marshhay cordgrass 85%, three-cornered grass 5%, and bulltongue 10%. This area is drained each time the tide is low in Little Lake and hunters/trappers have attempted to control the water levels with a small wooden bulkhead which has failed. Water salinity was 1 ppt and temp. was 22 C.

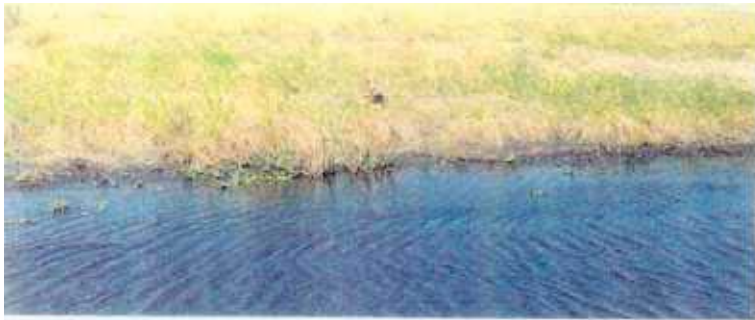
Figure 6

| <u>Figure</u> | | <u>Page</u> |
|---|---|---|
| 6. | There was extensive evidence of nutria feeding at station 2. Photo is to the west . . . . . | |

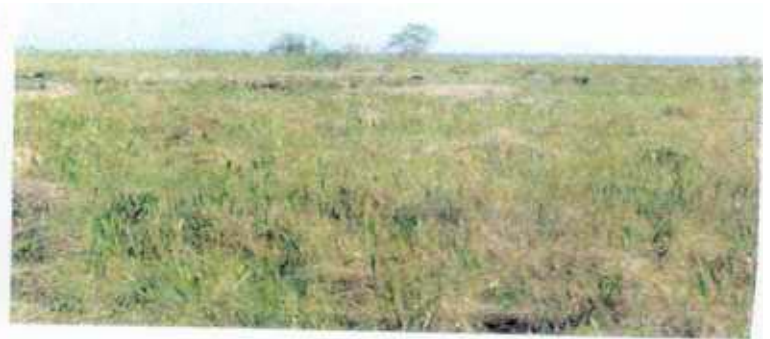
Figure 7

| <u>Figure</u> | | <u>Page</u> |
|---|---|---|
| 7. | Station 3 is on the south side of an interior lake in a brackish marsh with 90% marshhay cordgrass, 5% three-cornered grass and 5% bulltongue. Photo is to the southwest . . . . . | |

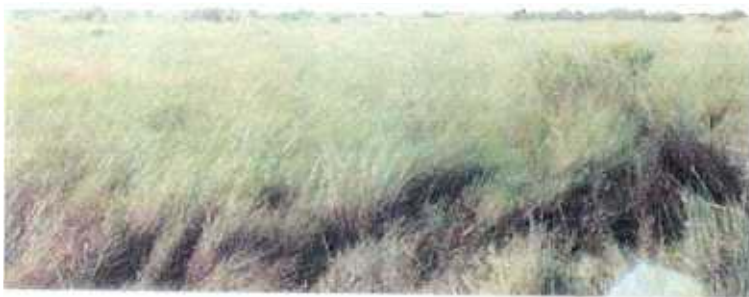
Figure 8

| <u>Figure</u> | | <u>Page</u> |
|---|---|---|
| 8. | Extensive drift deposits from Hurricane Andrew was noted at station 3. Photo is to the east . . . . . | |

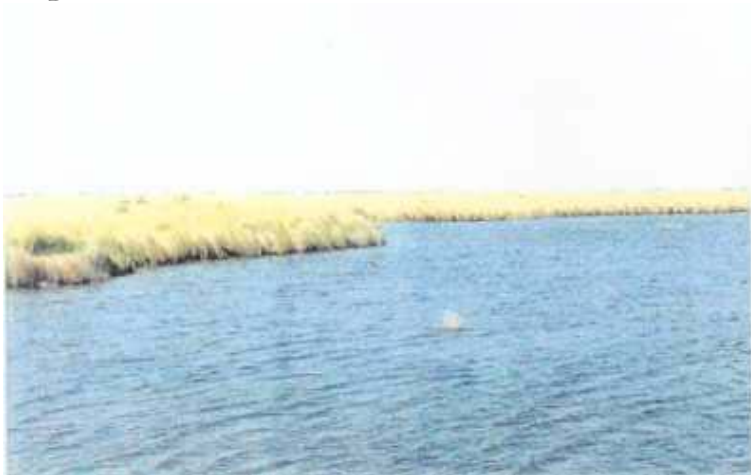
Figure 9

| <u>Figure</u> | | <u>Page</u> |
|---|---|---|
| 9. | Clumps of marshhay cordgrass had been washed into the large pond at station 3. Photo is to the northwest . . . . . | |

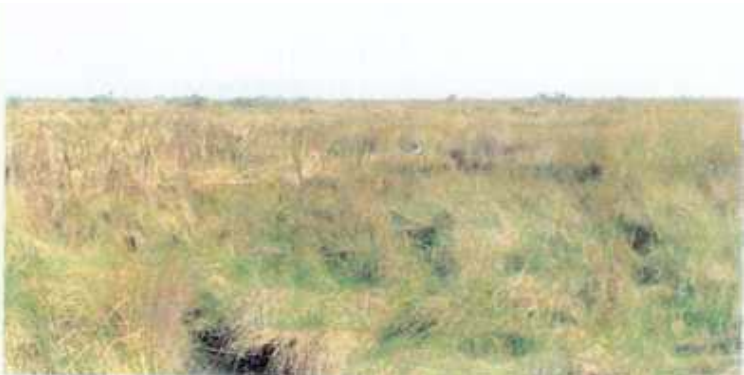
Figure 12

| <u>Figure</u> | | <u>Page</u> |
|---|---|---|
| 12. | The marsh at station 4 is brackish with 80% marshhay cordgrass, 10% three-cornered grass, 5% bulltongue and 5% cattail. Photo is to the northeast . . . . . | |

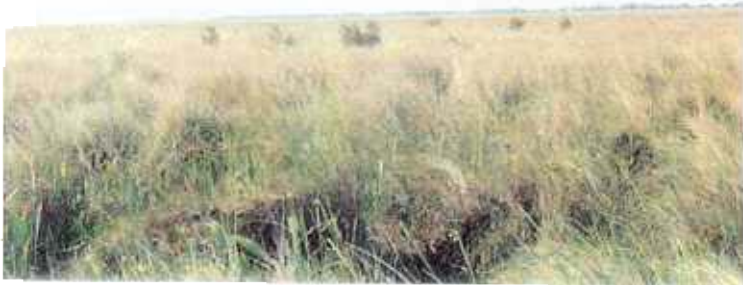
**Figure 19**

19. Station 7 is in a brackish marsh that has been influenced by saltwater intrusion through a canal system. Marshhay cordgrass was 90% with a mixture of bulltongue and three-cornered grass. Photo is to the northwest . . . . .

Station 7 is located north of a pipeline system and east of one fork of the original watershed of Bayou Des Amoreaux. The marsh at this site is 90% marshhay cordgrass and a 10% mixture of waxmyrtle, bulltongue, broomsedge, and three-cornered grass.

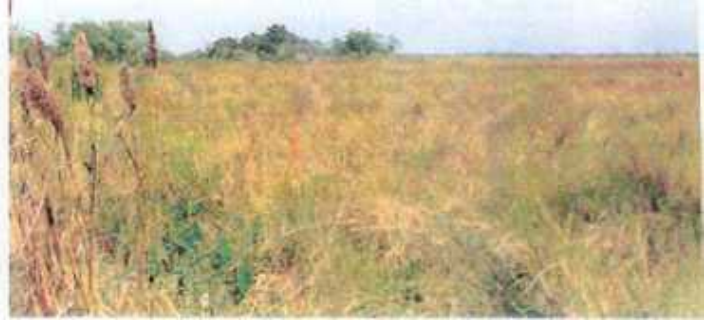
**Figure 22**

22. Marshhay cordgrass is invading the area at station 8. There was lots of white-tailed deer sign on the levee system. Photo is to the northeast . . . . .

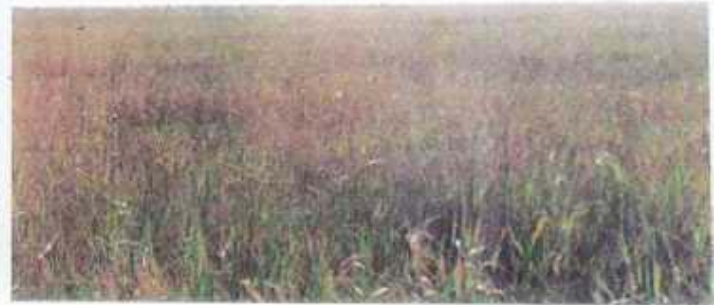
**Figure 24**

Photo is to the southwest from station 9 and is across the maidencane marsh . . . . .

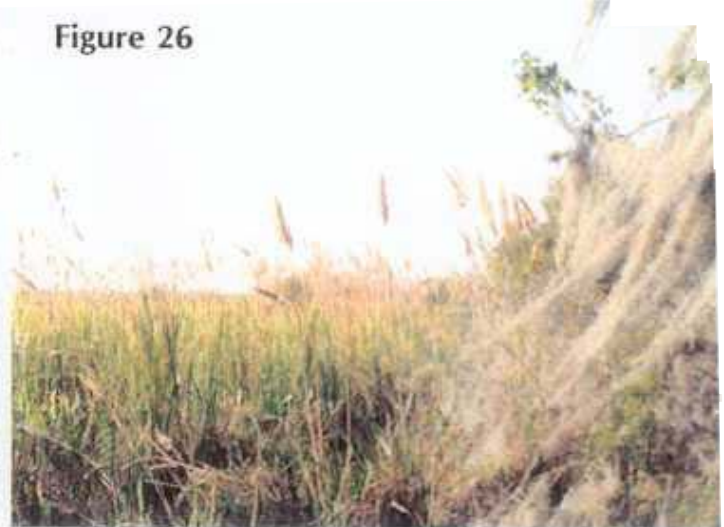
**Figure 26**

26. The levee at station 10 supports a good stand of woody vegetation  
Photo is to the northwest . . . . .

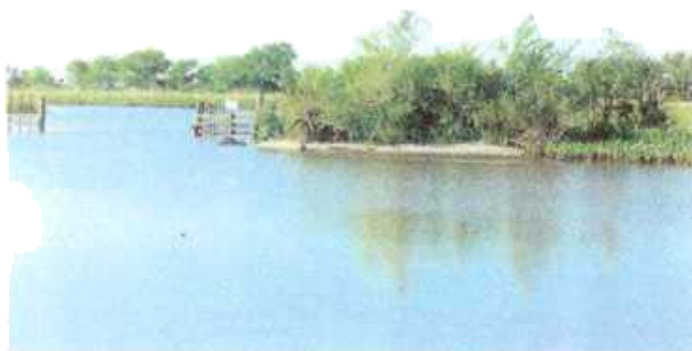
**Figure 29**

29. An Indian midden is located on the south bank of the bayou at station 12. Photo is to the south . . . . .

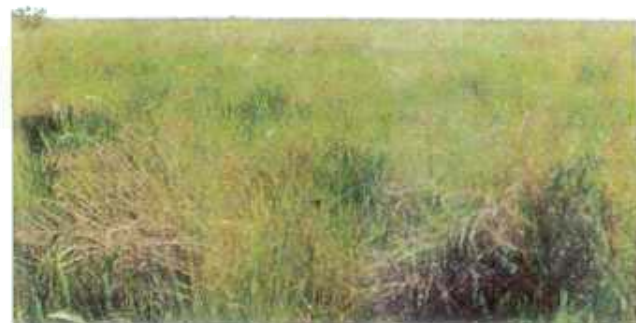
**Figure 30**

30. Station 13 is located along a trapping ditch that leads to the north out of the bayou. Marshhay cordgrass was 90% with 5% bulltongue and a mixture of three-cornered grass, smartweed, spikerush, and alligator-weed. Photo is to the northeast . . . . .

Station 13 is located along a trapping access ditch which leads north out of Bayou Des Amoreaux. The marsh plants were made up of 90% marshhay cordgrass, 5% bulltongue, and a mixture of spike rush, three-cornered grass, smartweed, alligatorweed, and baccharis. A mixture of watermilfoil and widgeon grass (*Ruppia maritima*) made up the aquatic plants in the ditch. Common salvinia was mixed with duckweed on the surface of the water in the ditch. The marsh in this area had been burned during early fall of 1992 and spring growth of marshhay cordgrass was excellent.

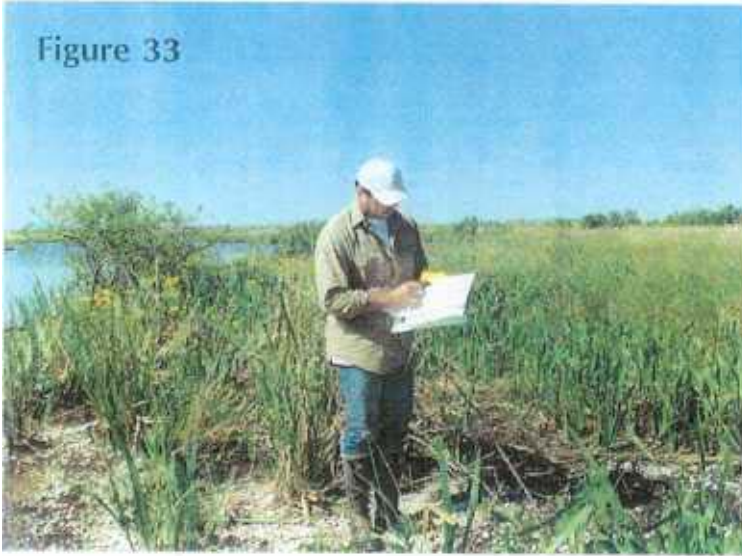
Figure 33

33. Station 14 is located at an Indian midden site on the west bank of Bayou Des Amoureux. Marshhay cordgrass has invaded this marsh and is now 95% with bulltongue 5%. Clumps of cutgrass and buttonbush along the bayou bank are indicators of fresher conditions. Photo is to the south . . . . .

Station 14 is located adjacent to an Indian midden along the west fork of Bayou Des Amoreaux near the east canal system of the Clovelly Farms. Marshhay cordgrass made up 95% of the plant community with 5% bulltongue. Small clumps of cutgrass and iris were located on the bayou banks. One small clump of buttonbush (*Cephalanthus occidentalis*) was growing on this shell ridge. This plant is very sensitive to salinity and is a good indicator of saltwater intrusion in fresh and intermediate marsh ecosystems.

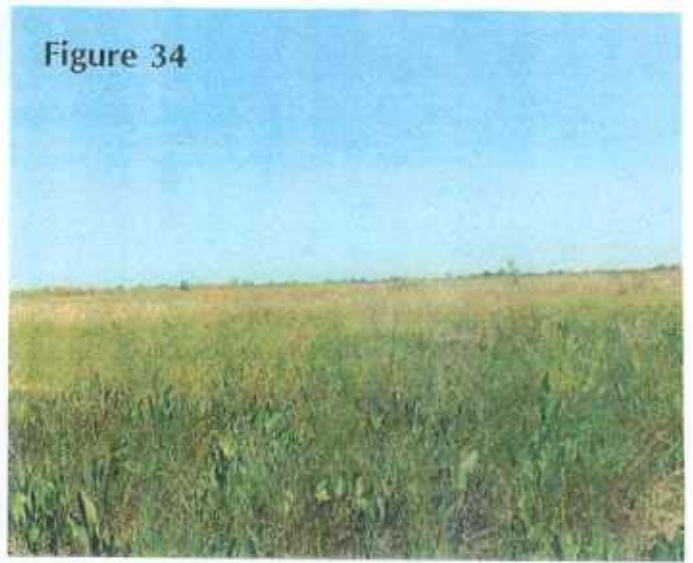
Figure 34

34. Station 14 is near the east levee of the Clovelly Farms. Photo is to the north . . . . .

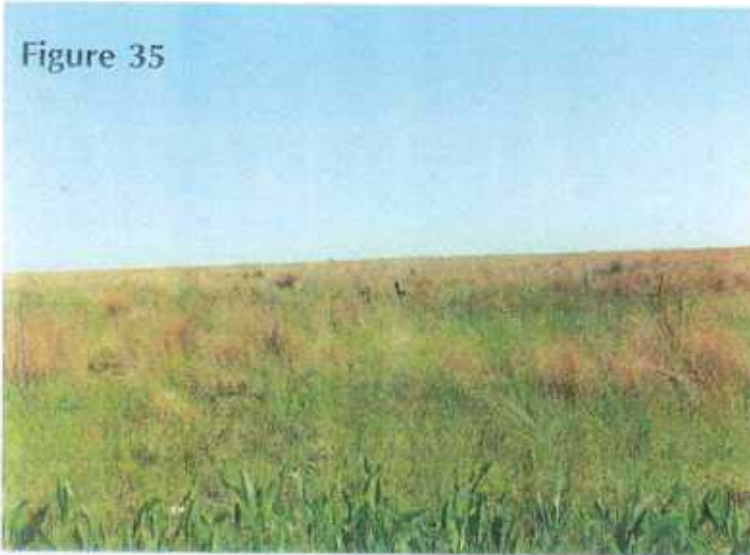
Figure 35

35. Station 15 is east of a mineral access canal in the Superior Field. The marsh is brackish with 95% marshhay cordgrass. Photo is to the northeast . . . . .
36. Station 16 is located on the north side of the canal that services the LOOP facility and is near the point where the powerline crosses this canal. Tidal action influences the water level in this brackish marsh. Photo is to the northwest . . . . .
37. The marsh at station 16 is very broken. Photo is to the northeast
38. Station 17 is located on the east side of a small bayou out of Bay L'Ours in a brackish marsh. Marshhay cordgrass was 80%, bulltongue 10% and three-cornered grass 10%. Photo is to the east . . . . .
39. Photo is to the northeast across the brackish marsh at station 17

Station 15 is located at the east end of one of the stub canals that service the oil field (Superior) north of the Loop Canal system. This is a brackish marsh with 95% marshhay cordgrass, 5% bulltongue with three-cornered grass, spike rush, and cattail. The marsh had been burned in late winter and had grown back. The spoil banks were covered with a stand of chinese tallowtrees, hackberry, black willow, baccharis, waxmyrtle, toothache-tree (*Zanthoxylum fagara*), roseau cane, and, elderberry (*Sambucus canadensis*).
