**2008 Operations, Maintenance, and
Monitoring Report**

**Isles Dernieres Restoration, Phase 0,
East Island Project**

State Project Number TE-20
Priority Project List 3

August 2008
Terrebonne Parish

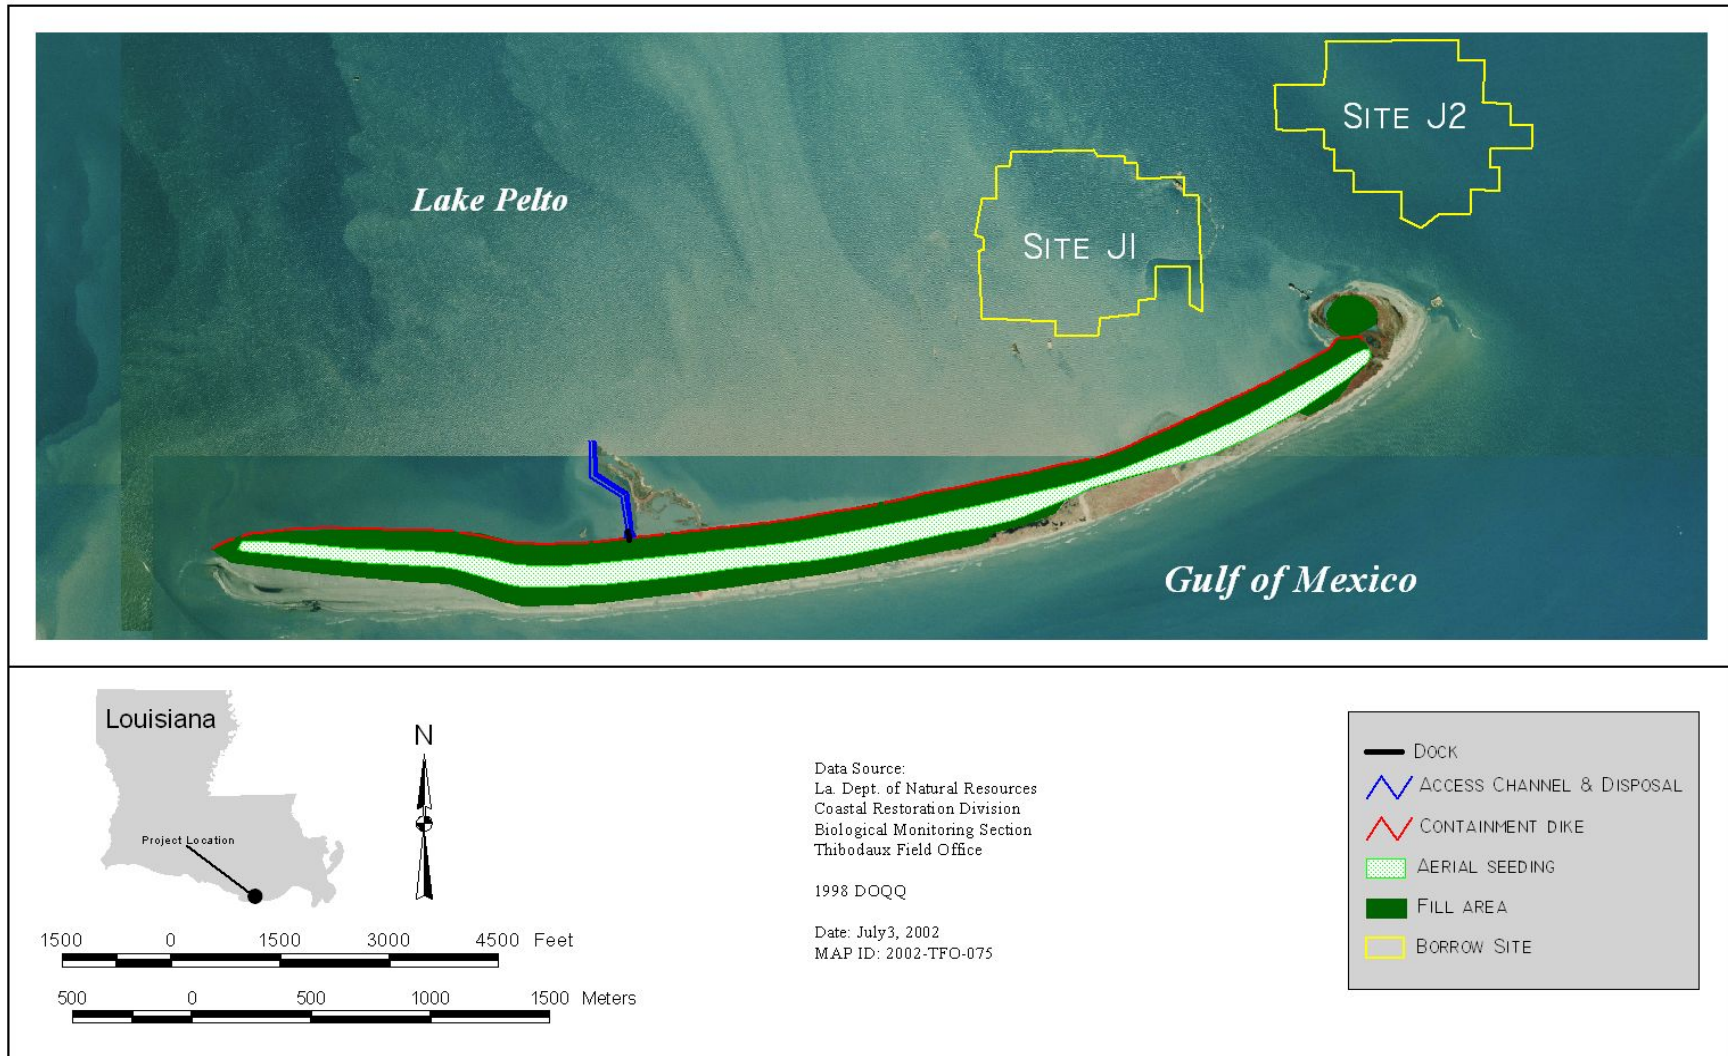
Figure 2. Isles Dernieres Restoration, Phase 0, East Island (TE-20) project area showing fill areas, aerial seeding sites, and borrow sites.

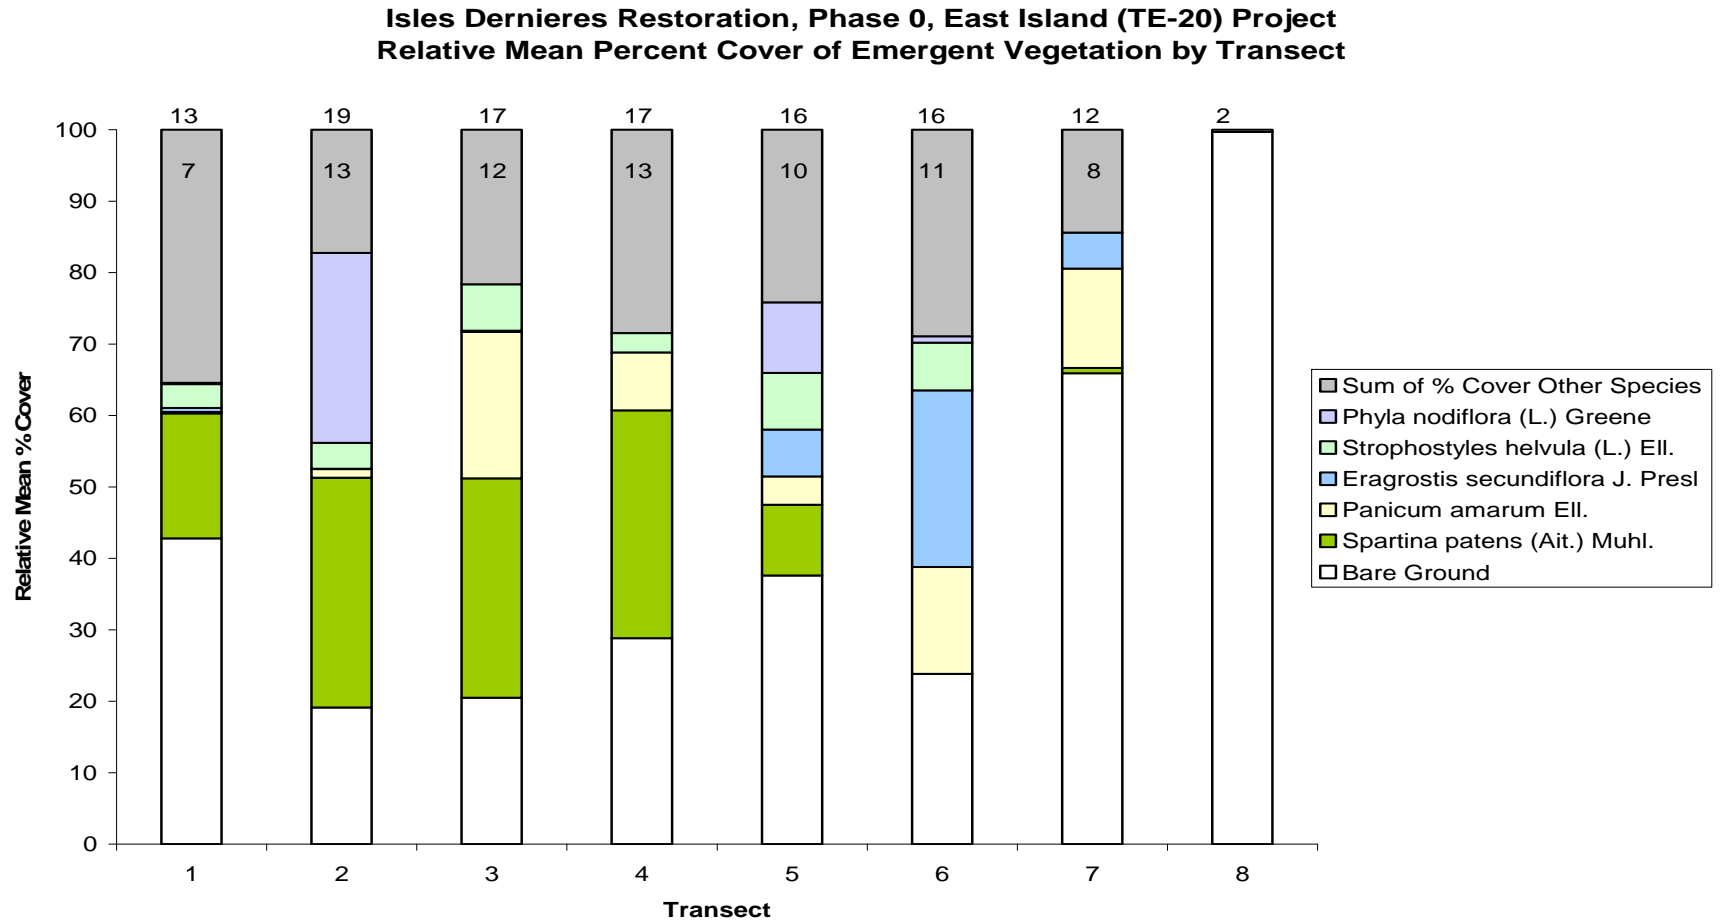
The relative mean percent cover per transect refers to the percent cover of an individual species, measured in five plots, across an entire transect, through the 3 different regions of East Island. At the time of sampling, Transect 2 illustrated the most diversity with 19 species (figure 9). Transect 8 contained the most bare ground of all transects at 99.7 percent, because of its location and elevation. This transect is at the end of East Island and seems to be overwashed frequently due to its low elevation.

Figure 9. Relative mean percent cover of emergent vegetation by transect in October 2007 showing the number of species per category and the total number of species found.

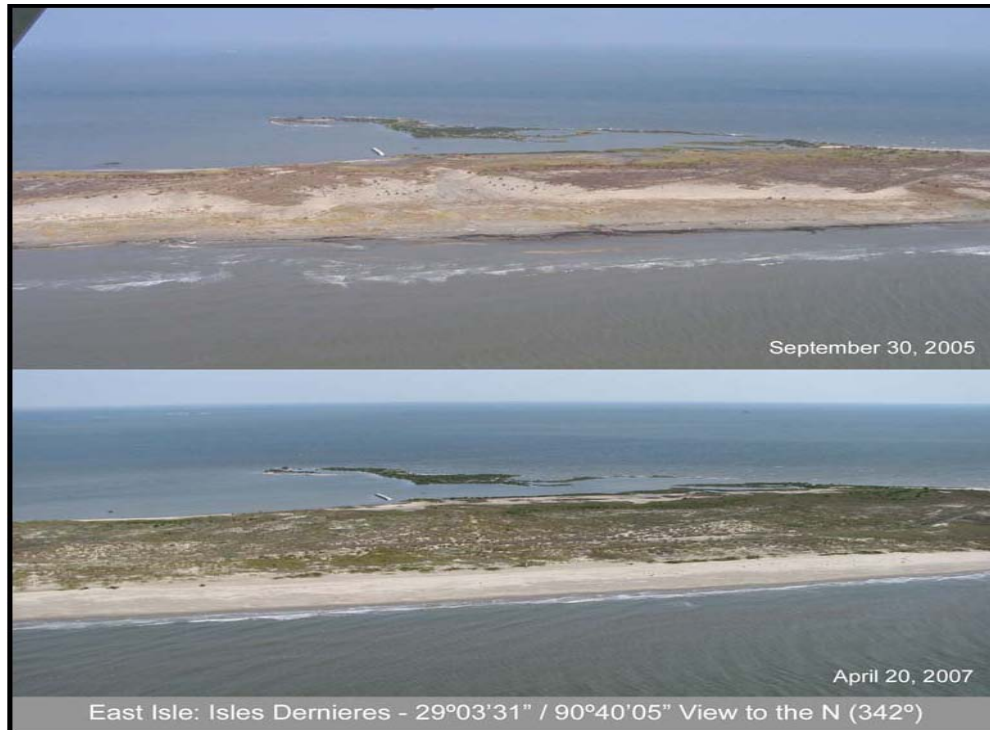
BICM oblique aerial photos of East Island Dock in 2005 (post-Katrina and Rita) and 2007. (Photos courtesy of UNO/PIES)

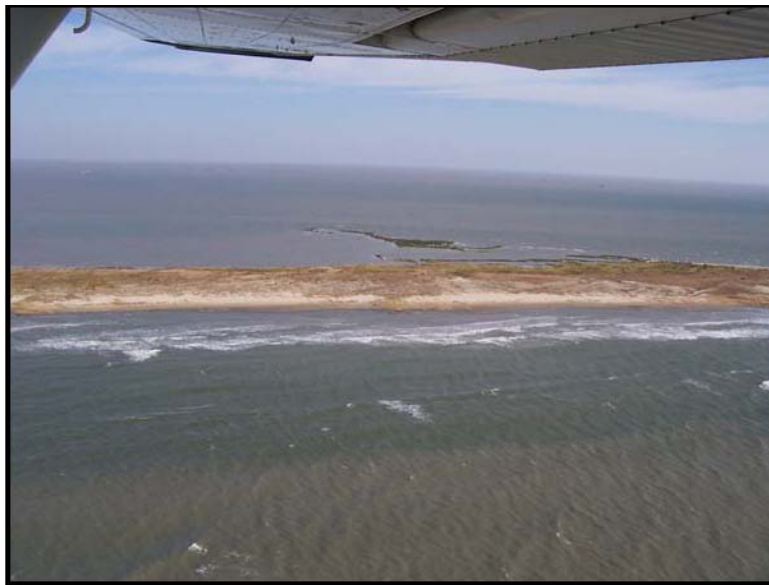
OCPR oblique aerial photos of east Island Dock on September 24, 2008 (post-Ike).

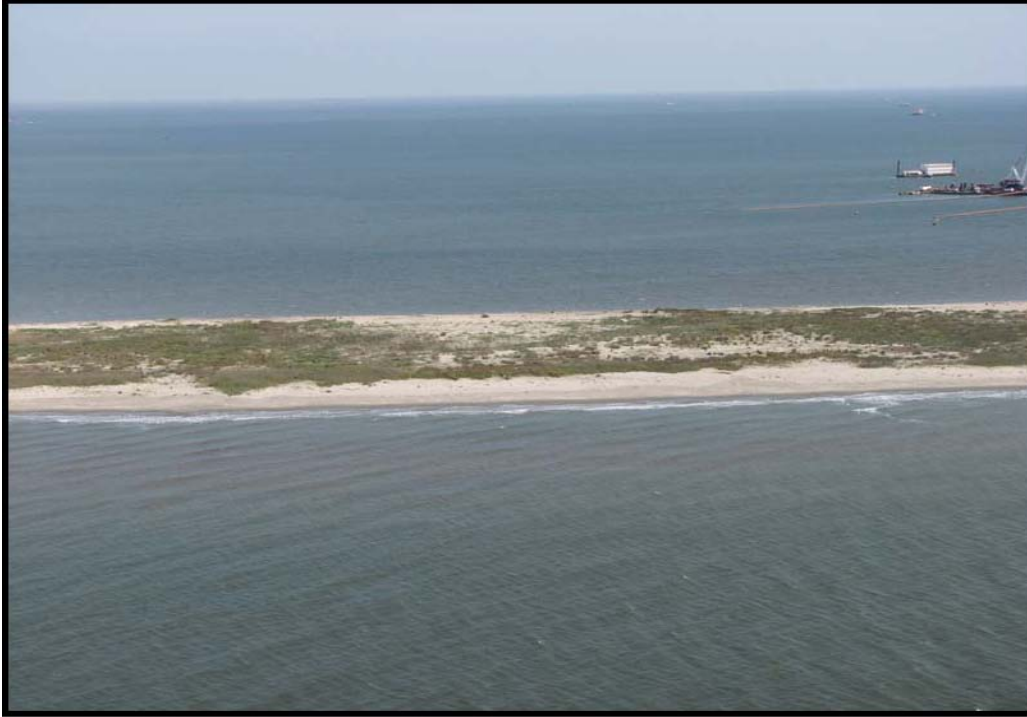
BICM oblique aerial photos of East Island near station 79+00 in 2007 (post-Katrina and Rita) and 2007. (Photos courtesy of UNO/PIES)

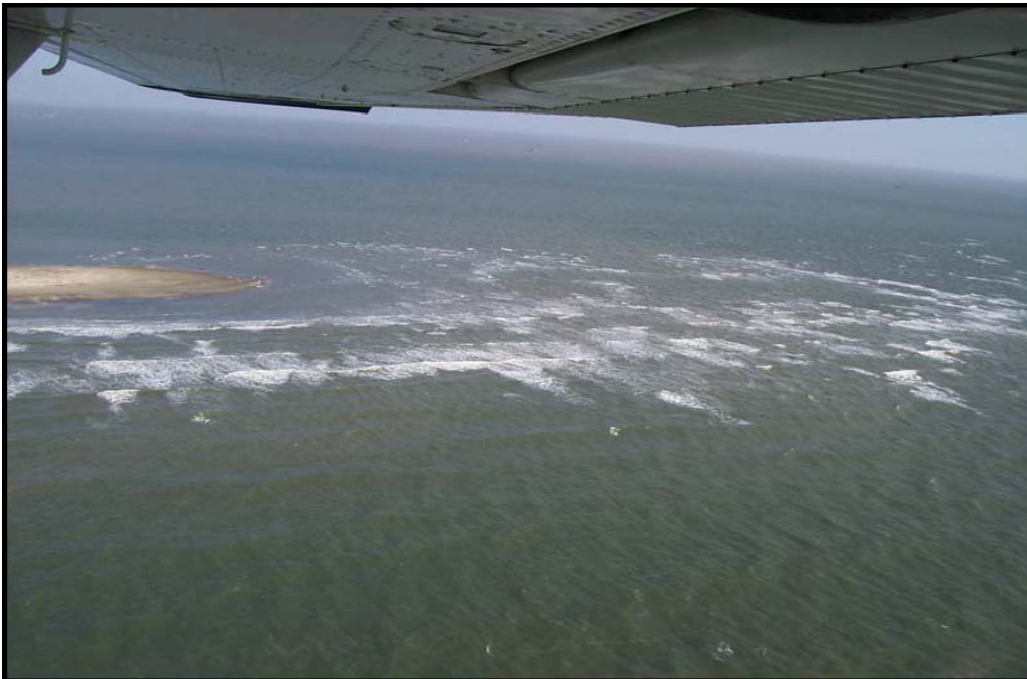
OCPR oblique aerial photos of East Island near station 79+00 on September 24, 2008 (post-Ike).

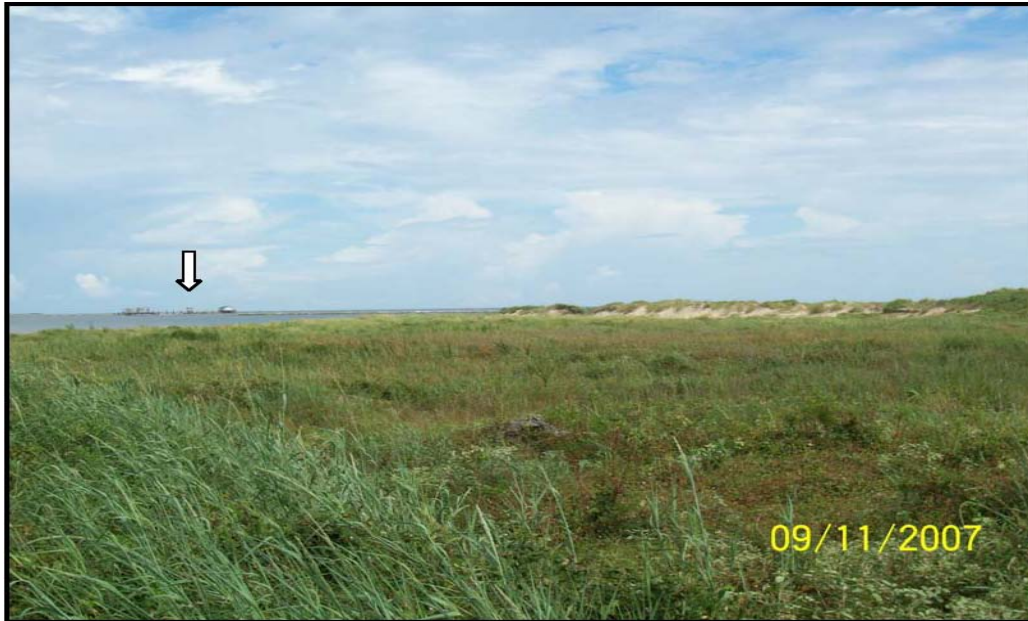
Photo from bay shoreline along East Island looking east at Sta. 79+00. (The back of dune on the east end of island can be seen in the photo).

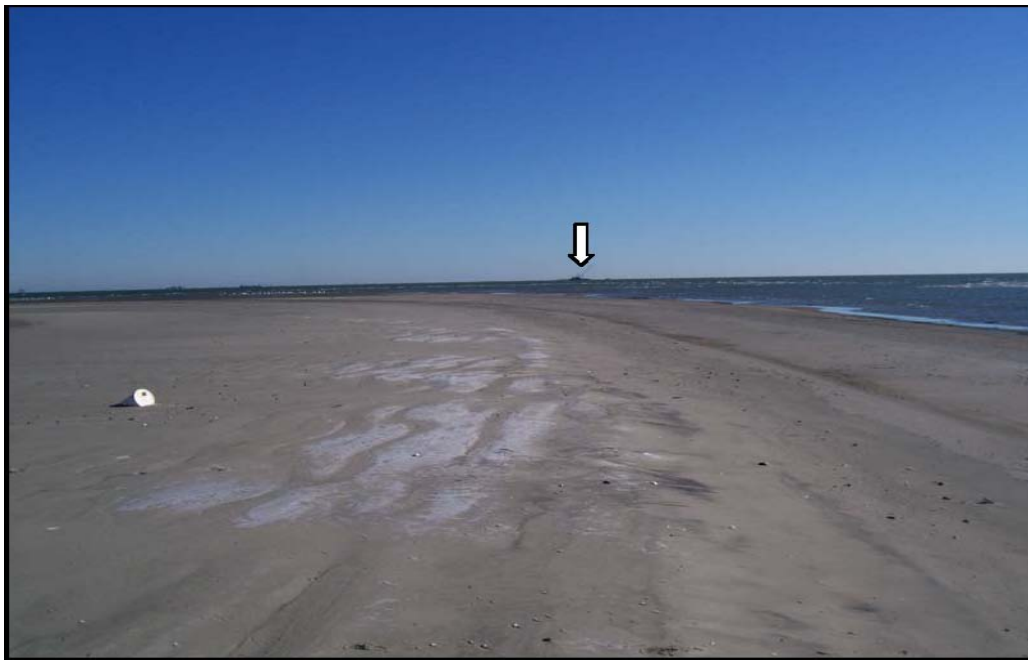
OCPR photos of East Island near station 79+00 looking east on September 24, 2008 (post-Ike).

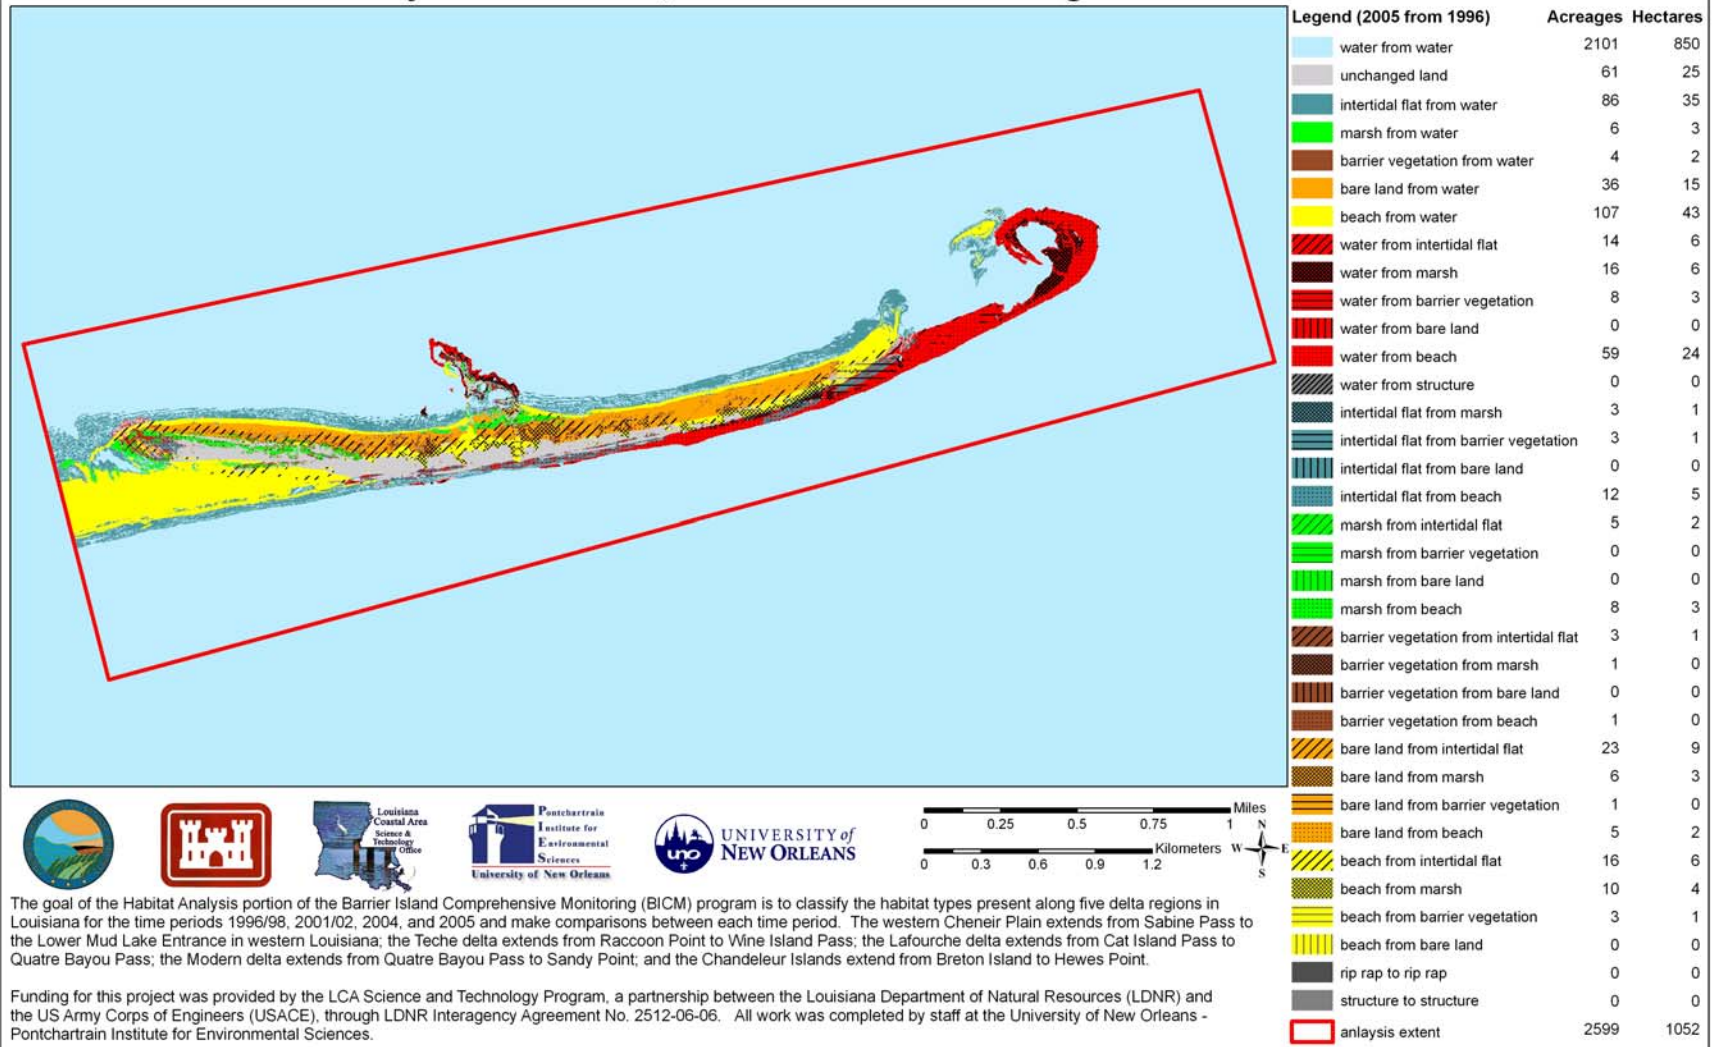
BICM Habitat Analysis: East Island, Teche delta Habitat Change Classification - 2005 from 1996

Figures illustrating the habitat change classification for 1996 to 2002, 2002 to 2004, 2004 to 2005, and 1996 to 2005 are presented in Appendix E. Data from those figures are presented in table 6 for all time periods. The most dramatic transformation in the project area between the 2004 and 2005 periods is the region that was classified as beach in 2004, near the eastern tip of the island, that has been mostly converted to open water as a result of the 2005 hurricanes. Habitat mapping has not been conducted on any photography after 2005; consequently; there are not supporting data sets for the impacts of the 2008 hurricanes.
