**2008 Operations, Maintenance,
and Monitoring Report**

**Isles Dernieres Restoration, Phase 0,
Trinity Island**

State Project Number TE-24
Priority Project List 3

December 2008
Terrebonne Parish

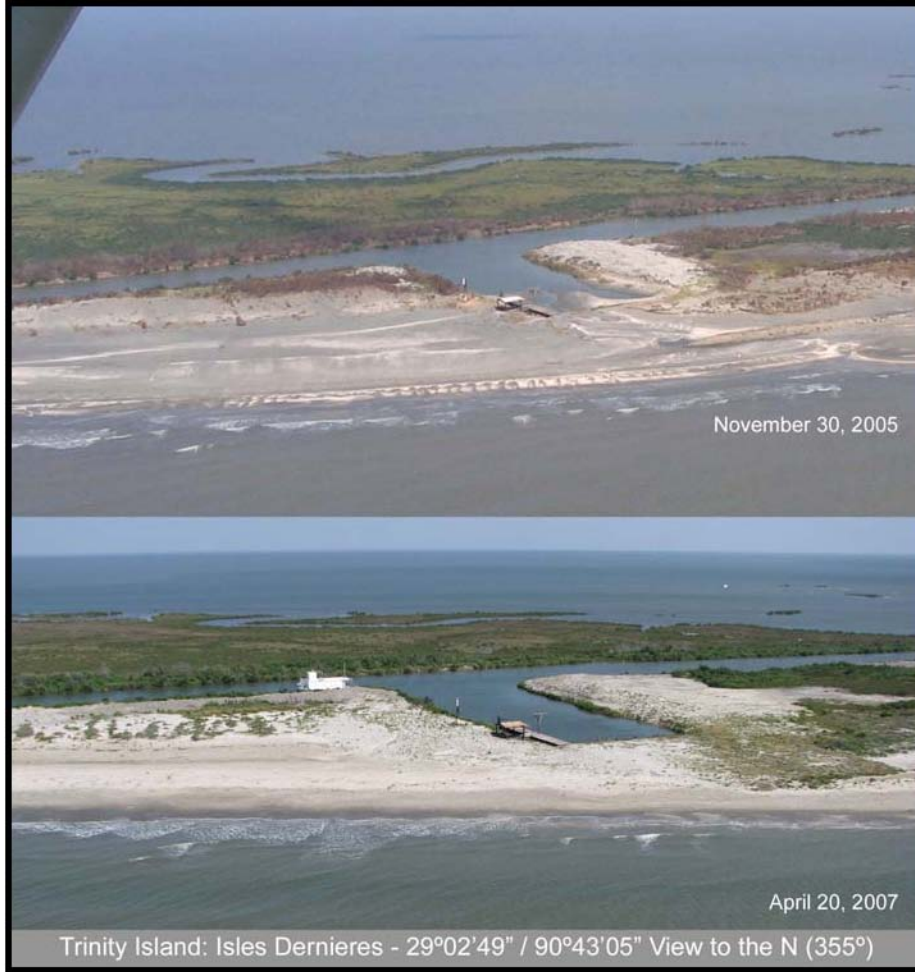
BICM oblique aerial photos of California Canal Dock in 2005 (post-Katrina and Rita) and 2007. Note that landowner placed some material from canal back onto beach. (Photos courtesy of UNO/PIES)

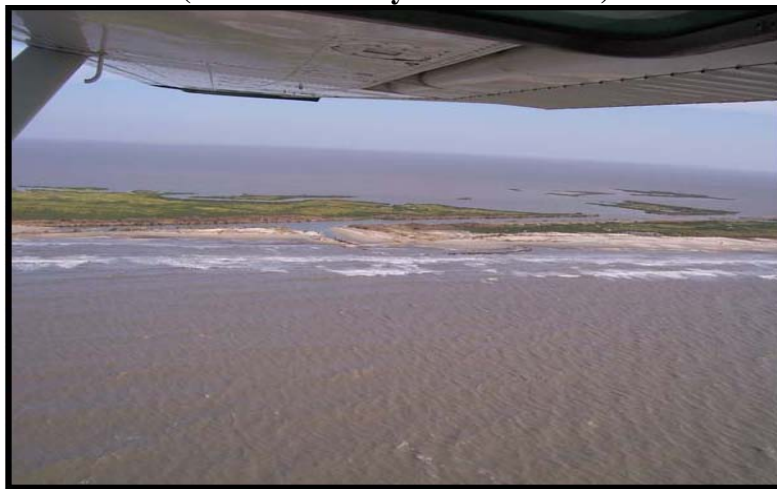
OCPR oblique aerial photos of California Canal Dock on September 24, 2008 (post-Ike).

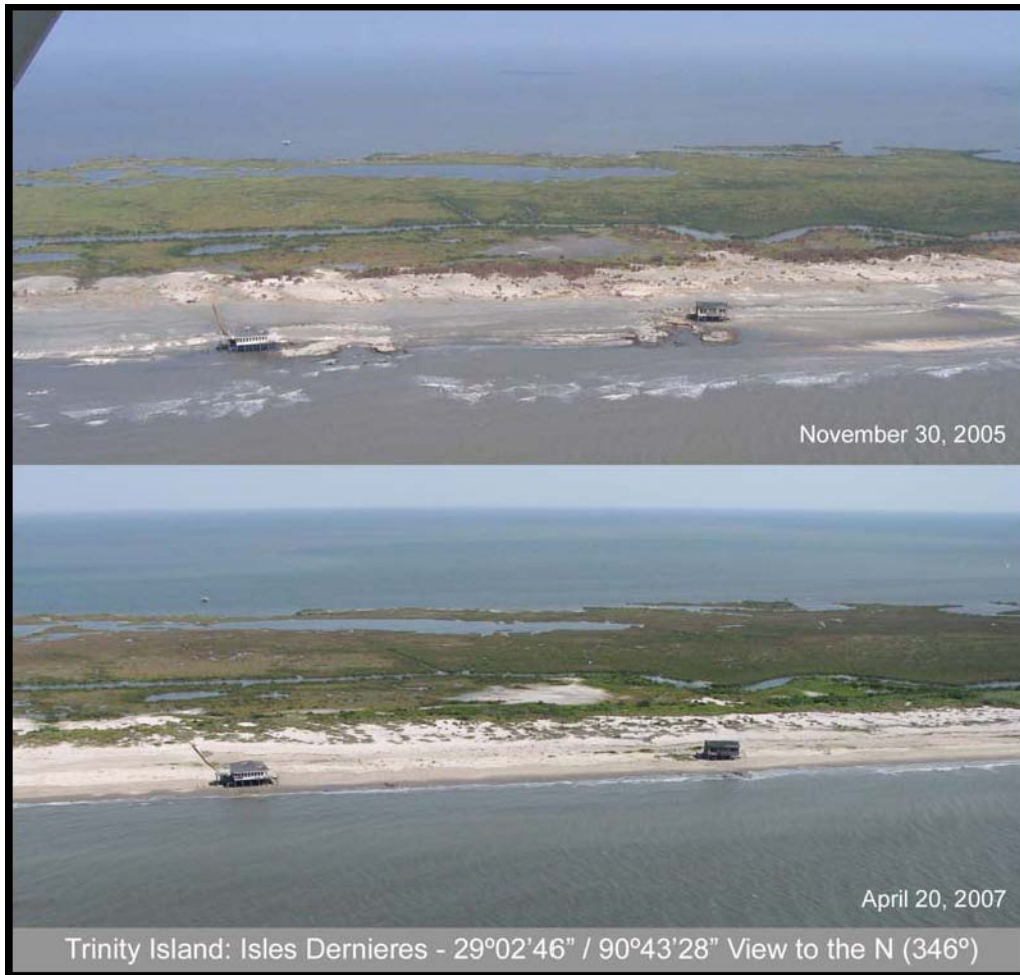
BICM oblique aerial photos of Trinity Bayou camps in 2005 (post-Katrina and Rita) and 2007. (Photos courtesy of UNO/PIES)

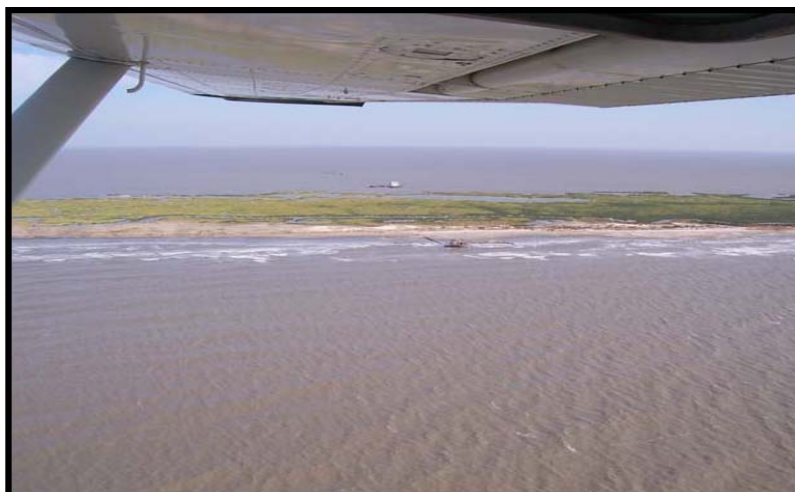
OCPR oblique aerial photos of trinity Bayou camps on September 24, 2008 (post-Ike).

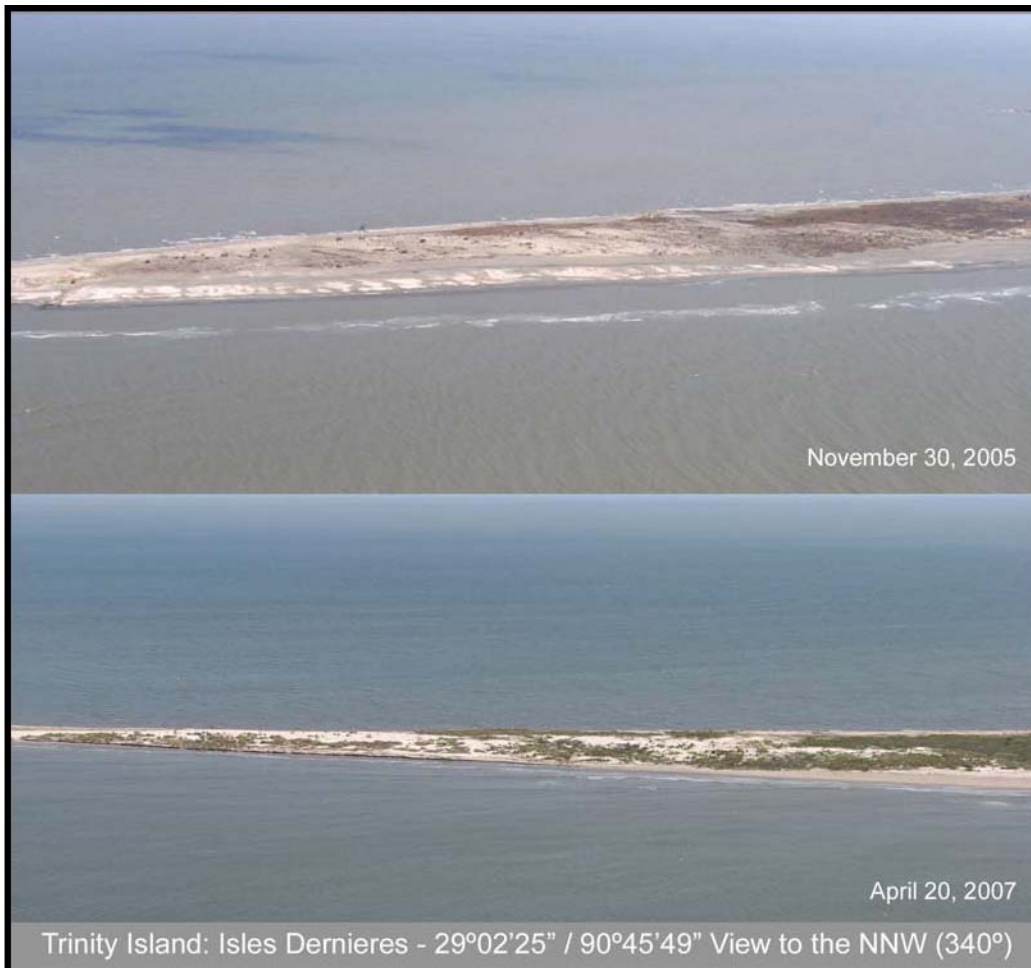
BICM oblique aerial photos of western end of Trinity Island in 2005 (post-Katrina and Rita) and 2007. (Photos courtesy of UNO/PIES)

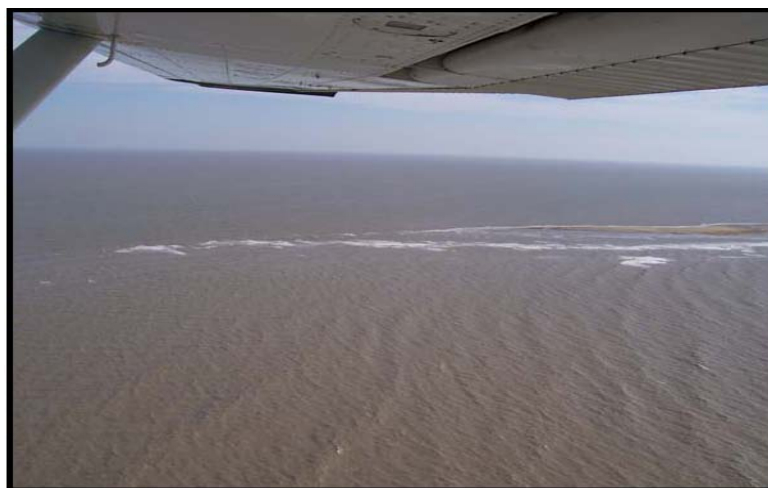
OCPR oblique aerial photos of western end of Trinity Island on September 24, 2008 (post-Ike).
