**State of Louisiana
Department of Natural Resources
Coastal Restoration Division and
Coastal Engineering Division**

**2004 Operations, Maintenance,
and Monitoring Report**

**Holly Beach Sand Management
Project**

State Project Number CS-31
Priority Project List 11

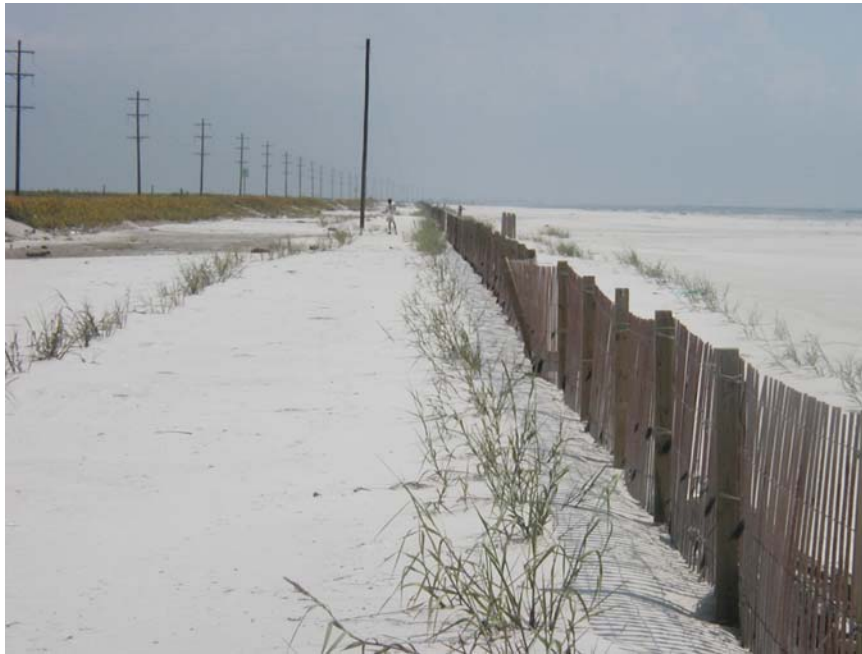
Figure 6a. View of the sand fencing and Vegetation Plantings at Station CS31-110 taken in October 2003. Note the dune formation already developing adjacent to the fences. The photograph is facing east.

Construction of 18,797 linear ft of sand fencing was completed March 26, 2003. Installation of plantings of *Panicum amarum* was completed on August 7, 2003. The first survey of 115 plots was completed in October 2003 (figure 6). At 2 months postplanting, mean percent survival was 82.5% and mean percent cover was 13.1% (figure 7).

Percent survival of the *Panicum amarum* plantings was high at 82% after 2 months, despite two storm events. Percent cover was typically low at 13%, after planting. Because the plants appear vigorous and healthy, an increase in cover is expected this year. A dune has formed behind the sand fencing already and has begun to cover some of the plantings.

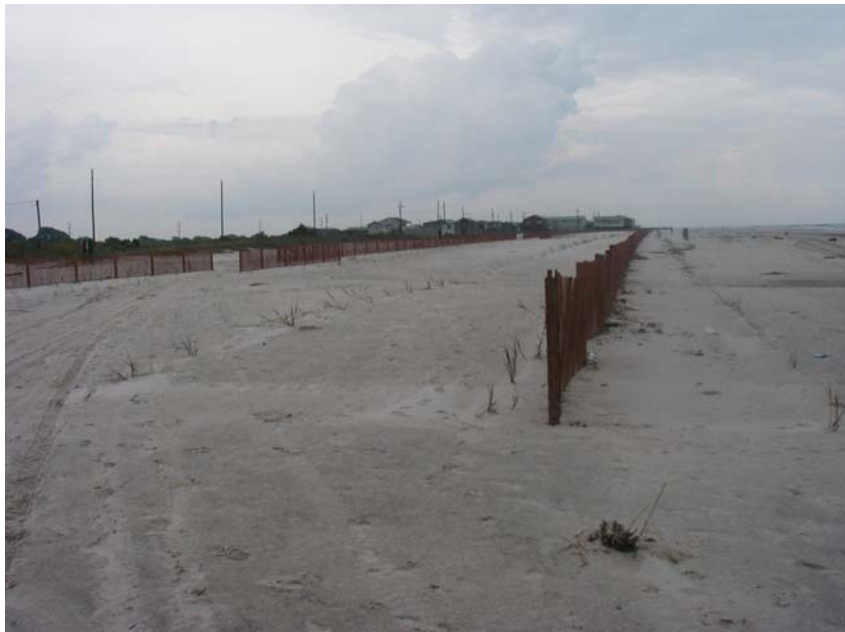
Figure 6b. View of the Sand Fencing and Vegetation Plantings at Station CS31-208 taken in October 2003. Note the double rows of fencing constructed here near the end of the project. The photograph is facing east.

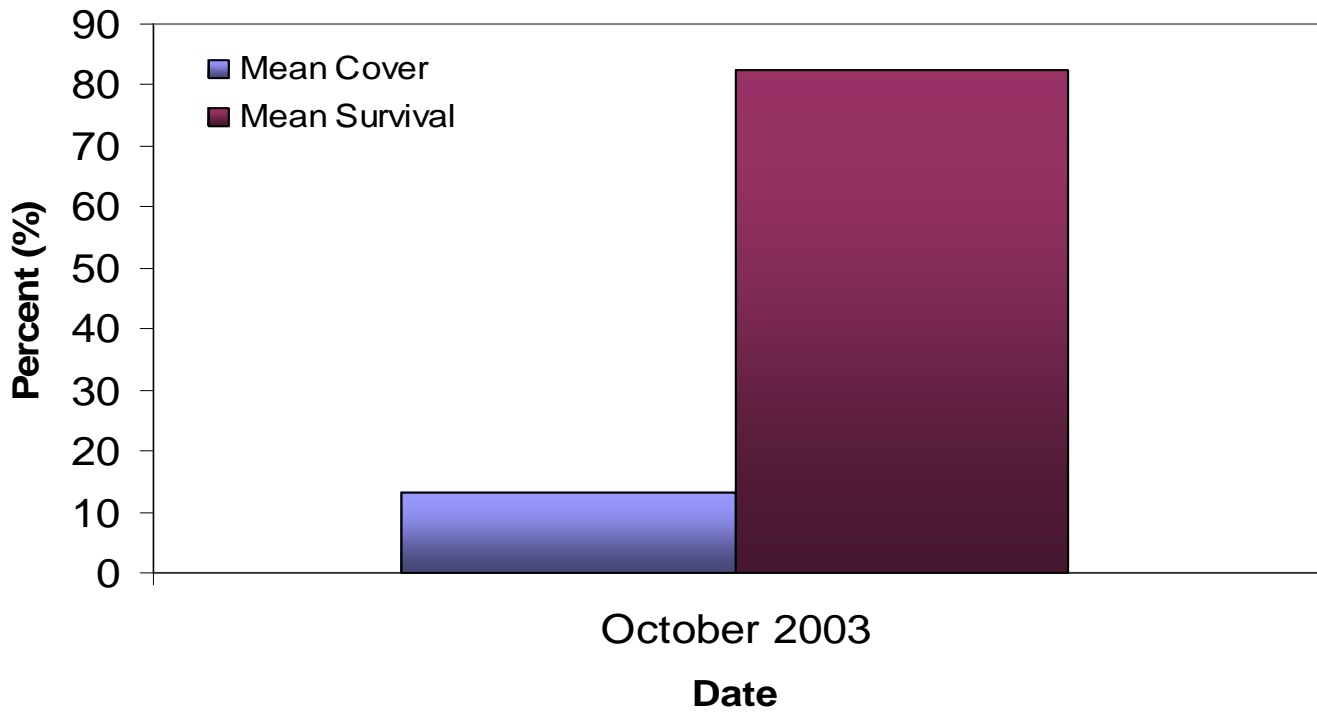
Figure 7. Mean percent cover and survival of the *Panicum amarum* plantings on the October 2003 survey.

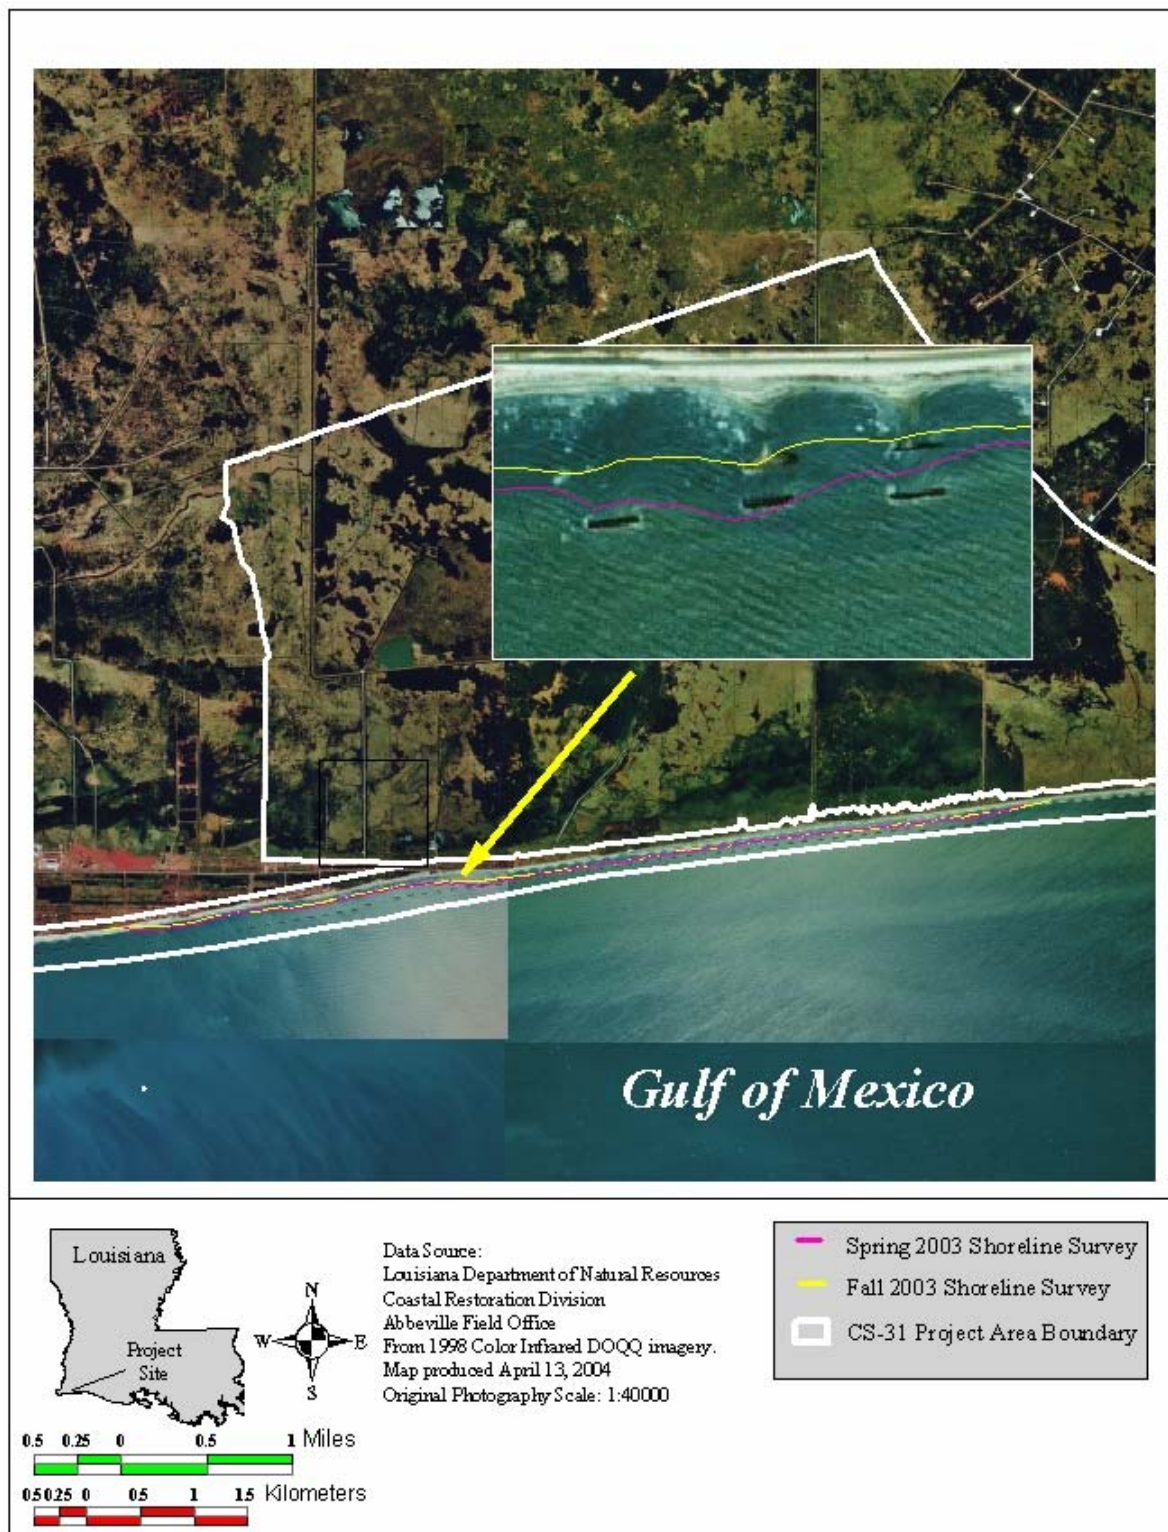
Figure 8. Location of spring and fall 2003 shoreline surveys at Holly Beach Sand Management (CS-31) project.

Data were collected in March (immediately following construction) and October 2003. The data show a loss of approximately 21.6 acres between the surveys. Most of the loss occurred near the western end of the project (Figure 8). It was expected that the shoreline would degrade rapidly after construction due to the overfill of sand by the contractors. Future surveys should more accurately reflect the change along the shoreline.

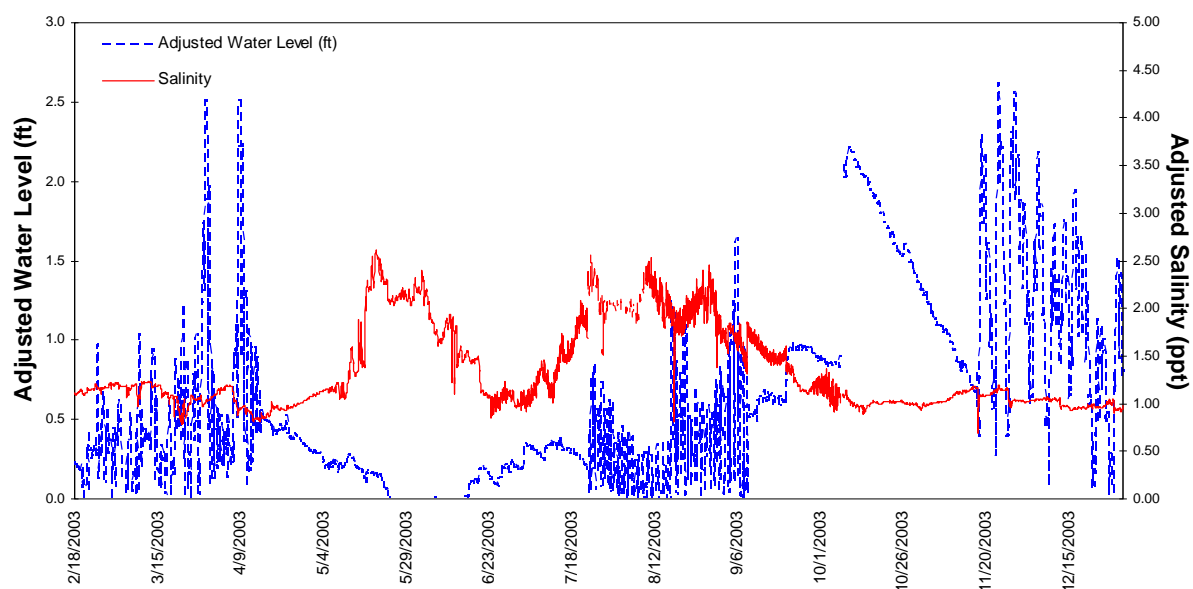
Station CS31-02 (2/18/03 – 12/31/03)

Figure 11a. Hourly salinity and water level at Station CS31-02 in the Holly Beach Sand Management (CS-31) project area during 2003. All water levels are relative. This station has not been surveyed to NAVD88 at this time.

It was reported by local residents that wave over-wash occurred at least twice in 2003 when Category 1 Hurricane Claudette (7/15/03) and Tropical Storm Grace (8/31/03) hit Texas. It is not certain exactly where the road was overwashed or for how long. The project recorders did not indicate salinity spikes during these two events. The rise in salinity at CS31-01 during the summer months mimics the pattern seen at Station CS23-01R and appears to be the result of a drop in water levels during August. Salinity levels did not rise above 4 ppt for the entire year at Station CS31-01 which is located near Highway 82. Therefore, the goal to maintain salinity within the intermediate to brackish target range of 3-12 ppt was met. The variability detected in other project stations is not evident in Station CS31-03 since it is located in a borrow ditch and is not hydrologically connected to any other water source. Further, the water level sensor at this station is out of the water during periods of low water. Figure 13 shows the 2003 hourly salinity and water level for Station CS23-01R in the Sabine Structure Replacement (CS-23) reference area, reflecting conditions in Calcasieu Lake.

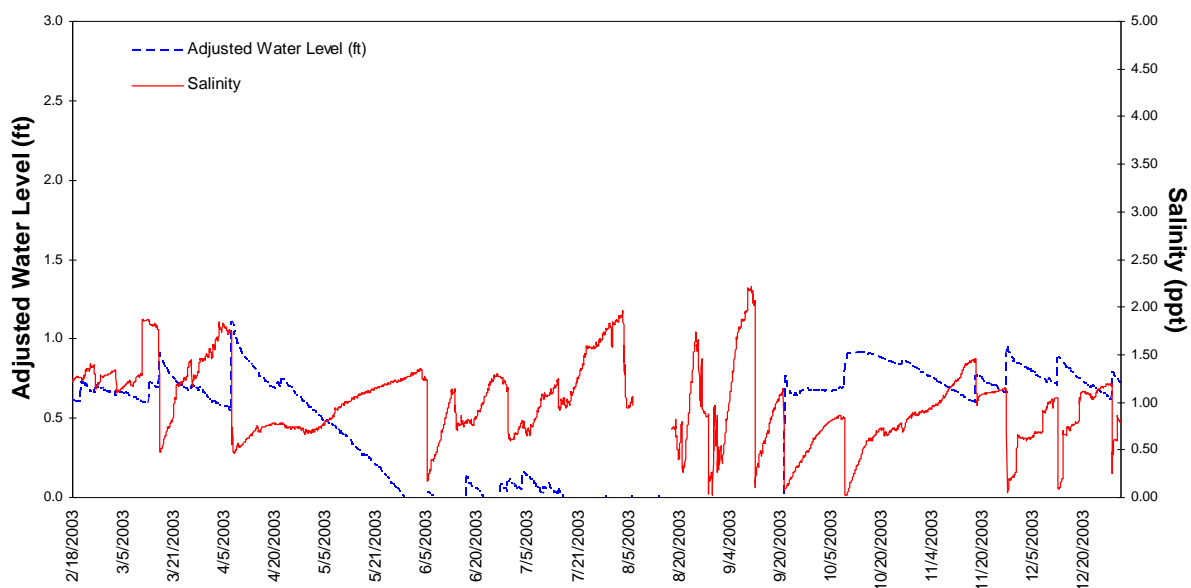
Station CS31-03 (2/18/03 – 12/31/03)

Figure 12a. Hourly salinity and water level at Station CS31-03 in the Holly Beach Sand Management (CS-31) project area during 2003. All water levels are relative. This station has not been surveyed to NAVD88 at this time.

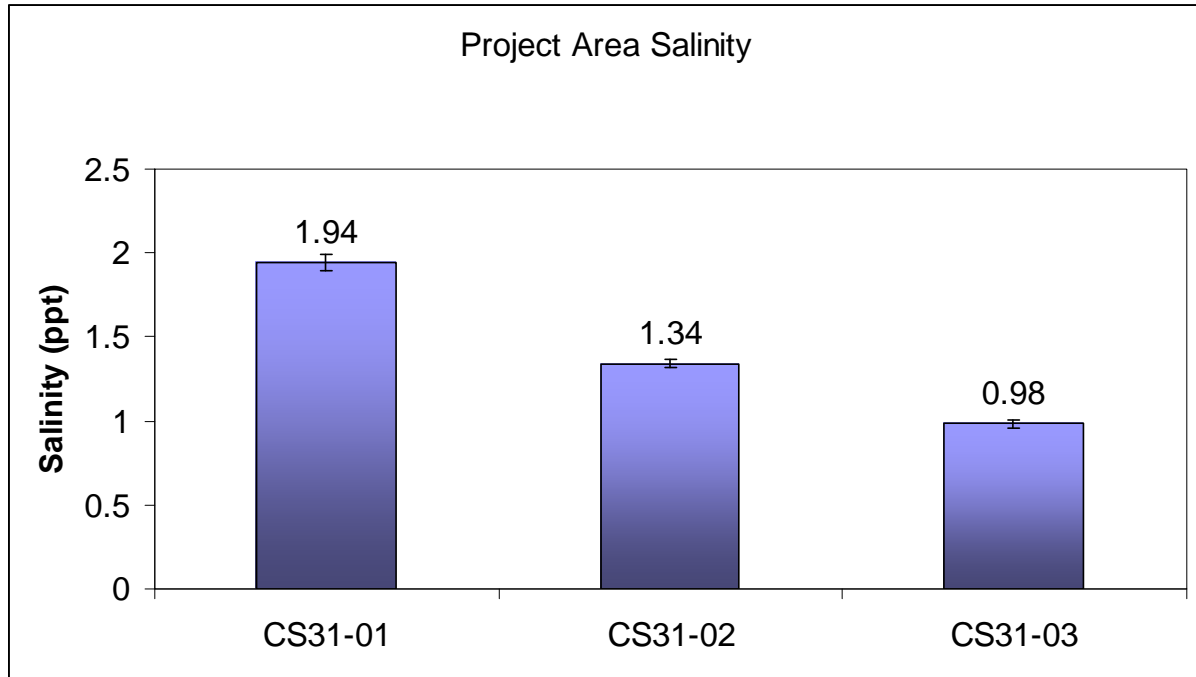
Figure 14. Yearly means derived from daily means of salinity (ppt) at 3 continuous recorders located in the Holly Beach Sand Management (CS-31) project area from period 1/1/03 – 12/31/03 for station CS31-01 and 2/18/03 – 12/31/03 for stations CS31-02 and CS31-03.

At least two tidal overwash events occurred during the year due to storms, however, data indicated that salinity spikes did not occur due to these events. Salinity levels were maintained within the intermediate to brackish target range and were below 4 ppt for the entire year at all project stations, while the reference station, which is directly linked hydrologically to the Calcasieu Ship Channel, experienced salinity levels of 15-25 ppt throughout much of the year. This indicates that the project area may not be influenced by salinity fluctuations in the CSC.

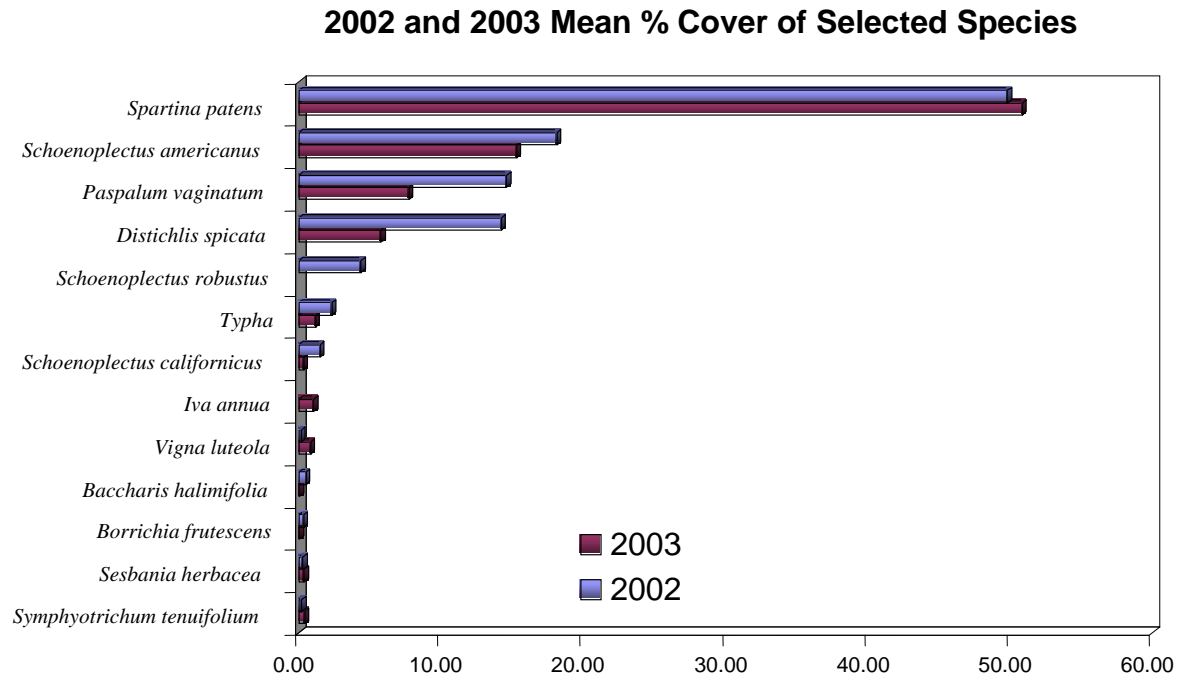
Figure 15. Mean % cover of selected species across all 4 m² plots within the CS-31 project area during October 2002 and 2003. Vegetation was sampled using the Braun Blanquet method.

Data were collected in October 2002 and 2003 (table 1 & figure 15). A T-test comparing total cover in the year pre and post-construction showed that cover in 2003 was significantly lower than in 2002 ($p=0.0190$). However, though the data were statistically significant, they do not appear to be ecologically significant. The differences in cover could be related to seasonal changes or to herbivory damage from cattle grazing in the area of many of the vegetation stations. Two-thirds of the plots experiencing decreases in cover occurred at stations where the cattle are allowed access.

Differences in vegetative cover were detected between the pre- and post-construction emergent vegetation surveys. These differences, however, do not appear to be ecologically significant and may be due to seasonal changes or herbivory from cattle grazing in the project area.
