VEGETATIVE DELINEATION REPORT

LABRANCH WETLAND PROJECT (PO-3a)

Delineation Date: July 27, 1992
Report Completion Date: June 5, 1993

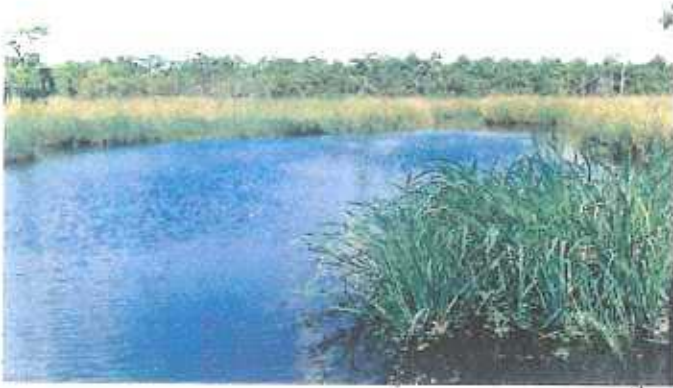
Figure 3

3.	Bayou LaBranche is the major waterway on the east bank of St. Charles Parish. Freshwater marsh adjoins the back side of the natural bayou terrace. Station 1. Photo direction to the west	26

Station 1 is along the edge of open water areas south of the Fall Canal on the east bank of Bayou LaBranche. This area is on the back side of the bayou's natural levee system and provides suitable sites for early seed germination of annual plants. Wild millet made up 95% of the stand and a combination of sprangletop, seashore paspalum (*Paspalum vaginatum*), and cutgrass made up the remaining 5%. Marsh salinity south of the railroad during the field investigation was 1 part per thousand (ppt) or less for the entire area (figures 3 and 4).

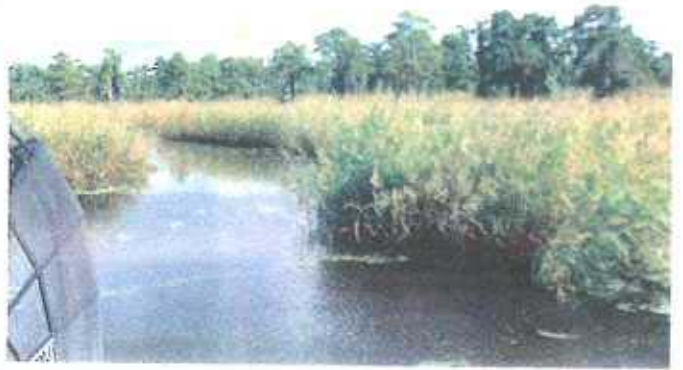
Figure 4

4.	Wild millet is an excellent seed producer and a major food source for migratory waterfowl. Station 1. Photo direction to the northwest	26
5.	The bald cypress timber standing along the bayou's east bank has been impacted by saltwater intrusion from the marsh side. Dead cypress trees in the marsh interior are common. Station 2. Photo direction to the southwest	26

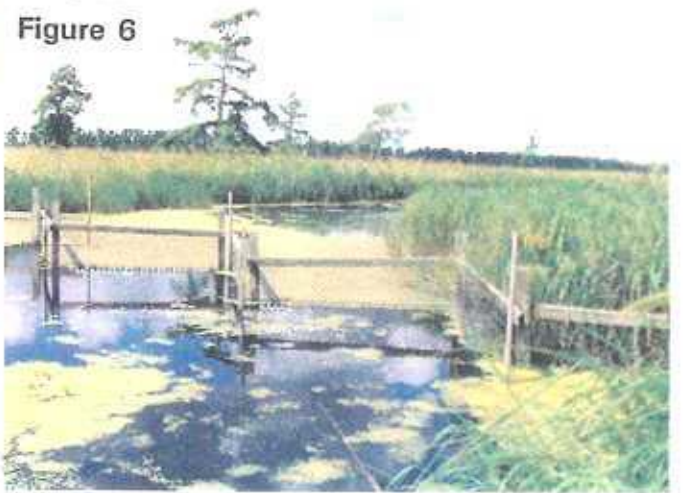
Figure 6

6.	Attempts have been made to reduce land loss in the area by installing drift fences of various designs. Station 3. Photo direction to the west	26
7.	Annual seed producing plants can be established in areas where water level control is possible. Station 3. Photo direction to the east	26

Station 3 is located where a zig-zag drift fence has been installed to trap marsh soil particles. Plants in this area are wild millet (70%), bulltongue (20%), and sprangletop (10%). Duckweed was common in the open water area at this site (figures 6 and 7).

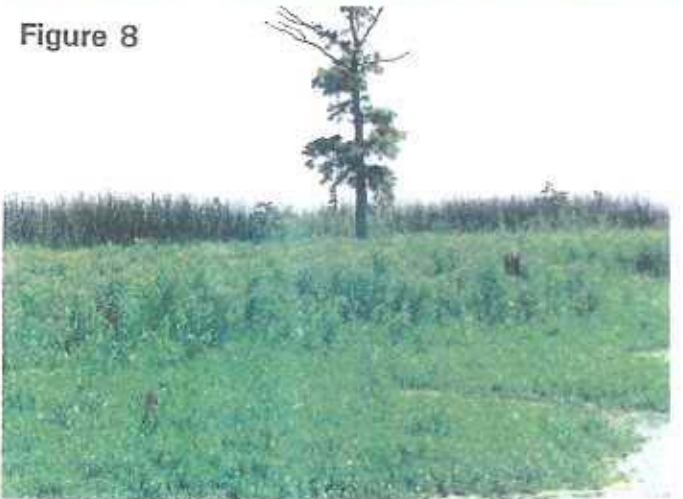
Figure 8

8.	Several large patches of bullwhip have survived the saltwater intrusion in the area between the railroad and Highway 61. Station 4. Photo direction to the northeast	26

Station 4 is south of Bayou Traverse in a stand of 90% bullwhip and 10% millet, waterhyssop, alligatorweed, deerpea, and camphorweed (*Pluchea camphorata*). Single cypress trees are common in this section (figure 8).

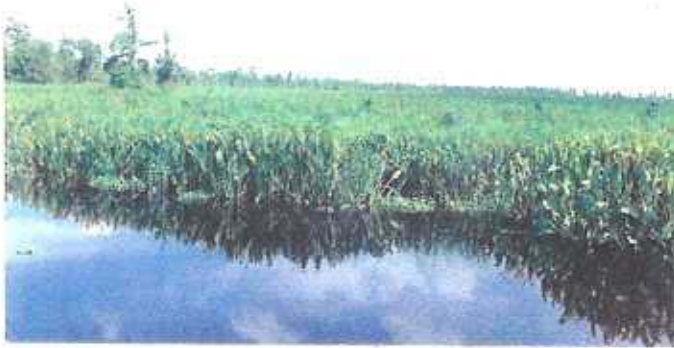
Figure 9

9.	Bulltongue is the dominate marsh plant species in the area between the railroad and Highway 61. Station 5. Photo direction to the northwest	27
10.	Small ponds within the bulltongue stand provides good habitat diversity for waterfowl, nutria, and alligators. Station 5. Photo direction to the south	27
	The La Branche wetland has an excellent stand of young bald cypress along the edge of the freshwater marsh. Station 6. Photo direction to the northwest	27

Station 5 is in the interior marsh east of Bayou LaBranche and south of Bayou Traverse. The marsh in this area is 90% bulltongue with many other plants such as sedge, millet, deerpea, belle dame, smartweed, alligatorweed, water hyacinth, and coffeeweed (*Sesbania exaltata*) making up the remaining 10% (figures 9 and 10).

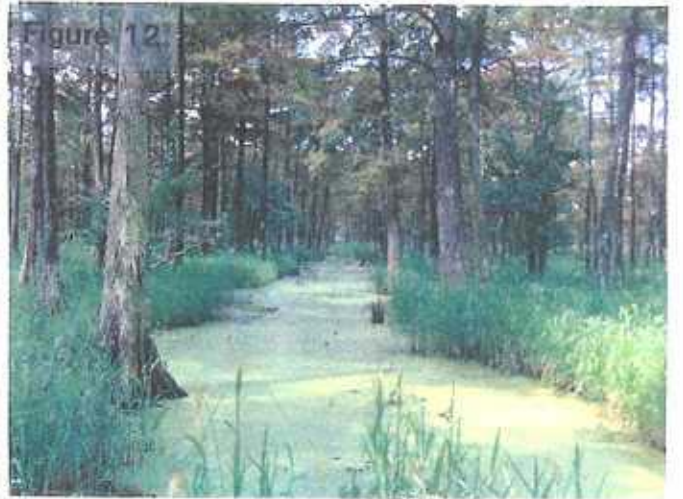
12.	At station 6, the cypress stand is in good condition and the understory plants provide good habitat for wood duck broods. Photo direction to the southwest	27

Station 6 is in a ditch approximately 1000 ft west of the Monteleone ditch. This site is on the fringe of the cypress swamp and freshwater marsh and is approximately 1 mi north of Highway 61. The swamp is composed of cypress (95%) and red maple and tupelo (5%). Understory is wild millet (95%) with smartweed, coffeeweed, marshmallow, rosemallow, alligatorweed, duckweed, coontail, and water hyacinth making up the remainder of the plant community. This is a very healthy freshwater marsh complex and is sheltered from saltwater except during extreme cases like hurricanes. This is a superb alligator and nutria producing area and provides excellent year-round habitat for wood ducks and winter habitat for migratory waterfowl (figures 11 and 12).

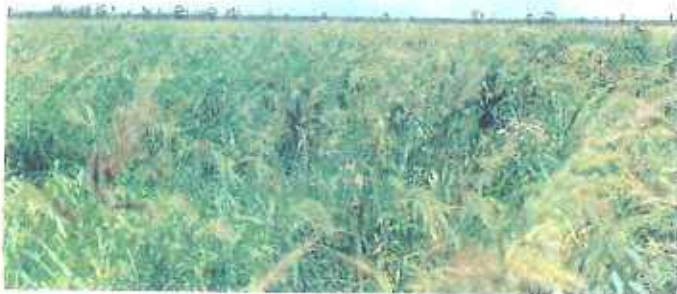
Figure 13

13.	The bulltongue stand is overshadowed by a healthy growth of wildlife millet in this intermediate marsh complex. Station 7. Photo direction to the west	27
	Wild millet and deerpea grow on elevated sites within the bulltongue stand. Station 7. Photo direction to the east	27

Station 7 is in a hunting access ditch about 1 mi east of Mr. Monteleone's camp. The marsh is 80% bulltongue with a dense stand of wild millet, deerpea, smartweed, rosemallow, belle dame, sedge, and camphorweed making up the remaining 20%. The ditch and pond water is covered with a dense stand of duckweed. This is also an excellent wildlife producing marsh area. This section is subject to occasional high tides from the lake. Flow into and out of the area is through the Walker Canal and the 16 Mile Trestle on the railroad. Large, open water

areas are located east and north of here. With proper water level management, this section could be revegetated and improved as wildlife habitat (figures 13 and 14).

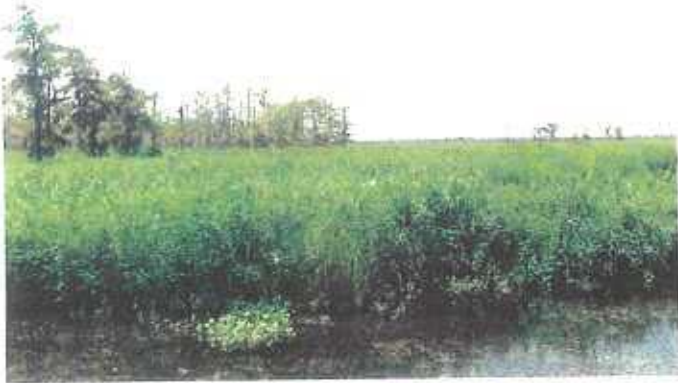
Figure 15

15.	At station 8 near the Walker Canal, impacts by saltwater intrusion into the bald cypress stand can be observed. An active bald eagle nest is located near this station. Photo direction to the south	28

Station 8 is at the Walker Canal south of the trestle. The marsh in this area is bulltongue (60%), marshhay cordgrass (20%), and wild millet (20%) along with sprangletop, smartweed, sensitive jointvetch, swamp loosestrife, and fourchette. The portion of the Walker Canal not covered with water hyacinth is producing good stands of southern naias and coontail. This area is showing signs of extensive saltwater intrusion with stressed cypress trees and expanding stands of marshhay cordgrass. An active southern bald eagle nest is located approximately $\frac{3}{4}$ mi south of the Walker Canal trestle and has consistently produced young birds for the past several years (figures 15, 16, and 17).

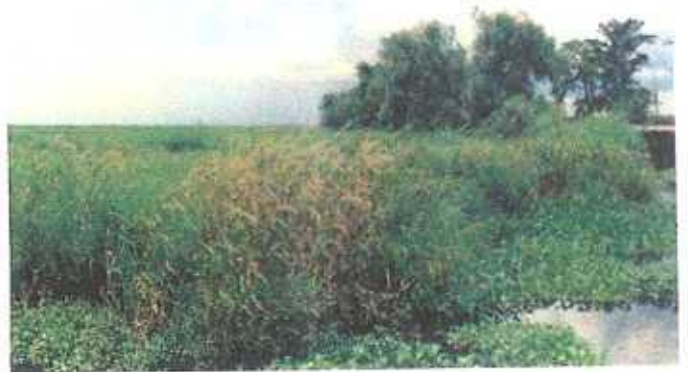
Figure 16

16.	A combination of brackish, intermediate, and fresh marsh plants grow in the area near the Walker Canal trestle. Station 8. Photo direction to the northwest	28
	An invasion of marshhay cordgrass is taking place in the cypress timber stand along the Walker Canal south of the railroad. Station 8. Photo direction to the southeast	28
	Marshhay cordgrass has become well established south of the railroad at the 16 Mile Trestle. Station 9. Photo direction to the northwest	28

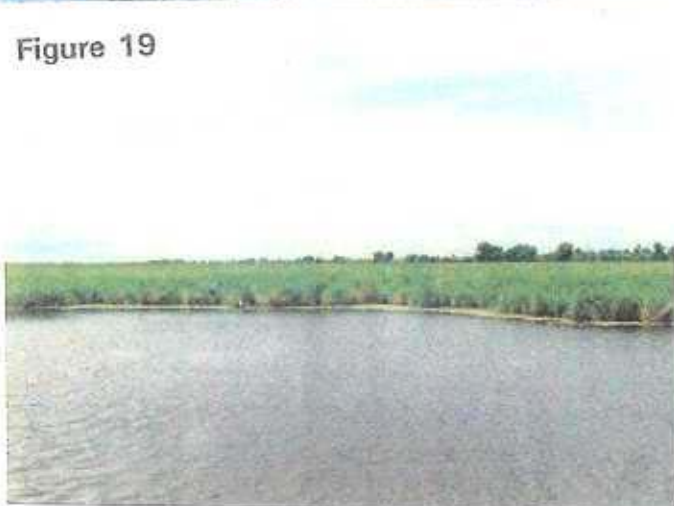
Figure 19

19.	Marshhay cordgrass is the dominant vegetation at station 10 which is south of the railroad and drained by the United Gas Pipeline. Photo direction to the northwest	28

Station 10 is west of the United Gas Pipeline near the railroad. This marsh is also showing saltwater influence with marshhay cordgrass making up 90% of the stand. Bulltongue is 10% with wild millet, sprangletop, and smartweed mixed in. There is a healthy stand of bullwhip (90%) near this station that glossy ibis use as a nesting site. The understory in the bullwhip stand is made up of deerpea, morningglory, and duckweed. This station is near the Tie Ditch Trestle and the water salinity was 1.0 ppt (figures 19 and 20).

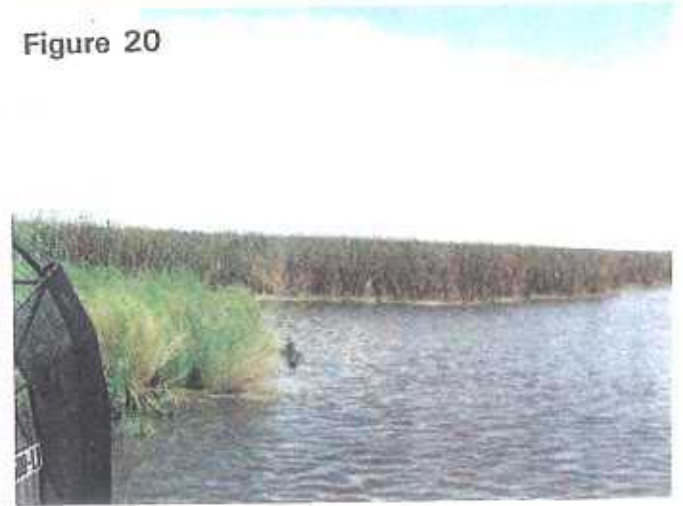
Figure 20

20.	A stand of bullwhip adjacent to station 10 provides ideal nesting areas for wading birds. Photo direction to the southeast	28
	At station 11, wild millet is mixed with cattail, bulltongue, and cypress trees. Photo direction to the northwest	29

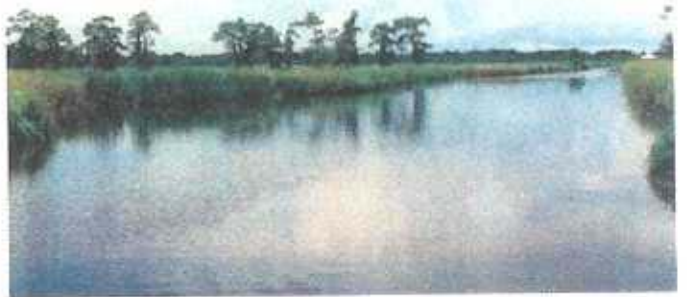
Figure 22

22.	Saltwater intrusion has been minimal in the marsh at station 11; however, the large hunting access ditch in the area presents a danger unless water levels are controlled at the railroad structures. Photo direction to the northwest	29

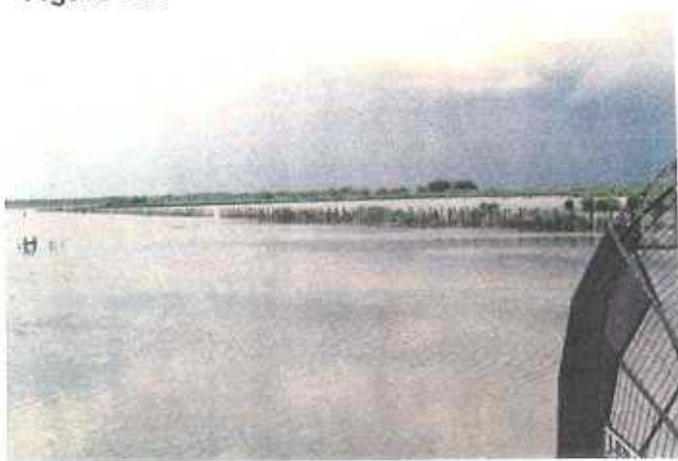
Figure 23

23.	Large open water areas exist north of the railroad near the Lake shore. Some of these sites are the results of former farming efforts in the area. Drift fences have been constructed in an attempt to trap soil particles. Station 12. Photo direction to the west	29

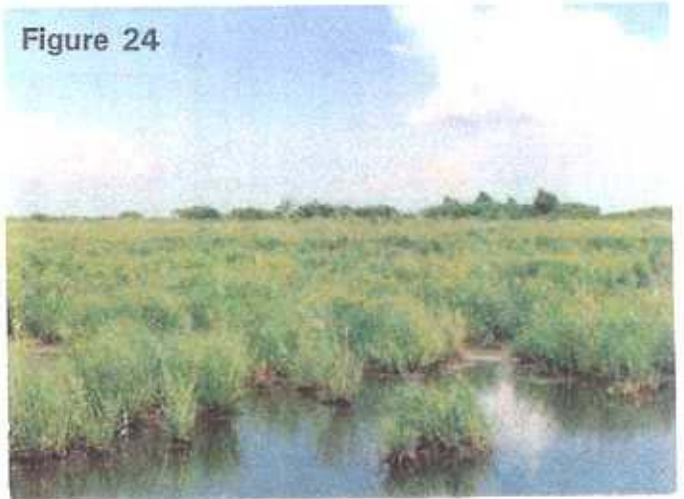
Figure 24

24.	Smooth cordgrass has become established in the mineral soil along the lake shore as a product of planting efforts by the Soil Conservation Service Station 12. Photo direction to the northeast	29

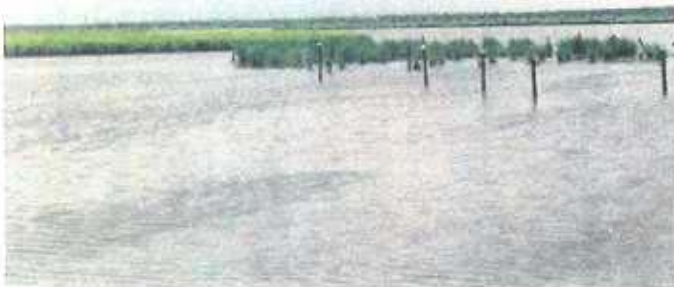
Figure 25

25.	Several research studies have been conducted in this area to evaluate impacts of nutria on plants and to determine planting success. Station 12. Photo direction to the southwest	29

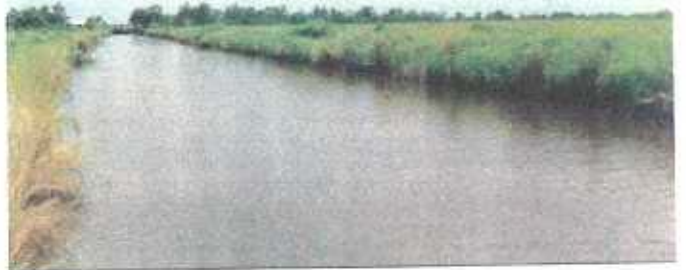
Figure 26

26.	Brackish marsh plant communities are well established at station 13. Hydrology in this area has been restored by two fixed crest weirs. Photo direction to the southeast	29
	Brackish marsh areas north of the railroad are in need of a scheduled burning program. Station 14. Photo direction to the south	30

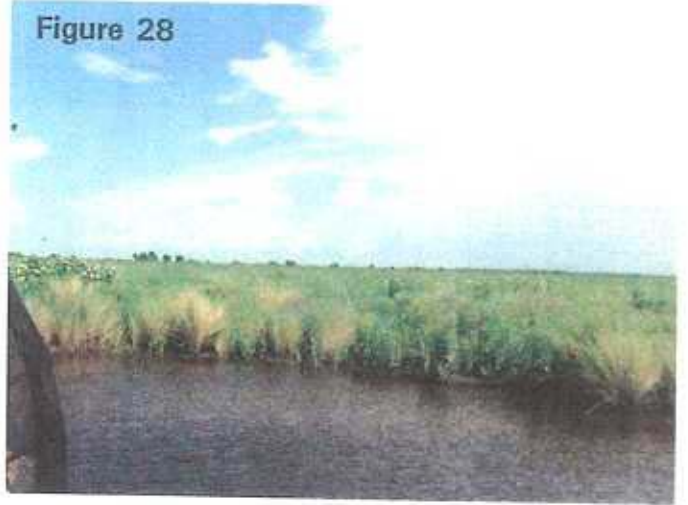
Figure 28

28.	Ponds within the brackish marsh zone support varying amounts of aquatic vegetation. Station 14. Photo direction to the east	30
29.	Annual rainfall in the New Orleans area is approximately 5 ft, which assists with reducing the impact of salt water introduced into the area from Lake Pontchartrain. Station 14. Photo direction to the north	30
	Dead cypress trees are visible in the area between the railroad and the lake shore. Station 15. Photo direction to the south	30

Station 14 is on the east side of the United Gas Pipeline and approximately 2000 ft north of I-10. This is a brackish marsh and marshhay cordgrass made up 90% of the plant community with 5% camphorweed and a combination of deerpea, baccharis, rosemallow, and marshmallow for the remaining 5%. Very little aquatic vegetation was noted in the area ponds (figures 27, 28, and 29).

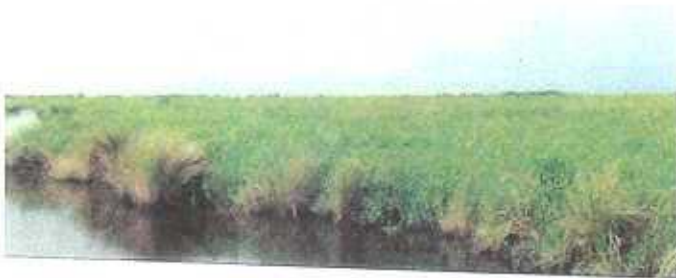
Figure 31

31.	Brackish marsh plants dominate the area at station 15. Photo direction to the northeast	30
32.	The marsh at station 16 is a healthy brackish marsh and provides protection to the interior marsh from Lake Pontchartrain flooding during extreme tide stages. Photo direction to the east	30

Station 15 is in the brackish marsh interior east of Bayou Piquant and approximately half way between I-10 and Lake Pontchartrain. Vegetation was 90% marshhay cordgrass with 5% camphorweed, and a 5% combination of deerpea and baccharis. This marsh appears not to have burned for several seasons and has a large amount of accumulated surface material (figures 30 and 31).

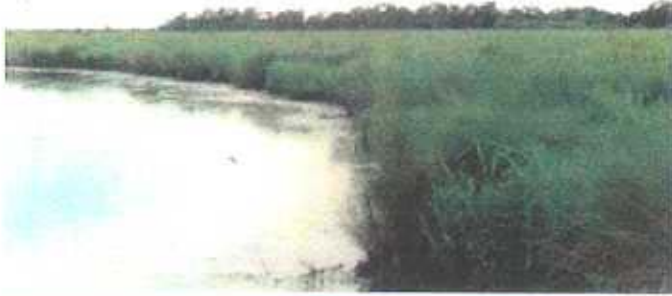
Figure 33

33.	Aquatic vegetation is well established in the marsh ponds near station 16. Photo direction to the southwest	31
	Woody vegetation is growing on the spoil bank of the former mineral access canal near station 16. Photo direction to the north	31
	A large electrical transmission line crosses the study area at station 17. Photo direction to the east	31

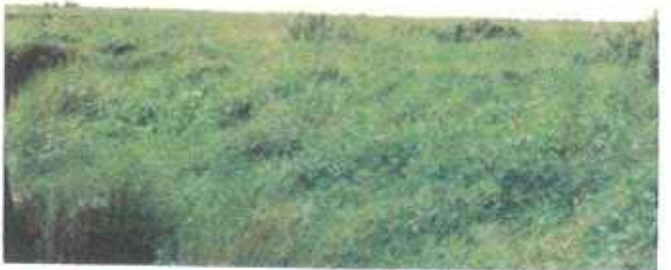
Figure 36

36.	Deerpea and rosemallow grow along the elevated shore of marsh ponds in the area. Station 17. Photo direction to the west	31

Station 17 is along a large pond area approximately 1 mi west of the Duncan Canal adjacent to the area's large power line. Vegetation was marshhay cordgrass (90%) with a 10% combination of camphorweed, deerpea, rosemallow, and marshmallow. One small clump of three-cornered grass (*Scirpus olneyi*) was noted at this station. Good stands of aquatic vegetation (southern naias and coontail) were observed in the ponds. Water salinity in the ponds was 1.5 ppt (figures 35, 36, and 37).

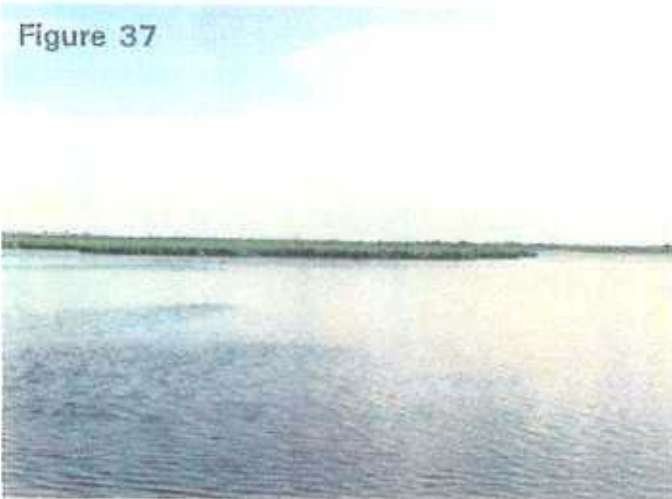
Figure 37

37. Southern naiad and coontail are the aquatic plants observed growing in the marsh ponds in the area around station 17. Photo direction to the south 31

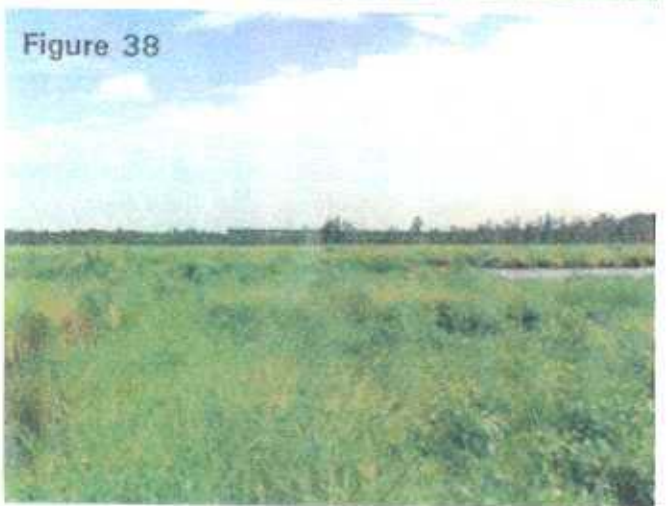
Figure 38

38. The Soil Conservation Service used the marsh at station 18 to establish average marsh elevation for the fixed crest water control structure at the Duncan Canal and the I-10. Photo direction to the southeast 31

southern naias and coontail. This station is near the cypress stand north of the spoil bank created for I-10 construction (figures 38, 39, and 40).

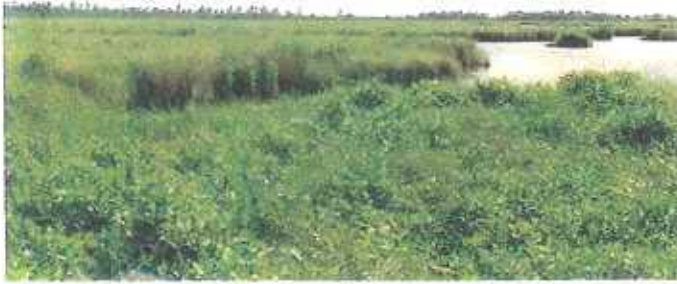
Figure 39

39. A small stand of bald cypress is located north of the I-10 spoil bank in the area of station 18. Photo direction to the southwest 32

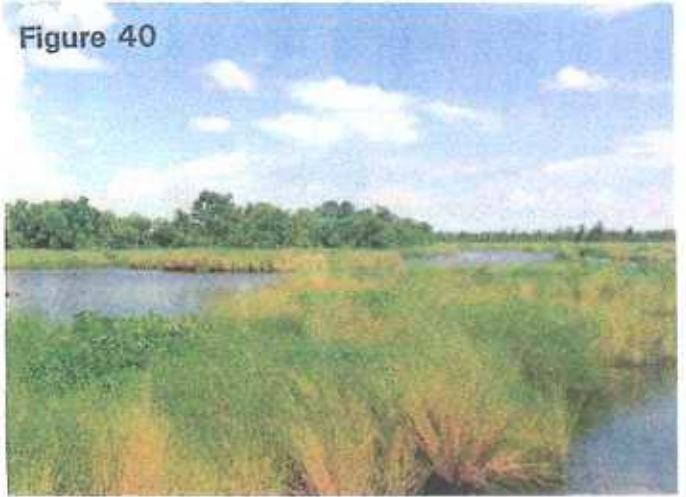
Figure 40

40. Woody vegetation grows on the spoil bank of a mineral access canal at station 18. Photo direction to the east 32

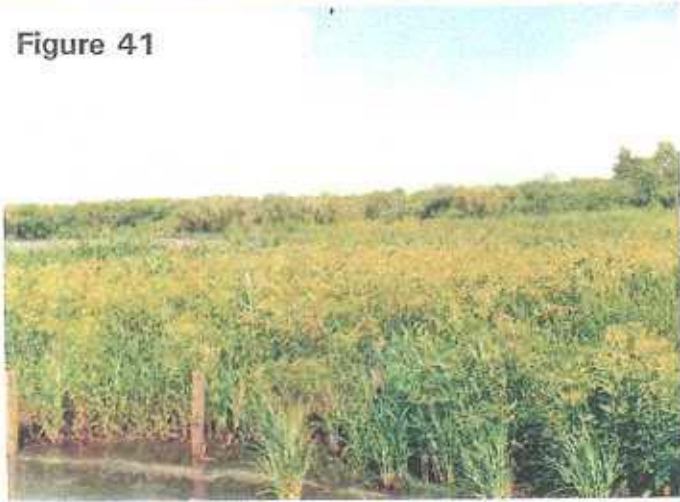
Figure 41

41. Silt-trapping fences constructed by using discarded Christmas trees have created mudflats along one shoreline of a large pond area. Plants have become established naturally and by planting of smooth cordgrass. Photo taken at south end of double structure in large pond west of pipeline canal and north of I-10. Photo direction to the east 32

The study area was the first site in Louisiana where efforts were tested to install drift fences to trap soil particles and recreate marshland. Discarded Christmas trees have been used successfully as shown in figures 41, 42, 43, and 44. The accretion process is dependent upon an availability of suspended material in the water column and in the case the material is decomposed marsh soil particles and decaying plant material washed into the from the interior marsh sites. Though a limited amount of mineral soil particles is available in Lake Pontchartrain, the natural tidal flow process to move these particles into the interior marsh is more destructive than beneficial.

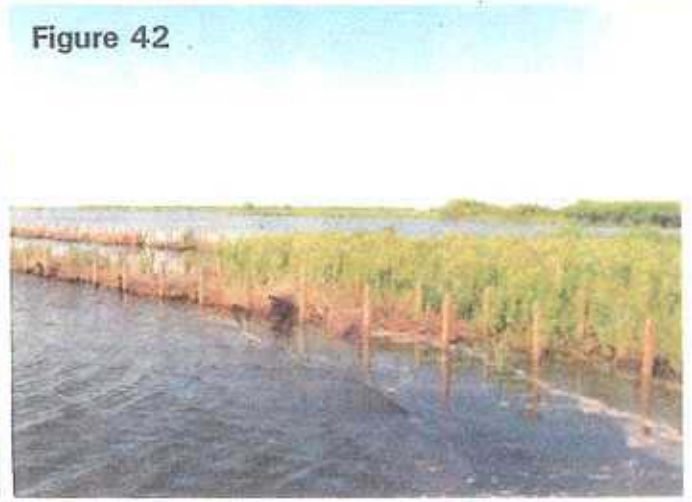
Figure 42

42. Silt-trapping fences constructed by using discarded Christmas trees have created mudflats along one shoreline of a large pond area. Plants have become established naturally and by planting of smooth cordgrass. Photo taken at south end of double structure in large pond west of pipeline canal and north of I-10. Photo direction to the east 32

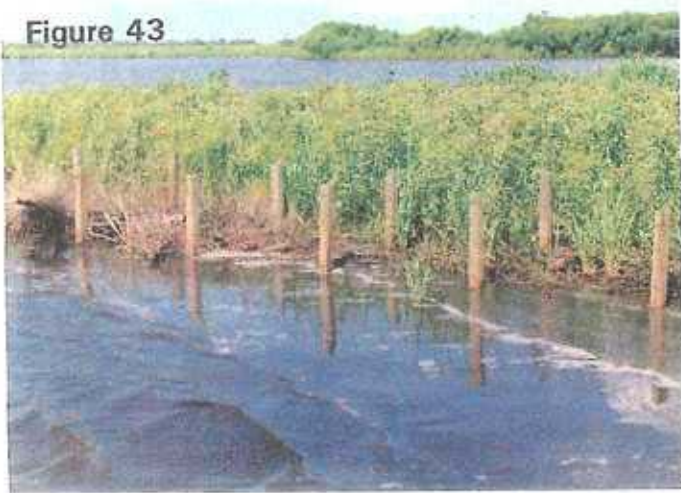
Figure 43

43. Silt-trapping fences constructed by using discarded Christmas trees have created mudflats along one shoreline of a large pond area. Plants have become established naturally and by planting of smooth cordgrass. Photo taken at south end of double structure in large pond west of pipeline canal and north of I-10. Photo direction to the east 32

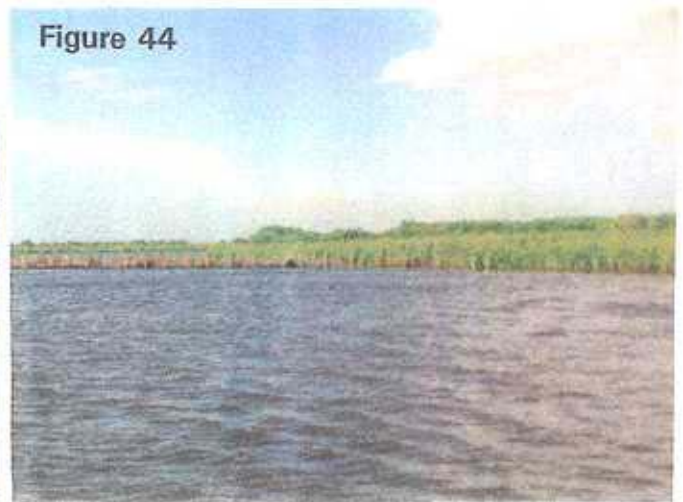
Figure 44

44. Silt-trapping fences constructed by using discarded Christmas trees have created mudflats along one shoreline of a large pond area. Plants have become established naturally and by planting of smooth cordgrass. Photo taken at south end of double structure in large pond west of pipeline canal and north of I-10. Photo direction to the east 32
