Monitoring Series No. TV-09-MSTY-0998-1

THREE-YEAR COMPREHENSIVE MONITORING REPORT

**BOSTON CANAL/VERMILION BAY SHORELINE  
PROTECTION  
T/V-09**

**Second Priority List Shoreline Protection Project  
of the Coastal Wetlands Planning, Protection, and Restoration Act  
(Public Law 101-646)**

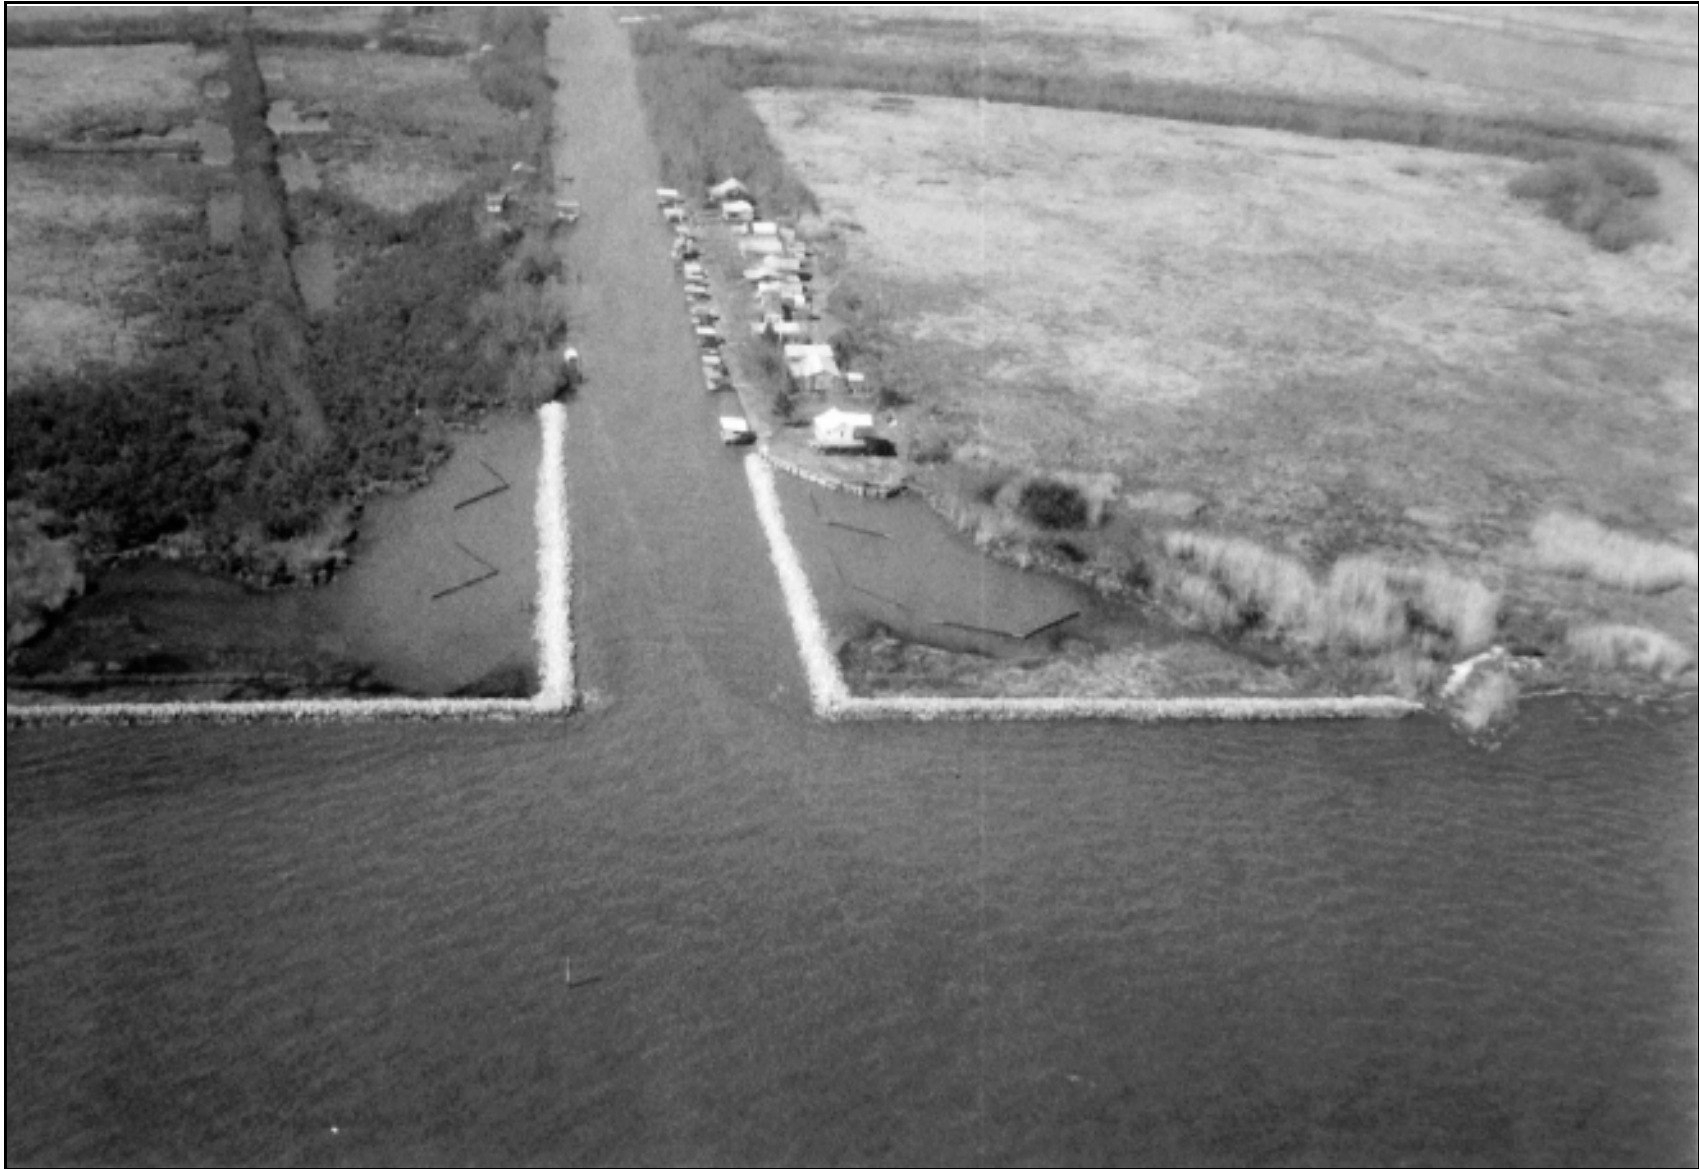
**Figure 2.** Boston Canal/Vermilion Bay Shoreline Protection (T/V-09) rock breakwaters and sediment fences at the mouth of Boston Canal.

The Boston Canal/Vermilion Bay Shoreline Stabilization (T/V-09) project was designed to abate wind-driven wave erosion along Vermilion Bay and at the mouth of Boston Canal. In December 1994, rock breakwaters were constructed parallel to the banks of Boston Canal, extending into Vermilion Bay and then turning 90 degrees to follow the bay shoreline (figure 2). Behind the breakwaters, sediment fences were installed to capture sediment during overwash events. In October 1995, approximately 34,000 trade gallon-size plants of *S. alterniflora* were installed along 14.3 mi (23 km) of bay shoreline, from Mud Point on the western end to Oaks Canal on the eastern end.

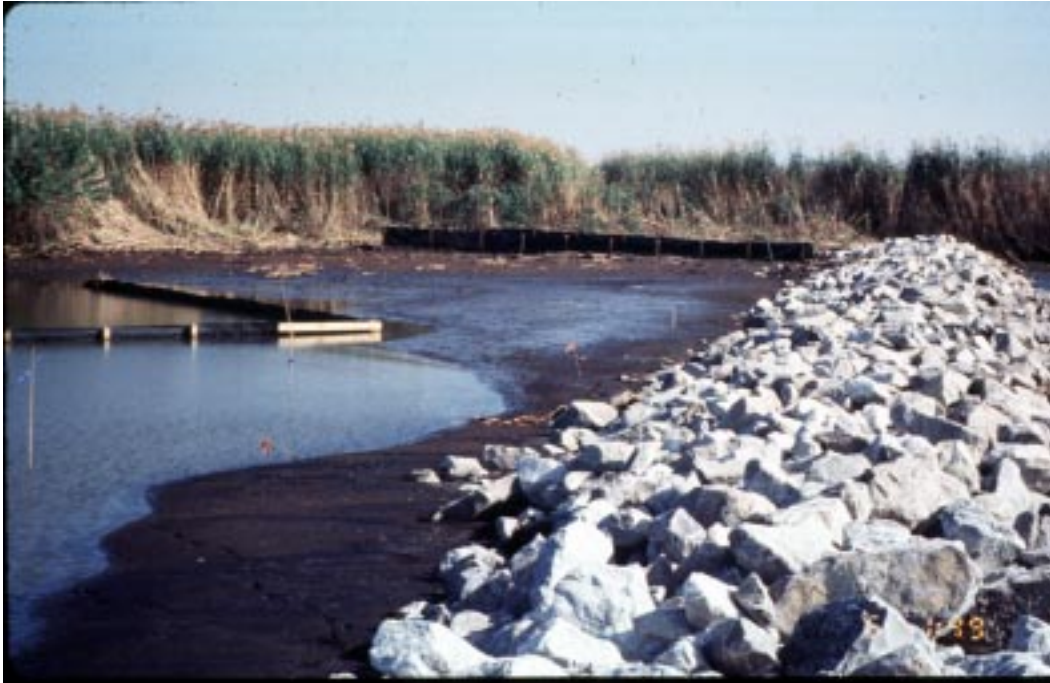
Observations to date suggest that the rock breakwaters have been effective in promoting sediment deposition and retaining this sediment at the mouth of Boston Canal (figure 12). Sediment laden waters appear to be overtopping the rock breakwater due to high water periods and boat traffic near the mouth of Boston Canal. Thus far, sedimentation is greatest in front of the sediment fences on the bay side. It appears that the fences closest to the bay are impeding the uniform distribution of sediments. Therefore, it is recommended that the sediment fences be removed to allow more uniform accumulation of sediment throughout the entire area behind the breakwater.

**Figure 12.** Boston Canal/Vermilion Bay Shoreline Protection (T/V-09) photographs: (A) sediment deposition, December 1994; (B) vegetation behind rock breakwater; February 1998.
