**BOSTON CANAL /VERMILION BAY SHORELINE PROTECTION (T/V-09)**

**T/V-09-MSPR-1295-1**

**PROGRESS REPORT NO. 1**

November 1, 1994 to December 04, 1995

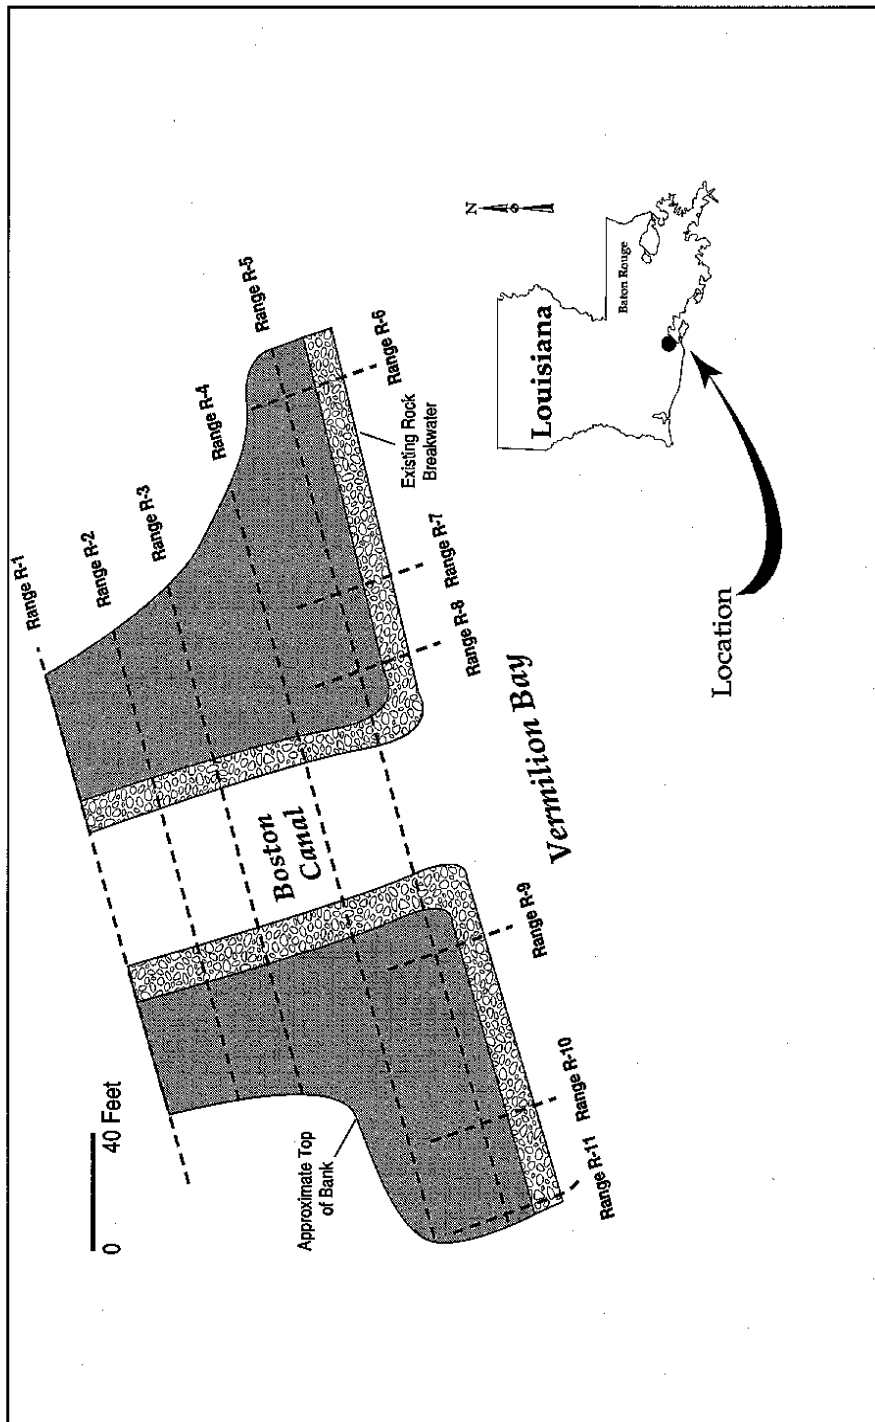
Figure 2. Boston Canal/Vermilion Bay Shoreline Protection (T/V-09) cross section of the mouth of Boston Canal labeling elevational transects.

**Rock breakwater:** In October 1994, preconstruction elevational transects were surveyed across the rock breakwaters (figure 2). Comparison with data from an additional survey conducted in May 1995 revealed that up to 4.5 ft of sediment has been deposited between the breakwaters and the existing shoreline (figures 3 and 4). The exposed mudflats are being colonized by Walter's millet (*Echinochloa walterii*) and Coast water hyssop (*Bacopa monnieri*). Observations to date suggest that the rock breakwaters have been highly effective in promoting and retaining sediment deposition at the mouth of Boston Canal.

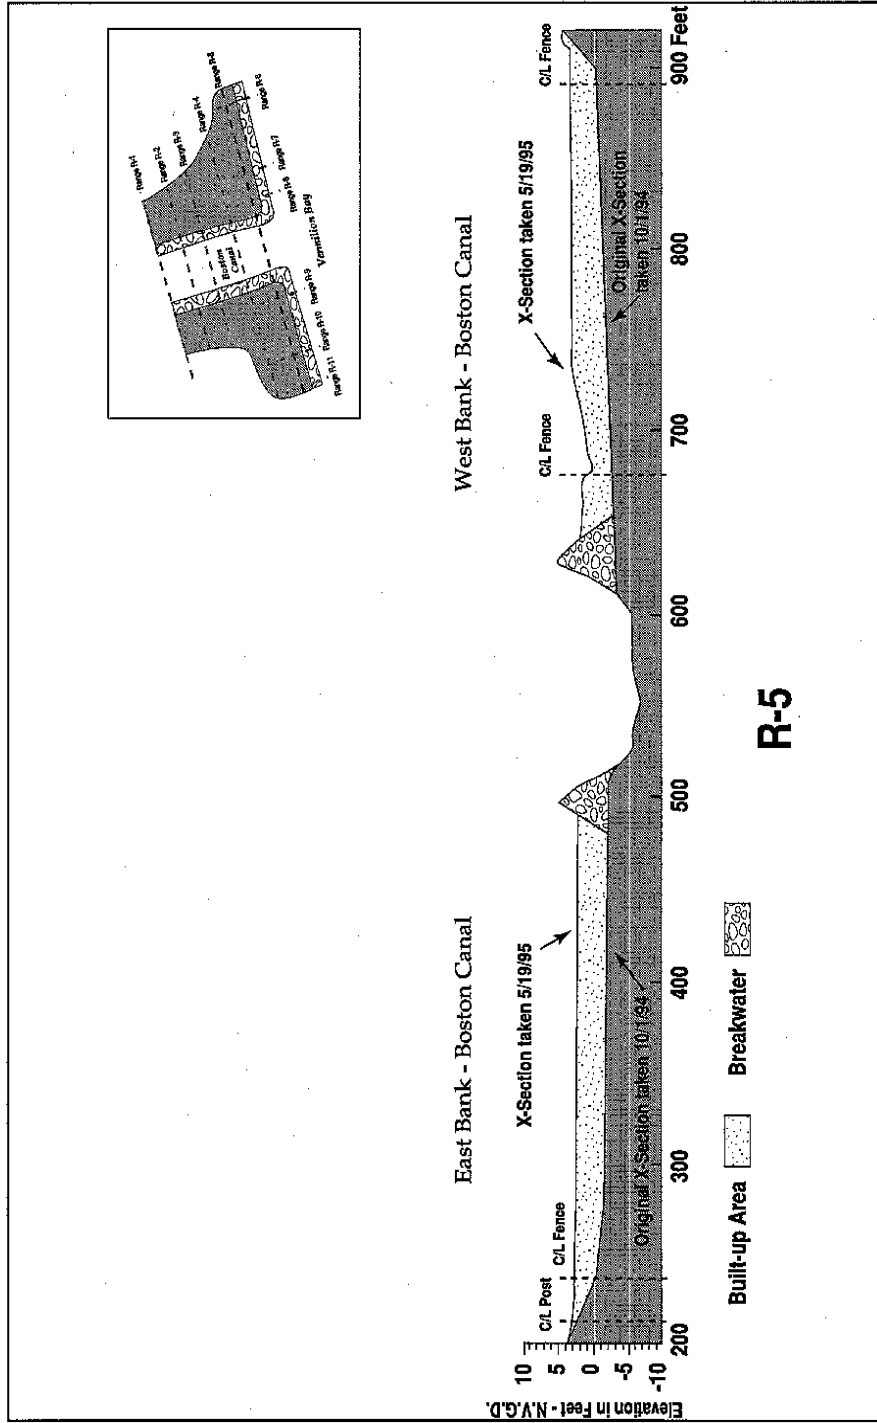
Figure 3. Boston Canal/Vermilion Bay Shoreline Protection (T/V-09) elevational profile of east-west transect R-5 showing accretion.

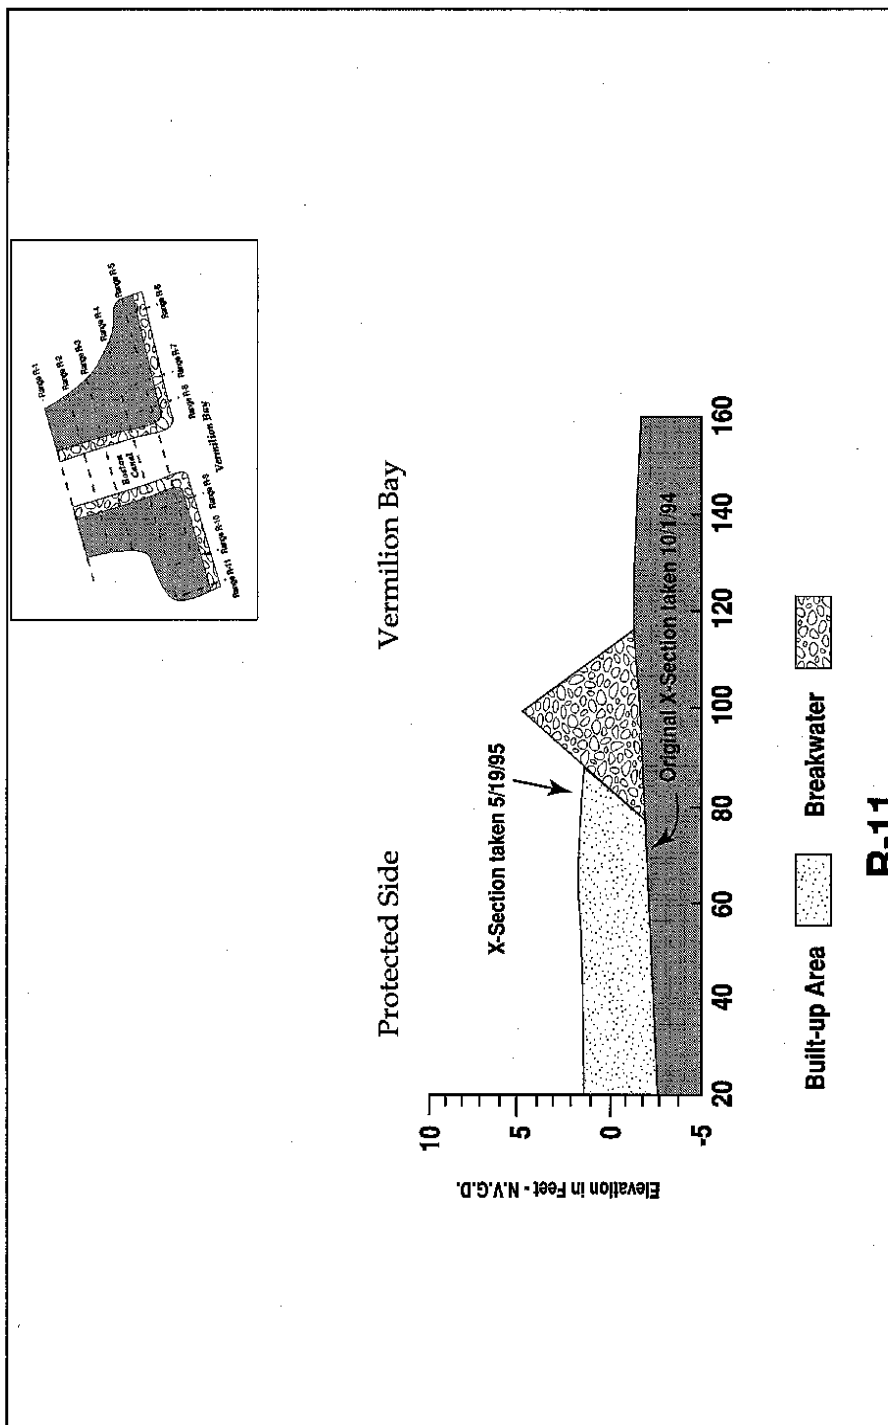
Figure 4. Boston Canal/Vermilion Bay Shoreline Protection (T/V-09) elevational profile of north-south transect R-11 showing accretion.

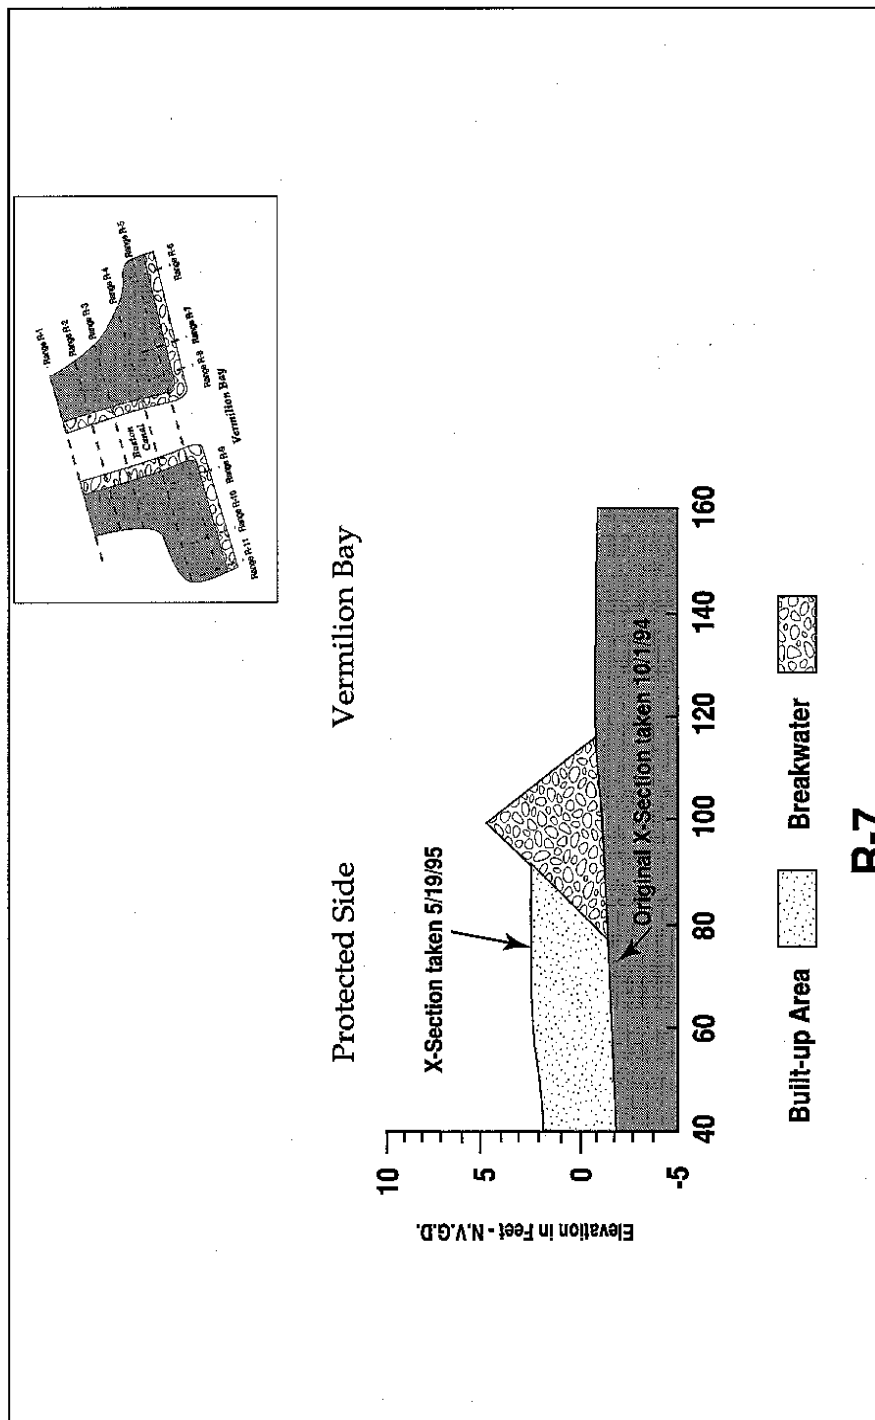
Figure 5. Boston Canal/Vermilion Bay Shoreline Protection (T/V-09) elevational profile of north-south transect R-7 showing accretion.
