CS-30

Perry Ridge West Bank Stabilization  
Summary Data and Graphics

# Perry Ridge West (CS-30)

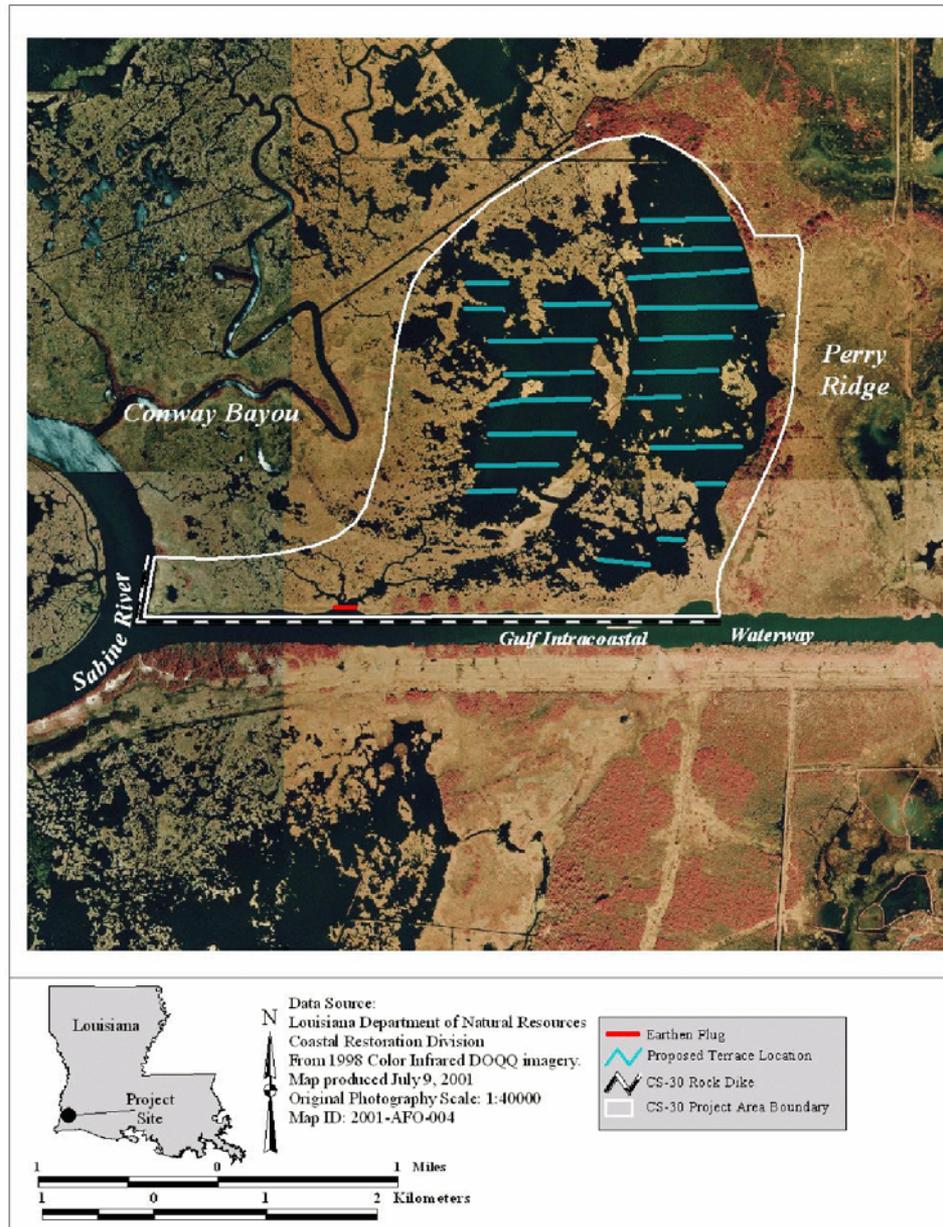
**Figure 1.** Perry Ridge West (CS-30) project boundaries

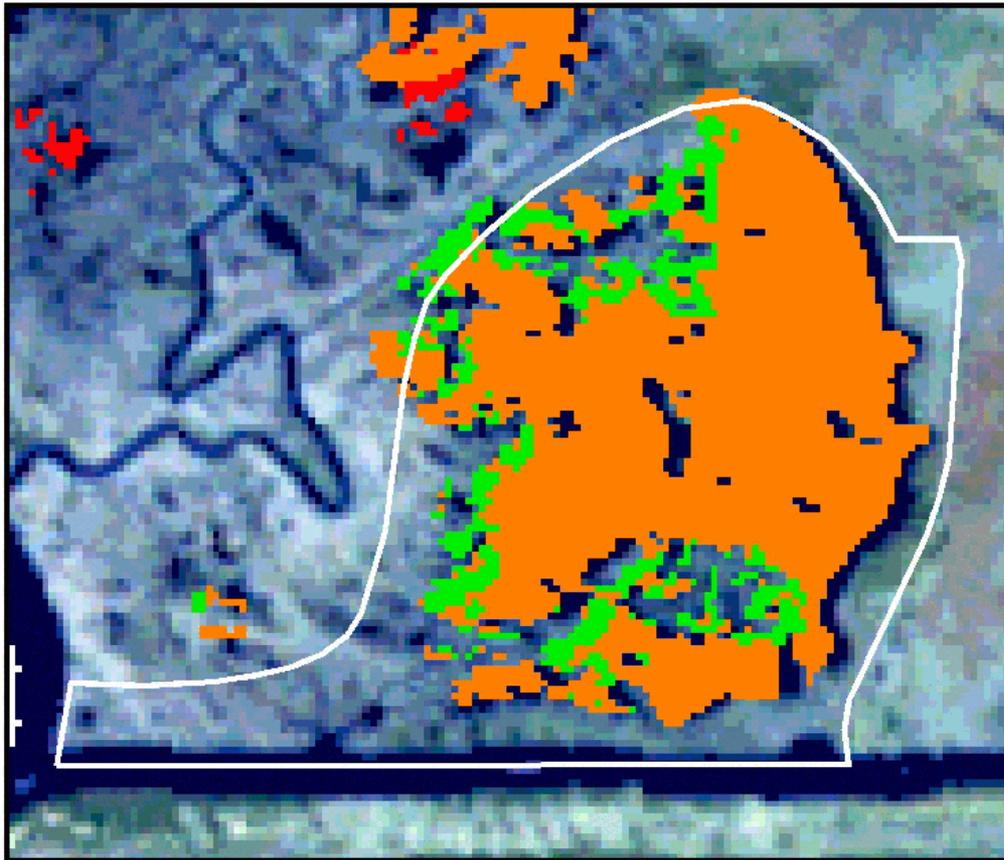
1956 - 1990 Loss/Gain Analysis				
Color	Class	Acres	Hectares	Percent
Orange	1956 - 1978 Loss	-659.93	-267.06	48.89
Yellow	1956 - 1978 Gain			
Red	1978 - 1990 Loss	96.22	38.94	48.89
Green	1978 - 1990 Gain			
	Totals	-563.71	-228.13

**Figure 2.** Perry Ridge West (CS-30) project land loss/gain analysis for the period 1956-1990.

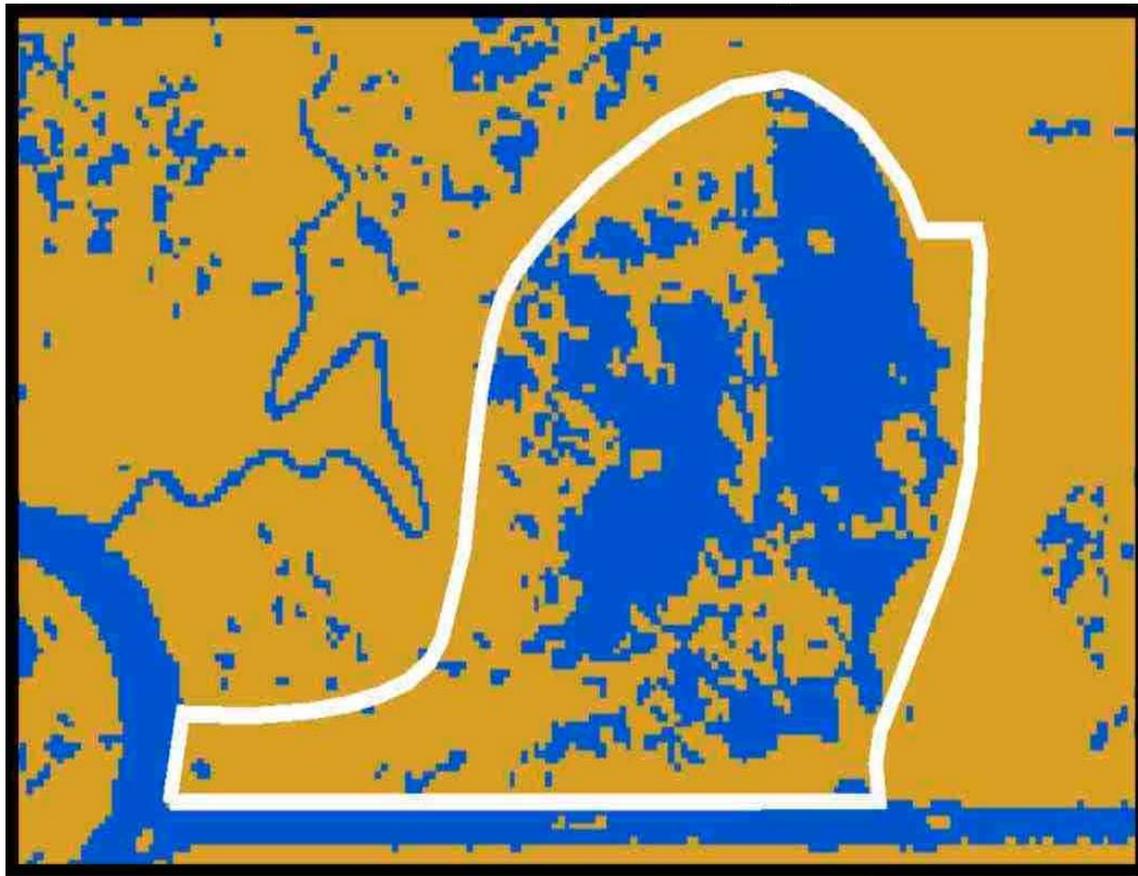
1993 Land/Water Analysis				
Color	Class	Acres	Hectares	Percent
Blue	1993 Water	533.59	215.94	46.28
Orange	1993 Land	619.31	250.63	53.72
	No Data Available	0.00	0.00	0.00
	Totals	1152.9	466.56	100.00

**Figure 3.** Perry Ridge West (CS-30) project 1993 land/water analysis.

- Pre-construction (1993) land:water classification of satellite imagery indicated 53.72% land and 46.28% water within the project area. Approximately 47% of the project area was classified as intermediate marsh.
- 2001 aerial photography was collected on November 17, 2001 and is currently being processed by NWRC.

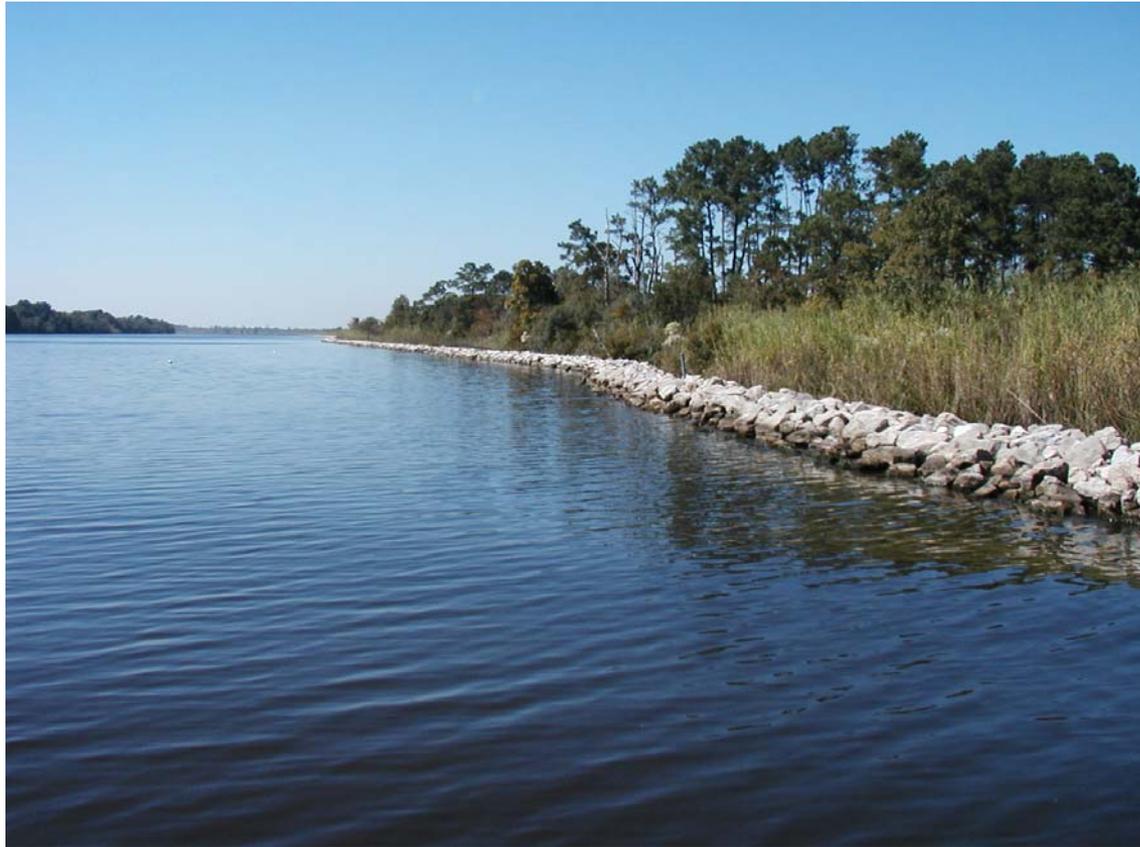
**Figure 4.** View of the Perry Ridge West rock dike taken October 21, 2003. The photograph is facing west.

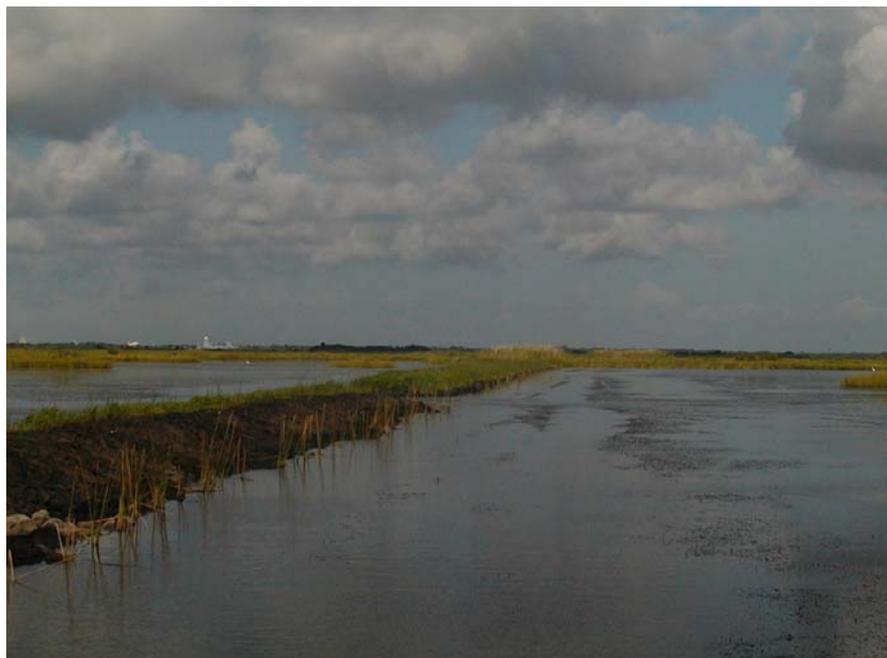
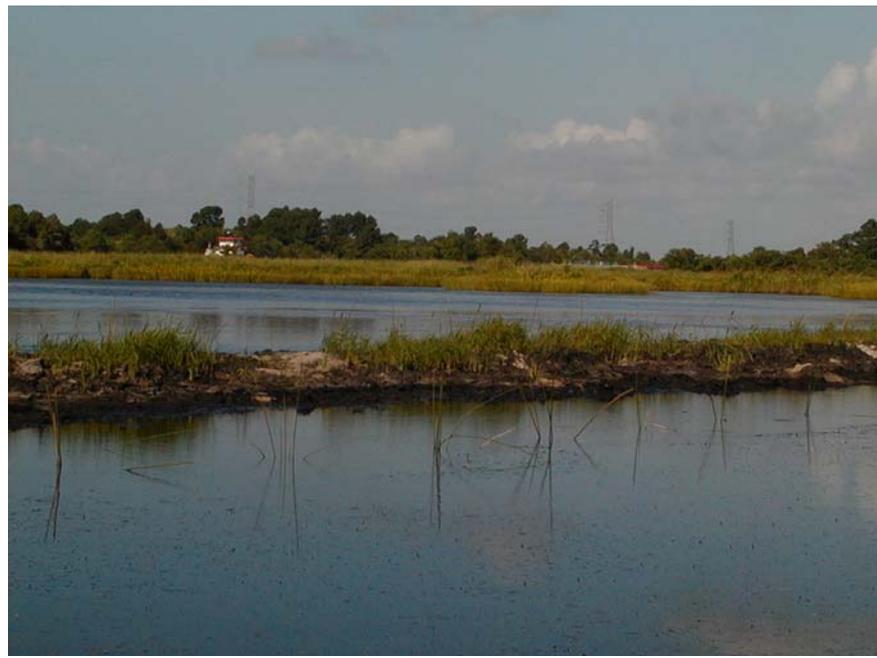
**Figure 5.** Views of the terraces and *Schoenoplectus californicus* plantings taken July 2002. The photograph on the left is facing southwest , and on the right is facing south.

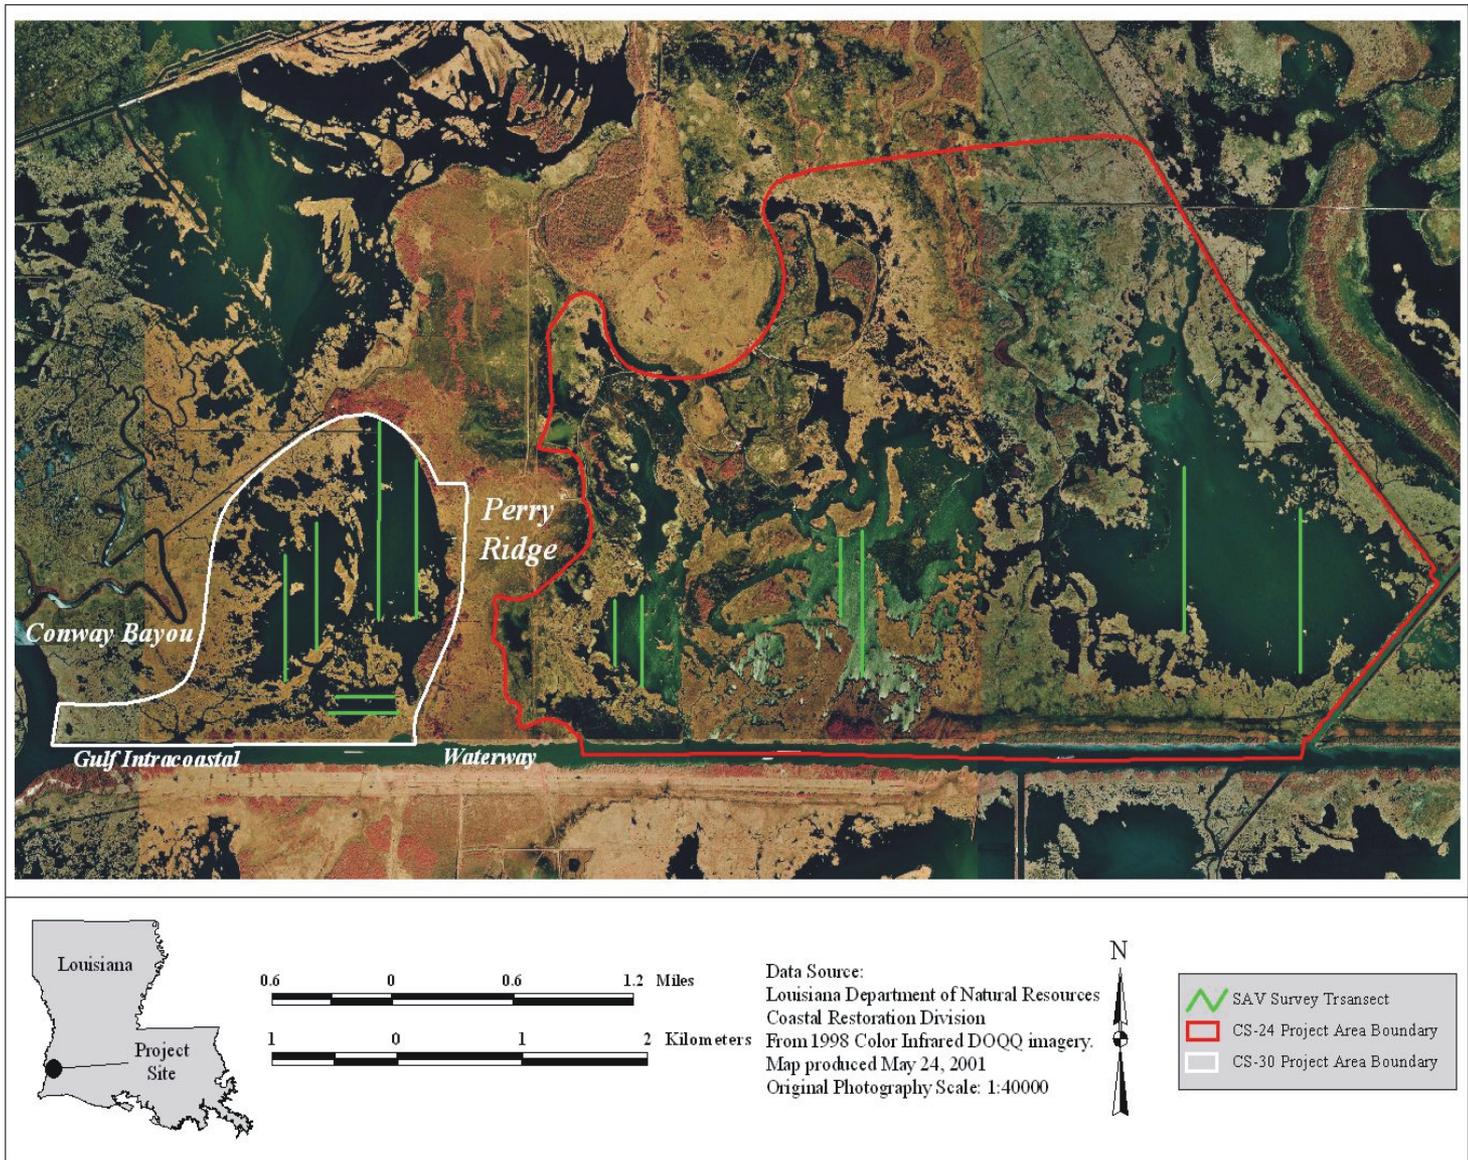
**Figure 6.** Location of SAV transects at Perry Ridge West (CS-30) project.

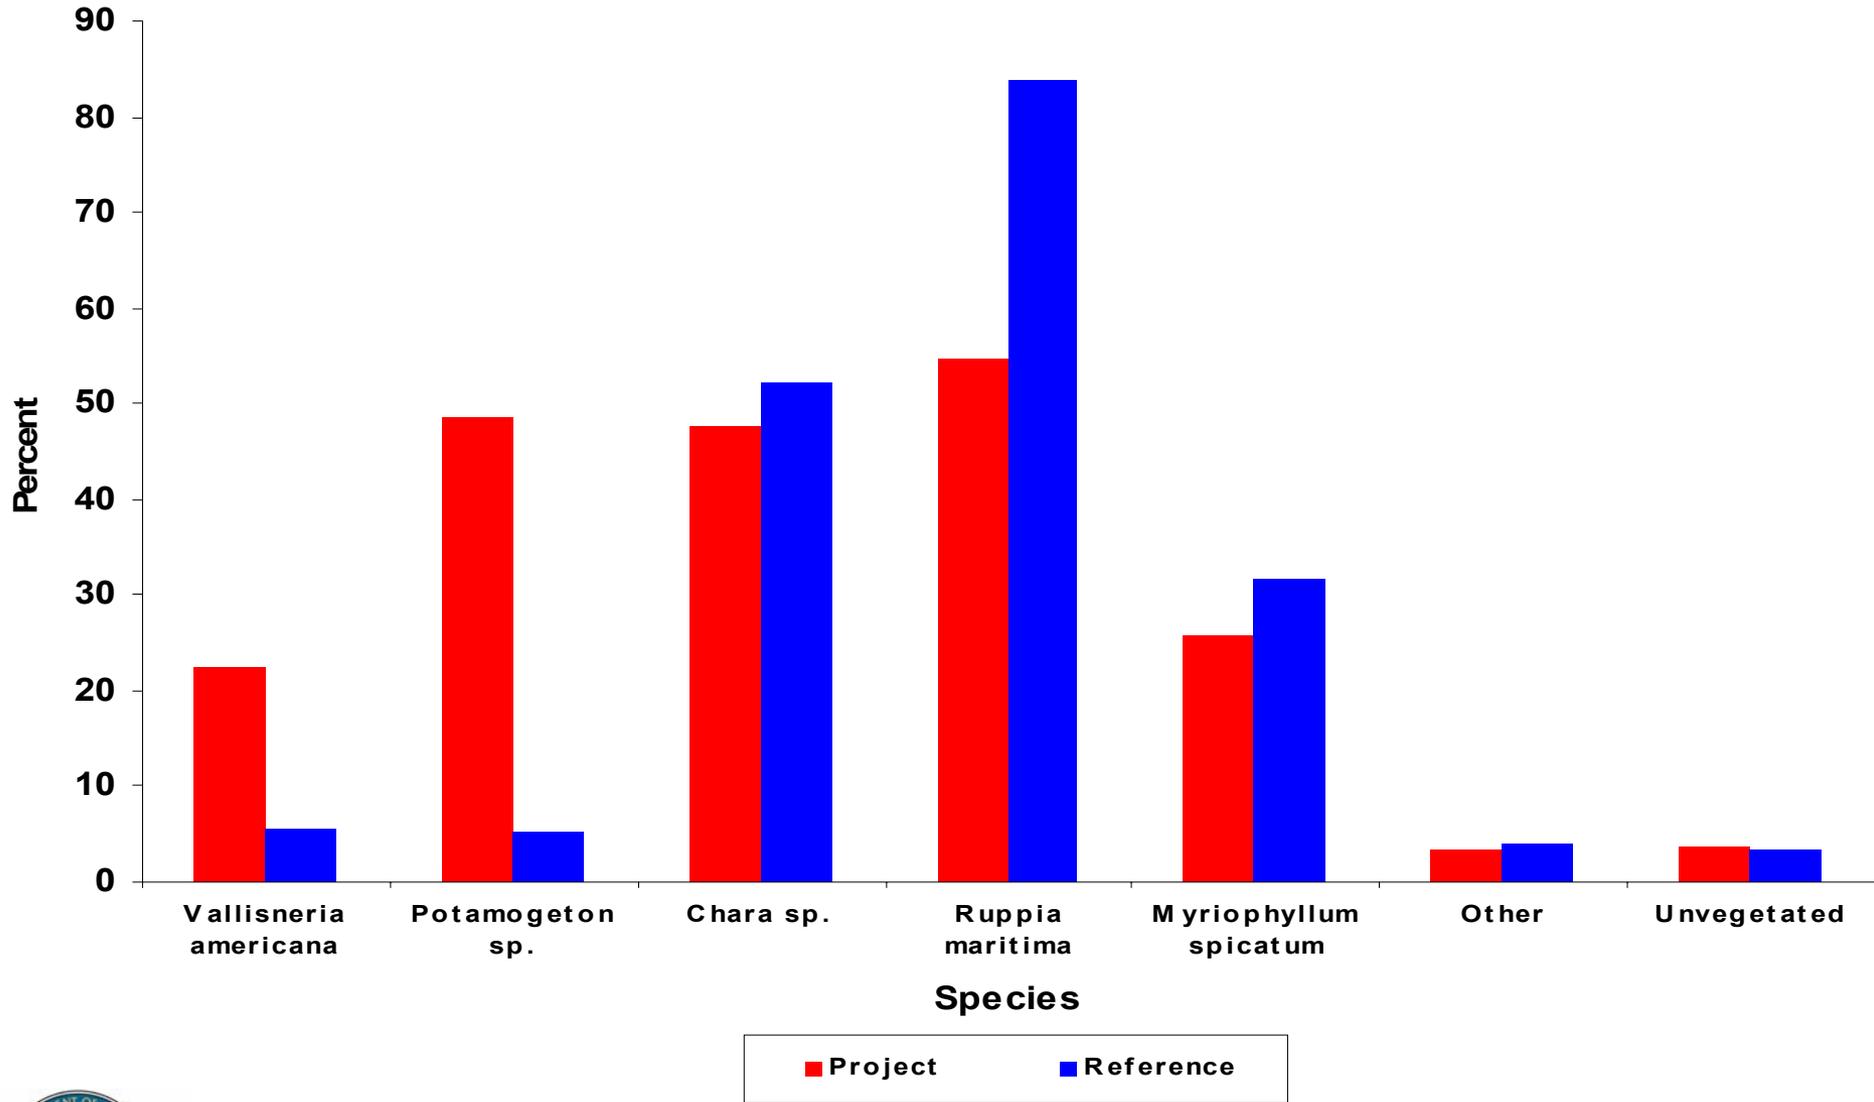
**CS-30 Project and Reference Areas  
Relative Frequency of SAV on 2 November 2000**

**Figure 7.** Perry Ridge West (CS-30) preconstruction SAV data

- On the pre-construction survey, the project area showed a slightly higher frequency of SAV than the reference area. Dominant species in the reference area include *Ruppia maritima* (Widgeon Grass), *Chara sp.* (chara), and *Myriophyllum spicatum* (Eurasian Watermilfoil), while dominant species in the project area include *R. maritima*, *Chara*, and *Potamogeton sp* (pondweed).
- Next survey scheduled for Oct 2003.
