Little Vermilion Bay Sediment Trapping Summary Data and Graphics

Castellanos, D. 2003. TV-12 Little Vermilion Bay Sediment Trapping Summary Data and Graphics, Louisiana Department of Natural Resources, Coastal Restoration Division, Baton Rouge, Louisiana. 22pp.

Little Vermilion Bay Sediment Trapping (TV-12)

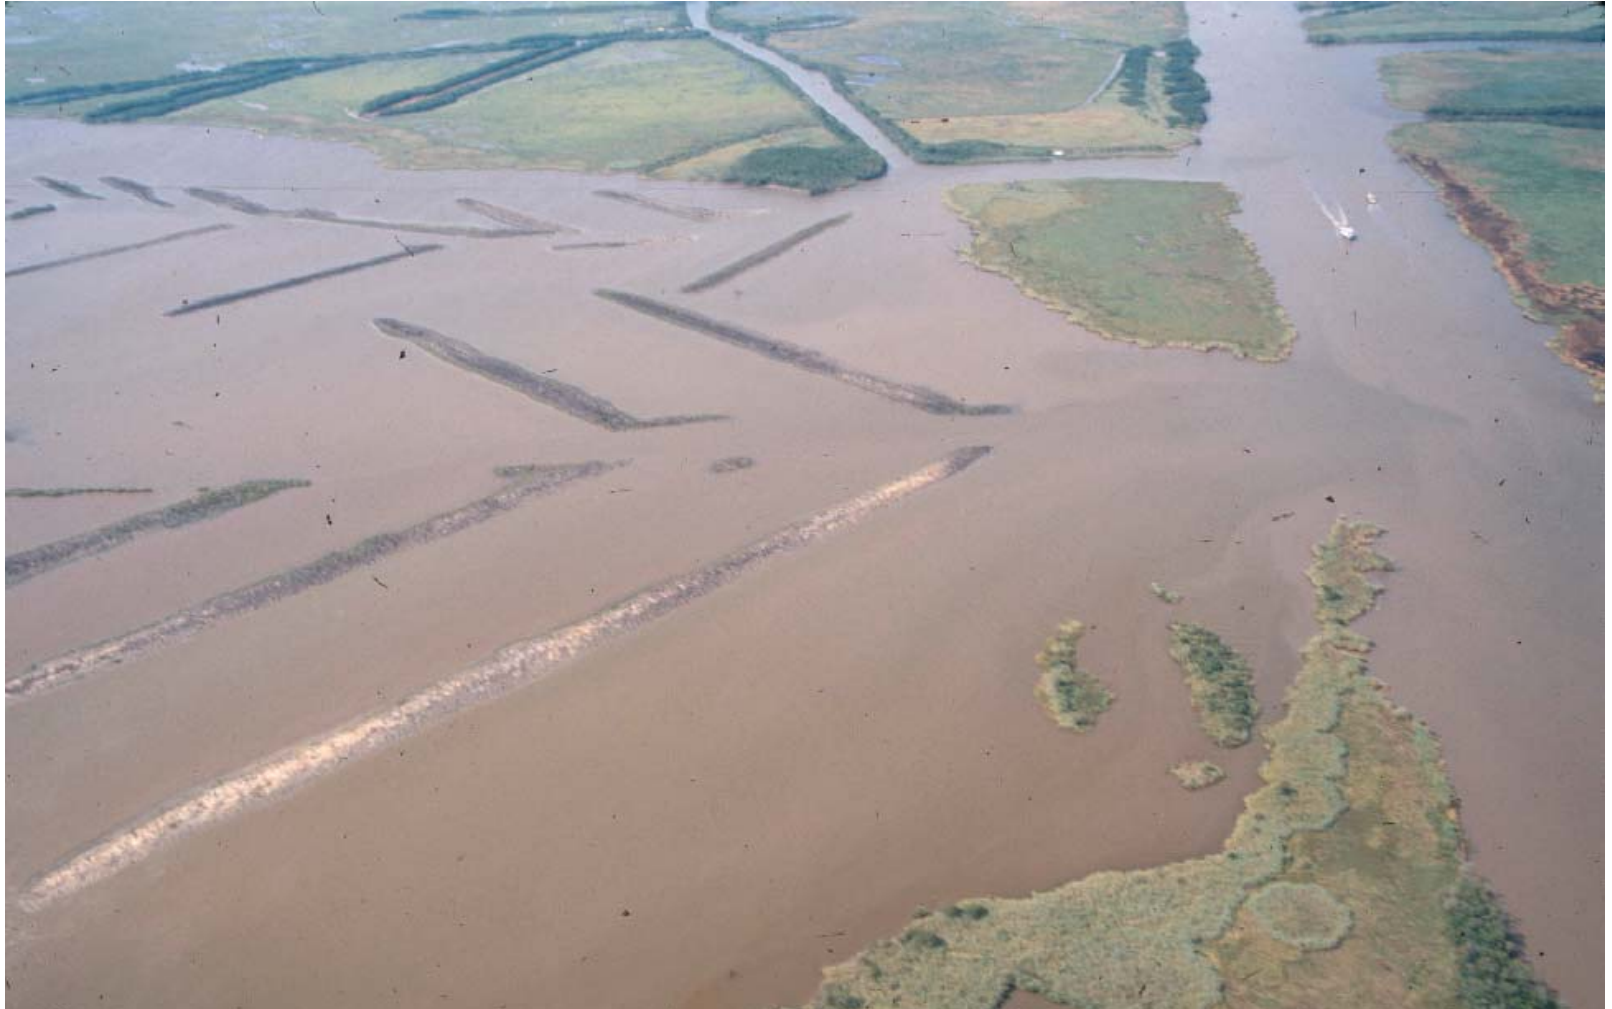
Figure 3. Aerial photo 9/30/99 immediately post construction. Terraces are only bare dirt. Freshwater Bayou is to the right.

Figure 3. Aerial photo 9/30/99 immediately post construction. Terraces are only bare ground with no vegetation. Freshwater Bayou is to the right.

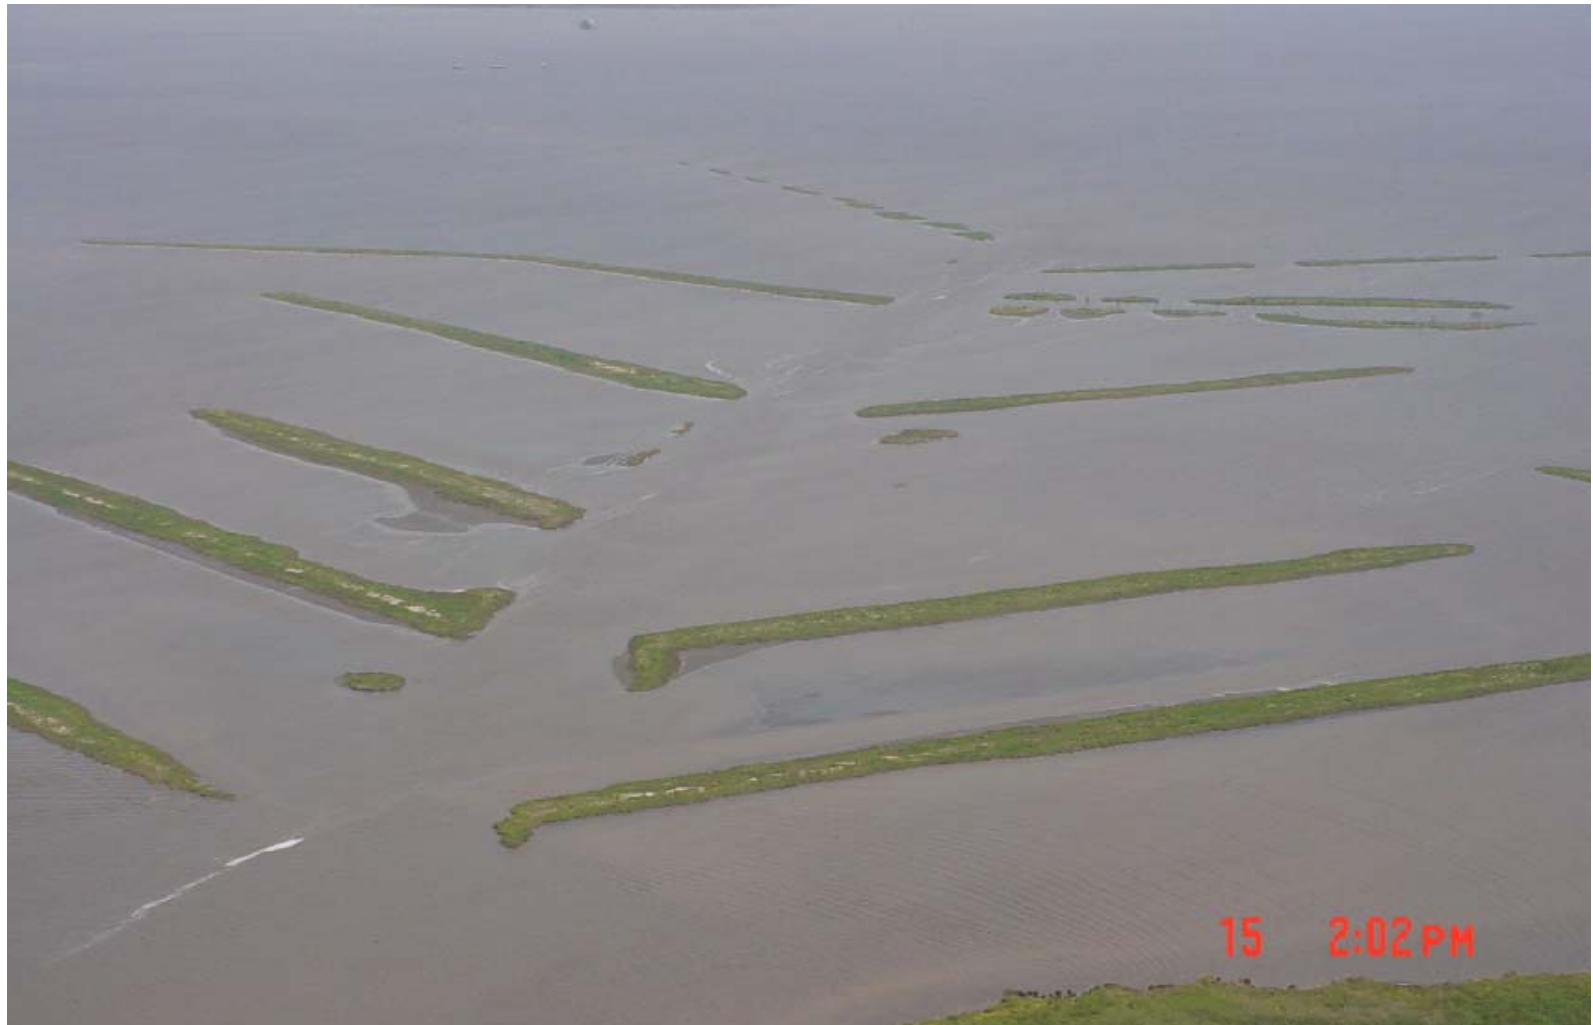
Figure 4. Aerial photo April 2003 almost four years after construction. Freshwater Bayou is outside of the frame nearest to the bottom left hand corner. View is from the north out to Little Vermilion Bay to the south. Vegetation almost completely covers all terraces, and possible sedimentation is visible between some terraces.

Figure 4. Aerial photo April 2003 almost four years after construction. Freshwater Bayou is outside of the frame nearest to the bottom left hand corner. View is from the north out to Little Vermilion Bay to the south. Vegetation almost completely covers all terraces, and possible sedimentation is visible between some terraces.

Bathymetry/Topography: A new elevation survey has not been completed yet, but aerial photography (figure 12) and the presence of mudflats with sprouting vegetation between terraces (spring 2003) suggest that sediment deposition has begun

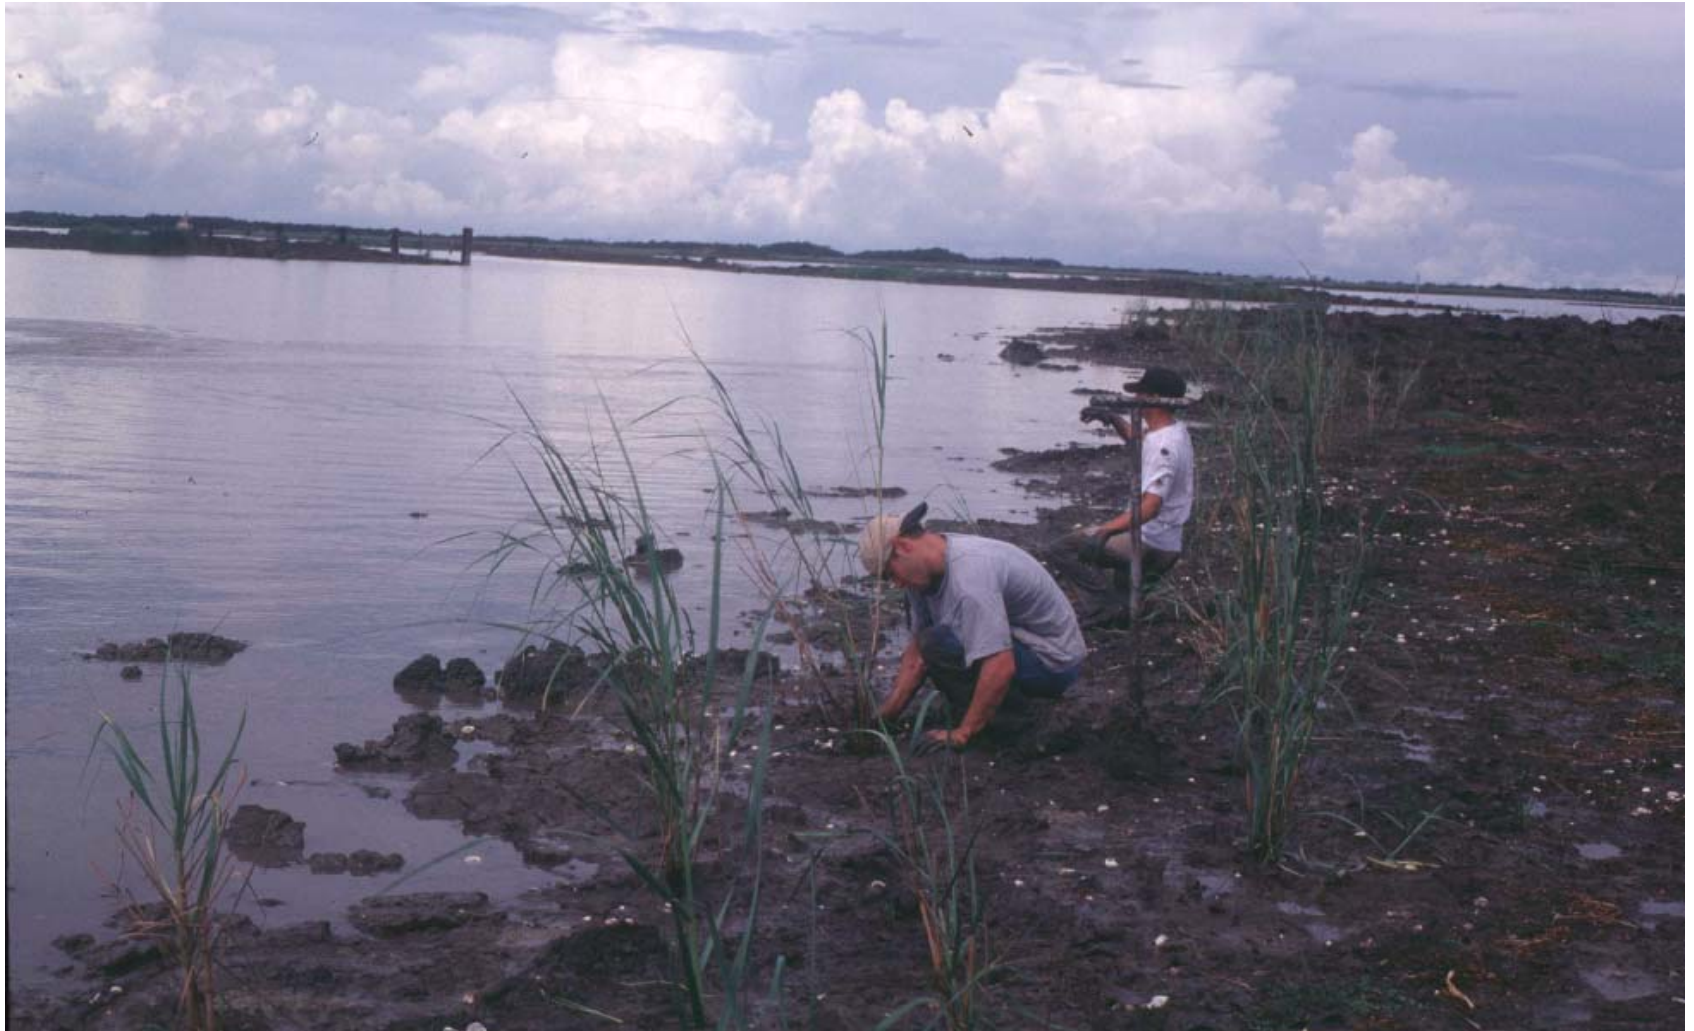
Figure 5. Newly constructed terrace being planted in summer 1999.

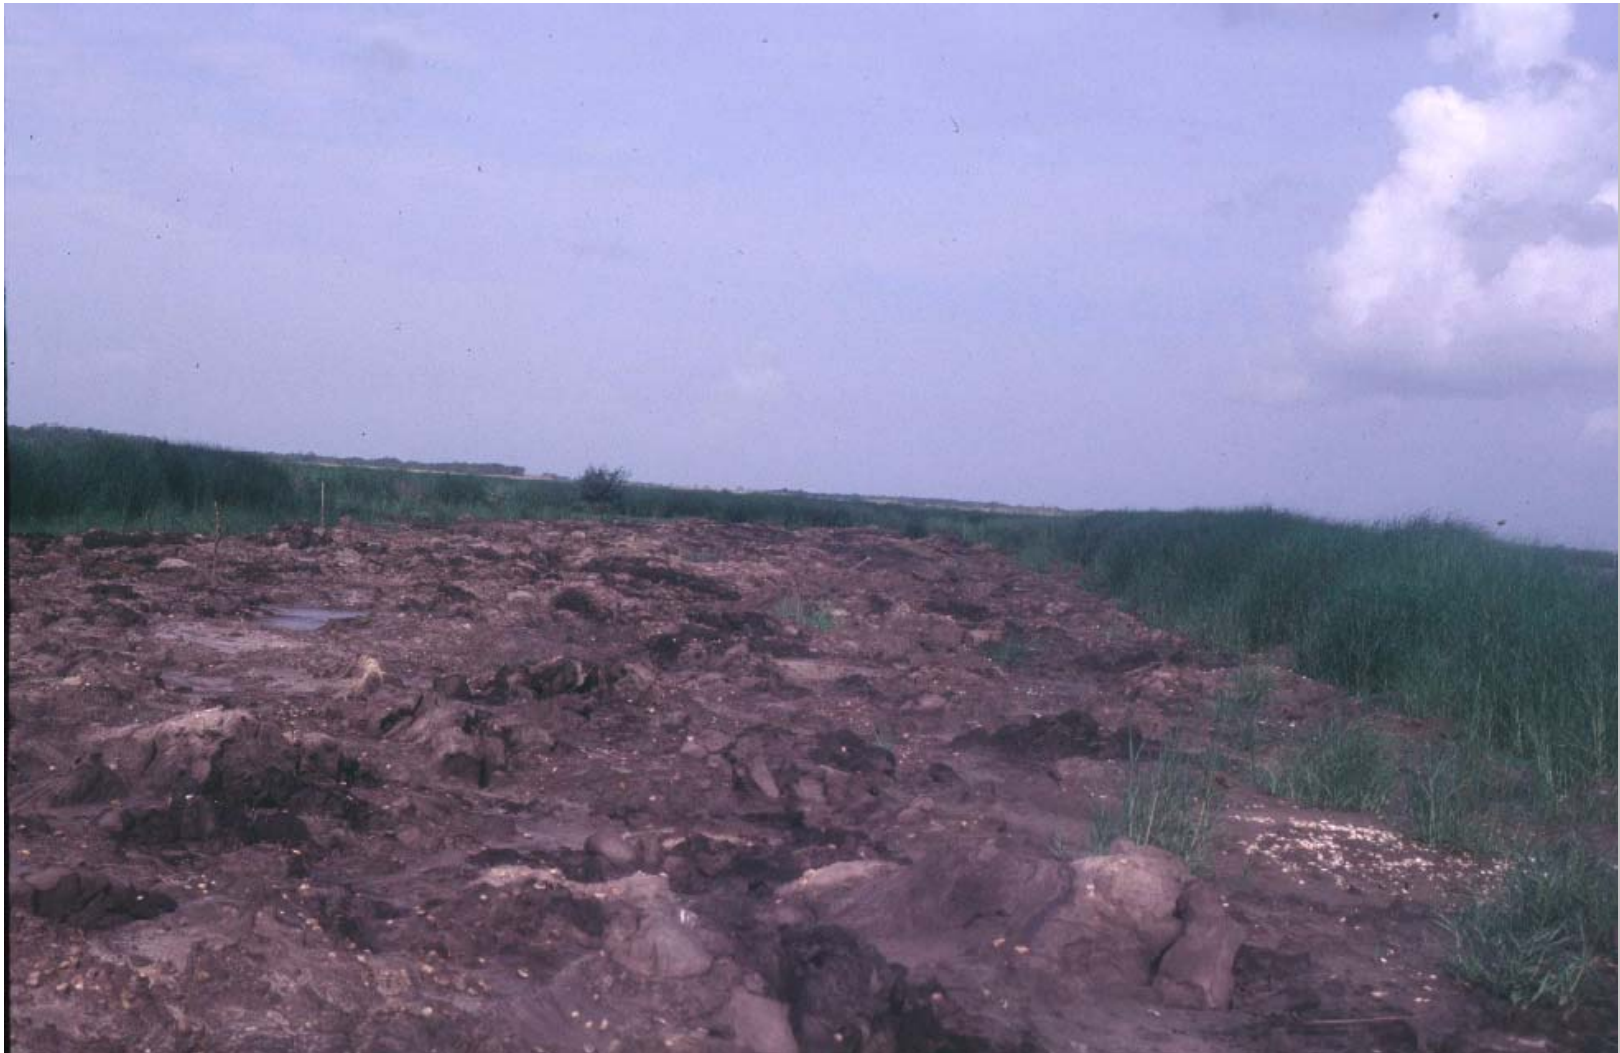
Figure 6. View from middle of a terrace in June 2000 one year after construction and planting, showing growth of planted *Spartina alterniflora* on either side.

Hydrophytic classification: Vegetation, both planted and naturally established, has quickly covered most of the terrace area since the construction and planting in summer 1999. By 2000, the *Spartina alterniflora* plantings covered much of the edges of the terraces with thick, tall vegetation (figure 9). In summer 2002, the emergent vegetation on the terraces was sampled. Full analysis has not been completed but preliminary results suggest that *S. alterniflora* plantings grew well and on most terraces remain dominant on the edges. Many other species have colonized and covered the terraces. Of the approximately 40 species found, 21 are obligate wetland, 17 are facultative wetland, 3 are facultative, and 1 is facultative upland. These plants and the plantings have covered all but the highest elevations in the middle of some terraces where some bare ground remains.

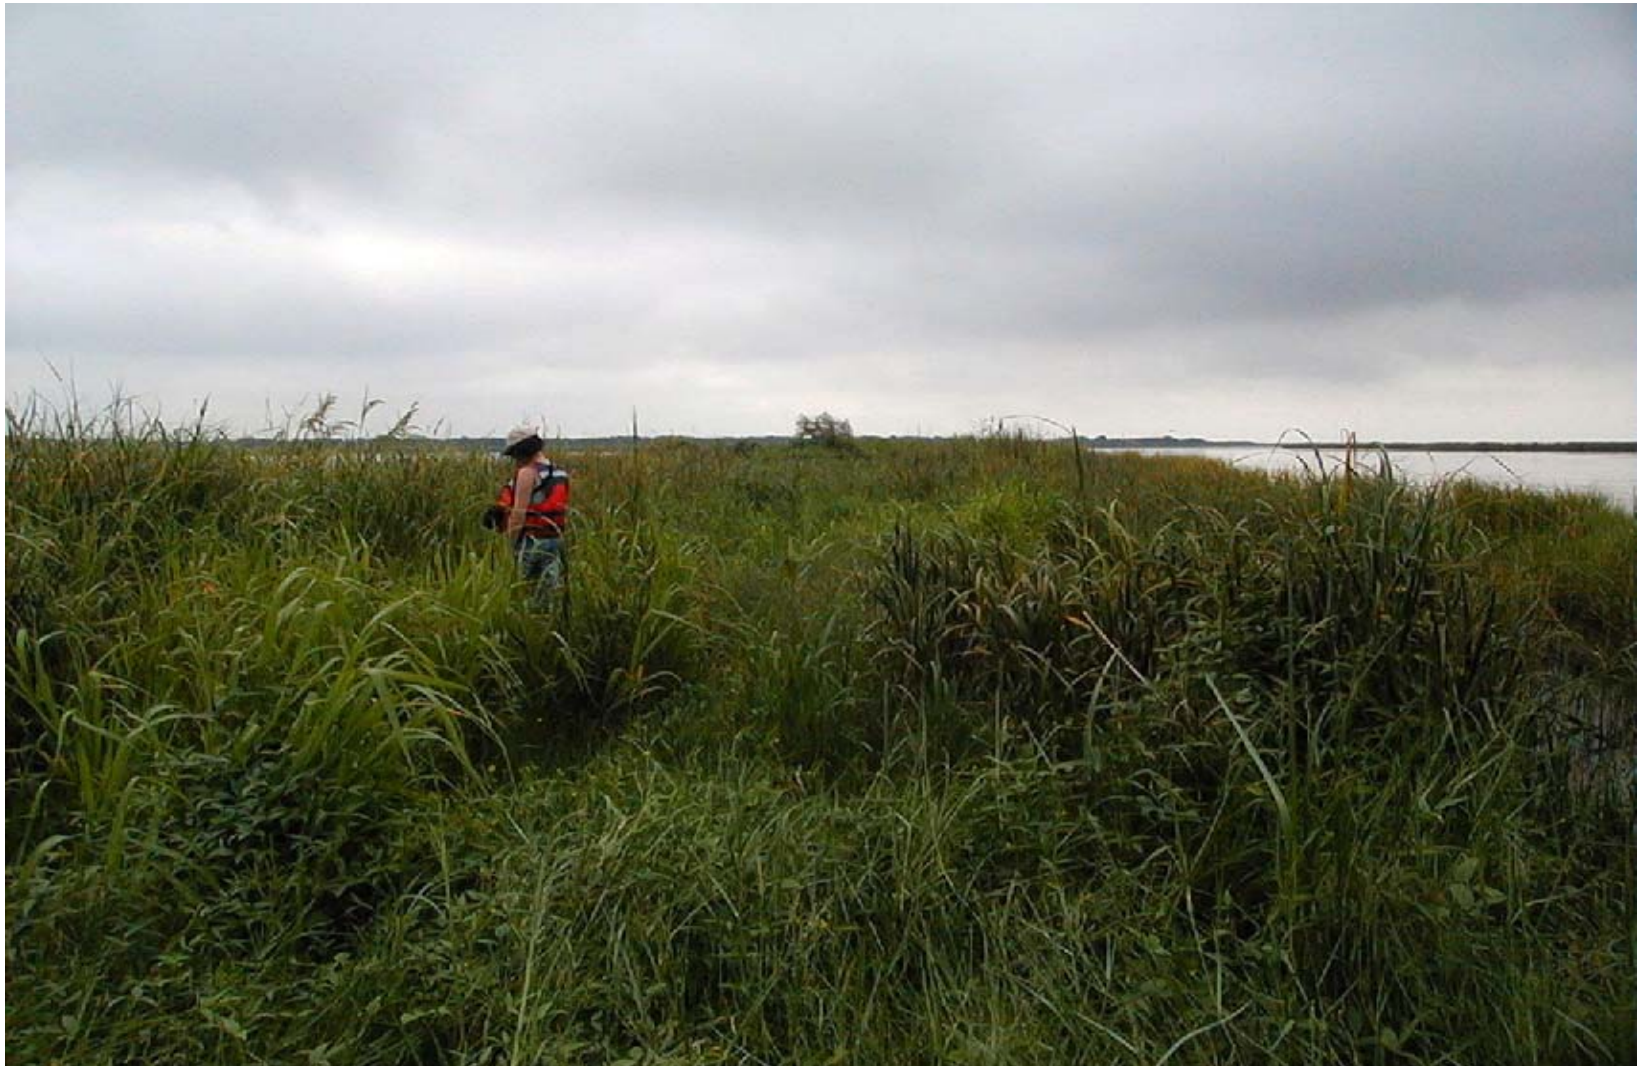
Figure 7. Planted and natural vegetation growth on a terrace in August 2001

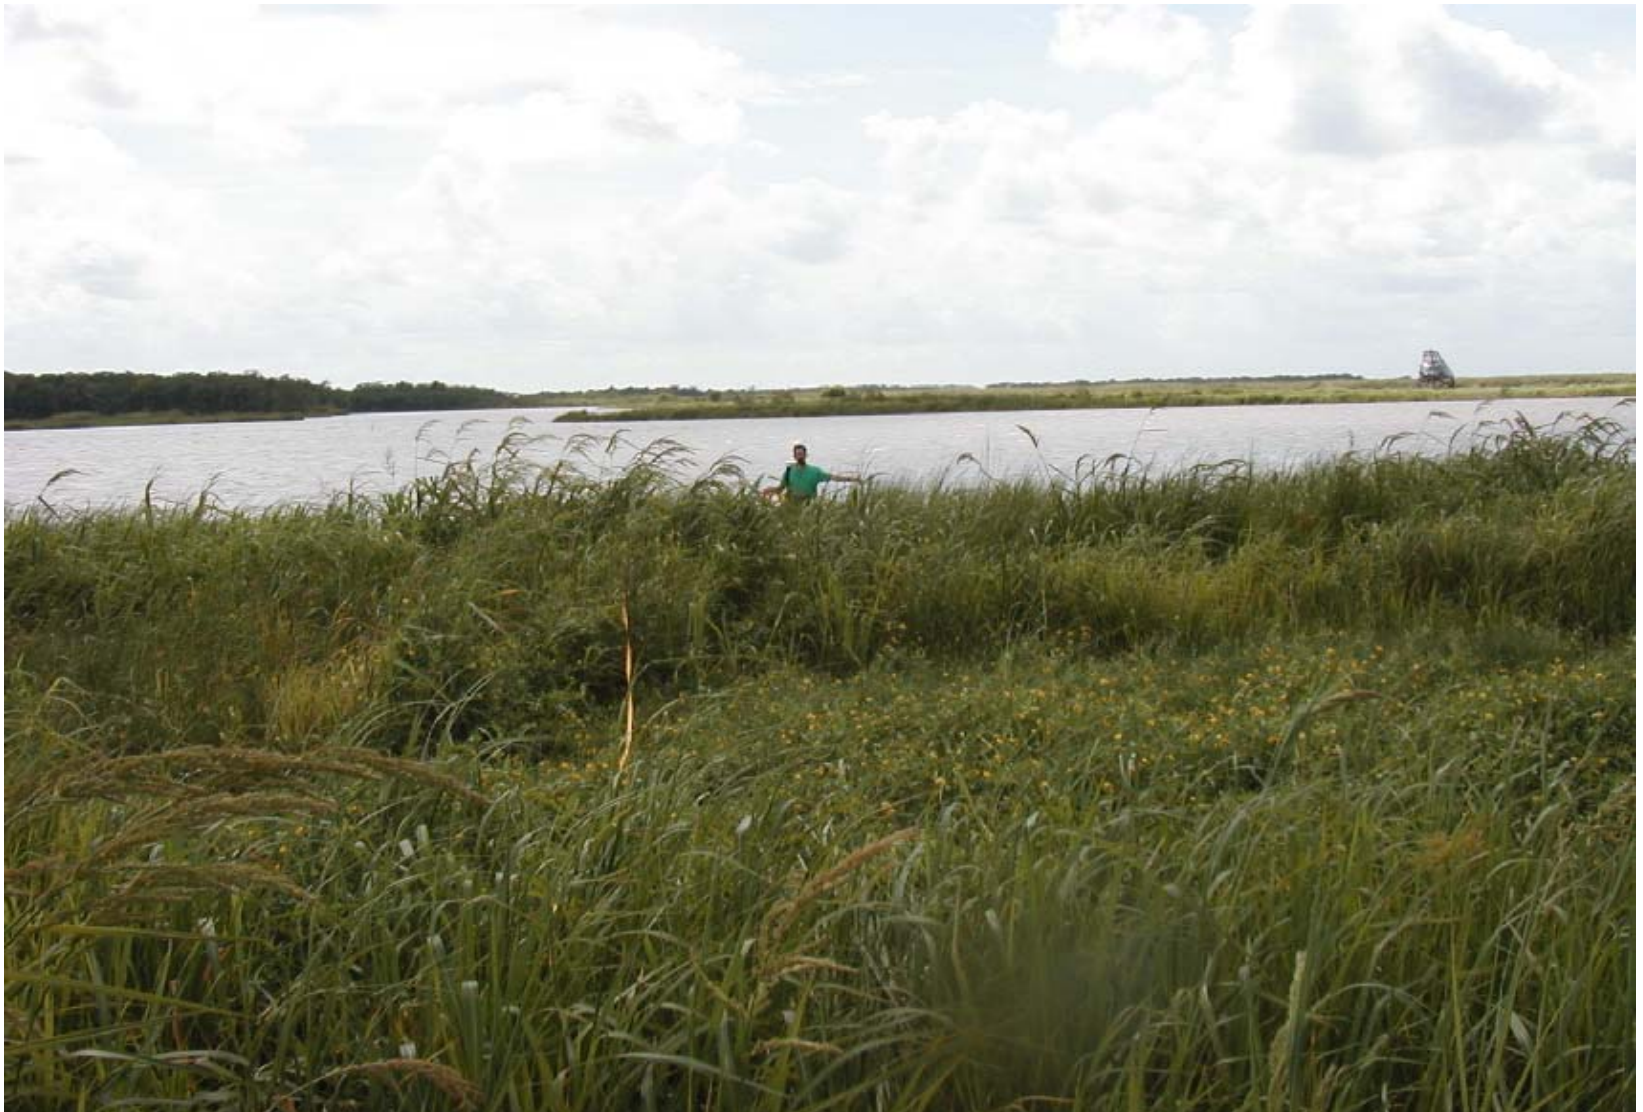
Figure 8. Vegetation on a terrace photographed during emergent vegetation survey in August 2002.
