## Hog Island Gully, West Cove & Headquarter Canal Structure Replacement Summary Data and Graphics

10/01/2003

# Hog Island Gully, West Cove & Headquarters Canal Structure Replacement (CS-23)

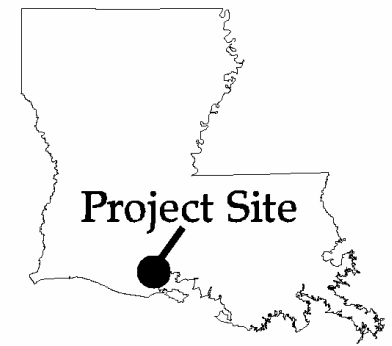
**Figure 1.** Replace Hog Island Gully, West Cove and Headquarters Canal Structures (CS-23) project features, project area boundaries and reference area boundaries.

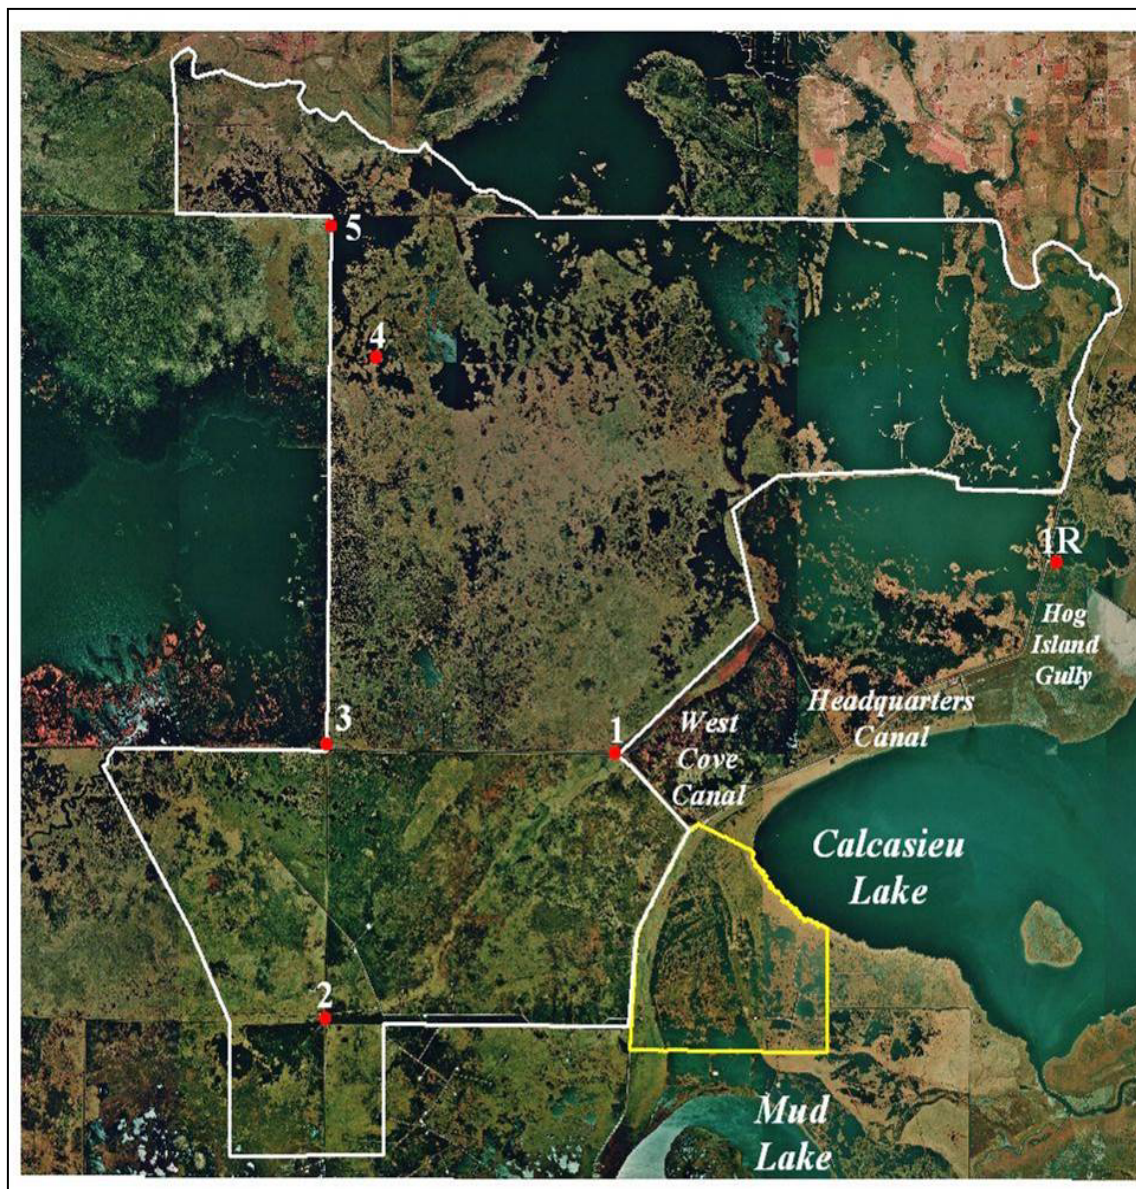
**Figure 3.** 1998 DOQQ imagery of continuous recorder monitoring stations in the Hog Island Gully, West Cove and Headquarters Canal Structure Replacement project and reference areas.

- Collected Hourly at 5 stations 1997 to present.
- **Figures and Tables:**
- **Figure 3.** 1998 DOQQ imagery of continuous recorder monitoring stations in the Hog Island Gully, West Cove and Headquarters Canal Structure Replacement project and reference areas.
- **Table 1.** Pre and Post construction flood and drain frequencies for stations CS23-02, CS23-03, CS23-05 and CS23-1R from 1997 to present.
- **Figure E1 – E16.** Hourly Salinity and Water Level Data by station (english)
- **Figure M1 – M16.** Hourly Salinity and Water Level by station (metric)
- **Table 2.** Least square means of adjusted salinity and water level data from 1998 – 2002.
