Monitoring Series No. TE17-MSPR-0599-1

COMPREHENSIVE MONITORING REPORT NO. 1

**FALGOUT CANAL - VEGETATIVE PLANTING
DEMONSTRATION PROJECT (TE-17)**

June 2000

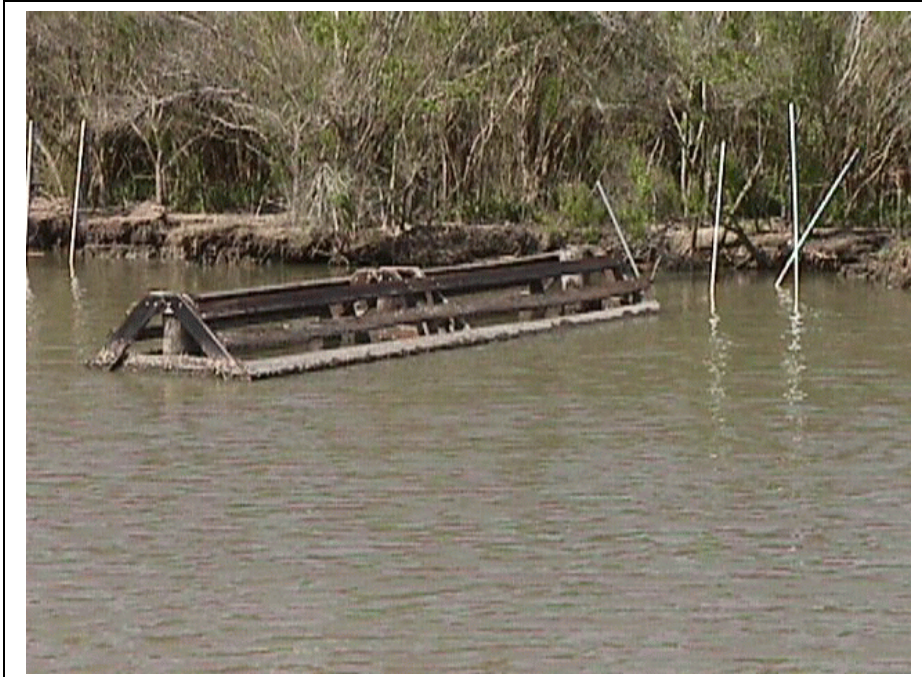
Figure 5. Shore perpendicular, four and five section double sided wooden A-frame (design A; treatments 1 and 8) at Falgout Canal - Vegetative Plantings Demonstration Project (TE-17) (Photo taken March 13, 2000).

Fence treatment (1) is a 20 ft (6.1 m) long wooden grated apex (design A) placed perpendicular to shore on 10 in x 15 ft (25 cm x 4.5 m) pilings, with a base width of 5 ft (1.5 m) and a height of 2 ft (60 cm) (figure 5). Creosote timbers, 20 ft x 6 in x 2 in (6.1 m x 15 cm x 5 cm), were bolted to wooden supports to form a grated apex. Four structures were placed perpendicular to the shoreline approximately 30 ft (9 m) apart, with the top of the structure at +2.5 ft (+76.0 cm) National Geodetic Vertical Datum (NGVD) and the bottom of the apex at +0.5 ft (+15.0 cm) NGVD. Fence treatment (8) is the same as design (A), with 5 structures placed 20 ft (6.1 m) apart. Fence treatment (7) is also, a similar wooden apex design. However, it is design B which is single sided, and was placed parallel to the shoreline (figure 6). (Appendix A-1)

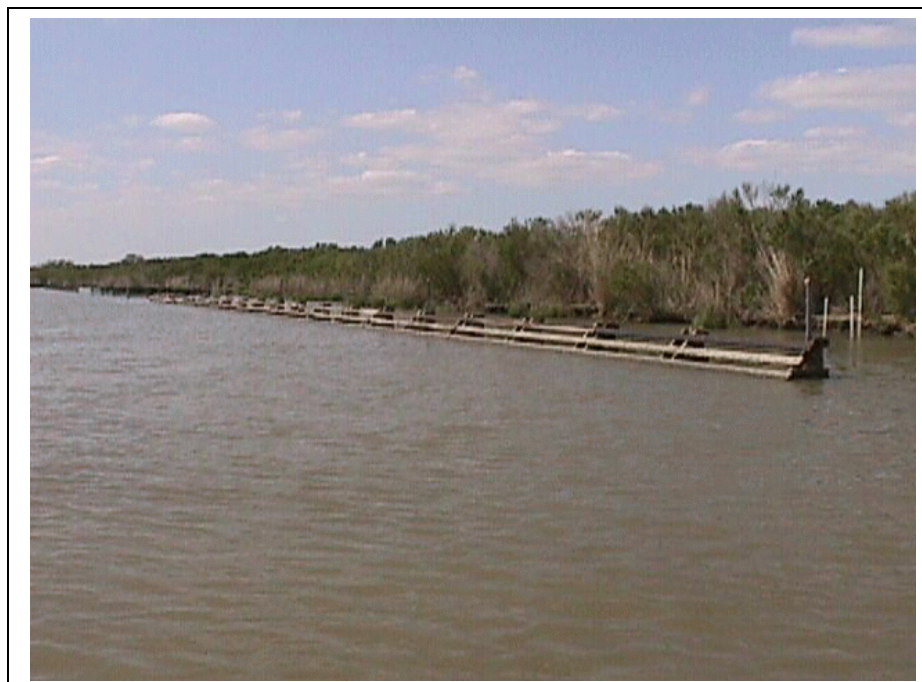
Figure 6. Shore-parallel single sided wooded A-frame (design B; treatment 7) at Falgout Canal - Vegetative Plantings Demonstration Project (TE-17) (Photo taken March 13, 2000).

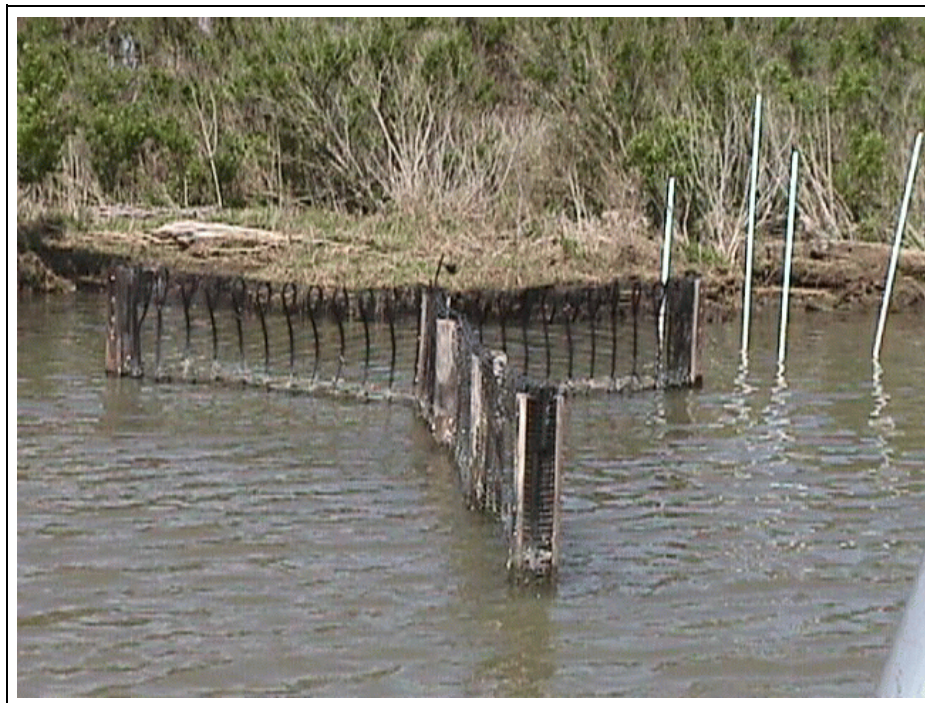
Figure 7. Shore-perpendicular, five and four section uniaxial geo-gid fence with flared end (design C) at Falgout Canal - Vegetative Plantings Demonstration Project (TE-17) (Photo taken March 13, 2000).

Fence treatment (2) is a 20 ft (6.1 m) long uniaxial geo-grid, supported by 4 in x 4 in x 10 ft (10 cm x 10 cm x 3 m) timber posts (design C). Five structures were placed perpendicular to the shoreline approximately 5 ft (1.5 m) apart, with the top of the structure at +2.5 ft (+76.0 cm) NGVD and the bottom of the fence at -1.0 ft (-30.0 cm) NGVD. The end nearest the shoreline bifurcates at a 90° angle for the last 5 ft (1.5 m) (figure 7). Treatment (4) was similarly spaced, but is design D and lacked the bifurcation at the end. Treatments (6) and (9) used the same construction designs as treatments (2) and (4), respectively, however, only four structures were built with a wider spacing of 30 ft (9 m) apart. (Appendix A-2)

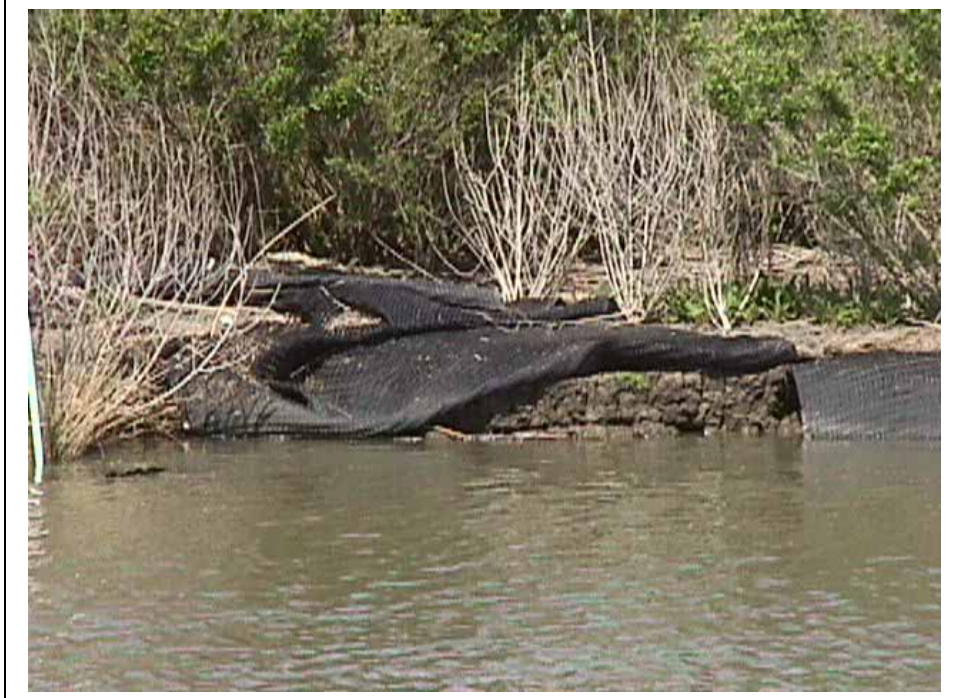
Figure 8. Geo-mesh fabric laid on shore (design F; treatment 3) at Falgout Canal - Vegetative Plantings Demonstration Project (TE-17). Fabric has been tossed up on shore due to wave action. (Photo taken March 13, 2000).

The wave damping structures have held up well, except for the geo-mesh fabric (figure 7). The geo-mesh fabric was displaced shoreward and eventually ended up on the shoreline. Minor damage has occurred on some support posts on the uniaxial geo-grid fence designs, and the damage appears to be from an impact, either a log or boat striking the structure (figure 15).

Fence treatment (3) is a geo-mesh fabric laid (design F) on a 100 ft (30.5 m) section of the shoreline and run to the bottom of the canal approximately 15 ft (4.5 m) offshore and 10 ft (3 m) onshore (figure 8). The fabric was secured at the top and bottom with sacks of concrete. (Appendix A-3). Fence treatment (5) is a 100 ft (30.5 m) long uniaxial geo-grid fence (design E), supported by 4 in x 4 in x 10 ft (10 cm x 10 cm x 3 m) timber posts every 5 ft (1.5 m). The fence was positioned parallel to the shoreline, with the top of the structure at +2.5 ft (+76.0 cm) NGVD and the bottom of the apex at -1.0 ft (-30.0 cm) NGVD (figure 9, Appendix A-3).

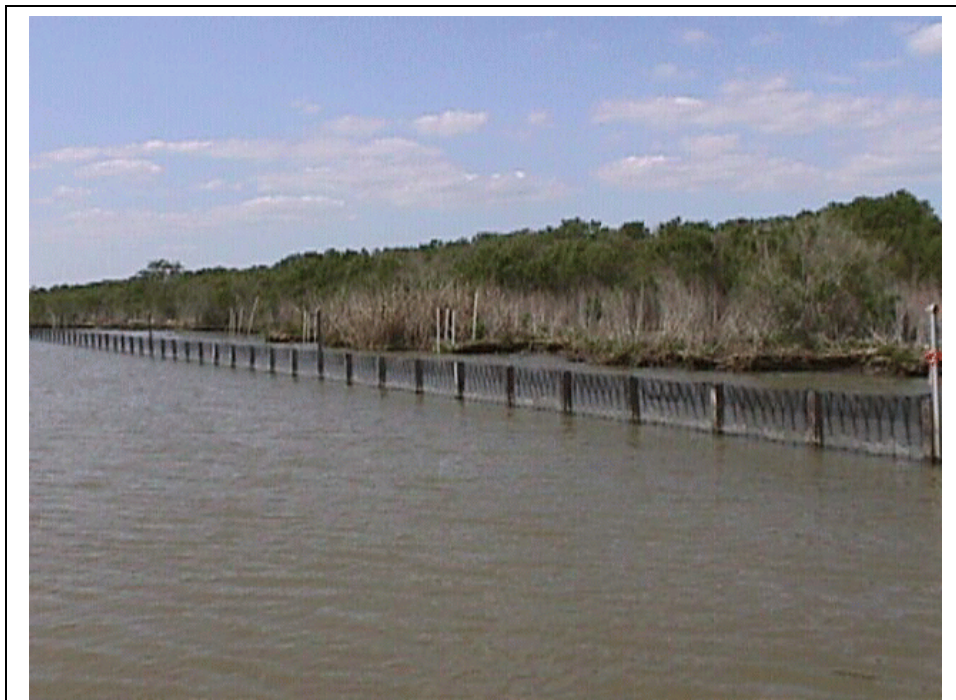
Figure 9. Shore-parallel, uniaxial geo-grid fence (design E; treatment 5) at Falgout Canal - Vegetative Plantings Demonstration Project (TE-17) (Photo taken March 13, 2000).

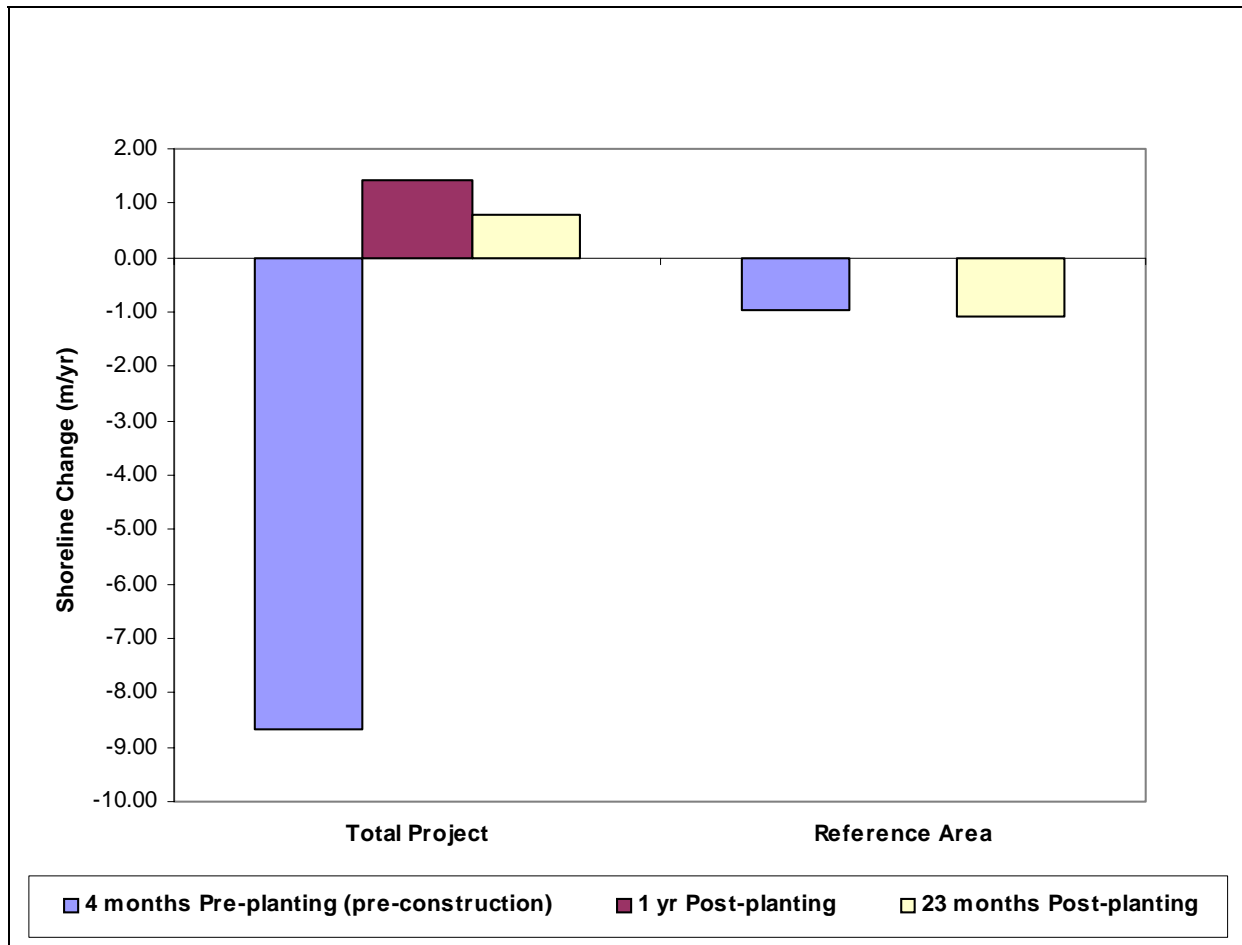
Figure 14. Shoreline change rates from DGPS data for project and reference area at Falgout Canal - Vegetative Plantings Demonstration project (TE-17).

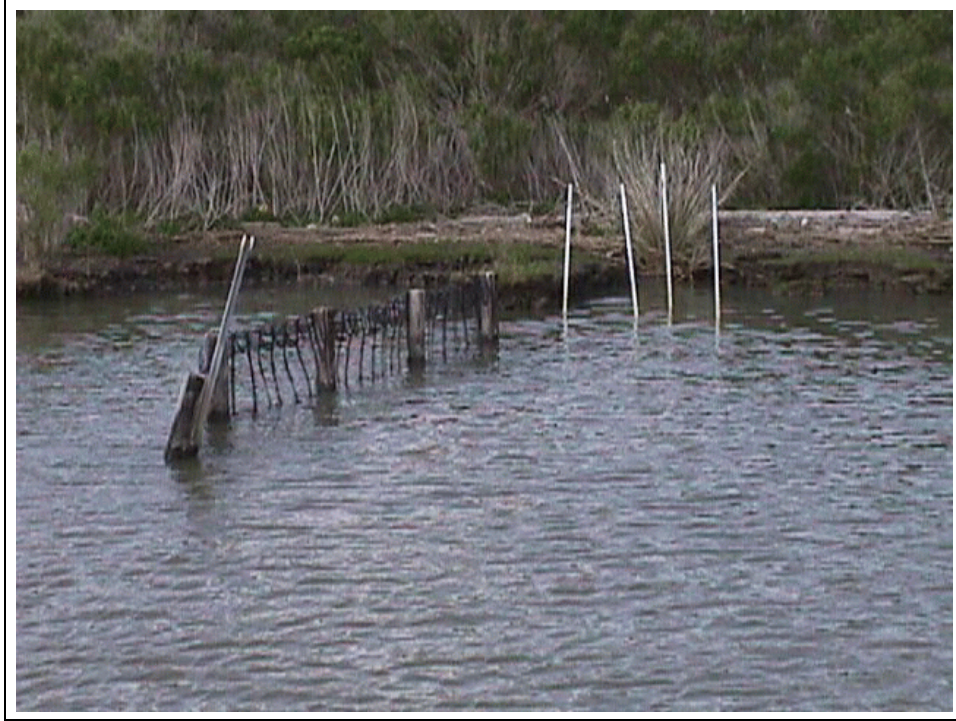
Figure 15. Damage on Shore-perpendicular, four section uniaxial geo-grid fence (design D; treatment 4) at Falgout Canal - Vegetative Plantings Demonstration Project (TE-17) (Photo taken March 13, 2000).
