Monitoring Series No. ME-12-MSTY-0698-1

CLOSEOUT MONITORING REPORT

**SW SHORE WHITE LAKE PROTECTION (DEMO)
ME-12**

**Third Priority List Shoreline Protection Project
of the Coastal Wetlands Planning, Protection, and Restoration Act
(Public Law 101-646)**

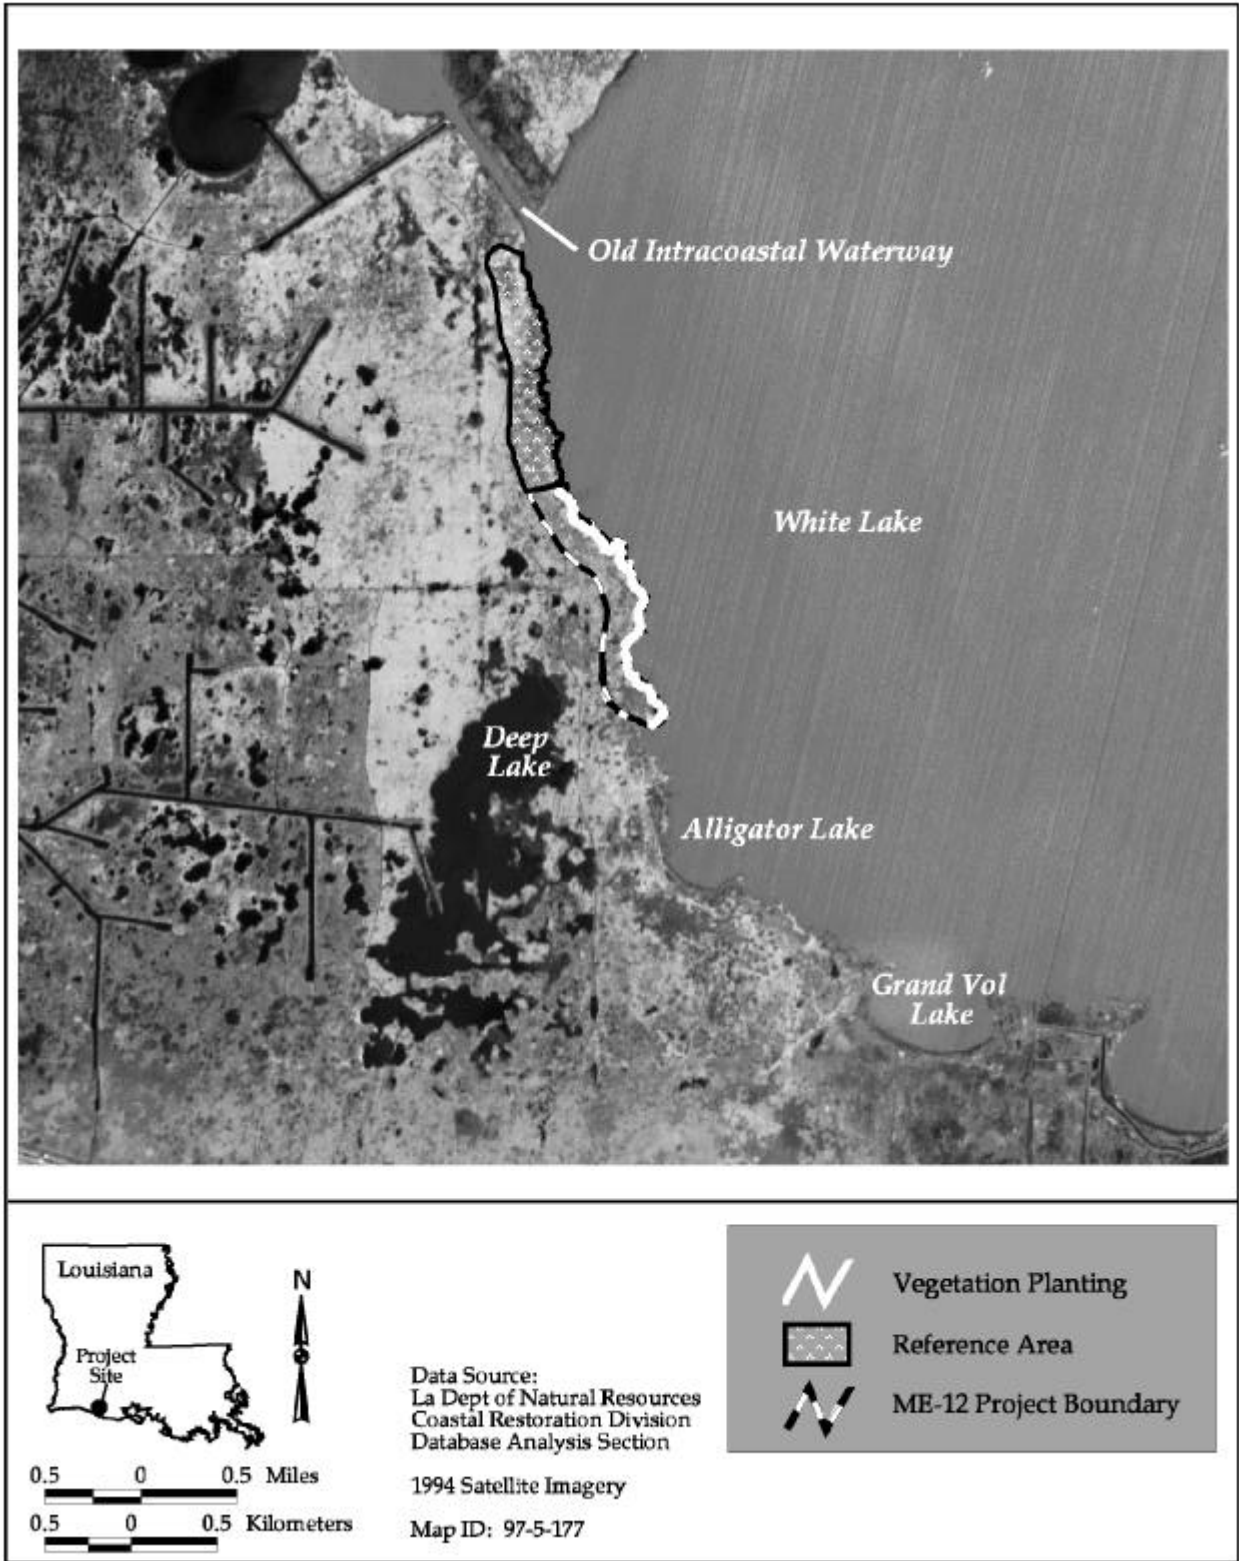
Figure 1. SW Shore White Lake Protection DEMO (ME-12) project and reference area boundaries and vegetation planting locations.

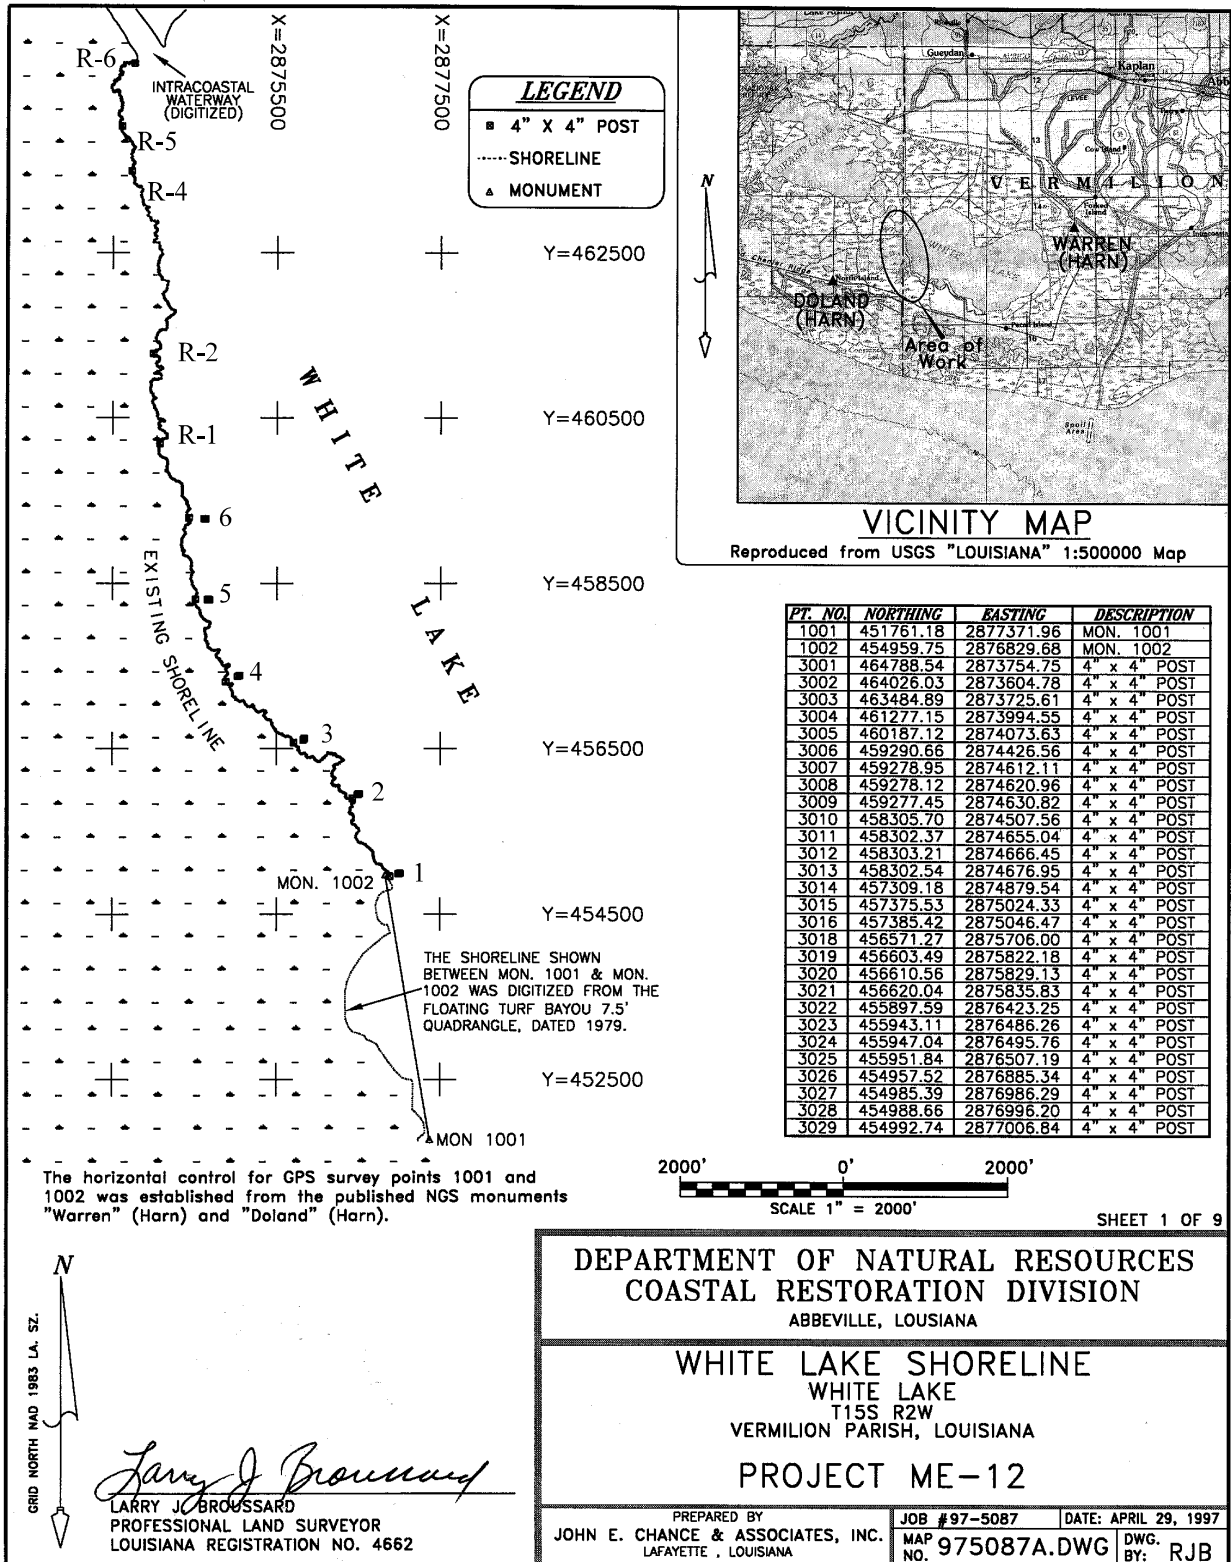
Figure 2. SW Shore White Lake Protection DEMO (ME-12) plan view showing the project and reference area.

A shoreline location survey was conducted on April 29, 1997 (figure 2). This survey included 11 permanent marker locations, 6 in the project area and 5 in the reference area. One reference station (R-3) was missing at the time of the survey. Measurements were taken from the 4x4 shoreline marker to the existing shoreline. Vegetation marker posts in the project area were included in the survey.

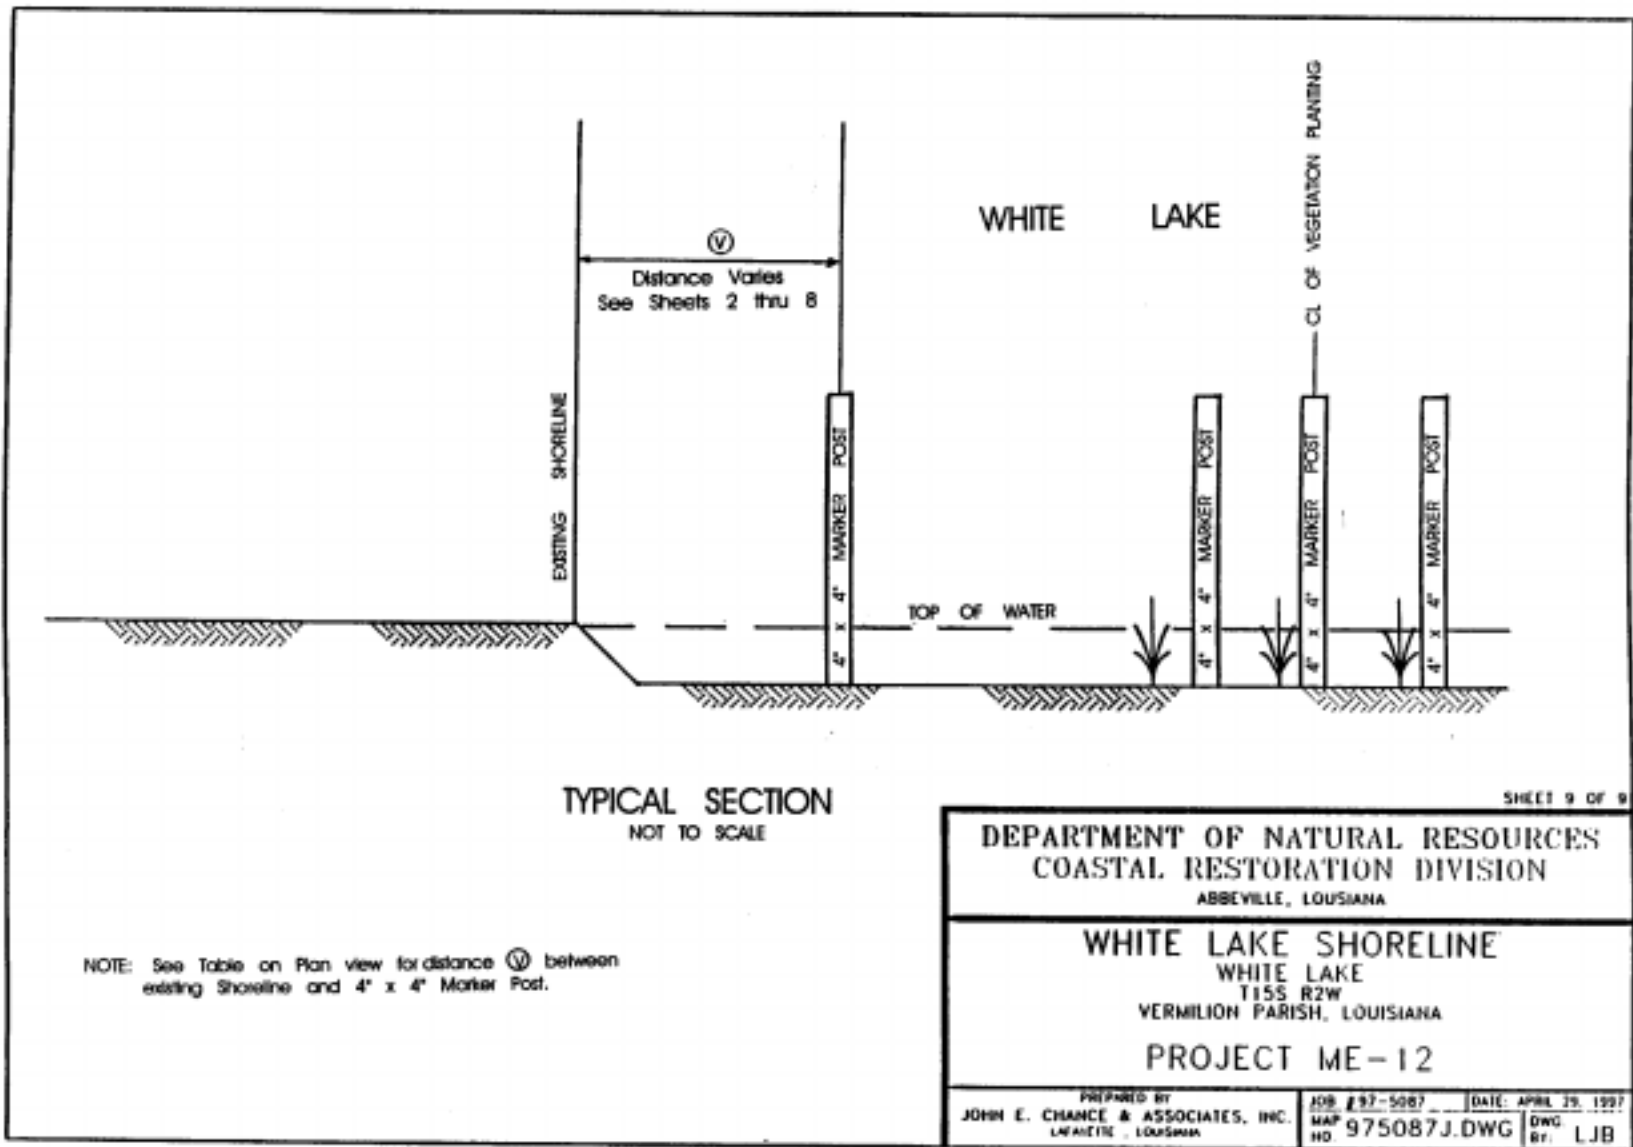
Figure 3. SW Shore White Lake Protection DEMO (ME-12) typical section showing existing shoreline, marker posts where direct measurements were taken, and location of plantings.

Measurements were taken east (lakeside) and west (shoreline) of the vegetation marker posts to determine lateral spread and amount of tillering of the transplanted vegetation (figure 3). Measurements from the six plots were averaged to obtain a mean and standard deviation (SD) for lateral spread for the 1 month, 6 month, and 12 month sampling period.

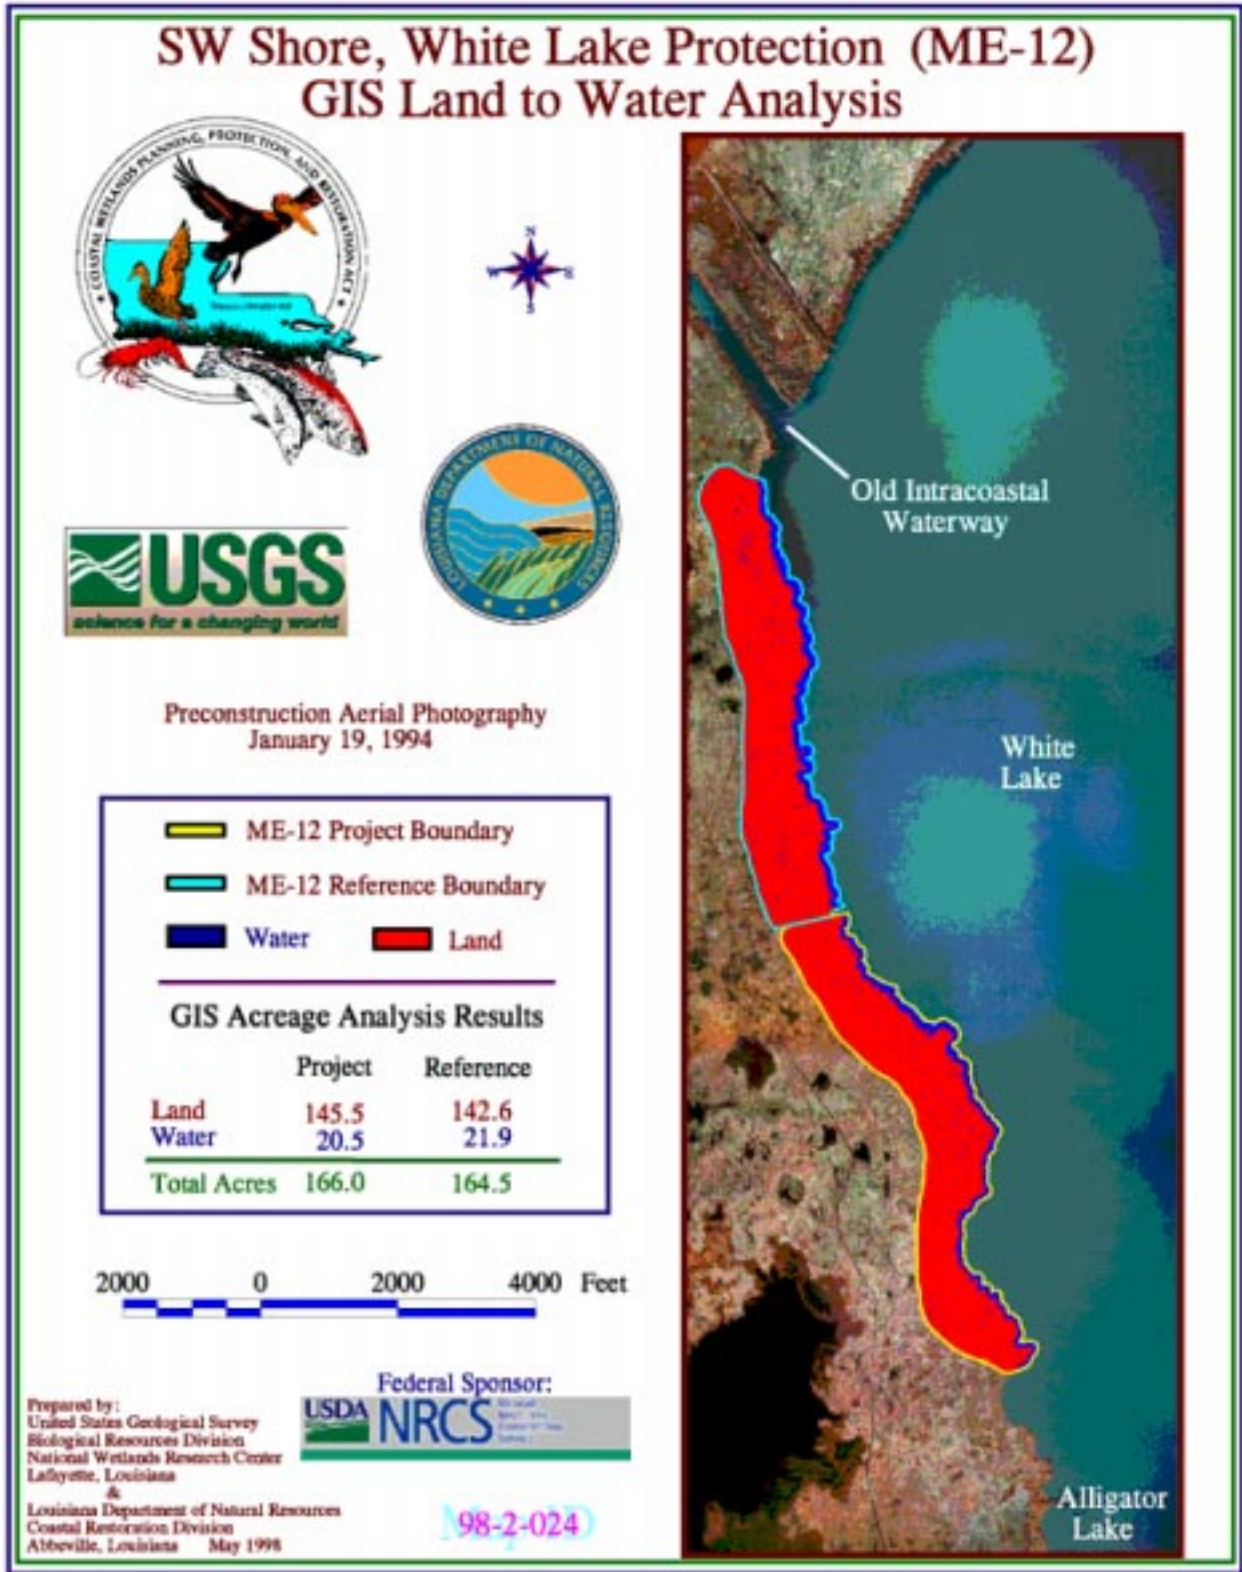
Figure 4. SW Shore White Lake Protection DEMO (ME-12) land/water acreage analysis.

Aerial Photography: The GIS analysis showed that at the time of the flight, the project area consisted of 145.5 ac (58.2 ha) of land and 20.5 ac (8.2 ha) of water. The reference area contained 142.6 ac (57 ha) of land and 21.9 ac (8.8 ha) of water (figure 4). The GIS land-water classification analysis was conducted on the approved project boundaries, but after further discussion with monitoring managers and sponsoring agency personnel, a 75 ft (22.9 m) coastline buffer was added to the project and reference areas to further study any transgression or regression of the shoreline. This increase is reflected in the acreage results from the GIS analysis.

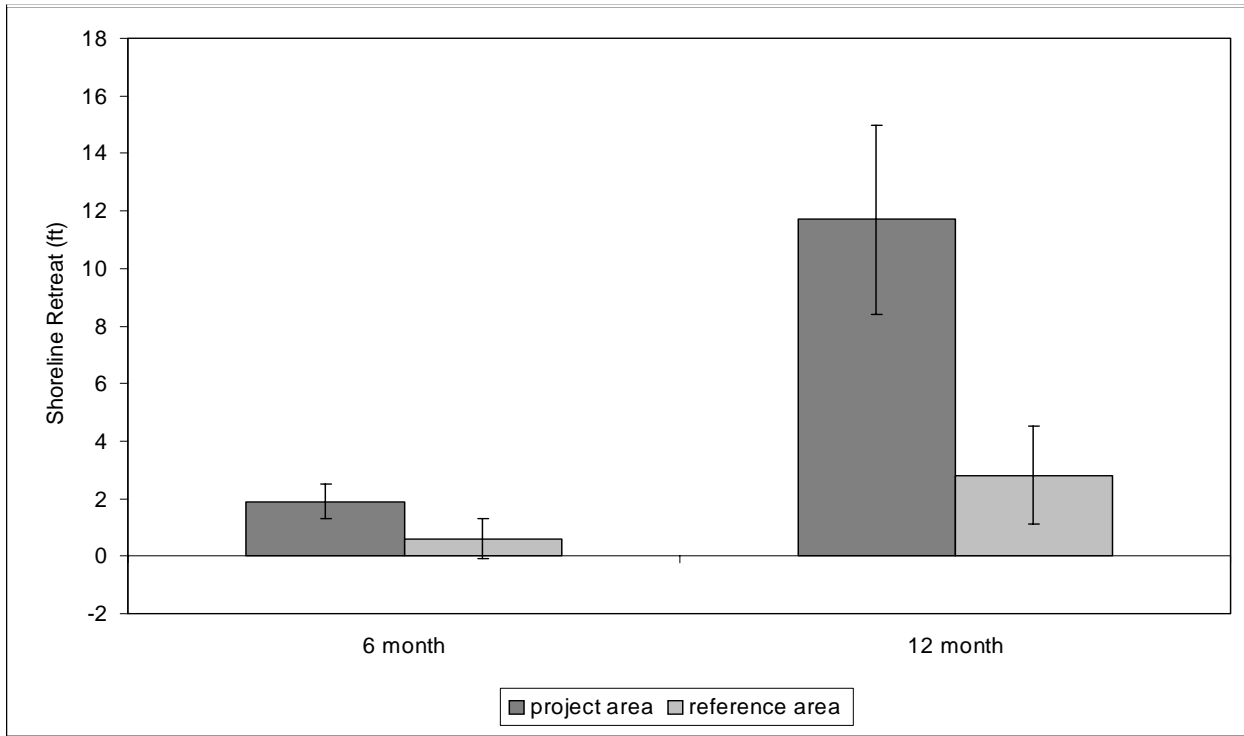
Figure 5. SW Shore White Lake Protection DEMO (ME-12) showing shoreline retreat (feet) in the project and reference area at the 6 and 12 month sampling period.

Shoreline change: Erosion was measured at all stations in the project area at the 12 month sampling period (table 1). Plot 6 showed the largest amount of erosion at 24.5 ft/yr (7.5 m/yr). Mean shoreline change within the project area was $-1.9 \text{ ft} \pm 1.1 \text{ SD}$ ($-0.58 \text{ m} \pm 0.33$), and $-11.7 \text{ ft} \pm 3.3$ ($-3.57 \text{ m} \pm 1.0$), at the 6 month and 12 month sampling period, respectively. In the reference area, R-1, R-2, R-4, and R-5 indicated erosion. R-3 had to be reestablished because the 4x4 shoreline marker post was missing. R-3 showed a 1.0 ft (0.3 m) gain while R-6 had no net loss. Mean shoreline change in the reference area was $-0.6 \text{ ft} \pm 1.1$ ($-0.2 \text{ m} \pm 0.3$), and $-2.8 \text{ ft} \pm 1.3$ ($-0.9 \text{ m} \pm 0.4$), at the 6 month and 12 month sampling period, respectively (figure 5).

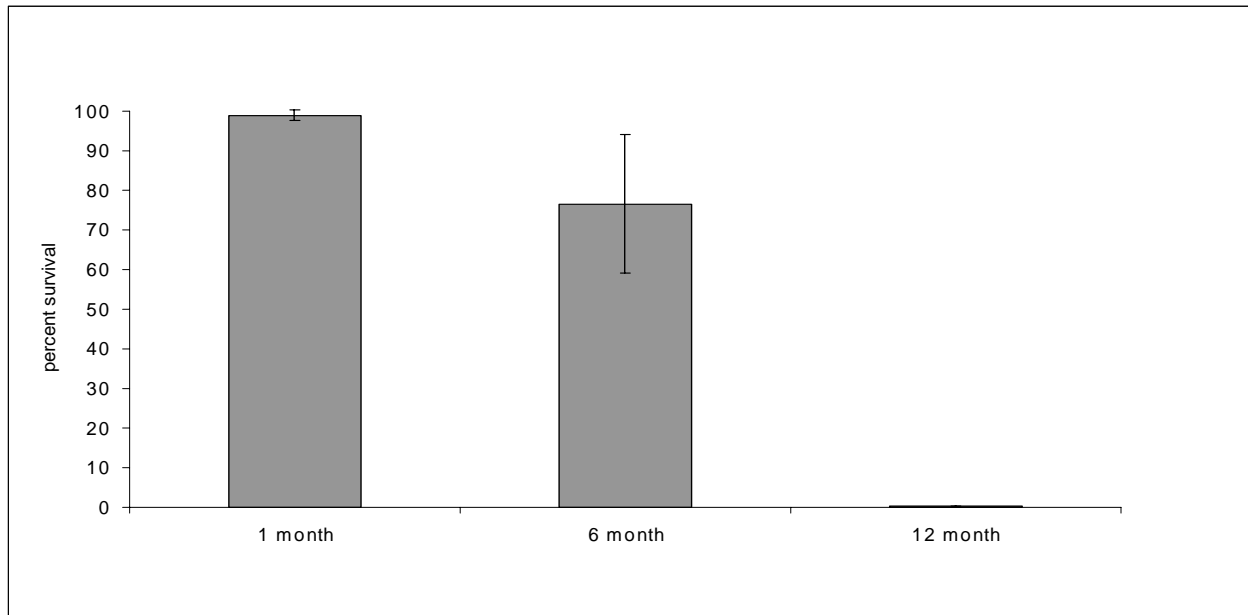
Figure 6. SW Shore White Lake Protection DEMO (ME-12) vegetative percent survival in the project area at the 1, 6, and 12 month sampling period.

Vegetation: Summary statistics from the vegetation surveys conducted at the 1, 6, and 12 month sampling period indicated that survivorship of *S. californicus* in the project area decreased from 0.99 at 1 month to 0.77 at 6 months with mortality increasing from 0.01 to 0.22 (table 2). At the 12 month sampling period survivorship decreased to 0.01 with mortality increasing to 0.76. Mean percent survival of the vegetative plantings was 98.8 ± 2.7 at the 1 month sampling period and decreased to 76.6 ± 34.7 at the 6 month sampling period. At the 12 month sampling period, percent survival decreased to 0.17 ± 0.4 (figure 6). Mean lateral spread of the vegetative plantings was $11.6 \text{ in} \pm 5.7$ ($29 \text{ cm} \pm 14.5$) at the 1 month sampling period, and $13.6 \text{ in} \pm 7.7$ ($35 \text{ cm} \pm 19.6$) at the 6 month sampling period. The mean lateral spread of the vegetative plantings was 0.0 in (0.0 cm) at the 12 month sampling period (figure 7).

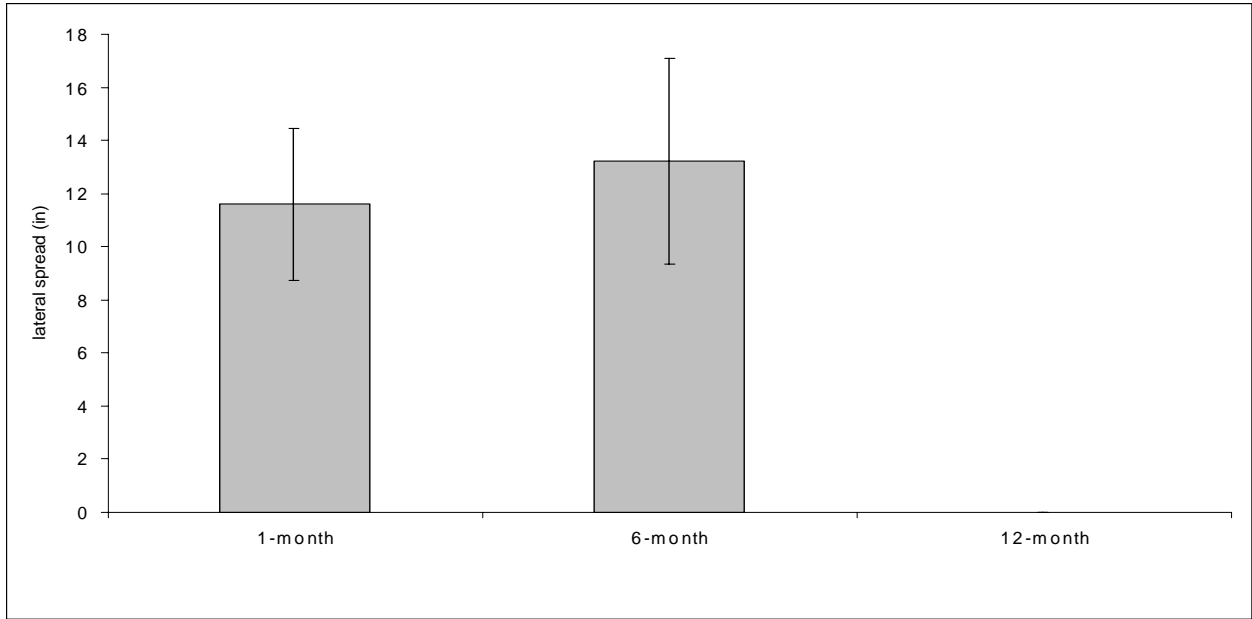
Figure 7. SW Shore White Lake Protection DEMO (ME-12) vegetative lateral spread (inches) in the project area at the 1, 6, and 12 month sampling period.

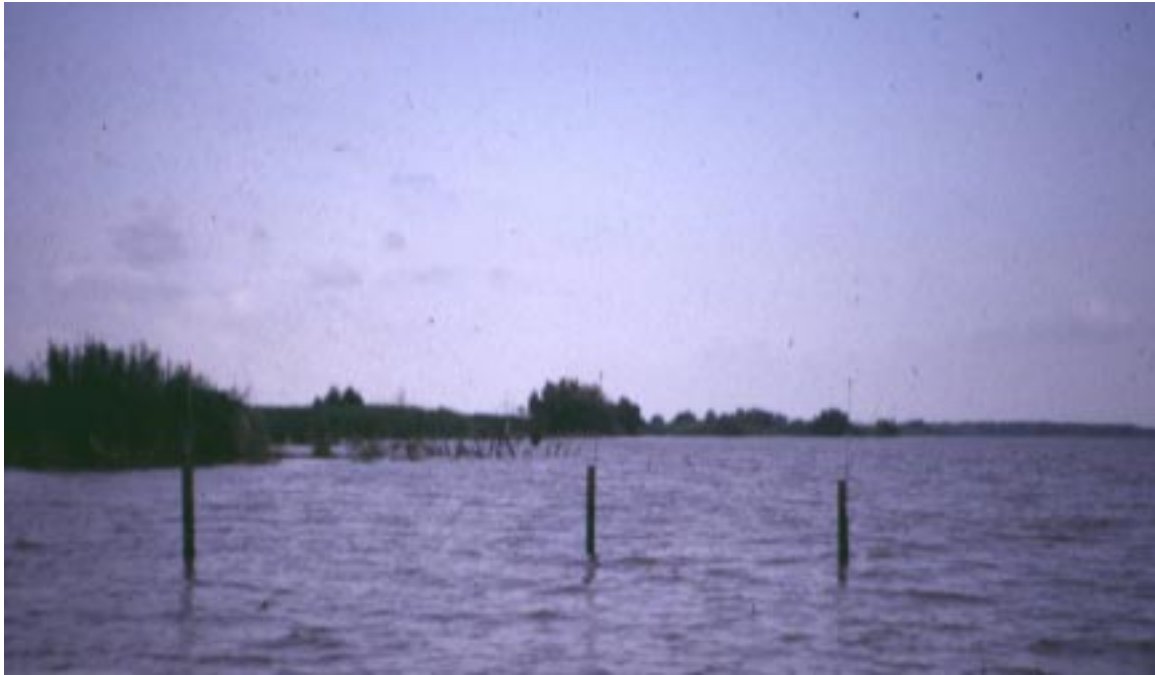
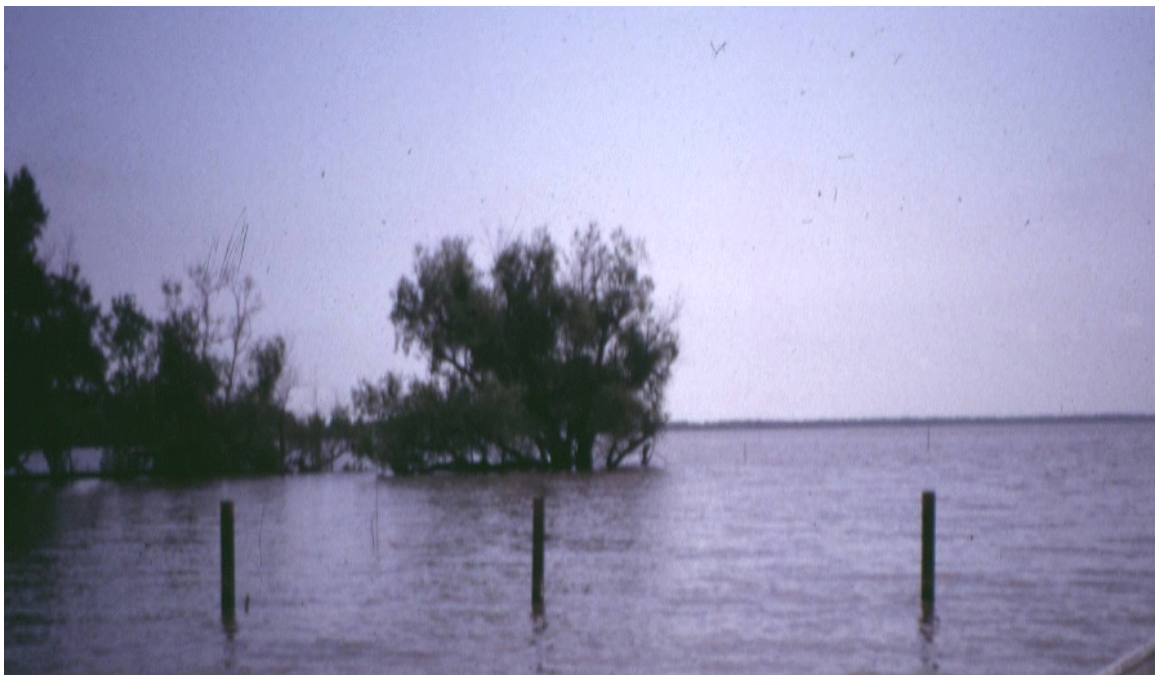
The project area showed a great deal of variance among the plots. The points along the shoreline were characterized by a sharp cutbank while the coves had gentle sloping banks. Plot 1 and 2 were both considered points but were very different in configuration. Plot 1 was a rounded wide point that tapered slightly. Plot 2 was a narrow point that once eroded exhibited a high erosion rate (figure 8). Plots 3 through 5 were similar coves with few defining characteristics such as an adjacent lobe or jagged shoreline. Plot 6 was a cove forming off of the side of a lobe jetting out into the lake with similar conditions to plot 2. In July 1996, the 1 month sampling period, DNR personnel noted the bank at plot 6 was sparsely vegetated with a few trees on the high areas of the lobe but in December, 1996, during the 6 month sampling period, the lobe was unvegetated. In July, 1997, during the 12 month sampling period, the lobe was approximately eighty-five percent eroded and the trees that remained were in standing water (figure 8). This situation was present throughout the entire project area shoreline where long thin points with traces of vegetation eroded leaving open water with uprooted trees and stumps scattered along the shoreline. All reference area sites were noted to be in coves without the extreme variance represented in the project area.

Figure 8. Photographs: (A) plot 2 showing an eroding lobe and the plot absent of *Scirpus californicus* plantings; (B) plot 6 showing another eroding lobe with trees in standing water with one *Scirpus californicus* planting present in the plot.

DNR and NRCS personnel investigated the entire project area noting that all six monitoring plots were devoid of *S. californicus* plantings except for station 6, which had one two-stemmed plant in the entire plot. Of the 2,650 *S. californicus* plants planted in the project area, only 30 to 40 were present after 12 months.

The results presented in this report suggest that *S. californicus* was not effective as a wave damping technique along the 1 mi (1.6 km) section of the southwest shoreline of White Lake. Unsuccessful establishment of the *S. californicus* plantings contributed to not meeting the goal of decreasing the rate of shoreline erosion along the southwest shoreline of White Lake. We hypothesize that the plantings had difficulty establishing due to the combined effects of water depth and high wind-driven wave energy. This does not indicate that all vegetative planting projects would be a failure in this area. Perhaps a different type of vegetation, another location, an earlier planting time, or some type of structure to lower the wave energy would increase the chances of success.

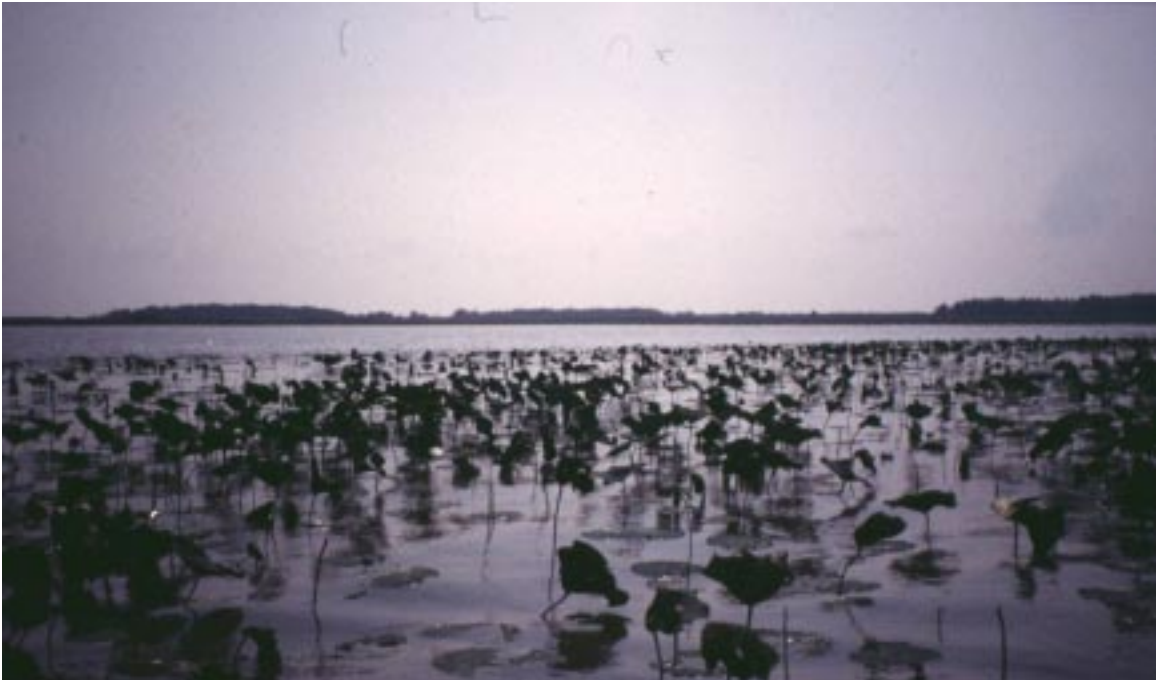
The only type of submersed aquatic vegetation present in stations 2, 3, R5, and R6 at the end of the 12 month sampling period was *N. lutea*. The stands of *N. lutea* that were present during the warmer months did provide some shore protection from southerly winds but were not very thick in the project or reference area. In areas near the project, *N. lutea* bordered the shoreline reaching out into the lake as much as 50 ft (15.2 m) (figure 9). In Grand Vol Lake, south of the project area (figure 1), DNR personnel observed at the 12 month sampling period that *N. lutea* covered approximately 75% of the lake. During the colder months *N. lutea* goes through a dormancy phase when most of the leaves and stems are not present. *N. lutea* does not protect the shoreline

from the northern winds that are most common in the colder months. There were no other types of SAV observed in the vicinity of the project and reference areas, which may be a due to turbid waters that are common to this area.

Figure 9. Photograph showing an area south of the project area where *Nelumbo lutea* is encroaching out lakeward providing some shore protection during the warmer months of the year.

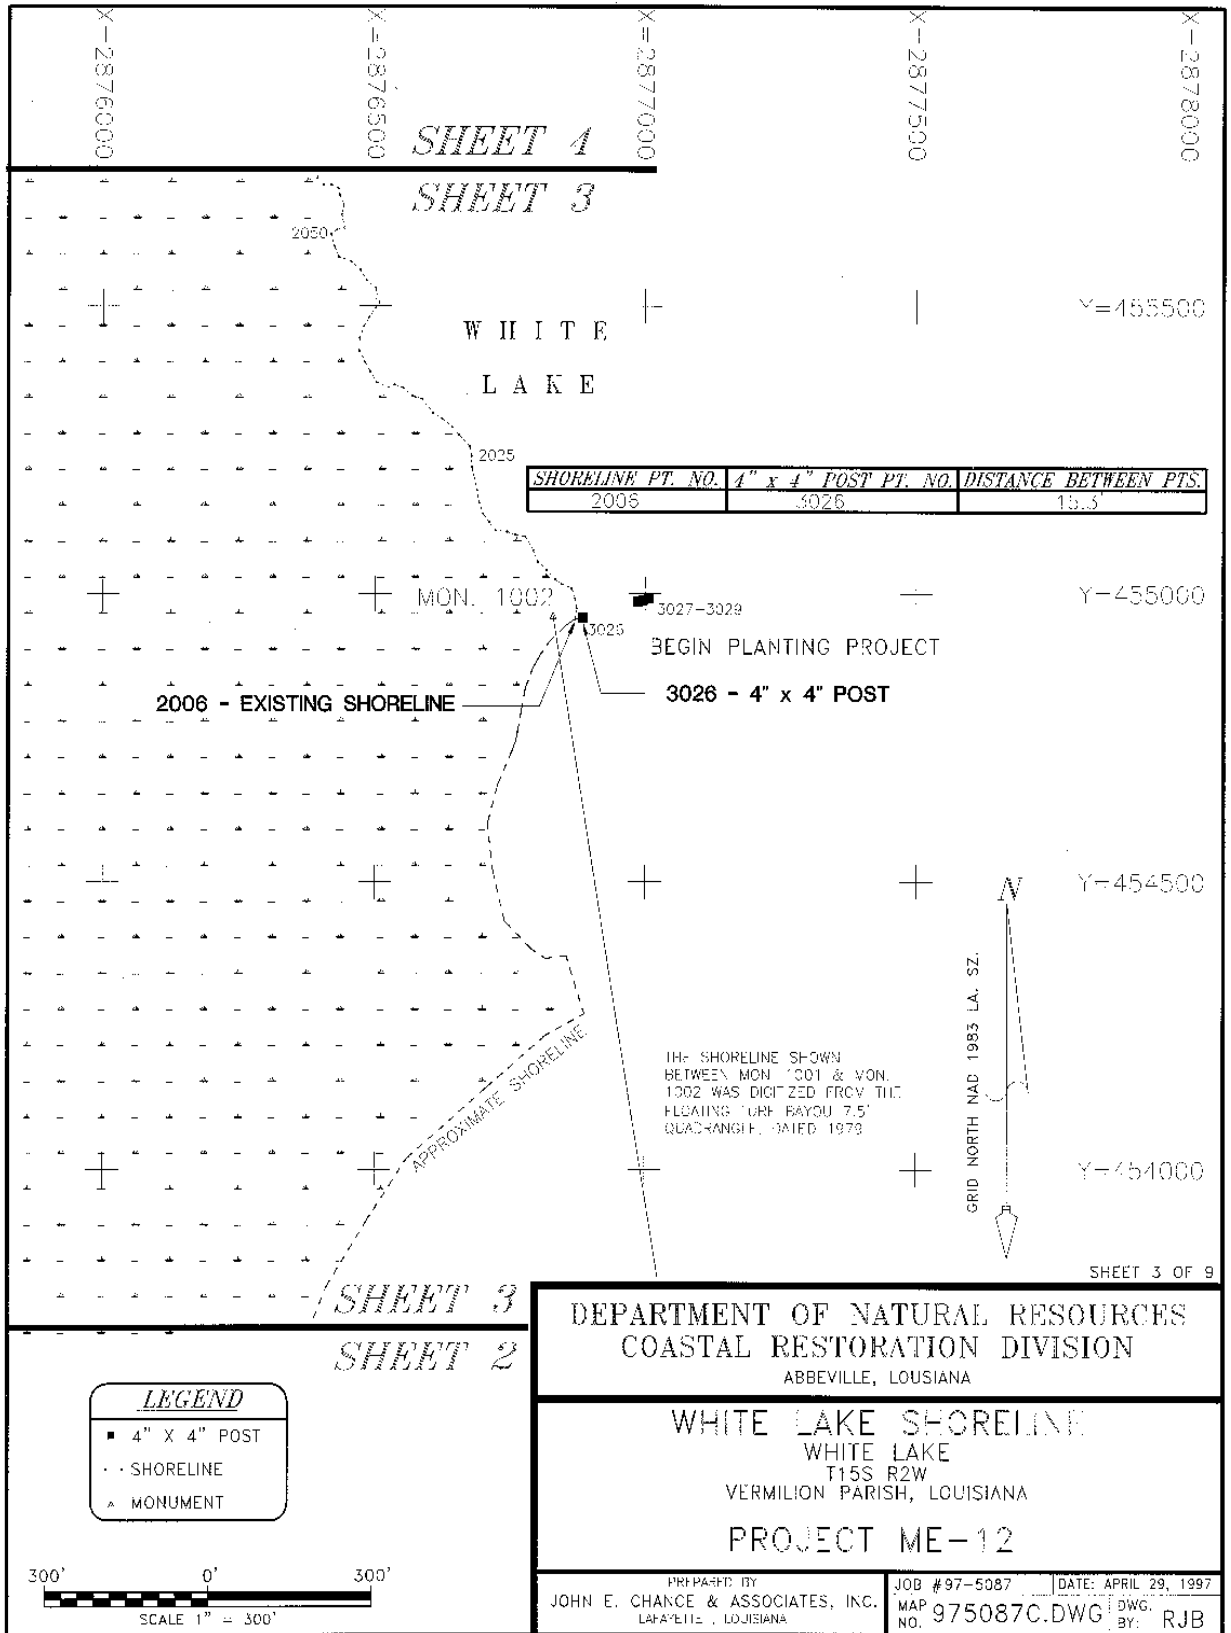
Figure A1. SW Shore White Lake Protection DEMO (ME-12) shoreline location survey showing station 1 (3026) in the project area, plant sampling location, and the distance from the shoreline marker to the existing shoreline.

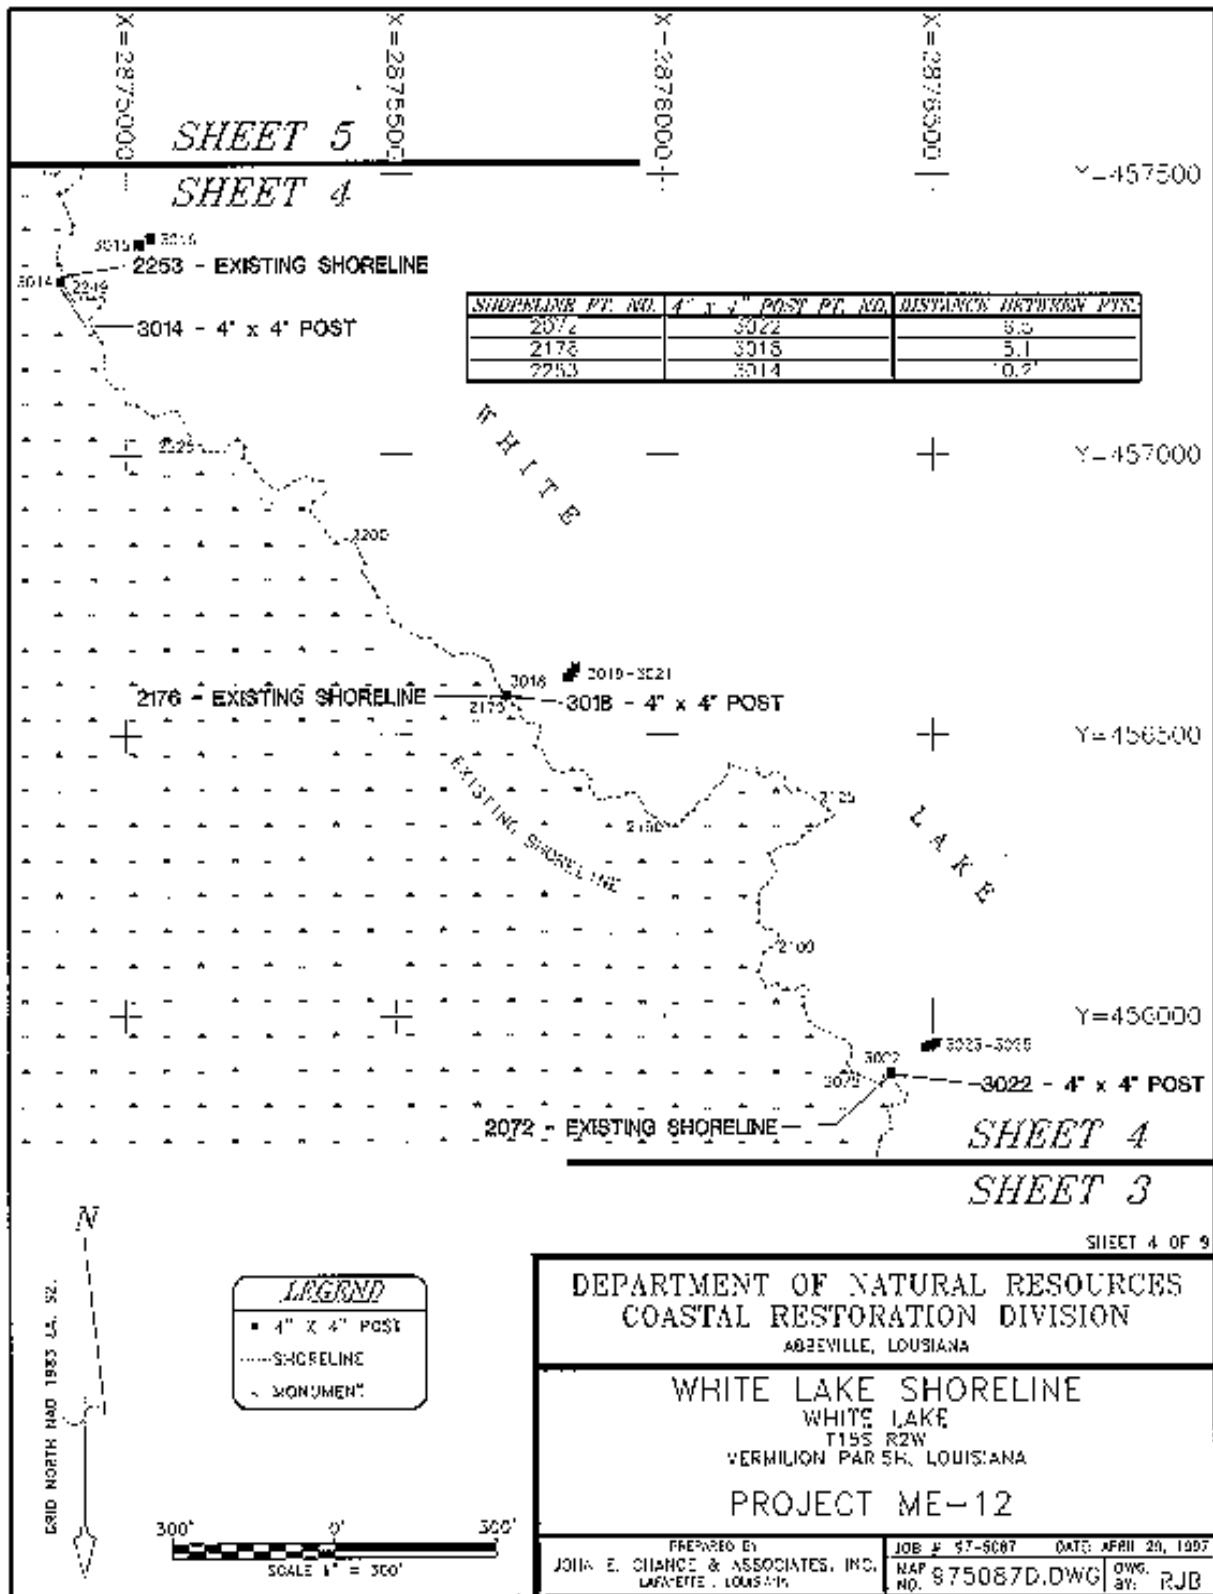
Figure A2. SW Shore White Lake Protection DEMO (ME-12) shoreline location survey showing station 2 (3022), 3 (3018), and 4 (3014) in the project area, plant sampling location, and the distance from the shoreline marker to the existing shoreline.

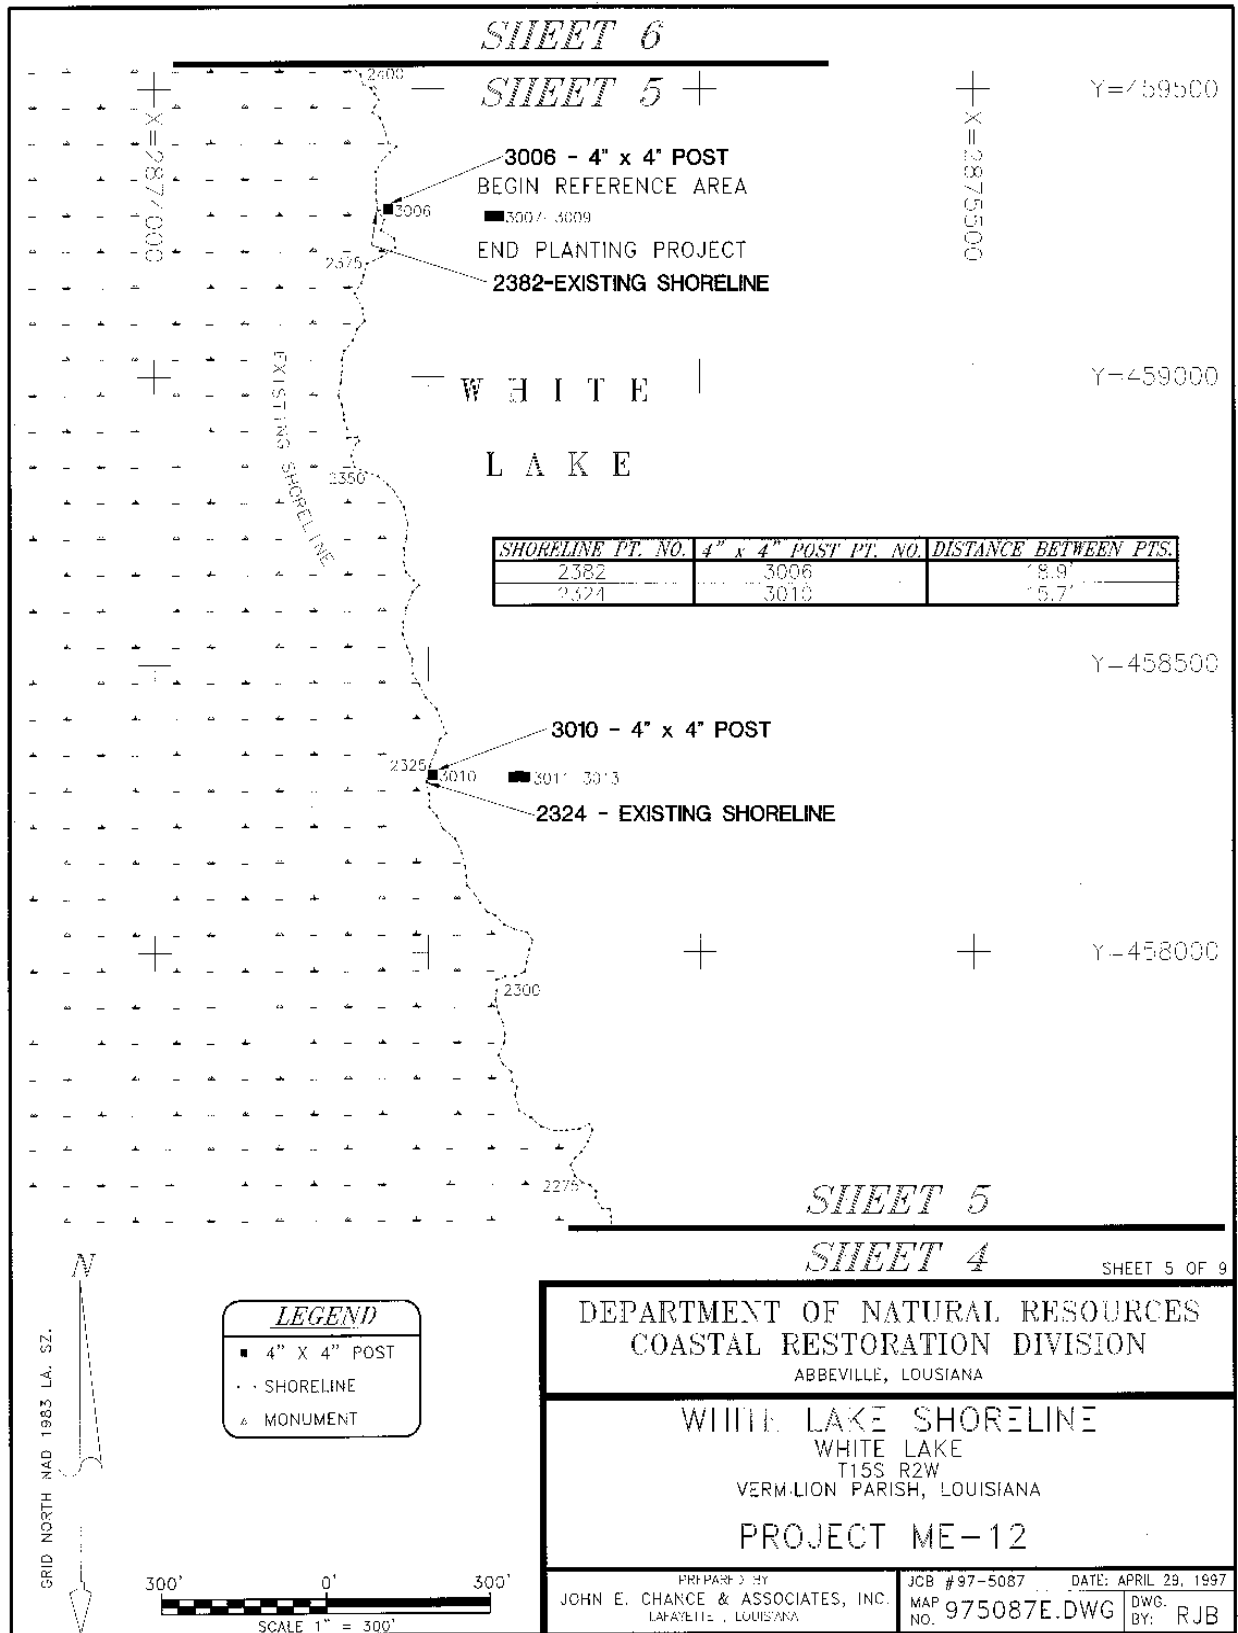
Figure A3. SW Shore White Lake Protection DEMO (ME-12) shoreline location survey showing station 5 (3010) and 6 (3006) in the project area, plant sampling location, and the distance from the shoreline marker to the existing shoreline.

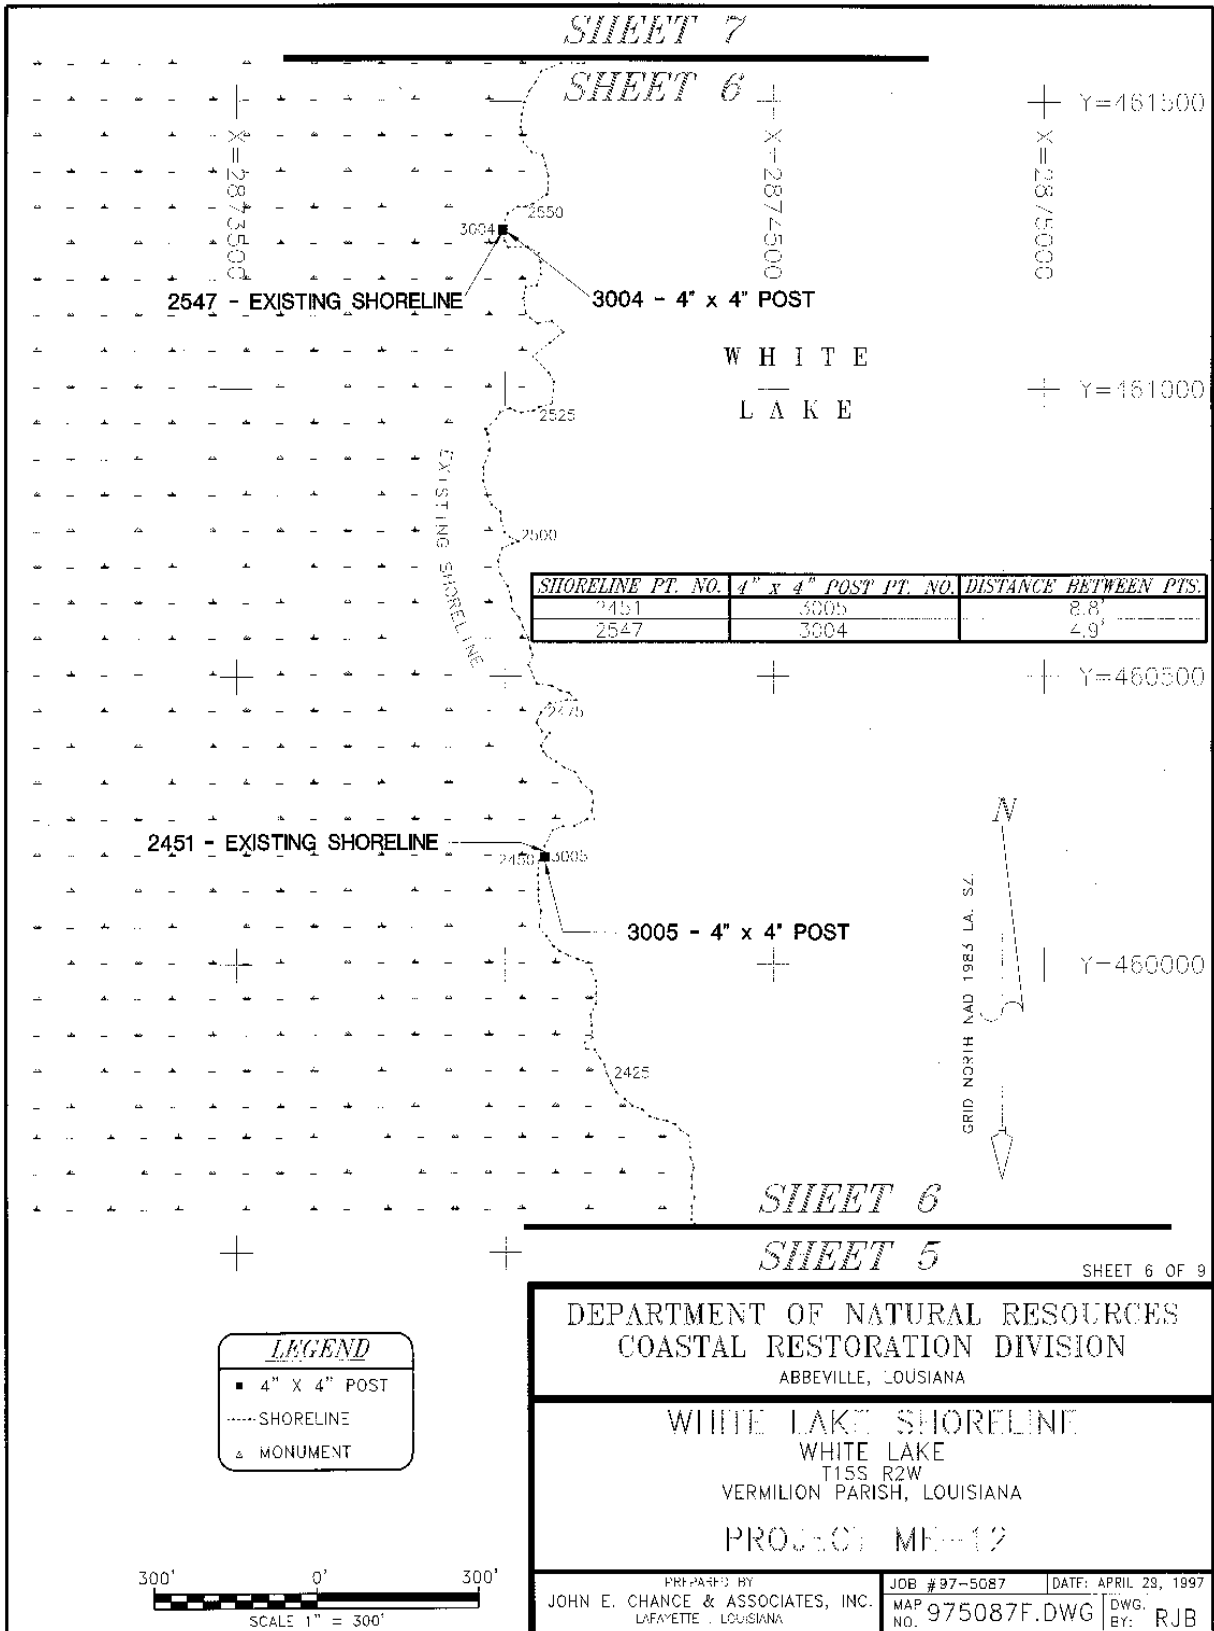
Figure A4. SW Shore White Lake Protection DEMO (ME-12) shoreline location survey showing station R-1 (3005) and R-2 (3004) in the reference area and the distance from the shoreline marker to the existing shoreline.
