Monitoring Series No. ME-12-MSTY-0698-1

CLOSEOUT MONITORING REPORT

**SW SHORE WHITE LAKE PROTECTION (DEMO)
ME-12**

**Third Priority List Shoreline Protection Project
of the Coastal Wetlands Planning, Protection, and Restoration Act
(Public Law 101-646)**

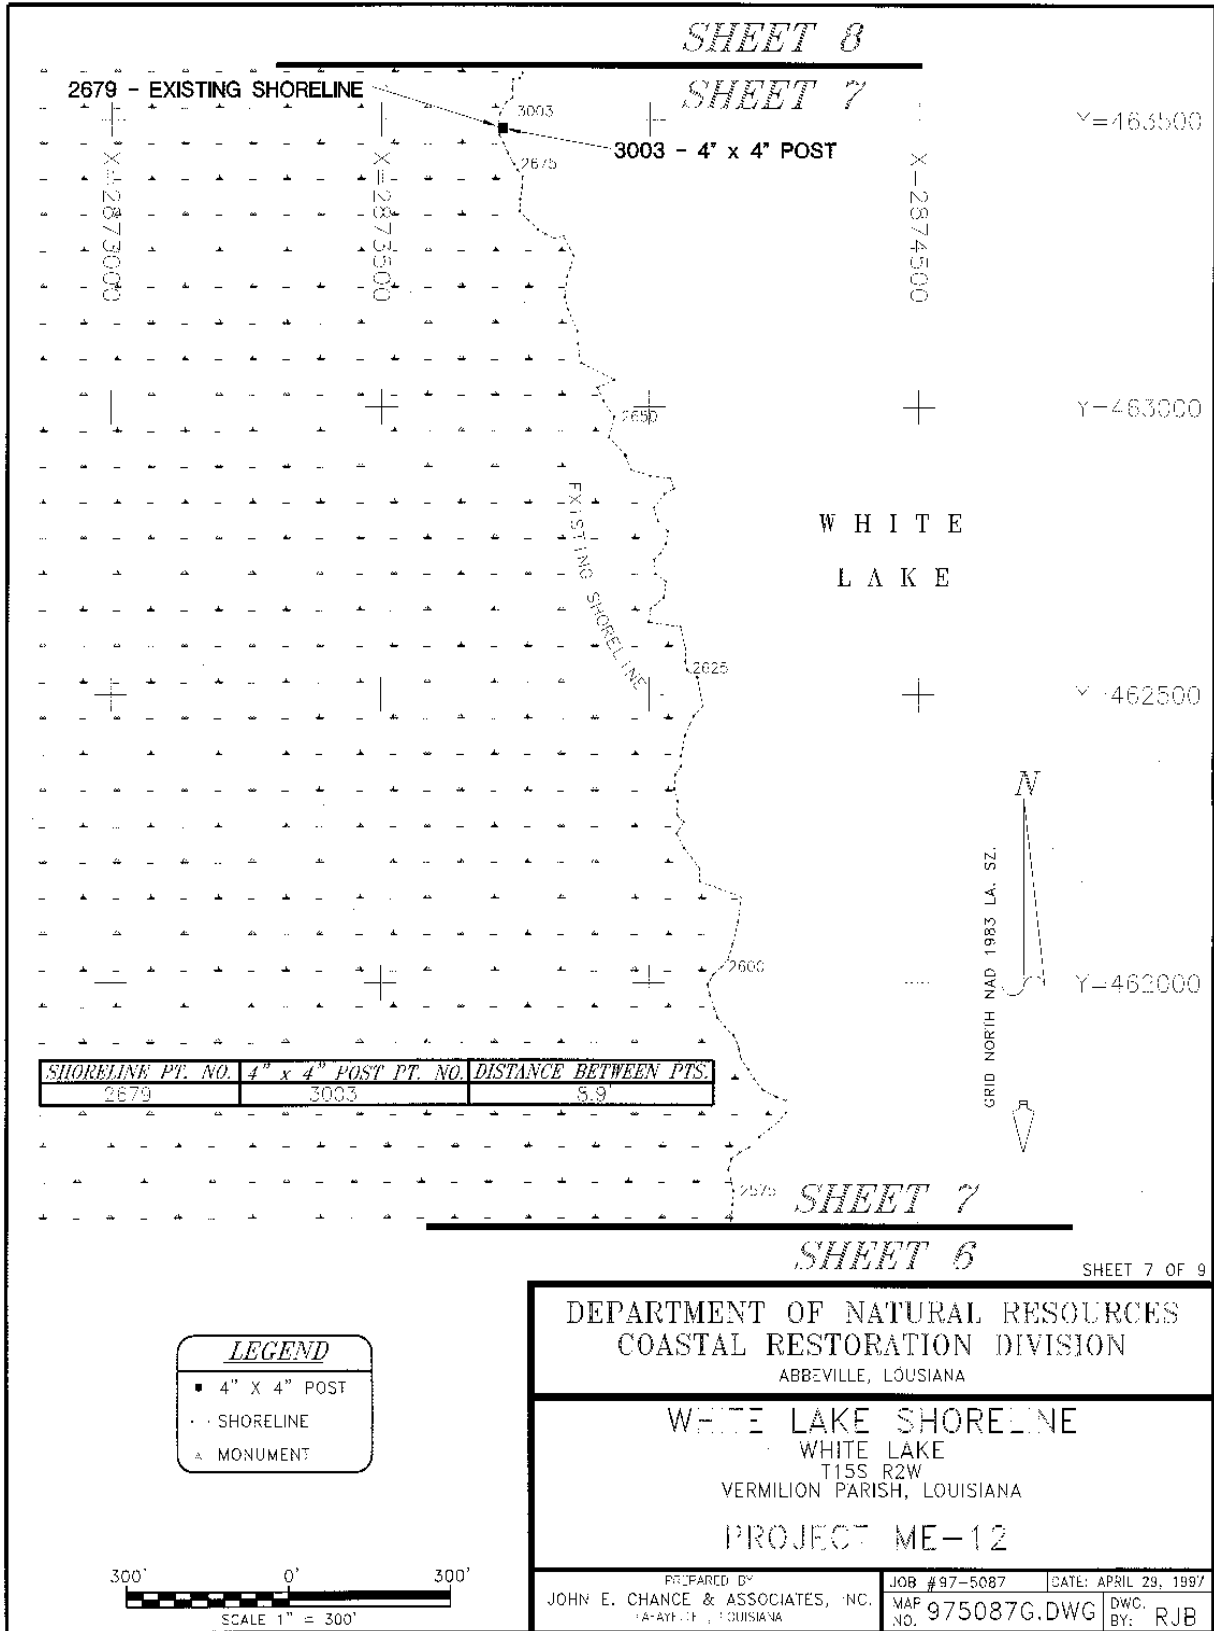
Figure A5. SW Shore White Lake Protection DEMO (ME-12) shoreline location survey showing station R-4 (3003) in the reference area and the distance from the shoreline marker to the existing shoreline. Station R-3 was missing at the time of the survey.

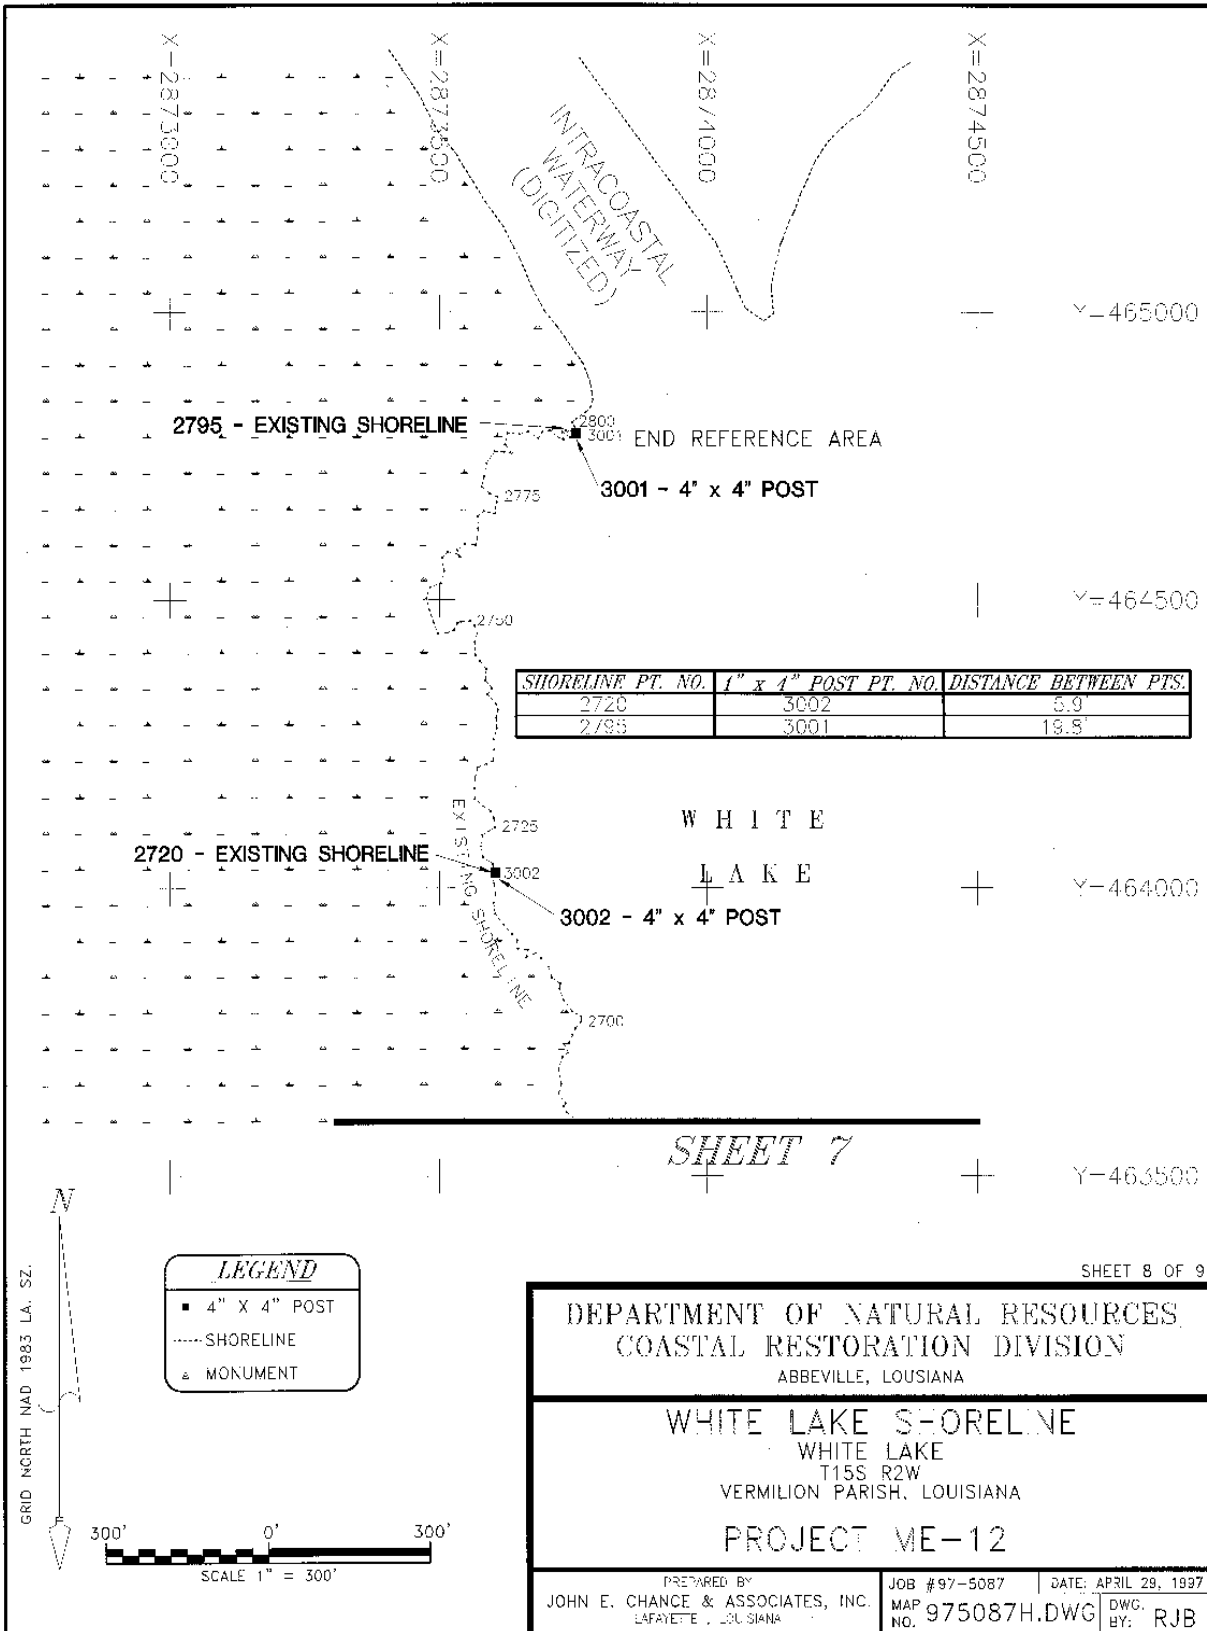
Figure A6. SW Shore White Lake Protection DEMO (ME-12) shoreline location survey showing station R-5 (3002) and R-6 (3001) in the reference area and the distance from the shoreline marker to the existing shoreline.
