**2007 Operations,  
Maintenance, and Monitoring  
Report**

**Jonathan Davis Wetland  
Protection**

State Project Number BA-20  
Priority Project List 2

July 30, 2007  
Jefferson Parish

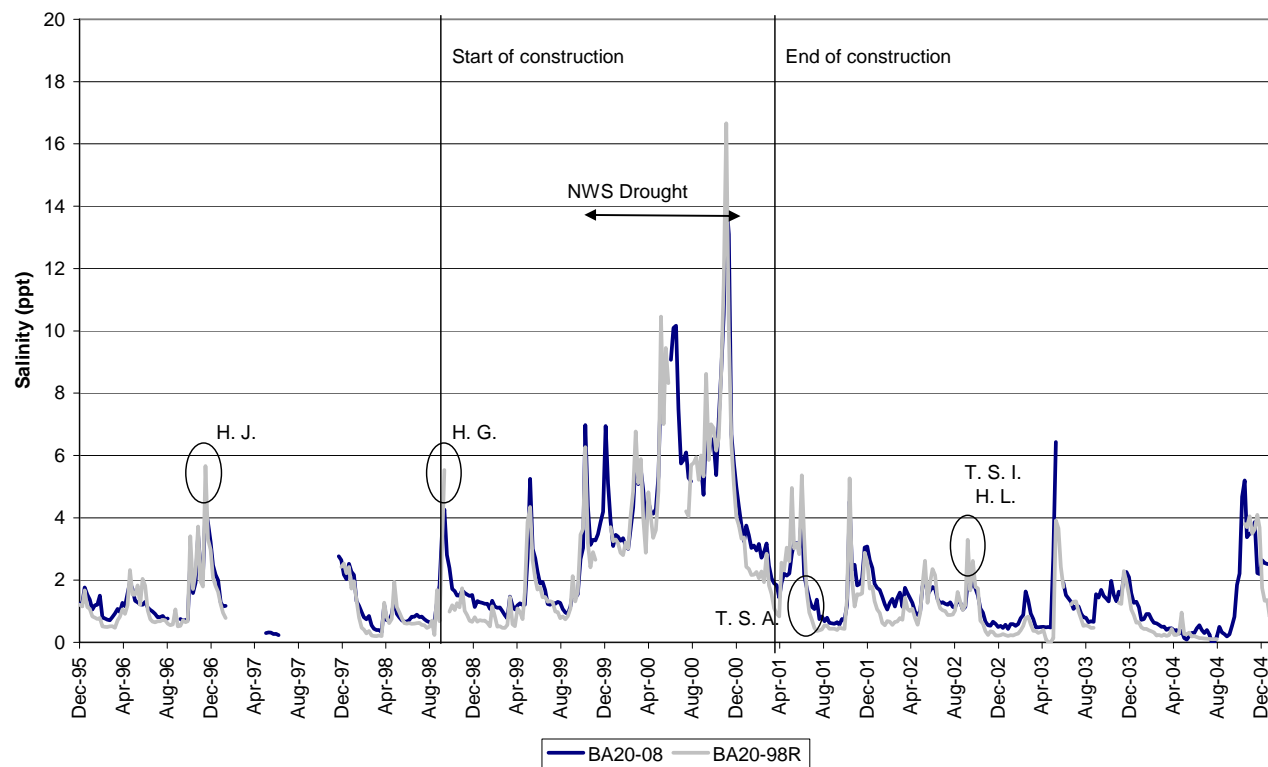
**Figure 8.** Comparison of weekly mean salinity for Jonathan Davis Wetland Restoration, western sondes (20 and 90R). The following storms are referenced in the chart: Hurricane Josephine (H. J.), Hurricane Georges (H. G.), Tropical Storm Allison (T. S. A.), Tropical Storm Isidore (T. S. I.), and Hurricane Lili (H.L.).

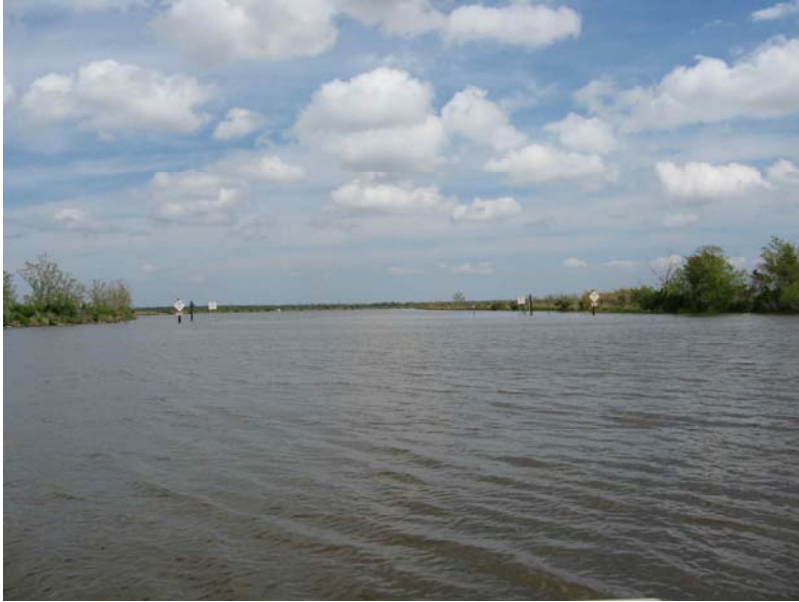
Photo 1  
Structure #13  
CU #1

We observed slight settlement on the west side of Structure No. 13. All signs and supports were in good condition. No maintenance will be required at this time. (Photo 1).

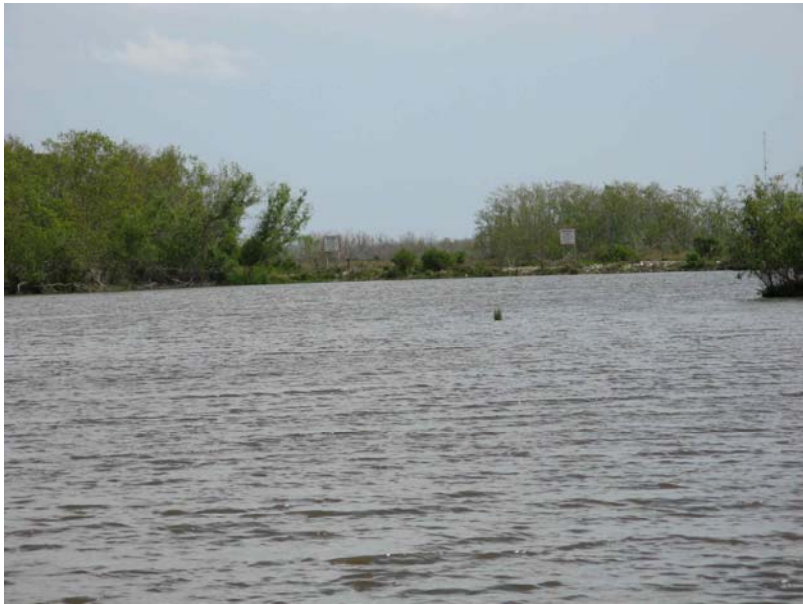
Photo 2  
Structure #14  
CU #1

Upon a visual inspection, we noticed a large breach on the west side of the structure (Photos 2 and 3). Due to poor soil conditions, this structure has experienced significant settlement problems since the time it was constructed. Several attempts were made during construction to stabilize the structure by placing several lifts of rock, but the structure continued to settle. The maintenance work for this structure will be performed during the construction of Construction Unit 4 (CU4), which is expected to begin in the summer of 2007.

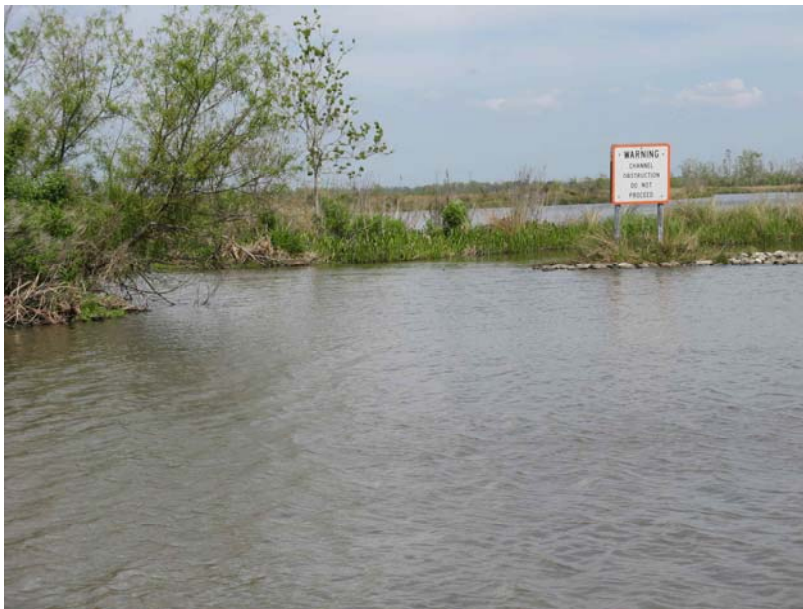
Photo 3  
Breach on west side of Structure #14

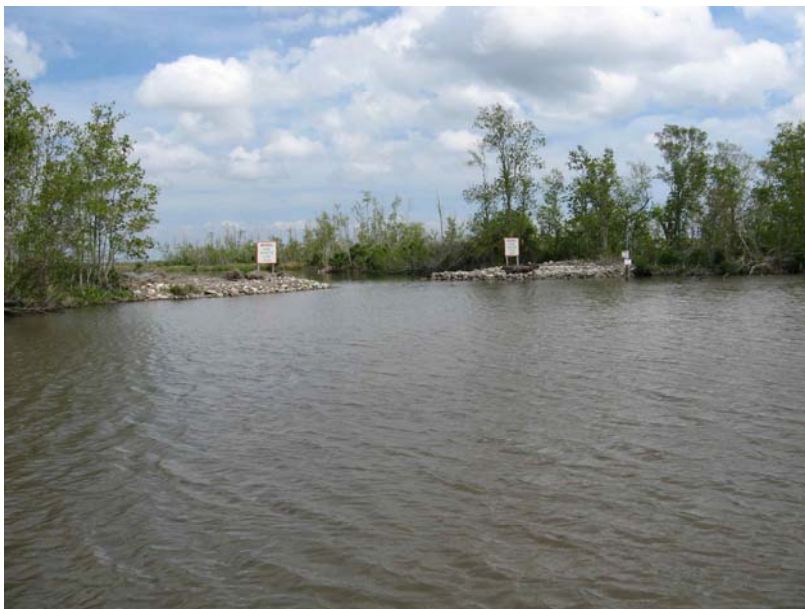
Photo 4  
Structure #15  
CU #1

Structure No. 15 appeared to be in good condition at the time of inspection, with little or no noticeable settlement of the rock weir (Photo 4). Signs and supports were also in good condition. The original design of this structure was modified to include a boat bay to accommodate oilfield activities and navigation on the interior marsh of the structure. During the construction of CU4, this structure will be modified so that it represents the original design more accurately. Construction Unit 4 (CU4) is scheduled to begin in the summer of 2007.

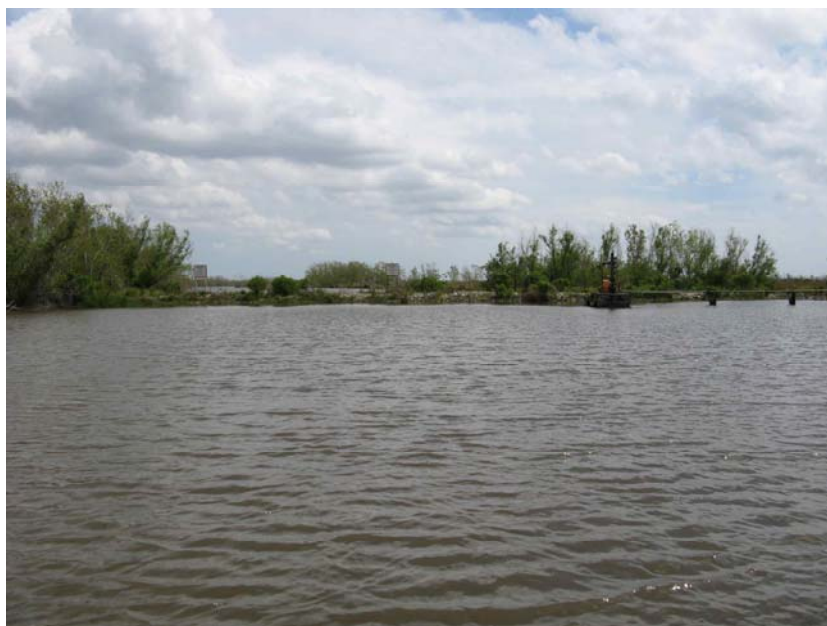
Photo 5  
Structure #16  
CU #1

Structure 16 appeared to be in good condition with the exception of a low area on the south side of the channel plug (Photo 5). The maintenance work for this structure will be performed during the construction of Construction Unit 4 (CU4), which is scheduled to begin in the summer of 2007.

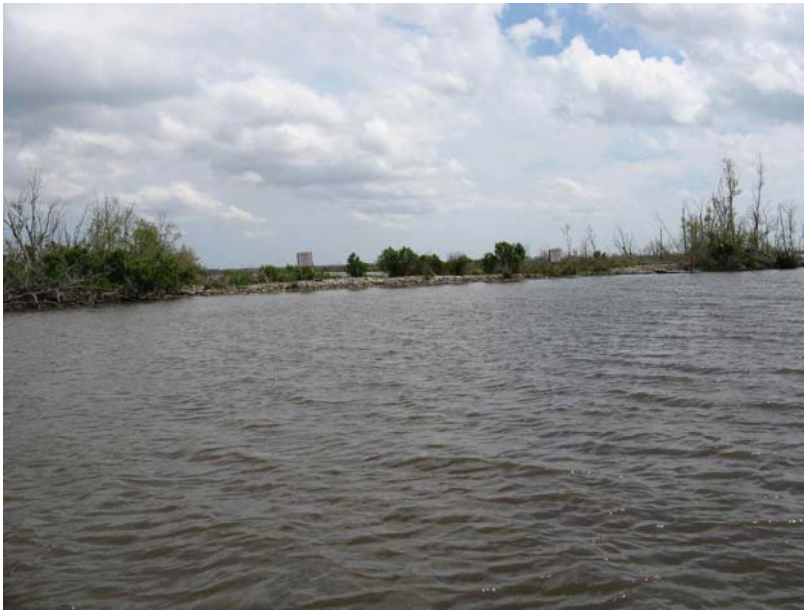
Photo 6  
Structure #17  
CU #1

During the inspection, we observed significant settlement near the warning sign on the south side of the structure and just east of the warning sign on the north side of the structure (Photos 6 and 7). The maintenance of this structure will be performed during the construction of Construction Unit 4 (CU4), which is scheduled to begin in the summer of 2007.

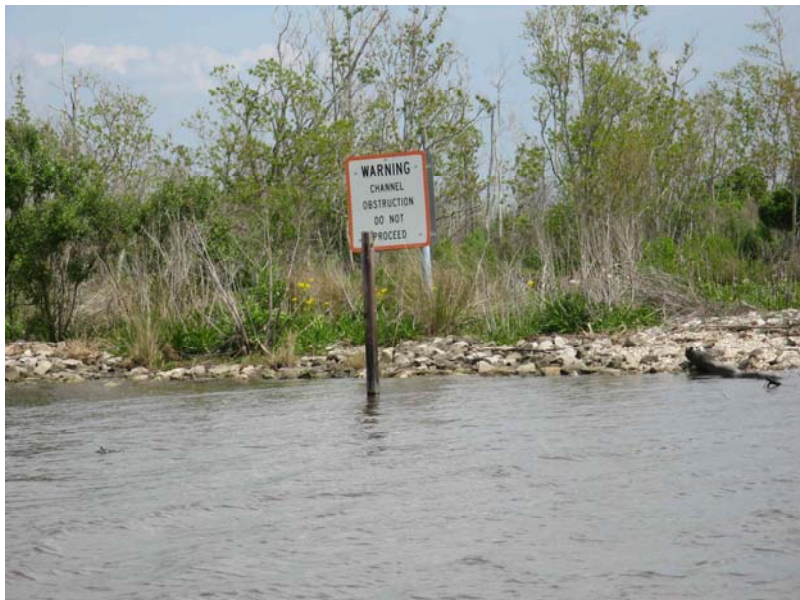
Photo 7  
Low area in Structure #17

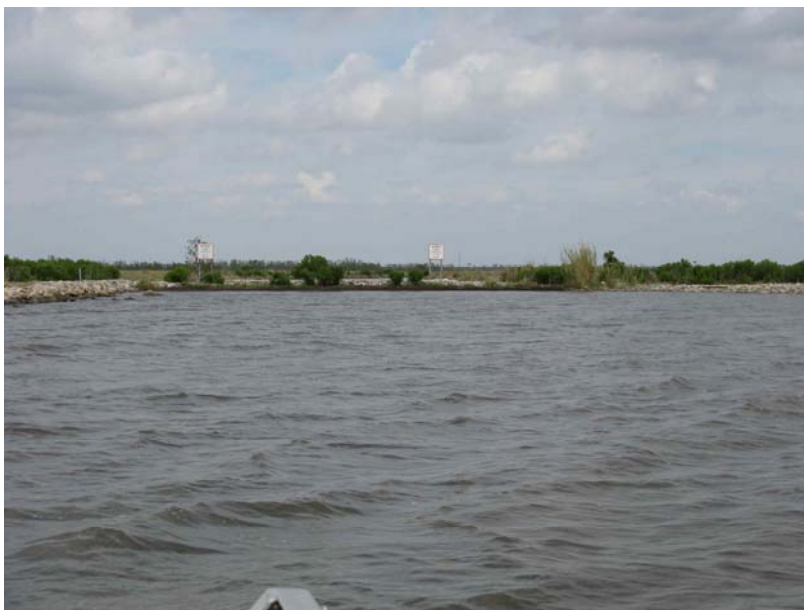
Photo 8  
Structure # 20  
CU # 1

Structure 20 appeared to be in good condition with no signs of settlement of the rock weir. The warning signs and supports were also in good condition (Photo 8). NRCS and LDNR agreed that this structure did not require maintenance.

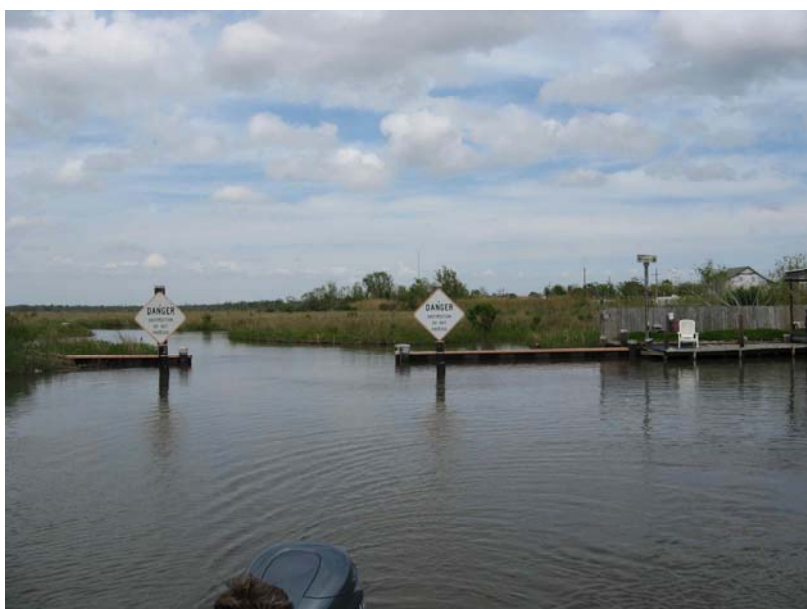
Photo 9  
Structure #22  
CU # 2

The structure itself appears to be in good condition along with the signs, supports, and sheet pile caps (Photo 9). LDNR and NRCS agree that this structure will require no work at this time.

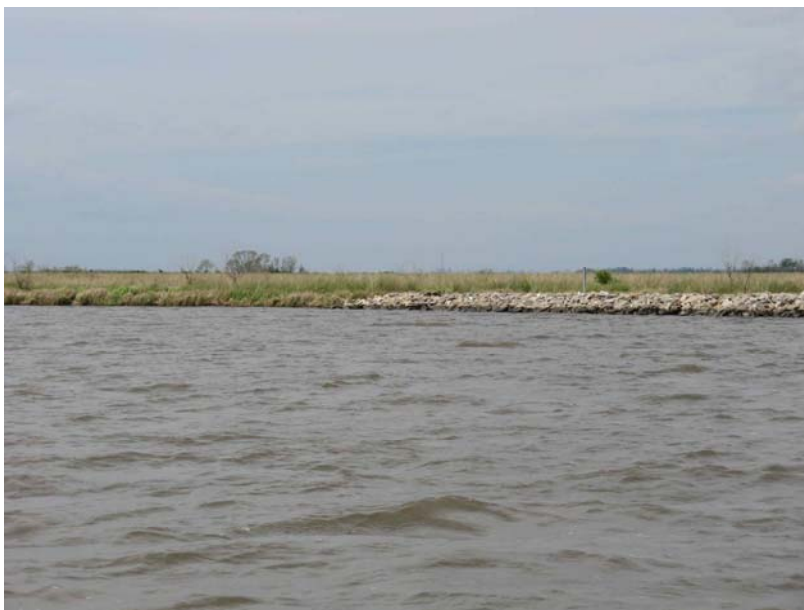
The rock dike along the northern shore of Bayou Rigolettes appeared to be in

good condition with a few signs of settlement (Photo 10). Maintenance work will not be needed at this time.

Photo 10  
West end of Bayou Rigolets Rock Dike  
CU # 2

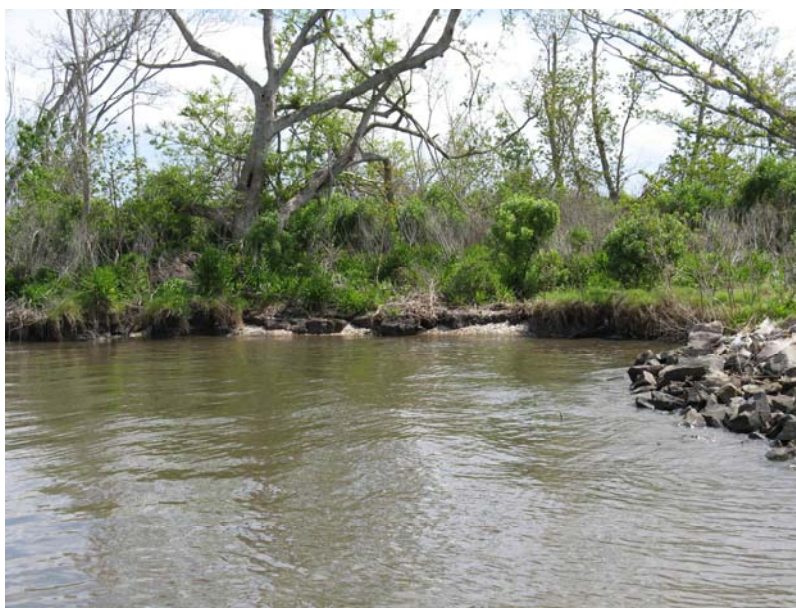
The Bayou Perot Bank Stabilization was in good condition. There was some slight erosion at the western most portion of the structure (Photo 11). There was also some settlement between Sta. 90+00 and 92+00 (Photo 12). The maintenance work for this structure will be performed during the construction of Construction Unit 4 (CU4) which is scheduled to begin construction in the summer of 2007 (Photo 12).

Photo 11  
Bank erosion at west end of  
Bayou Perot Rock Dike

The repairs noted at each structure will be included in the plans for Construction Unit 4.

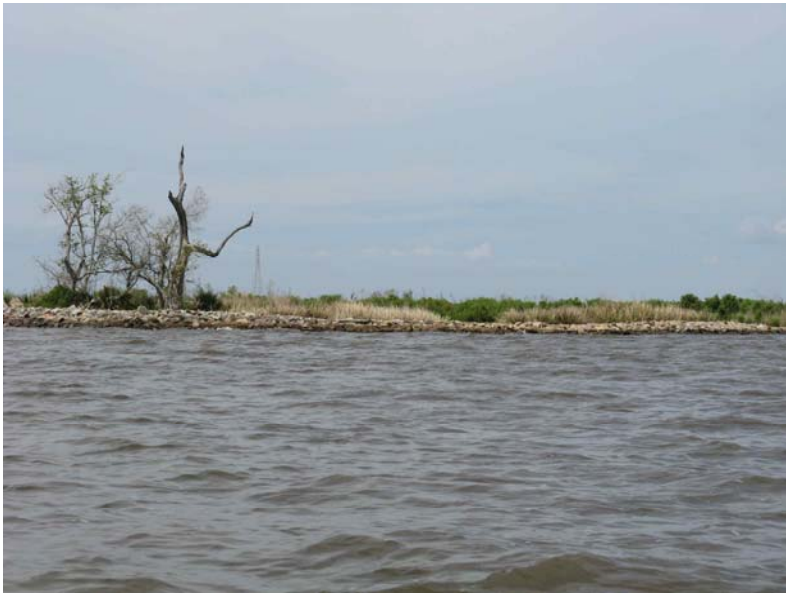
Photo 12  
Low area in Bayou Perot  
Rock Dike  
CU # 3
