**2007 Operations, Maintenance,
and Monitoring Report**

**BARATARIA BAY
WATERWAY WEST SIDE
SHORELINE PROTECTION**

State Project Number BA-23
Priority Project List 4

June 2007
Jefferson Parish

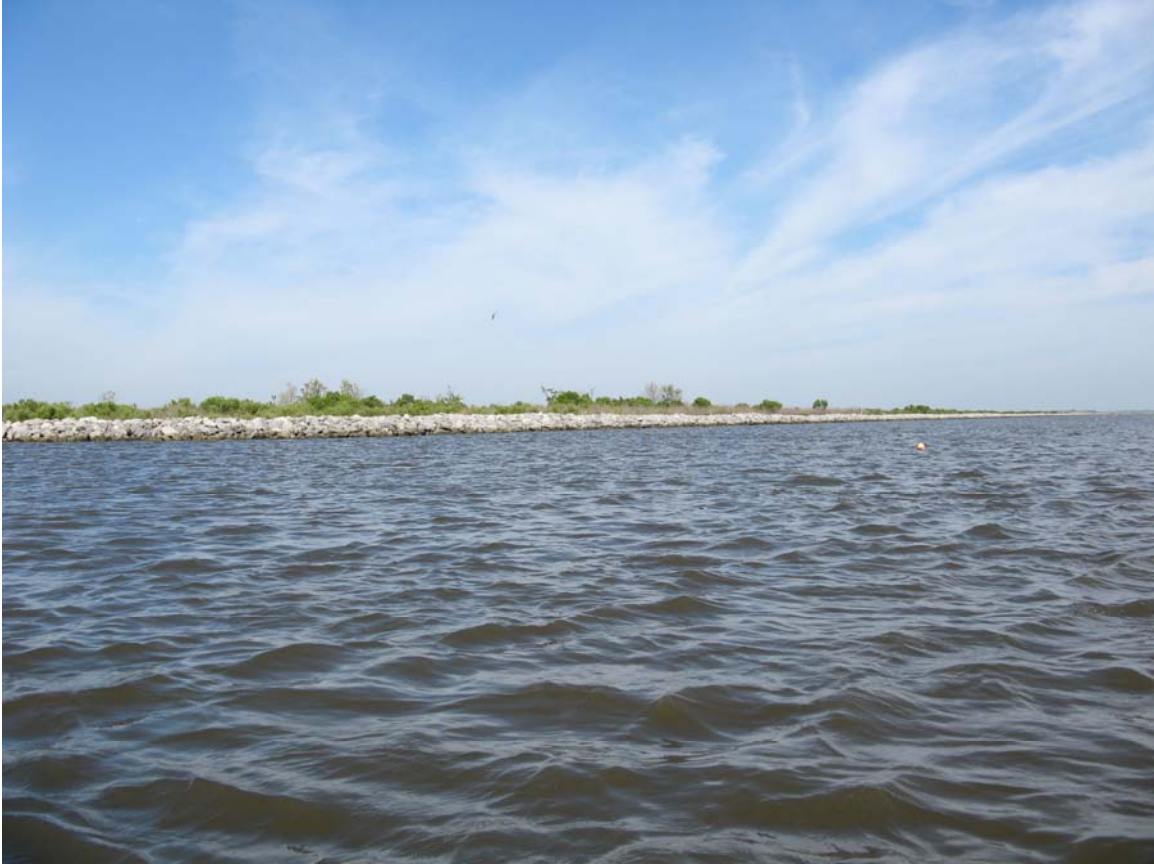
Picture 1. Shoreline protection.

Rock Riprap: The foreshore rock dike appeared to be in good condition at the time of the inspection (Appendix B Photos 1 and 2).
