**2007 Operations, Maintenance  
and Monitoring Report**

**FRITCHIE MARSH  
RESTORATION**

State Project Number PO-06  
Priority Project List 2

December 13, 2007  
St. Tammany Parish

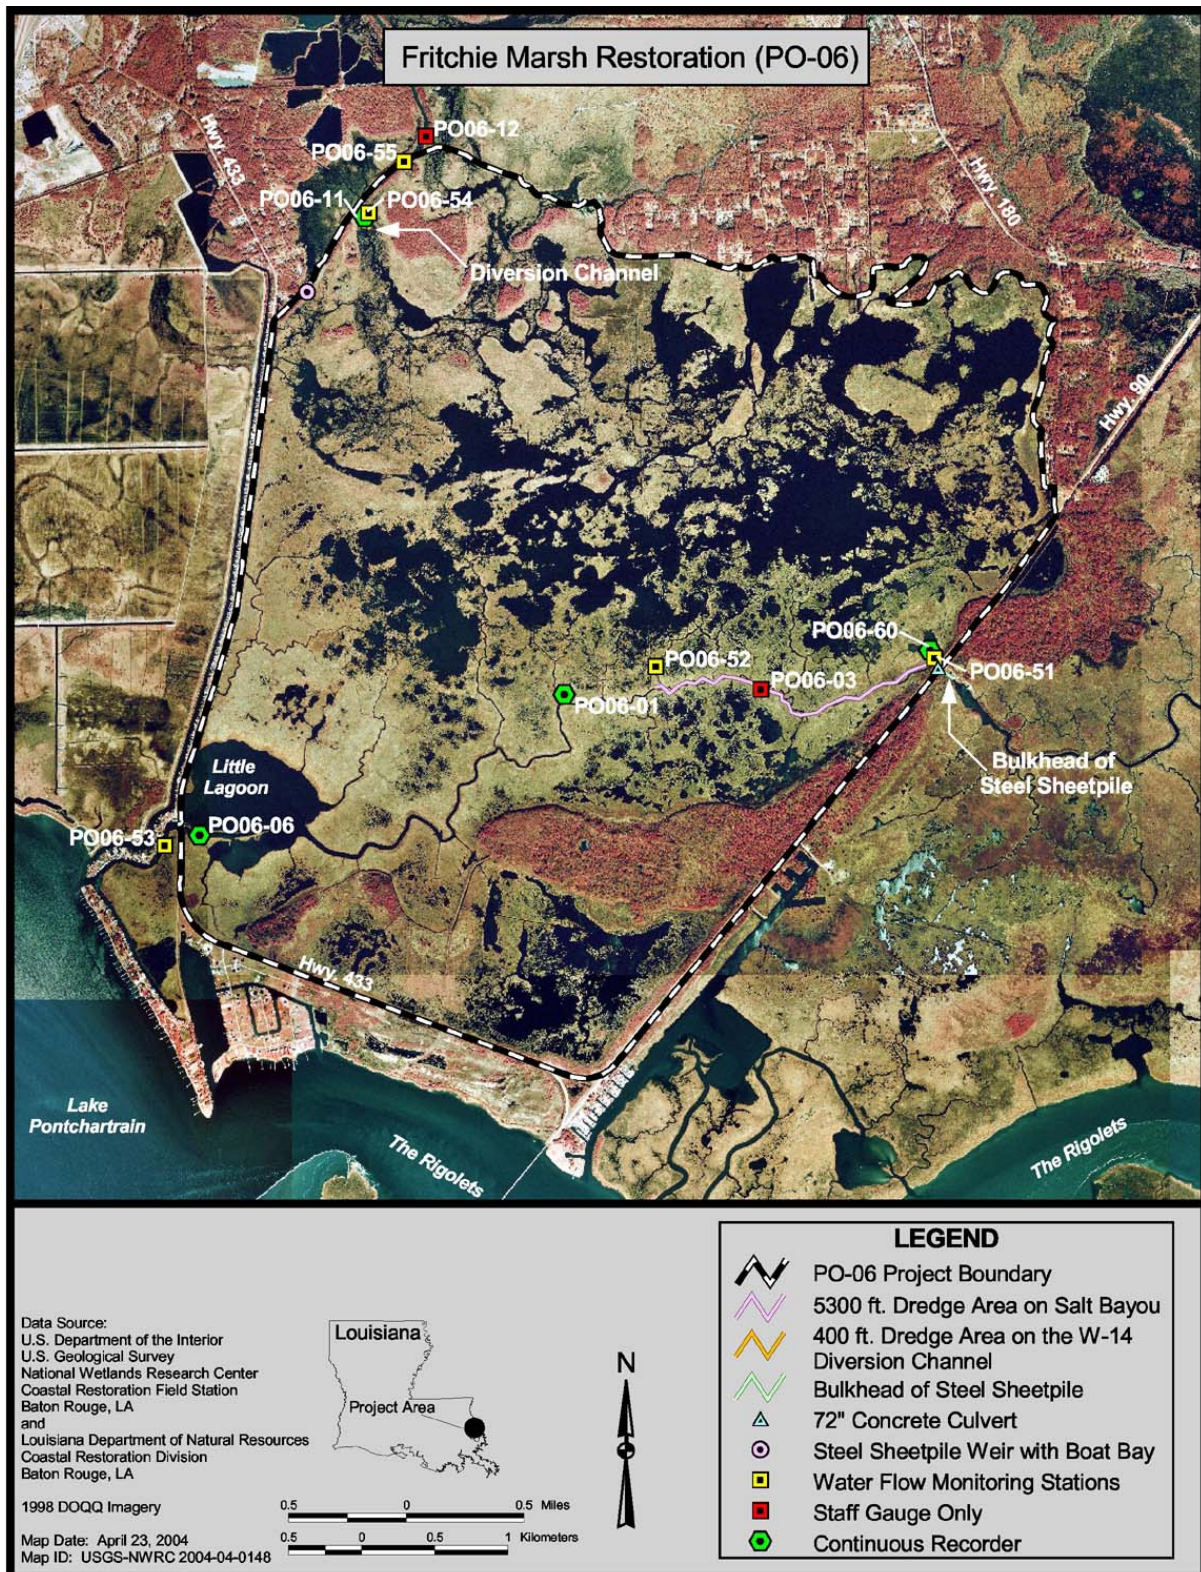
The Fritchie Marsh Restoration project area contains 6,291 acres (2,546 hectares) of intermediate and brackish marsh located southeast of Slidell in St. Tammany Parish (Figure 1). The area is bound by U.S. Highway (Hwy) 190 to the north, U.S. Hwy 90 to the south and east, and Louisiana Highway (La. Hwy) 433 to the west and south.

- Installation (jack and bore) of a 72-inch diameter by 136-foot long concrete culvert under U.S. Hwy 90, rock riprap lining of the Salt Bayou channel bottom and pipe outlets, and installation of 308 linear feet of sheet piling to form a bulkhead.
- Installation of a weir in the W-14 canal. The weir consists of 108 linear feet of sheet pile with a 20-foot wide boat bay.
- Dredging of approximately 400 linear feet of the W-14 diversion channel and 5300 linear feet of the Salt Bayou channel.

**Figure 1.** Fritchie Marsh Restoration (PO-06) project boundary, construction features, continuous recorder and staff gauge locations, and water flow monitoring locations.

Hourly salinity and water level data have been collected at the following continuous recorder stations (Figure 1):

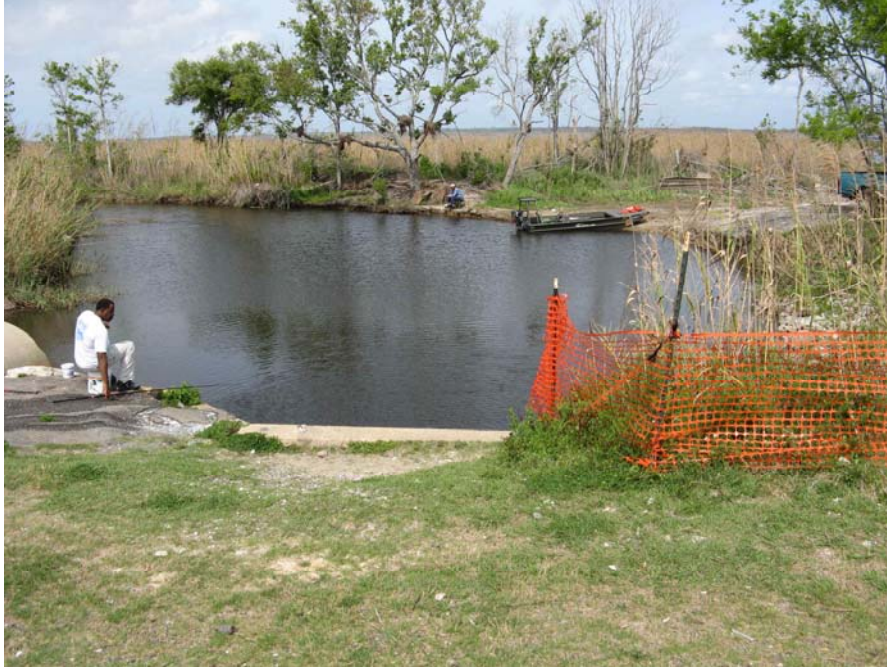
There is no change in this structure from the previous inspection. The bank scour reported in previous inspection reports is still of concern (Photo #1). If this bank were to completely breach, the hydrologic exchange between the marsh and Salt Bayou would be altered. Tracked vehicles appear to be using this route to access the marsh. Scour is also evident on the south bank just east of the culverts (Photo #2).

**Photo #1 –Salt Bayou Scour.** Facing the north bank of Salt Bayou inside the project area from the Hwy 90 culverts. Note the large section of bank which has been scoured out.

- Dredging of Salt Bayou and repair of the scour at Hwy 90 are recommended.

The structures showed little to no signs of damage due to Hurricane Katrina. However, the marsh and natural waterways were severely altered. In addition to the marsh deposits along Salt Bayou, large sections of interior marsh have converted to open water. Dredging of Salt Bayou and repair of the scour at Hwy 90 are recommended.

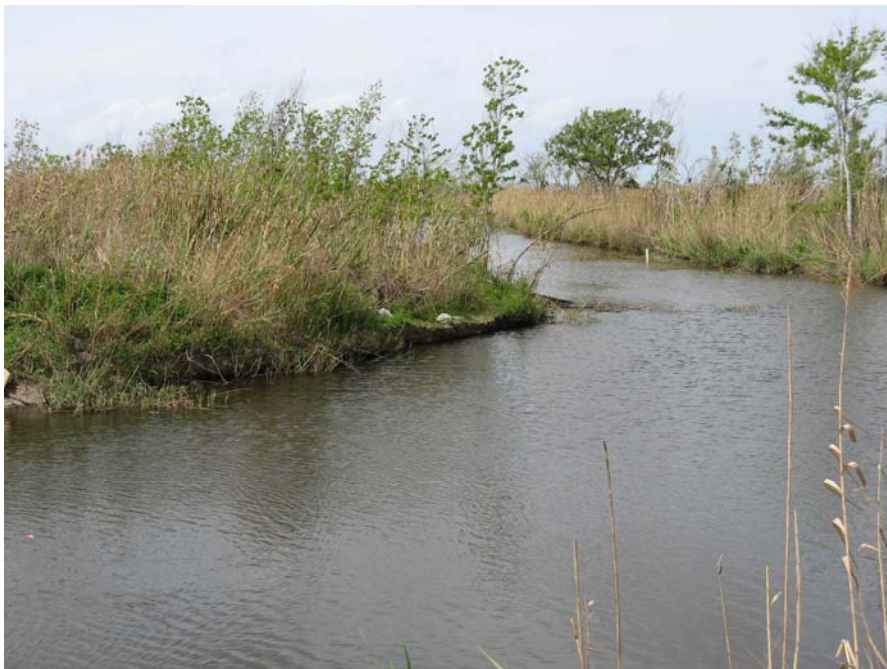
**Photo #2 – Salt Bayou Scour.** Facing the south bank of Salt Bayou inside the project area from the Hwy 90 culverts. Note the erosion of the far bank.

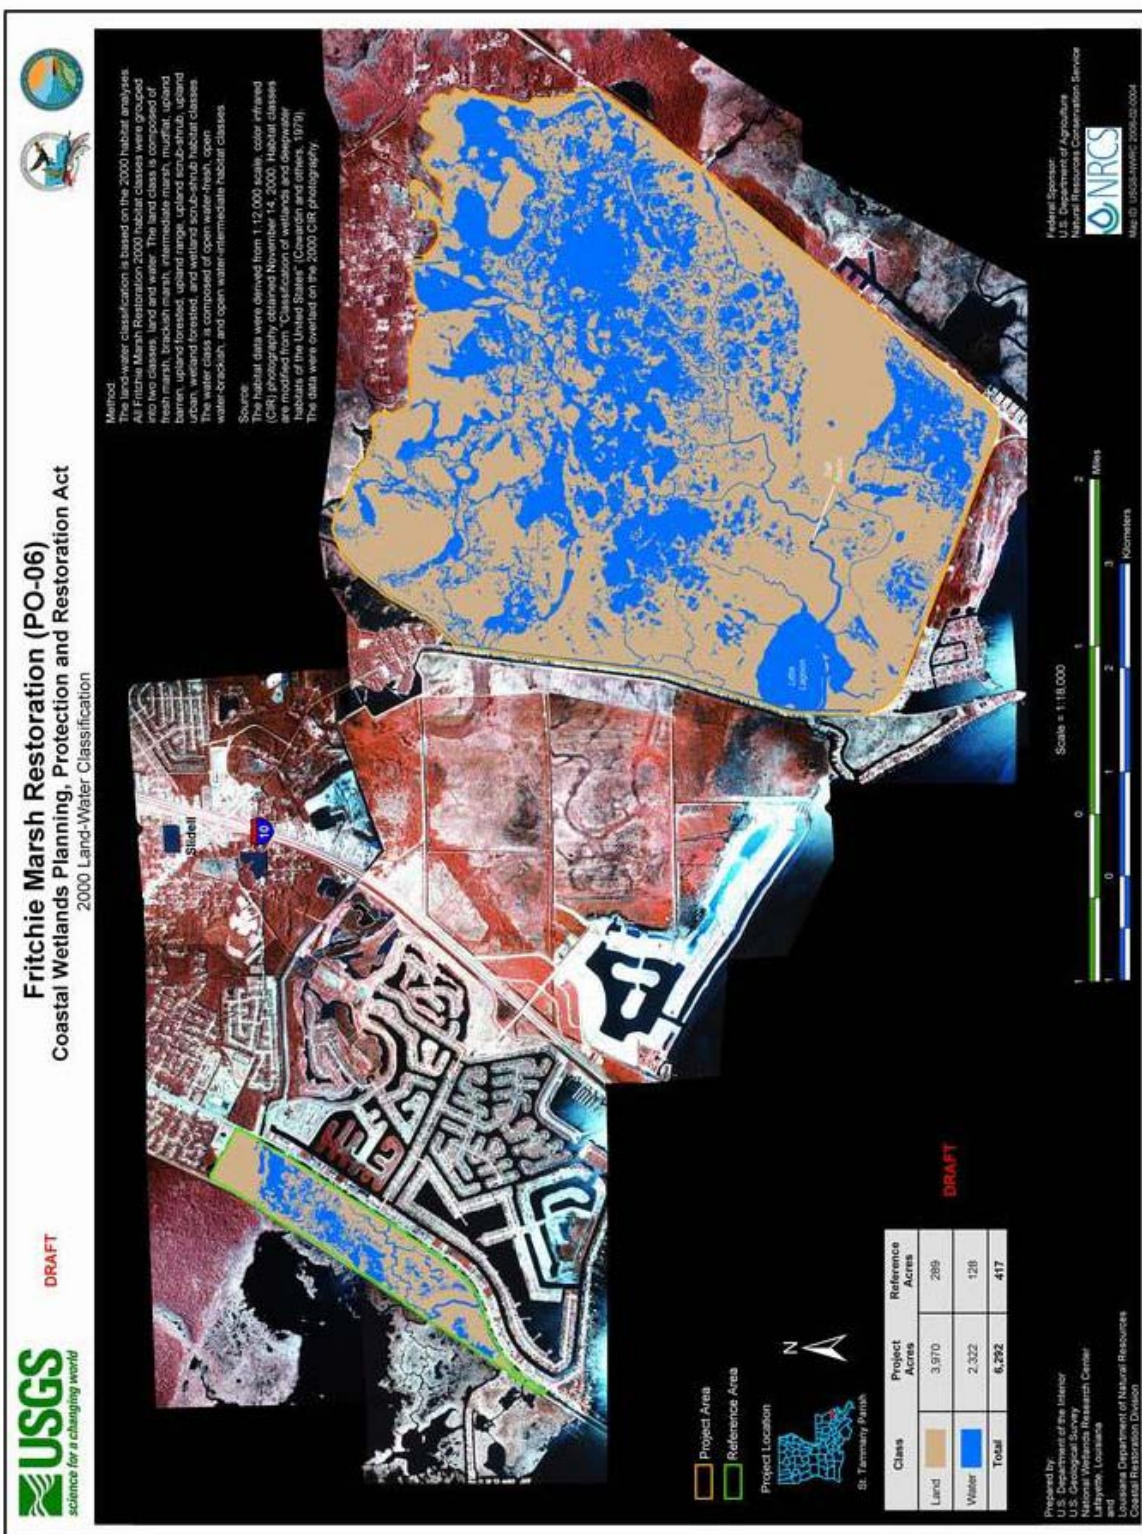
The 1996, 2000, and 2004 land/water analyses are shown in Figures 2, 3, and 4. The results are summarized in Table 1.

**Figure 3.** 2000 land/water analysis of the Fritchie Marsh Restoration (PO-06) project area.

According to the land/water analysis, the project area experienced a loss of 126 acres of land between 1996 and 2000, approximately 3% of the total 1996 land area. However, between 2000 and 2004 the acreage of land within the project area remained relatively stable and actually showed a gain of 13 acres. The reference area showed a loss of 6 acres of land between 1996 and 2000. Although this loss seems small by comparison, it represents about 2% of the land within the 1996 reference area, which is proportionally similar to the loss seen in the project area. The reference area lost another 4 acres of land between 2000 and 2004, indicating the rate of land loss within the reference area was very slow to nearly stable during that period.

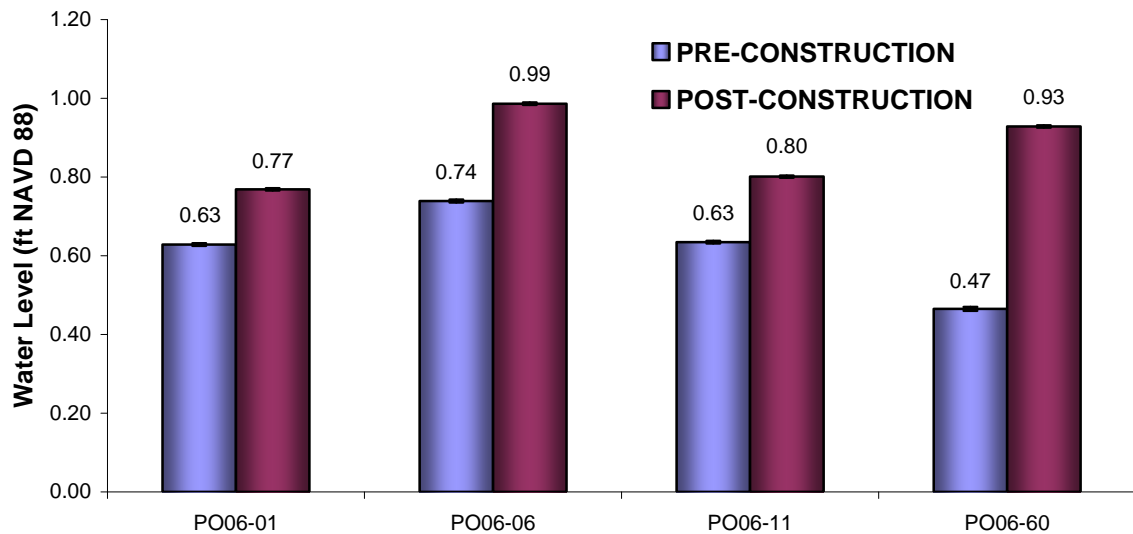
The data show that the mean weekly salinity was lower and water level was higher at all four continuous recorder stations during the post-construction period (Figures 6 and 7). Salinity and

**Figure 7.** Mean weekly water level at four YSI continuous recorder stations located in the Fritchie Marsh (PO-06) project area during pre-construction and post-construction periods.
