Monitoring Series No. BA-15-MSTY-0202-1

COMPREHENSIVE REPORT NO. 1  
For the Period October 1, 1997 to May 1, 2001

**LAKE SALVADOR SHORELINE PROTECTION  
DEMONSTRATION  
BA-15 (BA-15)**

**Third Priority List Shoreline Protection Project of the Coastal Wetlands Planning,  
Protection, and Restoration Act  
(Public Law 101-646)**

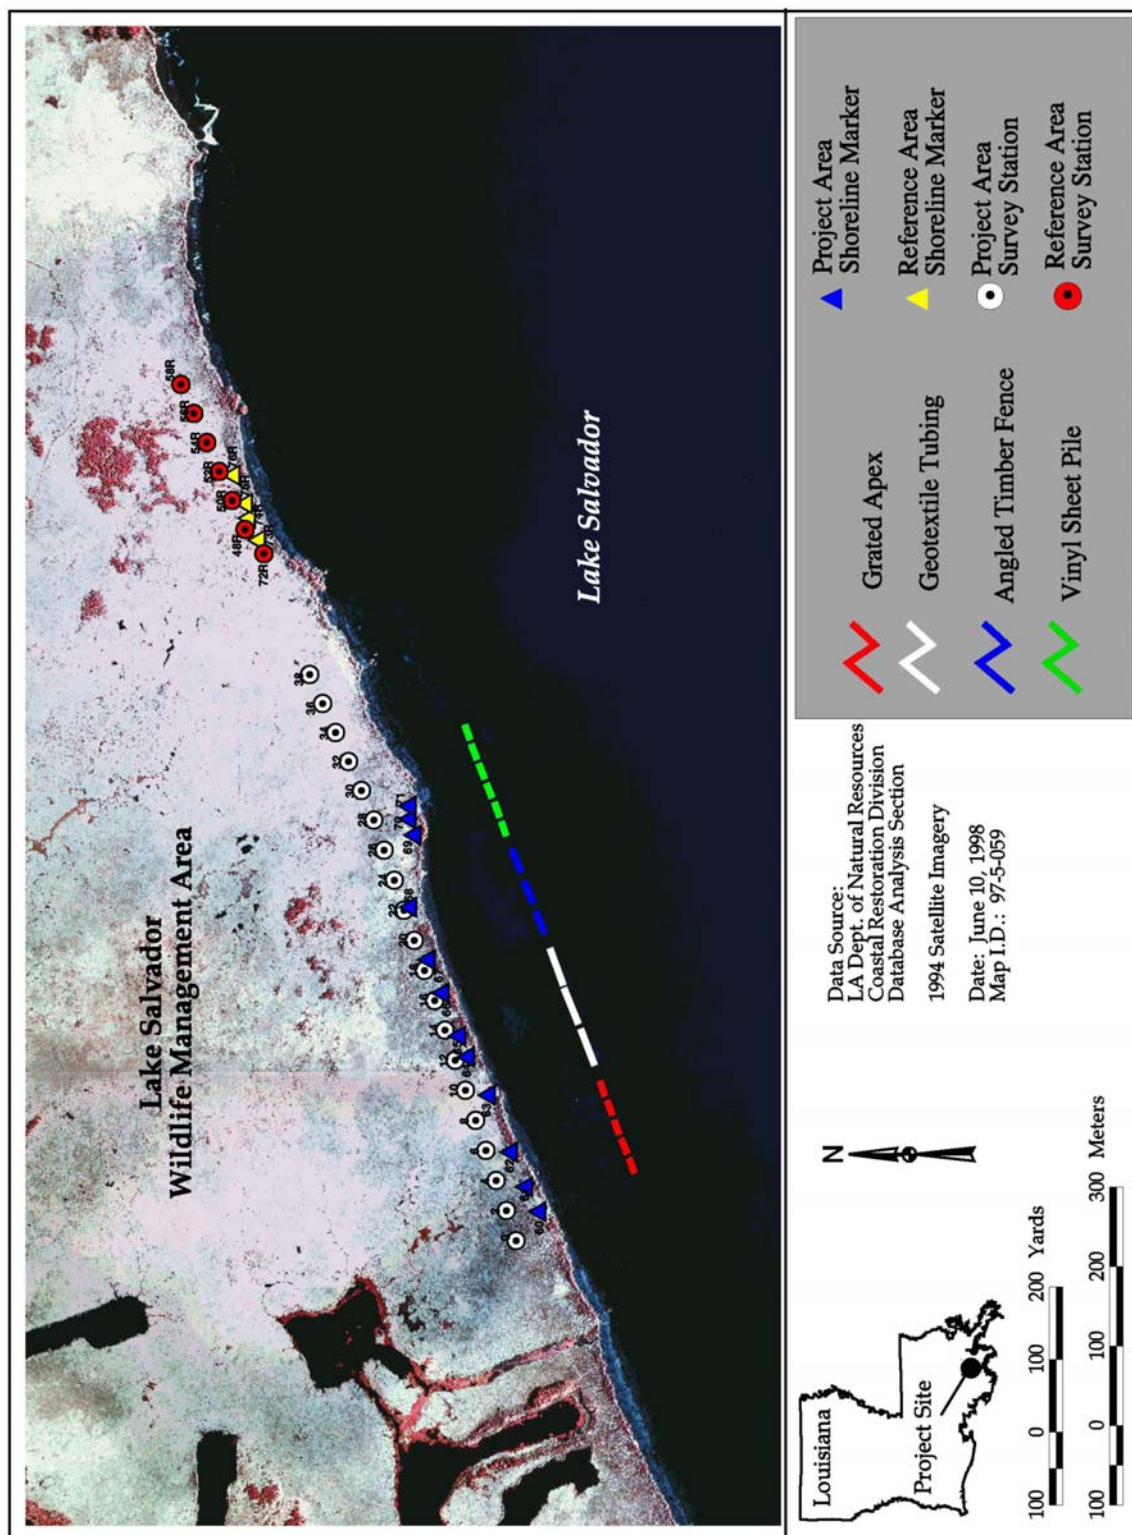
Phase 1 tests the effectiveness of four types of segmented wave damping structures (figure 5) in highly organic, unconsolidated sediments with poor load-bearing capacities. Unconsolidated sediments, such as those found in the Lake Salvador Shoreline Protection (BA-15) Demonstration project areas, reportedly make traditional shoreline stabilization techniques ineffective (Howard et al. 1984). Therefore, this phase of this shoreline protection project will examine the wave damping and shoreline stabilization capabilities of the four experimental breakwaters in the poorly drained, high wind environment found along the northern rim of Lake Salvador. Despite the assumption that a rock armor structure cannot be effective in protecting Lake Salvador's poor load-bearing shoreline,

Figure 5. Wave damping structure treatment positions at the Lake Salvador Shoreline Protection (BA-15) Demonstration project.

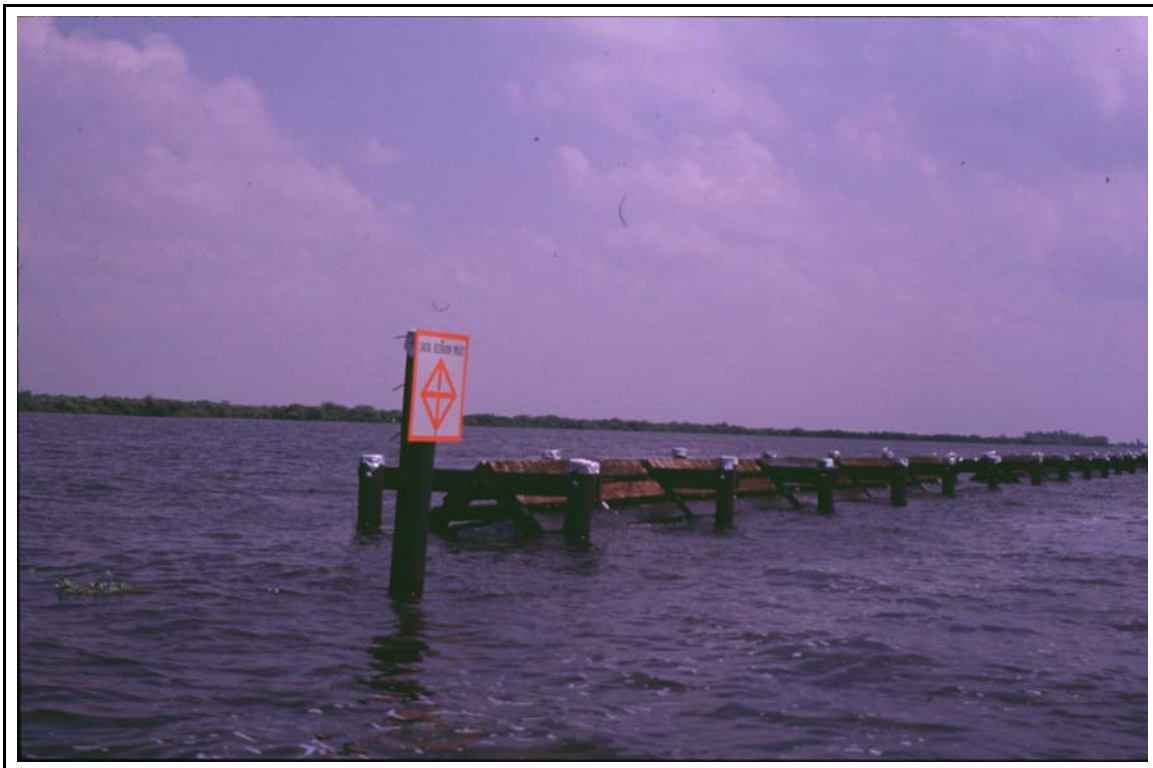
The Grated Apex treatment consists of five, 100 ft (30.48 m) long structures, separated by 30 ft (9.14 m) gaps. The structures were made of 20 ft (6.10 m) long 2 x 12 in (5.1 x 30.5 cm) treated lumber horizontally bolted to 40 ft (12.19 m) timber pilings driven into the soil. Lumber was placed in an A-frame design with a 10 ft (3.05 m) base and 5 ft (1.52 m) height, with 6 in (15.2 cm) gaps between the horizontal lumber (figure 6, appendix A-2). The bottom of the A-frame was placed approximately 6 in (15.24 cm) above the bottom. The structures cost \$390.00/ft (\$1283.00/m) or a total cost of \$195,000.00 and are designed to dissipate wave energy and pattern while allowing water to pass through the grated design, therefore preventing bottom scour.

**Figure 6. Typical Grated Apex structure at the Lake Salvador Shoreline Protection (BA-15) Demonstration project (photo taken December 1998).**

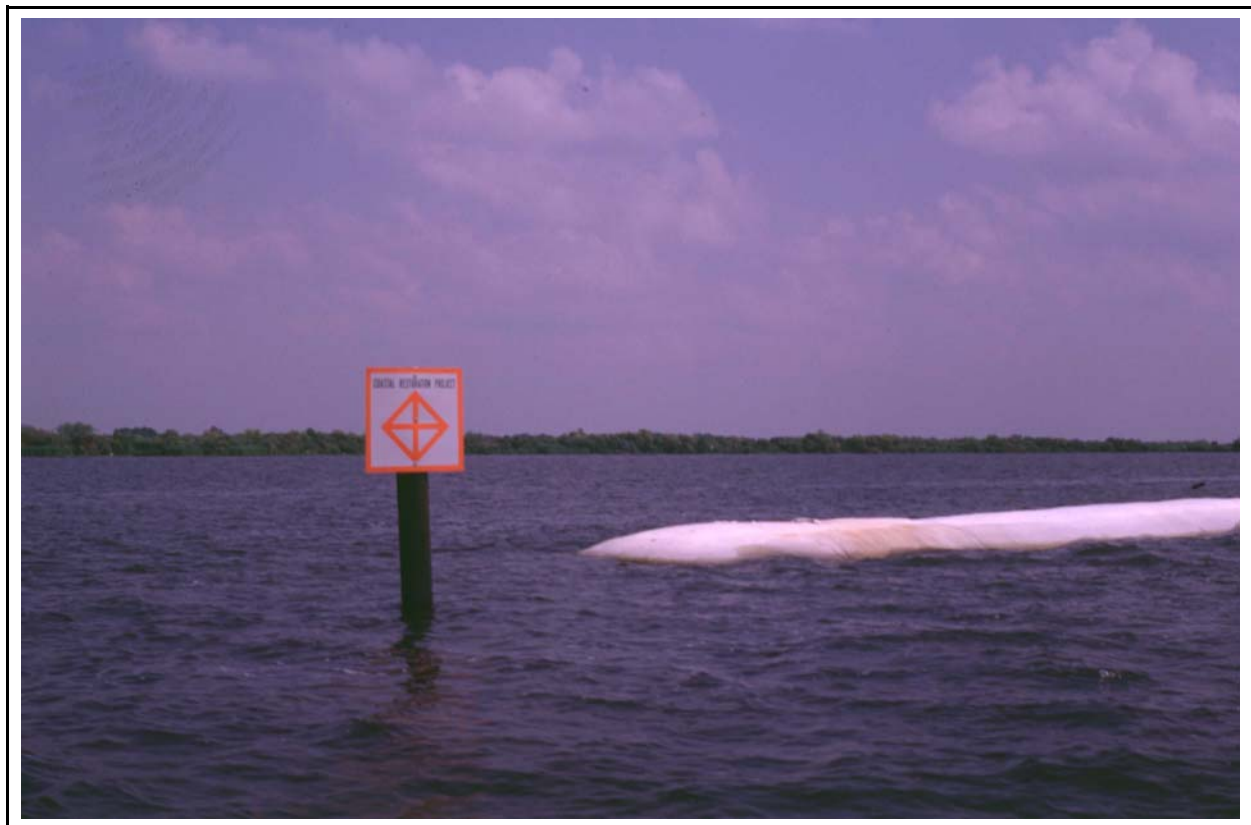
The Geotextile Tube treatment consists of three, 250 ft (76.20 m) long structures, separated by 30 ft (9.14 m) gaps. The three 250 ft (76.2 m) structures were composed of two adjoining 125 ft (31.8 m) Geotextile Tubes. The tubes were 32 ft (9.75 m) in circumference and 3.30 ft (1.01 m) high. Each tube was filled with a mixture of imported sand and concrete. The structures had a cost of \$340.00/ft (\$1114.00/m) or a total of \$255,000.00 and are designed to act as an earthen dike by dissipating wave energy (figure 7, appendix A-3).

**Figure 7. Typical Geotextile Tube structure at the Lake Salvador Shoreline Protection (BA-15) Demonstration project (photo taken December 1998).**

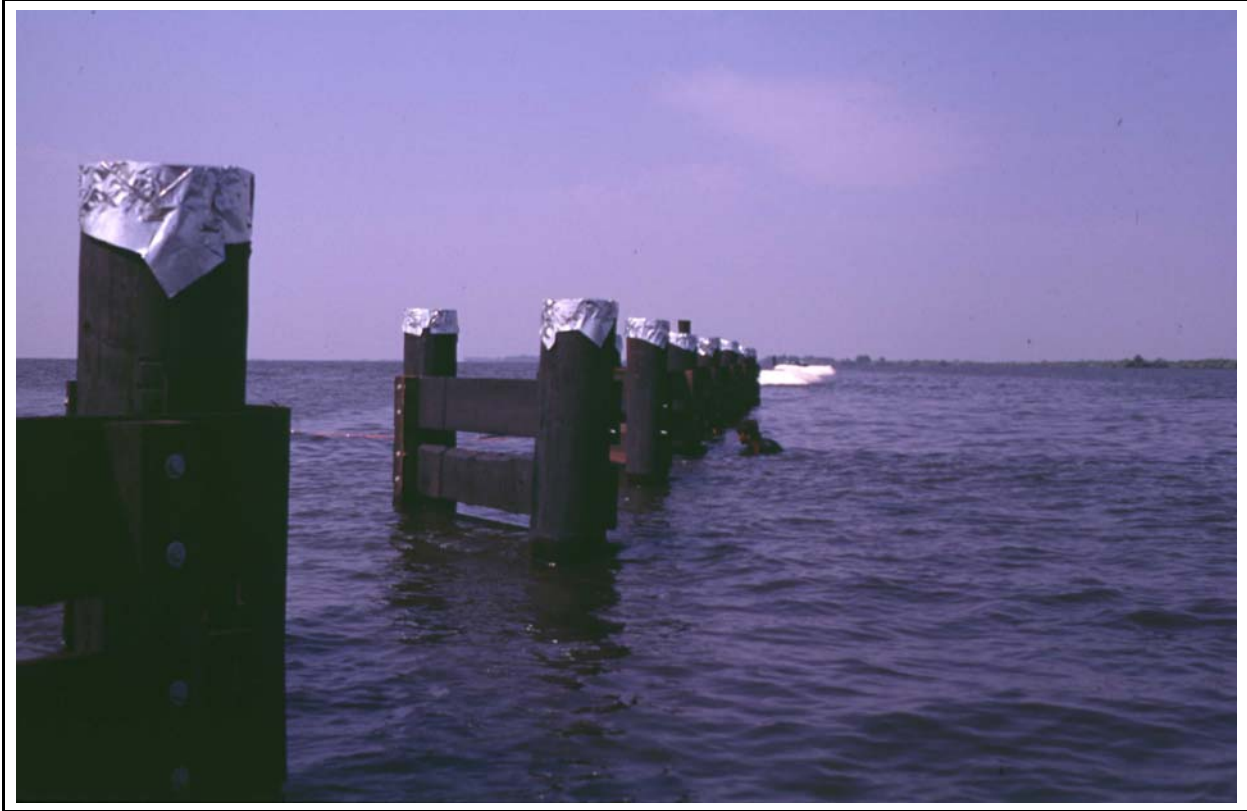
**Figure 8. Typical Angled Timber Fence structure at the Lake Salvador Shoreline Protection (BA-15) Demonstration project (photo taken December 1998).**

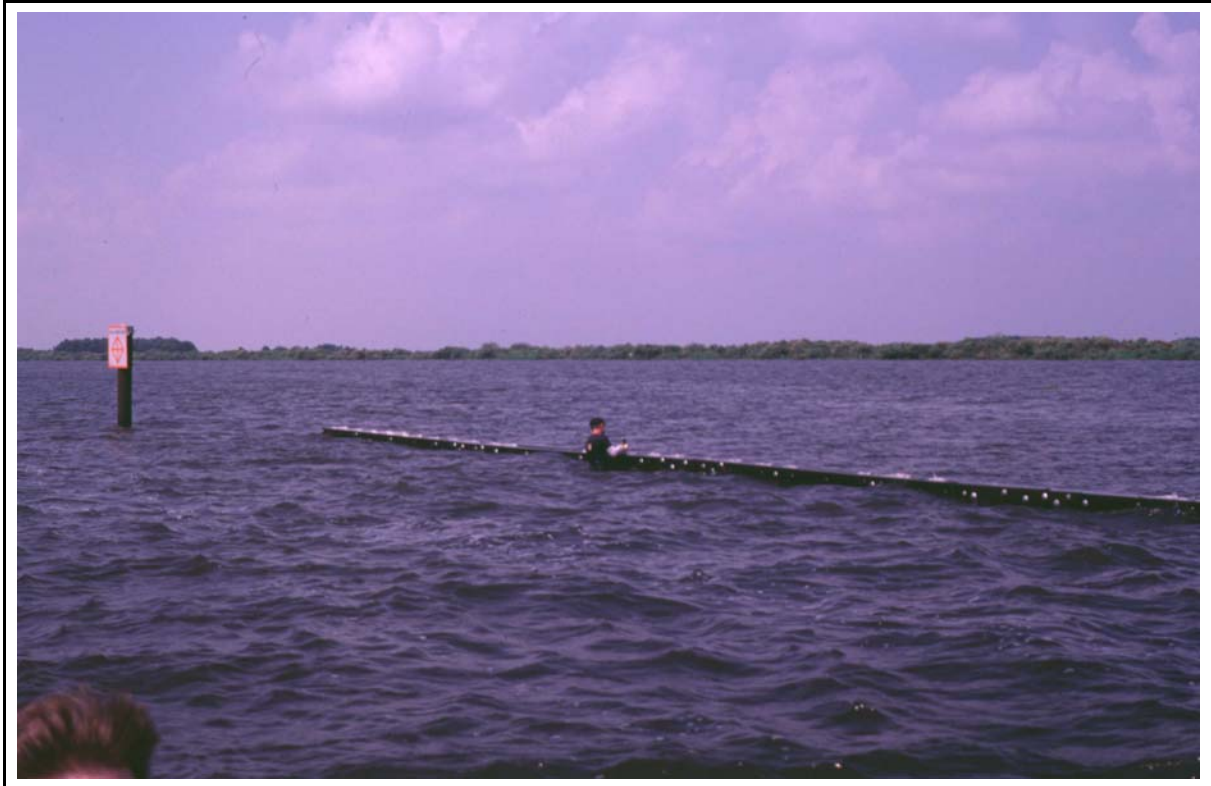
The Vinyl Sheet Pile bulkhead treatment consists of six, 100 ft (30.5 m) long structures, separated by 30 ft (9.1 m) gaps. The three easternmost sections are composed of 10 ft (3.1 m) long sheet piles

and are reinforced every 10 ft (3.1 m) with 40 ft (12.2 m) long treated timber piles, while the three westernmost sections are composed of non-reinforced 22 ft (6.7 m) long sheet piles. The reinforced treatment was constructed at 6 ft (1.8 m) below the mud line, and 4 ft (1.2 m) above the mud line. The non-reinforced treatment was constructed 18 ft (5.5 m) below the mud line and 4 ft (1.2 m) above the mud line. The vinyl sheets are 10 - 22 ft (3.1 - 6.7 m) long poly vinyl chloride (PVC) with a 0.25 in (0.64 cm) thickness. Sheets were attached to 4 x 6 in (10.16 x 15.24 cm) walers. The reinforced vinyl sheets were bolted to 40 ft (12.19 m) timber pilings driven 36 ft (11.28 m) into the soil. The height of the structure was 4 ft (0.91 m) from the bottom. Both the reinforced and the unreinforced structures had a cost of \$200.00/ft (\$656.00/m) or a total cost of \$120,000.00 and are intended to dissipate wave energy (figure 9, appendix A-5).

**Figure 9. Typical Vinyl Sheet Pile structure at the Lake Salvador Shoreline Protection (BA-15) Demonstration project (photo taken in December 1998).**

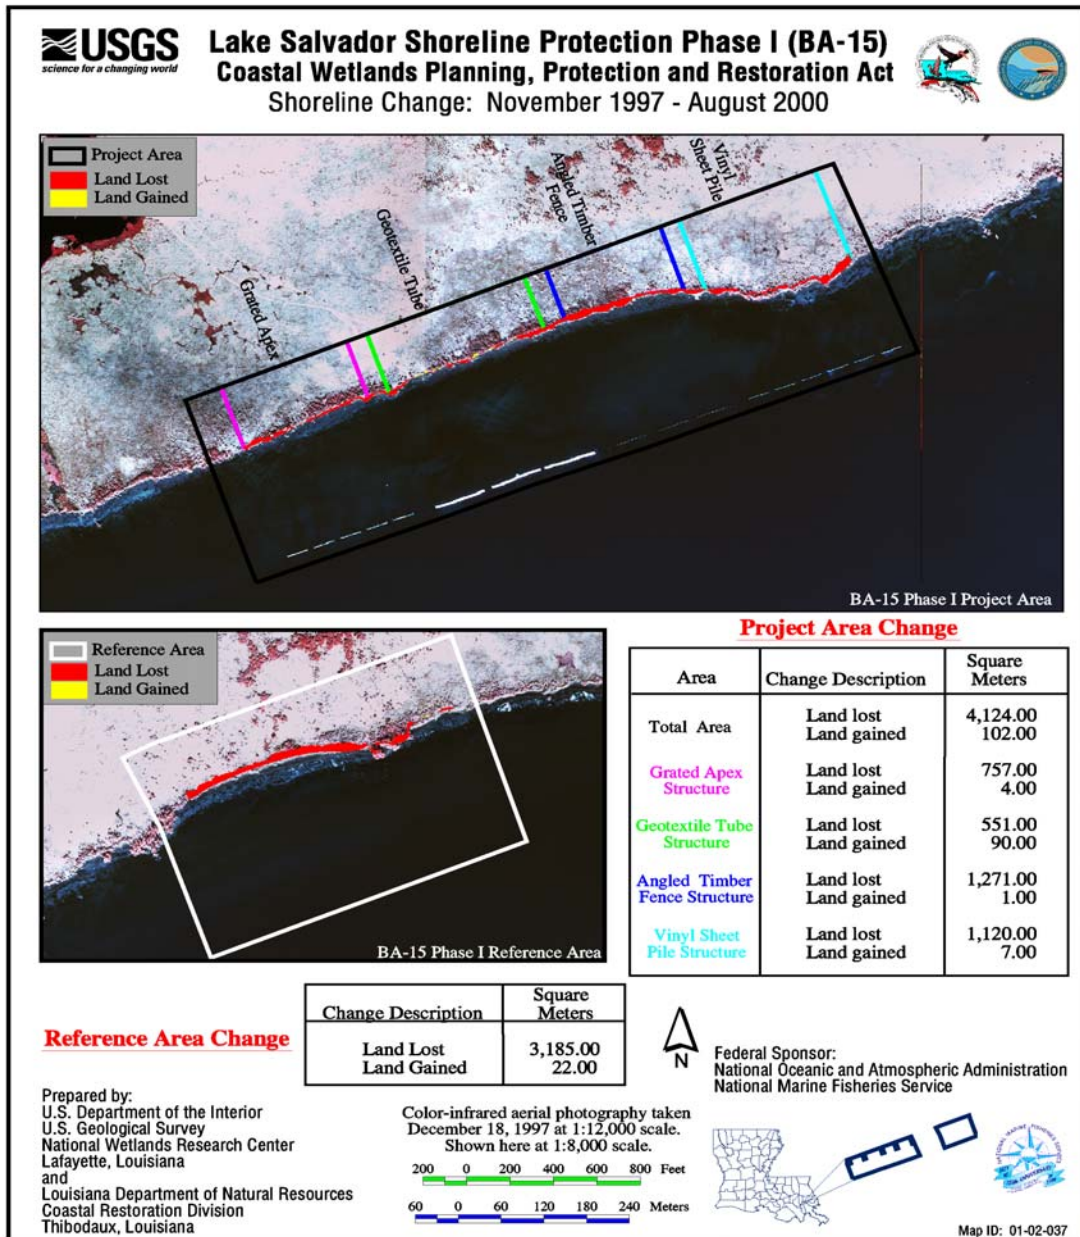
The post-construction shoreline change rates were determined by overlaying the November 1997, May 1998, August 1998, May 1999, August 1999, March 2000, and August 2000 DGPS data using ESRI ARC/Info® and ESRI ArcView® GIS Software. A polygon was established for each treatment, from the edges of the structure onshore to the baseline, with sides perpendicular to the structures. Polygons were also established in the gaps between treatments. Within each polygon, the area (m<sup>2</sup>)

**Figure 11. Post-construction shoreline change from DGPS data taken in November 1997 and in August 2000 at Phase 1 of the Lake Salvador Shoreline Protection (BA-15) Demonstration project.**

was determined and compared to the polygon formed by the shoreline position data for each sampling time period (figure 11). The difference between one time period's area and the next time period's area determined the total area change over the sampling period. This area was divided by the total length of the polygon to calculate average shoreline change within the polygon. The total shoreline change was divided by the number of days between the samples and multiplied by 365 days to get an annual shoreline change rate in  $\text{ft yr}^{-1}$  ( $\text{m yr}^{-1}$ ). A shoreline change rate was also calculated for the entire project area and the gaps between treatments for each time period.

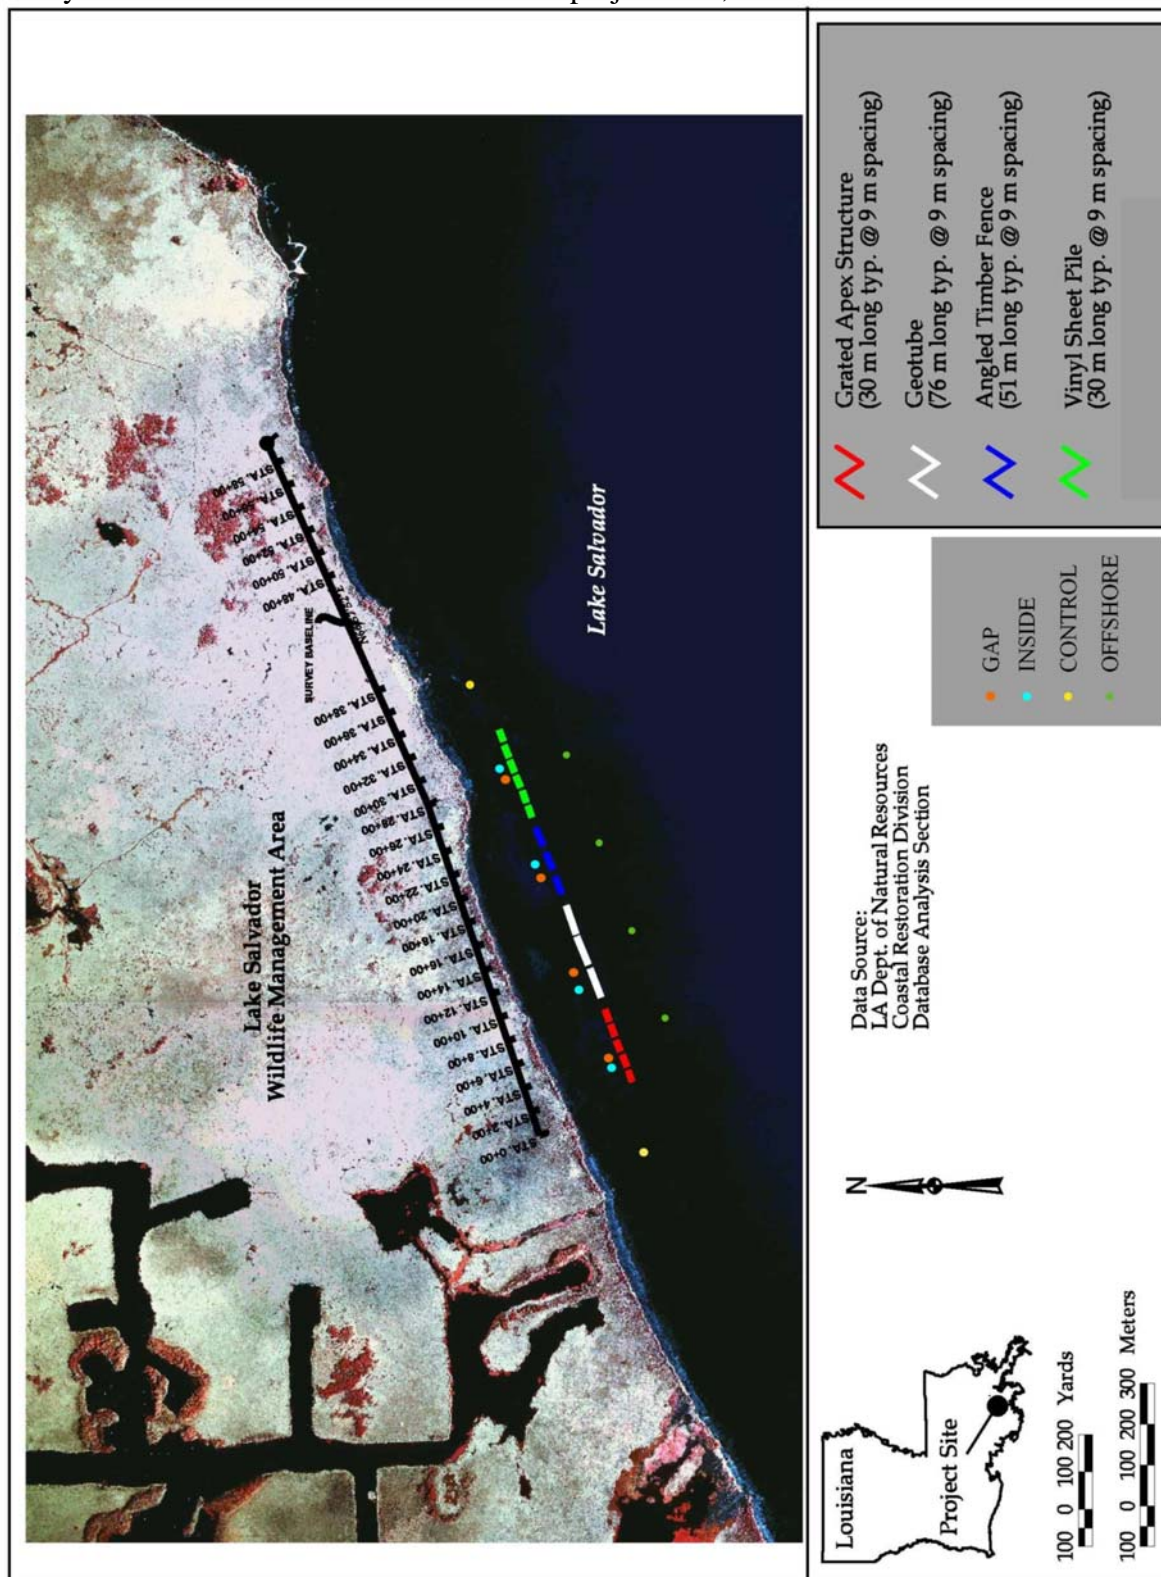
Figure 12. Location of LSU/CSI wave measurement gauges at Phase 1 of the Lake Salvador Shoreline Protection (BA-15) Demonstration project (modified from Stone et al. 1999d).

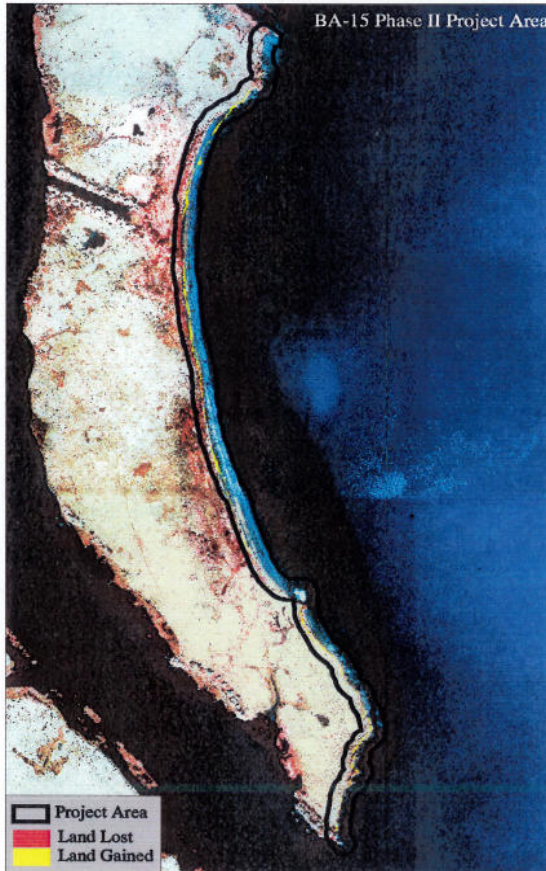
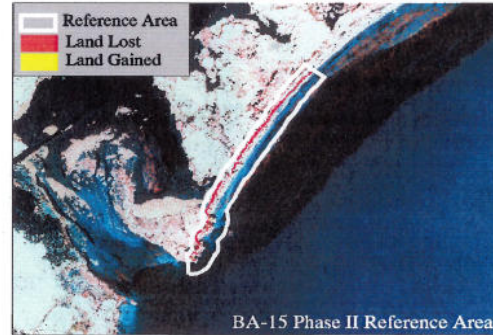
**Lake Salvador Shoreline Protection Phase II (BA-15)**  
**Coastal Wetlands Planning, Protection and Restoration Act**  
 Shoreline Change: March 1999 to April 2001

**Reference Area Change**

Change Description	Square Meters
Land lost	2,960.00
Land gained	39.00

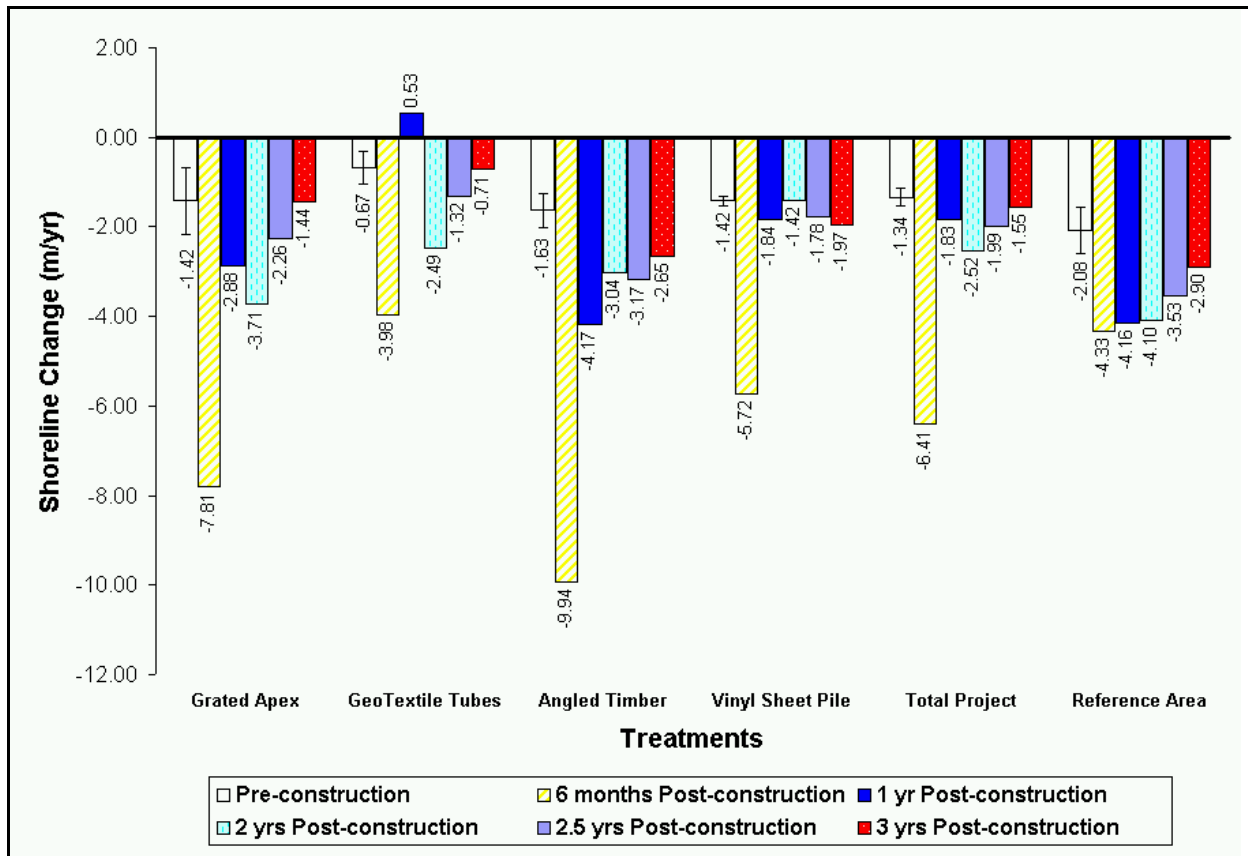
**Shoreline Change:** Comparison of pre and post-construction shoreline position data for Phase 1 indicate that pre-construction shoreline erosion averaged  $4.40 \text{ ft yr}^{-1}$  ( $1.34 \text{ m yr}^{-1}$ ) in the project area and  $6.82 \text{ ft yr}^{-1}$  ( $2.08 \text{ m yr}^{-1}$ ) in the reference area from January 1996 to November 1997 (figure 14). Post-construction results for the time period of November 1997 to August 2000 (3 years post-construction) indicated an average shoreline erosion rate of  $5.08 \text{ ft yr}^{-1}$  ( $1.55 \text{ m yr}^{-1}$ ) in the project area and  $9.51 \text{ ft yr}^{-1}$  ( $2.90 \text{ m yr}^{-1}$ ) in the reference area (figure 14). Only the Geotextile Tubes showed shoreline progradation [ $1.74 \text{ ft yr}^{-1}$  ( $0.53 \text{ m yr}^{-1}$ )], and this was only during the 1 year post-construction time period. Furthermore during the final sampling period (3 years post-construction), the Geotextile Tubes exhibited a shoreline erosion rate of  $2.33 \text{ ft yr}^{-1}$  ( $0.71 \text{ m yr}^{-1}$ ), which was the lowest erosion rate recorded for this time interval (figure 14). The shoreline directly behind the Angled Timber structures, recorded the highest erosion rate [ $8.69 \text{ ft yr}^{-1}$  ( $2.65 \text{ m yr}^{-1}$ )] for the 3 year post-construction time period followed by the Vinyl Sheet Pile structures [ $6.46 \text{ ft yr}^{-1}$  ( $1.97 \text{ m yr}^{-1}$ )] and the Grated Apex structures [ $4.72 \text{ ft yr}^{-1}$  ( $1.44 \text{ m yr}^{-1}$ )] (figure 14). Interestingly, only the Angled Timber structures produced erosion rates greater than [ $6.56 \text{ ft yr}^{-1}$  ( $2.00 \text{ m yr}^{-1}$ )] for all post-

Figure 14. Shoreline change rates (m/yr) from survey and DGPS data for all treatments at Phase 1 of the Lake Salvador Shoreline Protection (BA-15) Demonstration project from January 1996 to August 2000.

construction DGPS sampling events and recorded the highest shoreline erosion rates for all time intervals except the 2 year post-construction interval. In addition, the accuracy of the May 1998 (6 month post-construction) project area shoreline survey should be questioned since the erosion rates measured behind the breakwaters are substantially larger than any other project or reference area DGPS survey (figure 14).

The initial goal of reducing marsh edge erosion was not achieved, as indicated by the DGPS shoreline position data (figure 14). The shoreline markers as well as the DGPS data indicated that none of the structures appeared to affect shoreline erosion rates over the 3 year post-construction period when compared to the reference area. It should be noted that the reference area exhibited a higher erosion rate than the treatments pre-construction as well as 3 years after construction and direct comparisons are difficult due to the confounding factors mentioned earlier such as spatial and temporal variability, lack of treatment replication, and treatment interactions. The Geotextile Tubes and the Grated Apex treatments showed the lowest erosion rates during the 3 year post-construction time period, at 2.33 and 4.72 ft yr<sup>-1</sup> (0.71 and 1.44 m yr<sup>-1</sup>), respectively. However, the Vinyl Sheet Pile treatment produced the most consistent results over the duration of this study. Interestingly, the Phase 1 reference area transgressed at an intermediate rate between the erosion rate [13.0 ft yr<sup>-1</sup> (4.0 m yr<sup>-1</sup>)] established in the feasibility study (HNTB 1992) and the historical rate [7.74 ft yr<sup>-1</sup> (2.36 m yr<sup>-1</sup>)] reported by May and Britsch 1987 (figure 4, figure 14).

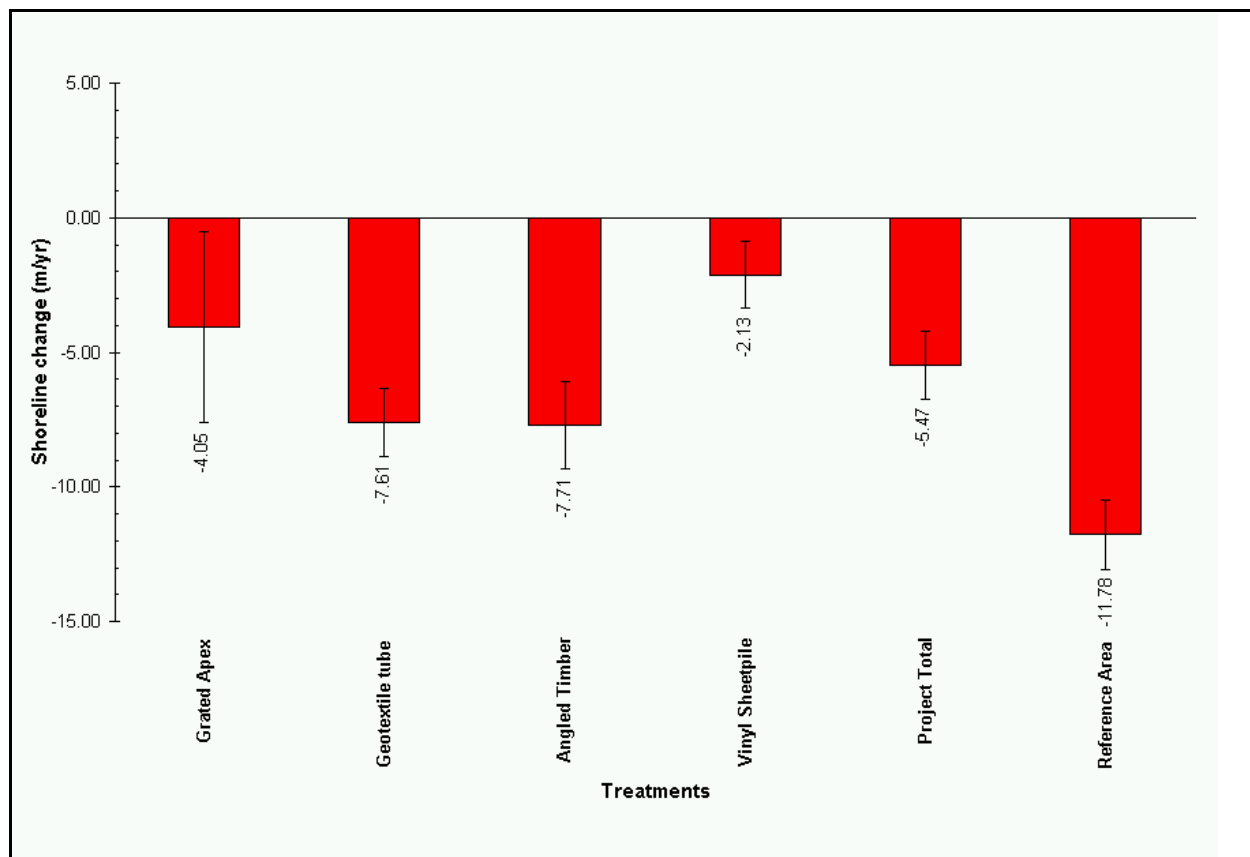
Shoreline markers were not measured in August 1998 as planned due to the fact that the rapid shoreline erosion had caused the majority of them to wash away, so only the January 1998 to May 1998 measurements were available. These measurements support the DGPS data, indicating the shoreline behind all Phase 1 structures and the reference area continued to erode during the first 6 months after construction (figure 15).

**Figure 15. Shoreline change rate (m/yr) from shoreline marker data for all treatments at Phase 1 of the Lake Salvador Shoreline Protection (BA-15) Demonstration project from January 1998 to May 1998.**

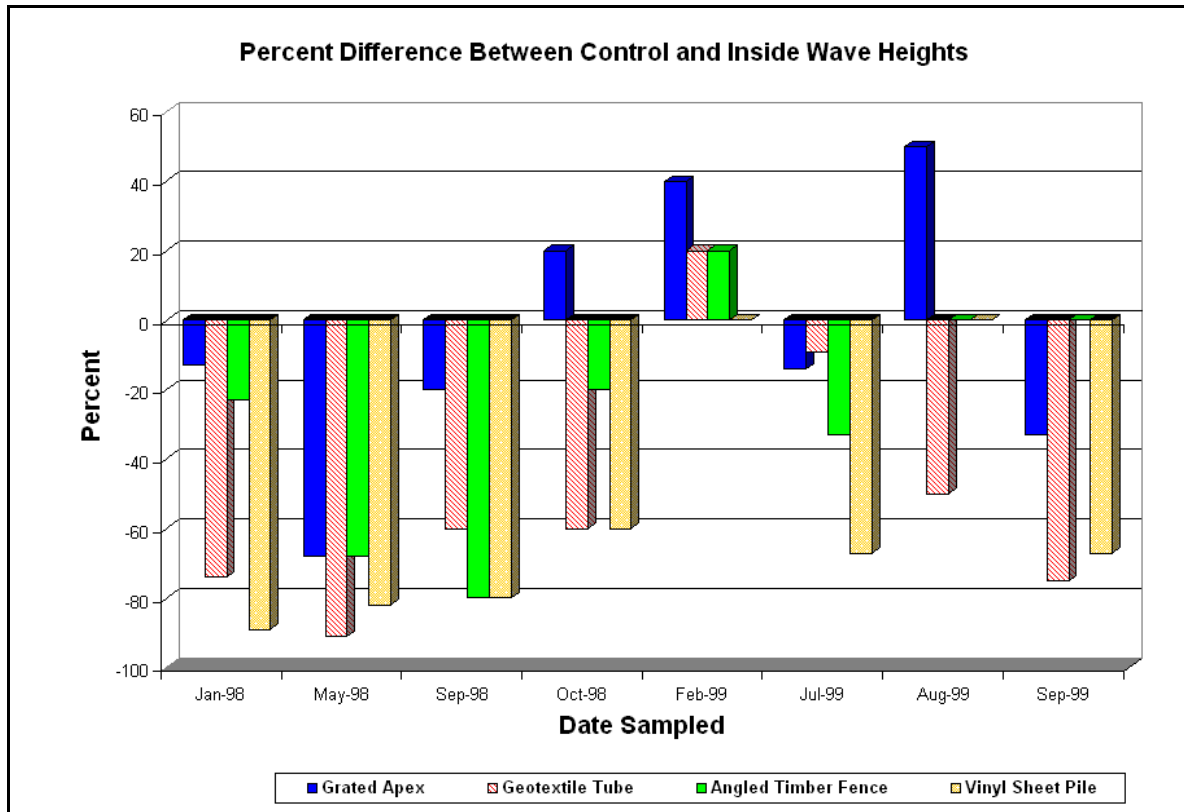
**Figure 16. Average significant wave height reductions for all treatments during all sampling periods at Phase 1 of the Lake Salvador Shoreline Protection (BA-15) Demonstration project (from Stone et al. 1998a, 1998b, 1998c, 1998d, 1999a, 1999b, 1999c, 1999d, 1999e).**

and the Vinyl Sheet Pile treatments are consistently effective in reducing wave heights landward of the structures when prevailing winds hail from the southern direction. The Vinyl Sheet Pile structures reduced average significant wave heights from 80 to 89% and the Geotextile Tubes reduced average significant wave heights from 60 to 91% during the January 1998, May 1998, and September 1998 sampling periods (figure 16). During these sampling periods, the winds were generated predominantly from the southern quadrant. Figure 17 delineates wind speed and direction measurements taken during the January 1998 sampling period. These wind measurements are also representative of the May and September 1998 sampling periods since wind speed and direction were fairly consistent throughout the first three sampling periods. While these impermeable structures were fairly consistent in damping wave energy during the first three sampling periods, the performance of the Grated Apex structure (approximately 20% porosity) and Angled Timber Fence structures (approximately 30% porosity) were variable although the prevailing winds hailed from the south in January 1998, May 1998, and September 1998. The Grated Apex treatment reduced average significant wave heights from 13 to 68% and the Angled Timber Fence treatment reduced average significant wave heights from 23 to 80% during the first three sampling periods (figure 16).

out of the northeast in October 1998. Conversely, the permeable treatments were not effective in lowering average significant wave heights during the October 1998 sampling period (figure 16). The Angled Timber Fence structures lowered average significant wave heights by 20% while the Grated Apex structures showed a 20% increase in wave heights when comparing the inside measurements with the control (figure 16).

The Vinyl Sheet Pile treatment also showed significant reductions in wave energy (approximately 90%) during all wind conditions except westerly winds (Stone et al. 1999a, 1999e) (figure 16). Despite this, the Vinyl Sheet Pile treatment had structural problems as well. The unreinforced Vinyl Sheet Pile structure showed failure due to wave energy warping the structure and loosening and removing the sheeting from the waler attachments (Stone et al. 1999d; B. Kendrick, LDNR/CRD, pers. comm.; Gotech 2000) (figure 22). However, the reinforced Vinyl Sheet Pile exhibited

structures reductions ranged from 13 to 68% (figure 16) (Stone et al. 1999e). However, these permeable structures demonstrated increases in average significant wave heights on several occasions (figure 16). Wind direction, velocity, and mean water level contributed to the performance of these structures. The western wind conditions encountered during the February 1999 sampling period (Stone et al. 1999a) produced 20 and 40% increases in average significant wave heights (figure 16). Both treatments effect on wave energies appeared dependant upon the average water level and wave height. When water levels were such that the mean water level was mid way between the horizontal slats, and the waves were low, a significant amount of the wave energy propagated through the structures. This was reduced as wave heights increased or mean water levels were at the same height as one of the horizontal slats (Stone et al. 1999e). Stone et al. (1999e) suggest that the direction from which the waves were propagating was another factor in these treatments ability to reduce wave energies. This phenomenon accounted for the variable wave energy reductions of both treatments and their affect on shoreline erosion rates.

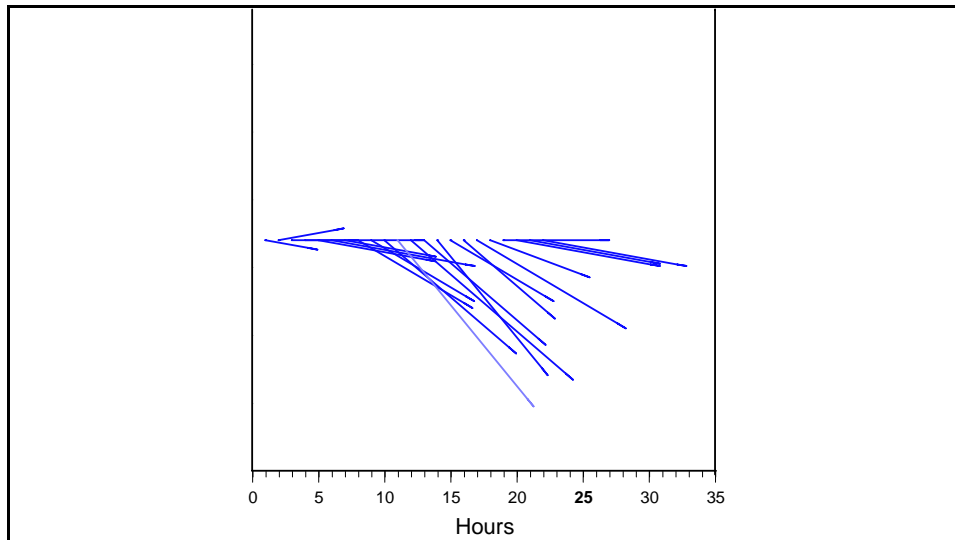
**Figure 17. Hourly wind speed and direction measurements at Moisant Field, New Orleans, LA during January 21, 1998 wave sampling time period.**

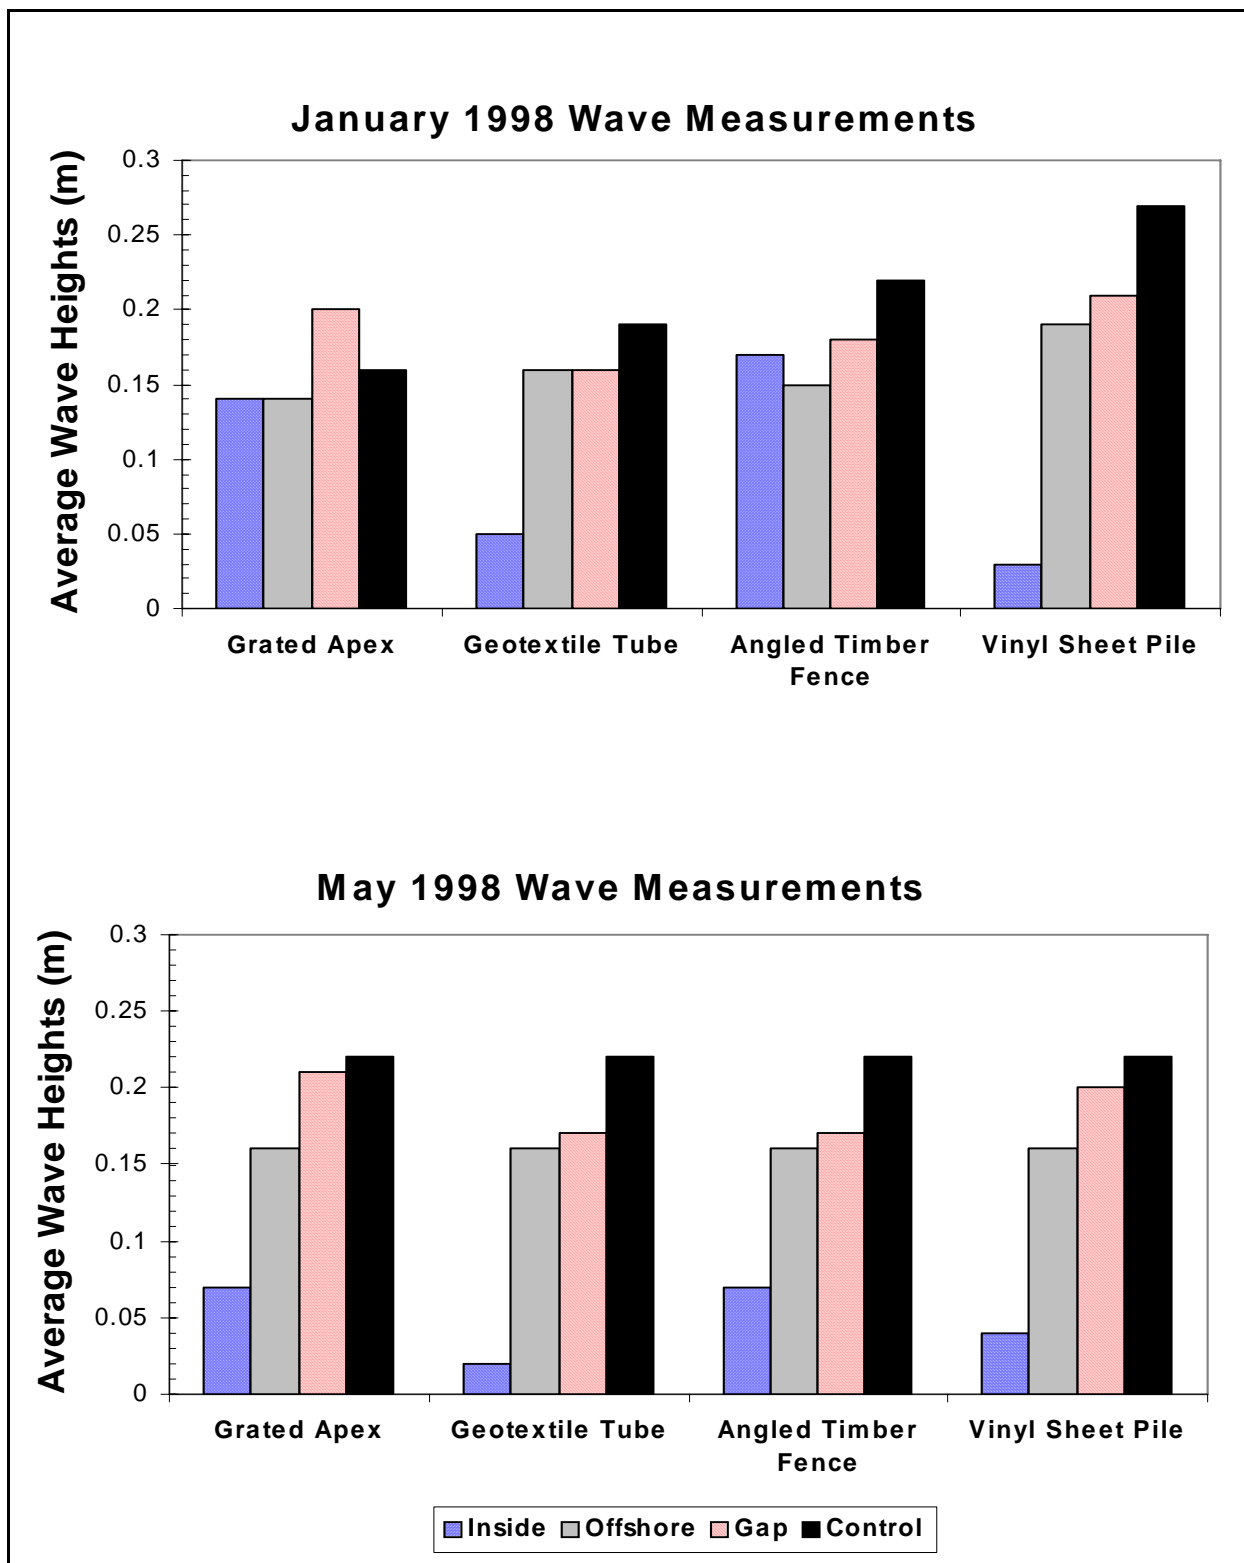
Figure 18. Average significant wave heights at each treatment on January 21, 1998 and May 6, 1998 at Phase 1 of the Lake Salvador Shoreline Protection (BA-15) Demonstration project (from Stone et al. 1998a, 1998b).

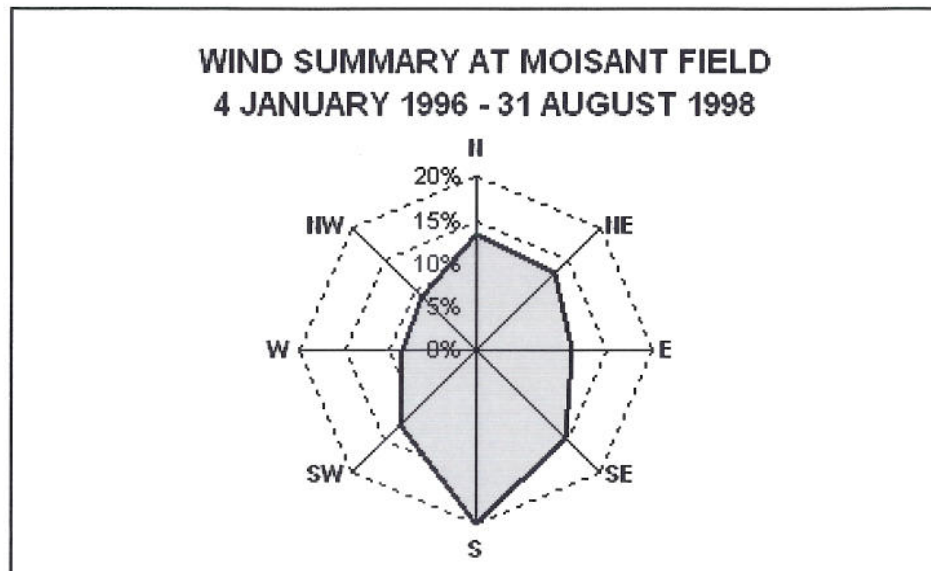
*Analysis of Winds:* An analysis of wind direction at Moisant Field north of Lake Salvador indicated that for a 2.5 year time period, winds were out of a southerly direction approximately 20% of the time, whereas the northerly component comprised 13% of the time (figure 19). Wind speed ranged from 0 to 20 knots but averaged 10 knots.

Figure 19. Hourly wind data summary from January 4, 1996 through August 31, 1998 at Moisant Field, New Orleans, LA.

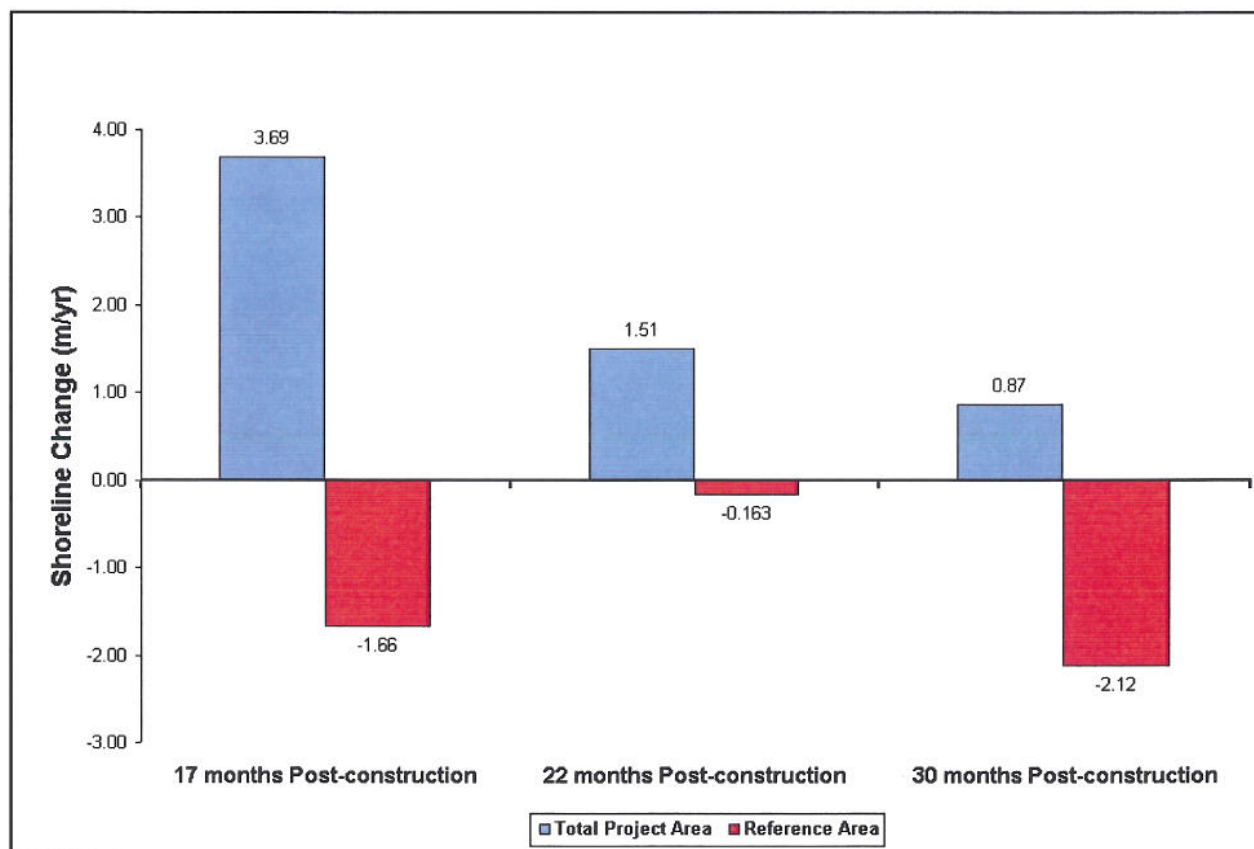
*Shoreline Change:* Post-construction analysis from the March 1999 to April 2001 time interval indicated that the project area prograded at a rate of  $2.85 \text{ ft yr}^{-1}$  ( $0.87 \text{ m yr}^{-1}$ ) while the reference area transgressed at a rate of  $6.95 \text{ ft yr}^{-1}$  ( $2.12 \text{ m yr}^{-1}$ ) (figure 20). The greatest shoreline progradation behind the rip-rap breakwater and the dredged material islands [ $12.11 \text{ ft yr}^{-1}$  ( $3.69 \text{ m yr}^{-1}$ )] occurred during the March 2000 sampling period while the smallest shoreline progradation rate [ $2.85 \text{ ft yr}^{-1}$  ( $0.87 \text{ m yr}^{-1}$ )] occurred during the April 2001 sampling period (figure 20). In contrast, the Phase 2 reference area shoreline continued to erode. The transgressions in the reference area were most prominent during the April 2001 survey which recorded an erosion rate of  $6.95 \text{ ft yr}^{-1}$  ( $2.12 \text{ m yr}^{-1}$ ) and least apparent during the August 2000 survey [ $0.535 \text{ ft yr}^{-1}$  ( $0.163 \text{ m yr}^{-1}$ )](figure 20). The October 1998 survey was not used as the baseline for post-construction analysis due to inconsistencies with future shoreline surveys. The March 1999 shoreline survey was used as the Phase 2 post-construction baseline survey. In addition, no DGPS data were collected in the project area for the August 1999 sampling period because of soft soil conditions encountered along the vegetation line (T. Hubbell and J. Rapp, LDNR/CRD, pers. comm.).

Figure 20. Shoreline change rates (m/yr) from survey and DGPS data for Phase 2 of the Lake Salvador Shoreline Protection (BA-15) Demonstration project.

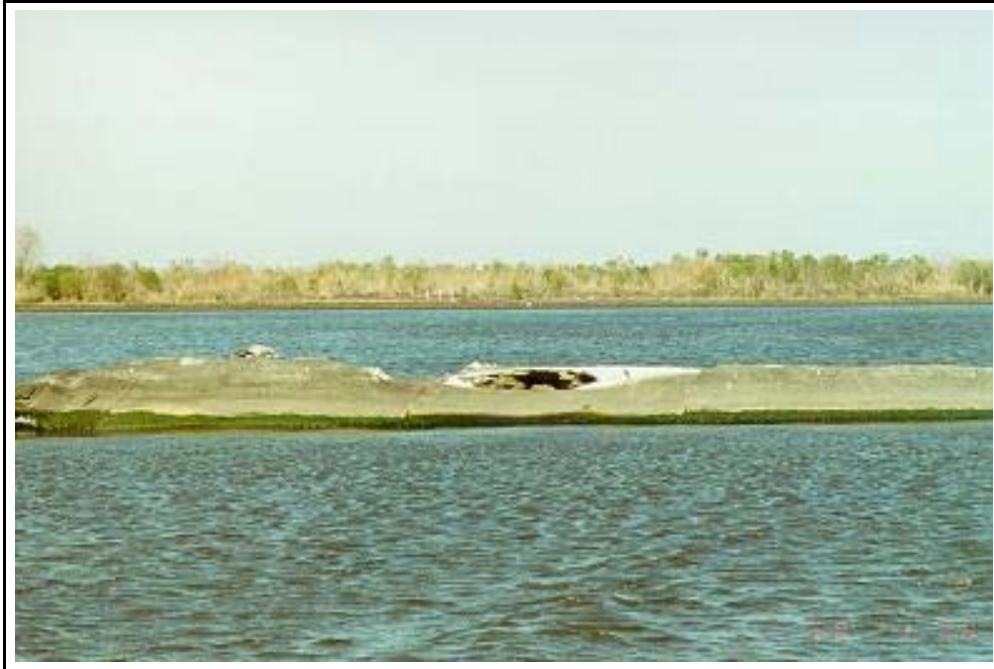
The Geotextile Tubes began to show signs of structural failure after the September 1998 sampling period (Stone et al. 1998c) (figure 21), and this may indicate that there was some impact to the shoreline change rate due to this treatment. However, since the longevity of the structures and potential maintenance must be considered in the evaluation of these treatments, the long-term implication of the Geotextile Tubes to reducing shoreline erosion looks poor, unless better designs or different deployment conditions can be formulated. Moreover by June of 2000, only 33% of these structures were above the waterline (Gotech 2000).

**Figure 21. Typical damage to the Geotextile Tube structures at the Lake Salvador Shoreline Protection (BA-15) Demonstration project (photo taken January 2000).**

The structural failure of the tubes appears to be due to: 1) differential settlement rates within each tube causing the internal concrete and sand to fracture and then wear the fabric during motion caused by wave energy (Stone et al. 1999e) and 2) problems with these Geotextile Tubes design and installation (B. Kendrick, LDNR/CRD, pers. comm.). Furthermore, Gotech (2000) reported that the sand and concrete inner fill material was not well mixed during construction. Once the tube failed, the wave energy removed fill material, depositing some of it landward of the structure. Geotextile Tubes have been used in other areas to successfully reduce shoreline erosion (Gill et al. 1995), and may still have potential in Louisiana. Gill et al. (1995) reported on Geotextile Tubes in Chesapeake Bay and noted during the winter of 1994 ice in the area up to 12 ft (3.6 m) thick, and no movement or apparent damage to the Geotextile Tube structures the following spring. Possible changes in fill material, installation methods, placement of the tubes in relation to the shoreline, and restrictions of the Geotextile Tube treatment to firmer soil locations could maximize the durability and performance of this treatment. However, it should be noted that this was the second most expensive treatment and over twice as expensive as the rock structure placed at Phase 2 (table 1).
