Monitoring Series No. BA-15-MSTY-0202-1

COMPREHENSIVE REPORT NO. 1  
For the Period October 1, 1997 to May 1, 2001

**LAKE SALVADOR SHORELINE PROTECTION  
DEMONSTRATION  
BA-15 (BA-15)**

**Third Priority List Shoreline Protection Project of the Coastal Wetlands Planning,  
Protection, and Restoration Act  
(Public Law 101-646)**

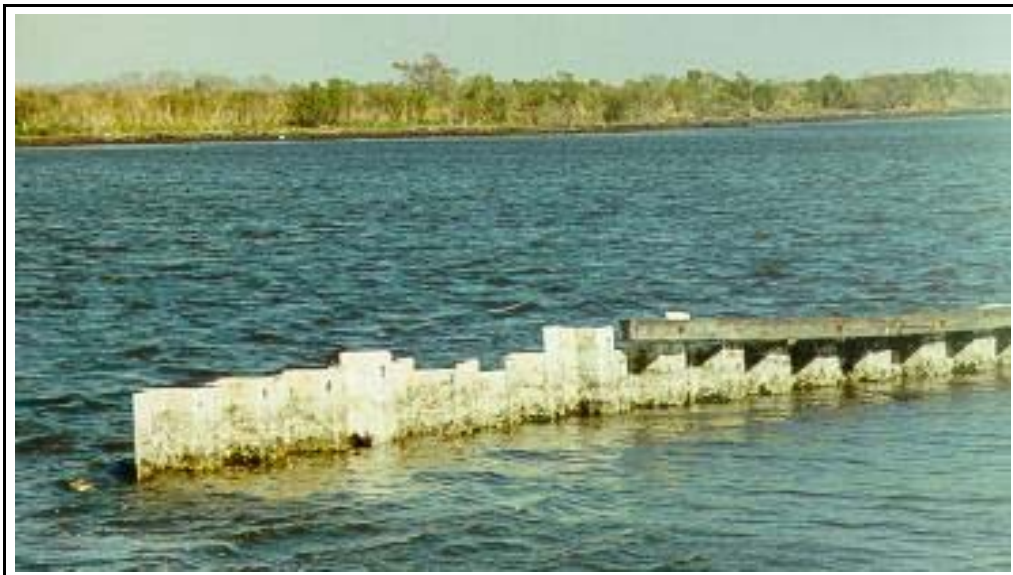
The Vinyl Sheet Pile treatment also showed significant reductions in wave energy (approximately 90%) during all wind conditions except westerly winds (Stone et al. 1999a, 1999e) (figure 16). Despite this, the Vinyl Sheet Pile treatment had structural problems as well. The unreinforced Vinyl Sheet Pile structure showed failure due to wave energy warping the structure and loosening and removing the sheeting from the waler attachments (Stone et al. 1999d; B. Kendrick, LDNR/CRD, pers. comm.; Gotech 2000) (figure 22). However, the reinforced Vinyl Sheet Pile exhibited

**Figure 22. Typical structural damage to the unreinforced Vinyl Sheet Pile structures at the Lake Salvador Shoreline Protection (BA-15) Demonstration project (photo taken January 2000).**

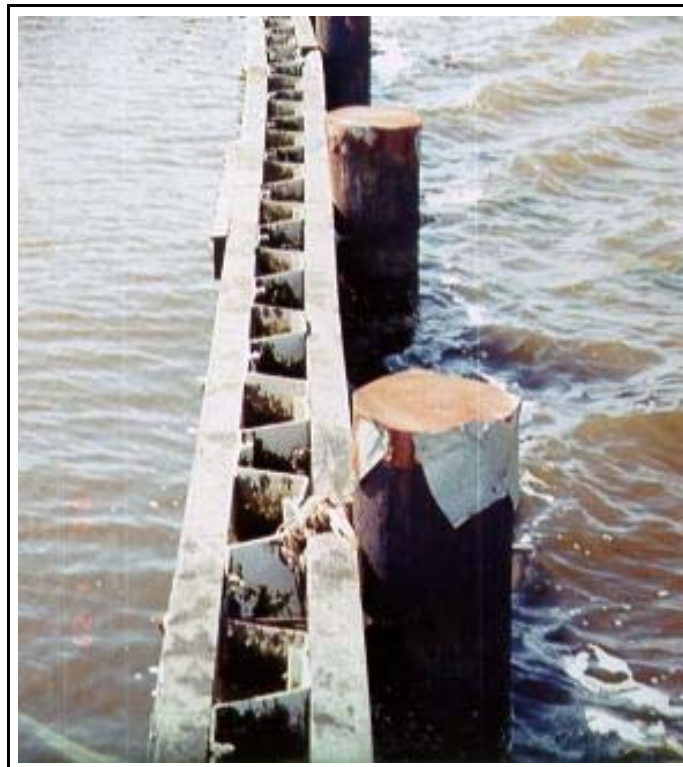
structural integrity over the 3 years of monitoring (figure 23) (Gotech 2000). The Vinyl Sheet Pile was the least expensive of the treatments tried at Phase 1 (table 1). Nevertheless, the Vinyl Sheet Pile structures were still more expensive than the rock structure placed at Phase 2. Due to the reinforced Vinyl Sheet Piles ability to reduce wave energies (Stone et al. 1999e) and better maintain structural integrity 3 years post-construction, they appear at this point to perform the best of all the treatments applied at Phase 1. However, it should be noted that these structures were only monitored for 3 years after construction, and no definitive reductions in shoreline erosion rates could be detected due to current project design with a lack of replication, treatment interactions, and other confounding factors.

**Figure 23. Typical structural stability of the reinforced Vinyl Sheet Pile structures at the Lake Salvador Shoreline Protection (BA-15) Demonstration project (photo taken January 2000).**

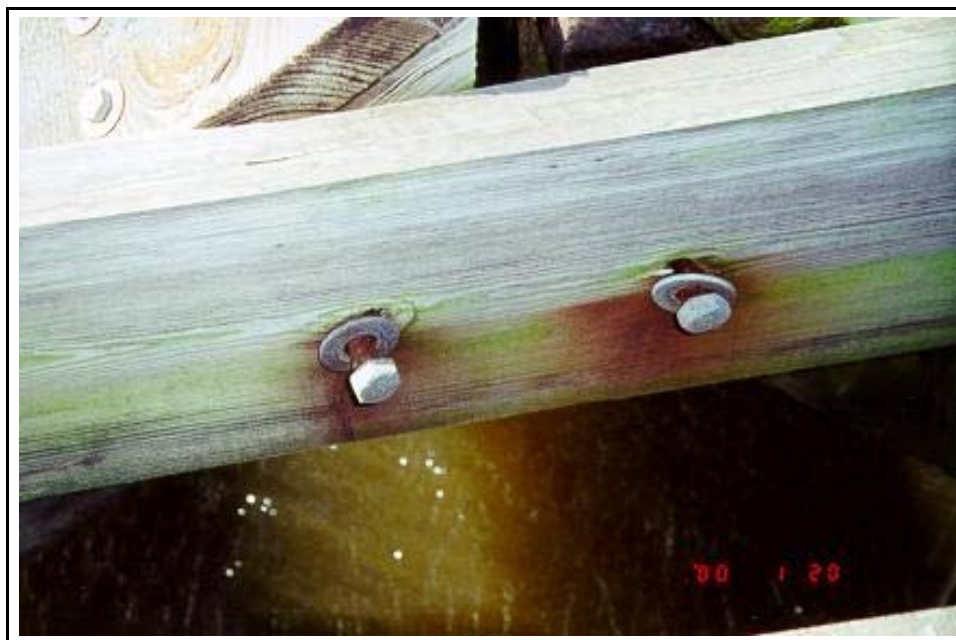
The Angled Timber and Grated Apex treatments both exhibited better structural performance than the Geotextile Tubes and unreinforced Vinyl Sheet Pile treatments (Gotech 2000). However, the Grated Apex structure is showing damage at piling attachments near the bottom, and loosening of bolts though out the structure (B. Kendrick, LDNR/CRD, pers. comm.). The Angled Timber Fence treatment seems to be holding up the best of all the treatments, and shows only some minor wear, as boards and bolt attachments begin to wear and loosen (Gotech 2000) (figure 24). The Grated Apex structure was the most expensive treatment applied at Phase 1, while the Angled Timber fences had the second lowest cost (table 1). Both were more expensive than the rock structure installed for Phase 2.

**Figure 24. Typical structural damage exhibited by the Grated Apex and Angled Timber Fence structures at the Lake Salvador Shoreline Protection (BA-15) Demonstration project (photo taken January 2000).**

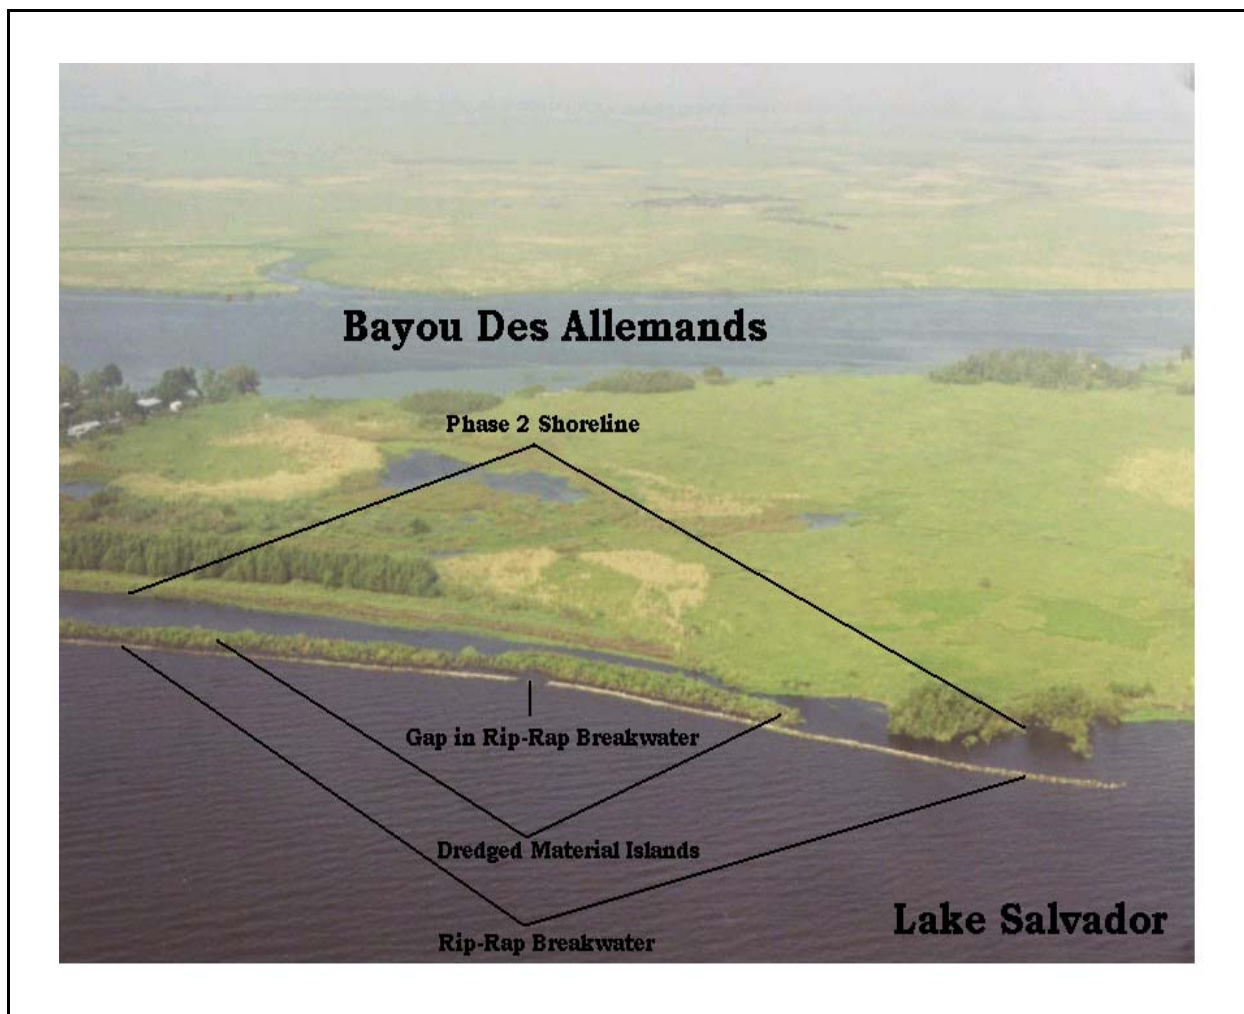
The Phase 2 rip-rap structure itself appears to be holding up well, showing little signs of deterioration or subsidence (B. Kendrick, LDNR/CRD, pers. comm.). The rip-rap breakwater

**Figure 25.** View of a segment of the Phase 2 project area at the Lake Salvador Shoreline Protection (BA-15) Demonstration project.

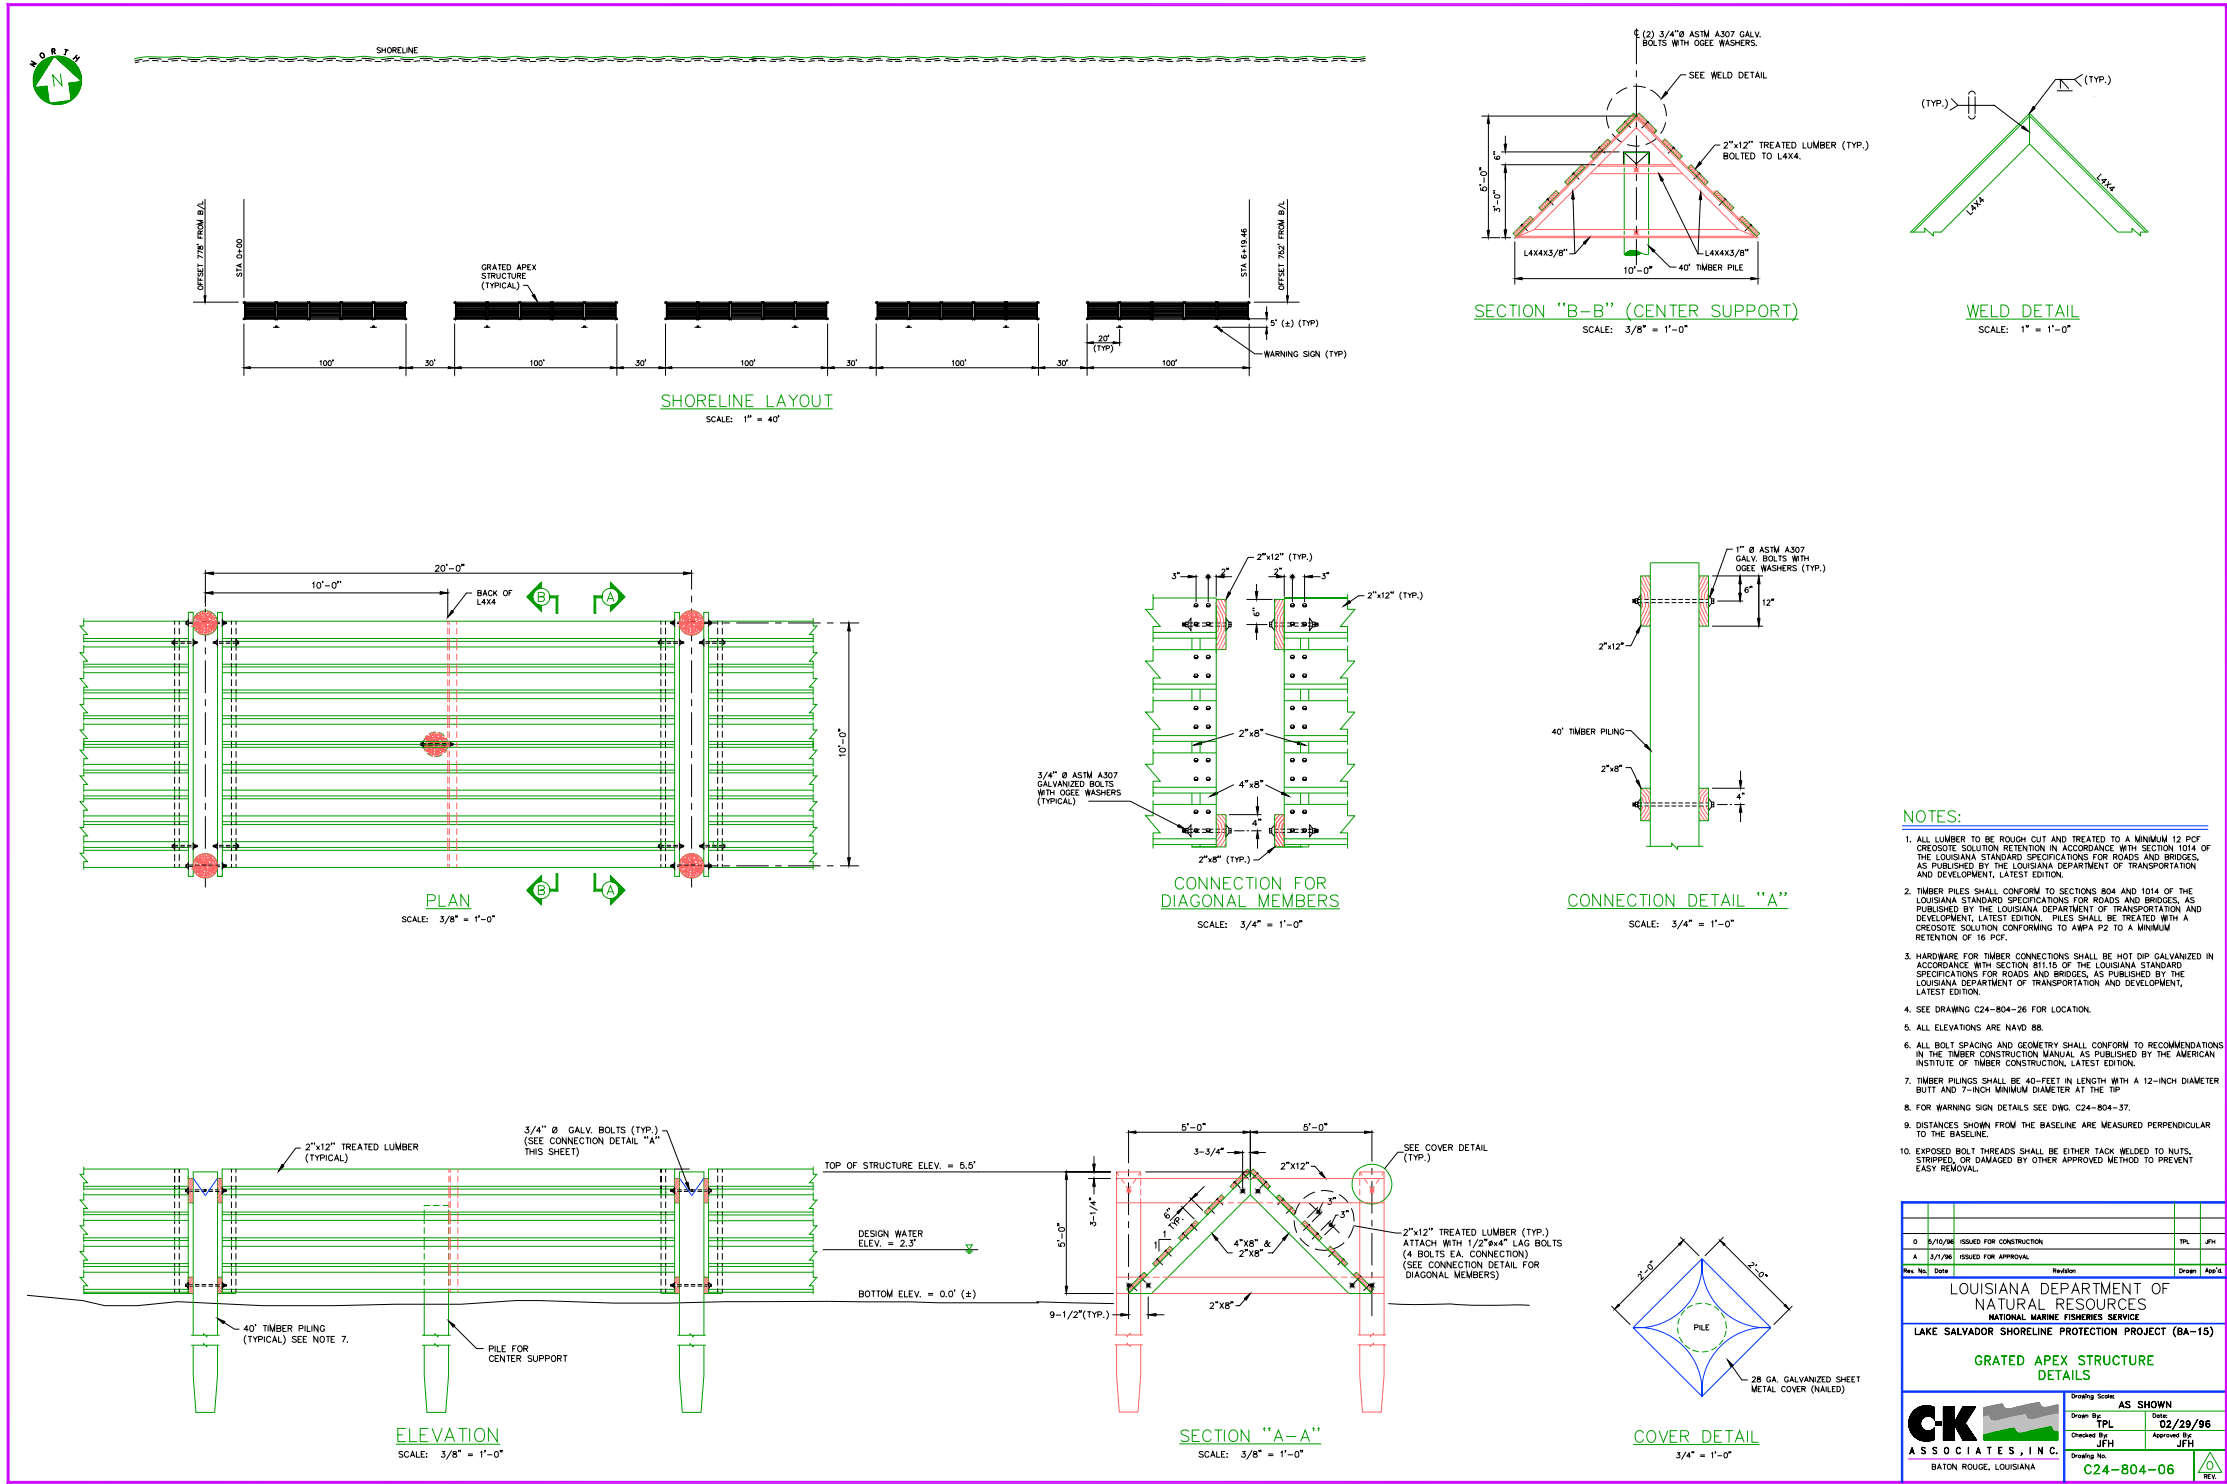
AutoCAD design drawing of typical Grated Apex structure construction and layout by C-K Associates, Inc. (not to scale).

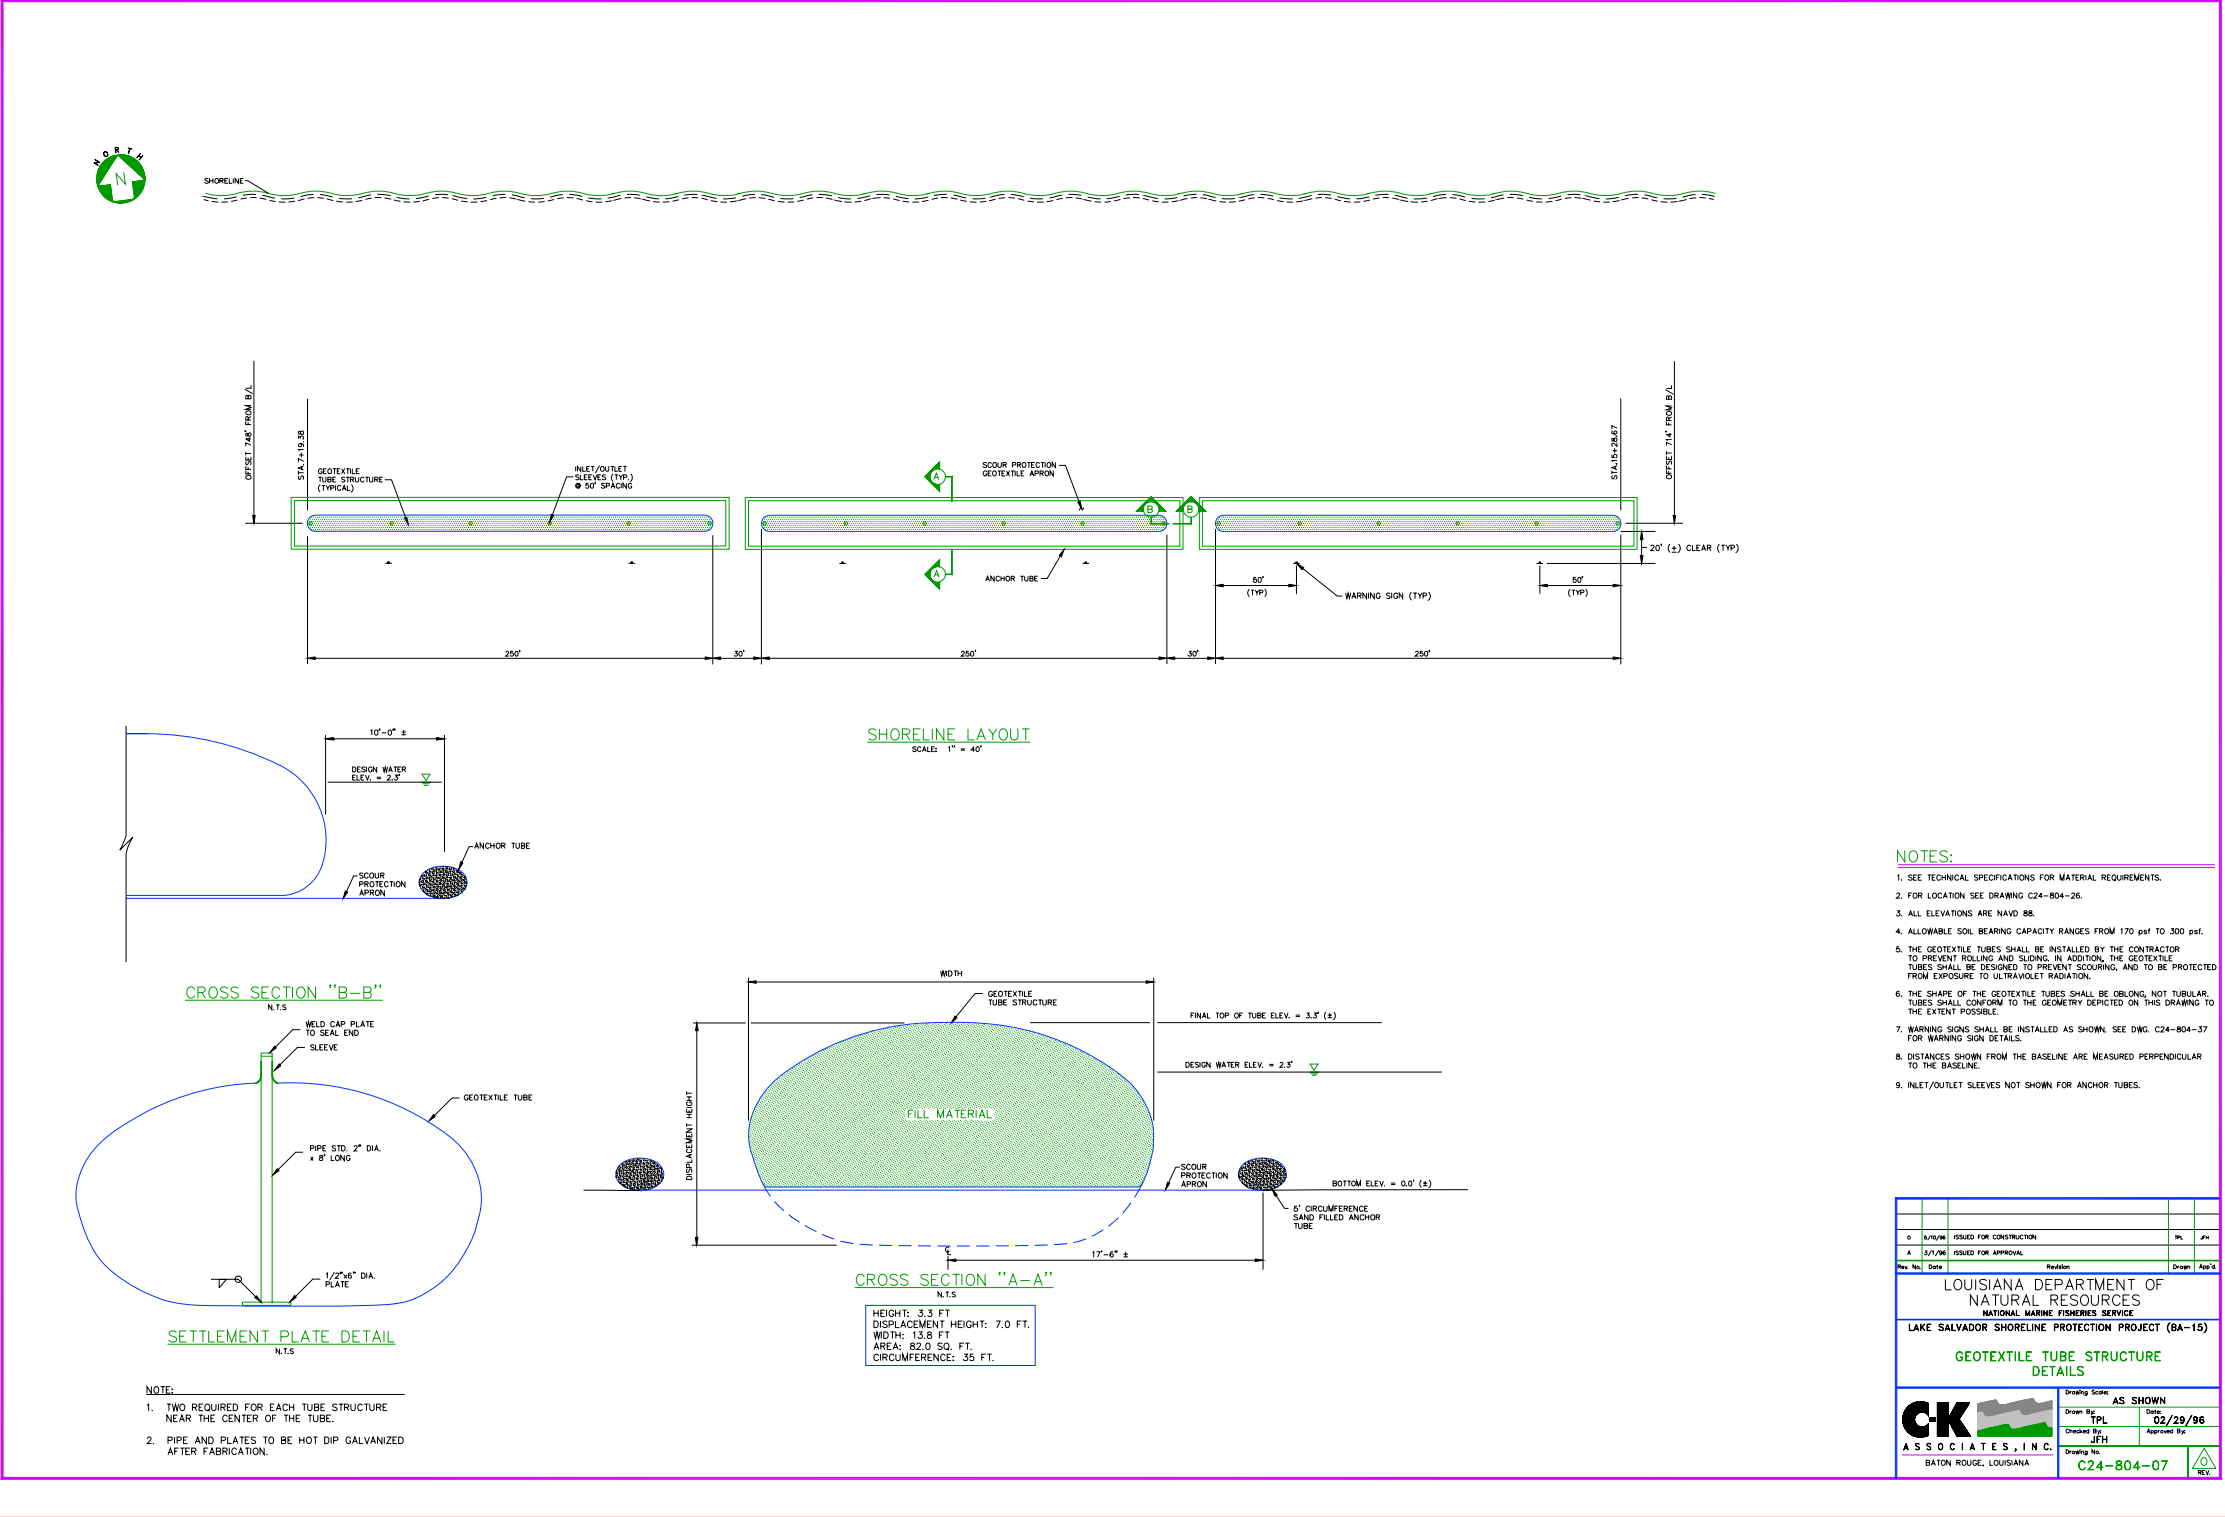
AutoCAD design drawing of typical Geotextile Tube structure construction and layout by C-K Associates, Inc. (not to scale).

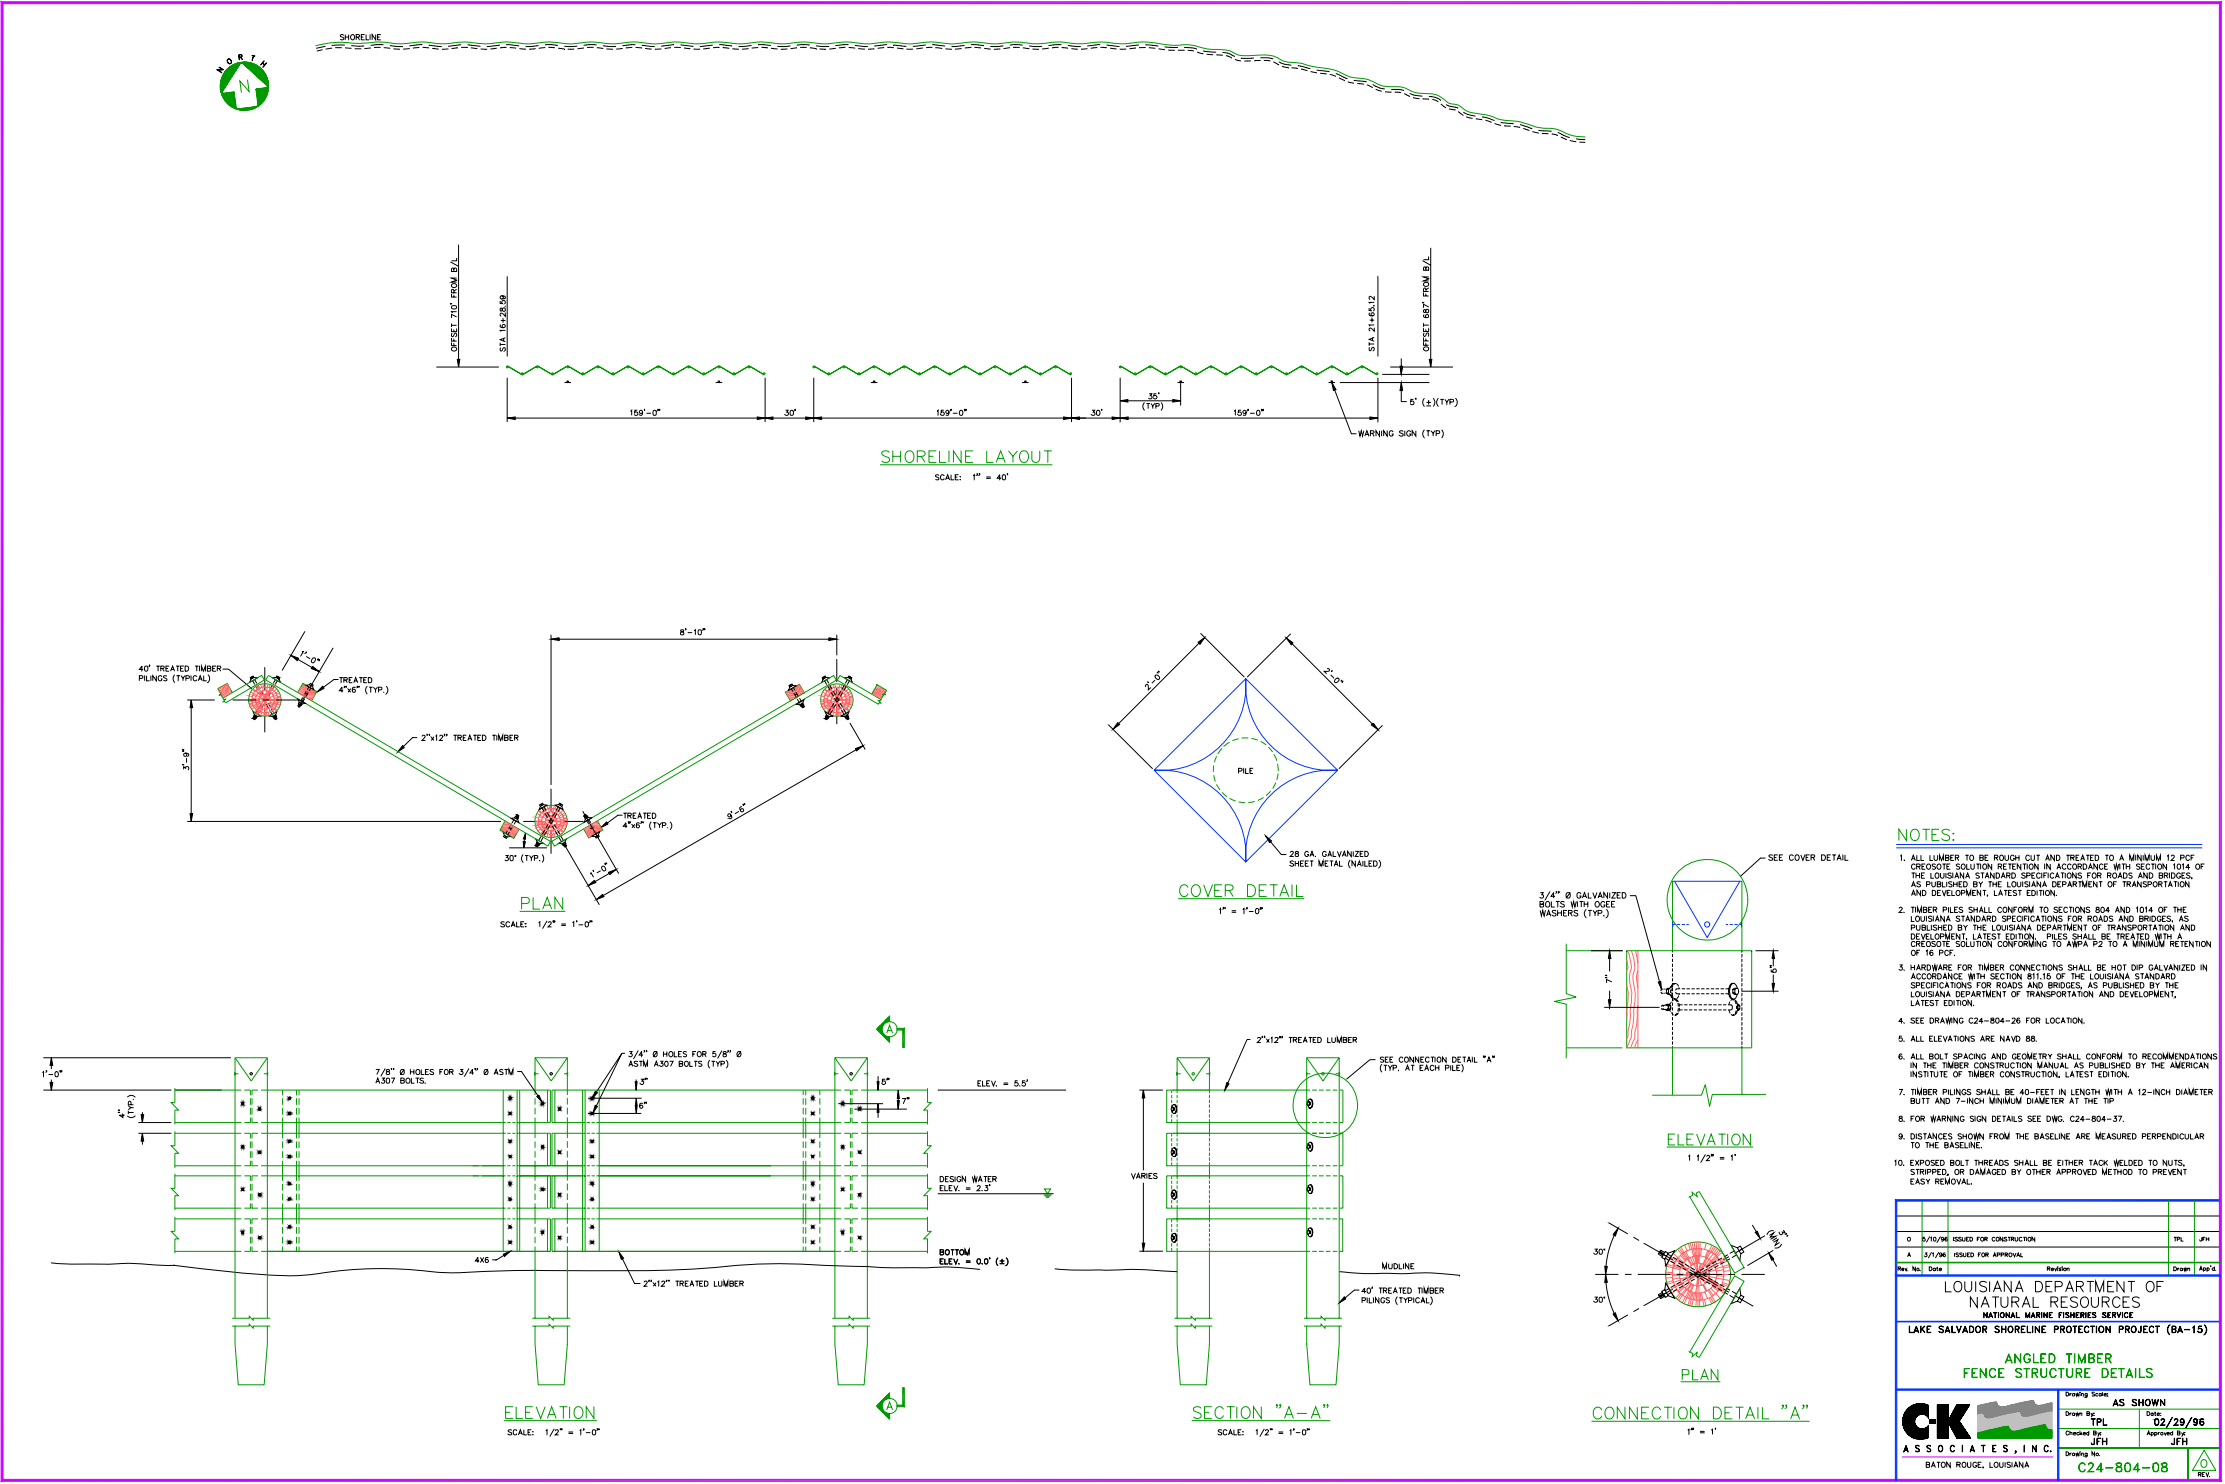
AutoCAD design drawing of typical Angled Timber Fence structure construction and layout by C-K Associates, Inc. (not to scale).

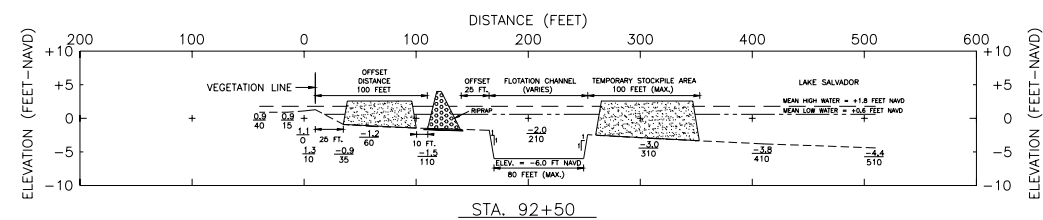
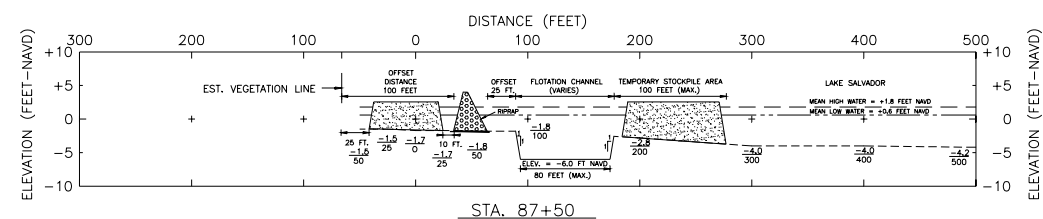
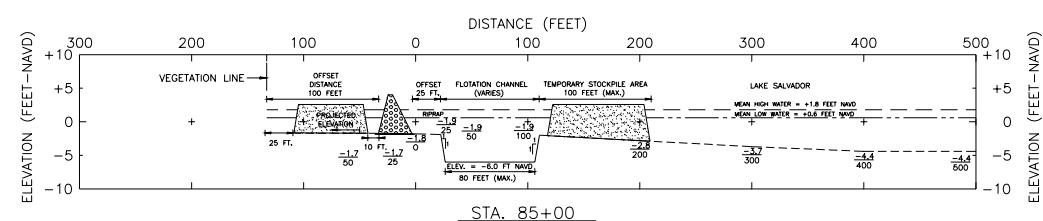
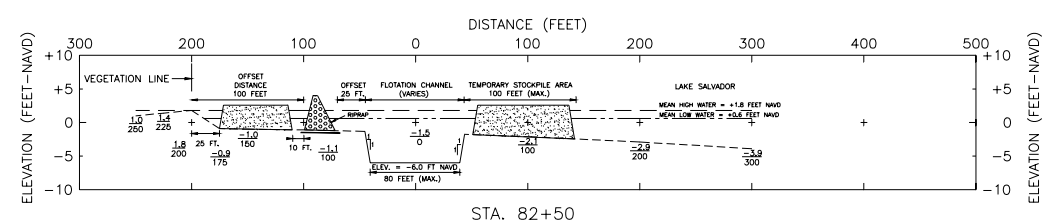
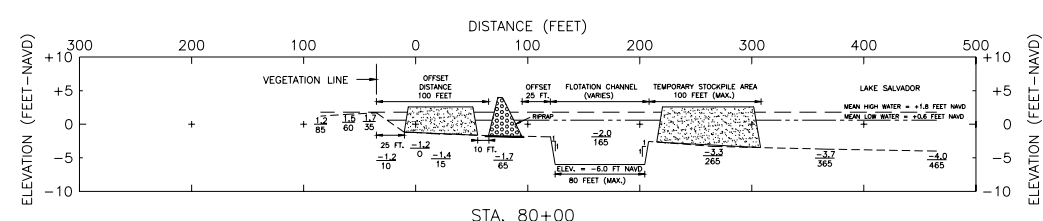
SURVEY CROSS SECTIONS			
LAKE SALVADOR DEMONSTRATION PROJECT - PHASE II (BA-15) ST. CHARLES PARISH, LOUISIANA			
LOUISIANA DEPARTMENT OF NATURAL RESOURCES COASTAL RESTORATION DIVISION 425 NORTH 4TH STREET BATON ROUGE, LOUISIANA 70804			
SCALE: AS SHOWN	DRAWN BY: D.B.K.		
DATE: SEPTEMBER, 1997	GEORGE BOODKE, P.E.		
		DRAWING NO. 14 OF 15

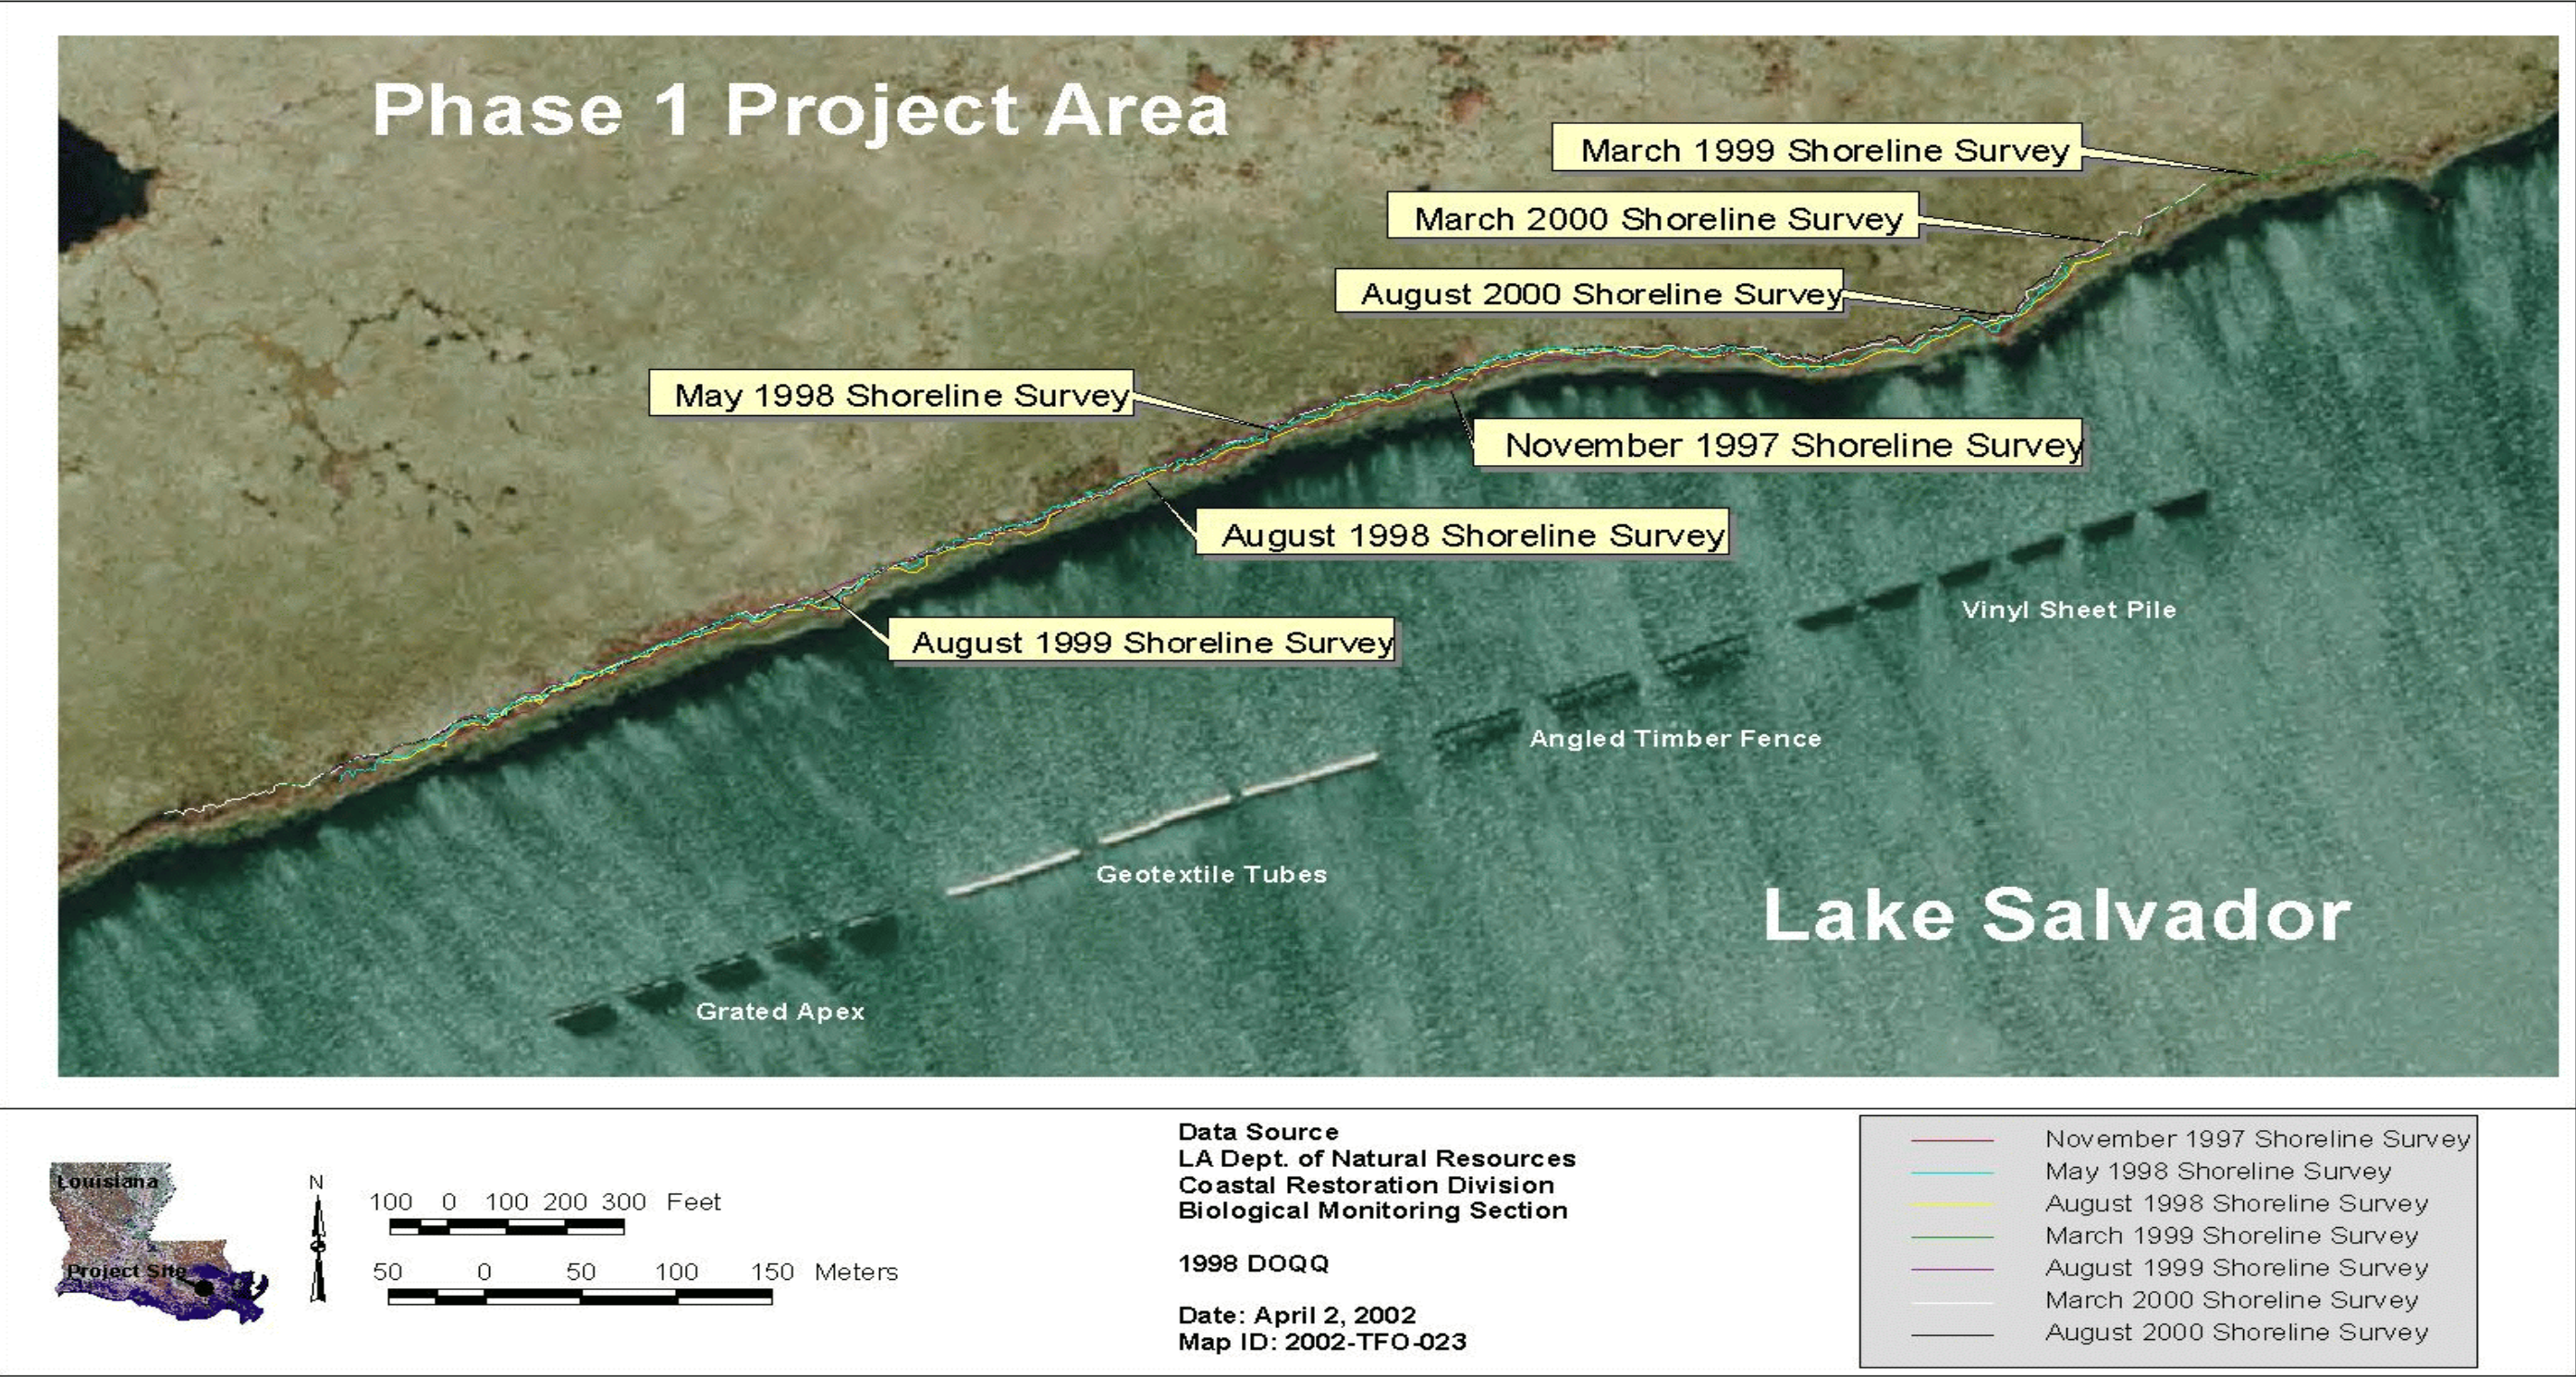
Phase 1 project area shoreline surveys for the Lake Salvador Shoreline Protection Demonstration (BA-15) project.

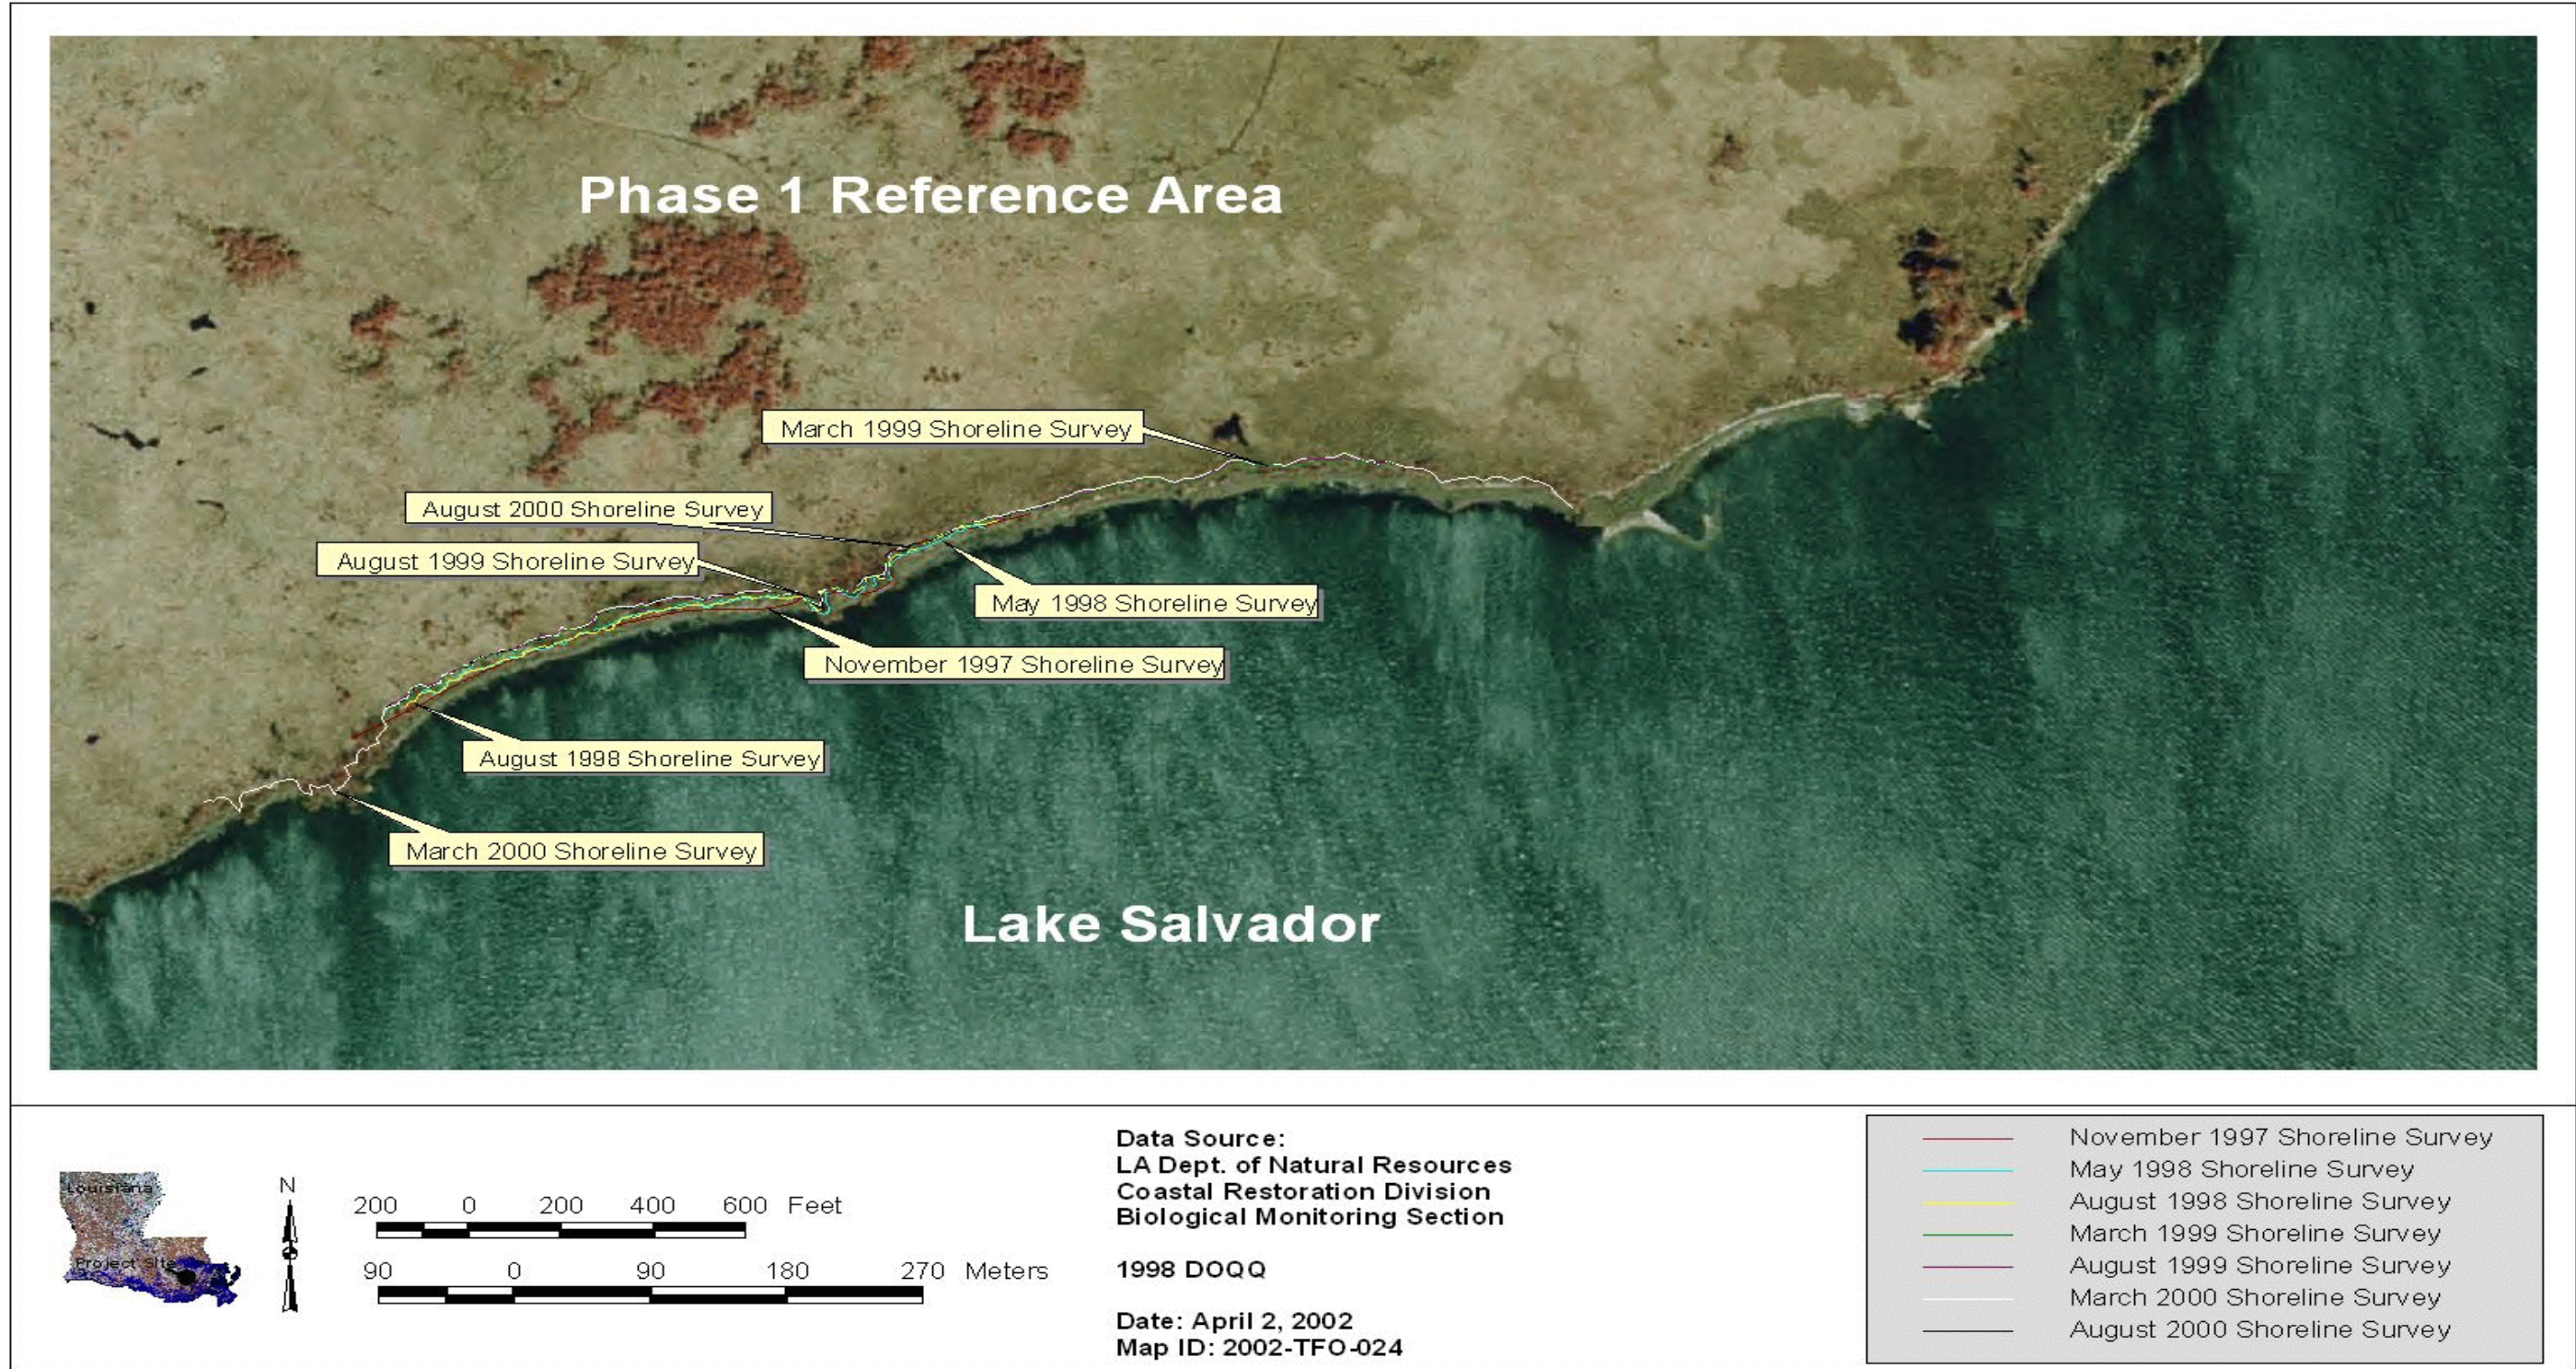
Phase 1 reference area shoreline surveys for the Lake Salvador Shoreline Protection Demonstration (BA-15) project.
