Monitoring Series No. BA-15-MSTY-0202-1

COMPREHENSIVE REPORT NO. 1  
For the Period October 1, 1997 to May 1, 2001

**LAKE SALVADOR SHORELINE PROTECTION  
DEMONSTRATION  
BA-15 (BA-15)**

**Third Priority List Shoreline Protection Project of the Coastal Wetlands Planning,  
Protection, and Restoration Act  
(Public Law 101-646)**

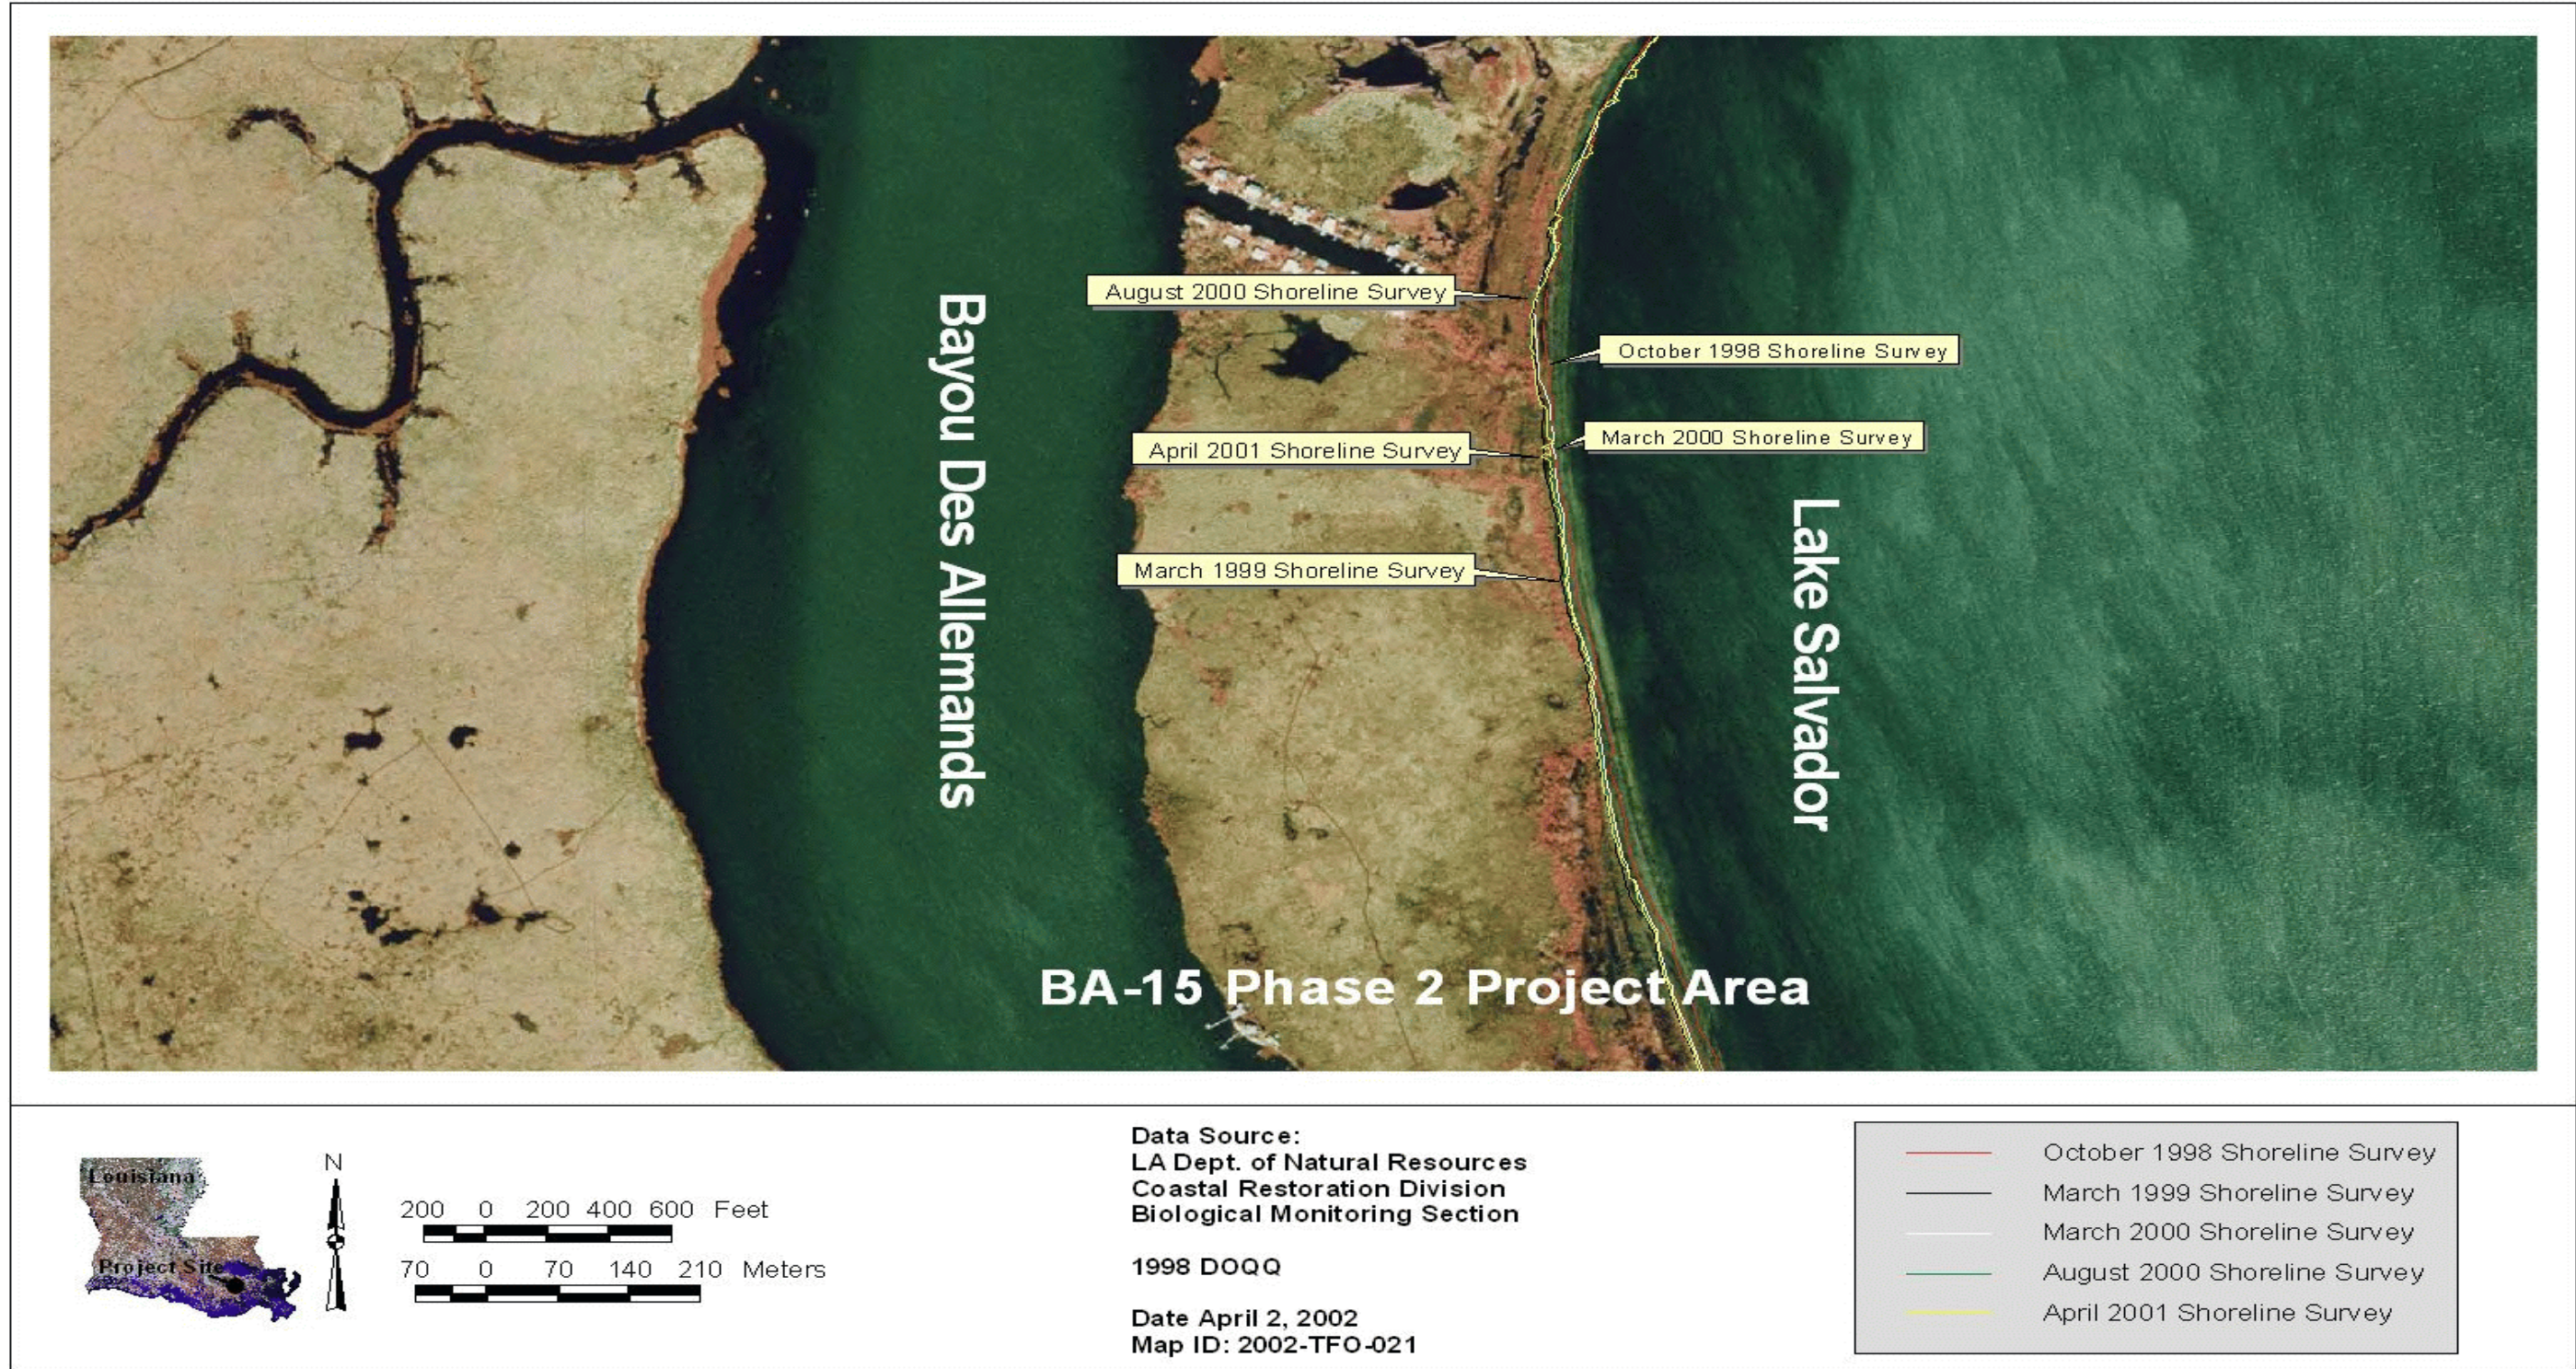
Phase 2 project area shoreline surveys for the Lake Salvador Shoreline Protection Demonstration (BA-15) project.
