**SABINE REFUGE PROTECTION (C/S-18)**  
**C/S-18-MSPR-0796-3**  
**PROGRESS REPORT NO. 3**  
for the period  
January 27, 1995 to July 29, 1996

Prepared on June 18, 1996, by Karl A. Vincent and Bin Sun.

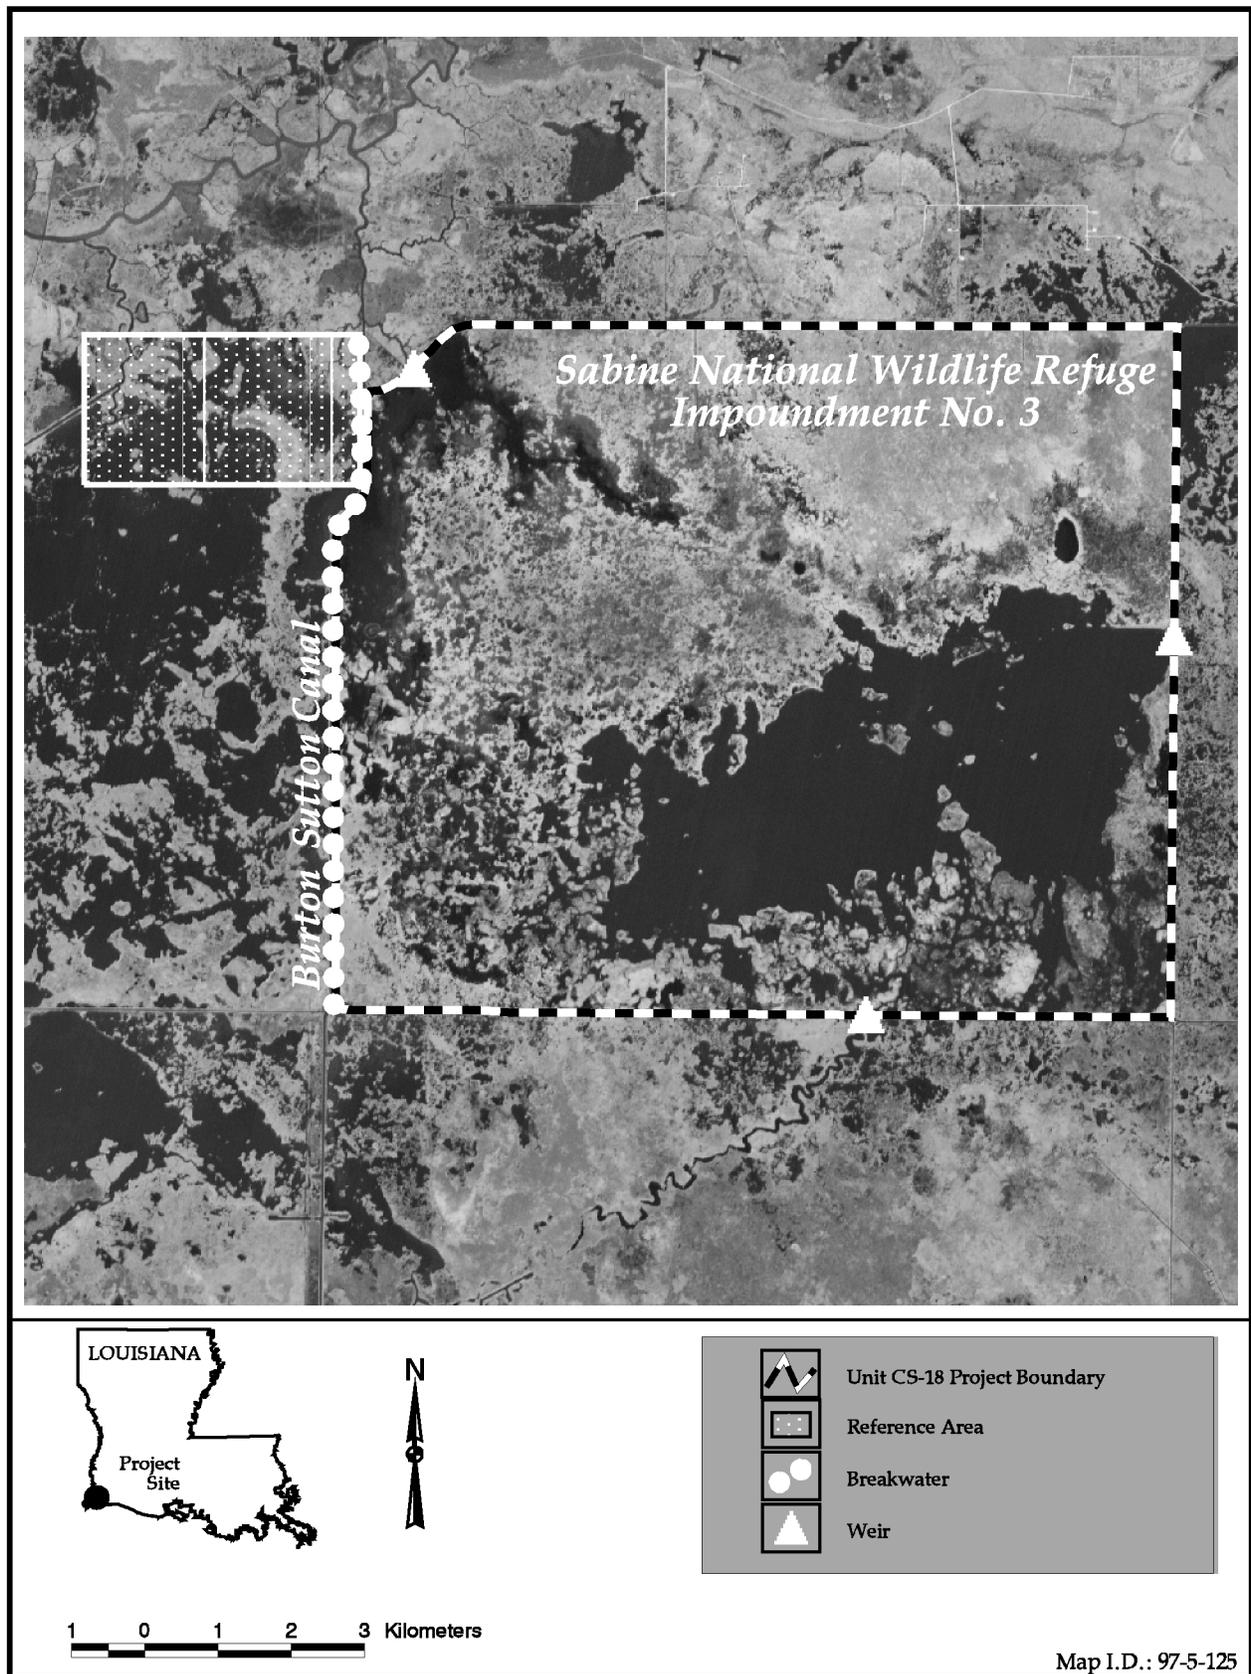
Figure 1. Sabine Refuge Protection (C/S-18) project area map.

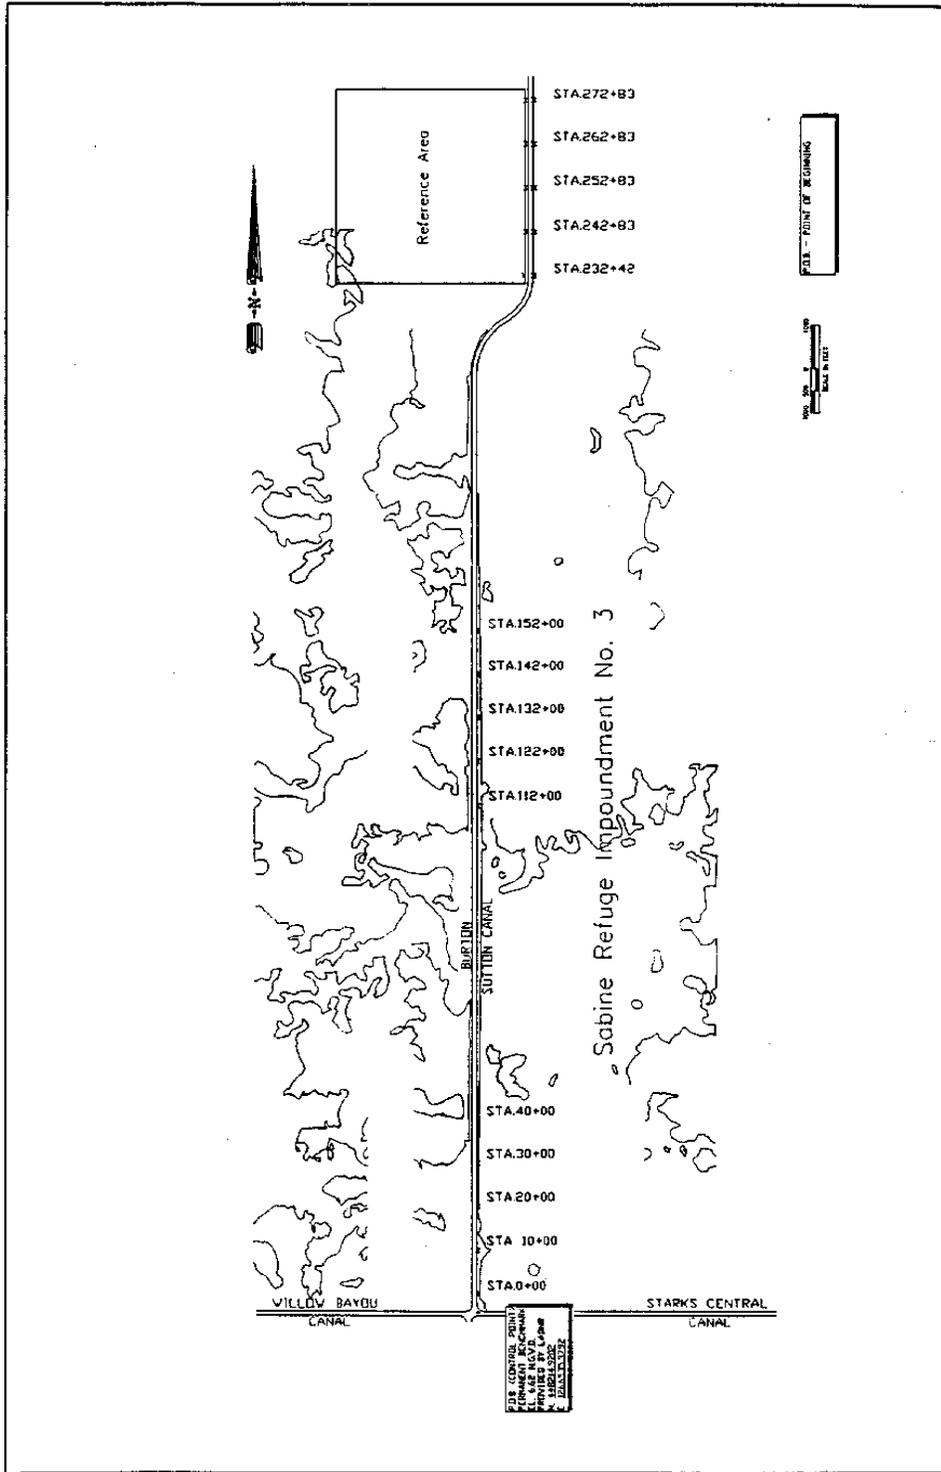
**Figure 2.** Plan view of the Sabine Refuge Protection (C/S-18) project rock dike along the Burton-Sutton Canal showing the location of the survey cross sections established to monitor shoreline movement.

**Shoreline Markers:** During August 1995, Professional Engineering and Environmental Consultants of New Orleans completed a shoreline and cross-sectional survey of the Burton-Sutton Canal. This baseline survey data will be compared to future data sets to evaluate project success. Representative plan view and channel cross-sectional drawings from the survey are provided as examples in figures 2 and 3. The survey will be repeated in 1998.

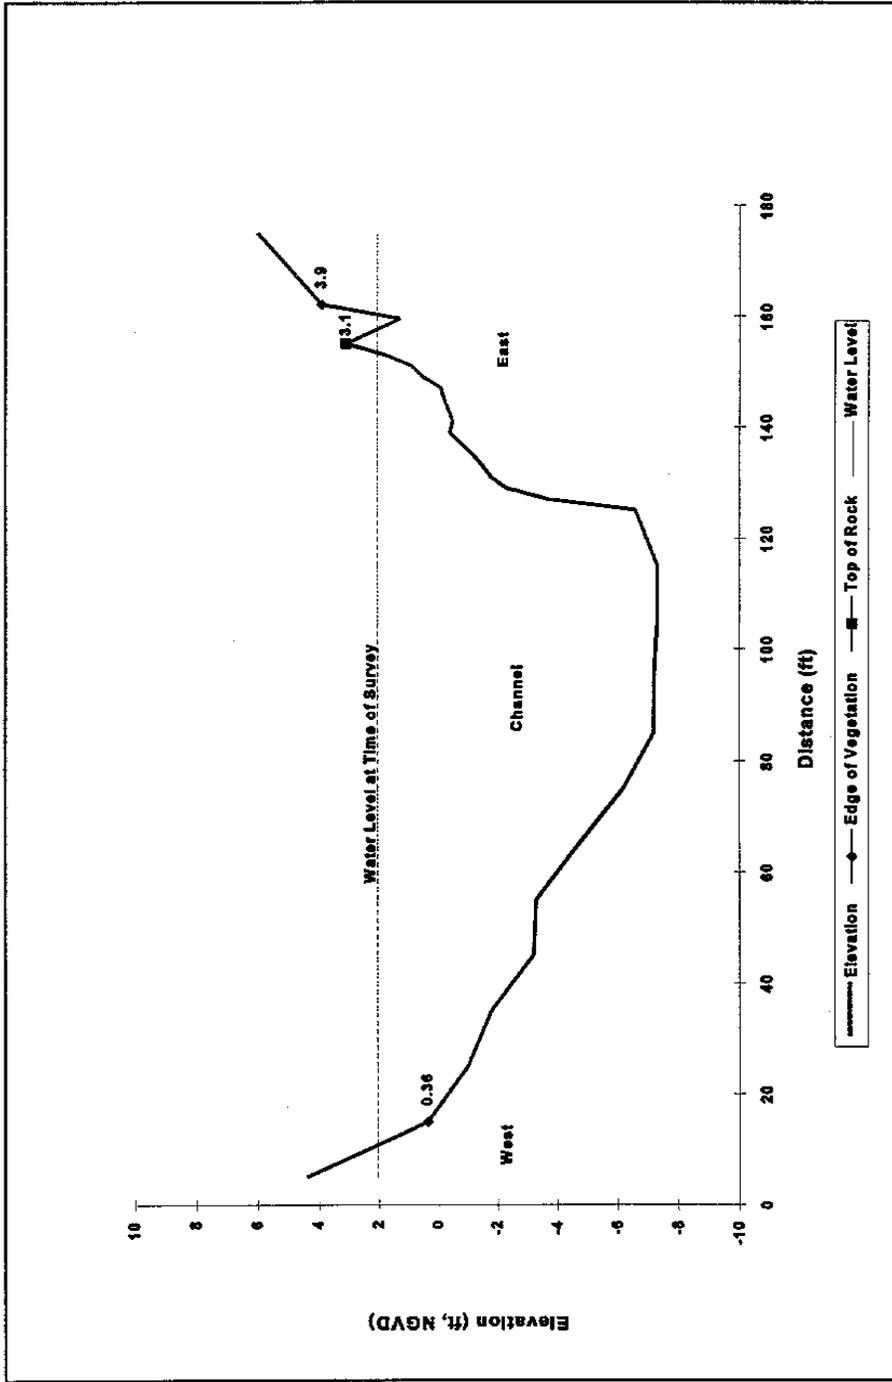
**Figure 3.** Cross-sectional view of the Burton-Sutton Canal at station 272+83 on the west side of Impoundment No. 3 at Sabine National Wildlife Refuge, showing channel profile, locations of the vegetative edge, the Sabine Refuge Protection (C/S-18) project rock dike, and the water level at the time of the survey in October 1995.
