Coast 2050 Region 4
SABINE REFUGE PROTECTION (C/S-18)
C/S-18-MSPR-0197-4
PROGRESS REPORT NO. 4
for the period
January 27, 1995 to January 27, 1997

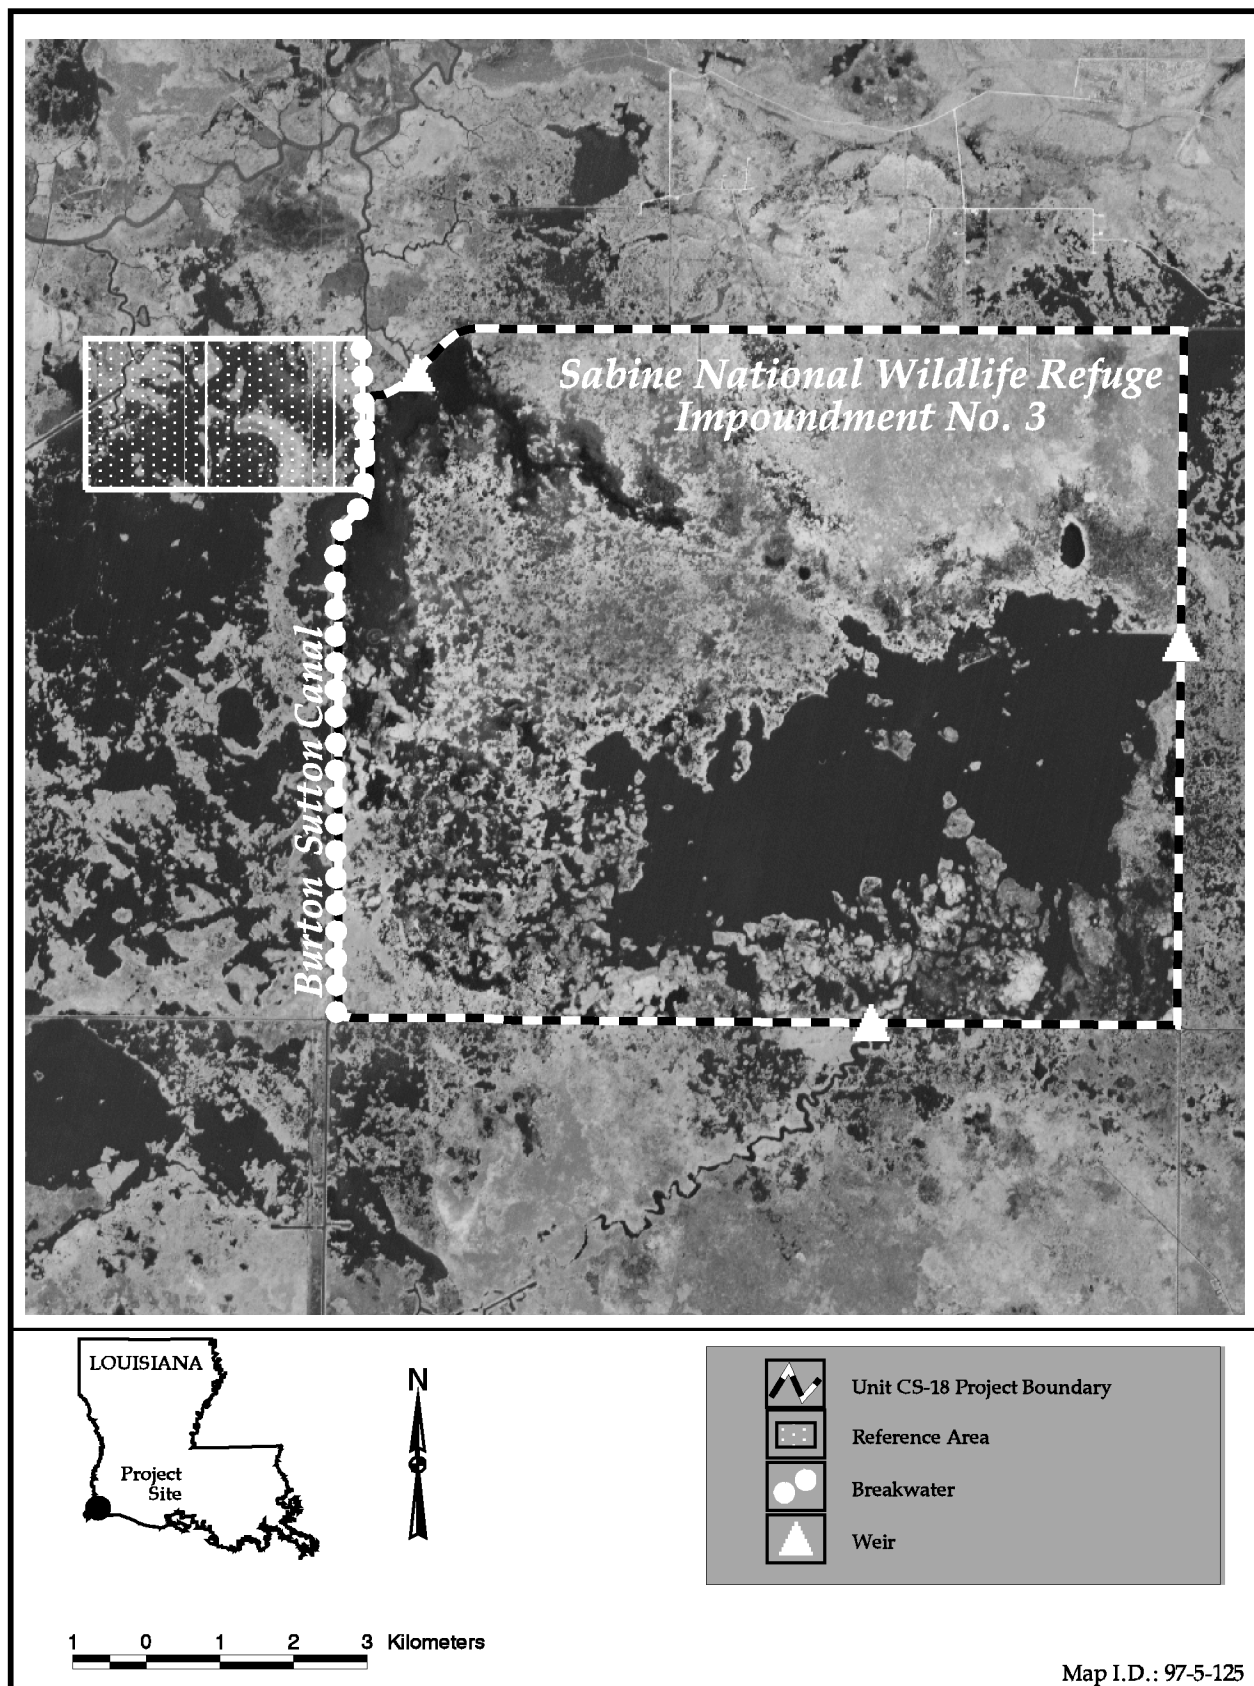
Figure 1. Sabine Refuge Protection (C/S-18) project area map.

Impoundment No. 3 (figure 1) at Sabine National Wildlife Refuge in Cameron Parish, Louisiana, includes approximately 27,000 acres of freshwater wetlands that depend almost exclusively on precipitation as the source of fresh water. The tidally connected canals surrounding the impoundment hold brackish water, which would negatively impact the freshwater wetlands and fishery in Impoundment 3 if a breach developed in the impoundment levee. The west levee of Impoundment 3 also forms the east spoil bank along the Burton-Sutton Canal, which is used by barges and boats to reach two oil and gas fields located on the refuge south of Impoundment 3. Bank erosion along this canal, along with deterioration resulting from weathering of the spoil bank over time, prompted the need to protect this levee from further deterioration.

The Sabine Refuge Protection (C/S-18) project (figure 1) was designed to prevent further erosion of the Impoundment No. 3 west levee, and protect the existing freshwater wetlands from saltwater intrusion. The specific goals of the project are to restore and protect the west levee of the impoundment using dredged material and a free-standing rock dike, and to protect the existing freshwater vegetation within Impoundment No. 3 from saltwater intrusion via the Burton-Sutton Canal.

Construction of approximately 5.5 linear mi of free-standing, continuous rock dike along the east bank of the Burton-Sutton Canal (which forms the west bank of the impoundment) was completed in January 1995 (figure 1).

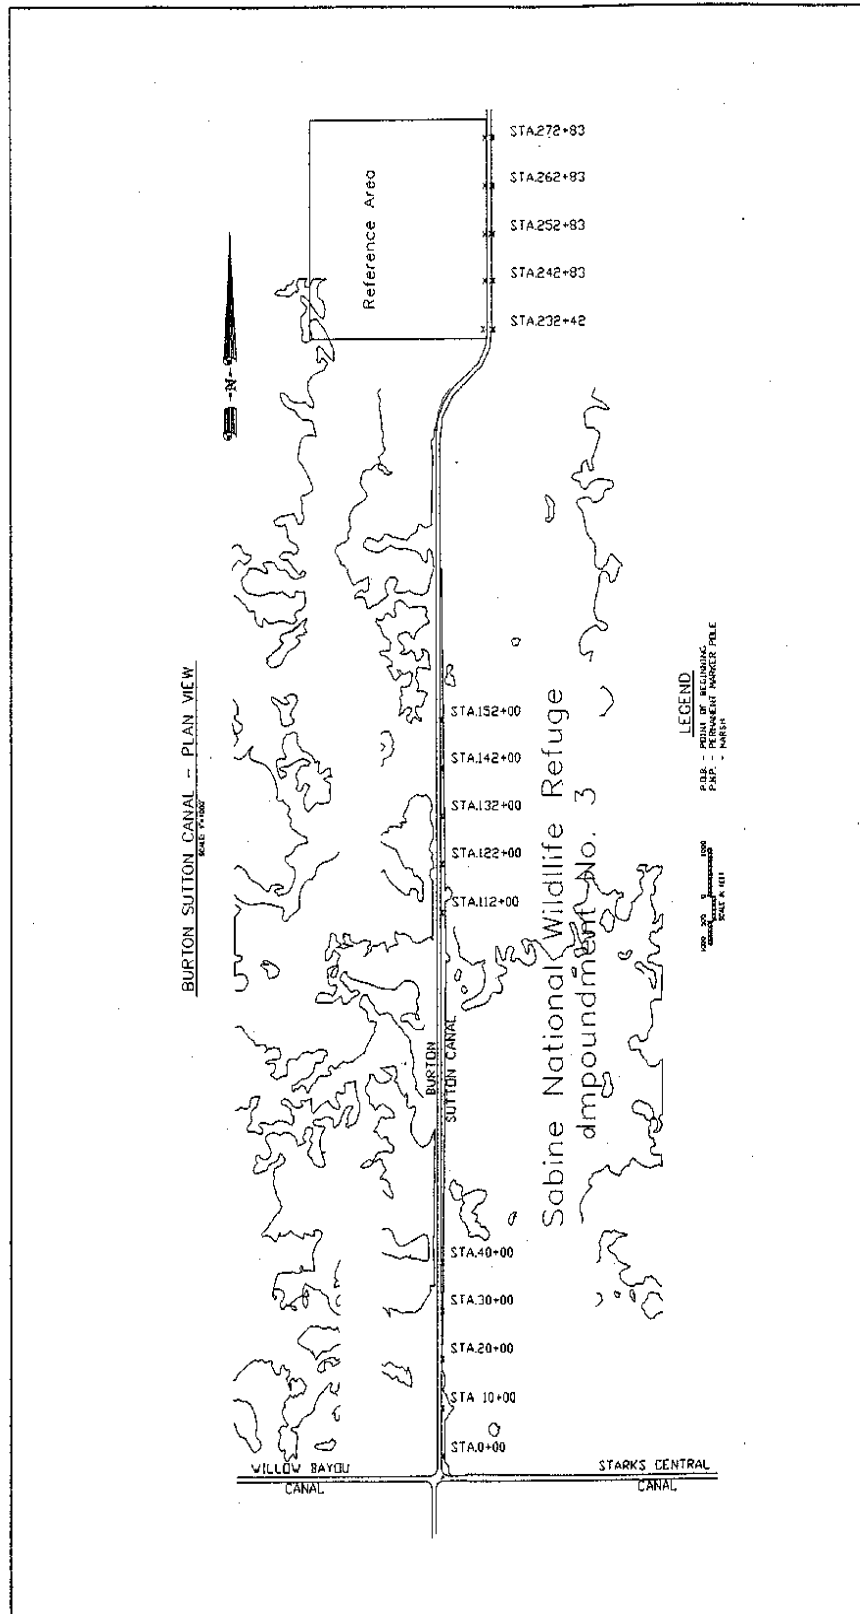
Figure 2. Plan view of the Sabine Refuge Protection (C/S-18) project rock dike along the Burton-Sutton Canal showing the location of the survey cross sections established to monitor shoreline movement.

Shoreline Markers: During August 1995, Professional Engineering and Environmental Consultants of New Orleans completed a shoreline and cross-sectional survey of the Burton-Sutton Canal. This baseline survey data will be compared to future data sets to evaluate project success. Representative plan view and channel cross-sectional drawings from the survey are provided as examples in figures 2 and 3. The survey will be repeated in 1998.

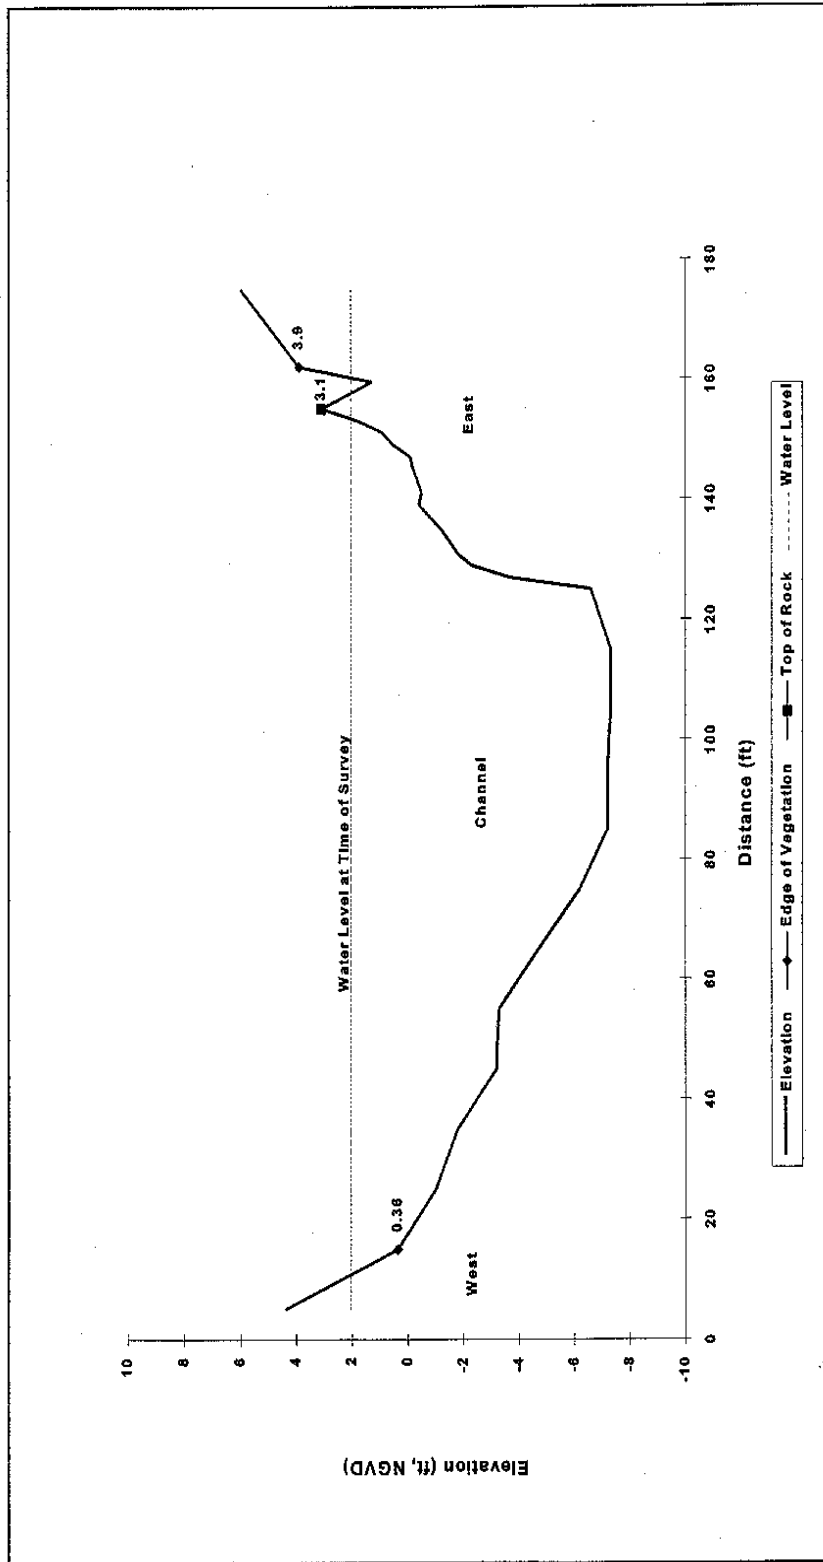
Figure 3. Cross-sectional view of the Burton-Sutton Canal at Station 272+83 on the west side of Impoundment No. 3 at Sabine National Wildlife Refuge, showing channel profile, locations of the vegetative edge, the Sabine Refuge Protection (C/S-18) project rock dike, and the water level at the time of the survey in October 1995.
