**State of Louisiana
Department of Natural Resources
Coastal Restoration Division and
Coastal Engineering Division**

**2005 Operations, Maintenance,
and Monitoring Report**

Cameron Creole Plugs Project

State Project Number CS-17
Priority Project List 1

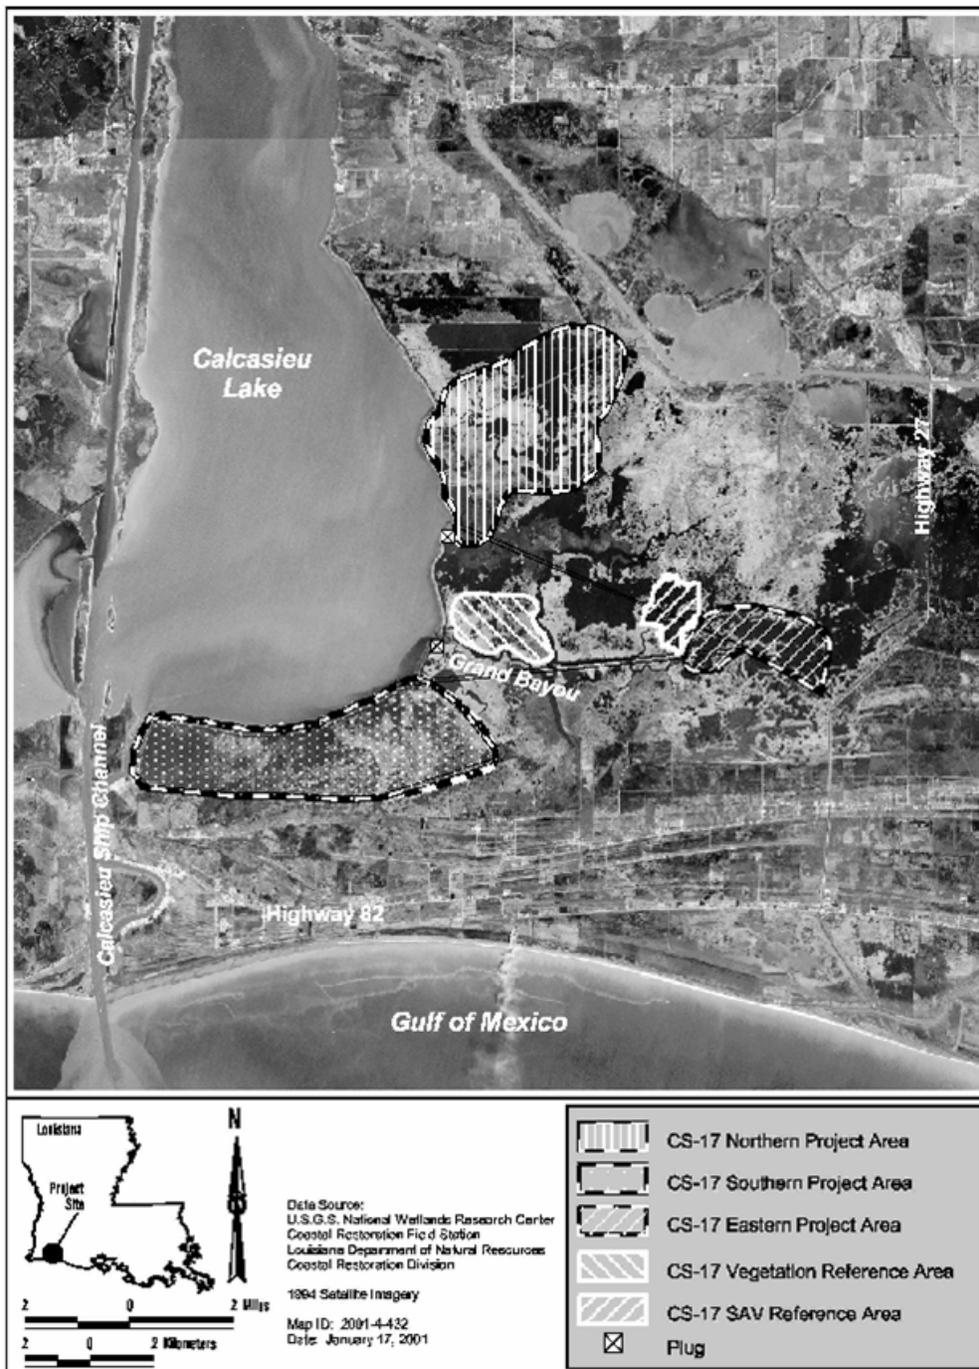
Figure 1. Cameron Creole Plugs (CS-17) project and reference areas.

The CS-17 project comprises 14,471 acres (5,858 ha) of brackish marsh divided into three project areas and two reference areas (figure 1). The plug south of Mangrove Bayou was intended to influence 6,082 acres (3,462 ha) in the northern project area (figure 2). In order to investigate the effect of the plug south of Mangrove Bayou on the surrounding marshes, water flow and the response of emergent vegetation were measured in the northern project area.

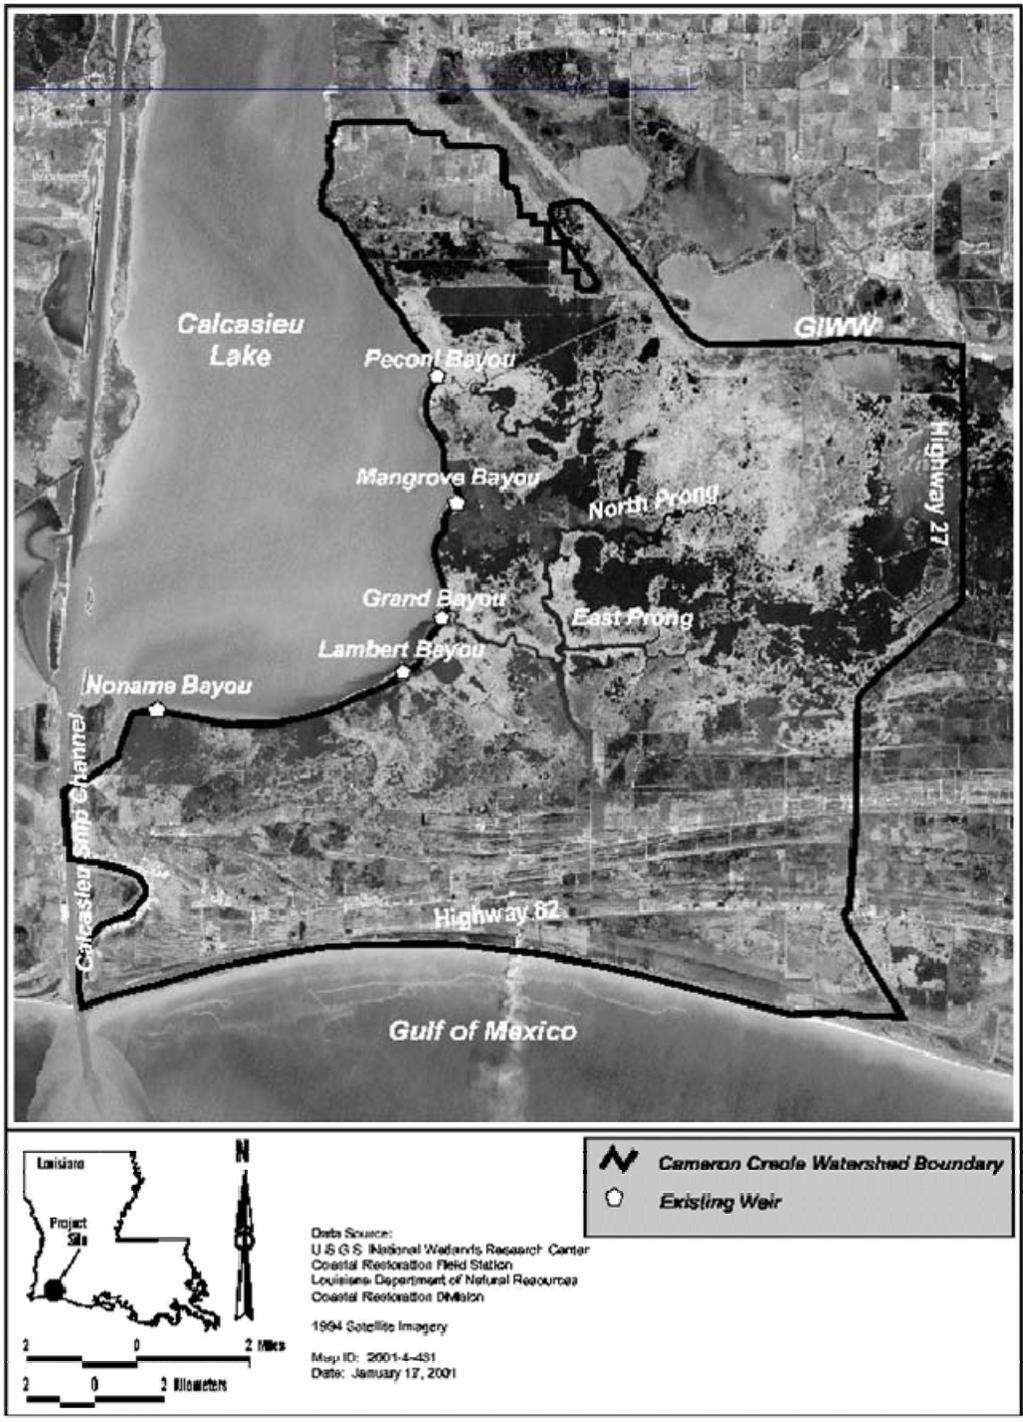
Figure 2. Cameron Creole Plugs (CS-17) project boundaries and structures.

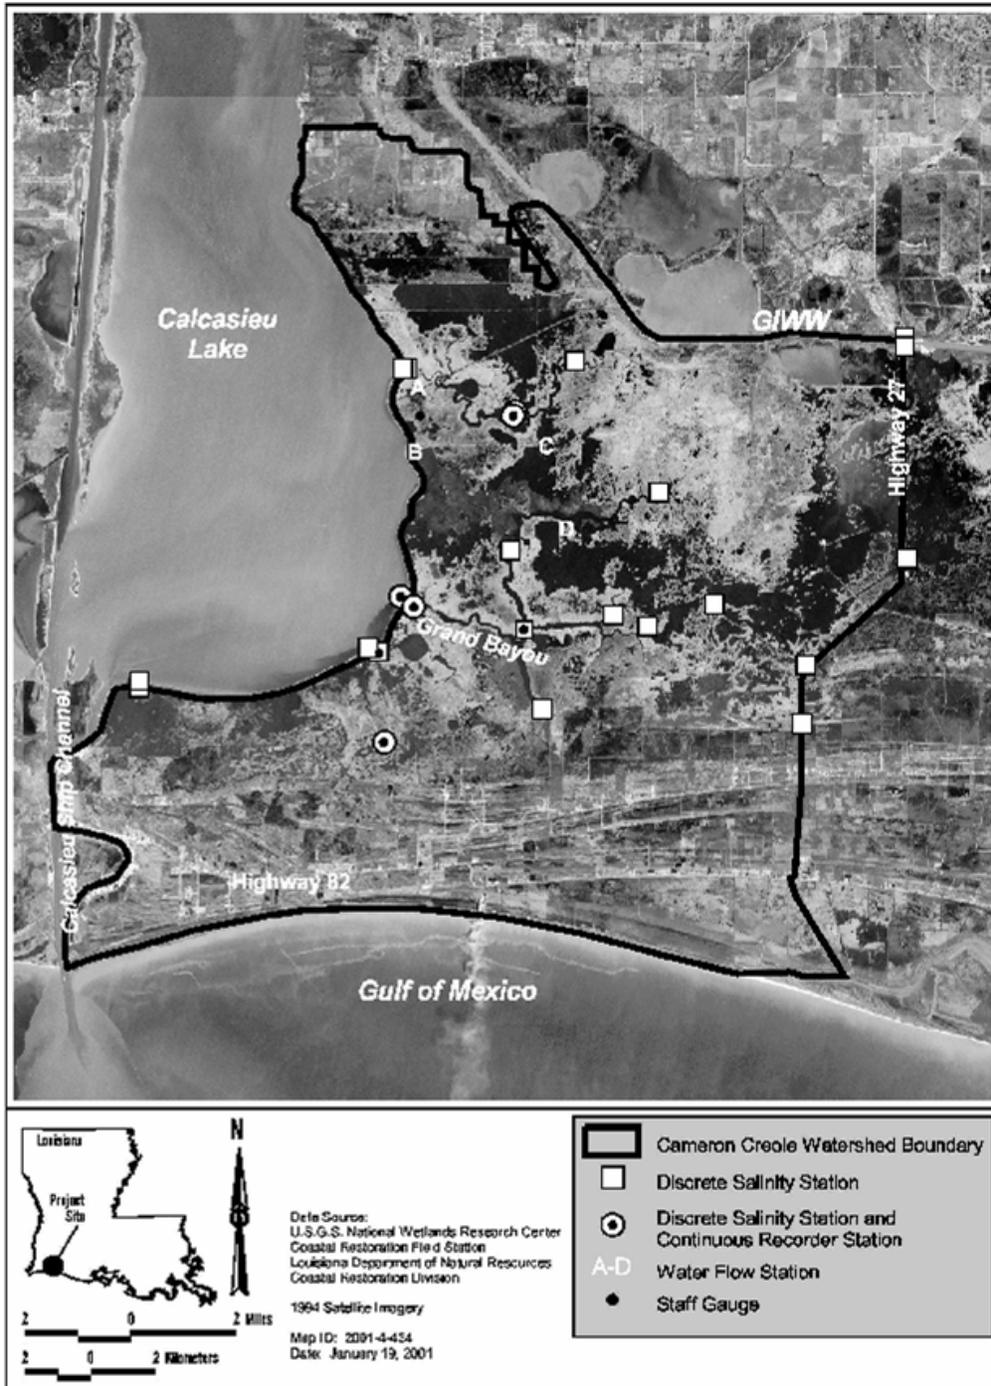
Figure 3. Cameron Creole Plugs (CS-17) permanent and discrete station locations.

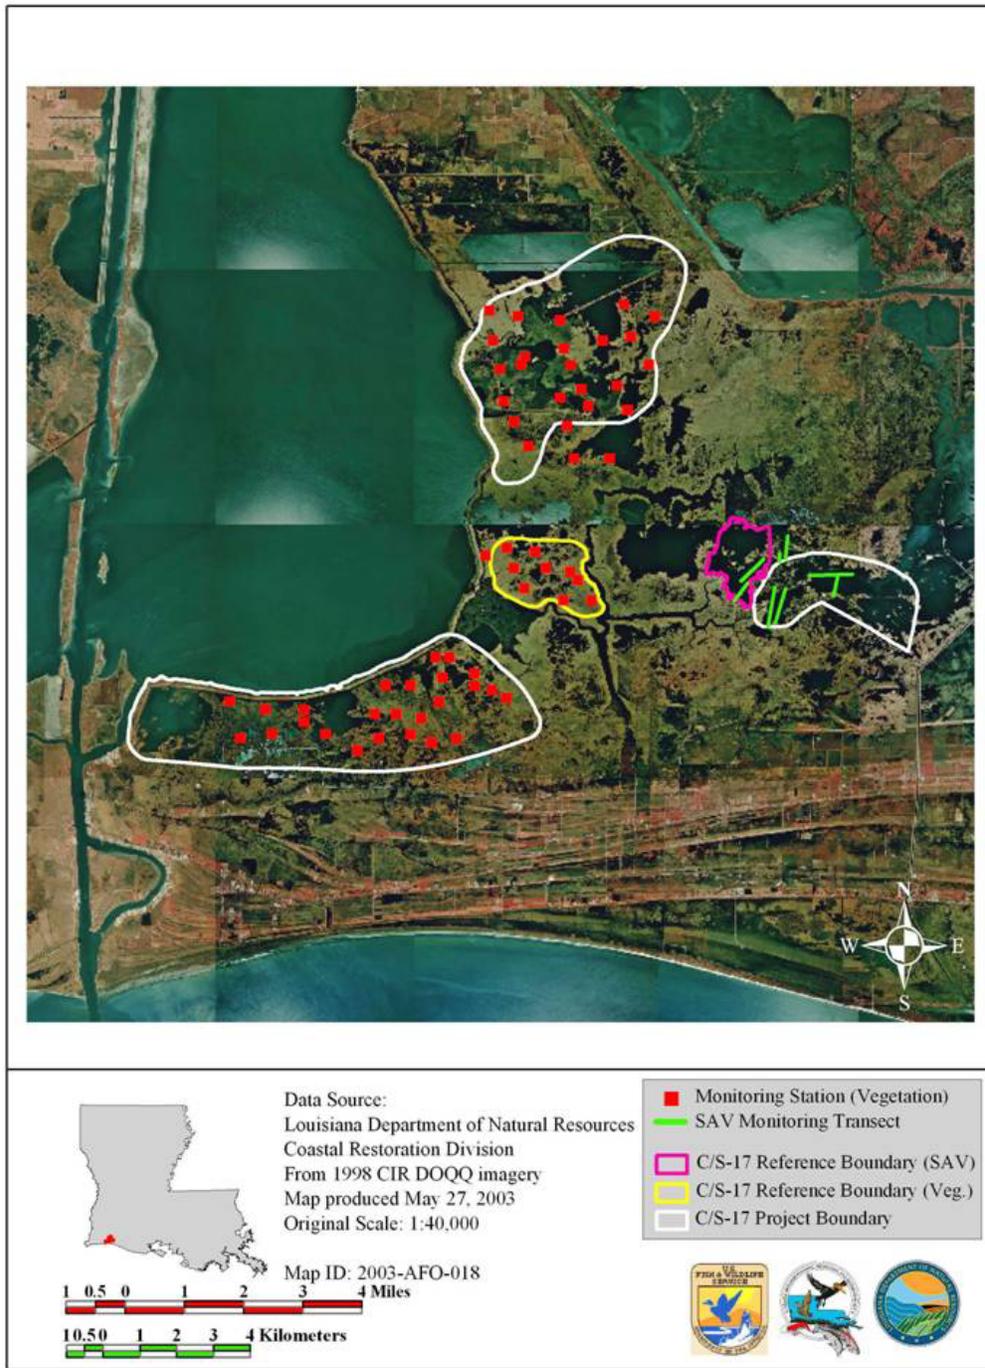
Figure 4. Cameron Creole Plugs (CS-17) vegetation and SAV sampling transects.

Species composition and relative frequency of occurrence were determined for SAV in two ponds in the eastern project area and two ponds in an SAV reference area (figure 4). Presence or absence of SAV was recorded at no less than 25 random points along two transects in each pond, using the rake method (figure 4) (Chabreck and Hoffpauir 1962; Nyman and Chabreck 1996). SAV was monitored pre-construction in October 1996 and post-construction in October 1997, September 2000, and September 2002. Means of relative frequency of occurrence of each species, species richness, and water depth and salinity were calculated and compared in the eastern project and SAV reference areas.

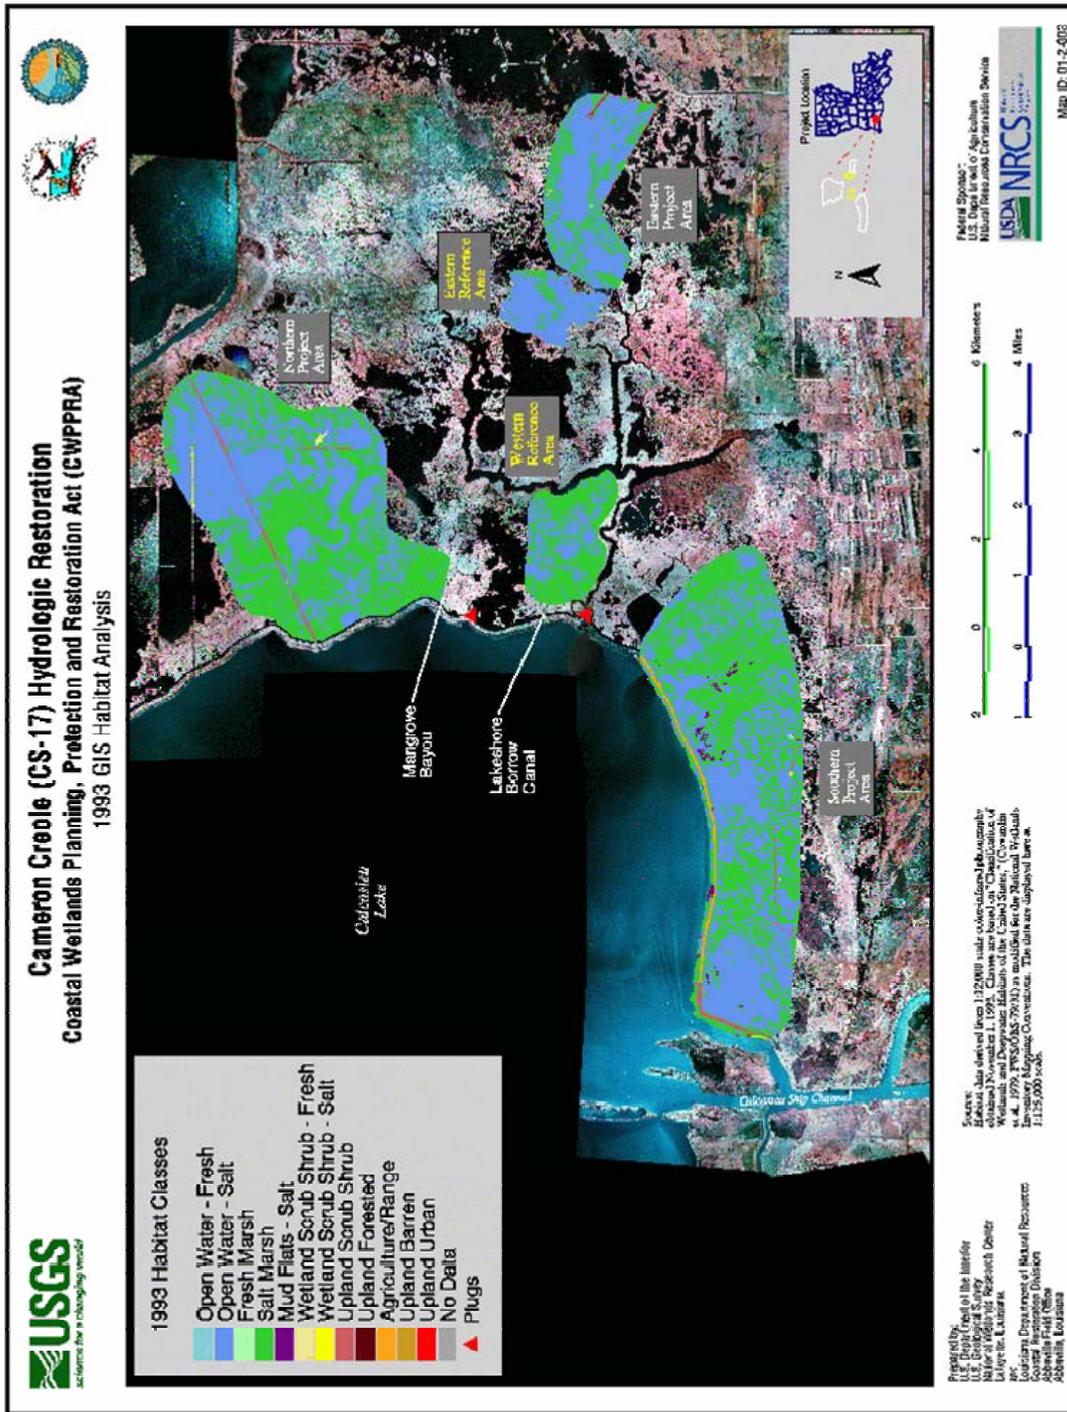
Figure 5. 1993 GIS habitat analysis of the Cameron Creole Plugs (CS-17) project area.

Aerial photography was obtained pre-construction in 1993 and has not been obtained post-construction. Using the National Wetlands Inventory (NWI) classification system, the photography was photo interpreted by NWRC personnel and classified to the subclass habitat level (Cowardin et al. 1992). A habitat map and the acreages of each habitat are presented in figure 5 and table 1. The post-construction flight has not been scheduled.

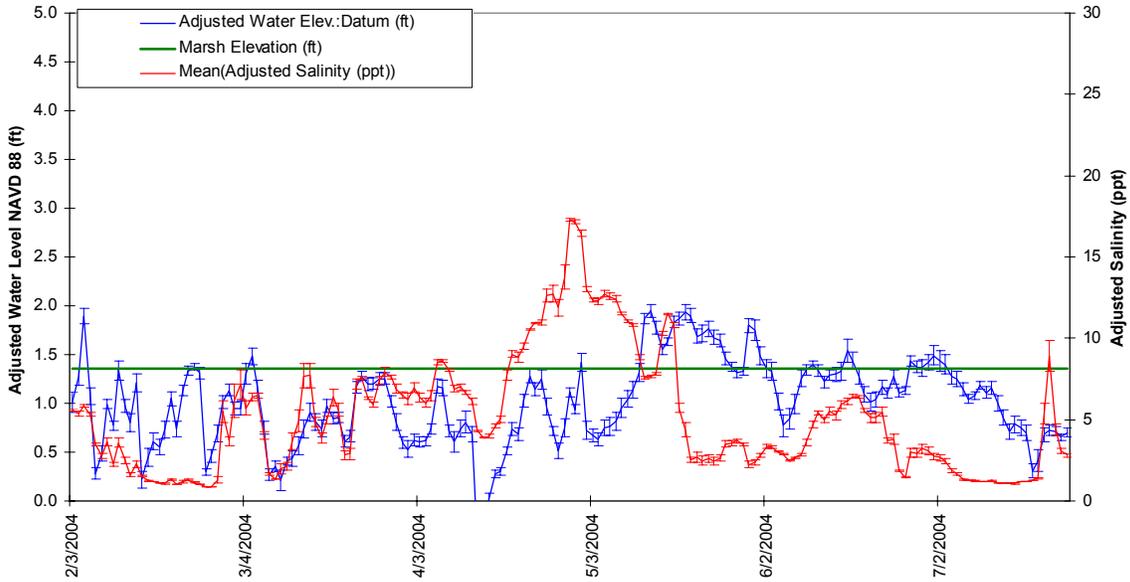
Figure 6. Daily Mean Water Level at CS17-01R from 2-3-04 to 7-24-04. The sonde was down from December to February 2004.

Salinity and water level for 2004 are summarized in figures 6-9.

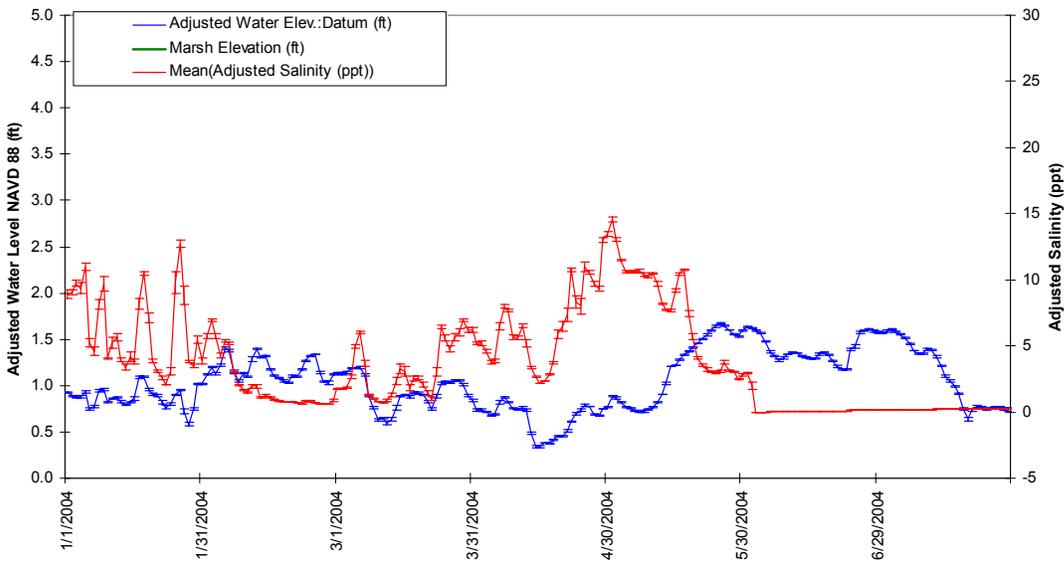
Figure 7. Daily Mean Water Level at CS17-02R from 1-1-04 to 7-28-04.

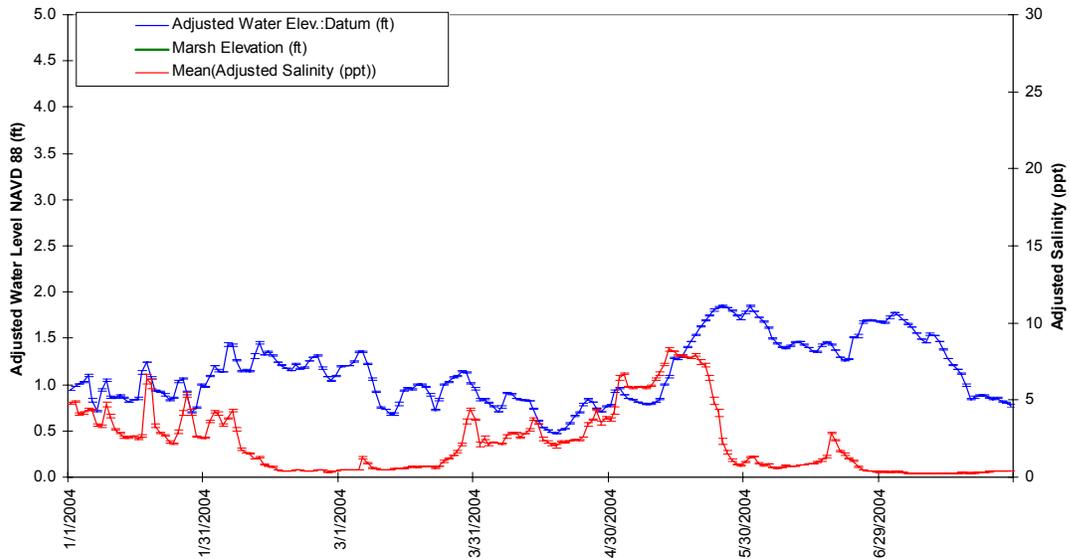
Figure 8. Daily Mean Water Level at CS17-11 from 1-1-04 to 7-28-04.

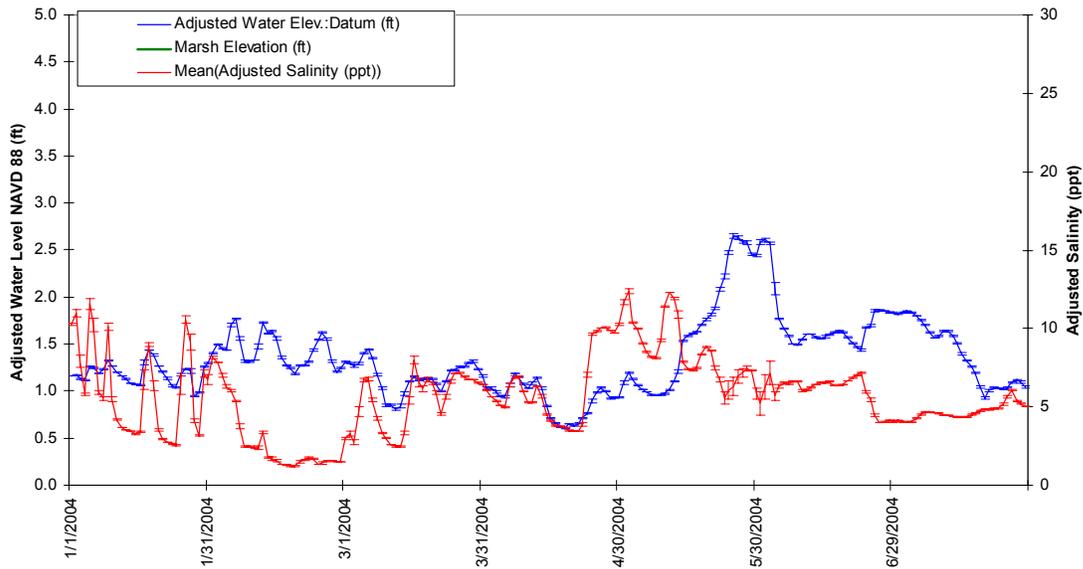
Figure 9. Daily Mean Water Level at CS17-12 from 1-1-04 to 7-28-04.

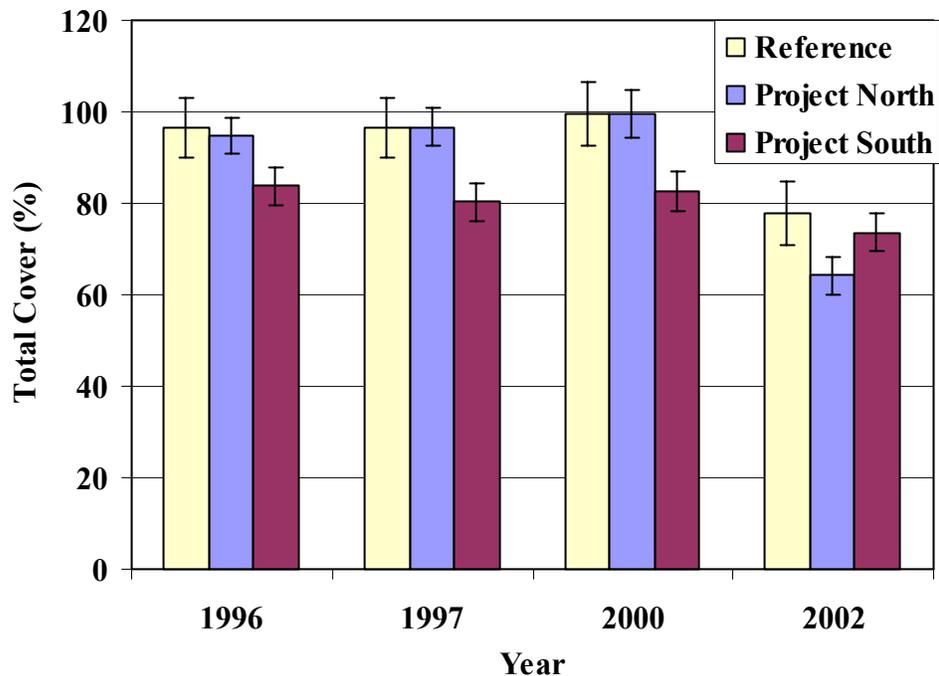
Figure 10. Total percent cover in the two project and reference areas for each sampling year for the CS-17 Cameron Creole Plugs project (LS Mean \pm SE). Cover in 2002 was significantly lower than in the other sampling years ($p < 0.0001$). There was also a significant interaction between project/reference areas and years ($p = 0.0211$). Post-ANOVA contrasts showed that the southern Project area was significantly lower than the Reference area in both 1997 and 2000. The low cover values in 2002 could be due to increased frequency of inundation in 2001 and 2002.

Percent cover of emergent vegetation was relatively similar in the northern project and reference area until 2002 (figure 10), when cover decreased in both the northern and southern project areas. Cover in the southern project area has been lower than in the reference area throughout the project. The decrease in cover could be due to increased frequency of inundation in 2001 and 2002, but that alone would not explain loss of cover in the northern project area because inundation there was approximately the same as the reference area, which did not decrease as much as the northern project area did. SAV decreased in 2000, then recovered, increasing in 2002 (table 3). Changes in SAV are most likely due to changes in salinity from year to year.
