**2005 Operations, Maintenance,
and Monitoring Report**

Vermilion River Cutoff

State Project Number TV-03
Priority Project List 1

June 2005
Vermilion Parish

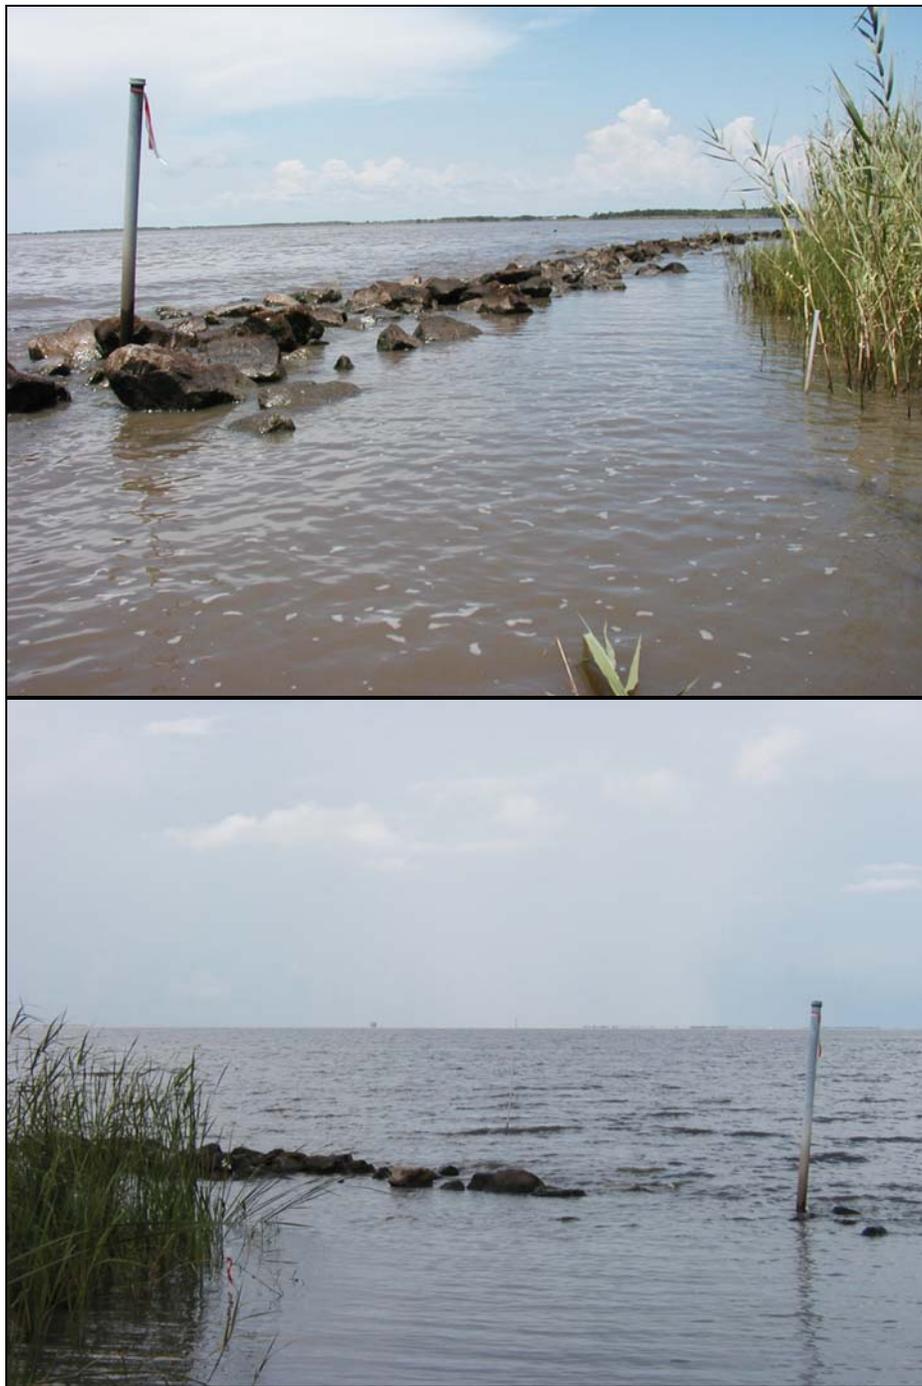
Direct shoreline measurements taken from each settlement plate (figure 6) to the vegetated edge of the marsh behind the rock breakwater in the project area indicate progradation at three of the five sites. Only one site, at settlement plate 1006, experienced a loss of approximately 0.77 ft/yr (0.23 m/yr). Settlement plate 1005 showed the greatest gain of 2.56 ft/yr (0.78m/yr) from 2000-2002, and settlement plate 1007 remained unchanged (table 1). The data from these measurements indicate the shoreline behind the rock breakwater on the three northernmost settlement plates is prograding. The loss of shoreline nearest settlement plate 1006 may be attributed to the sinking elevation of the rock breakwater at or below 2 ft NAVD 88.

Figure 6. Photograph of rock breakwater and vegetation growth at settlement plate 1005 (upper) and water overtopping rock breakwater at settlement plate 1006 (lower).

A maintenance construction contract is currently being developed to address an area of the foreshore dike that has deteriorated below acceptable standards. Construction is scheduled for Summer 2005.

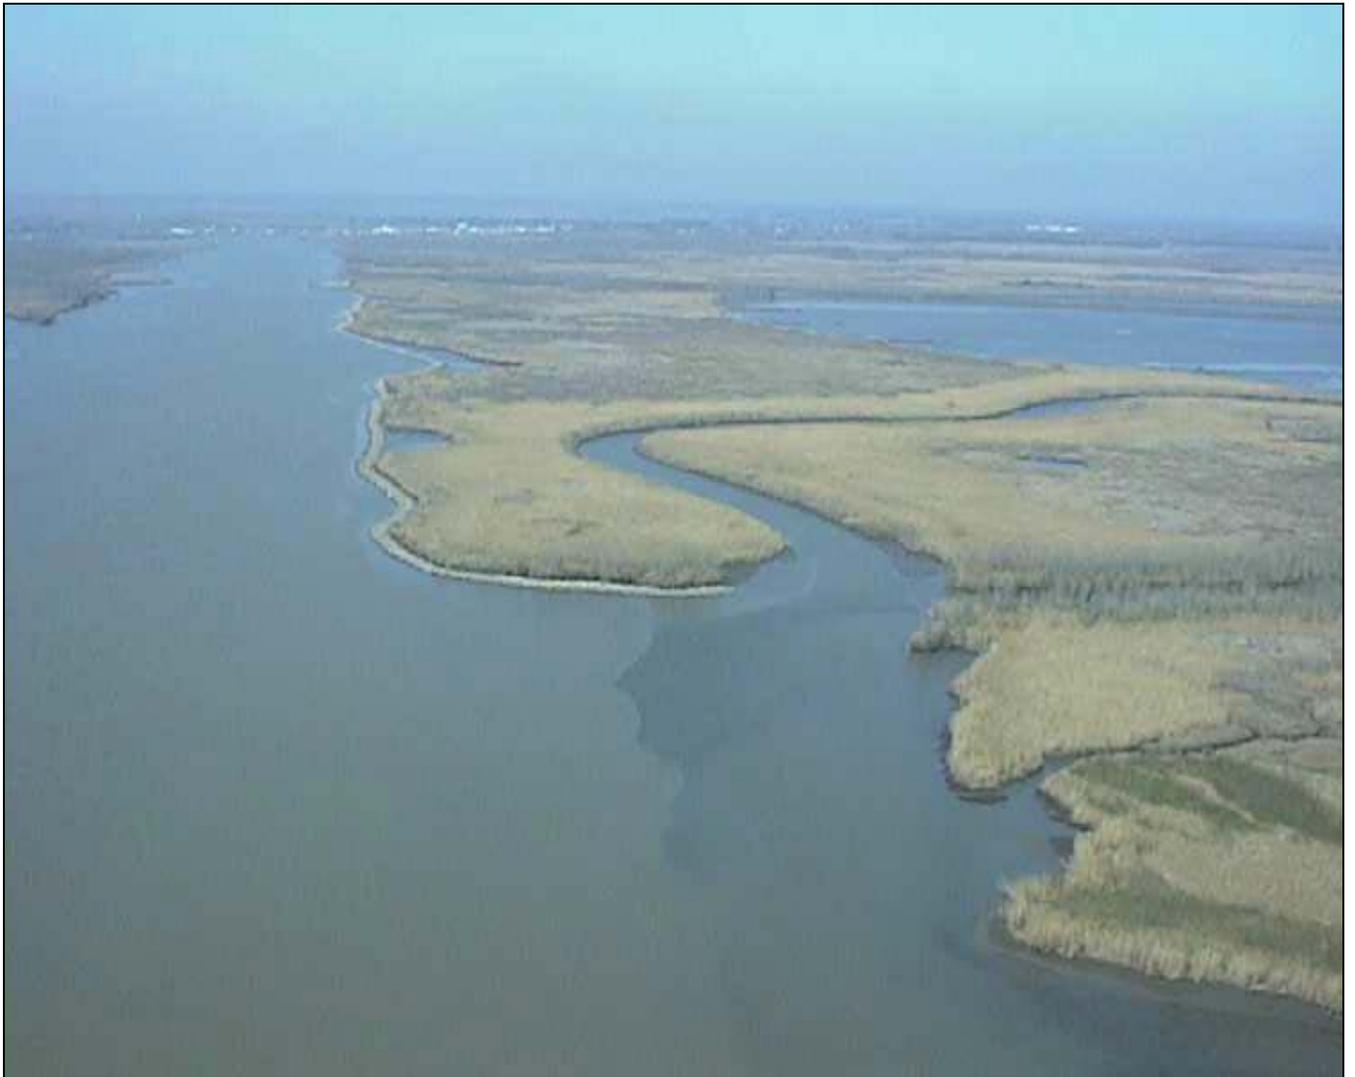
Figure 7. Aerial photograph of Vermilion River Cutoff (TV-03) shoreline protection project showing the Onion Lake complex on the right side of the rock breakwater.
