**2005 Operations, Maintenance,  
and Monitoring Report**

**Cheniere Au Tigre Shoreline  
Demonstration**

State Project Number TV-16  
Priority Project List 6

June 2005  
Vermilion Parish

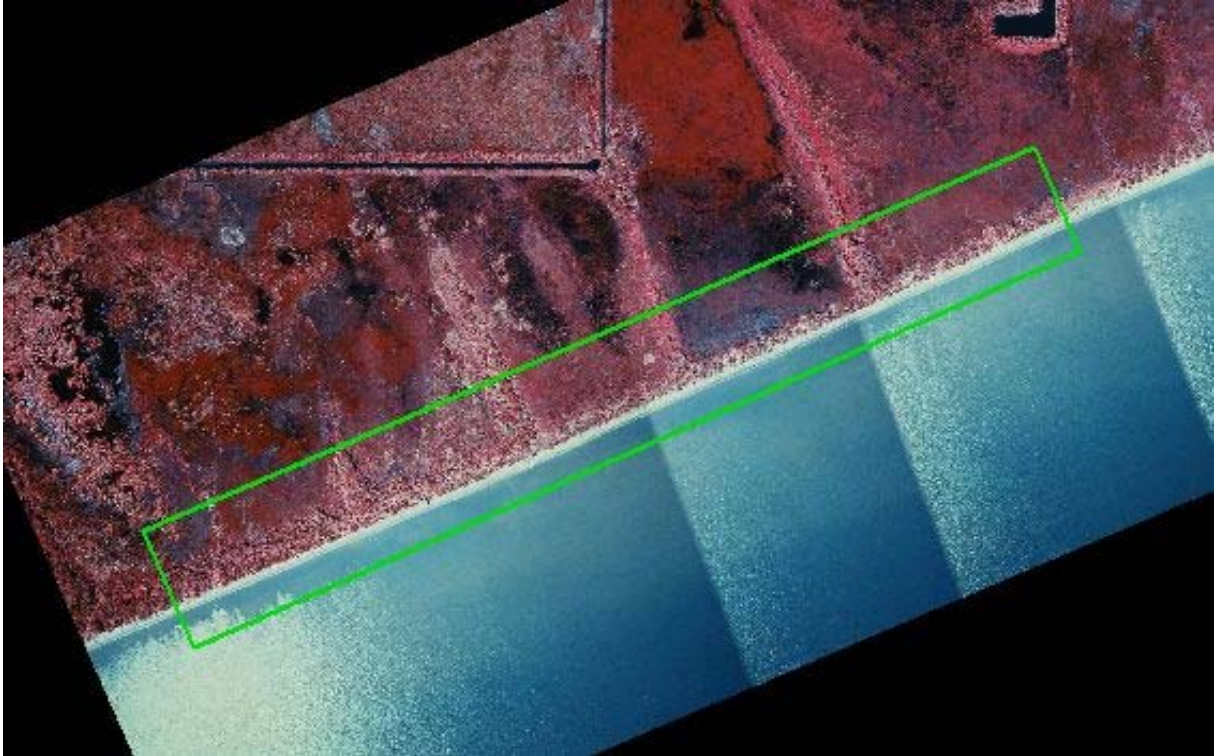
**Figure 2.** 2000 photo mosaic with overlaid project TV-16 boundary acquired approximately 10 months prior to construction.

Pre-construction aerial photography acquired in 2000 (figure 2), approximately 10 months prior to construction, indicated that the project area consists of 31 acres (12.5 ha) of land and 29 acres (11.7 ha) of water. Comparison of the pre-construction and 2004 post-construction aerial imagery indicated a 2-acre (0.81-ha) increase in unvegetated beach area within the project (figure 3). However, this increase includes the constructed breakwaters. Additionally, classified acreages are variable, based on water level at the time of aerial image acquisition.

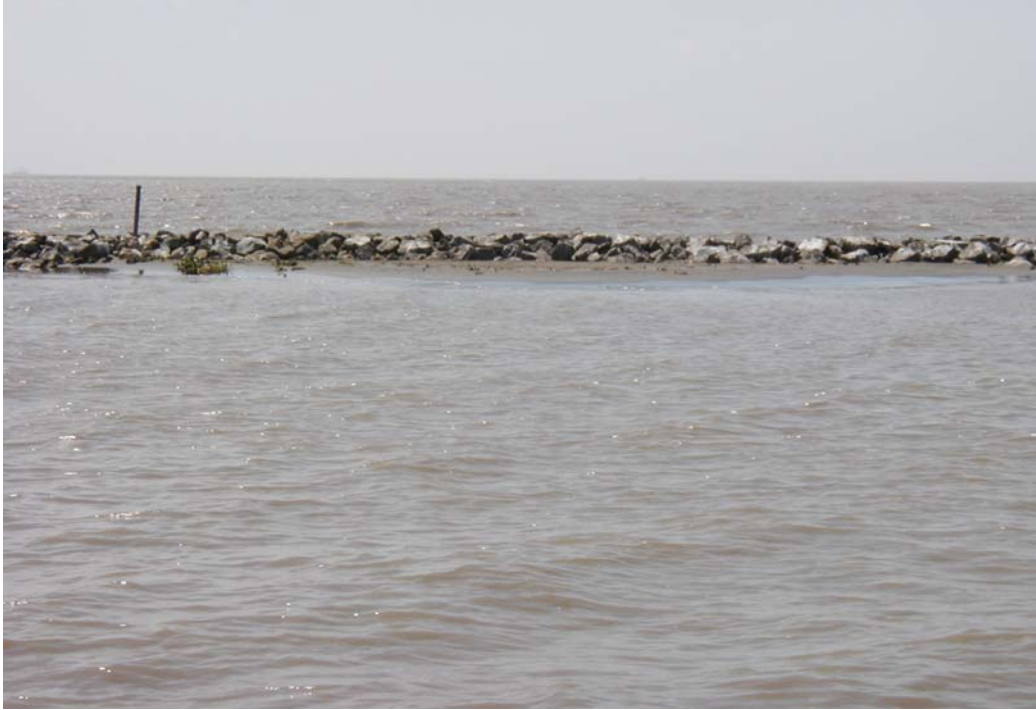
**Figure 5.** Segmented rock breakwater in project TV-16 area, showing foreshore accreted sand approximately 6 months following construction.

As-built shoreline position was documented in 2002 (figure 4) and although no subsequent shoreline information has been collected, qualitative observations indicate that the shoreline is prograding and sediment is accumulating both along the shoreline and immediately shoreward of the breakwater segments (figures 5 and 6).

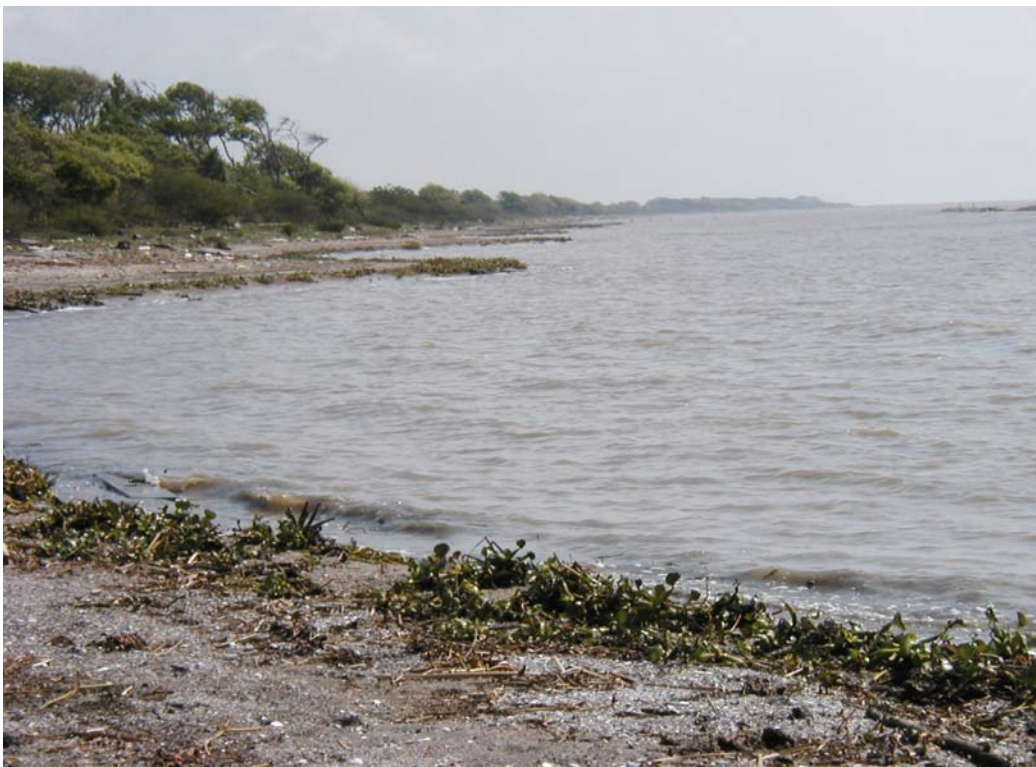
**Figure 6.** Shoreline of Cheniere au Tigre, project TV-16.
