**WAVE HEIGHT MEASUREMENTS AT THE RACOON ISLAND  
BREAKWATERS DEMONSTRATION PROJECT(TE-29) :  
REPORT ON OCTOBER 1997 FIELD DEPLOYMENT**

Coastal Studies Institute  
329 Howe-Russell Geoscience Complex  
Louisiana State University  
Baton Rouge, LA 70803-7527

October 25, 1997

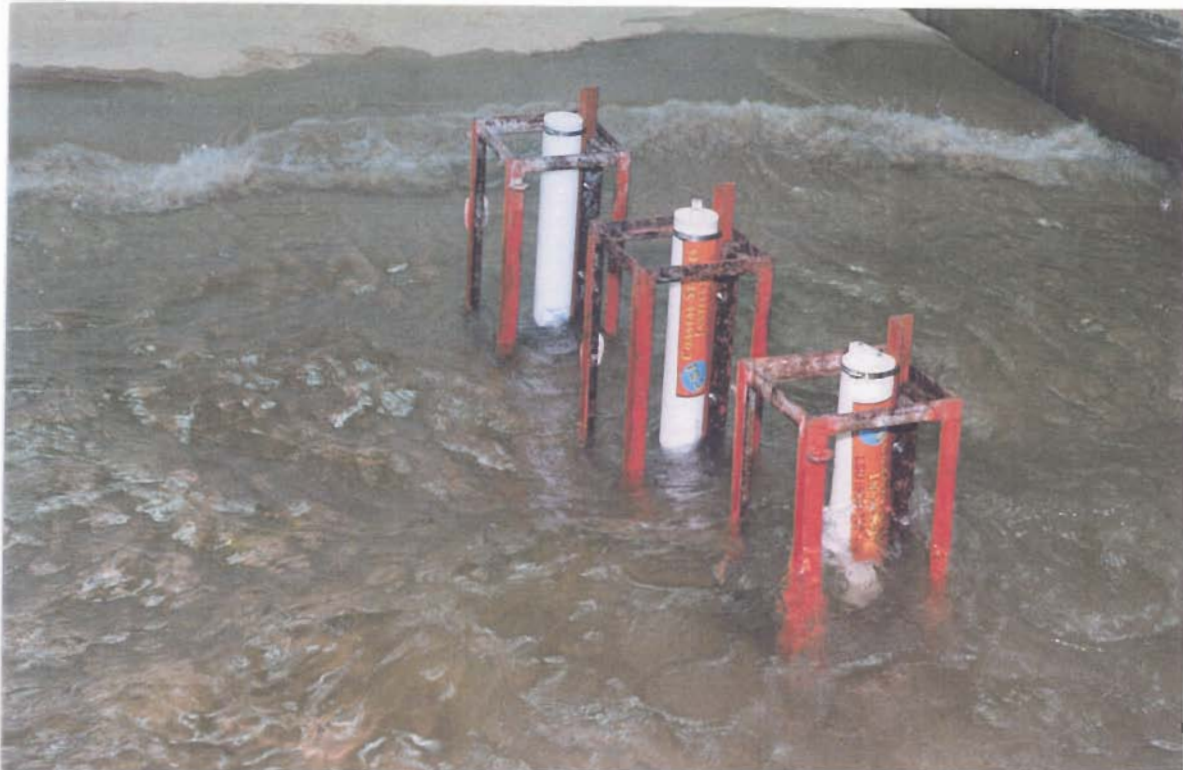
Plate 1. The pressure transducer arrays used in the Raccoon Island breakwaters study. The pressure sensors and solid-state recorders are housed in the water-tight housing and are being tested in the Coastal Studies Institute's Wave Simulating Facility.

Wave height and period were measured with 3 precise, Paroscientific digital quartz pressure transducers. The pressure transducers, which record the instantaneous fluctuation of water level, are capable of 0.01% accuracy and 0.0001% resolution. For conditions at the Raccoon Island breakwaters site, the accuracy is expected to be well within 5 mm (0.2 in.). The pressure transducers were assembled by CSI personnel in a self-contained, solid-state recording package, suitable for underwater deployment. An example of the pressure sensor array is shown in Plate 1. The instrument packages are capable of sampling at a high frequency of 4 Hz.

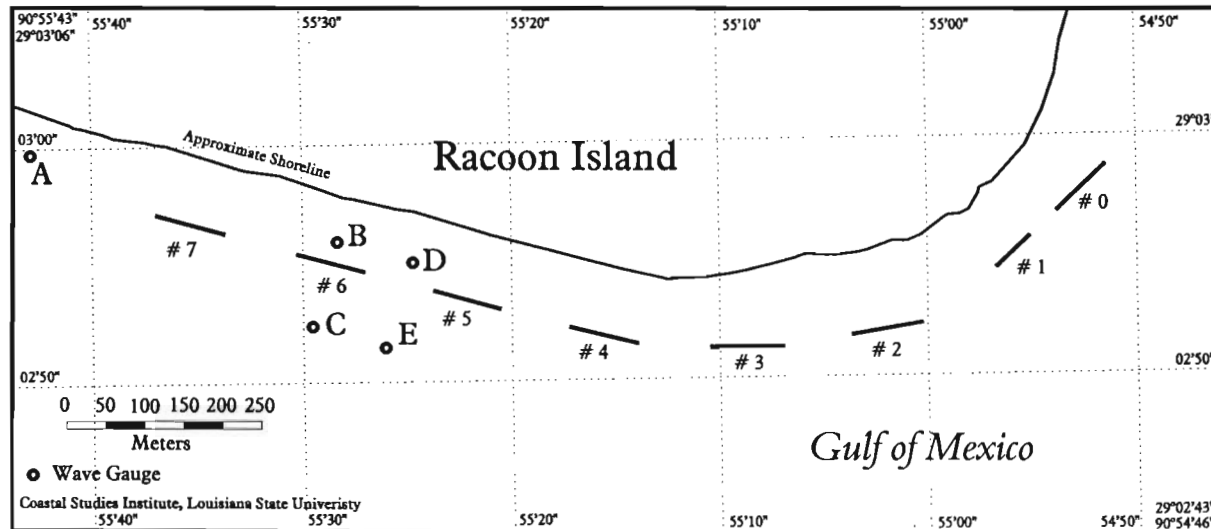
Figure 1. Study area, showing the locations of wave gages

After a series of on-site experiments, an optimal sampling scheme, which allowed maximum temporal coverage and efficient data processing, was determined. Two thousand and forty-eight (2048) readings (one burst of 8.5 minutes) were recorded every 20 min at 4 Hz. The 4-Hz sampling allows reliable measurement of high-frequency waves with periods as low as 1 second. The 8.5-minute burst, which is sufficient enough in duration to include 100 to 150 waves of 3- to 5-second periods, yields reliable statistical analysis of wave spectra and was deemed appropriate for the objectives of this study. A total of eighteen 8.5-min bursts were recorded during the first measurement. The locations of the deployments are shown in Figure 1, and include those sites landward and seaward of the breakwaters, and the control site to the west.

Simultaneous wave measurements were conducted at 3 locations (Figure 1). Wave gage A, served as a control, and was deployed approximately 150 m (500 ft) west of breakwater #7. The average water depth at the control site approximated 1.7 m (5.2 ft). Wave gage B was deployed approximately 21 m (70 ft) landward of the center of breakwater #6 (Figure 1). Wave gages A and B were deployed the same distance of approximately 30 m (100 ft) seaward of the shoreline. The average water depth at the inside location B was 1 m (3.3 ft). Wave gage C was deployed 100 m (305 ft) seaward of the center of breakwater #6. The average water depth at location C (offshore the breakwater) was approximately 1.6 m (5.2 ft). Wave gages at sites B and C were moved to the gap (sites D and E) between breakwaters #6 and #5 at 1320 hours (Figure 1). The water depths at sites D and E were 1.0 (3.3 ft) m and 1.6 m (5.2 ft), respectively.

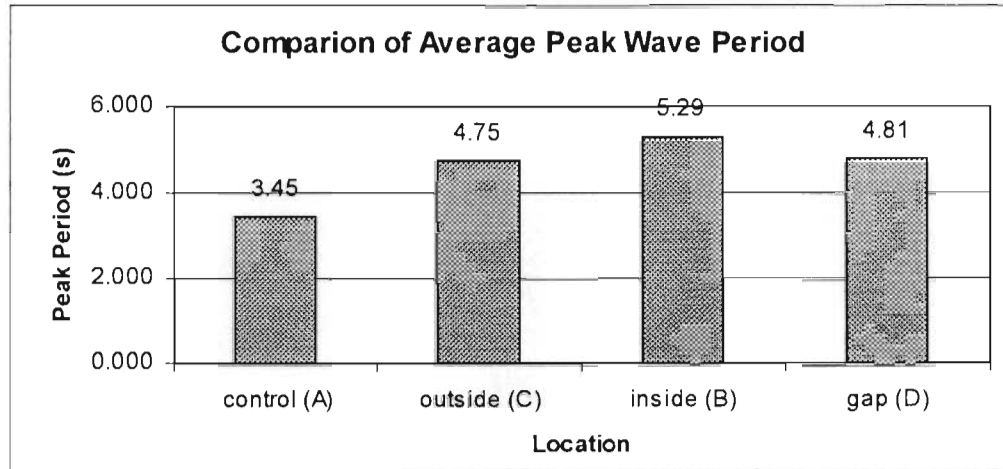
Figure 3. Comparison of peak wave periods at different locations

Peak wave period, also referred to as dominant wave period or period of maximum wave energy, is defined as the wave period corresponding to the center frequency of the frequency band with the maximum non-directional spectral density. The average peak wave period measured seaward of the breakwater was 4.75 seconds (Figure 3). The average peak period measured at the control site was 3.45 seconds. A reduction of 1.3 seconds (27%) was measured. The average peak period measured behind the breakwater was 5.29 seconds, an increase of 0.54 seconds (12%). As compared to the control site, the peak wave period behind the breakwater was 1.85 seconds (54%) longer. The average peak period in the gap between the breakwaters was 4.81 seconds, almost identical to the offshore wave period (Appendix 4).

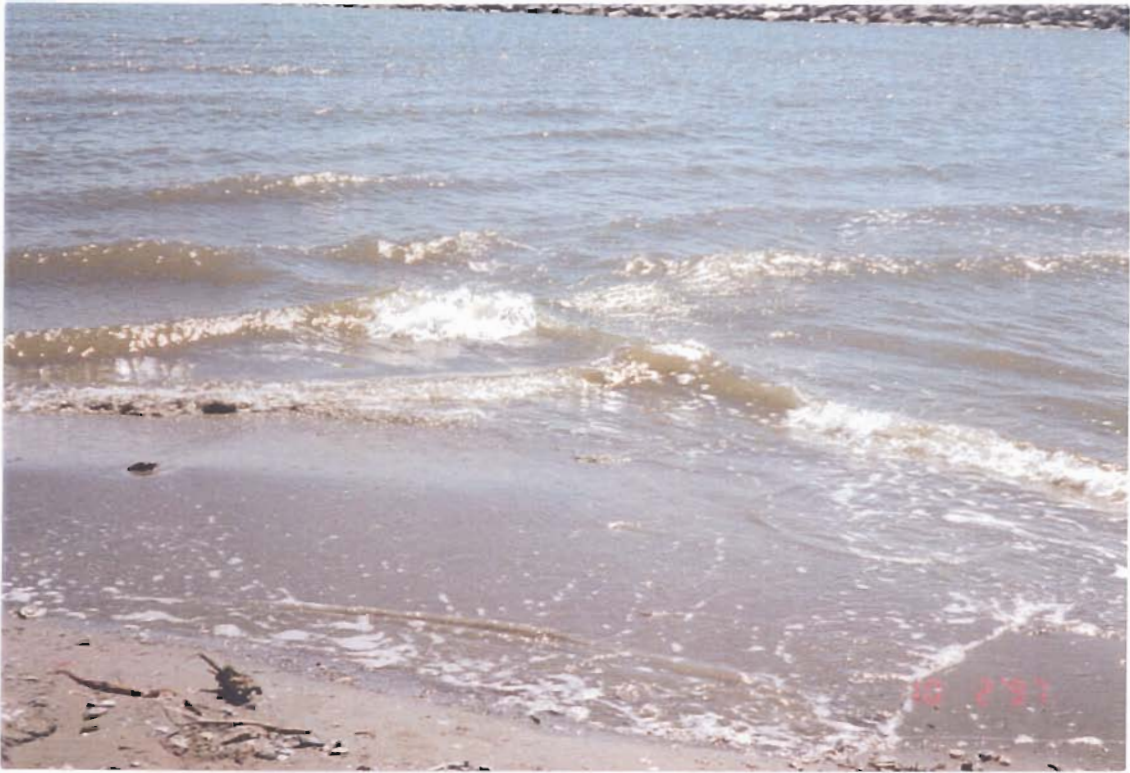
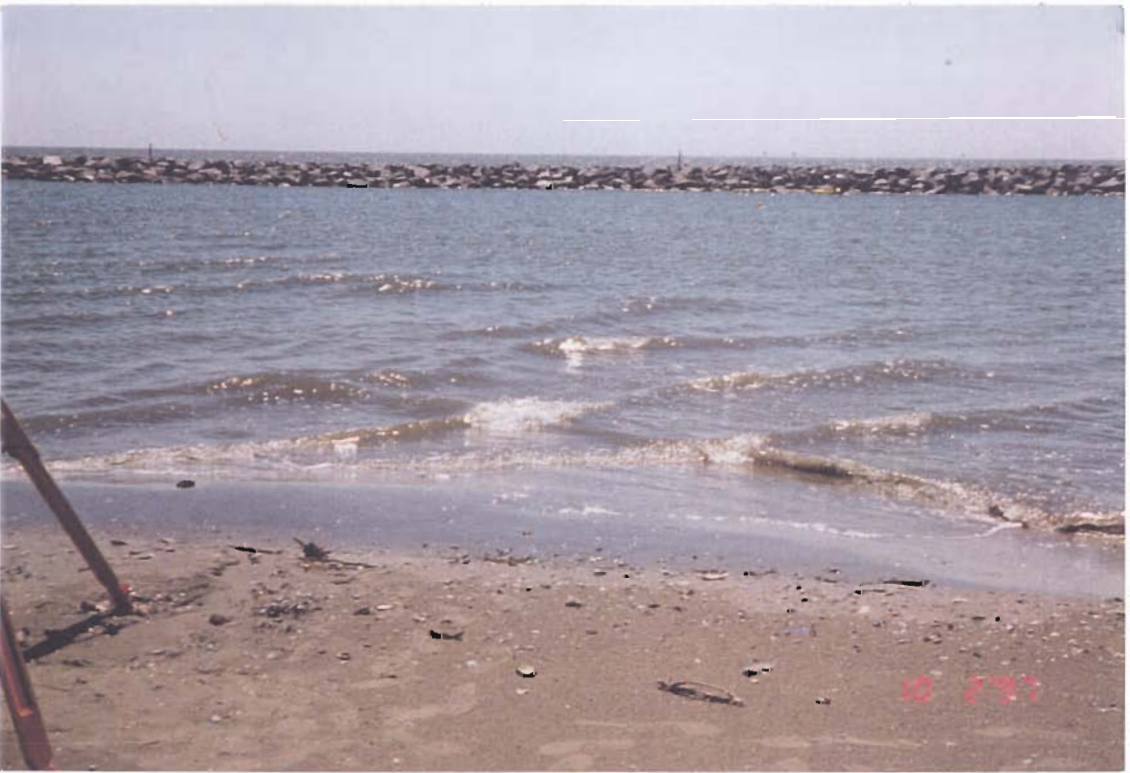
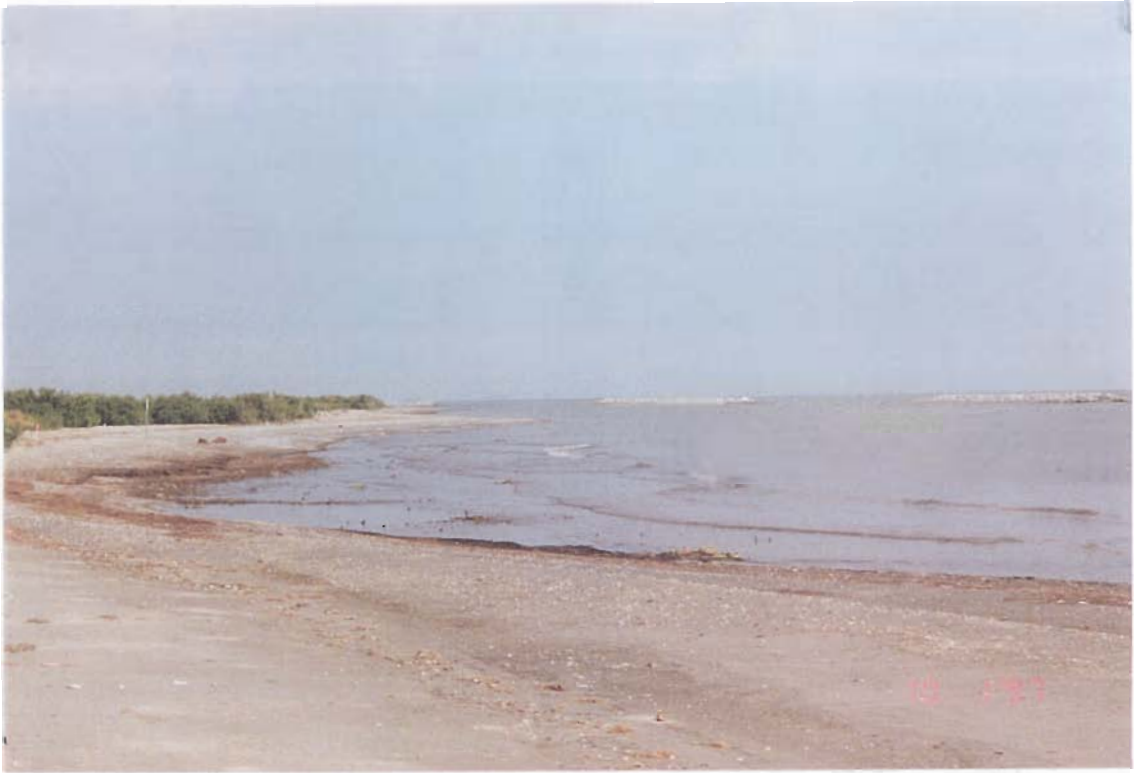
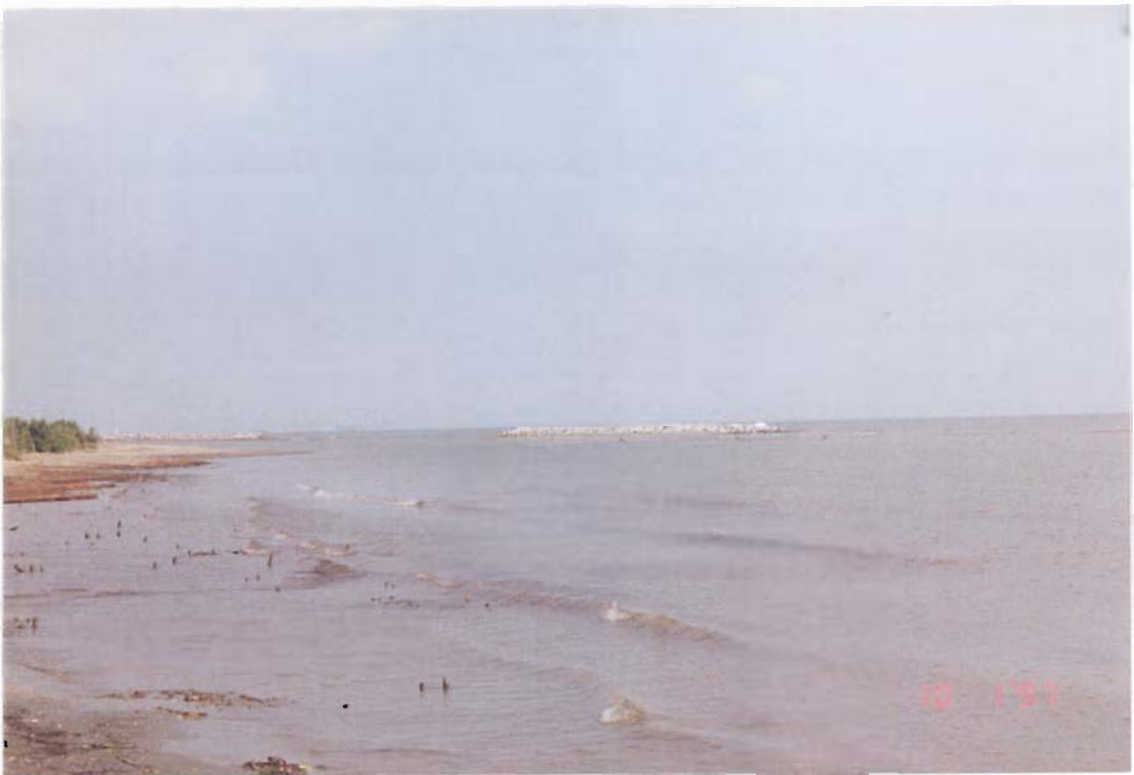
A: Diffraction in the lee of breakwaters #6 and #7 resulting in well defined caustic zones along the adjacent beach on Raccoon Island.

B: Wave divergence along the beach at Raccoon Island adjacent to the gap between breakwaters #6 and #7. The divergence of these waves resulted in erosion at the site with longshore sediment transport being to the east and west.

Wave diffraction patterns were well established in the lee of the breakwaters and had a significant influence on the patterns of wave breaking at the shoreline, and, therefore, influences on shoreline changes. Behind the center of the breakwaters towards the beach, diffraction caused convergence of the shoaling waves resulting in classic caustic zones (Appendix 2). Convergence of waves at these nodal points appeared to result in accumulation of sediment behind the center of breakwaters along the adjacent beach. Behind the gaps in the breakwaters, diffracted waves expended higher energy along the adjacent beach. Sediment was observed being transported to the east and west along the beach at these sites, resulting in the development of a vertical, beach scarp.

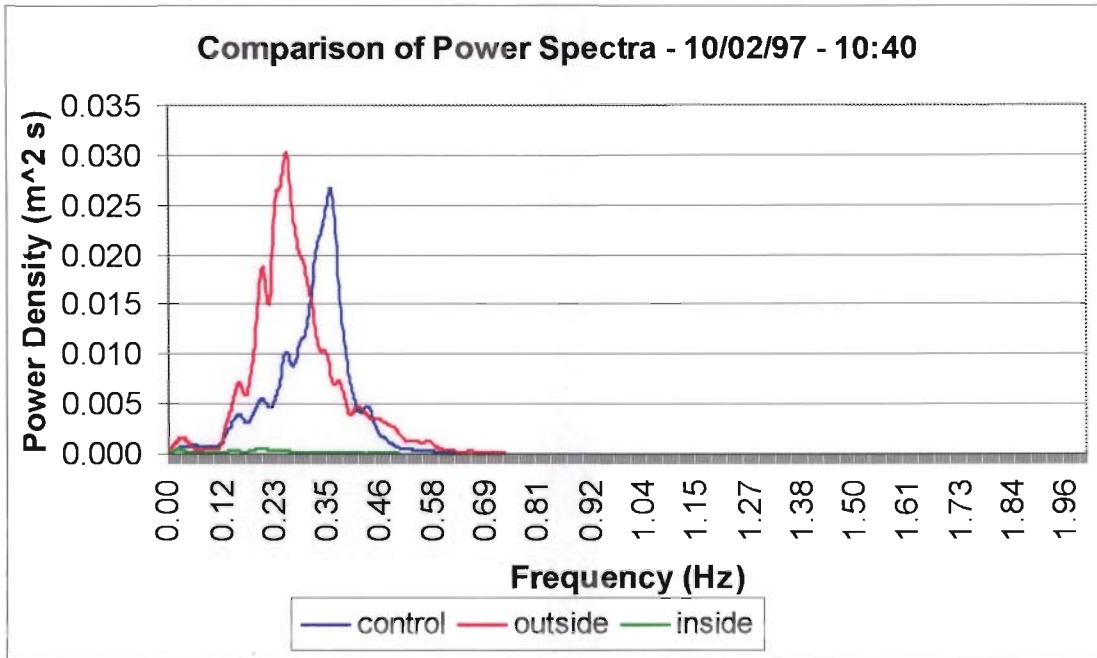
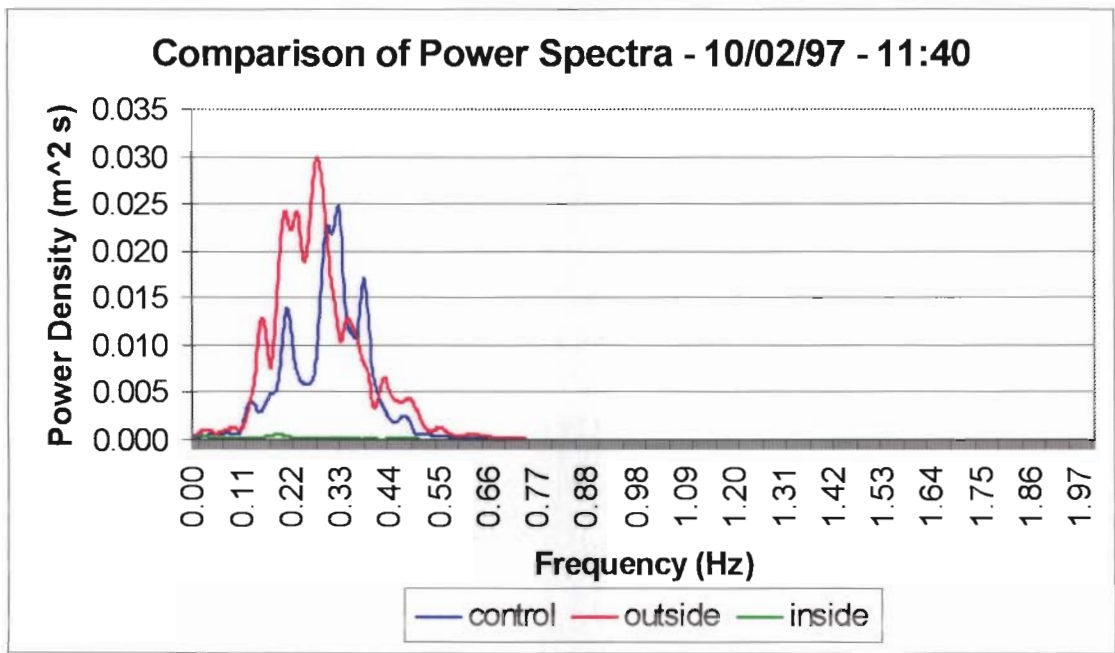
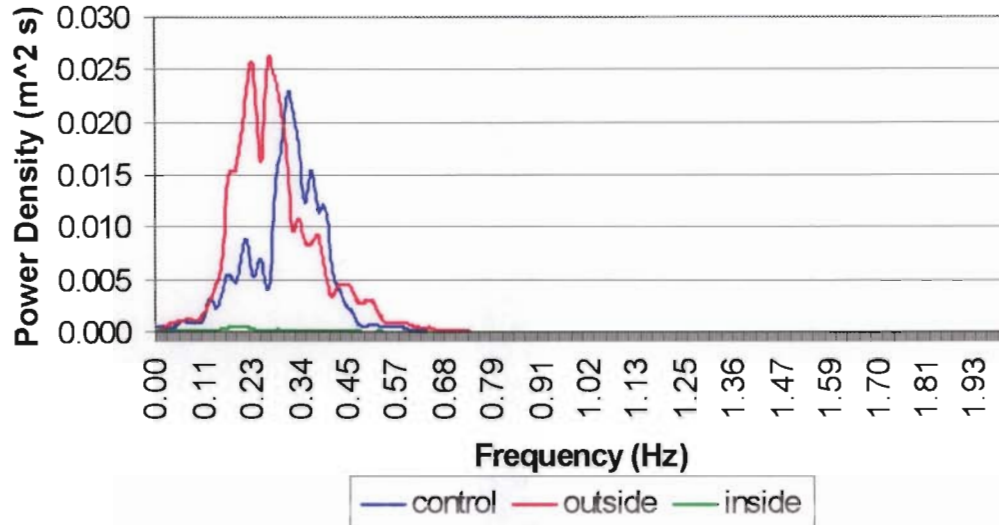
Wave spectra

The wave spectra of the 18 records are summarized in Appendix 5. The wave spectra illustrate the distribution of wave energy with respect to each frequency component. The peaks in the wave spectra indicate that the waves of the specific frequencies carry more energy than other frequencies. Several distinct features were observed from the October measurements:

1. The magnitudes of the wave energy for the inside wave gage (site B), as indicated by the power density, were much smaller than that of the control, the outside, and the gap gages (sites A, C, and D). These differences in the

2. Almost all the wave energy was distributed between 0.1 to 0.6 Hz, or 1.7 to 10 seconds. Waves with longer than 10 seconds or shorter than 1.7 seconds period were not significant during the period of measurement.
3. Energy distribution of the offshore (sites C and E) wave was skewed to the lower frequency end, while energy distribution of nearshore waves (control, site A) was skewed toward the higher frequency end. In other words, the energy peak at low frequency measured offshore decreased, while the minor peak at higher frequency increased as the waves propagated onshore. These differences in the shape of the spectra caused the differences in peak wave period.
4. Toward late afternoon, as the wind-speed decreased, the energy from the long-period swell component increased. This caused the increase of peak periods toward the end of the afternoon.

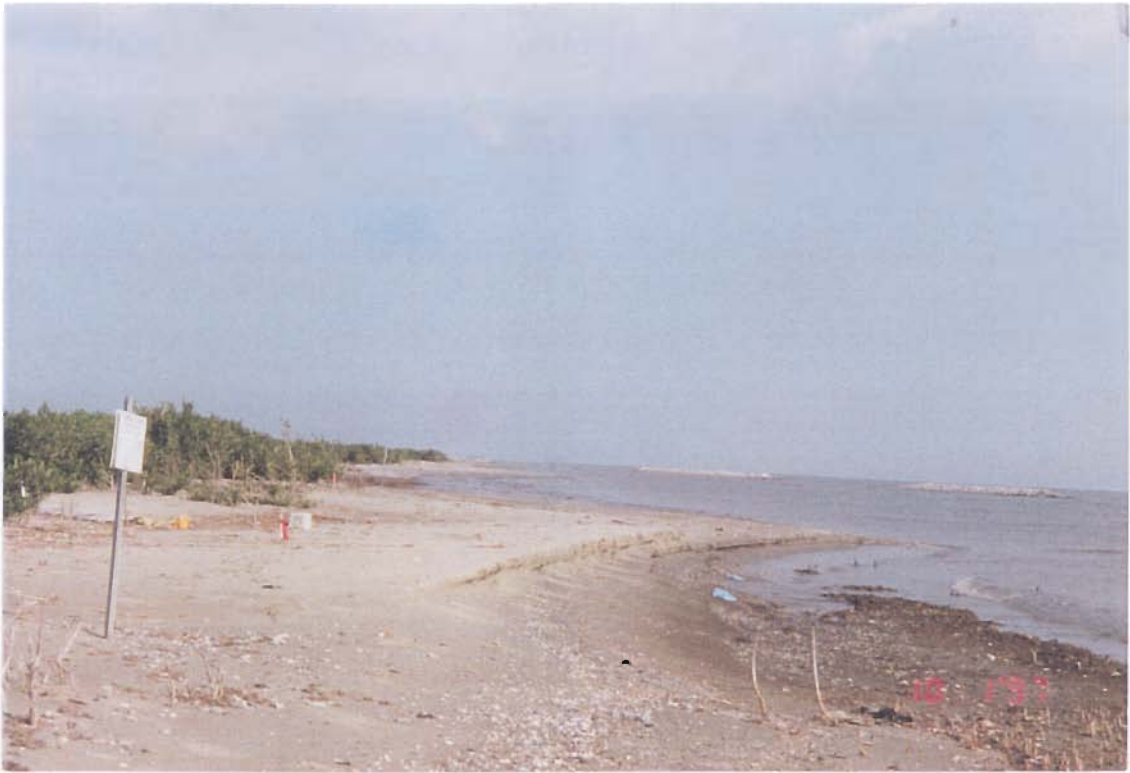
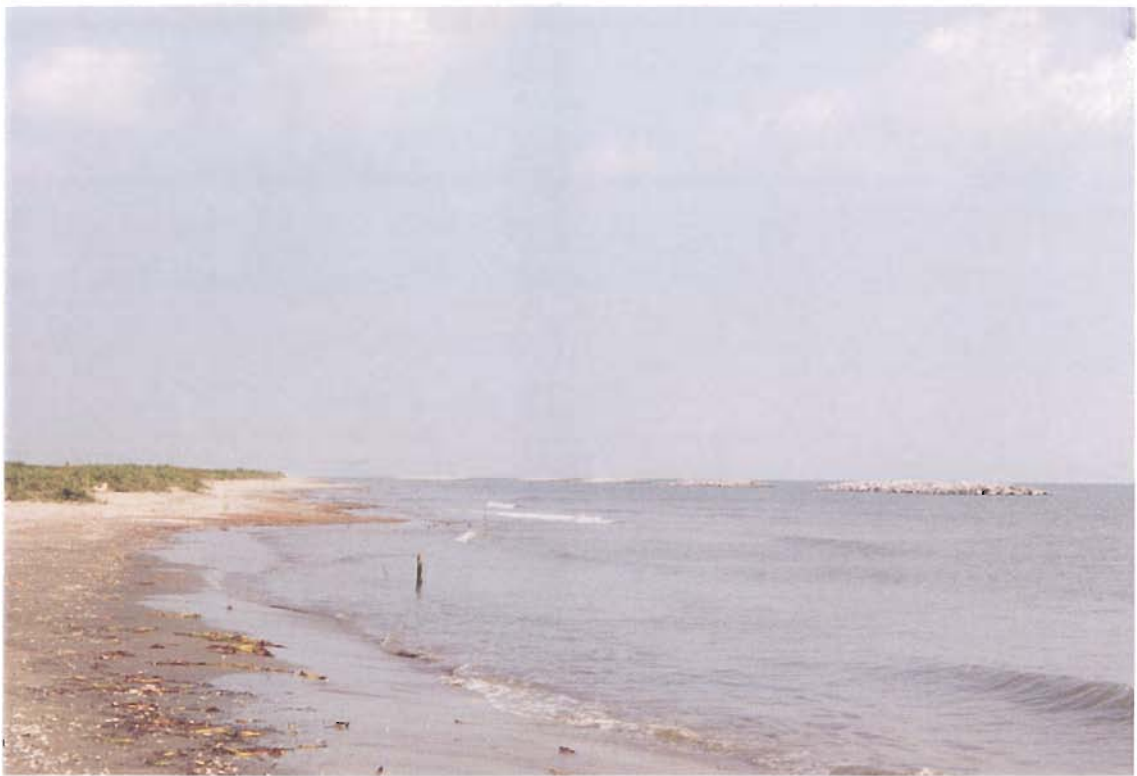
A: Photos illustrating shoreline accretion behind the center of the breakwaters and retreat along Raccoon Island adjacent to the gap between the breakwaters

The existence of the segmented breakwaters induced an obvious change in shoreline configuration. The shoreline changes correspond with the alteration of the wave field induced by the breakwaters. Shoreline features similar to beach cusps were observed along the stretch of the protected shoreline (Appendix 6). These features are commonly observed between segmented, detached breakwaters, and are often explained as the results of the intercept to longshore sediment transport due to the shadow effect of the
