**WAVE HEIGHT MEASUREMENTS AT THE RACCOON ISLAND
BREAKWATERS DEMONSTRATION (TE-29) PROJECT:
REPORT ON SEPTEMBER 1998 FIELD DEPLOYMENT
AND REVIEW OF 12-MONTH MONITORING PROGRAM**

Coastal Studies Institute
336 Howe-Russell Geoscience Complex
Louisiana State University
Baton Rouge, LA 70803

November 20, 1998

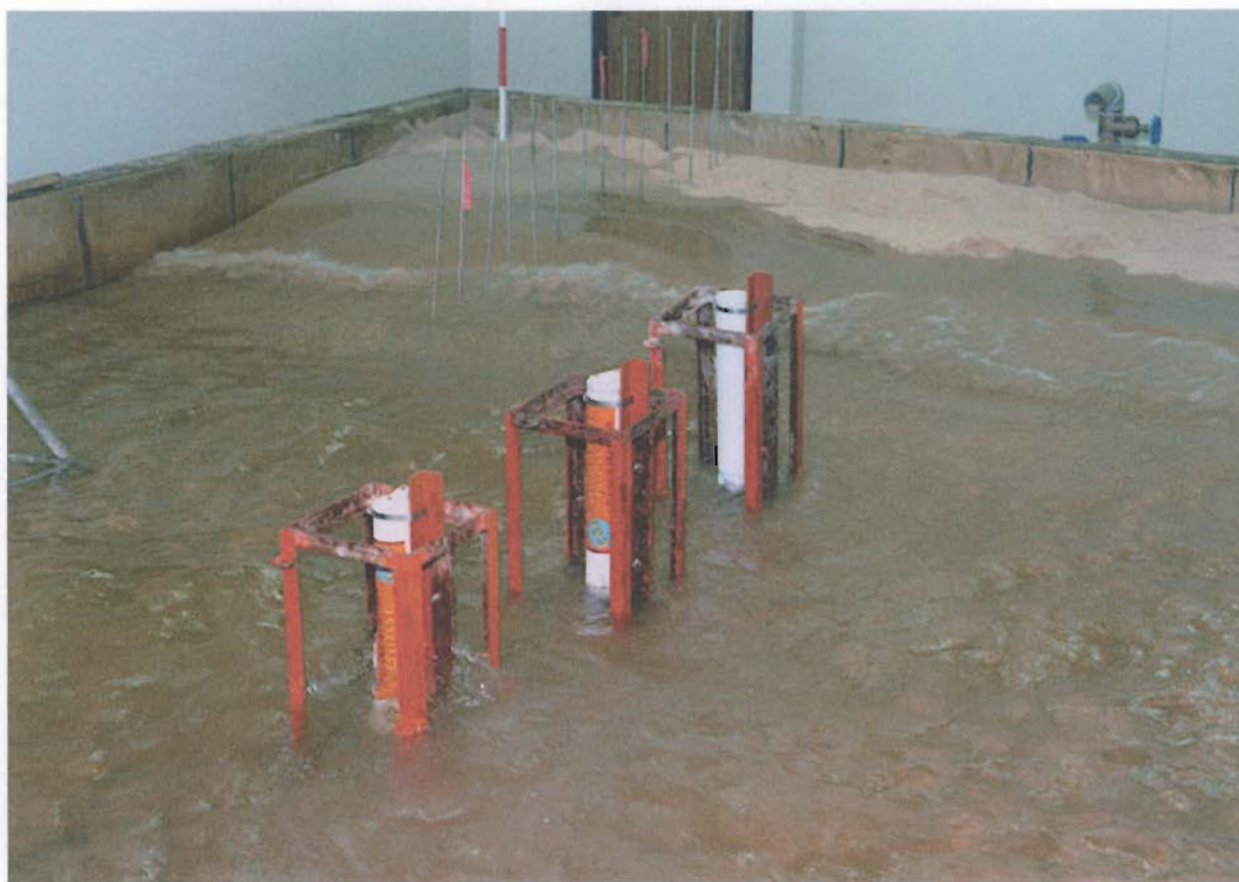
Plate 1. The pressure transducer array used in the Raccoon Island breakwater study. The pressure sensors and solid-state recorders are housed in a water-tight casing and are being tested in the Coastal Studies Institute's Wave Simulation Facility.

Wave height and period were measured with four precise, Paroscientific digital quartz pressure transducers. The pressure transducers, which record the instantaneous fluctuation of water level, are capable of 0.01% accuracy and 0.0001% resolution. For

conditions at the Raccoon Island breakwaters site, the accuracy of the instrument is expected to be well within 5 mm (0.2 in). The pressure transducers were assembled by CSI personnel in a self-contained, solid-state recording package, suitable for underwater deployment. An example of the laboratory test of the pressure sensor array is shown in Plate 1. The instrument packages are capable of sampling at a high frequency of 4 Hz.

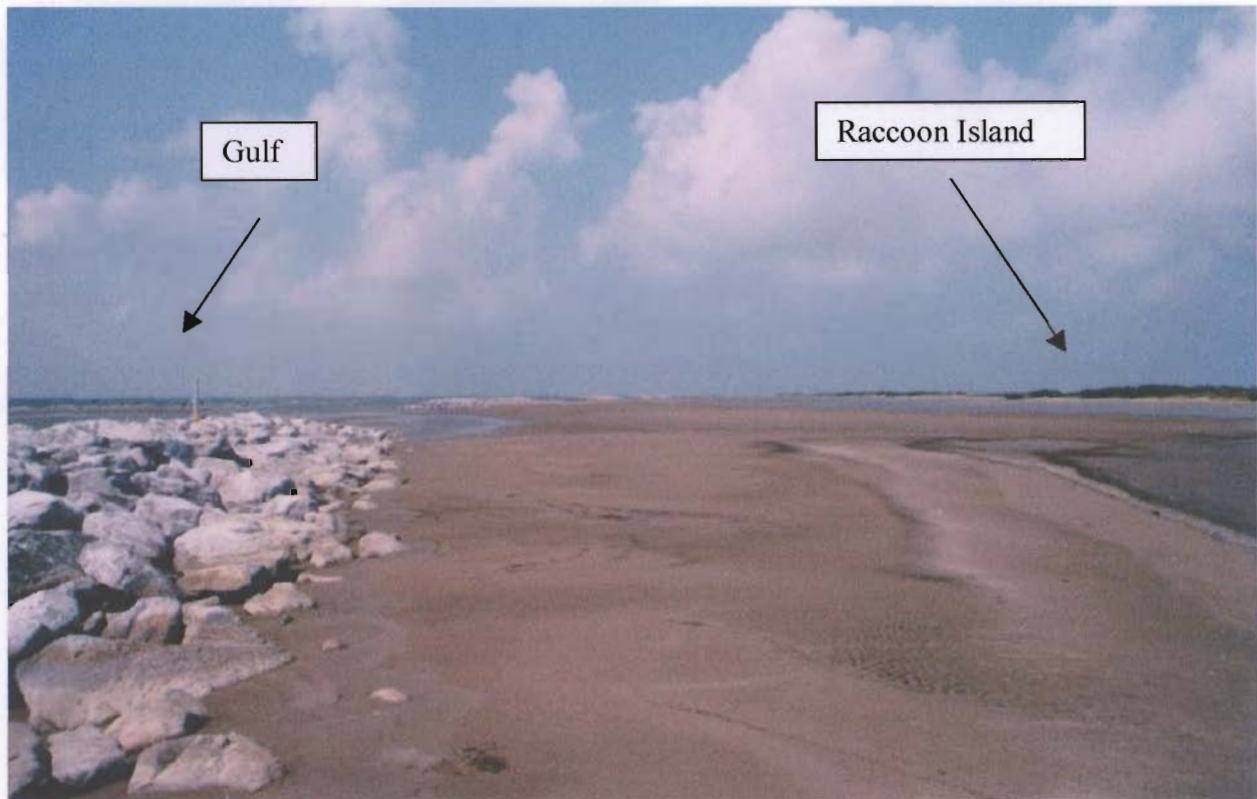
Plate 4. The breakwaters #6, #5, #4, and #3 were connected by an emerged sand body. The sediment that had accumulated immediately seaward of the breakwaters had been eroded between July and September 1998. Note the narrow water body landward of the breakwaters. Photograph looking west, September, 1998.

propagated from the Gulf. Due to low wind speeds encountered during both the July and September 1998 measurements, as well as the narrow water body, practically no waves were observed landward of the breakwaters (Plate 4), both landward of the center and the gaps.

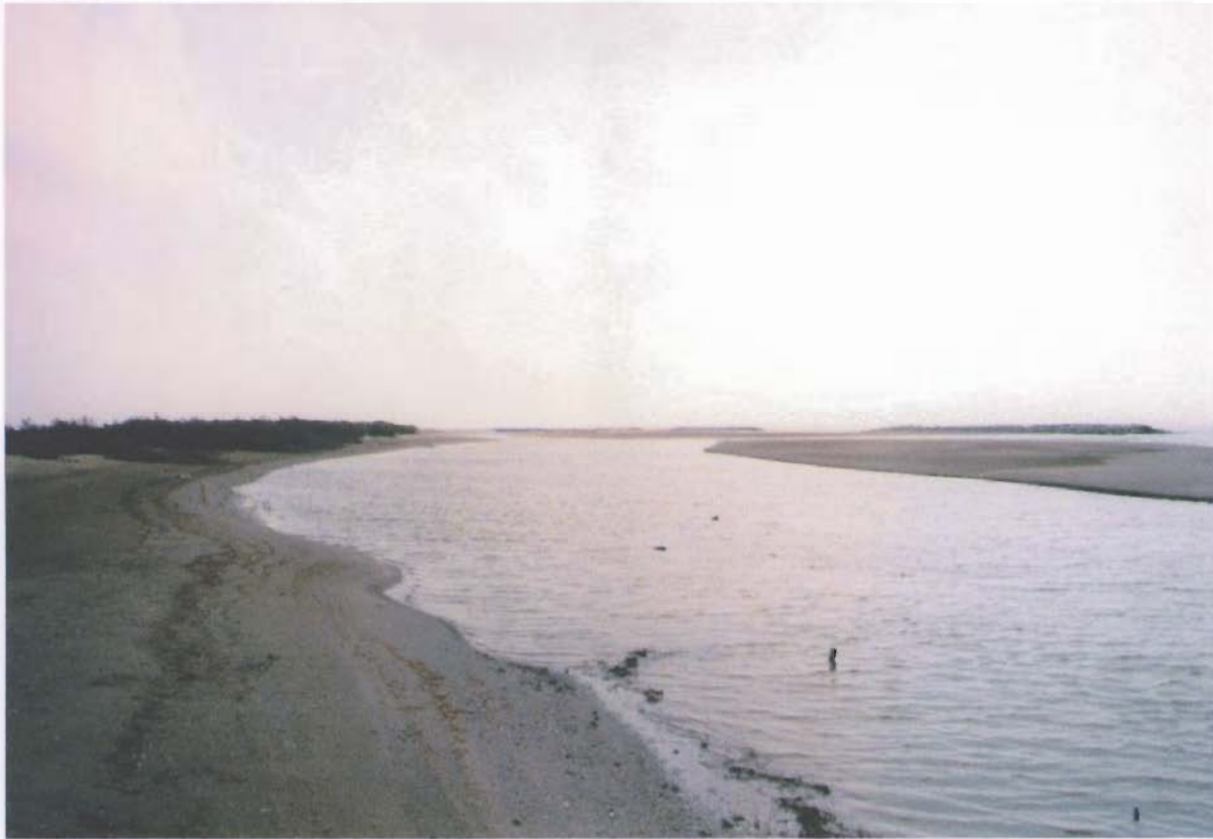
Plate 5. Photograph showing negligible wave action landward of breakwaters #6 and #5 and at the adjacent Raccoon Island shoreline. Note the shallow and narrow water body. Photograph looking southeast, September 24, 1998.

Hydrodynamic conditions landward of the breakwaters and at the Raccoon Island shoreline have changed substantially due to the emergence of the sand body in the gaps between breakwaters. Waves during fairweather conditions were entirely blocked by the emerged sand body adjacent to the breakwaters. Wave breaking was not observed at the shoreline landward of the breakwaters (Plate 5).

Significant wave heights measured at the offshore site during the September 1998 deployment ranged from 0.16 m (0.52 ft) to 0.30 m (0.98 ft) with an average of 0.22 m (0.72 ft) (Figure 2). Wave heights increased moderately toward late afternoon. Similar wave heights and trends were measured at the control site, with significant wave heights ranging from 0.15 m (0.49 ft) to 0.27 m (0.89 ft) (Figure 2). Landward of the breakwaters, the average water depth was less than 0.35 m (1.15 ft) throughout the period of measurement, and the water body was narrow, approximately 15 m (49 ft) wide, and almost entirely isolated from the Gulf (Plates 5 and 6).

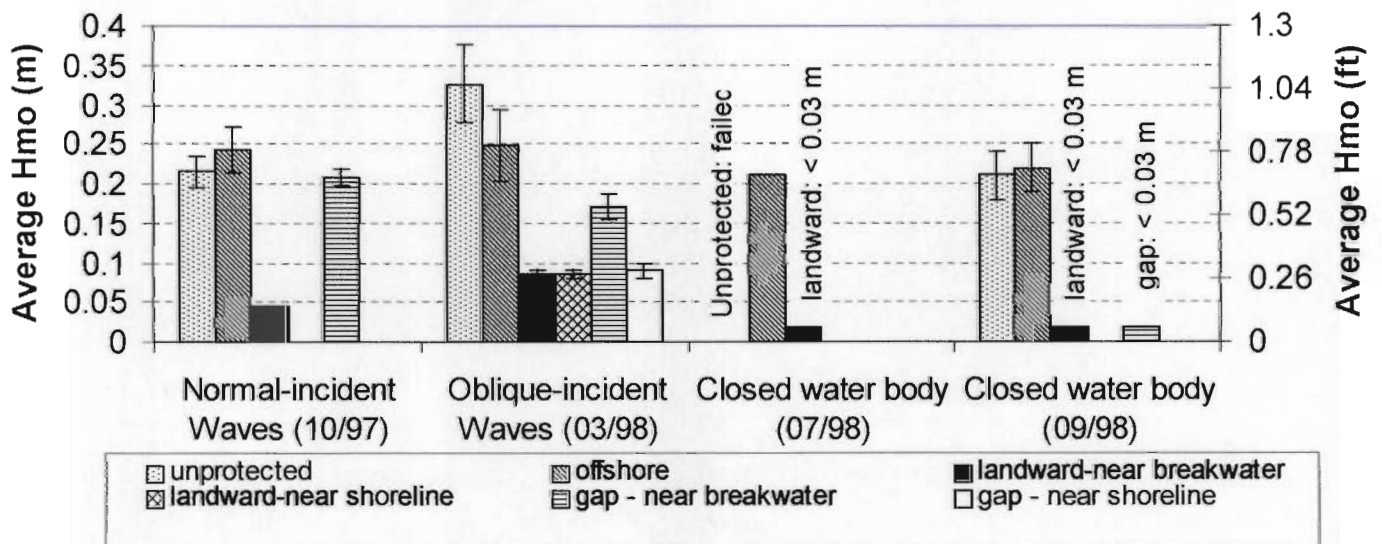
Figure 3. Comparison of significant wave heights at various locations for October 1997, March 1998, July 1998, and September 1998 deployments.

Results from the October 1997, March 1998, July 1998, and September 1998 measurements are summarized in Figure 3 for comparison. It is worth emphasizing that the difference between landward of the center of the breakwater and landward of the gap did not exist during both the July and September 1998 measurements, and wave heights were reduced by nearly 100% landward of the breakwaters. No sediment transport was observed landward of the breakwaters and at the Raccoon Island shoreline.

During the first two wave measurement experiments conducted on October 1997 and March 1998, a considerable wave-height reduction of more than 70%, was measured in the lee of the structures during both normally (October, 1997) and obliquely (March, 1998) incident wave conditions. A greater percentage of wave-height reduction landward of the center of the breakwaters, 90% as compared to 70%, was measured during normally incident waves. This is directly attributable to the influence of the breakwaters. In the gap between the breakwaters, wave heights were virtually unchanged when compared to the unprotected site during normally incident wave conditions. A wave-height reduction of 50% was measured, however, during obliquely incident waves.

Substantially modified morphological conditions were encountered during the July and September 1998 measurements, and waves propagating from the Gulf were totally dissipated by the emerged sand body in the vicinity the breakwaters. There were no differences between wave conditions landward of the center of the breakwaters and landward of the gap between the breakwaters (Plates 3 and 4). The extremely shallow water landward of the breakwaters, presented technical difficulties with instrumentation during the July 1998 measurements. During the September 1998 measurements, the shallow water body narrowed significantly due to further sediment accumulation. Water depths were significantly different at the inside and gap sites when compared with the depth at the control site. Comparison of wave conditions among the protected and unprotected sites are somewhat influenced by the depth difference.

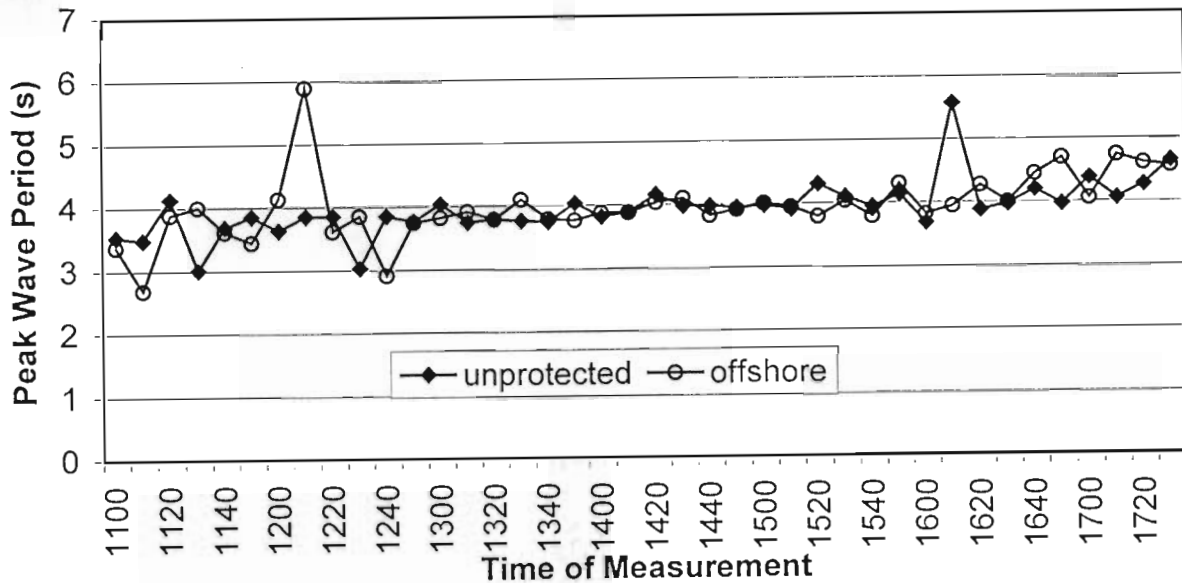
Figure 4. Measured peak wave period during September 1998. Note the relatively short period averaging 4 s indicating locally wind-generated wave conditions.

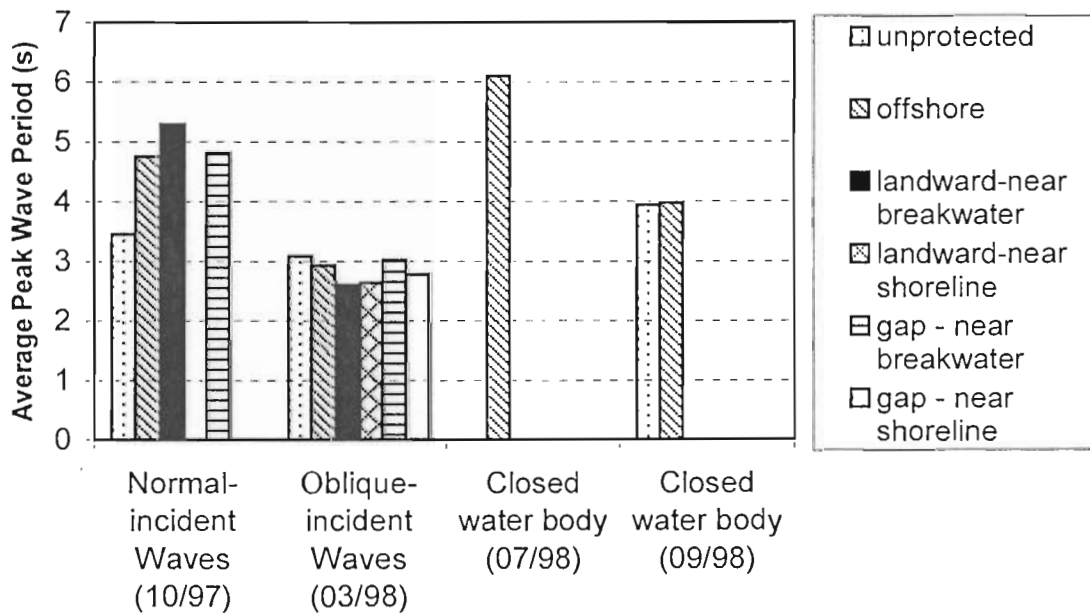
Figure 5. Comparison of peak wave periods at various locations.

frequency waves more effectively than their lower frequency counterparts (SPM, 1984). This low-pass effect was apparent during the normally incident wave conditions encountered in October 1997 (Figure 5). The average peak wave period measured landward of the center of the breakwaters was considerably longer than those at other sites, especially that at the unprotected site. Differences in peak wave period were minimal during the oblique incident wave conditions (Figure 5) encountered during the March 1998 measurements. During the July 1998 measurements, the offshore wave periods were much longer than those encountered during the October 1997, March 1998, and September, 1998 measurements, indicating swell-dominated conditions as opposed to locally generated seas. Wave periods landward of the structures during the July and September 1998 measurements were not reliable due to minimal signal strength.

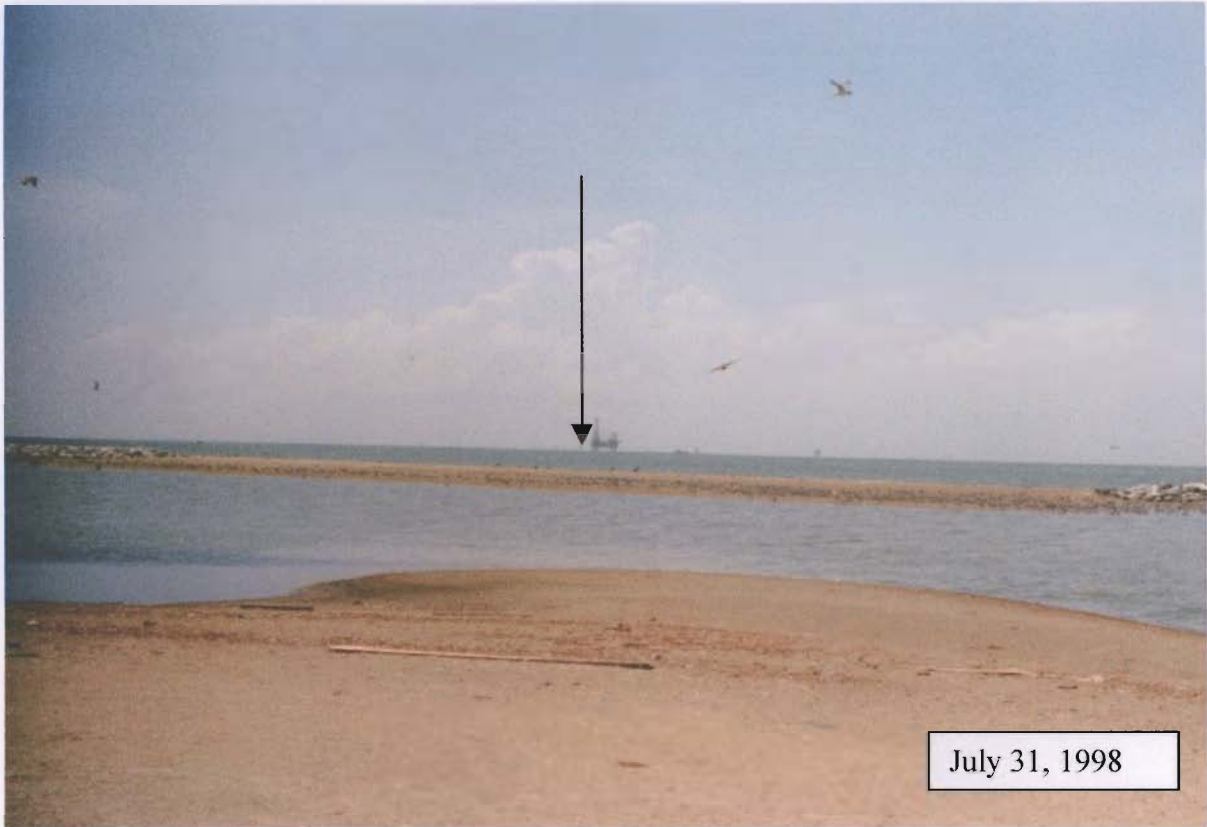
Emerged sand body in the gap between breakwaters.
