**State of Louisiana
Department of Natural Resources
Coastal Restoration Division and
Coastal Engineering Division**

**2004 Operations, Maintenance
and Monitoring Report**

Sabine Refuge Marsh Creation

State Project Number CS-28
Priority Project List 8

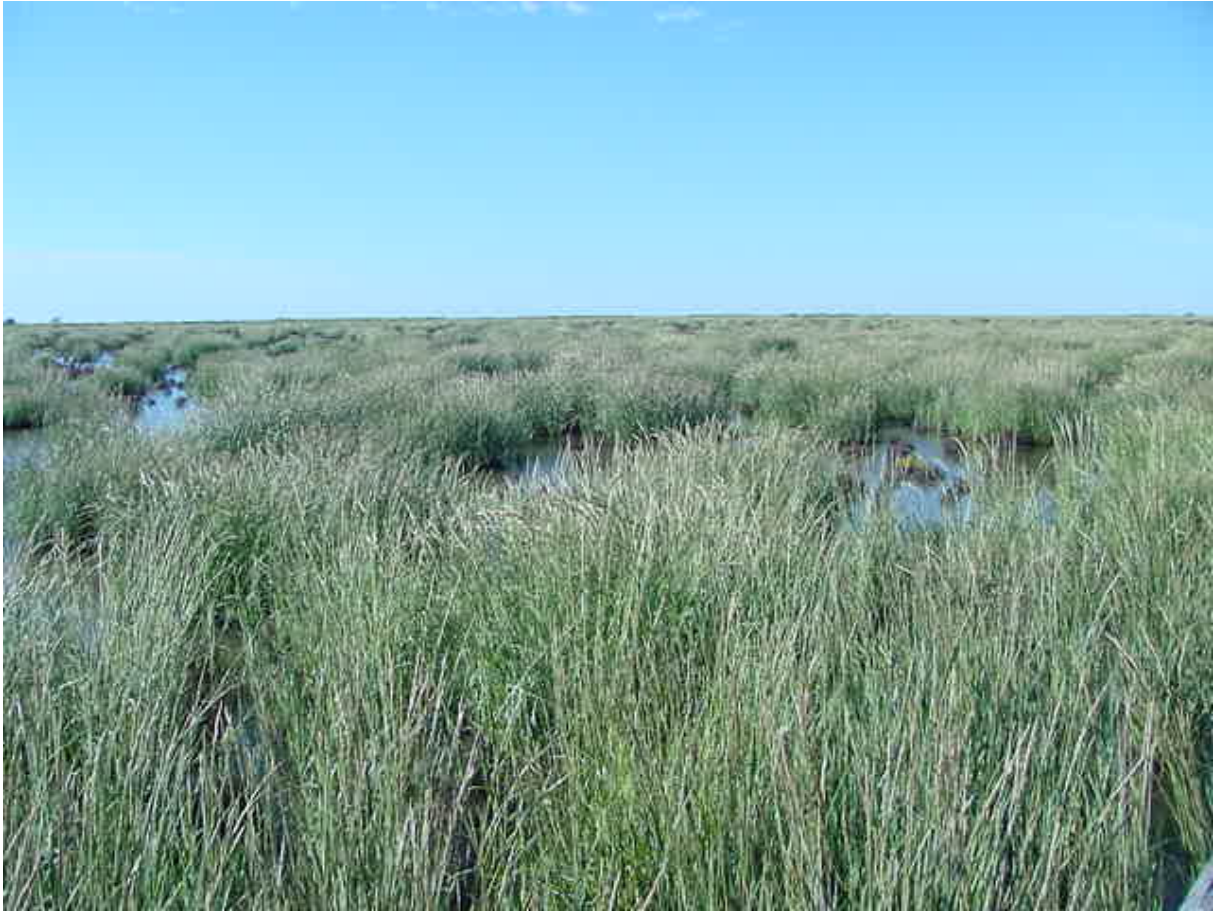
Figure 5. Photograph of marsh vegetation within the Cycle 1 deposition area. Photo taken from the north corner facing south in October, 2003 by LDWF personnel.

Land / Water analysis was recently completed for the photography acquired in December, 2002. The 2000 photography was collected for the adjacent Hog Island Gulley Project (CS-23) and was processed for CS-23, but has not yet been subset for the CS-28 project area. The 2002 acreages are presented in figure 4. When the photography was flown, the area was entirely mudflat. During recent field trips (October and December, 2003), it appeared that the mudflats were thoroughly vegetated (figure 5).

The first cycle of Marsh Creation resulted in a densely covered marsh more quickly than anticipated. The plantings were installed one year post construction on the edge of the project area and along the edges of the interior canals that were constructed. The interior marsh quickly filled with vegetation (*S. patens*) one year post construction. The next four cycles should produce similar results.

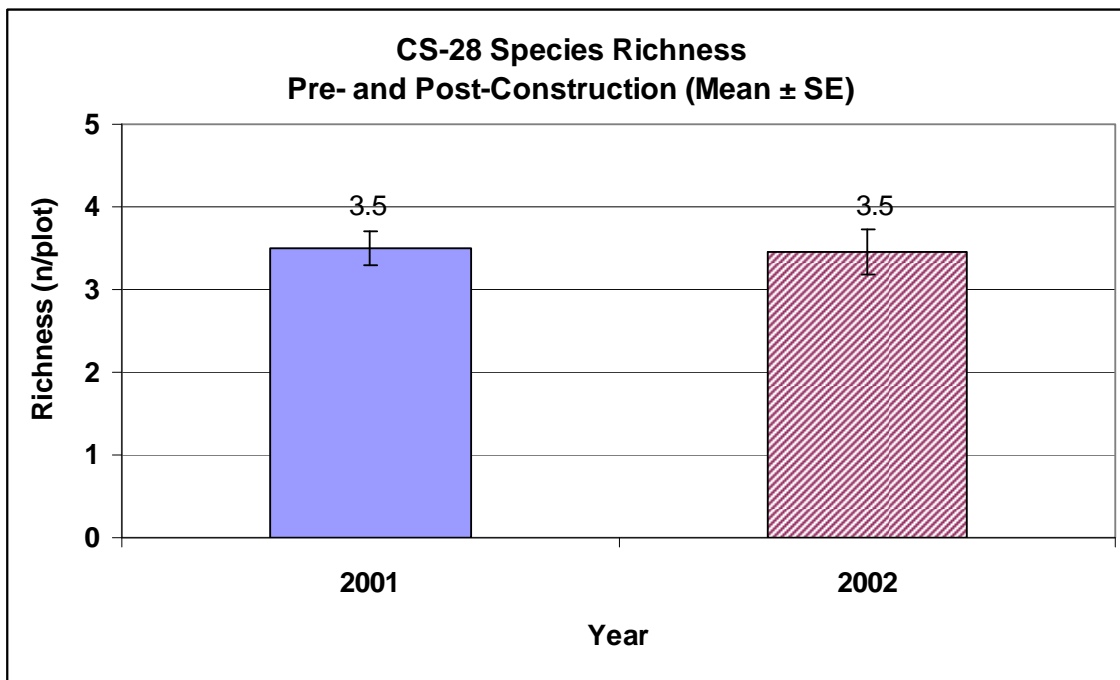
Figure 8. CS-28 Species richness of emergent vegetation at sites in pre-existing marsh adjacent to the dredge fill Cycle 1 area Pre- and Post-construction.

In order to determine whether the project had an effect on pre-existing emergent vegetation one year after construction, a t-test was conducted using data from the 10 stations in the marsh adjacent to the constructed Cycle 1 project area. Total cover of emergent vegetation was 98.8% pre-construction and 97.2% post-construction. There was no significant difference in total percent cover (figure 6), height of the dominant species (figure 7), or species richness (figure 8) in response to the project. Sediment was expected to escape the first cycle of marsh creation through constructed breaches thereby affecting marsh vegetation in the project area. The breaches were constructed after the sediment had already settled. It does not appear that sediment affected the adjacent marsh.

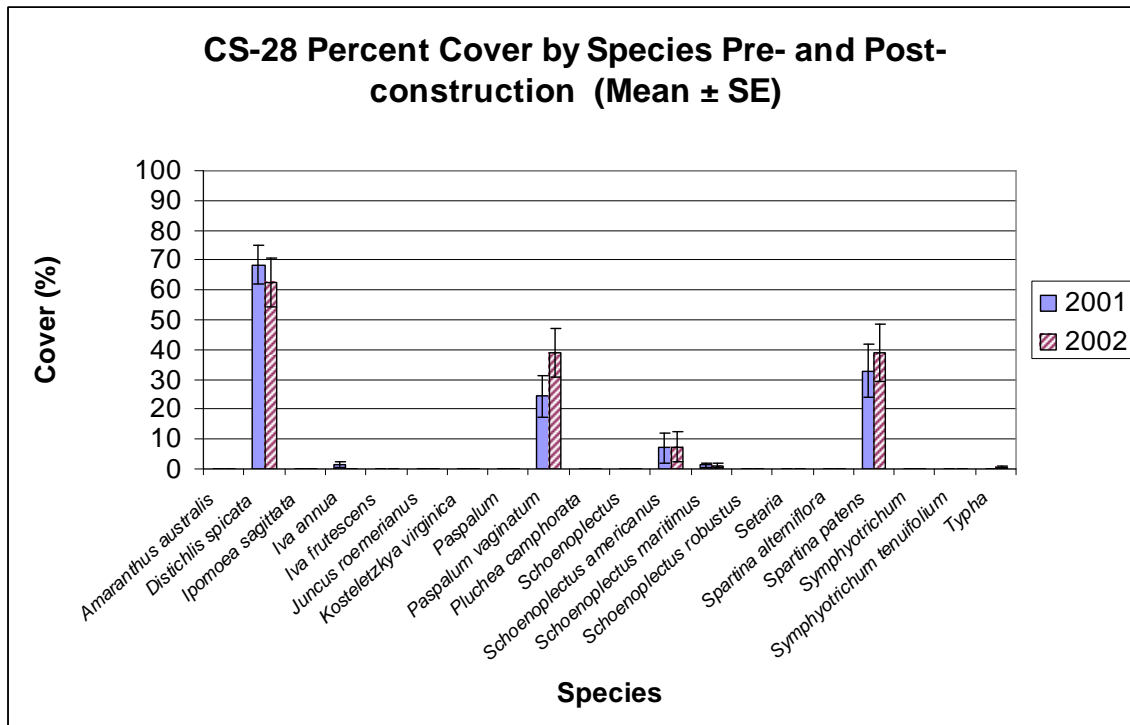
Figure 9. CS-28 Mean cover values for each species present in 2001 and 2002 at sites in pre-existing marsh adjacent to the dredge fill Cycle 1 area.

The vegetation plots were predominantly composed of *Spartina patens* (saltmeadow cordgrass), *Distichlis spicata* (seashore saltgrass), *Paspalum vaginatum* (seashore paspalum), and *Schoenoplectus americanus* (bulrush) (figure 9 and table 1). Cover of the dominant species, *S. patens* was 91.2% pre-construction and 91.7% post-construction.
