Monitoring Series No. CS-19-MSTY-1200-3

CLOSEOUT MONITORING REPORT  
For the period April 01, 1994 to December 31, 2000

**WEST HACKBERY PLANTINGS AND SEDIMENT  
ENHANCEMENT  
CS-19**

**First Priority List Vegetative Planting Project  
of the Coastal Wetlands Planning, Protection, and Restoration Act  
(Public Law 101-646)**

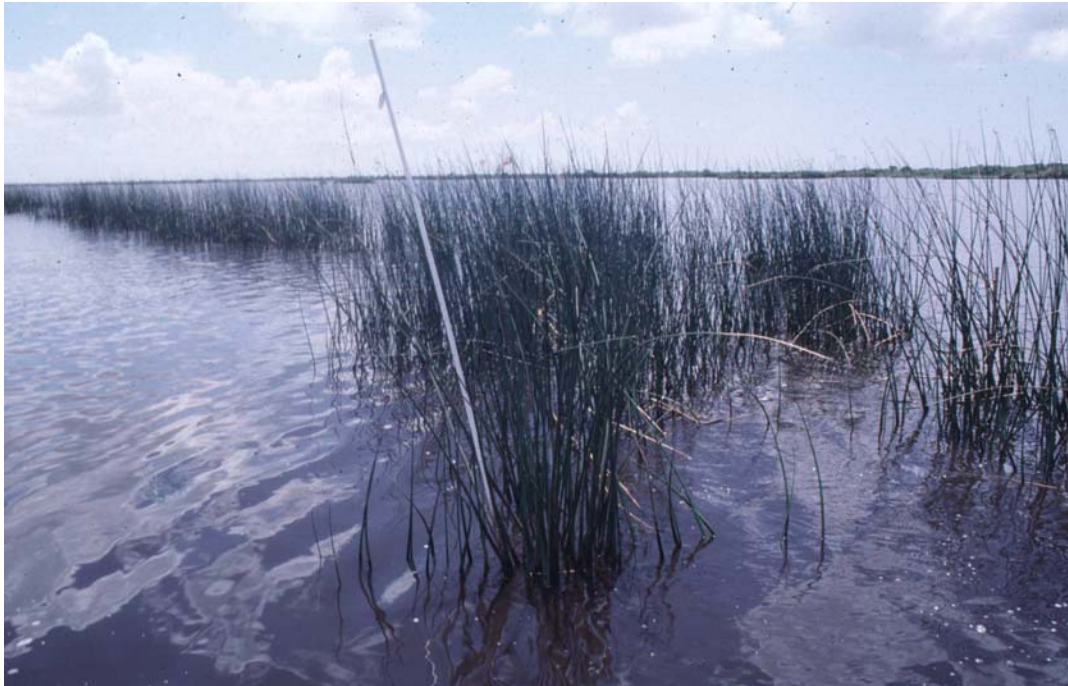
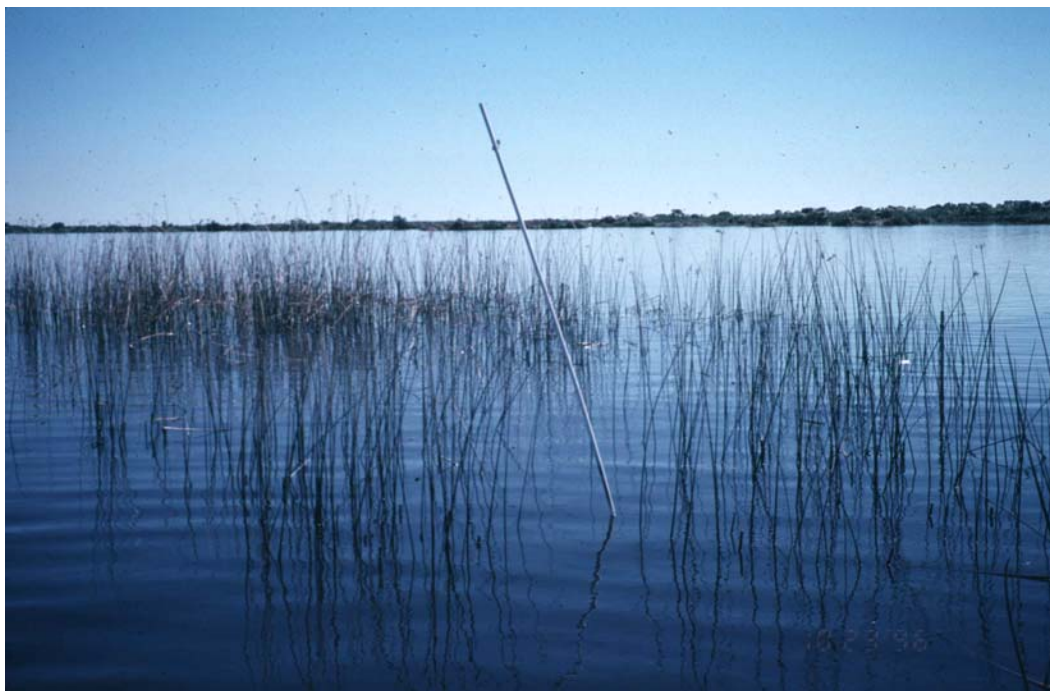
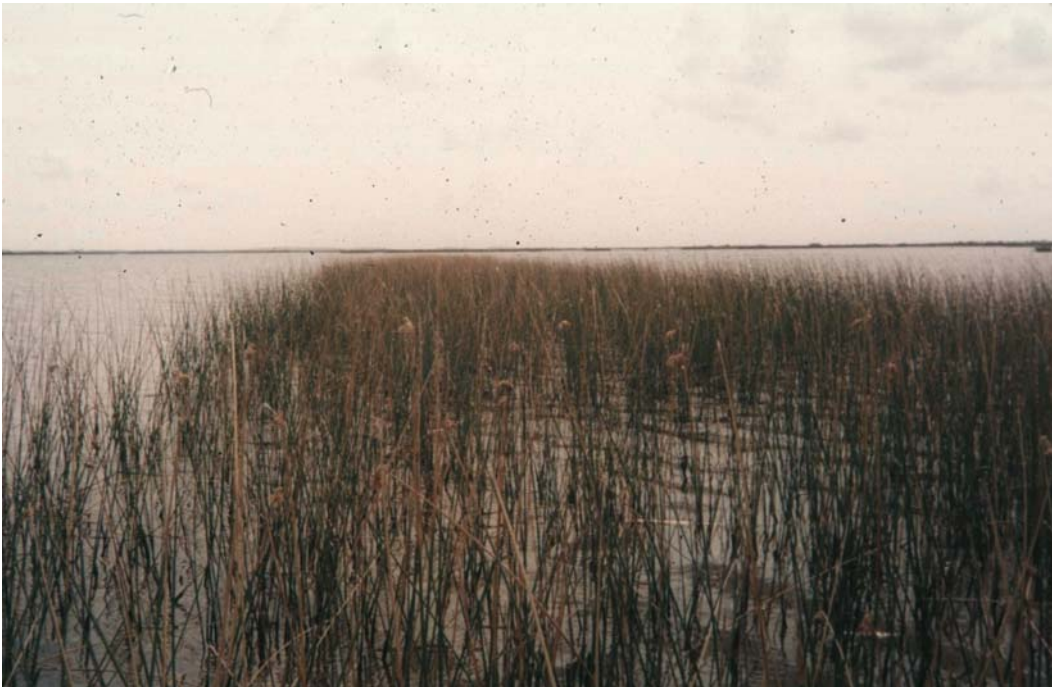
Before the 1996 drought, all mature stems on the plantings were noticed to be dark green in appearance and the greatest percent cover was recorded. After the drought, nearly all of the mature stems on the plantings were brown and appeared to be dead, and most of the remaining transplants did not bear obvious young, green shoots. However, the plantings were growing in approximately 2 ft (0.6 m) of turbid water, and it is likely that any additional new growth was submerged and was not apparent. The planting rows on the east side of the planting area showed the greatest impact. Vigorous growth of the transplants has developed only on the south end of planting row A1, and on rows B1 and B2 (figures A3 to A10).

**Figure A3.** Row A1 vegetative plantings within the CS-19 project area for the 1995 monitoring period.

**Figure A4.** Row A1 vegetative plantings within the CS-19 project area for the 1996 monitoring period.

**Figure A5.** Row A1 vegetative plantings within the CS-19 project area for the 1997 monitoring period.

**Figure A6.** Row A1 vegetative plantings within the CS-19 project area for the 1999 monitoring period.

**Figure A7.** Row B2 vegetative plantings within the CS-19 project area for the 1995 monitoring period.

**Figure A8.** Row B2 vegetative plantings within the CS-19 project area for the 1996 monitoring period.

**Figure A9.** Row B2 vegetative plantings within the CS-19 project area for the 1997 monitoring period.

**Figure A10.** Row B2 vegetative plantings within the CS-19 project area for the 1999 monitoring period.

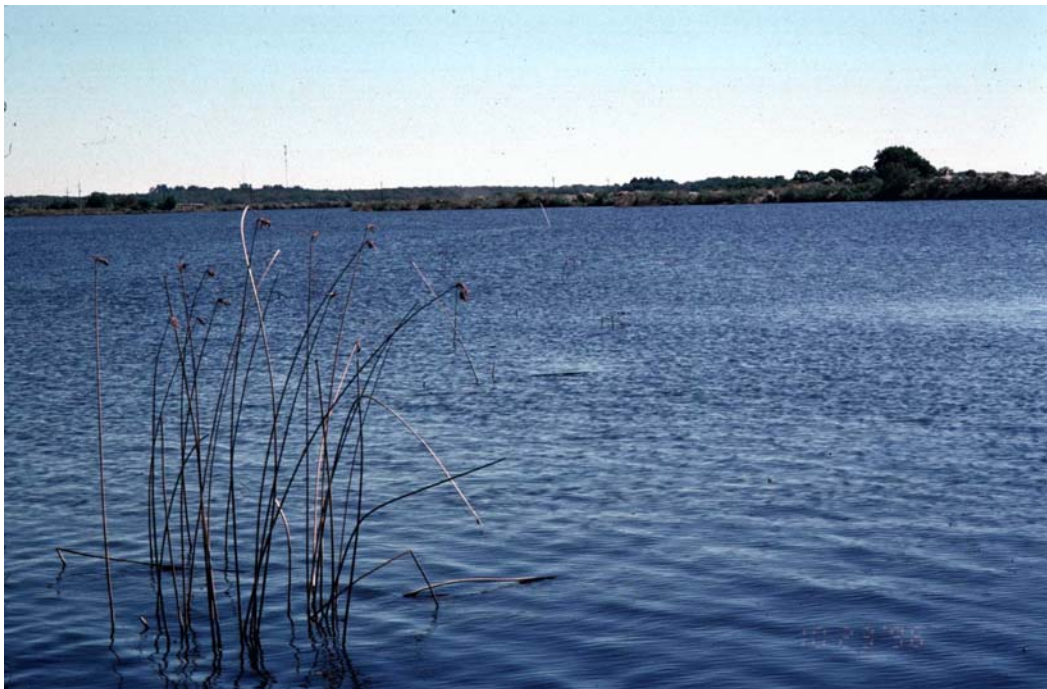
**Figure A11.** Row C3 vegetative plantings within the CS-19 project area for the 1995 monitoring period.

**Figure A12.** Row C3 vegetative plantings within the CS-19 project area for the 1996 monitoring period.

**Figure A13.** Row C3 vegetative plantings within the CS-19 project area for the 1997 monitoring period.

**Figure A14.** Row C3 vegetative plantings within the CS-19 project area for the 1999 monitoring period.
