Monitoring Series No. ME-04-MSPR-1099-5

**PROGRESS REPORT NO. 5**

**FRESHWATER BAYOU WETLANDS  
ME-04 (XME-21)**

**Second Priority List Hydrologic Restoration Project  
of the Coastal Wetlands Planning, Protection, and Restoration Act  
(Public Law 101-646)**

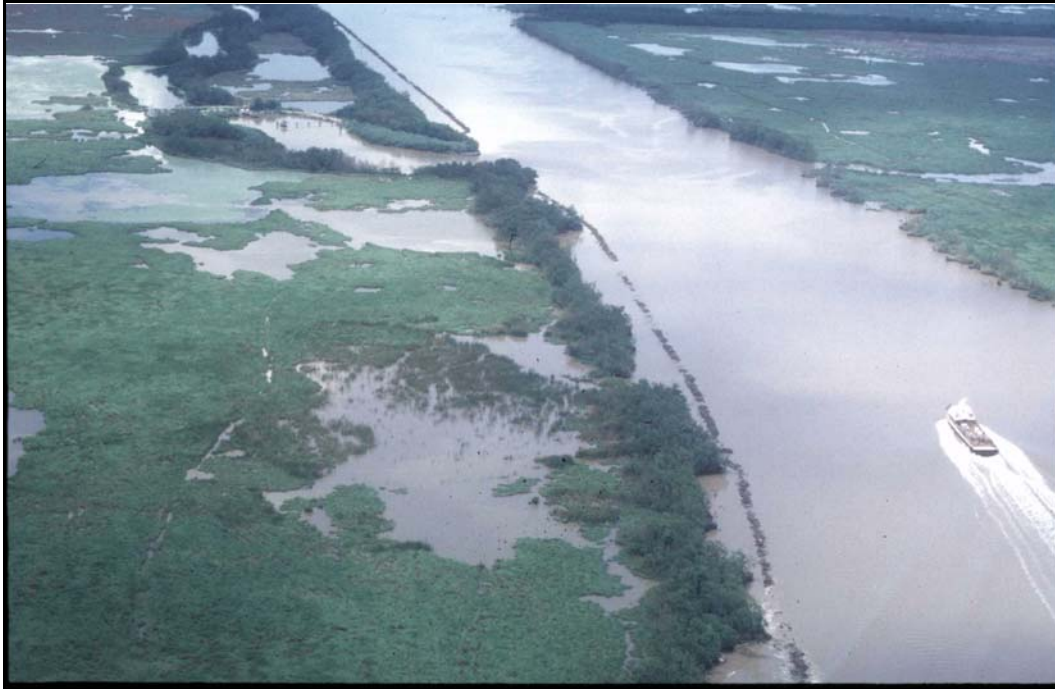
**Figure 2.** Photo of the Freshwater Bayou Canal channel between CTU 1 (left side) and reference area R2 (right side) showing part of the ME-04 rock dike, deteriorated spoil banks, and ponded areas in the marsh along both sides of the channel.

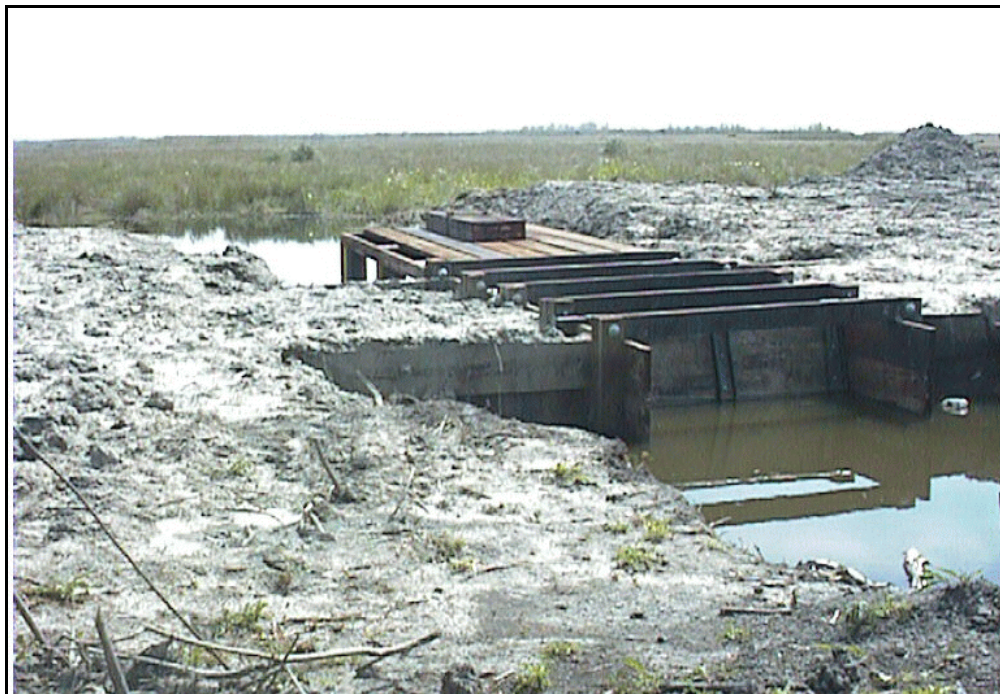
**Figure 3.** Photo of CWPPRA structure 6 in CTU 1 of the ME-04 project area taken just after installation in March 1998.

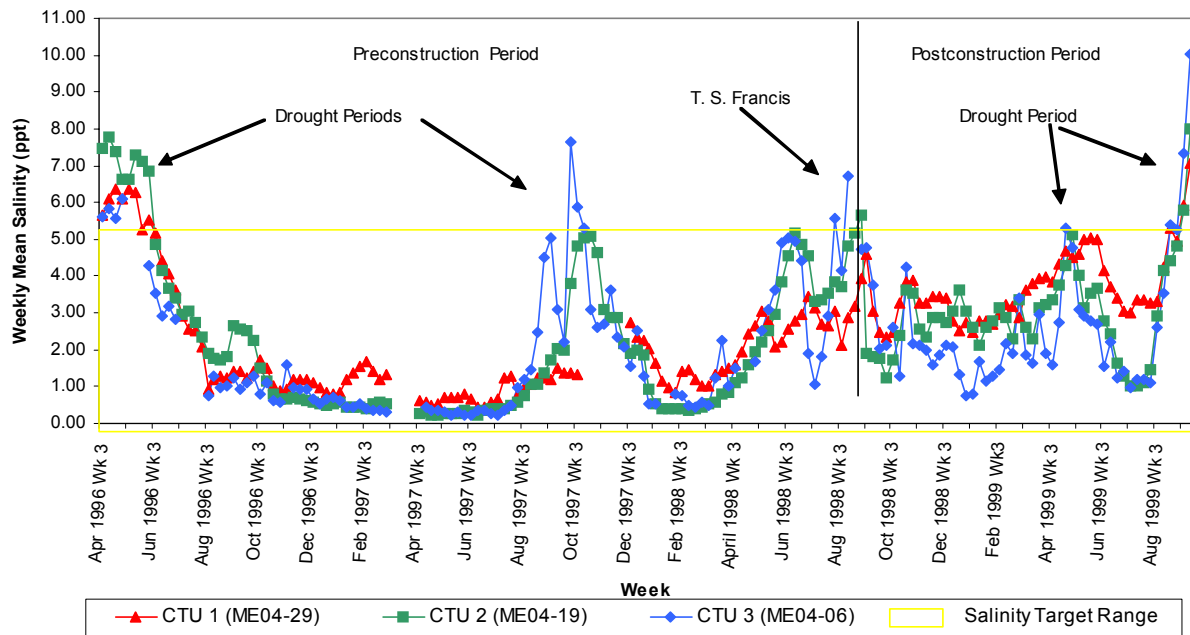
**Figure 7.** Weekly mean water salinity (ppt) in the ME-04 project area from April 1996 through September 1999, based on hourly data from continuous recorders located in CTU's 1,2, and 3 at stations ME04-29, ME04-19, and ME04-06, respectively. Data gaps represent time periods when recorders were out of service.

Water salinity: Weekly mean water salinity (ppt) calculated using hourly data from the 7 continuous recorders (figure 1) shows that water salinity in the project area during the period of record generally fell within the target range for fresh to intermediate marsh, which is 0-5 ppt (figure 7). Deviations from this pattern appear to be associated with either periods of drought, when the reduced inflow of freshwater from White Lake and rainfall allows salinity to increase, or during periods of tropical storm activity, when extreme high tides and storm surges cause an inflow of higher salinity water into the project area through breeches in the perimeter embankments and over the tops of some structures. During these time periods, weekly mean water salinity can range from 5-11 ppt. Weekly mean water salinity during the winter and spring months of the postconstruction period was generally higher than during the winter and spring months of the preconstruction period due to the lingering effects of the Tropical Storm Francis storm surge and drought conditions during 1999. These same pattern hold true for the exterior canals surrounding the project area and for reference area R2 (figure 8). Water salinity in reference area R3 is generally less than 1 ppt, with only slight increases during periods of drought and tropical storm activity (figure 9).

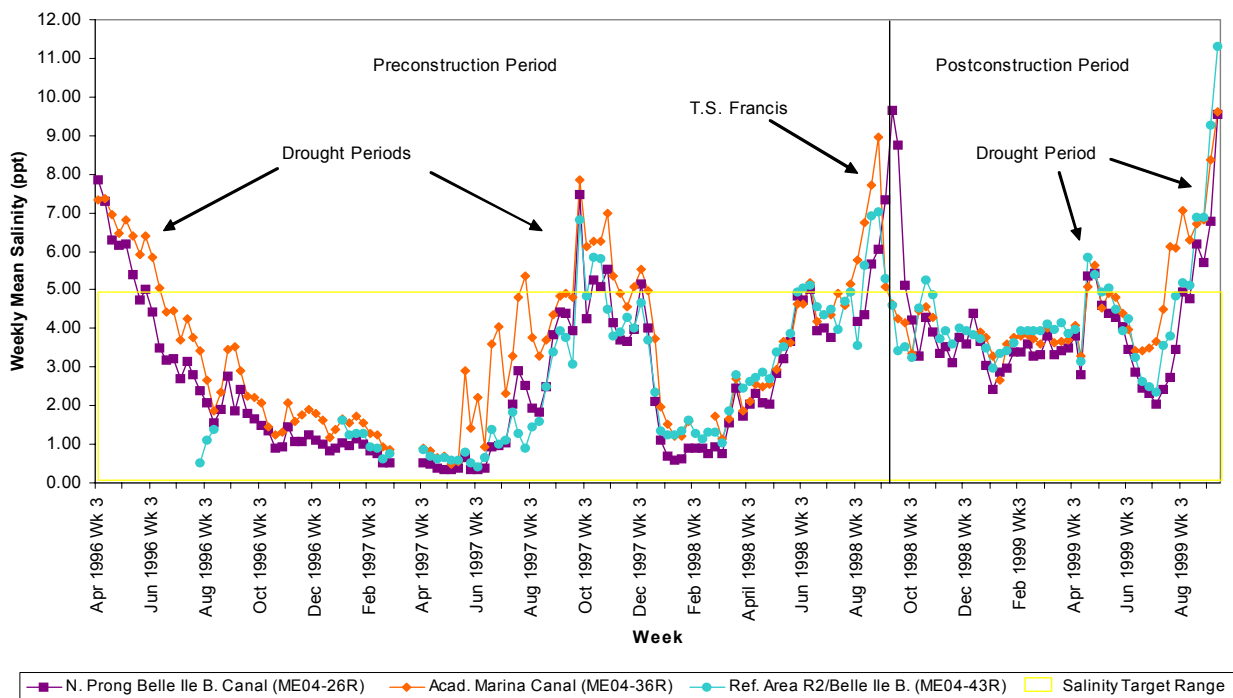
**Figure 8.** Weekly mean water salinity (ppt) in N. Prong Belle Isle Bayou Canal, Acadiana Marina Canal, and in the ME-04 reference area R2 access trenasse at its confluence with Belle Isle Bayou, from April 1996 through September 1999, based on hourly data from continuous recorders located at stations ME0426R, ME04-36R, and ME04-43R, respectively.

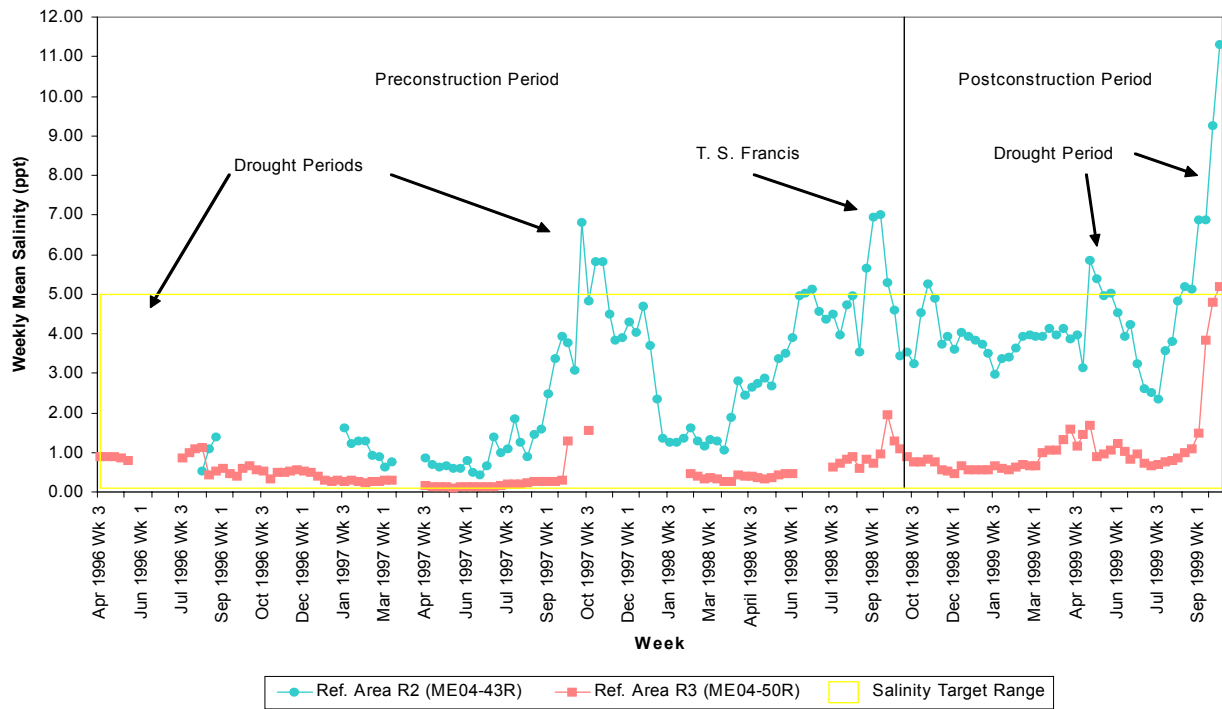
**Figure 9.** Weekly mean water salinity (ppt) in the ME-04 reference areas R2 and R3 from April 1996 through September 1999, based on hourly data from continuous recorders located at stations ME04-43R and ME04-50R, respectively. Data gaps represent time periods when the recorders were out of service.

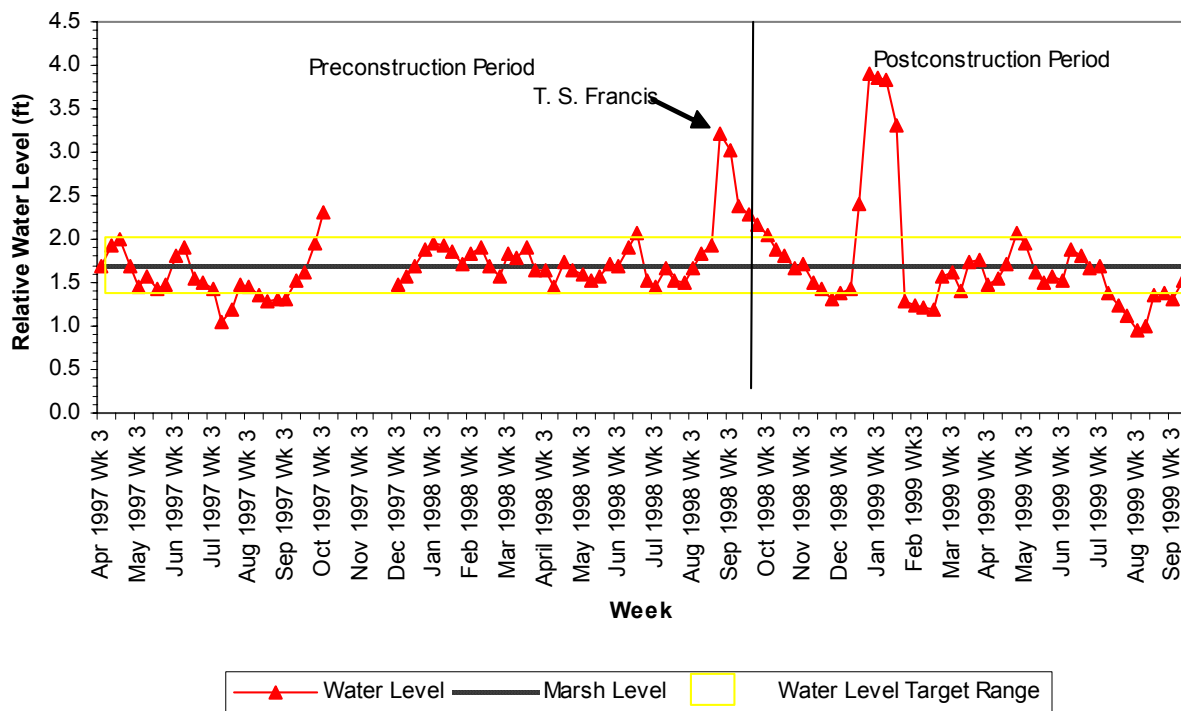
**Figure 12.** Weekly mean water level (ft) in relation to marsh level in CTU1 of the ME-04 project area, calculated from hourly data from a continuous recorder deployed at station ME04-29. Data gaps represent time periods when the recorder was out of service.

Water level: Weekly mean water level (ft, relative to marsh elevation) calculated from hourly continuous recorder data shows that water level in CTU 1 of the project area (figure 12) generally fluctuated within the water level target range for fresh to intermediate marsh, which is 6 inches (15.2 cm) below to 2 inches (5 cm) above marsh elevation (figure 12). However, the weekly mean water level tended to remain above the target range for 1- to 5-week intervals, especially during the preconstruction period. Data from the CTU 2 recorder station (figure 13) shows that weekly mean water level in this unit generally fluctuated within the target water level range, but tended to remain above the target range for 1- to 8-week intervals, especially during the postconstruction period. Water level in the vicinity of the CTU 3 recorder station (figure 14) tended to fluctuate below the water level target range, usually falling between 6-12 inches (15.2-30.5 cm) below the marsh elevation recorded at this station. The pattern in the vicinity of the reference area R3 recorder station (figure 15) is similar to that of the CTU 1 recorder station (figure 12). Variation and fluctuation in water level is greatest in the vicinity of the recorder stations in the more tidally influenced canals surrounding the project area and in reference area R2 (figure 16), with the amplitude appearing to increase with increasing channel depth. This pattern is very similar to that seen at the CTU 3 recorder station (figure 14). Like water salinity, elevated water levels in the project and reference areas appear to be somewhat associated with extreme high tides and tropical storm activity.

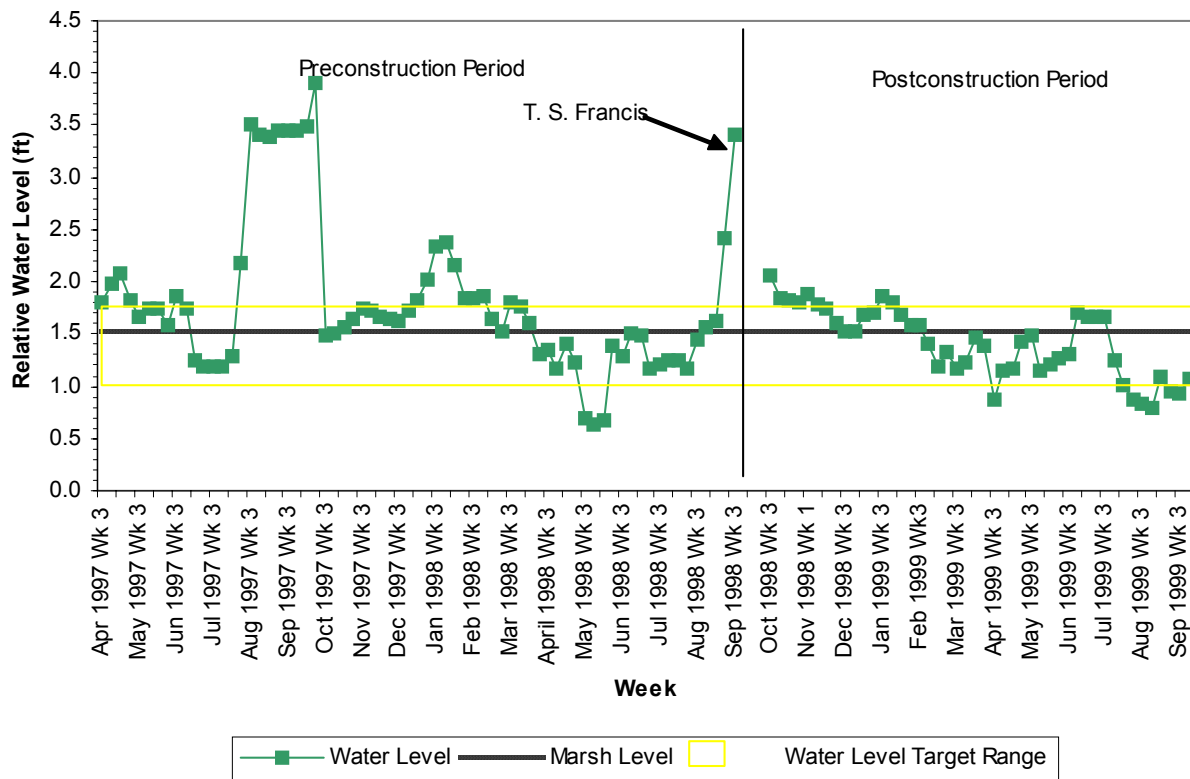
**Figure 13.** Weekly mean water level (ft) in relation to marsh level in CTU2 of the ME-04 project area, based on hourly data from continuous recorders deployed at station ME04-19. Data gaps represent time periods when the recorders were out of service.

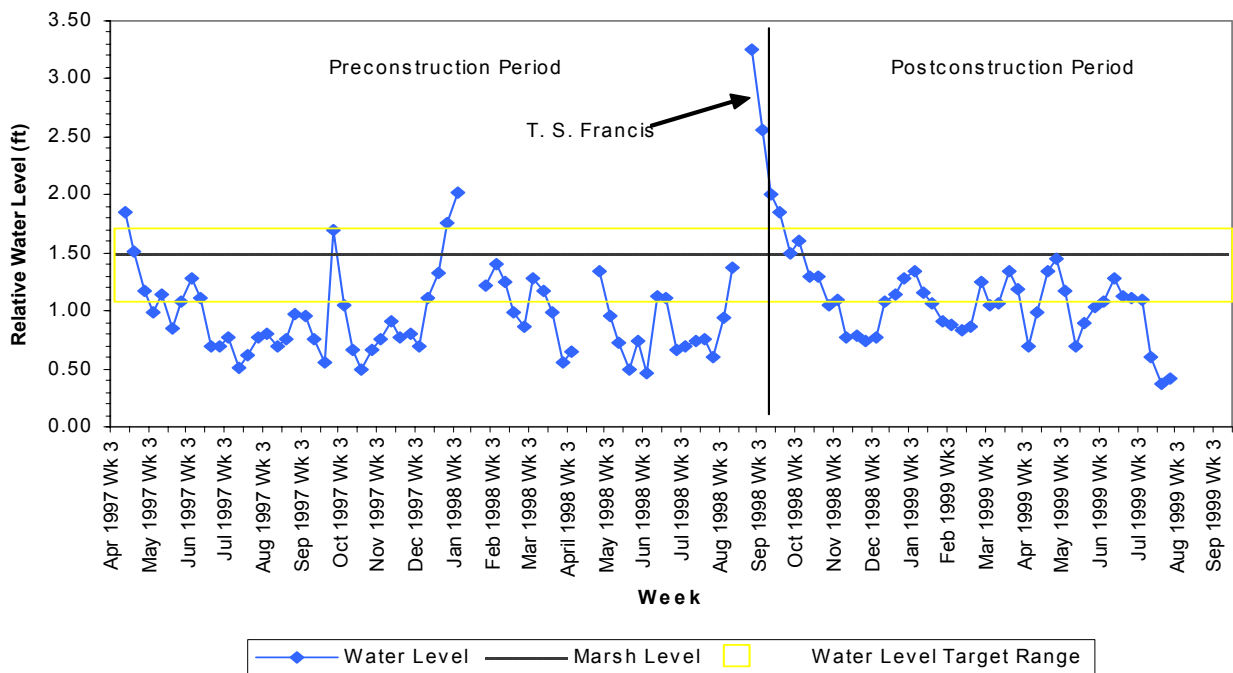
**Figure 14.** Weekly mean water level (ft) in relation to marsh level in CTU3 of the ME-04 project area, calculated from hourly data from a continuous recorder deployed at station ME04-06. Data gaps represent time periods when the recorder was out of service.

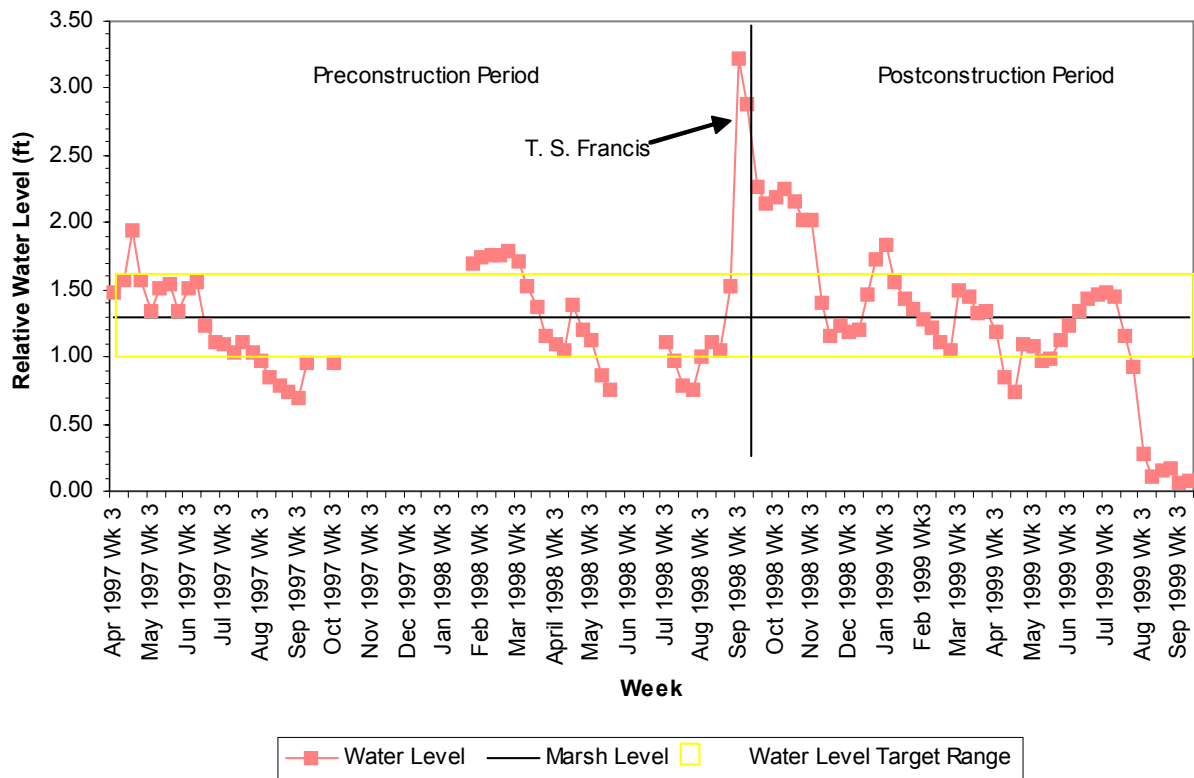
**Figure 15.** Weekly mean water level (ft) in relation to marsh level in reference area R3 of the ME-04 project area, based on hourly data from continuous recorders deployed at station ME04-50R. Data gaps represent time periods when recorders were out of service.

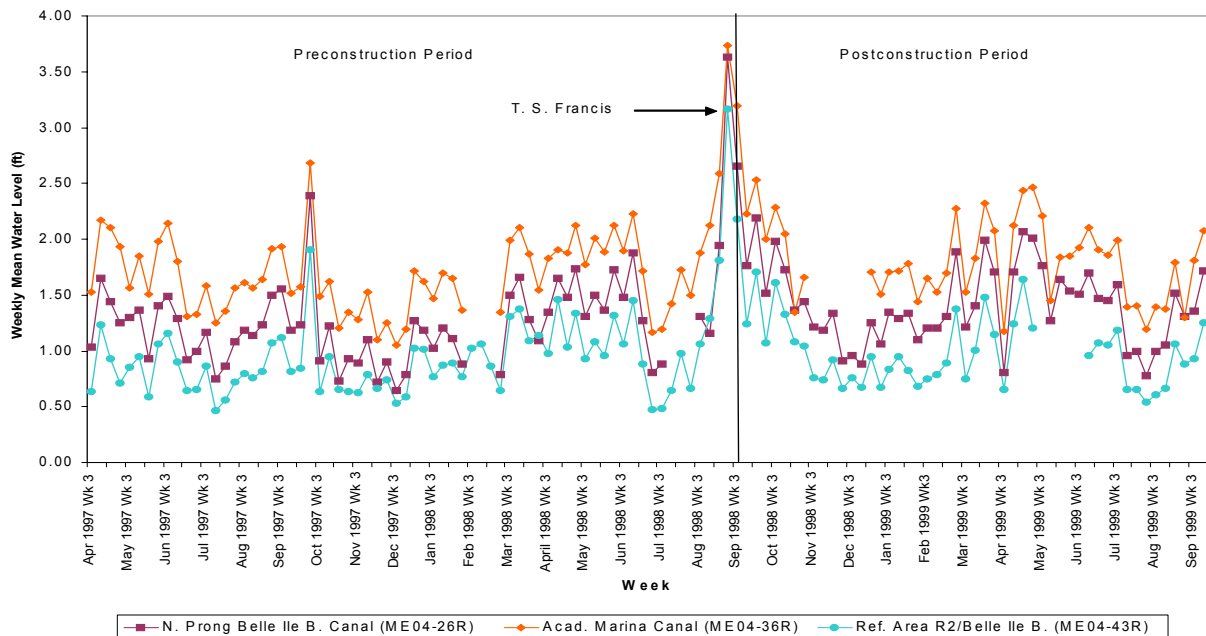
**Figure 16.** Weekly mean water level (ft) in N. Prong Belle Isle Bayou Canal, Acadiana Marina Canal, and in the ME-04 reference area R2 access trenasse at its confluence with Belle Isle Bayou, from April 1997 through September 1999, based on hourly data from continuous recorders located at stations ME04-26R, ME04-36R, and ME04-43R, respectively. Data gaps represent time periods when recorders were out of service.
