CS-24

Perry Ridge Shore Protection Summary Data and Graphics

May 2001
Updated 12/30/02

CS-24 Perry Ridge

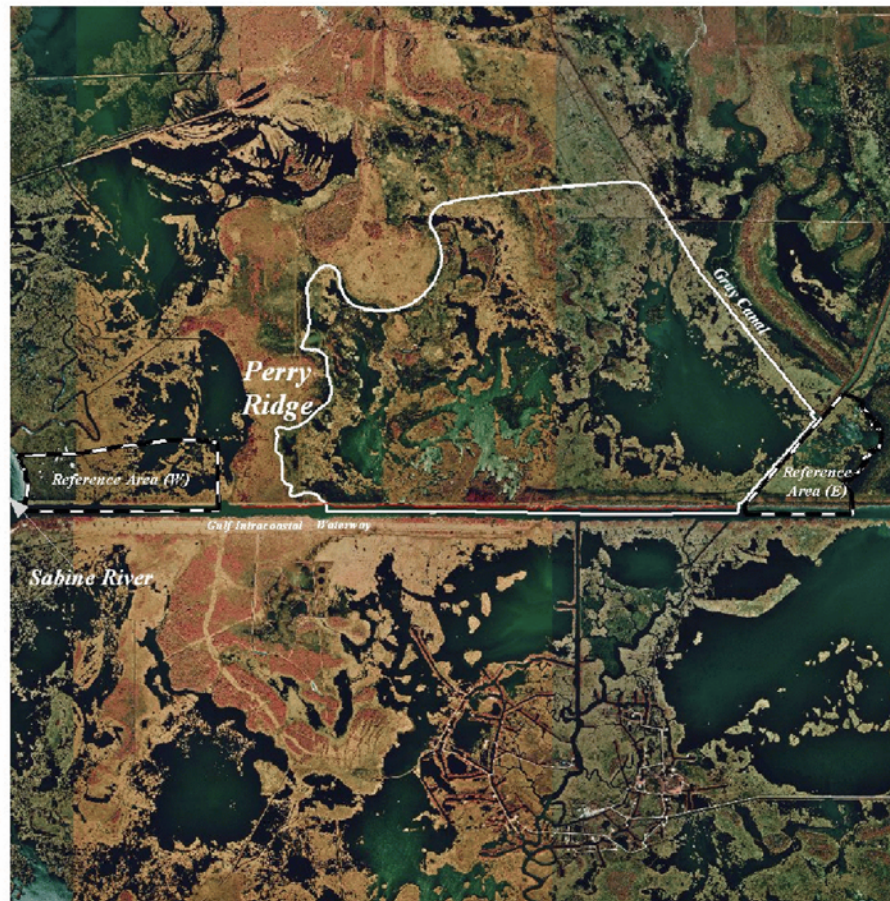
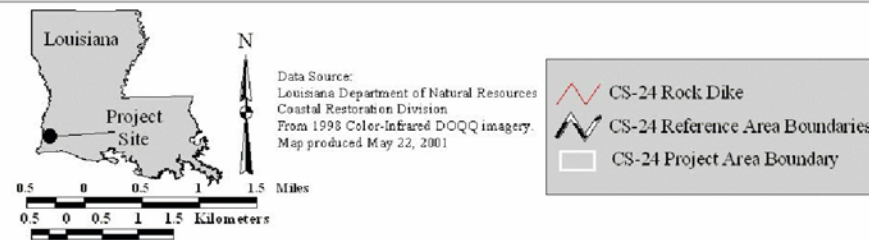
Perry Ridge Shore Protection (CS-24) project boundary, reference area, and rock dike location.

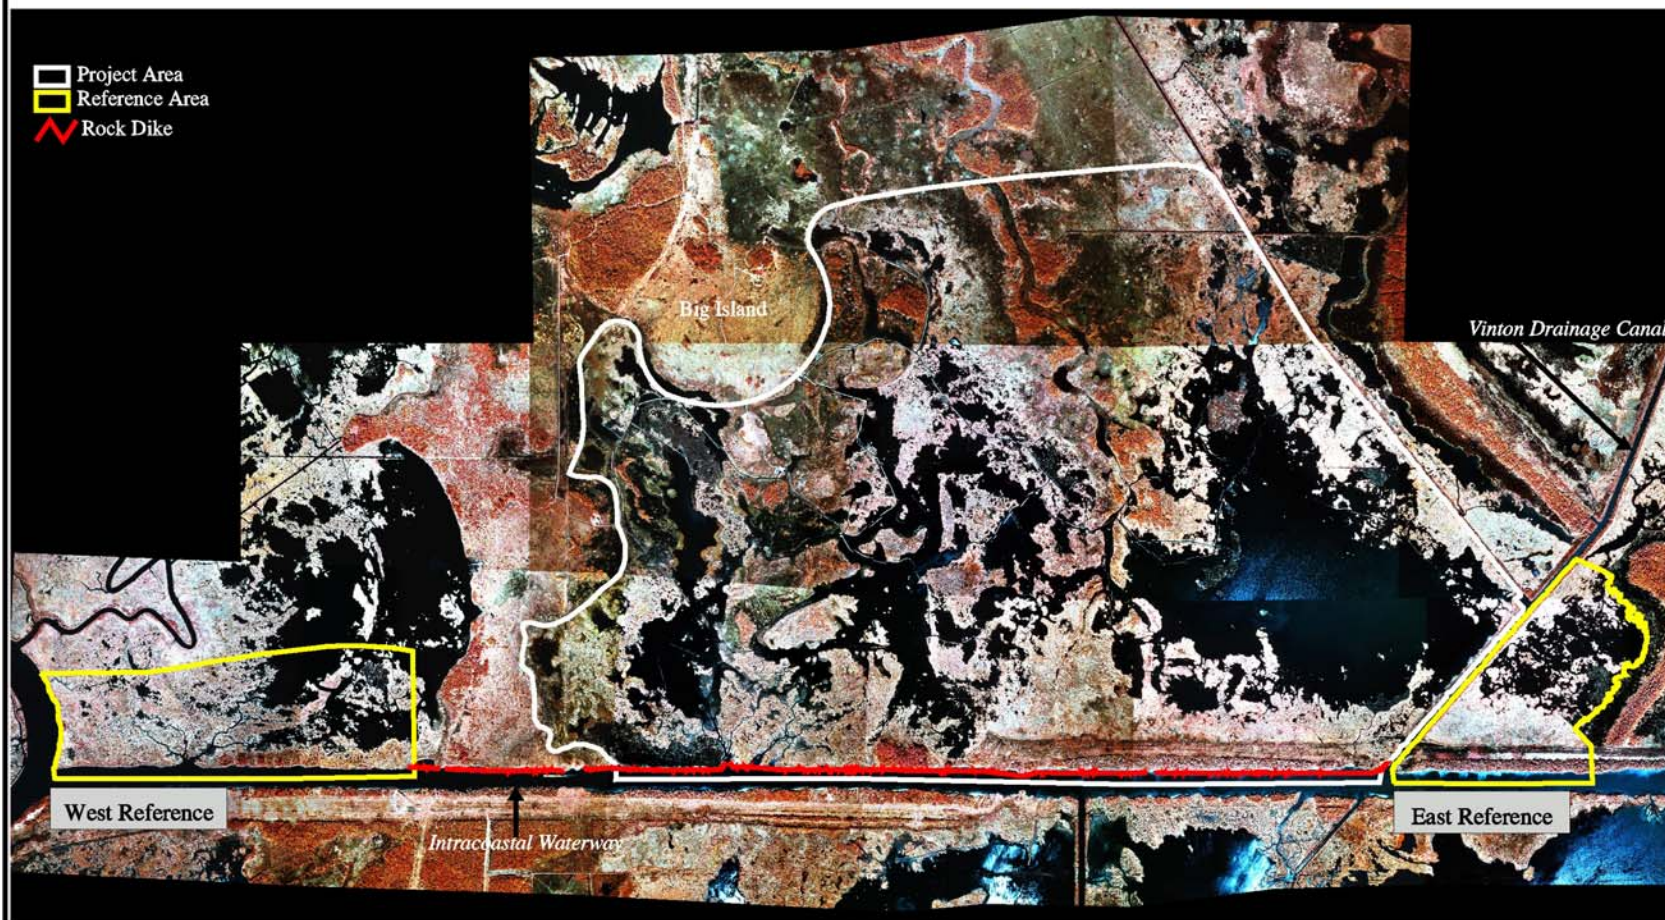
Map ID: 01-02-013

Perry Ridge Shoreline Protection (CS-24) Coastal Wetlands Planning, Protection and Restoration Act 1997 Photomosaic

Source:
The 1:12,000 color infrared aerial photography
was acquired on November 23, 1997.

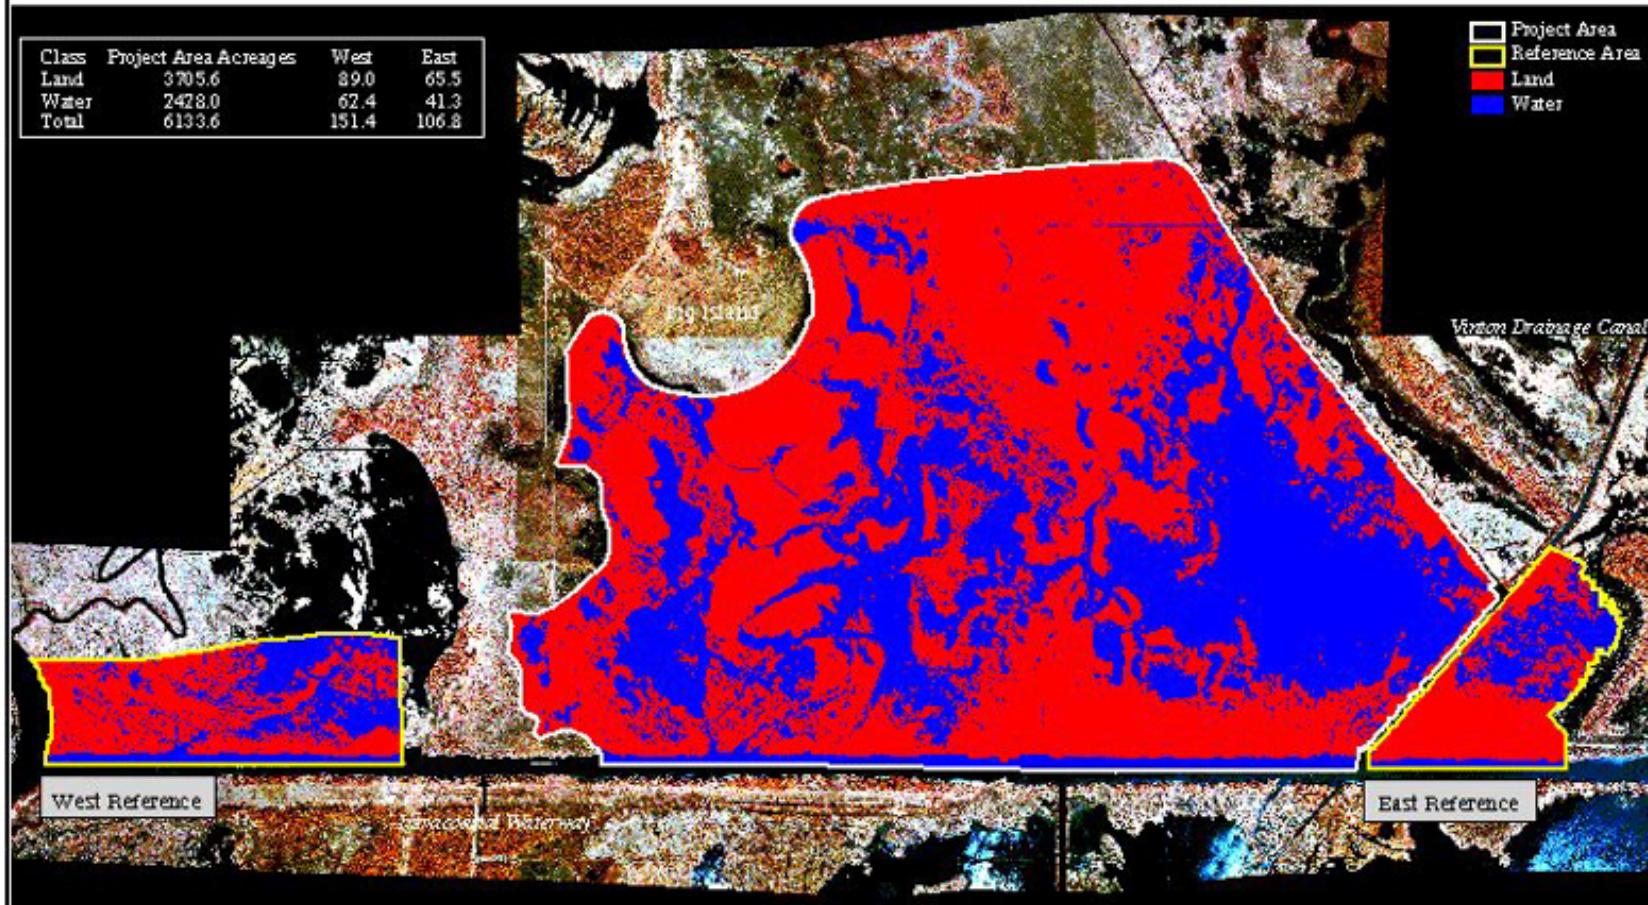
Map ID: 01-02-014

Perry Ridge Shoreline Protection (CS-24) Coastal Wetlands Planning, Protection and Restoration Act 1997 Land-Water Analyses

Class	Project Area Acreages	West	East
Land	3705.6	89.0	65.5
Water	2428.0	62.4	41.3
Total	6133.6	151.4	106.8

Source:
The land-water analyses were derived from
1:12,000 color infrared aerial photography
acquired on November 22, 1997.

- Pre-construction (11/23/97) land:water classification indicated 60.6% land and 39.4% water within the project area.
- 2001 aerial photography was collected on 11/17/2001 and is currently being processed by NWRC.

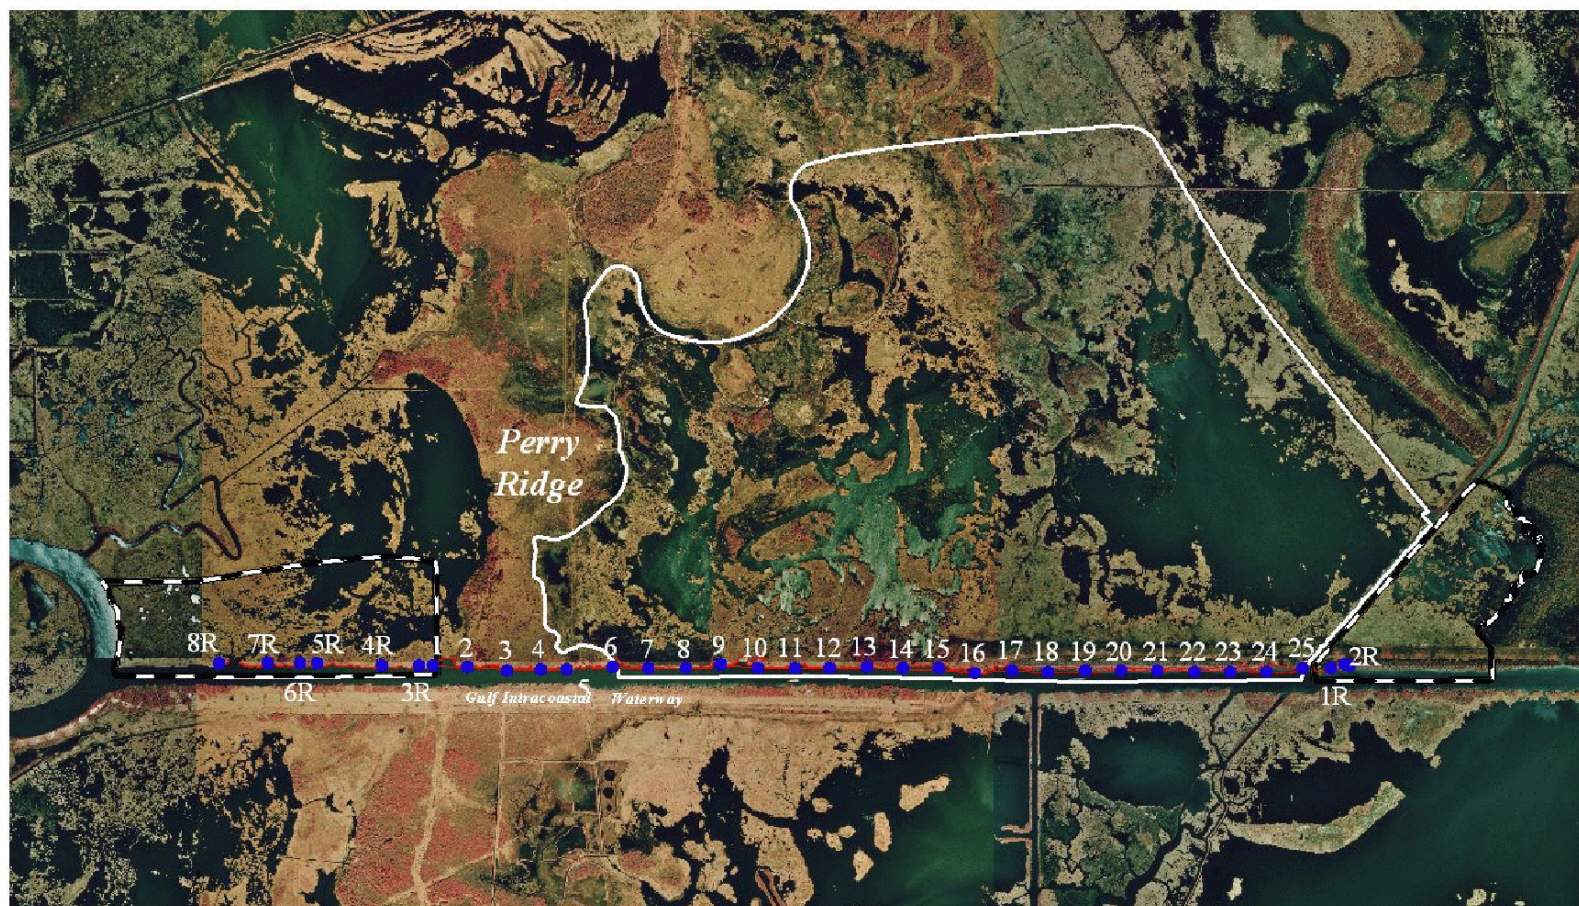
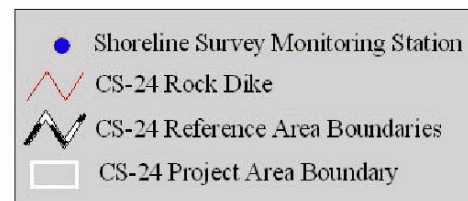
Data Source:
Louisiana Department of Natural Resources
Coastal Restoration Division
From 1998 Color-Infrared DOQQ imagery.
Map produced May 21, 2001

Perry Ridge Shore Protection (CS-24) shoreline marker station locations.

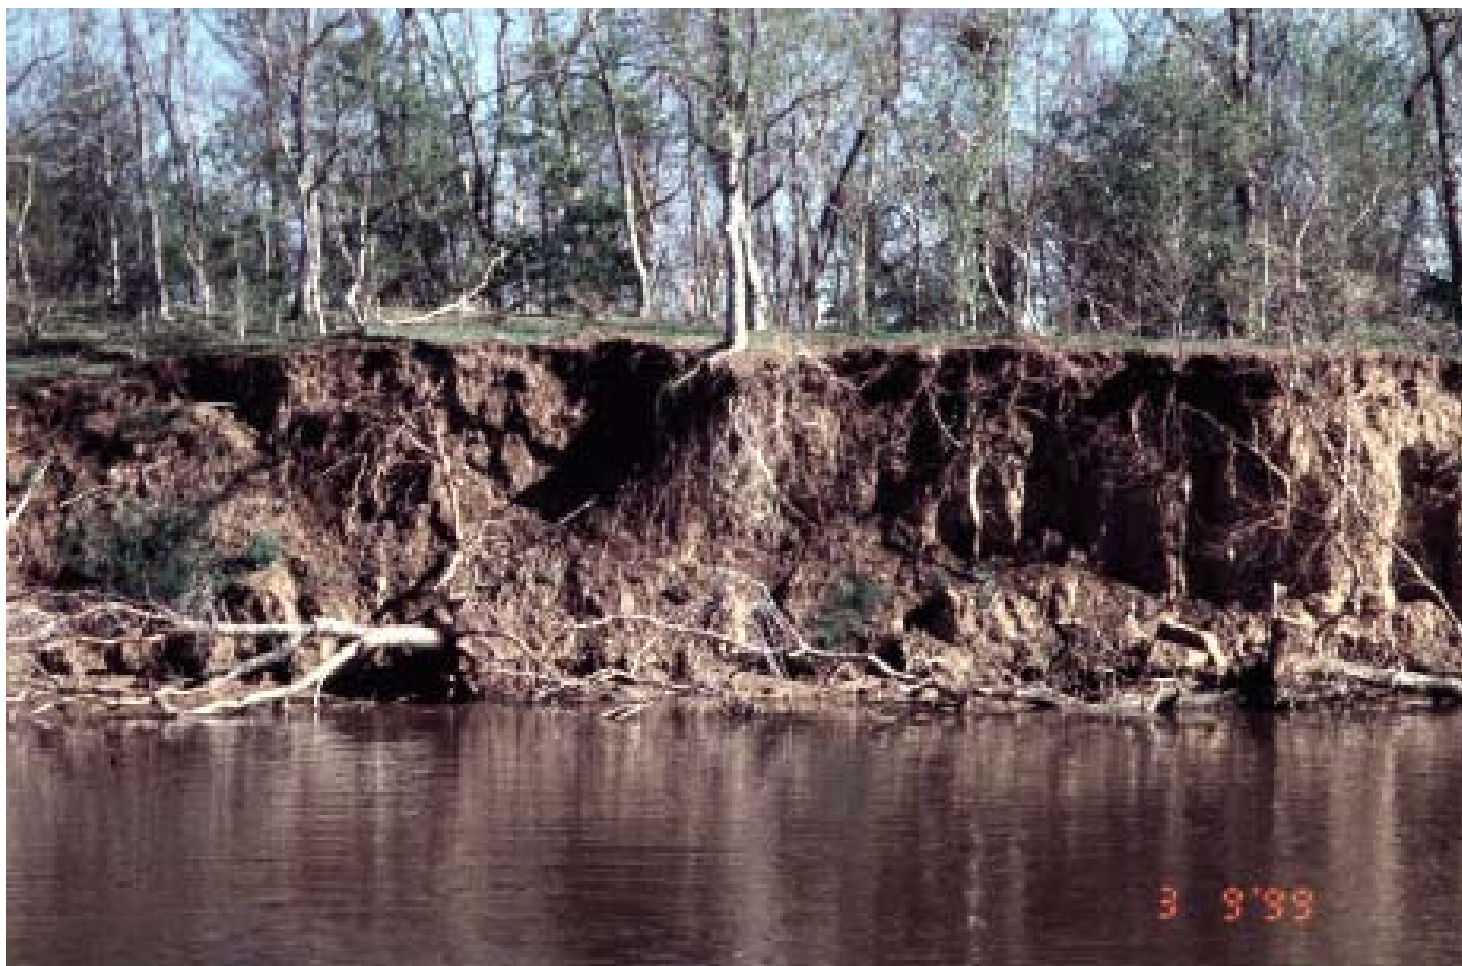
Photograph illustrating the high cut-bank along the northern shore of the GIWW within the Perry Ridge Shore Protection (CS-24) project area.

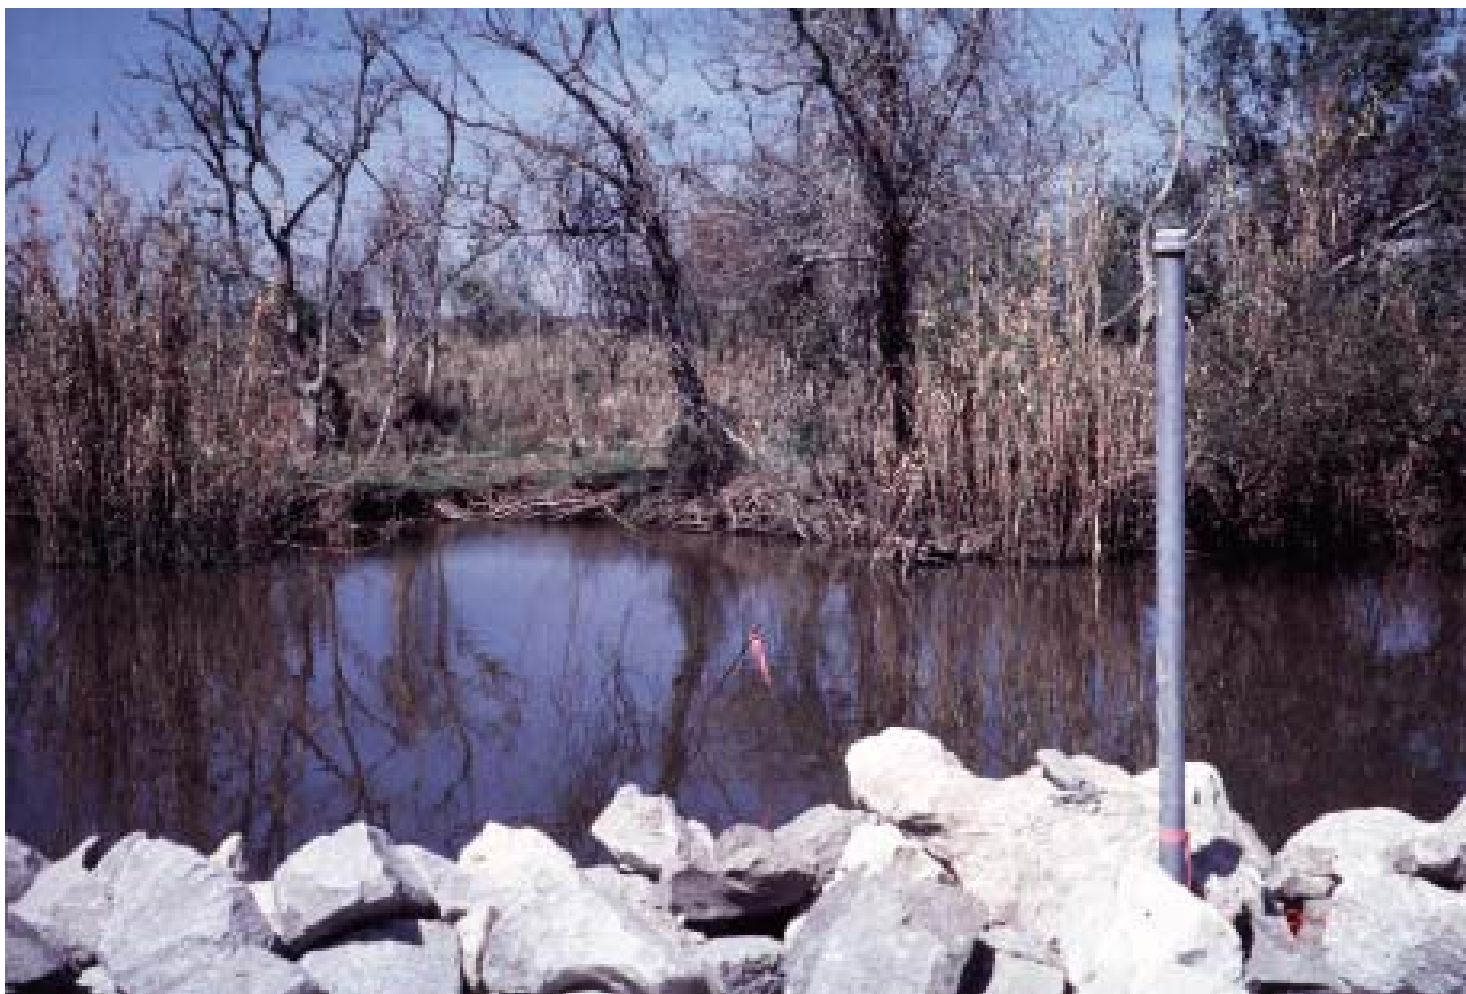
Photograph illustrating the settlement plate in the rock dike marking the shoreline survey stations within the Perry Ridge Shore Protection (CS-24) project area. Also note the fragile shoreline being protected by the rock dike. Shorelines such as this and cutbanks illustrated in the previous photo are both common within the CS-24 project area.

- Data were collected in March 1999 (as-built) and in 2001, however only the baseline data were presented. The 2001 shoreline data are currently being processed and will be presented in the next update and in the first Comprehensive Report, currently in review.
- Field observations indicate that the rock dike appears to have halted shoreline erosion within the project area. Quantitative results will be reported in the next update.
