VEGETATIVE DELINEATION REPORT
LAKE BOUDREAUX WETLAND (TE-7)

Alan Ensminger
Wetlands and Wildlife Management Co.

Chris Simon
Geoscience Specialist I
Louisiana Department of Natural Resources
Coastal Restoration Division

Delineation Date: August 12, 1992
Report Completion Date: October 19, 1993

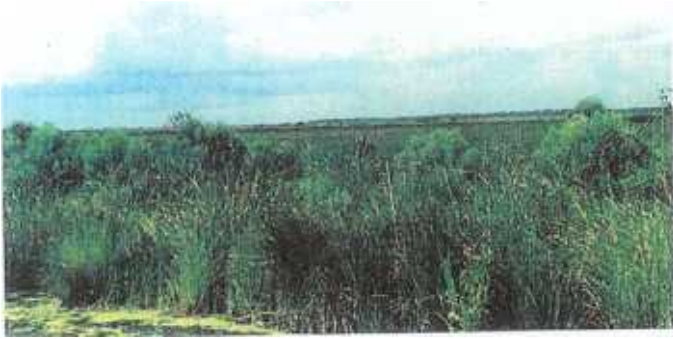
Figure 3

<u>Figure</u>	<u>Page</u>
1.	General map showing project area location
2.	Project area showing location of vegetative zones and stations
3.	A healthy brackish marsh is located along the northwest side of Lake Boudreaux near the mouth of Butler Bayou. Photo direction is to the west from station 1

ragweed (*Ambrosia artemisiifolia*), dogfennel (*Eupatorium capillifolium*), eastern baccharis (*Baccharis halimifolia*), marshelder (*Iva frutescens*), black willow, and tallowtree (*Sapium sebiferum*). Aquatic vegetation in the bayou was Eurasian watermilfoil (*Myriophyllum spicatum*), southern naiad (*Najas quadalupensis*), coontail (*Ceratophyllum demersum*), widgeongrass (*Ruppia maritima*), duckweed (*Lemna minor*), and common salvinia (*Salvinia rotundifolia*). Dwarf spikerush (*Eleocharis parvula*) was common along the edge of all waterways and ponds (figure 3).

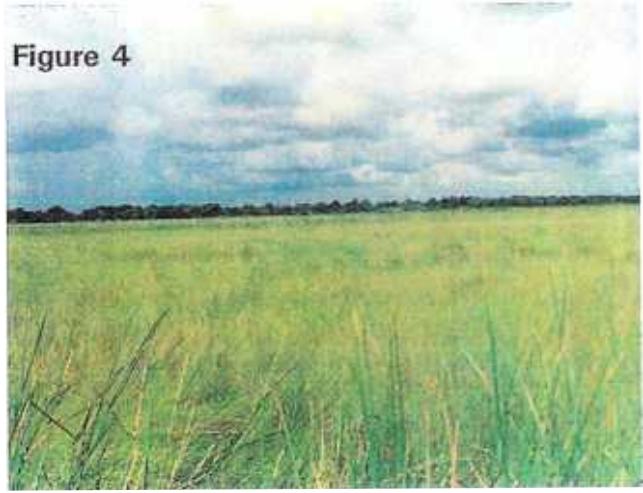
Figure 4

4.	Marshhay cordgrass is the dominate vegetation northwest of station 2. Photo direction is to the northwest
5.	Three-cornered grass was the dominate vegetation across Butler Bayou from station 2. Photo direction is to the southwest

Station 2 is along a small canal running east-northeast out of Butler Bayou. To the right of the canal, three-cornered grass was 80% and marshhay cordgrass 20%. Northwest of the station, marshhay cordgrass was 90%, three-cornered grass 5%, and baccharis 5%. Smooth cordgrass was growing along the edge of the small bayou and canal system and may have been planted during former restoration efforts in the area. Aquatic plants were coontail, widgeongrass, Eurasian watermilfoil, and duckweed. Small clumps of water hyacinth (*Eichornia crassipes*) were noted in the canal system. This marsh appears very healthy and may be in a transition from an intermediate marsh to a brackish marsh (figures 4 & 5).

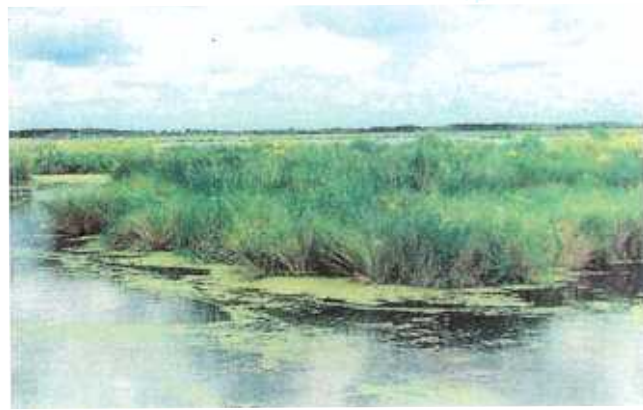
Figure 6

6.	A broken brackish marsh is adjacent to the Bayou Chauvin Canal near station 3. Photo direction is to the southwest
7.	Clumps of sawgrass are visible within the marshhay cordgrass at station 3. Photo direction is to the west

Station 3 is at a large pond area on the west side of the Bayou Chauvin canal system. Salinity was 2 ppt and vegetation was marshhay cordgrass (90%), three-cornered grass (5%), and a 5% combination of bulltongue (*Sagittaria lancifolia*), cattail (*Typha spp.*), wild millet (*Echinochloa walteri*), sawgrass (*Cladum jamaicense*), marshmallow (*Hibiscus lasiocarpus*), and belle dame. Small clumps of alligatorweed (*Alternanthera philoxeroides*), sedge (*Carex spp.*), pennywort (*Hydrocotyle umbellata*), cutgrass, and smooth cordgrass were located along the edge of the canal and spoilbank (figures 6, 7, 8, & 9).

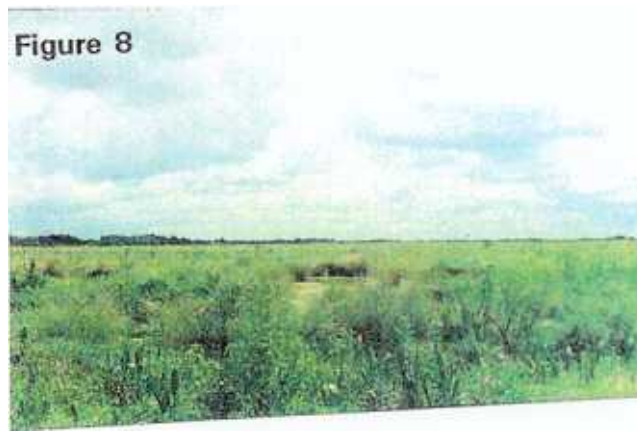
Figure 8

8.	The marsh on the east side of the Bayou Chauvin Canal is a broken brackish marsh. Photo direction is to the northeast
9.	A small trapping access ditch enters Bayou Chauvin Canal from the east near station 3. Photo direction is to the north

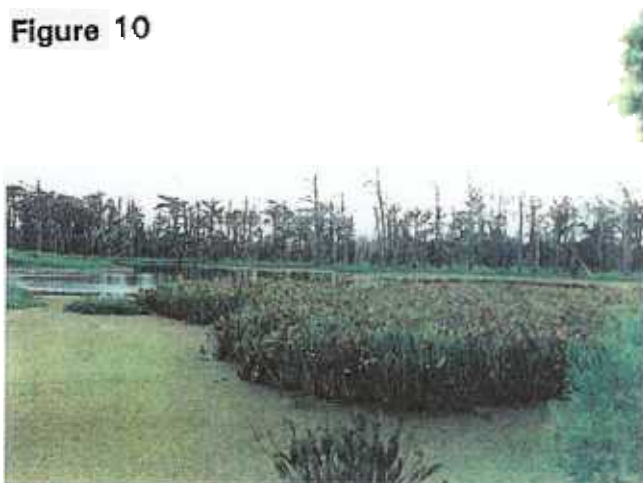
Figure 10

10.	Station 4 is located near the edge of the cypress swamp. A large number of trees have been killed by saltwater intrusion. Photo direction is to the north

Station 4 is at a Fina-LaTerre property line near an oil and gas well site. Water salinity at this station was 1 ppt. A large stand of dead cypress trees is located north of this station. Bulltongue was 90% and alligatorweed and sensitive jointvetch (*Aeschynomene indica*) were 5% of the plant community. Belle dame, wild millet, coffeeweed (*Sesbania macrocarpa*), and goldenrod

(*Solidago sempervirens*) were common in the marsh and along the levee system at this station. Water hyacinth mats were more common in the waterways and common salvinia had formed dense mats in the pond area and may be a pest plant because of its poor quality as a wildlife food plant (figures 10, 11, & 12).

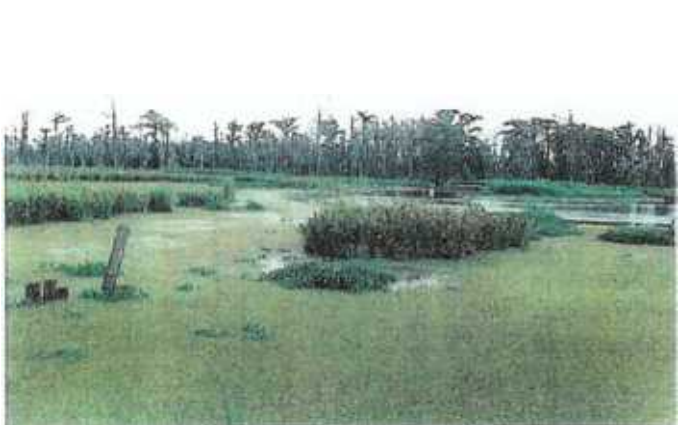
Figure 11

11.	Large ponds have developed near the edge of the cypress swamp. Common salvinia has covered many ponds and may be a pest plant due to it's poor value as a food plant for wildlife. Photo direction is to the north

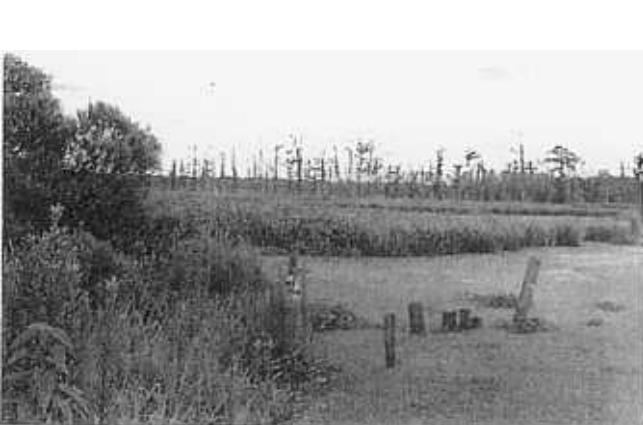
Figure 12

12.	Bulltongue was the dominate vegetation at station 10. Photo direction is to the west
13.	At station 5, dead waxmyrtle trees were common on the floating marsh. Waterhyssop was the dominate marsh surface vegetation. Photo direction is to the north

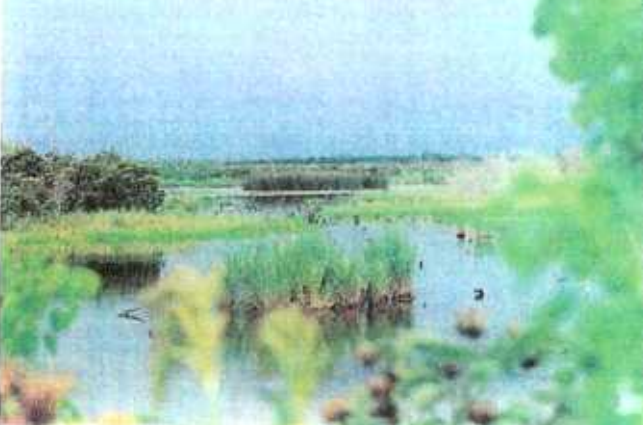
Figure 14

14.	Broken marsh at station 5 provide good quality habitat for waterfowl. Clumps of bullwhip are found throughout this section of the study area. Photo direction is to the northwest

Station 5 is on the north side of an east-west mineral canal where a large stand of waxmyrtle is showing extensive stress and an estimated 60% of the trees are dead. Water salinity was 2 ppt. The pond next to the waxmyrtle stand was covered with waterhyssop, and clumps of bullwhip (*Scirpus californicus*) are in the interior of this section (figures 13 & 14).
