Monitoring Series No. CS-18- MSTY-0801-2

COMPREHENSIVE REPORT NO. 2
For the period January 28, 1998 to June 27, 2001

**SABINE REFUGE PROTECTION
CS-18 (CS-18)**

**First Priority List Shoreline Protection Project
of the Coastal Wetlands Planning, Protection, and Restoration Act
(Public Law 101-646)**

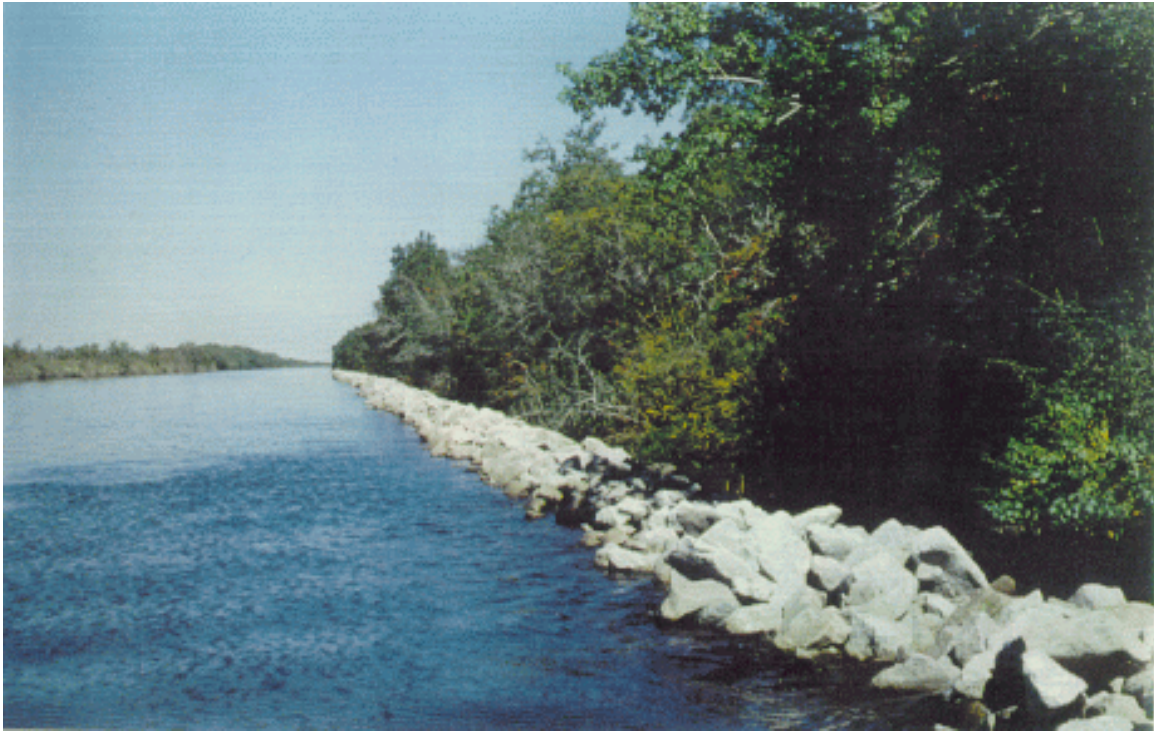
Figure 2. Photograph of the Sabine Refuge Protection (CS-18) project following construction in August 1995, illustrating the shoreline of the impoundment and the installed rock breakwater. Photograph faces north along the eastern bank of the BSC.

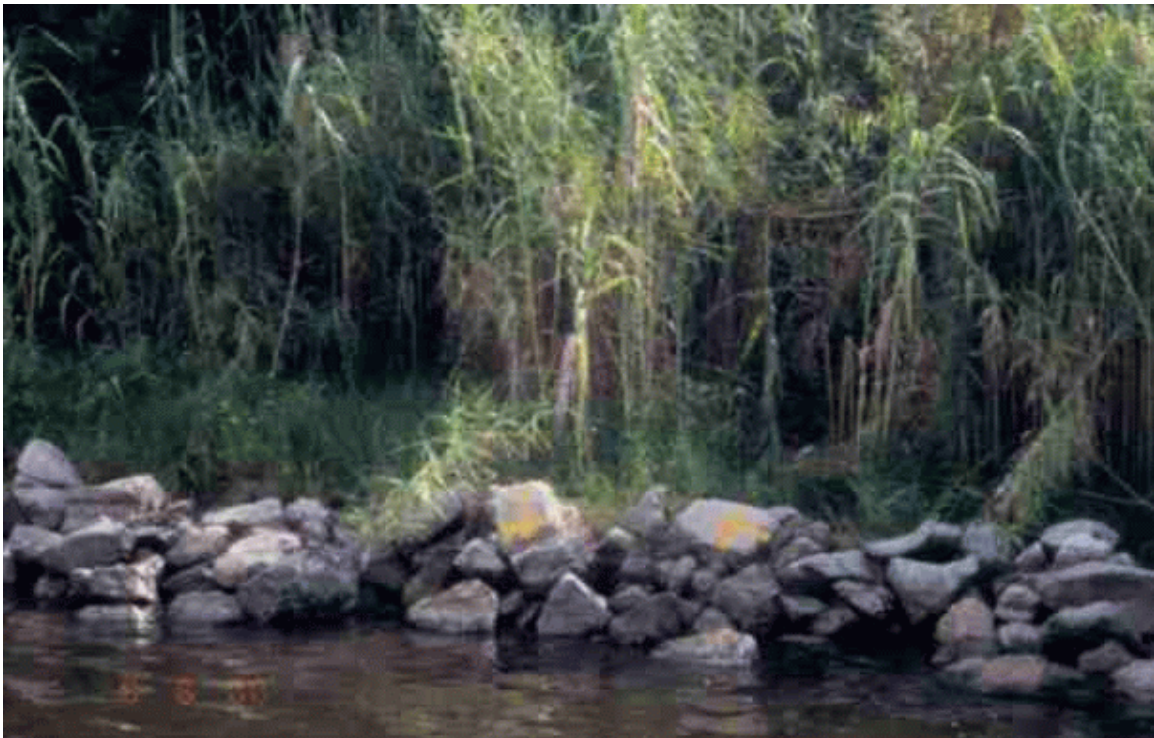
Observations while at the project site and data collected during the shoreline surveys demonstrate that the integrity of the west bank of the SNWR Impoundment No. 3 has been maintained and the freshwater vegetation within the impoundment has been preserved (Louisiana Department of Wildlife and Fisheries, Fur and Refuge Division and USGS/NWRC 1997). The results of the shoreline surveys indicated no significant difference in shoreline change rates between the project and reference areas. This is important because, not only did the project and reference areas exhibit the same shoreline change rates, both showed minor amounts of shoreline advance. This is contrary to the assumption that the lack of any significant difference in shoreline change rates between a project and reference area usually indicate negative effects of the project. According the survey results, this is clearly not the case. It is important to note that the shoreline advanced observed, as well as any future advance, is expected to be restricted to the area behind the rock breakwater in the project area. The impoundment levee appears to be stable and the rock dike seems to be in good condition at this time, according to observations made by CRD personnel in 1997 and 2000. No breaches of the levee were found (figure 7).

Figure 7. Photograph of the Sabine Refuge Protection (CS-18) project 5 yr following construction in August 2000, showing shoreline advance to the rock breakwater at one of the project stations.

The goals and objectives of the monitoring plan appear to have been met thus far. The project has been effective in preventing saltwater intrusion into the SNWR impoundment number 3. The BSC has not compromised the levee and freshwater vegetation remains dominant in the impoundment. Extensive levee erosion has not been observed during active monitoring of this project. Additionally, little change was observed in the shoreline position of the unprotected reference area. Scheduled shoreline change surveys (for years 2005, 2010, and 2014), and comprehensive monitoring reports for years 2006, 2011, and 2015 will be completed and will provide further monitoring documentation for this shoreline protection project. Future inspections of the project area by CRD engineers will be conducted at regular intervals to document the condition of the rock breakwater and any required maintenance.
