## EAST MUD LAKE (CS-20)

### I. INTRODUCTION

#### I.1. Project Description

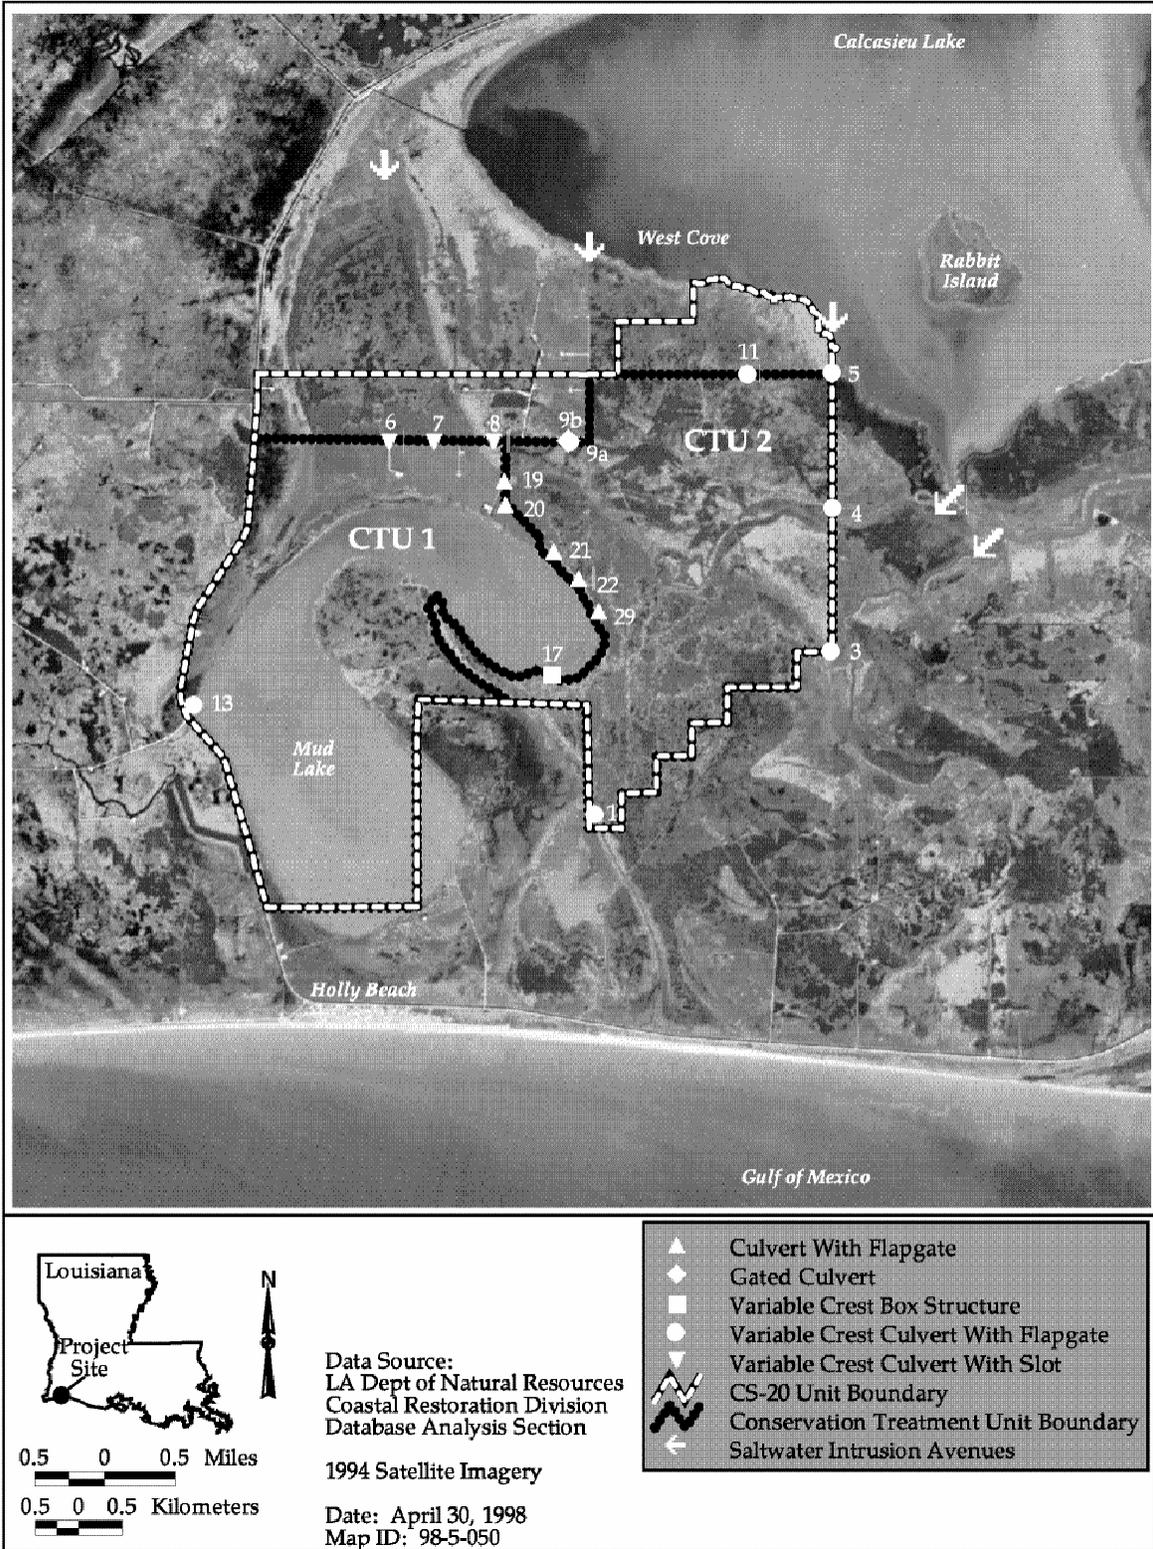
Figure 1. Location and features of the East Mud Lake Marsh Management Project (CS-20).

The project area is bounded by an access canal and the southern tip of Mud Lake to the south, Highway 27 to the west, Magnolia Road to the north and an existing levee and property line near Oyster Bayou to the east (figure 1).

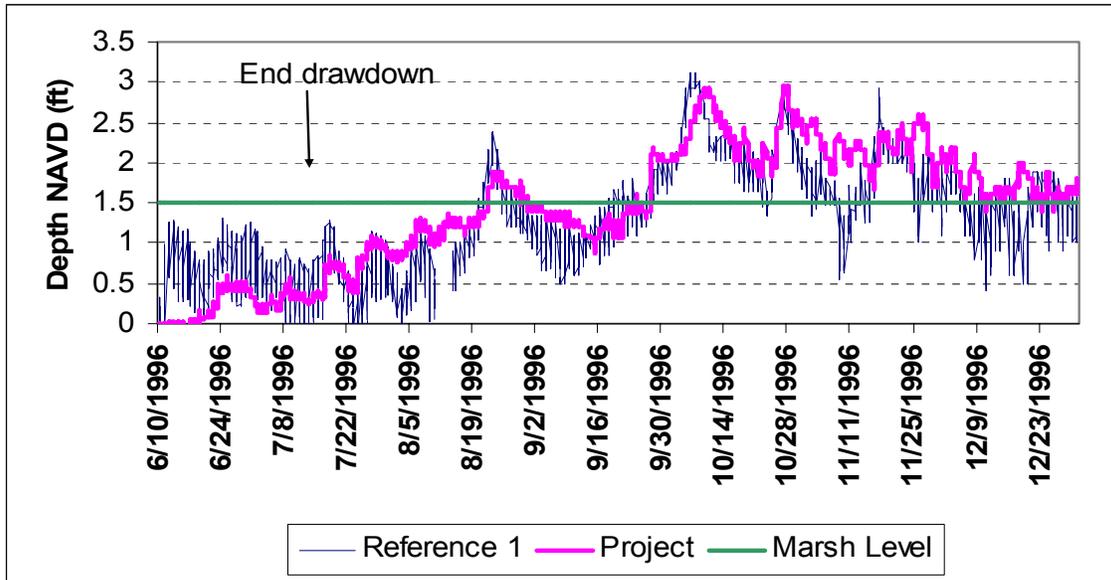
Figure 2. Water levels in the project and reference areas showing the extreme drought followed by inundation of saline water in 1996.

Target range for water levels is six inches below marsh level to two inches above marsh level, which will support healthy brackish marsh vegetation. Water levels were low for a large percentage of the post-construction period due to two consecutive drawdown years (1996 and 1997) and three consecutive dry years (1996-1998). In 1996, the most severe drought in 20 years lasted for six months, causing drying contraction, and compaction of the soil surface in the project area. At this time water levels were too low and water was not let into the project area due to high salinities, often above 20 ppt. Following the drought, tropical storms caused flooding with water remaining on the marsh for three months at high salinities (Figure 2).

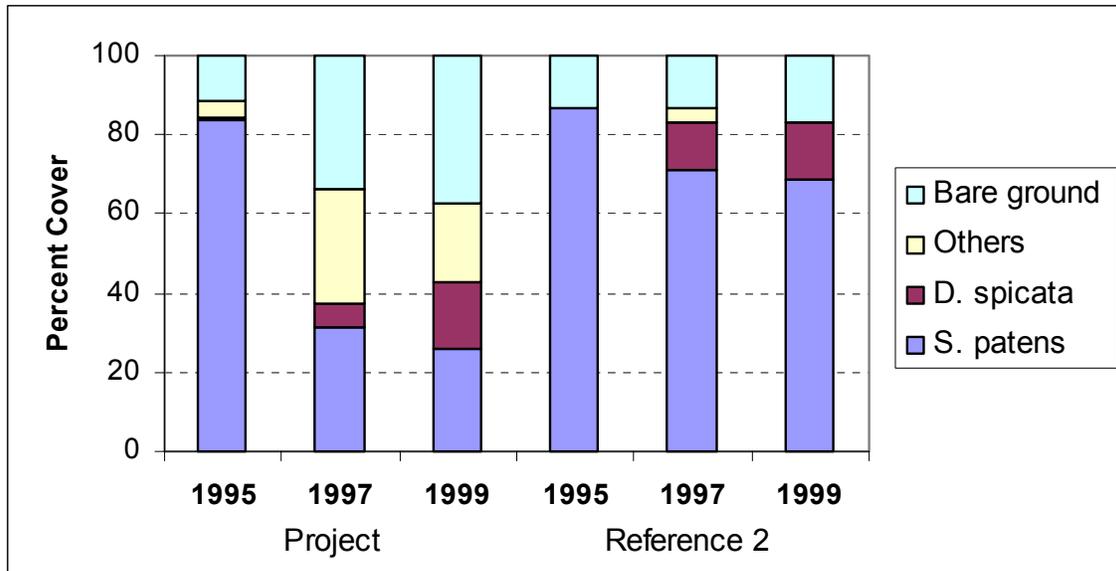
Figure 3. Change in vegetative cover of the project and reference sites from 1995 to 1999.

Cover of *S. patens* had decreased dramatically from 1995 to 1997 in the project area (Figure 3) from a combination of drought stress, high soil salinity followed by three months of flooding conditions. As cover values of dominant species decreased, opportunistic species such as *Acnida australis*, *Cyperus odoratus*, and *Aster subulatus* increased. Overall species diversity was higher in the project area. A gradual increase of *Distichlis spicata* has occurred. As *S. patens* decomposes, it provides organic matter for other species. The project area did experience an increase in *Paspalum vaginatum* from colonization of pond edges after 2 consecutive drawdown years. In some areas, extending 10-12 feet into existing ponds.
