**Coastal Protection and Restoration
Authority of Louisiana
Office of Coastal Protection and
Restoration**

**2008 Operations, Maintenance,
and Monitoring Report**

**NAOMI OUTFALL
MANAGEMENT**

State Project Number BA-03c
Priority Project Lists 5

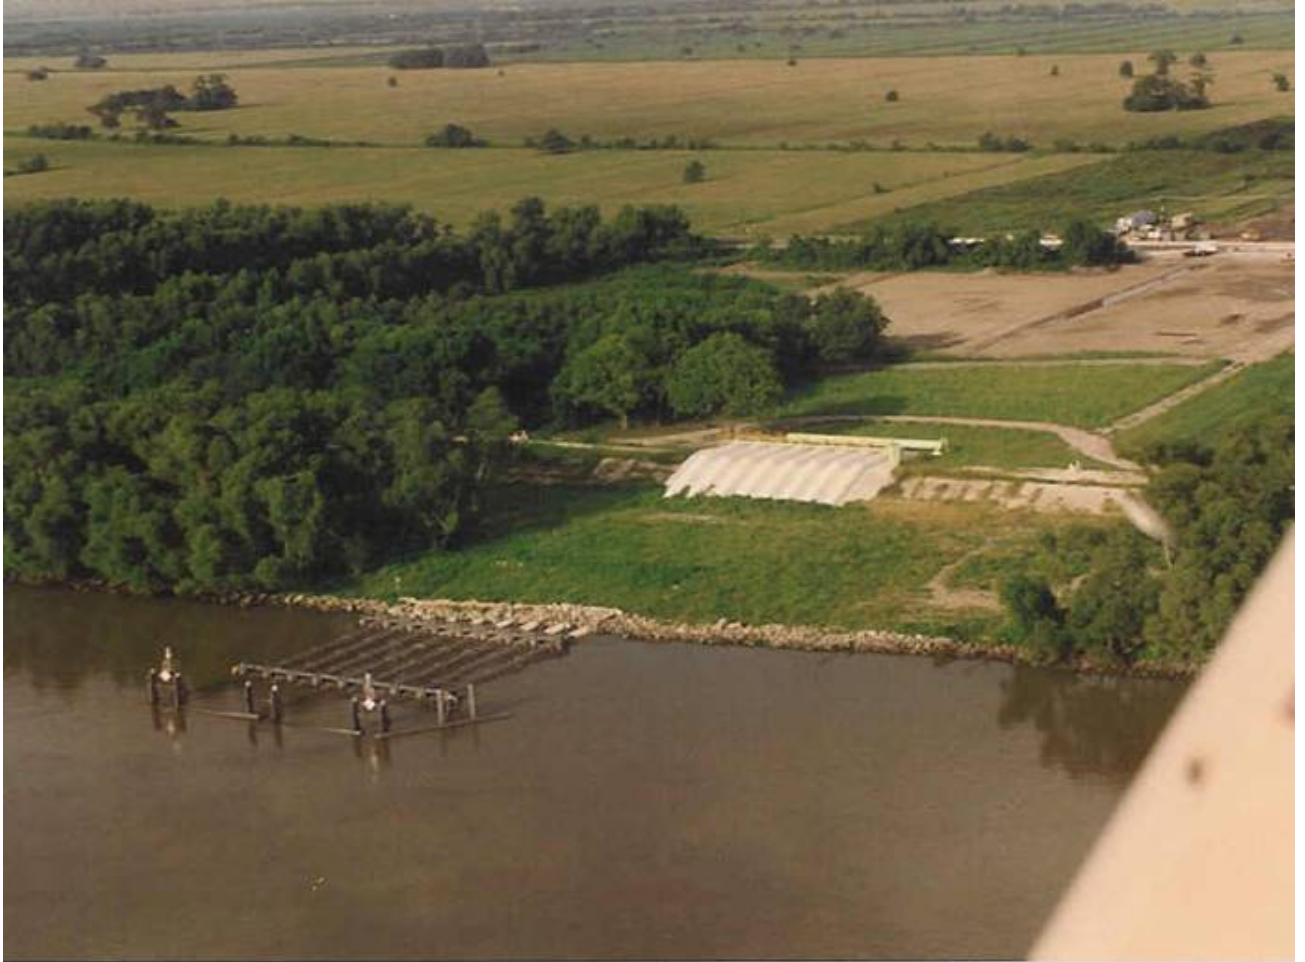
Figure 1. Siphons constructed in 1992 as part of the Naomi-Siphon Diversion (BA-03) project and funded by the state of Louisiana. Mississippi River water is siphoned from the river intakes, discharged into a ponding area, and distributed through a single channel into the surrounding marshes.

In 1992, the state-funded Naomi- Siphon Diversion (BA-03) project was built to re-introduce (or divert) freshwater from the Mississippi River into the adjacent marshes through a set of eight siphons (Figure 1). The freshwater re-introduction was intended to restore some of the ecological functions supported by periodic over-bank flooding that occurred prior to the placement of the flood-control levee system. In order to manage freshwater from the diversion and to protect the area marshes from shoreline erosion and saltwater intrusion, the CWPPRA-funded Naomi Outfall Management Project (BA-03c) and the Barataria Bay Waterway East Bank Protection Project (BA-26) were completed in 2002. Monitoring of the state-funded BA-03 project was expanded in 1997 to include both the BA-03c and BA-26 project areas because they were adjacent to one another. Thus, for monitoring purposes, all three projects are combined into one project and will be referred to in this report as the Naomi Outfall Management project. All references to “project area” will refer to the unified area of all three projects. Although the three projects are combined for monitoring purposes, the BA-26 inspection reports along with the description of its features and maintenance budgets will remain separate.

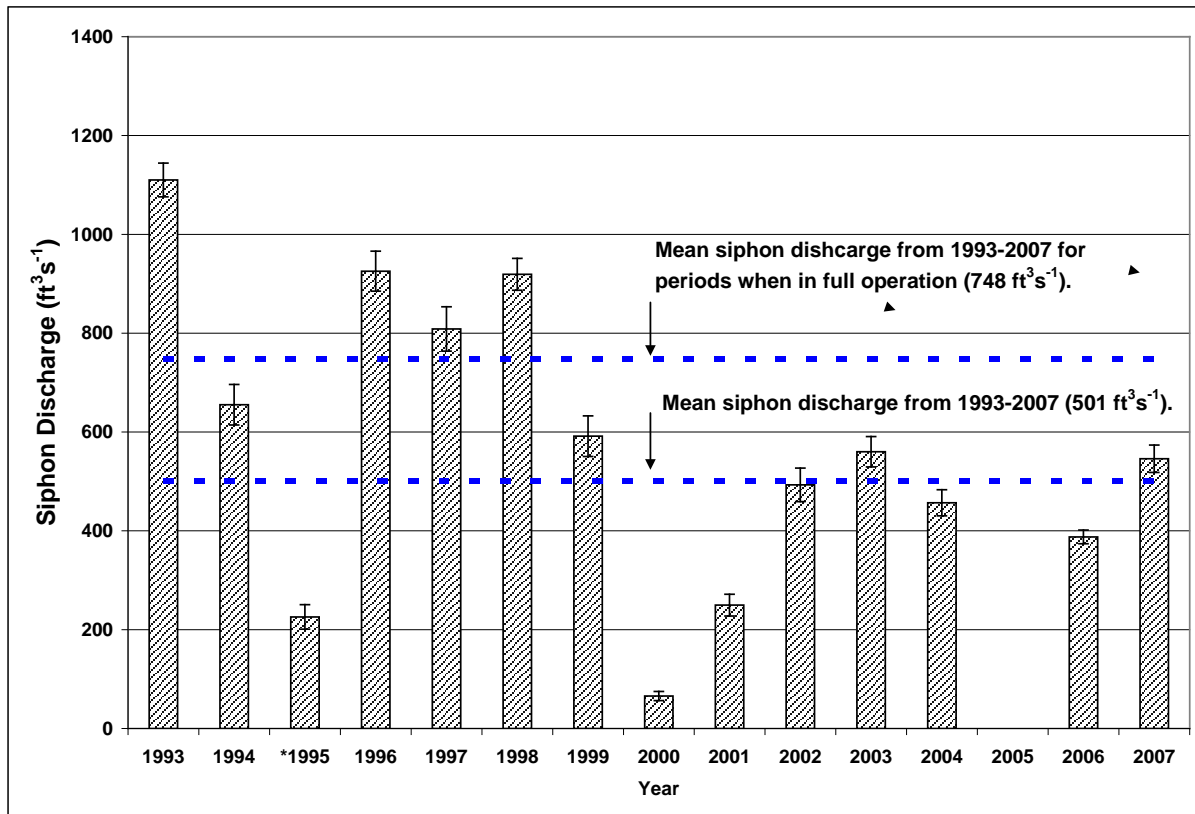
Figure 3. Yearly mean (\pm SE) siphon discharge for the Naomi Outfall Management (BA-03c) project from 1993 to 2007. Dotted lines represent mean discharge through 2007 when siphons were in full operation. Daily siphon discharge was estimated from the Mississippi River gauge at Alliance LA, the immediate staff gauge in the outfall area, and the number of siphons in operation. *Siphons were limited in operation during 1995 (operations), 2000 (drought), and 2005 (Hurricane Katrina).

The siphons are capable of a maximum discharge of $2,144 \text{ ft}^3\text{s}^{-1}$ with the optimum river stage and uninterrupted operation. However, from 1993 through 2007 the structure was only in operation 74% of the time. Discharge averaged $748 \text{ ft}^3\text{s}^{-1}$ when fully operational (i.e. all eight pipes), and $501 \text{ ft}^3\text{s}^{-1}$ over the entire period, including times of no flow (Figure 3). In addition, siphon flow varied each year due to limited operations, seasonal low river stages, and droughts. When the Mississippi River gauge in Alliance, LA dropped below 1.5 feet NAVD88 the siphons began to lose prime and were rendered inoperable. Additional obstacles to operation were: marine fisheries, tropical storms, oil spills, maintenance problems, and staffing limitations within PPG.

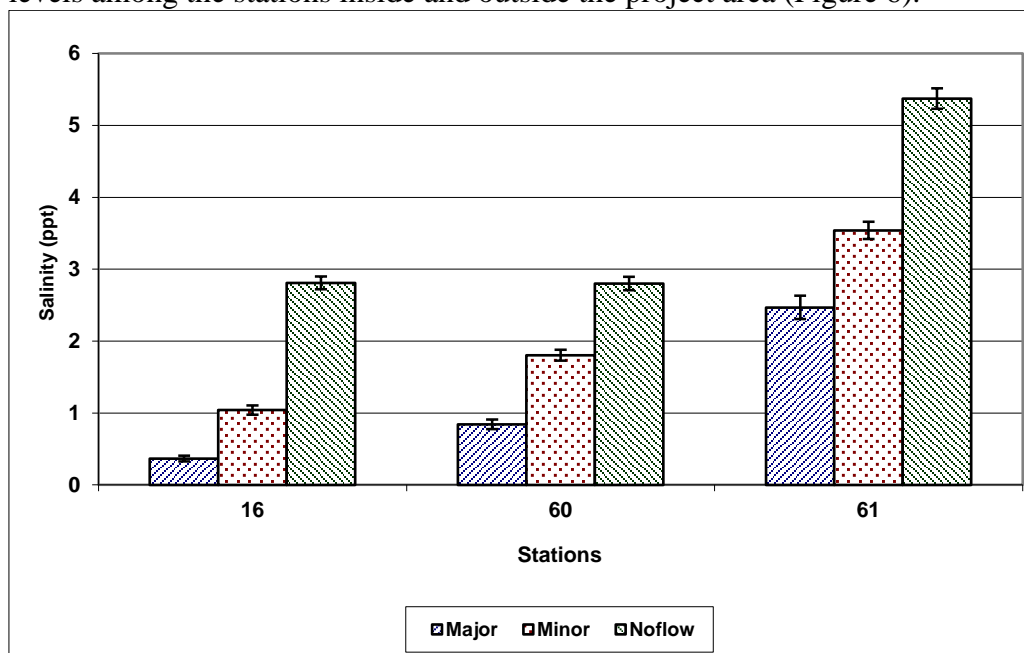
Figure 4. Naomi Outfall Management (BA-03c) Project mean (\pm SE) salinity for the period 1999 to 2007 for 3 operational categories at YSI continuous recorder stations (major discharge $>1,072 \text{ ft}^3 \text{ s}^{-1}$; minor discharge $>0, <1,072 \text{ ft}^3 \text{ s}^{-1}$; no flow = $0 \text{ ft}^3 \text{ s}^{-1}$).

Mean daily salinity measured at the three continuous recorders was lower during periods when all siphons were in either major or minor operation (vs. no-flow), indicating that the siphons are capable of reducing salinity in the project area (Figure 4). However, salinity during these periods was influenced by factors other than siphon operation, particularly normal seasonal variability within the Barataria Basin (Swenson and Swarzenski 1995; Wiseman et. al. 1990). For example, salinity is generally lowest throughout the Barataria Basin during the spring which corresponds to the period of highest flow for the Mississippi River. During a drought from September 1999 to December 2000, mean yearly salinity levels in the project area increased greatly, while siphon operation decreased substantially due to low river stage. This occurred again in 2005 following Hurricane Katrina (Figure 5). Since siphon operation is a function of river stage, the ability to control salinity during drought or normal low river stages (e.g. late summer and fall) was limited. Pre-construction salinity levels were higher than post-construction levels at all continuous recorders. Therefore, the percent change were compared at each continuous monitoring station within the project to the reference salinity measured at station BA01-10, a Barataria Bay Waterway station, figure 2, located outside the project. The percent change between pre and post data for stations 16, 60, 61 and 10 among stations were 46%, 48%, 44% and 46% indicating little difference for pre and post salinity levels among the stations inside and outside the project area (Figure 6).

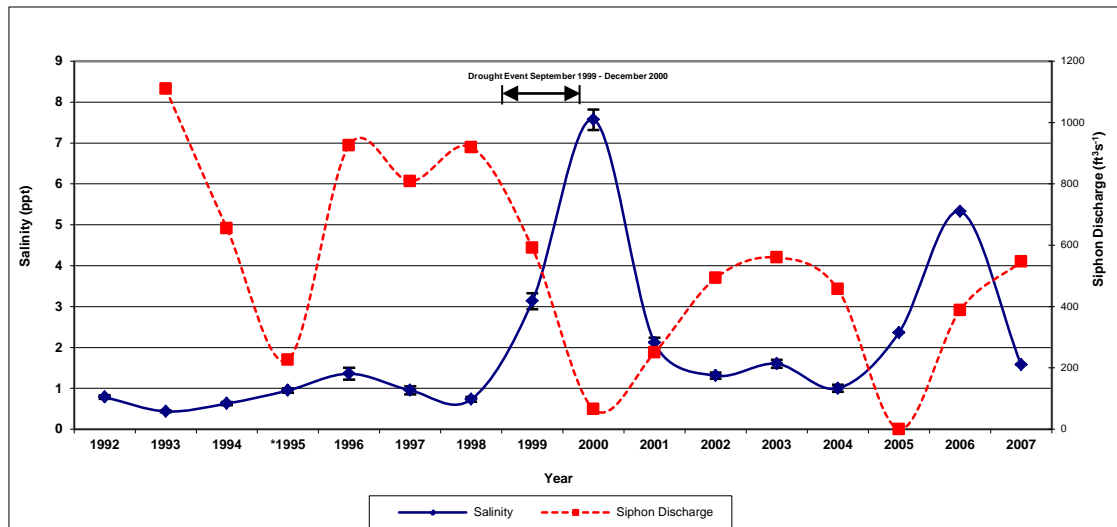
Figure 5. Naomi Outfall Management (BA-03c) Project yearly mean (\pm SE) salinity and siphon discharge. Salinity was measured at 16 discrete monthly hydrologic stations for the period 1992 to 2003 and at 24 stations from 1999 to 2007. *Siphons were not operational for 9 months during 1995.

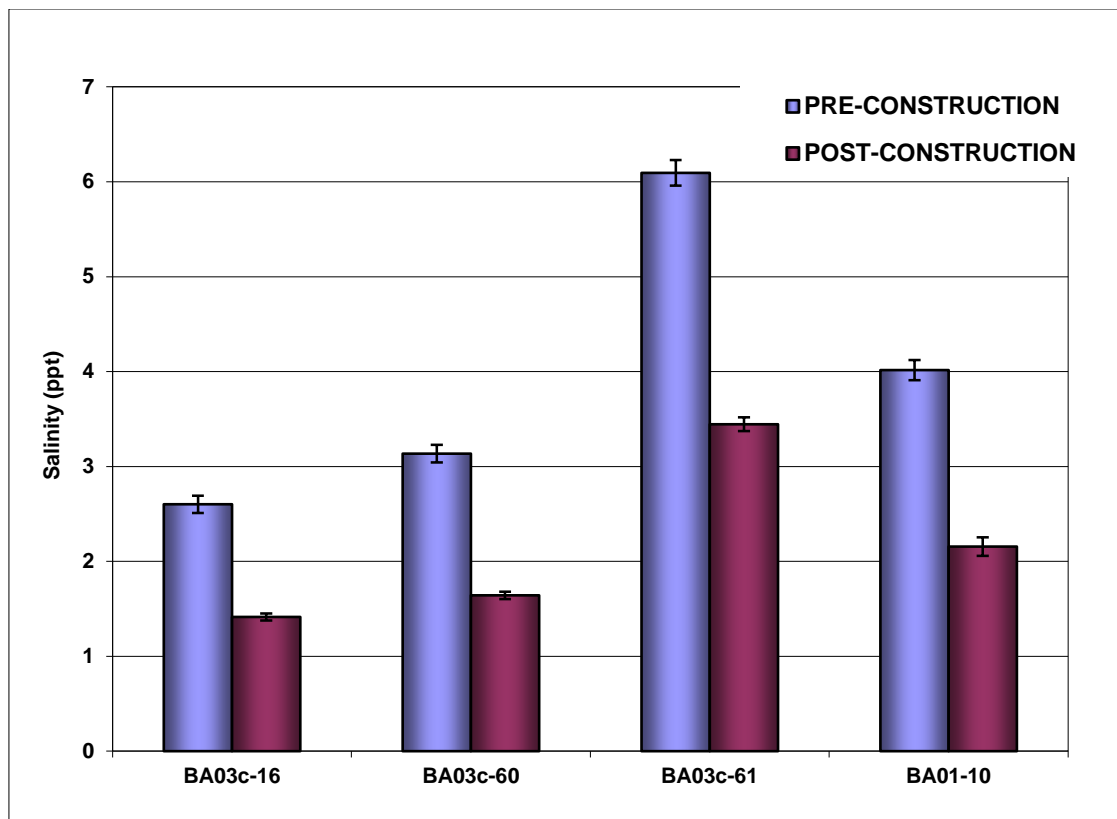
Figure 6. Naomi Outfall Management (BA-03c) Project mean daily salinity during pre-construction (05/01/1999 to 08/15/2002) and post-construction (08/15/2002 to 12/31/2007) for project and reference (BA01-10) stations.

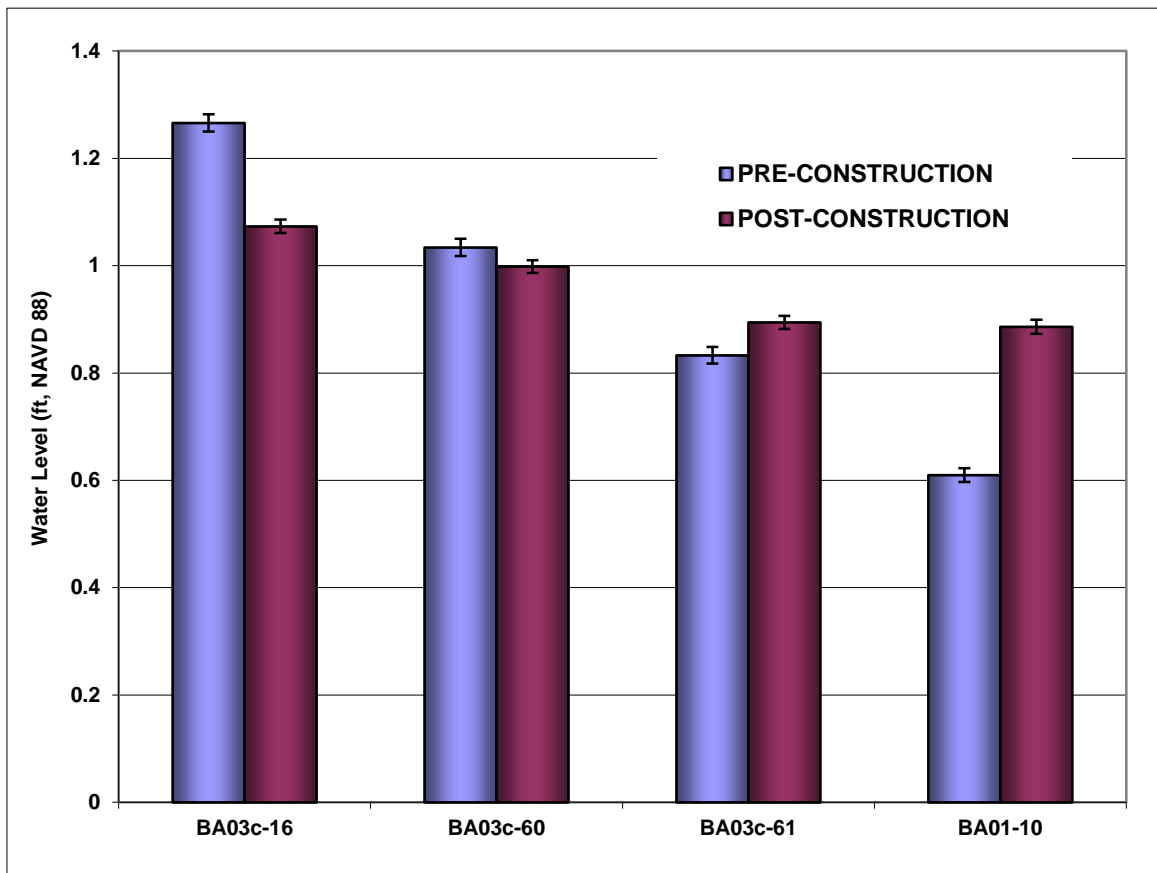
Figure 7. Naomi Outfall Management (BA-03c) Project mean monthly water levels during pre-construction (05/01/1999 to 08/15/2002) and post-construction (08/15/2002 to 12/31/2007) within the project and reference areas.

Hourly water levels indicated that water levels changed very little between the pre- and post-construction periods. The difference between mean pre-construction and post-construction water levels at station 60 and 61, the stations farthest from the diversion, was ≤ 1 inch, while that of stations BA01-10 (the reference station) and 16, the stations closest to the diversion, was 2.3 and 3.3 inches (Figure 7).

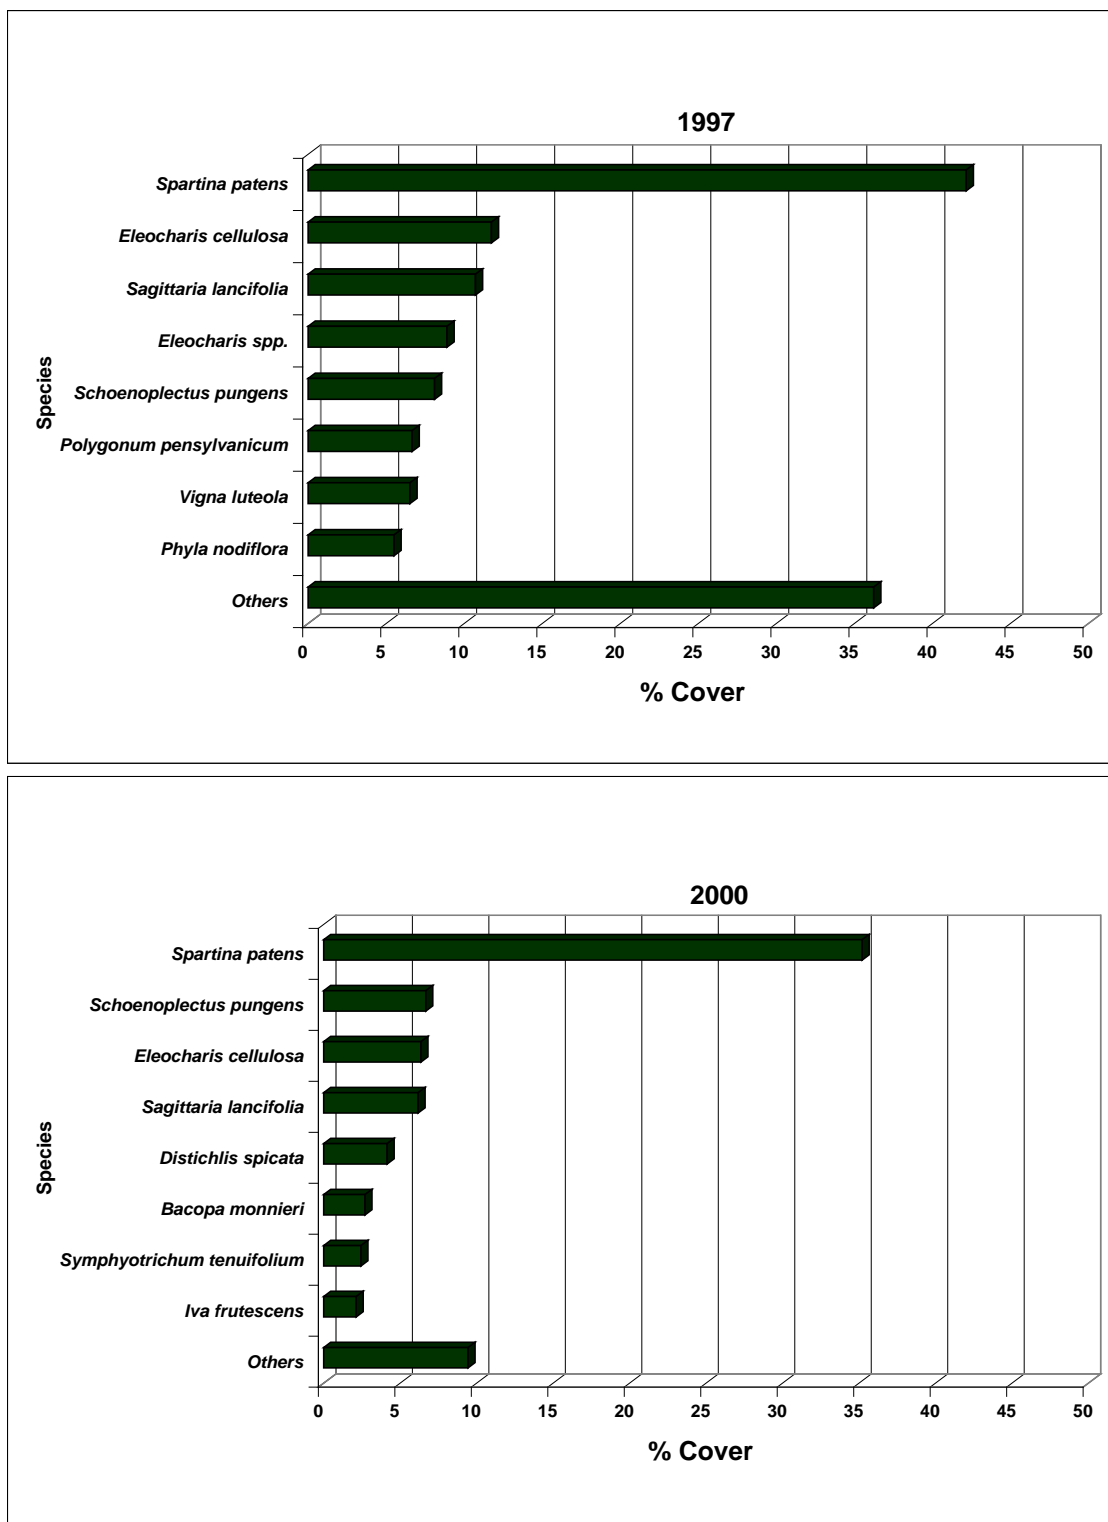
Figure 8. Mean percent cover of dominant vegetative species across all 4m² plots during the 1997 and 2000 (pre-outfall structure construction) vegetation surveys in the Naomi Outfall Management (BA-03c) project area.

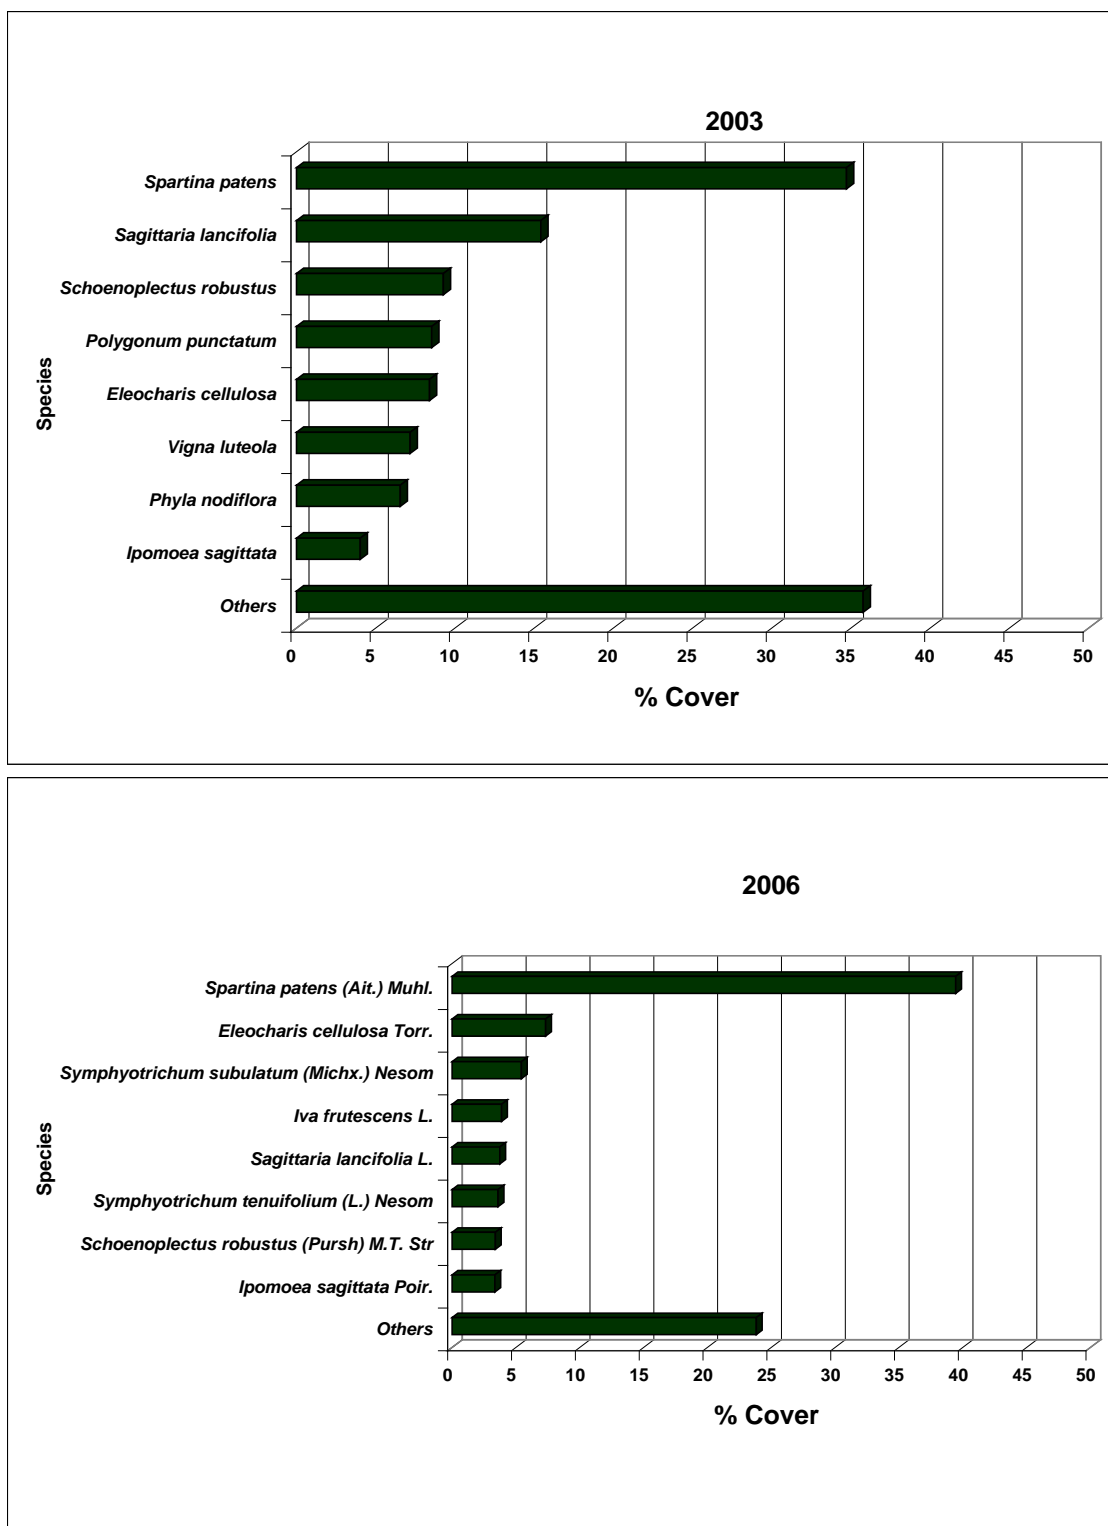
Figure 9. Mean percent cover of dominant vegetative species across all 4m² plots during the 2003 and 2006 (post-outfall structure construction) vegetation surveys in the Naomi Outfall Management (BA-03c) project area.

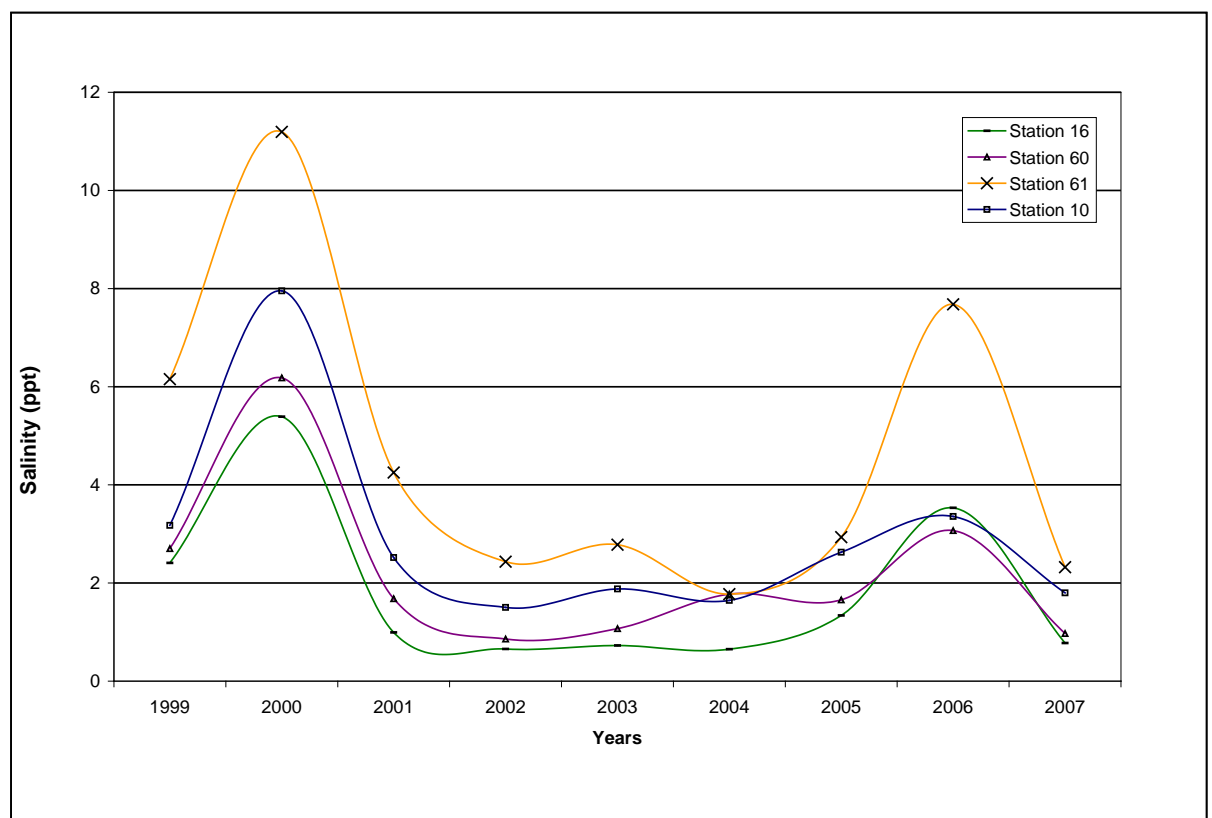
Figure 12. Yearly mean salinity within the BA-03c Naomi Outfall Management project. Salinity was measured hourly at three hydrologic stations within the project and at one hydrologic station outside the project (BA-10 reference) from 1999 to 2007.

Freshwater introduced by the siphons as a part of the state/PPG funded Naomi- Siphon Diversion (BA-03) project reduced salinity in the project area when the siphons were operated. However, the full potential benefit of the siphon was not realized because of various operation limitations. Some evidence was found to suggest that the outfall management structures associated with the Naomi Outfall Management (BA-03c) project had an effect on reducing the mean project salinity. Salinity was usually lower in the project area at the northern continuous recorder stations 16 and 60 than at the reference site, station BA01-10 (figure 12). These structures were designed to: 1) retain freshwater from the diversion and direct it south and 2) cut off inflow of saltwater from the Barataria Bay Waterway.

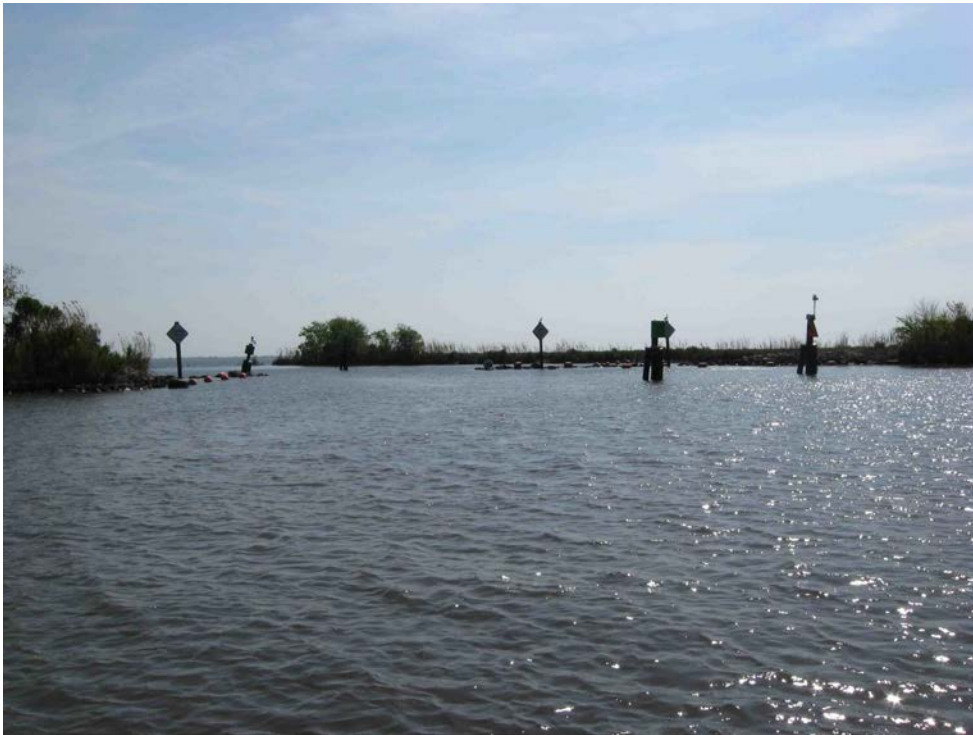
Photo #1 – The Bayou Dupont Canal Weir, approaching the structure from the Barataria Waterway, looking toward the Pen.

Item	Condition	Physical Damage	Corrosion	Photo #	Observations and Remarks
Rock Riprap	Good	None	N/A	#1	
Creosote Piling	Fair	None	None	#1, 2	Some damage to pile clusters
Warning Signs and Day Board Navigation Signs	Fair	None	None	#1, 2	
Navigation Aid Lights	Fair	None	None	#1, 2	
Warning Buoys	Poor	See observations	None	#1	One missing and one up on rocks.
Vandalism	N/A	N/A	N/A

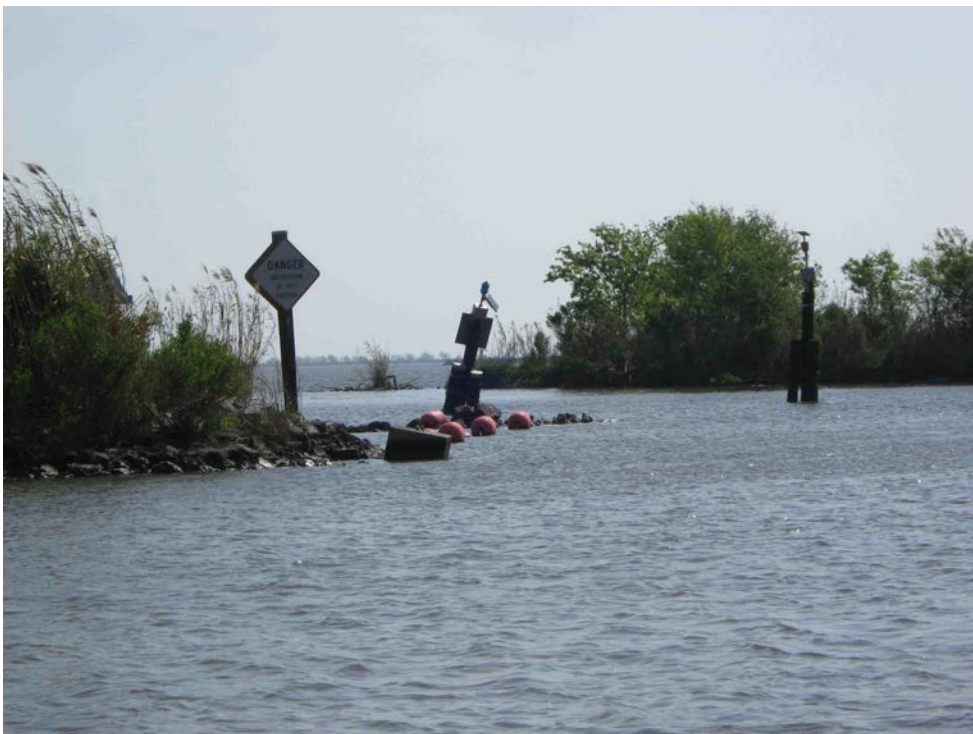
The two pilings on either side of the boat bay, which were found to be damaged during the previous annual inspection, have been replaced with regulatory marker buoys. Two piling clusters supporting navigation lights appeared to have been damaged. One cluster was leaning significantly and the other displayed physical signs of damage.

Photo #2 - The Bayou Dupont Canal Weir. Note the leaning piling cluster with the navigation light.

Bayou Dupont repair needs are listed in the previous section.

One problem which is currently being repaired is the piling damage at the Bayou Dupont Canal Weir. There have been at least three occasions where one of the two warning pilings has been hit by water vessels. To remedy this problem, we recommend placing buoys in the same location as the pilings. These buoys will be monitored closely to make sure they perform as planned. It may be necessary to look into installing the buoys in areas of high traffic for future projects instead of installing only pilings with signs.

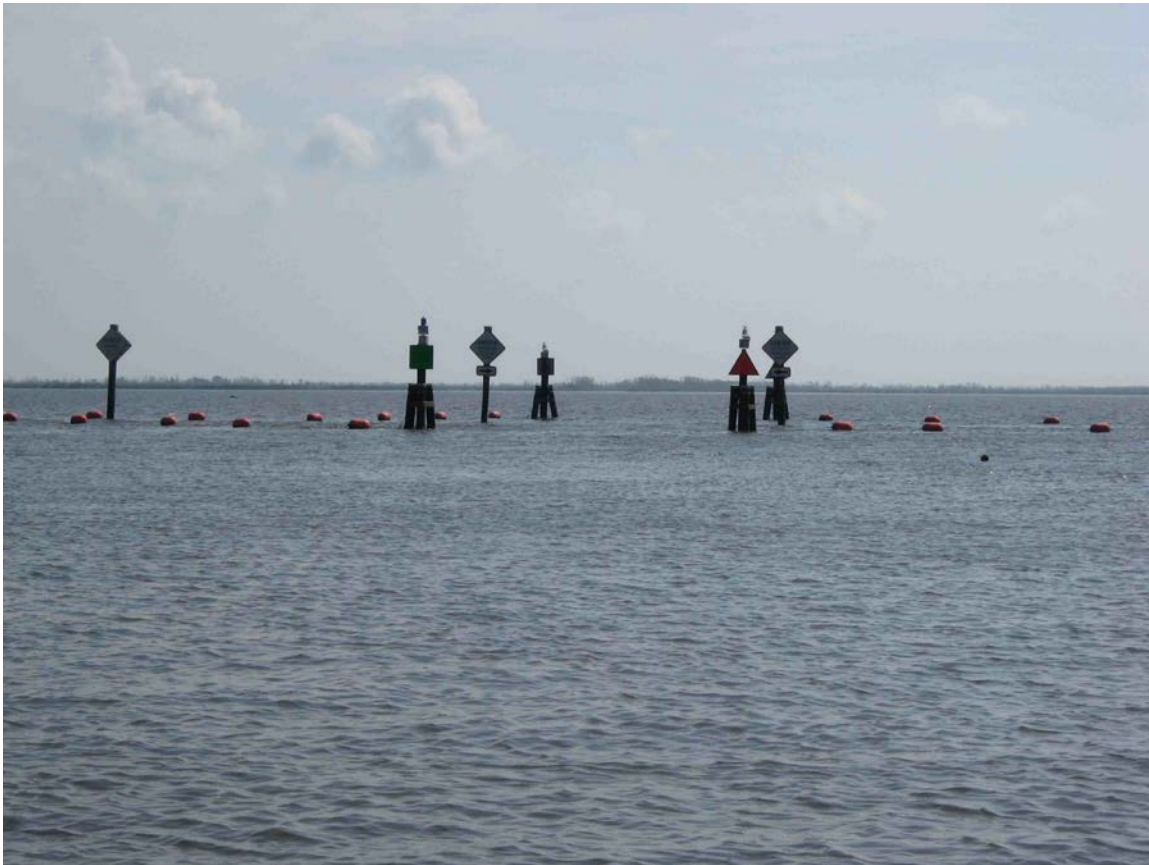
All pilings appeared to be in good condition (see Appendix A, Photograph 3).

Photo #3 – The Goose Bayou Canal Weir. Looking East toward the Pen.

Item	Condition	Physical Damage	Corrosion	Photo #	Observations and Remarks
Rock Riprap	Good	None	N/A		
Creosote Piling	Good	None	None	#3	
Warning Signs and Day Board Navigation Signs	Good	None	None	#3	
Navigation Aid Lights	Good	None	None	#3	
Warning Buoys	Good	None	None	#3	
Vandalism	N/A	N/A	N/A
