**2008 Operations,
Maintenance, and Monitoring
Report**

**BAYOU CHEVEE SHORELINE
PROTECTION**

State Project Number PO-22
Priority Project List 5

July 2008
Orleans Parish

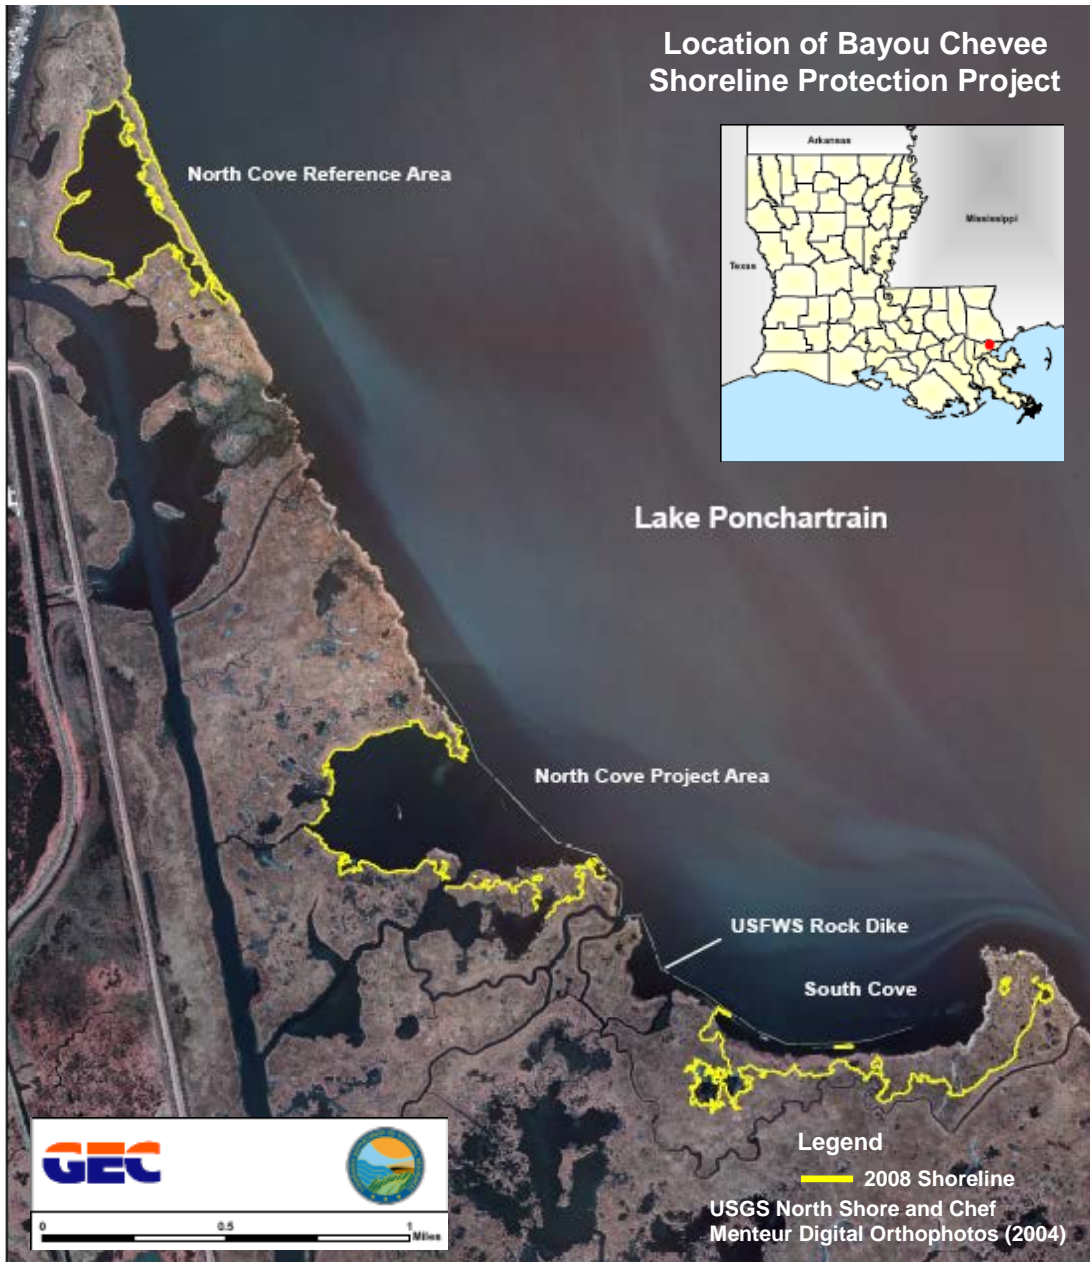
Figure 1. Location of Bayou Chevee Shoreline Protection (PO-22) project and reference areas with 2008 shoreline.

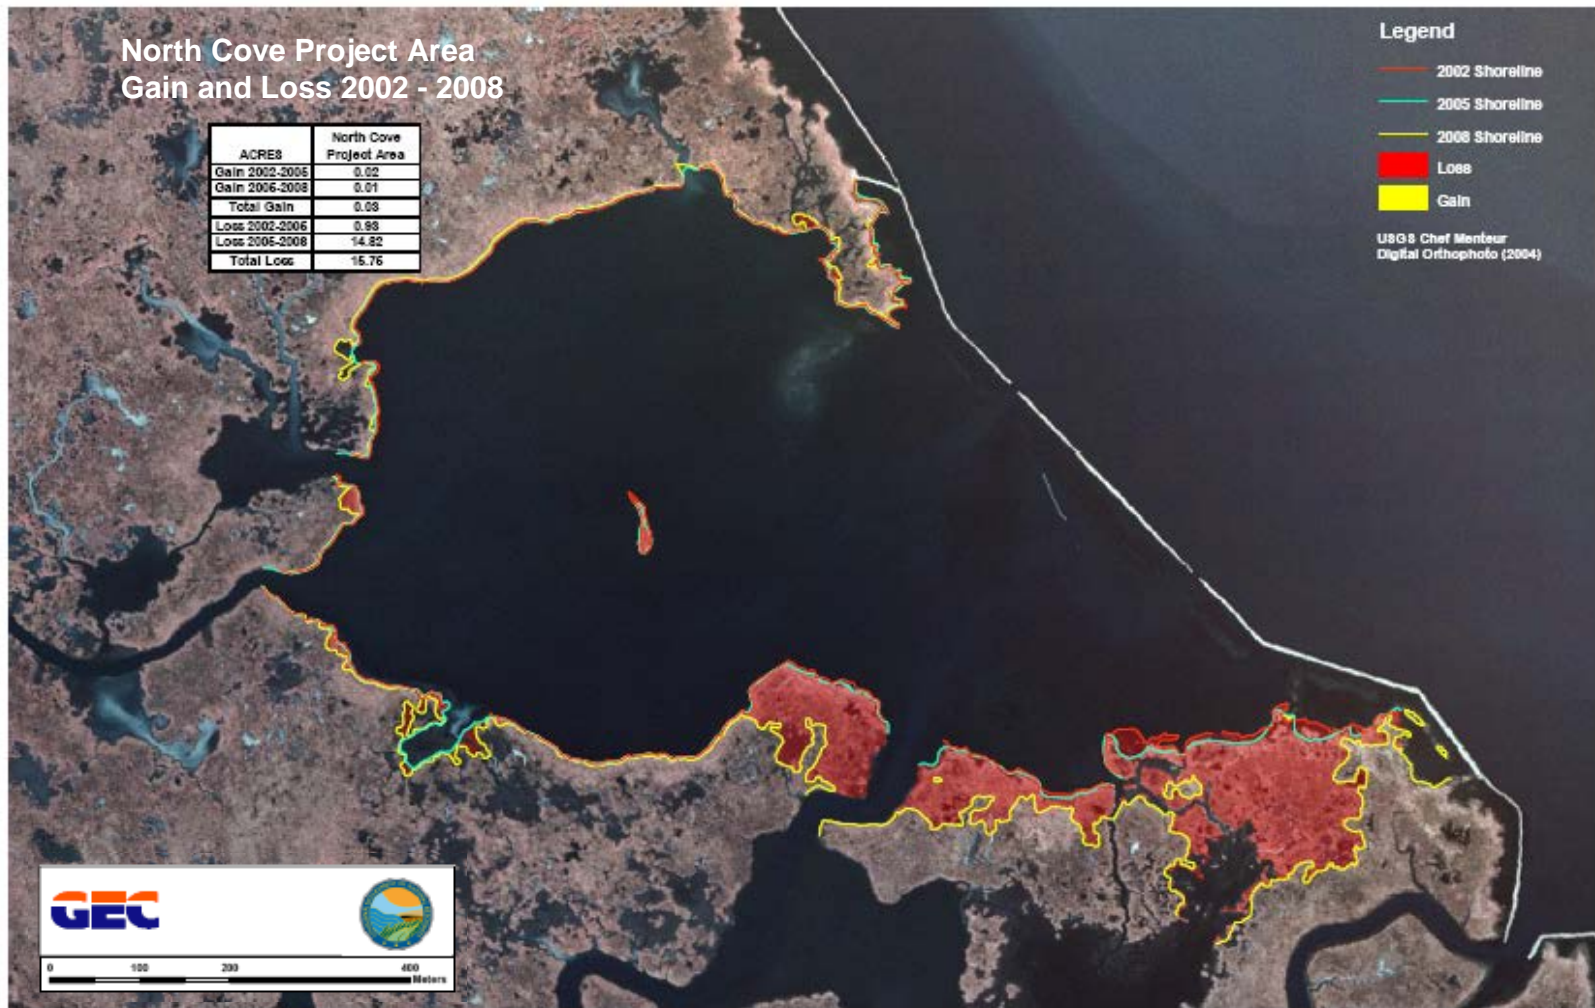
The North Cove project area experienced a loss of 14.82 ac from 2005 to 2008 (Fig. 3). The majority of the land loss in this area occurred on the north facing bank along the southeastern shoreline. Additionally, the small island in the center of the North Cove project area has eroded completely since the 2005 survey.

Figure 3. 2002, 2005, and 2008 shoreline position with estimates of land loss and gain for the North Cove project area of the Bayou Chevee Shoreline Protection (PO-22) project.

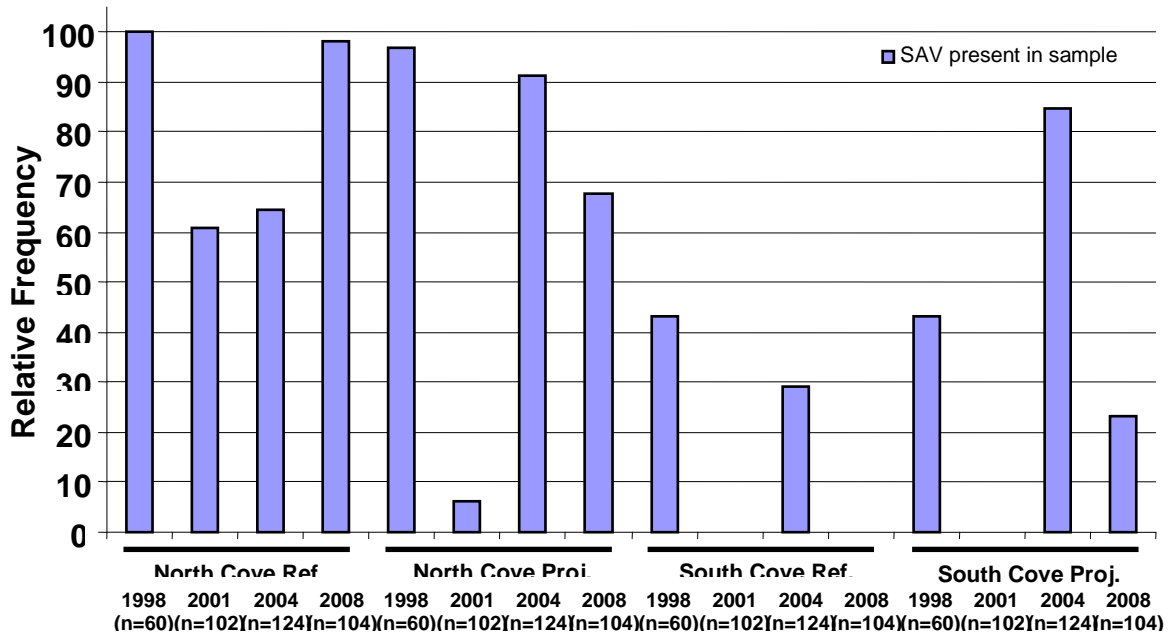
The North Cove project area showed a similar decline between 1998 and 2001, with only algae and a small amount of *R. maritima* (6.19%) recorded during 2001 sampling compared to a high frequency and diversity of SAV in 1998 (table 2, Fig. 6). The 2004 survey of the North Cove project area resulted in an increase of both diversity and frequency of occurrence of SAV relative to the survey of 2001. The 2008 survey revealed a decrease in frequency of SAV with 30.63% of samples containing no SAV (up from 5.65% in 2004). The area was dominated by *Potamogeton pusillus* (56.76%) and *Myriophyllum spicatum* (31.53%).

Figure 6. Frequency of occurrence of submerged aquatic vegetation in samples for North and South cove project and reference areas 1998, 2001, 2004, and 2008 for the Bayou Chevee Shoreline Protection (PO-22) project.

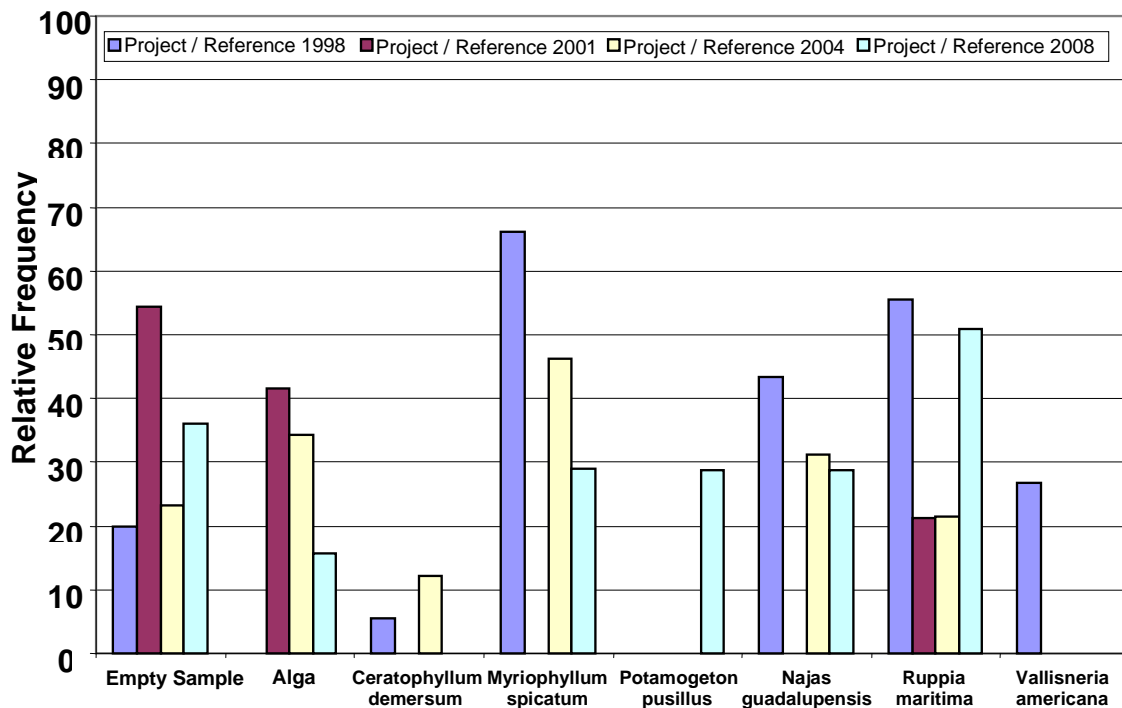
Figure 7. Relative frequency of submerged aquatic vegetation species for project and reference areas of the Bayou Chevee Shoreline Protection (PO-22) project.
