2010 Operations, Maintenance, and Monitoring Plan

Holly Beach Sand Management

State Project Number CS-31
Priority Project List 11

December 2010
Cameron Parish

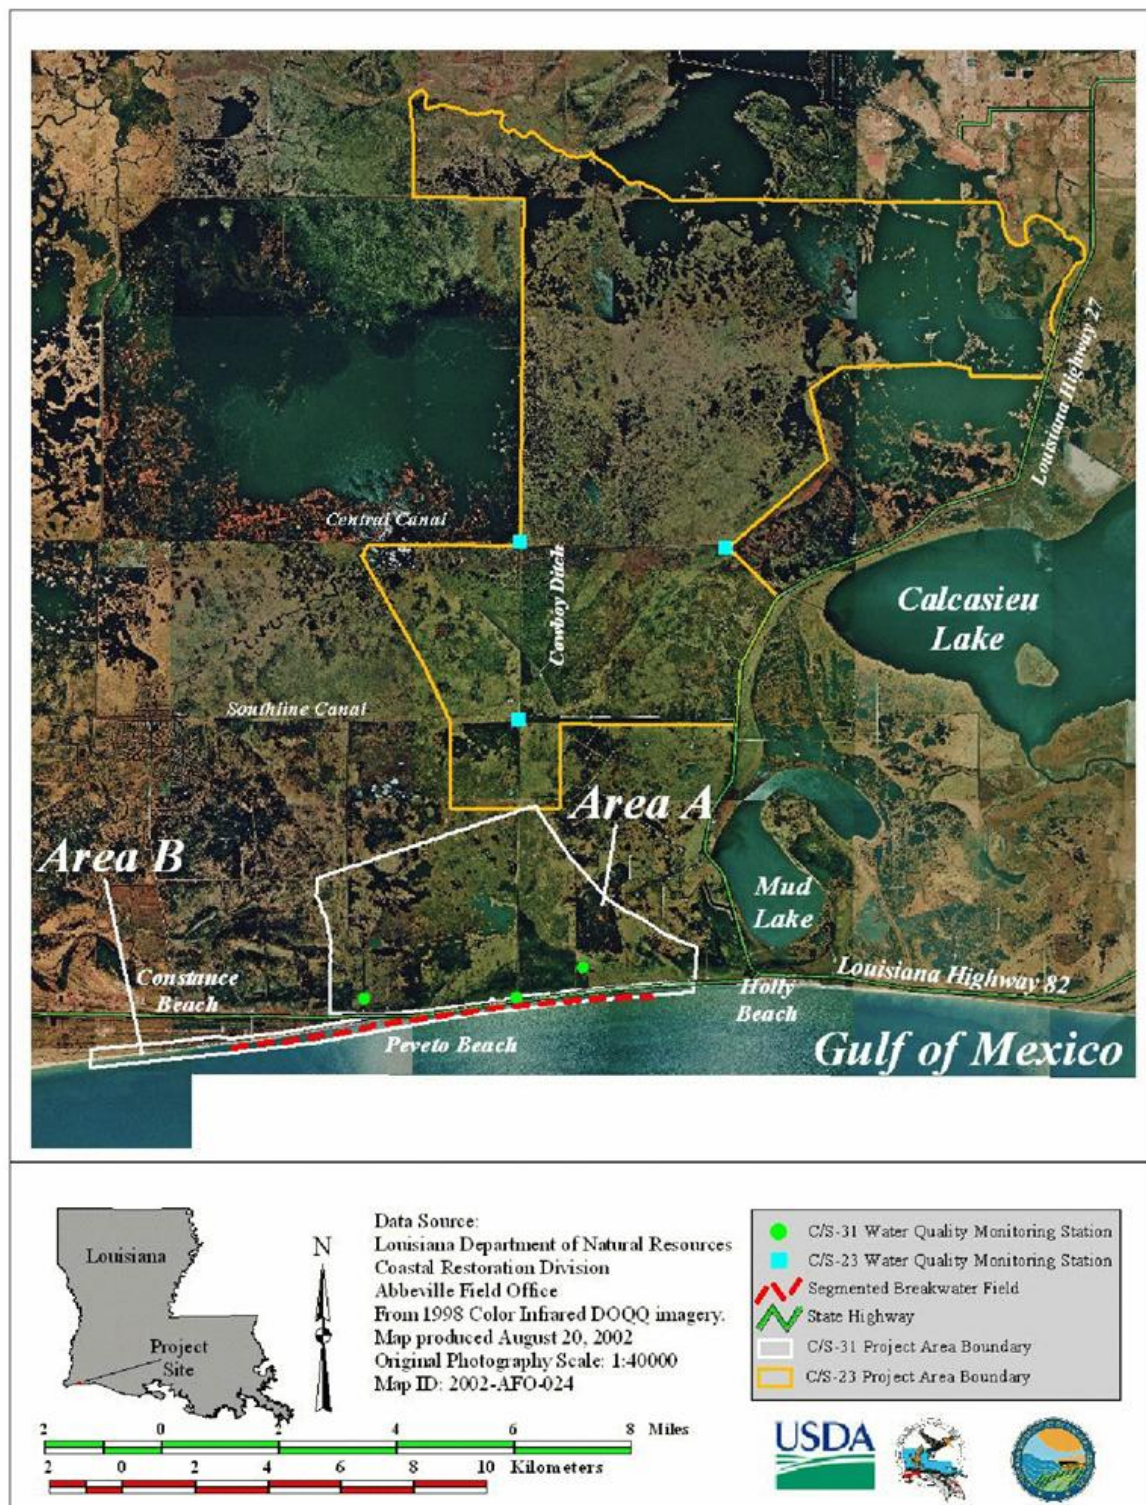
Figure 1. Holly Beach Sand Management (CS-31) project area boundaries.

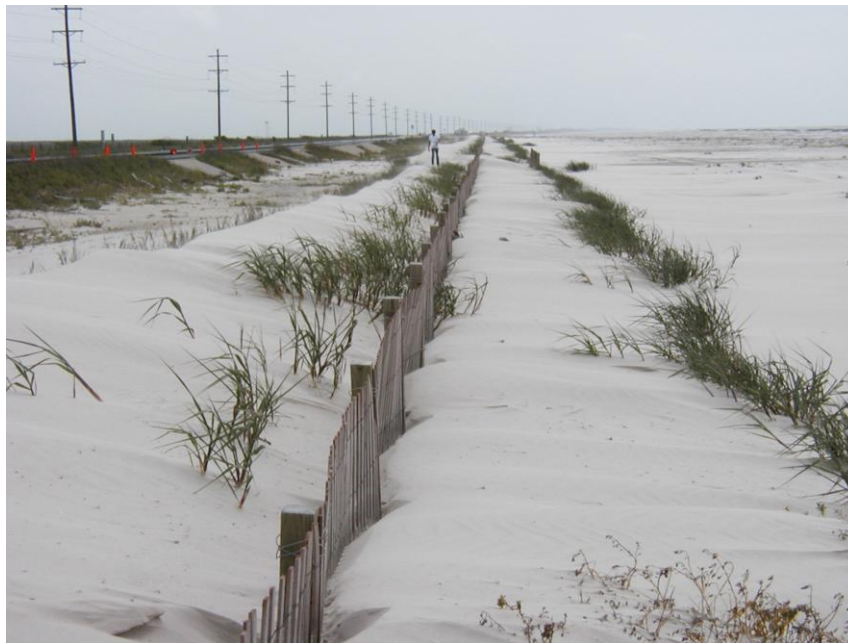
Figure 8a. View of the sand fencing and Vegetation Plantings at Station CS31-108 taken in April 2004. Note the dune formation almost covering the fences. The photograph is facing east.

Data were collected on October 6, 2003, April 20, 2004 and October 12, 2004 (Table 1, figures 8 & 9). Mean percent survival and mean percent cover in the fall of 2003 were 82.5% and 13.07%, respectively. In the spring of 2004 mean percent survival was 81.1% and mean percent cover was 26.7%. Mean percent survival dropped to 76.7% in the fall of 2004, while mean percent cover increased to 46.4% (figure 9). Many of the original plants were actually covered by the dune that formed behind the fences. The dunes were becoming colonized by both *Panicum amarum* and other species as well. The last scheduled monitoring of the vegetation plantings occurred in the fall of 2004. As documented in the inspection report, though, the plantings were severely impacted by Hurricane Rita and were replanted by the La Dept. of Agriculture and Forestry. These plantings were again severely impacted by Hurricane Ike and are to be replanted in the summer of 2011. The condition of the vegetation plantings and dunes will be documented using O&M surveys.

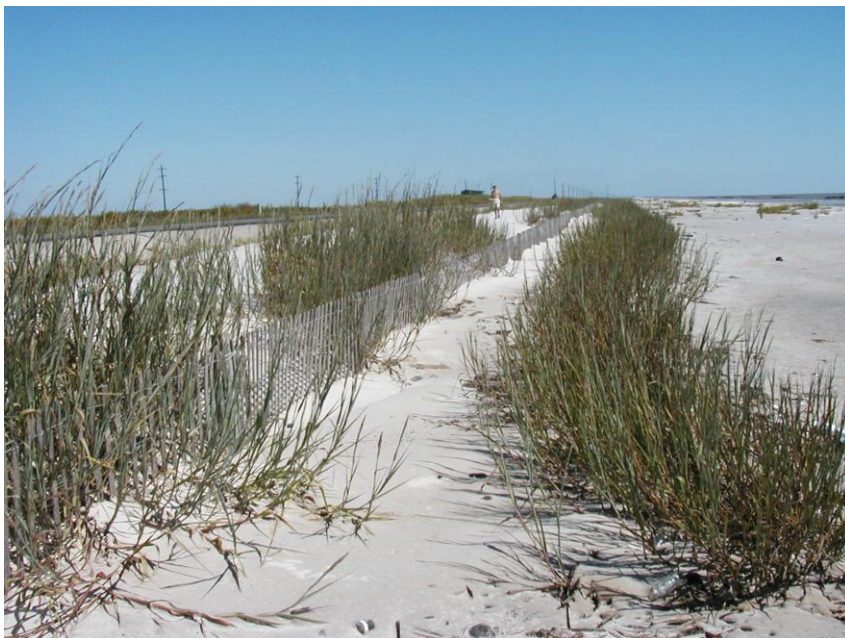
Figure 8b. View of the Sand Fencing and Vegetation Plantings at Station CS31-150 taken in October 2004. The photograph is facing east.

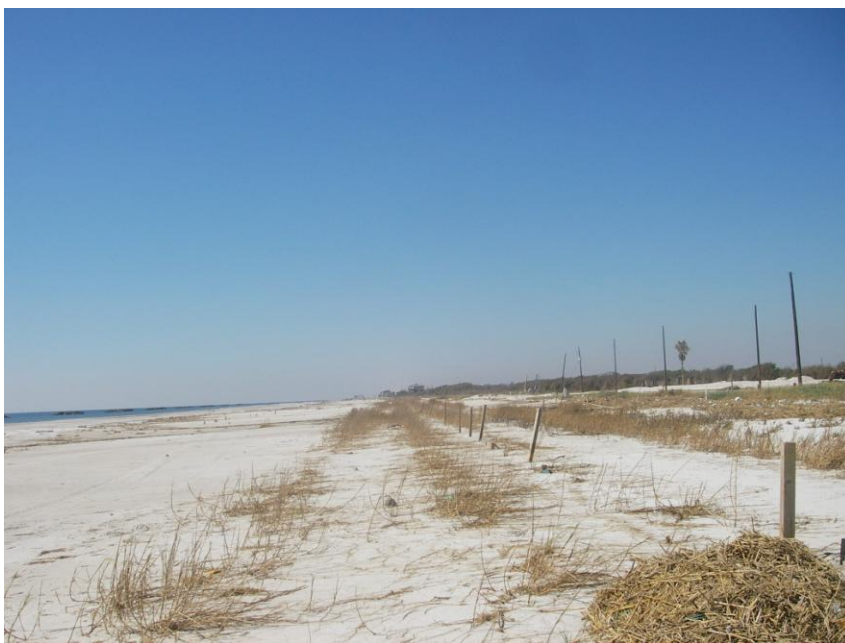
Figure 8c. View of a section of the sand fencing and vegetation plantings taken October 2005, following Hurricane Rita. The photograph is facing west.

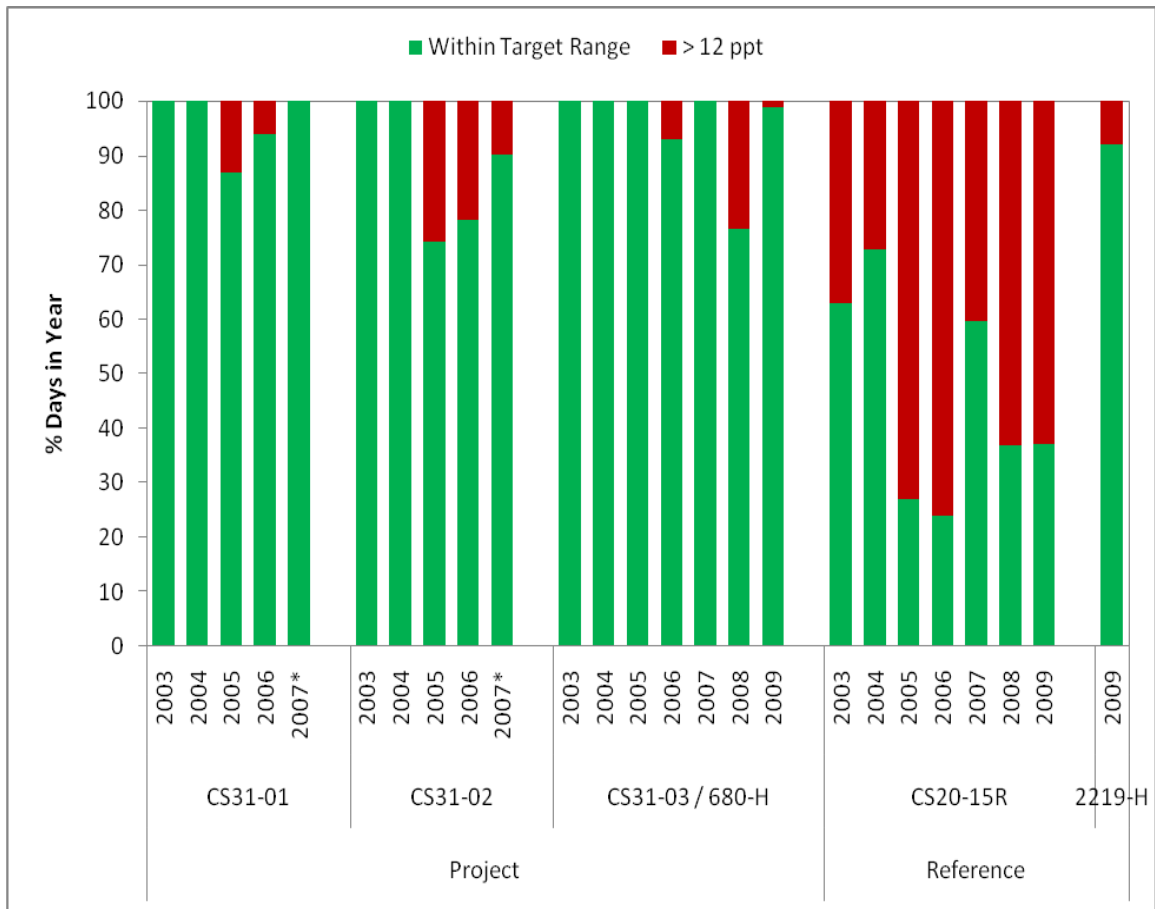
Figure 14d. Percentage of year salinities were inside and outside of target range post-construction for project and reference stations.

Project area yearly salinities were within the target range of 3-12 ppt 93% of the time in years 2003 – 2009 (Figure 14d). Yearly salinities at reference station CS20-15R were within this range only 46% of the time.

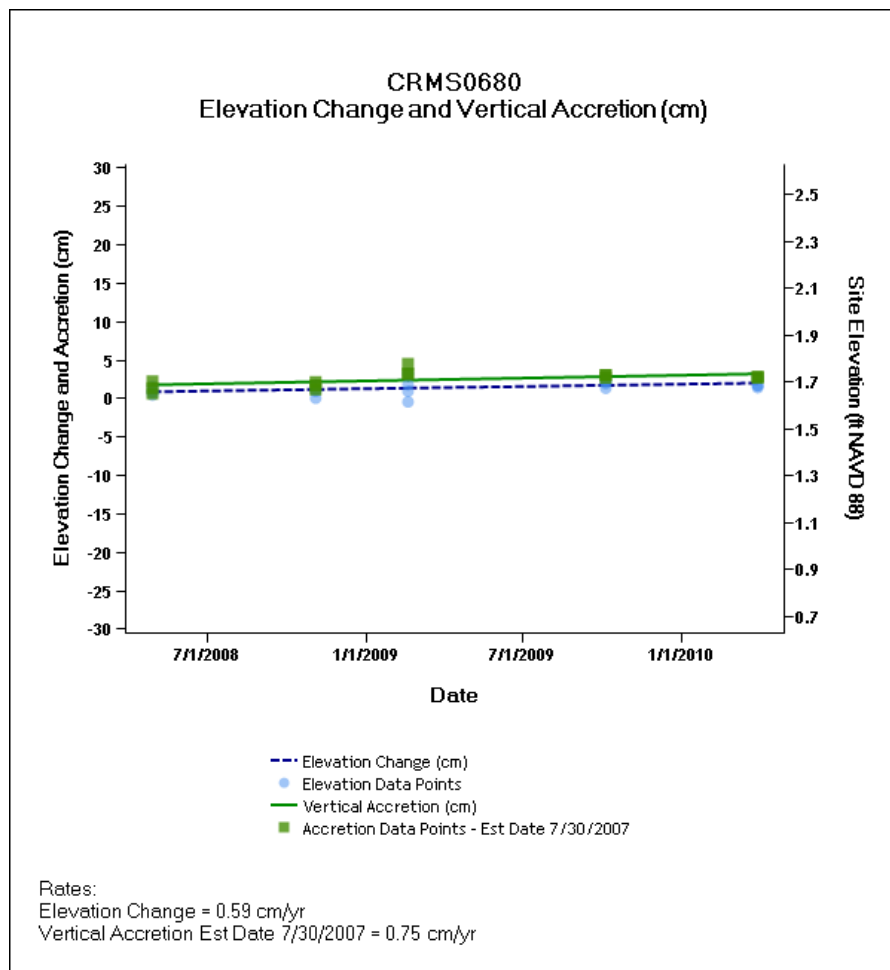
Figure 18. Accretion and Elevation change for project station CRMS0680 over 5 samplings for the period July 2007 to March 2010.

Project station CRMS0680 (Figure 18) showed almost identical accretion and elevation change rates for the sampling period indicating the material being accreted is contributing to the elevation change. There was a slight gain in elevation (0.59 cm/yr). Reference station CRMS2219 has not had enough samplings to generate an elevation change rate at this point. These rates are still preliminary and caution should be used in making decisions from a limited dataset. Estimates will improve with time.

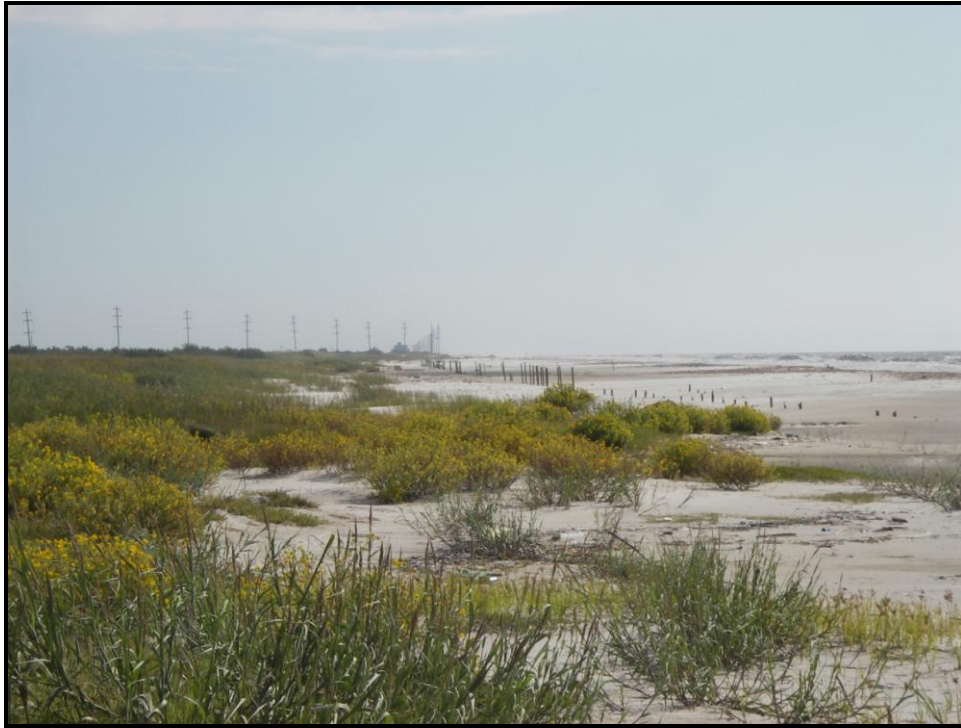
The sand beach nourishment area was fairly clean with some litter and debris from high tides. The sand plateau has suffered erosion from Hurricanes Rita and Ike over the last several years. Based on post storm surveys an estimated 415,000 CY of sand has been displaced. Also, there are several areas where the receding storm surge waters created cuts into the sand beach pushing the sand out into the Gulf towards the segmented rock breakwaters. Some of the sand from the beach has been pushed inland around the camps. Strong southeasterly winds were pushing the sand in a northwestern direction across Hwy 82 as well as across the beach plateau. (Photos: Appendix A, Photos 1 – 4).

The sand fence has been completely destroyed with no visible signs of the sand fence material. There are some remaining 4x4 posts left standing, however the majority are broken off near the sand or leaning. There are no signs of any vegetation left that was planted along and adjacent to the sand fence alignment. (Photos: Appendix A, Photos 1 - 4).

Photo No. 1, Typical view of destroyed sand fence and erosion to beach

Replace sand fence and vegetative plants.

Overall, the Holly Beach Sand Management Project is in fair condition and functioning as designed with problems as noted above. The existing remnants of the sand fencing will need to be removed and disposed of and new sand fencing will need to be installed. Vegetative plantings will need to be placed along the new sand fence alignment. A post Hurricane Ike survey was conducted in January 2009 to compare to post Hurricane Rita survey performed in 2005 to determine any sand quantities lost that can be attributed to Hurricane Ike which will made part of a FEMA claim. The initial response from FEMA was to deny the claim. An appeal has been submitted by the State objecting to the denial of the claim. Replacement of the displaced sand is considered a priority by residents in Cameron Parish. A maintenance event is planned for FY 2010 to address the following:

- Replace 46,000 linear feet of sand fence.
- Replace 28,000 vegetative plantings.

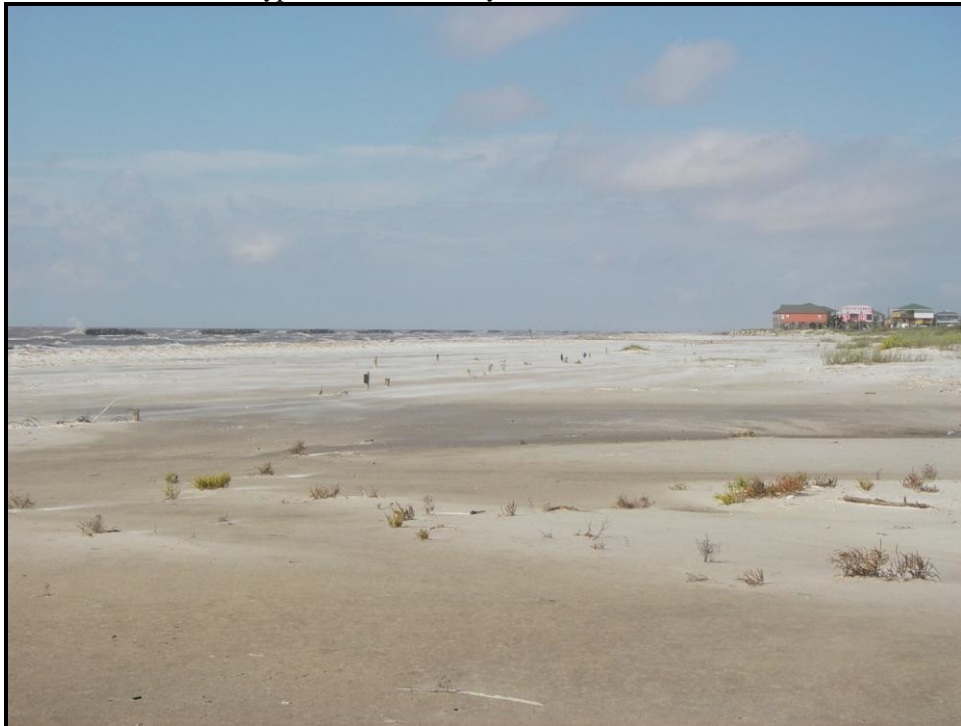
Photo No. 2, Close up view of beach

| Item | Condition | Physical Damage | Corrosion | Photo # | Observations and Remarks |
|---|---|---|---|---|---|
| Sand (fill) | Fair | | | 1-4 | Beach fill in fair condition, minimal trash and debris from high tides. |

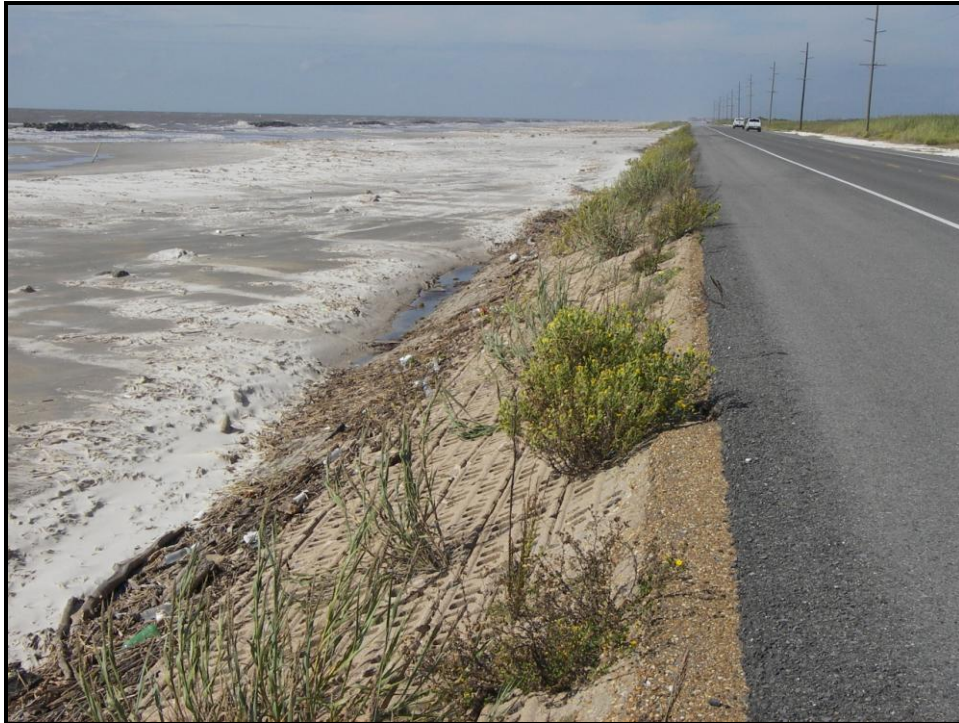
Photo No. 3, View of beach near Hwy 82

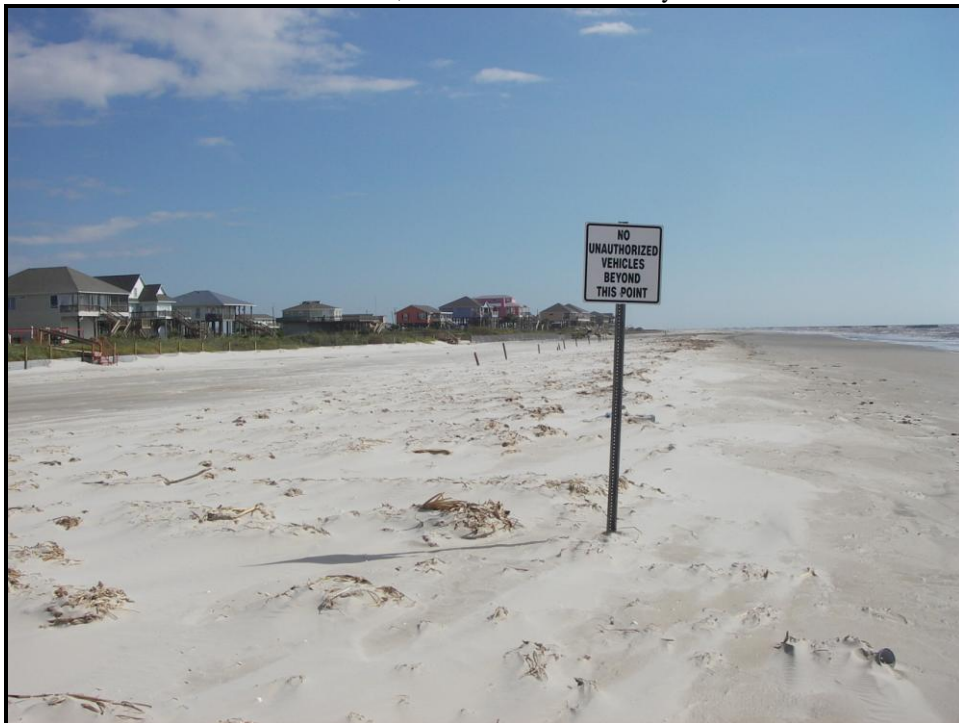
Photo No. 4, View of western end of project looking eastward
