**2008 Operations, Maintenance,
and Monitoring Report**

**Four-Mile Canal Terracing and
Sediment Trapping**

State Project Number TV-18
Priority Project List 9

July 2008
Vermilion Parish

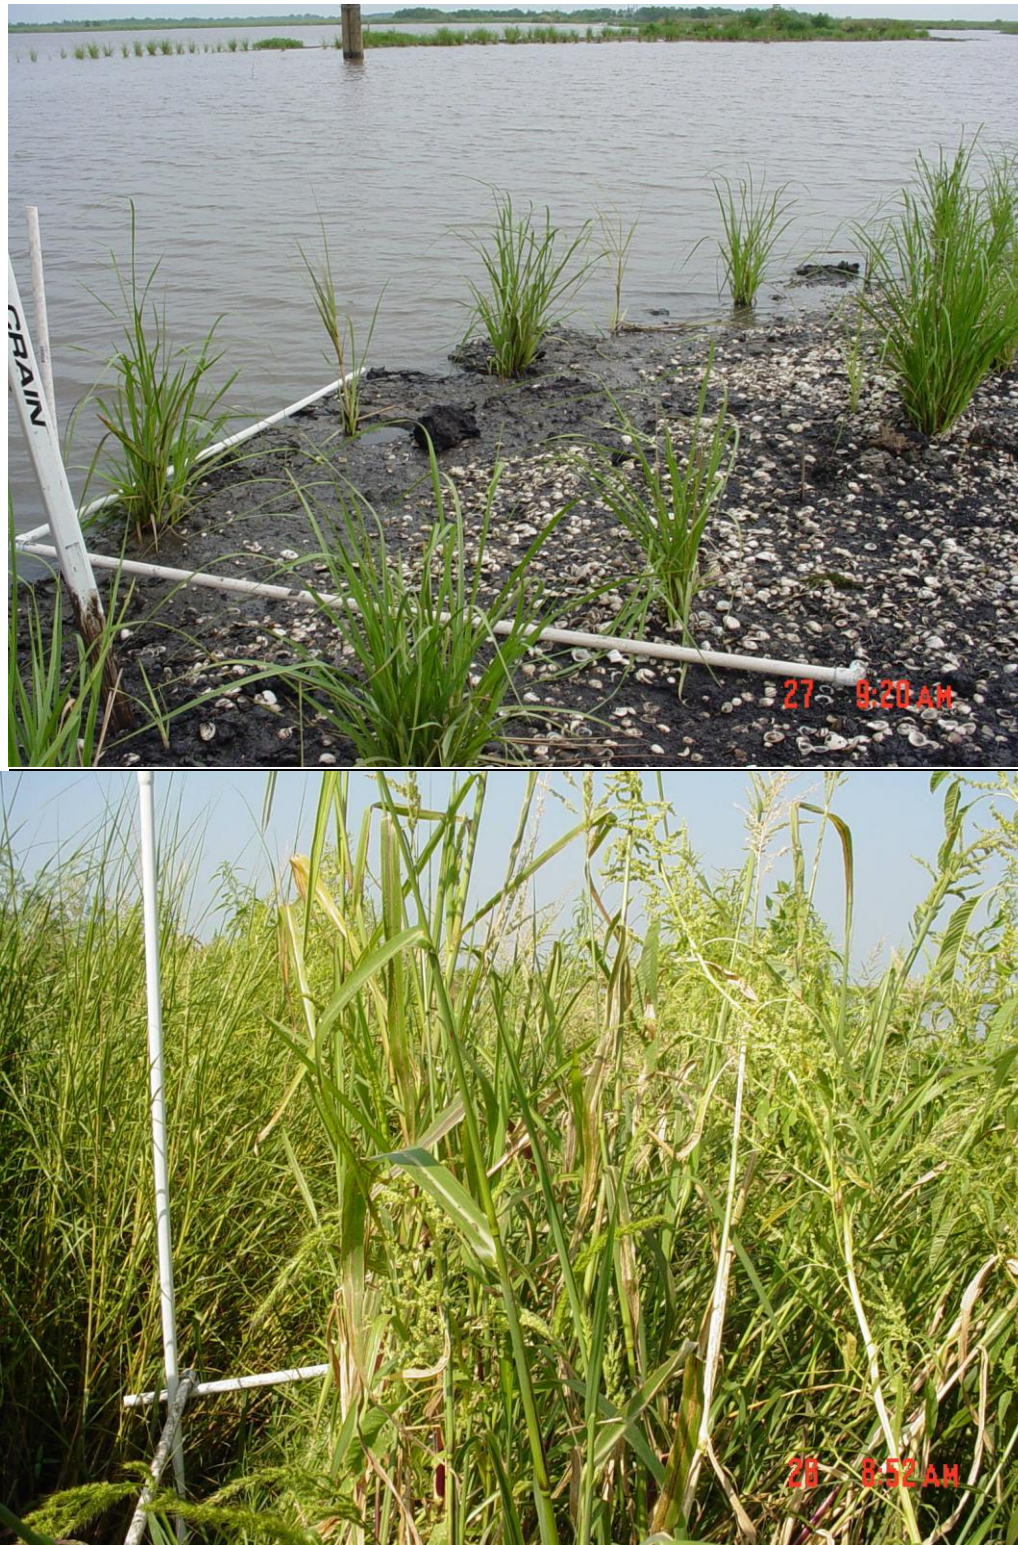
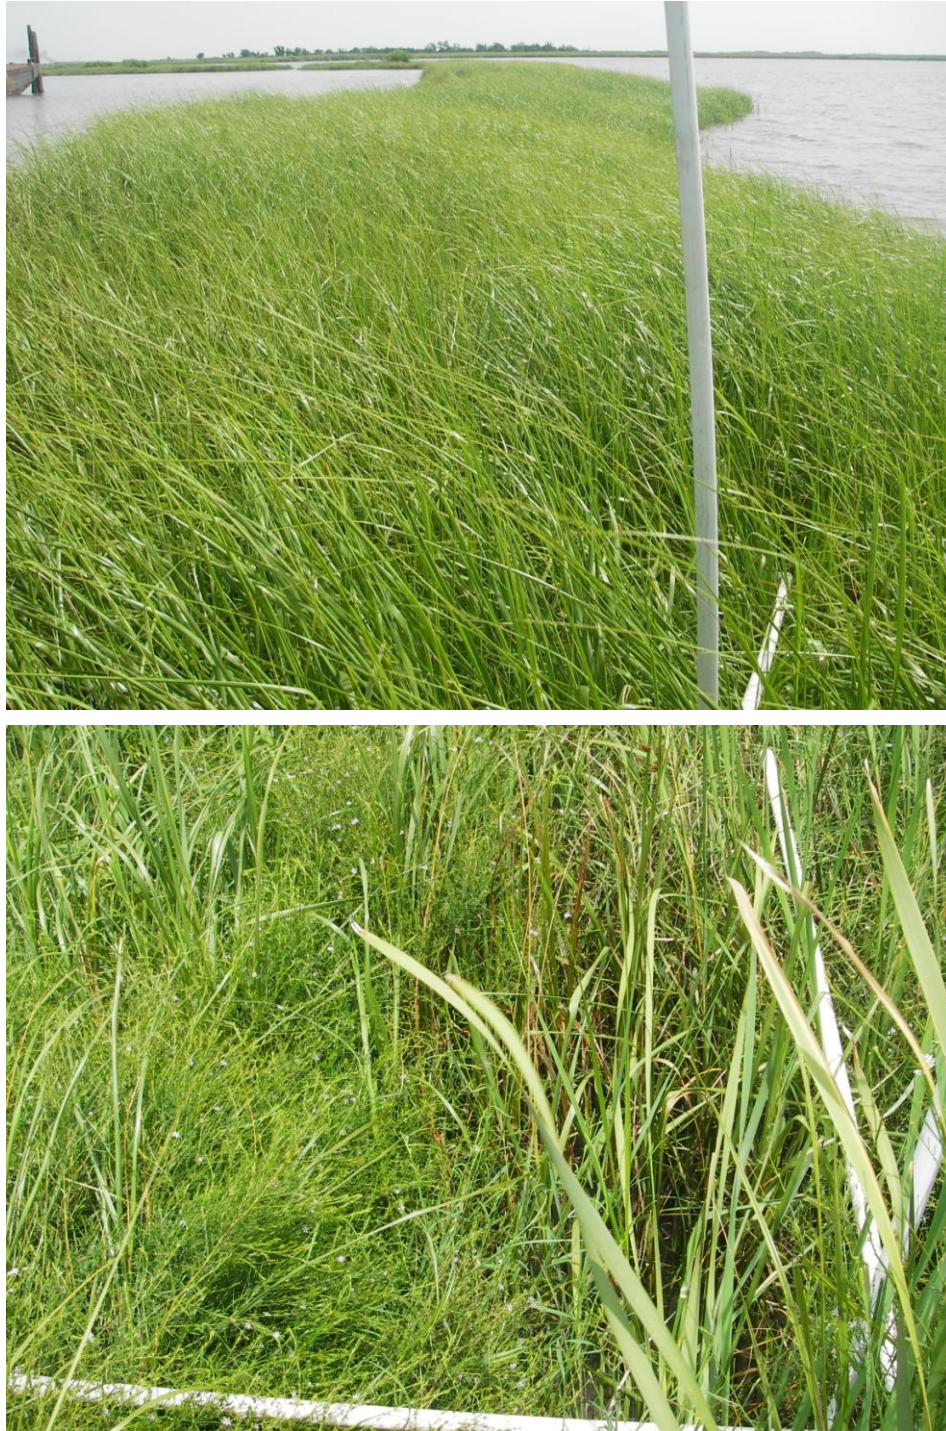
Figure 6. Vegetation sampling plot of terrace located in Little White Lake (upper) and Vermilion Bay (lower) areas taken July 27, 2004 and July 28, 2004, respectively.

Figure 7. Vegetation sampling plot of terrace located in Little White Lake (upper) and Vermilion Bay (lower) areas taken July 19, 2007.

Terrace vegetation was monitored on July 27 and 28 of 2004 and July 18 and 19 of 2007 (Figures 6 and 7). Mean percent cover of vegetation from the 2004 sampling to the 2007 sampling in the 33 plots located on the Little White Lake (LWL) terraces increased from 12.3 % to 38.1 %. Mean percent cover of the vegetation on the Vermilion Bay (VB) terraces remained the same from 71.6 % to 70 % (Figures 8a and 8b). There is significant difference in cover between the two terrace areas but not between years (Figure 9). In LWL, the terraces located on the northeast lake rim were protected by the terrace rows in front of them and showed a higher number of species. The outer most terrace row was subjected to more wave energies and experienced the lowest number of species and high rates of erosion. In VB, terraces located behind an existing island and in the innermost terrace field had the highest number of species while the first set of terrace rows opened to VB experienced the most erosion and low species numbers.

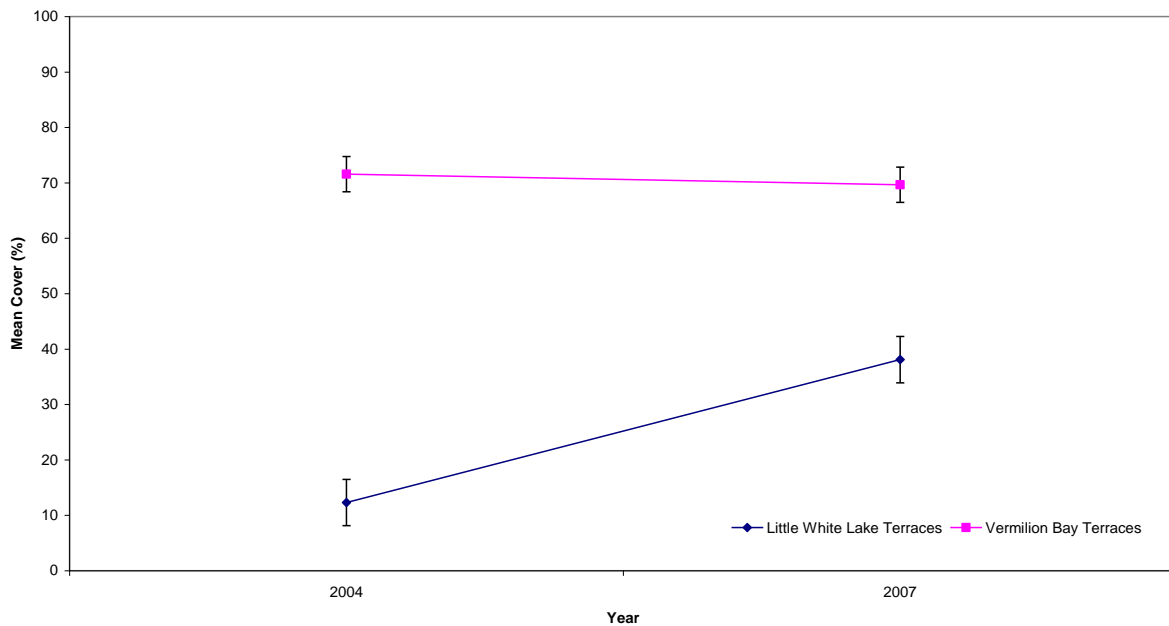
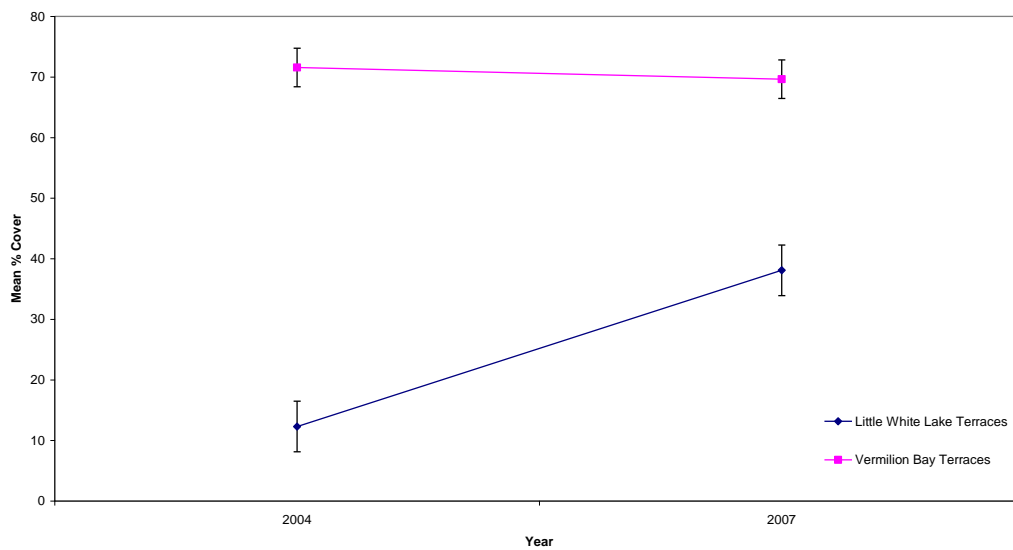
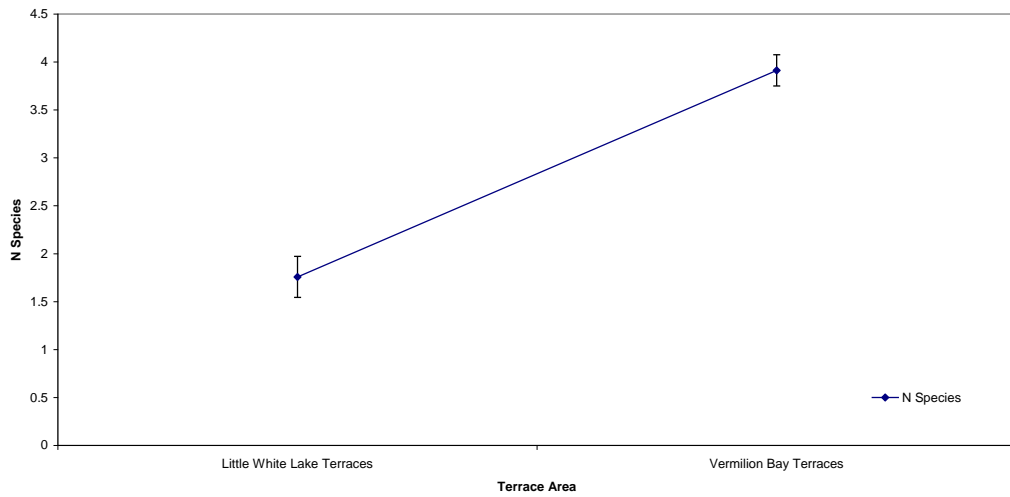
Figure 8a. Mean percent cover of vegetation on the Little White Lake terraces and the Vermilion Bay terraces from 2004 to 2007.

Figure 8b. Mean percent cover from 2004 to 2007 of vegetation species in located in Little White Lake and Vermilion Bay areas.

Figure 9. Comparison of vegetation in Little White Lake terrace area to the Vermilion Bay terrace area from two sampling periods in 2004 and 2007.

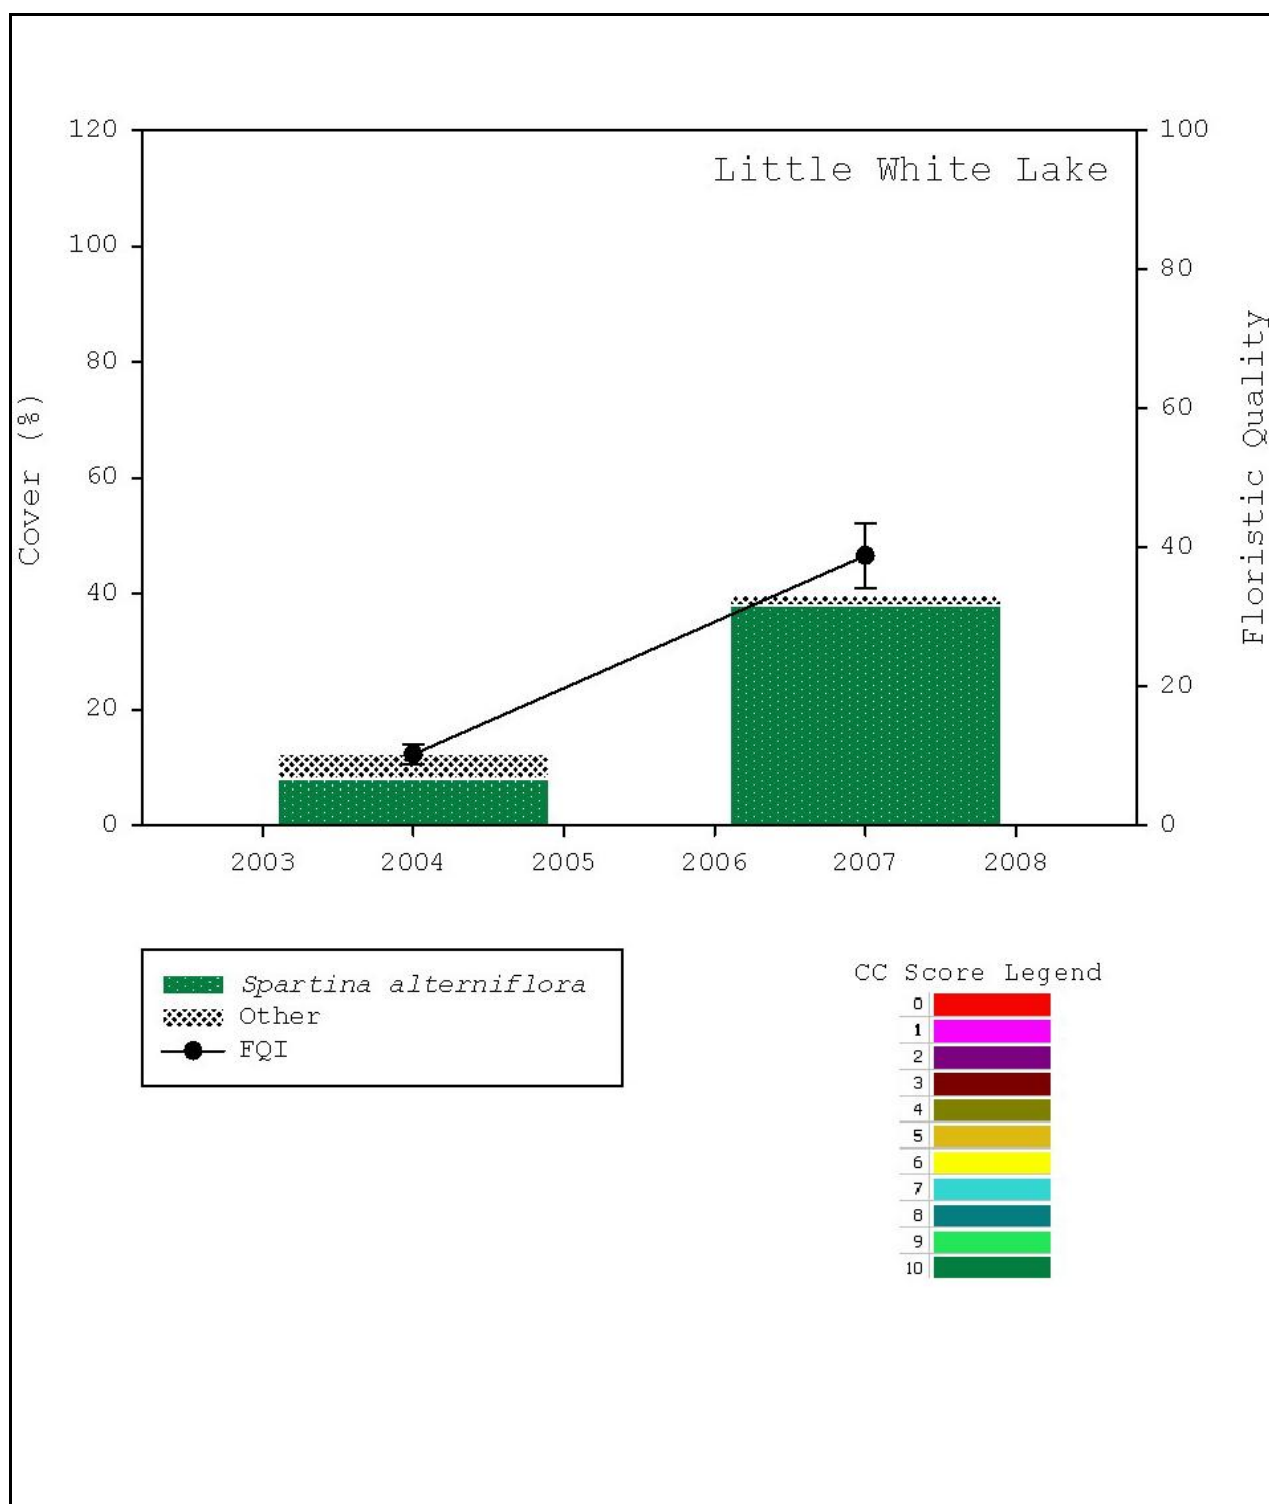
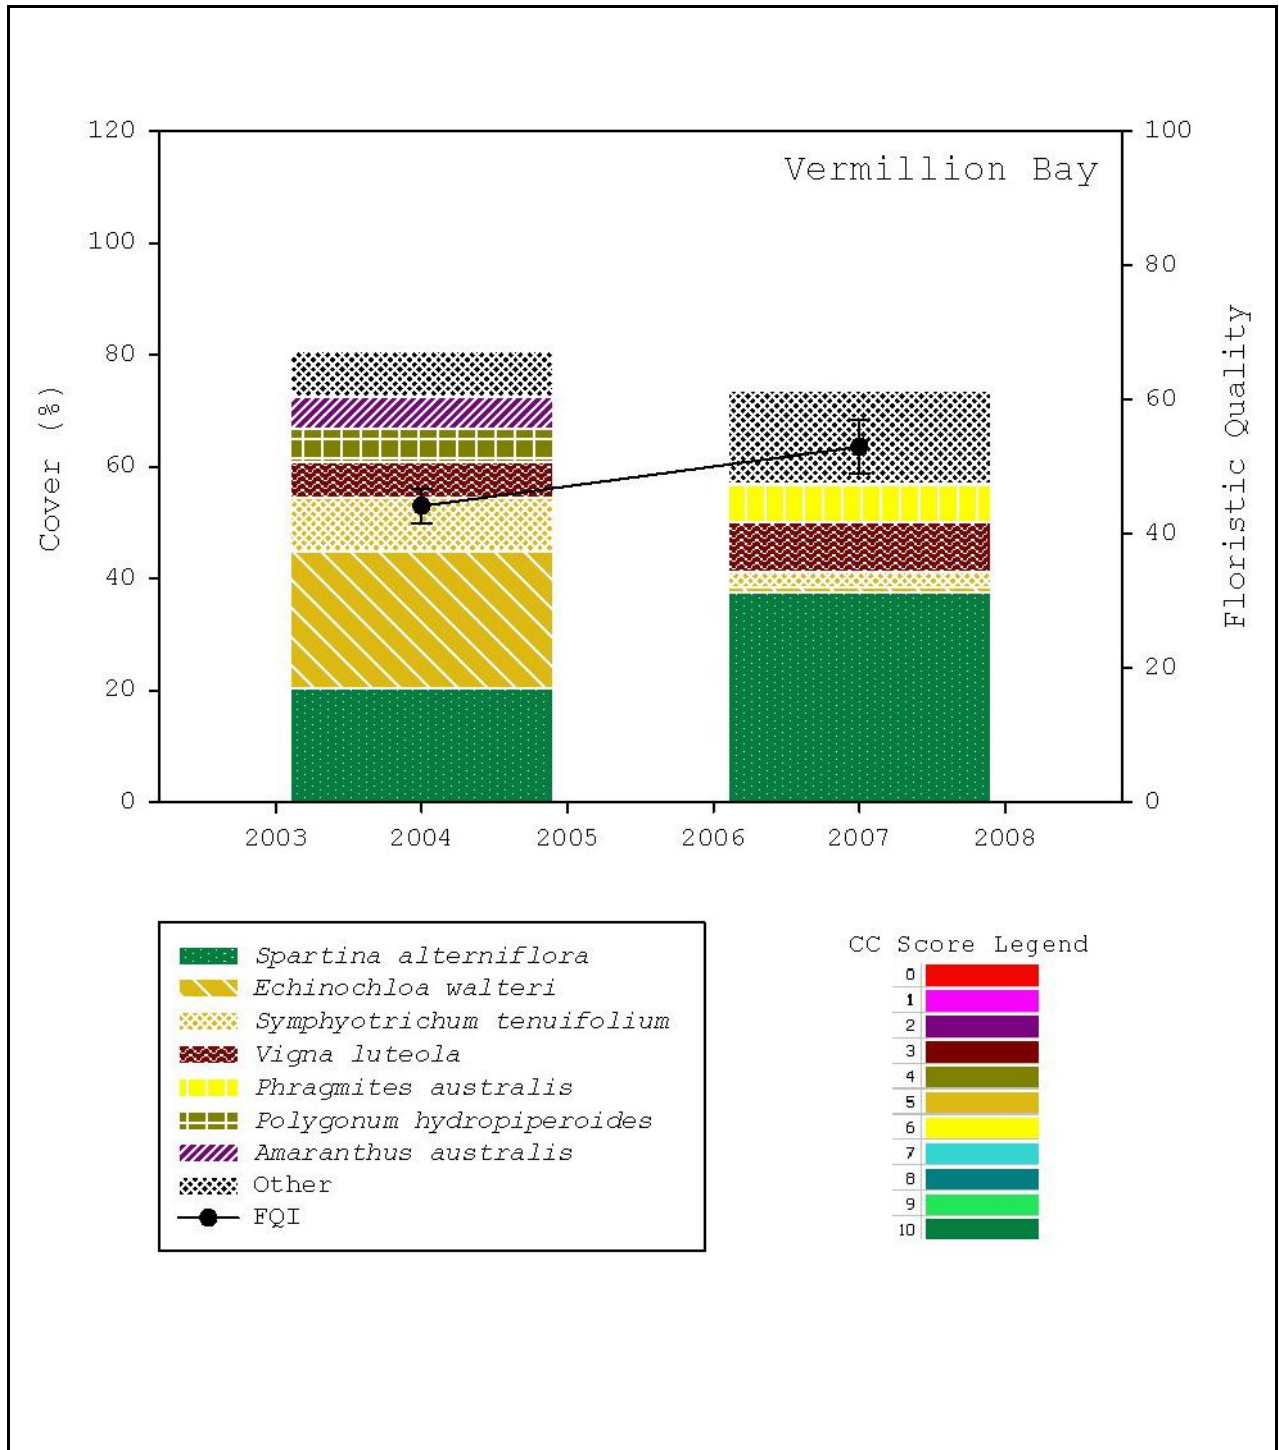
Figure 10a. Percent coverage of species and floristic quality index of vegetation data collected on the Little White Lake terrace area. Values are means of 33 stations within the site; therefore, the sum of % coverage of individual species can be greater than 100 %.

Figure 10b. Percent coverage of species and floristic quality index of vegetation data collected on the Vermillion Bay terrace area. Values are means of 57 stations within the site; therefore, the sum of % coverage of individual species can be greater than 100 %.

Floristic quality of the vegetation in both the LWL terrace area and the VB terrace area increased from 2004 sampling period to the 2007 sampling period (Figures 10a-10b). The dominant species in the LWL area was the planted species, *Spartina alterniflora*, for both sampling years. Other species represented low cover value for both sampling periods. On the VB terrace area *Echinochloa walteri* was the dominant species for 2004 and was replaced by *S. alterniflora* in 2007. Percent cover, although higher than the LWL area, decreased slightly along with species richness from 2004 to 2007. However, the species that were not present in 2007 were lower quality, annual disturbance species.

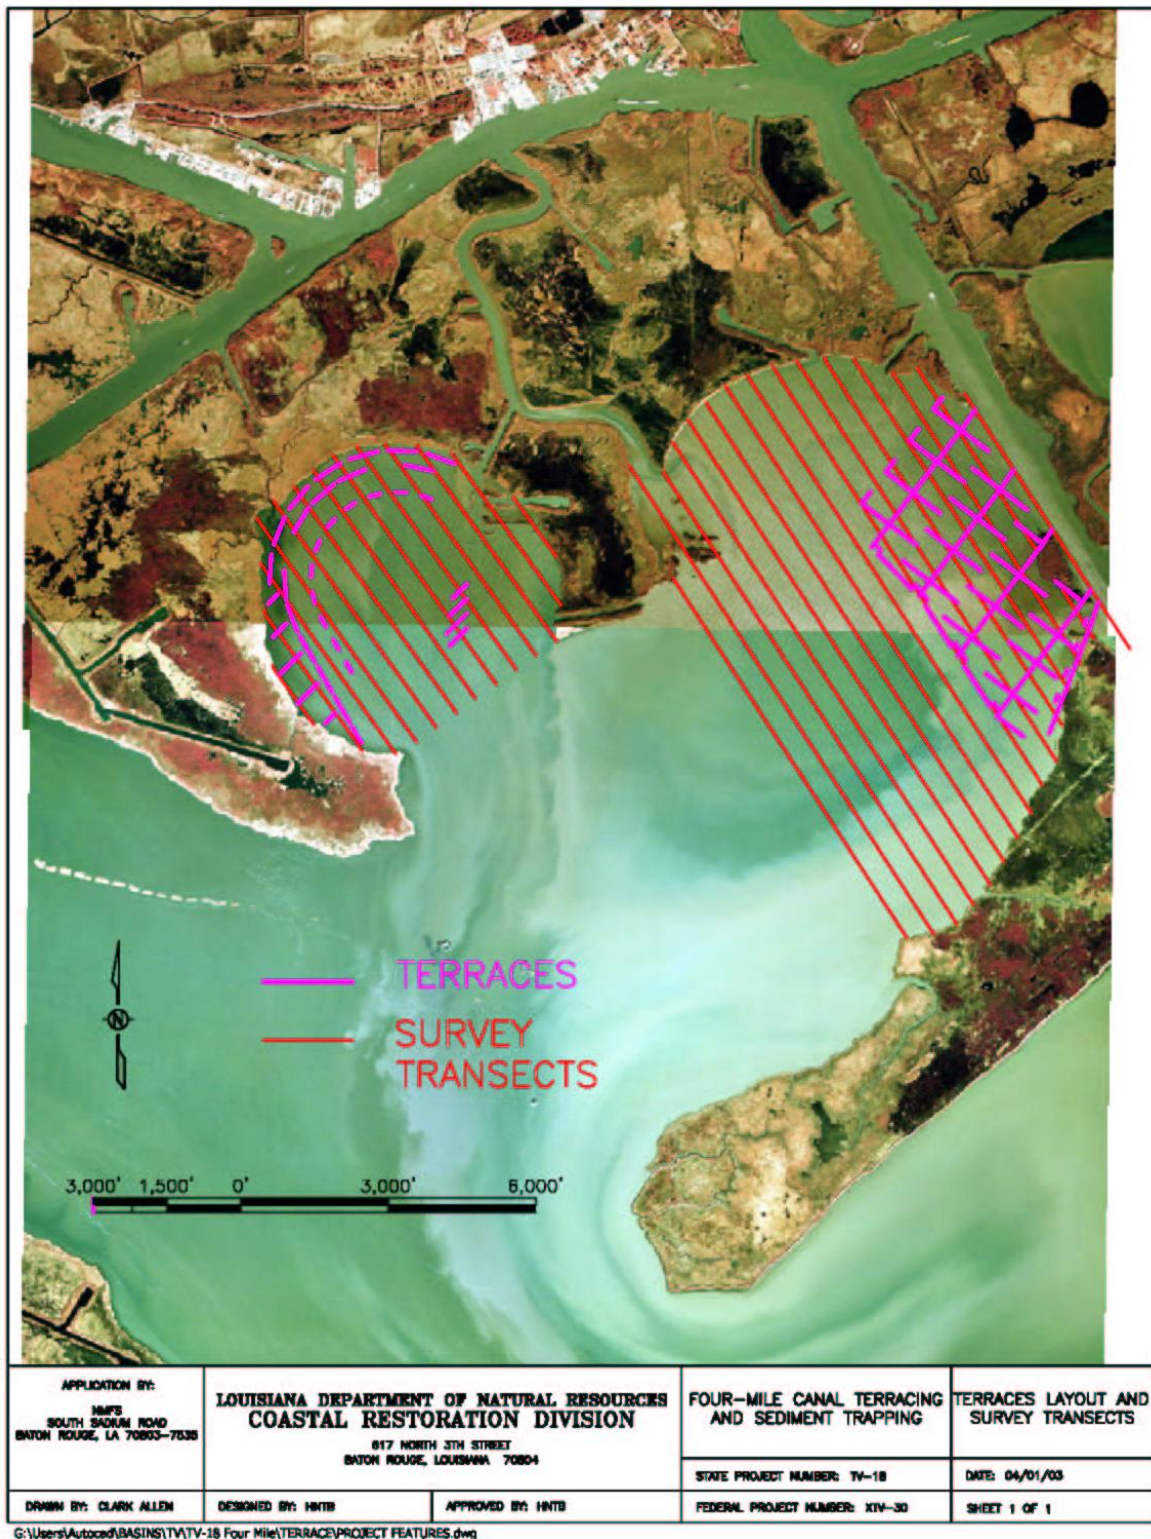
Figure 11. Layout for terraces and survey transects for Four-Mile Canal Terracing and Sediment Trapping (T/V-18).

Preliminary bathymetry surveys were completed in 2003 and differences will be calculated after the second survey scheduled for June 2010 (Figure 11).

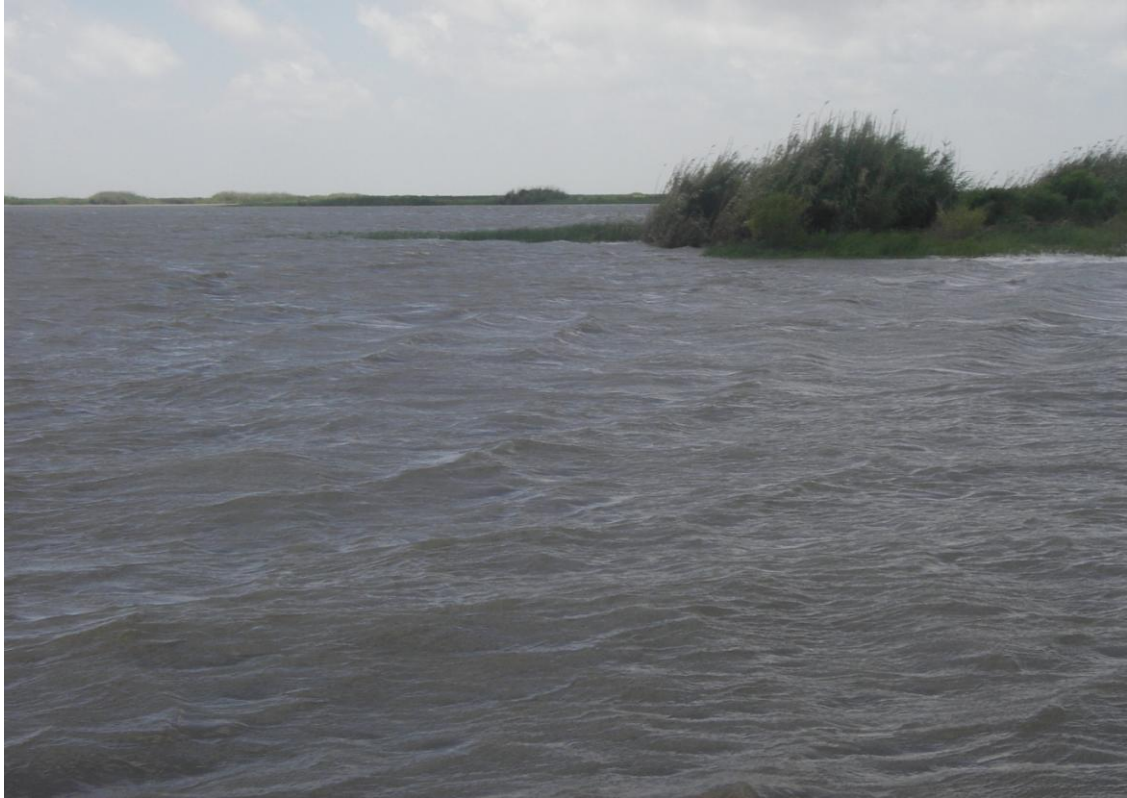
The interior terraces in both Little White Lake and the ones off of the Vermilion River Cut-Off are in excellent condition. Terraces nearest the Vermilion River Cut-Off and on the southwestern rim of this area of the project are eroding but are still functional. Submerged aquatic vegetation is becoming established between the terraces. The two exterior rows of terraces in Little White Lake have eroded significantly. Vegetation is still evident on what is left of some of the terraces. No maintenance needed at this time. (Photos: Appendix B, Photo 1-4)

Photo 1—terraces along Vermilion River Cut-Off

Terraces created in high energy environments such as the ones located adjacent to the Four-Mile Canal may benefit from a hard structure, fence, or breakwater to minimize the erosive effects from boat wake traffic.

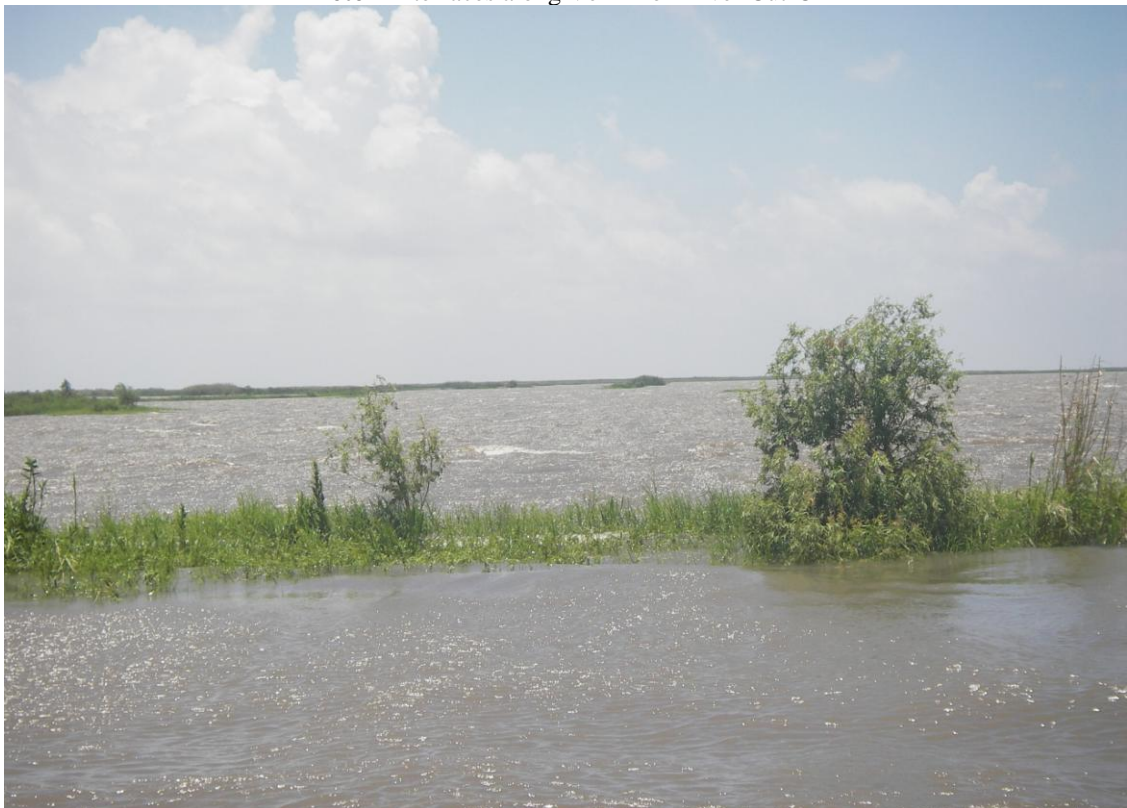
Photo 2—terraces in Little Vermilion Bay

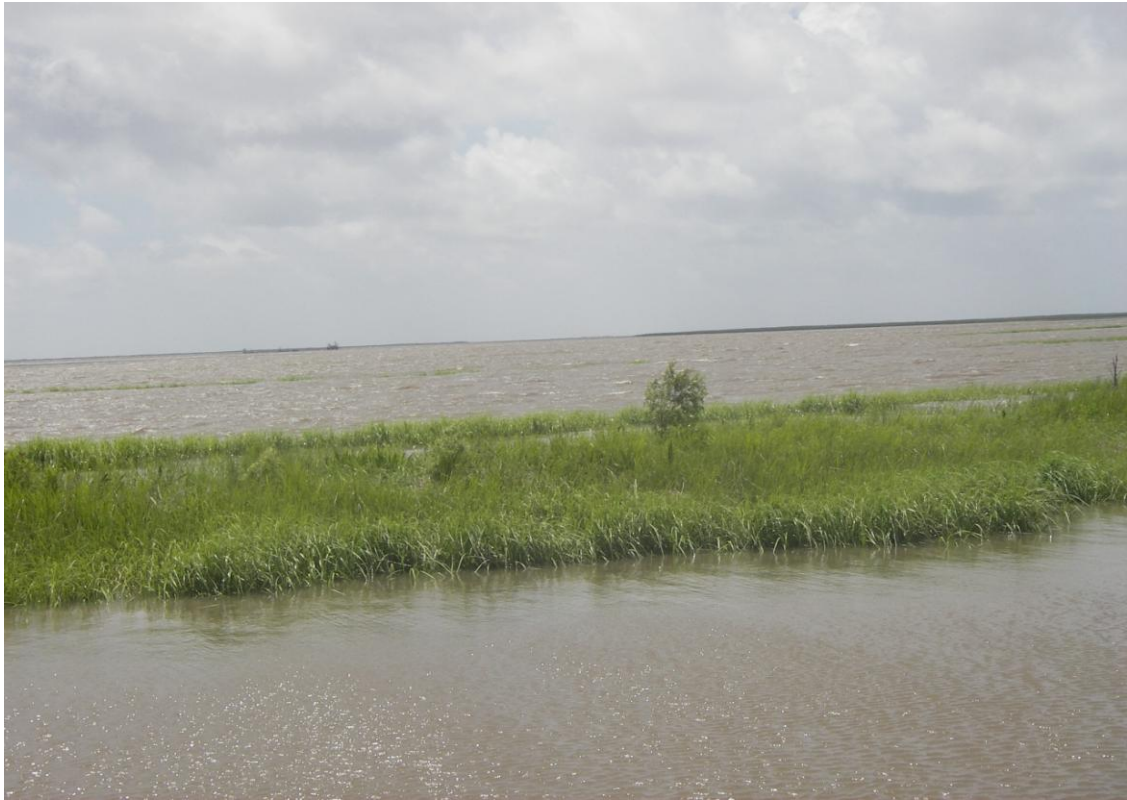
Photo 3—terraces in Little White Lake

Vegetation has spread throughout the terraces. A staff gauge needs to be installed in the vicinity of the Little White Lake terraces. No other maintenance needed at this time.

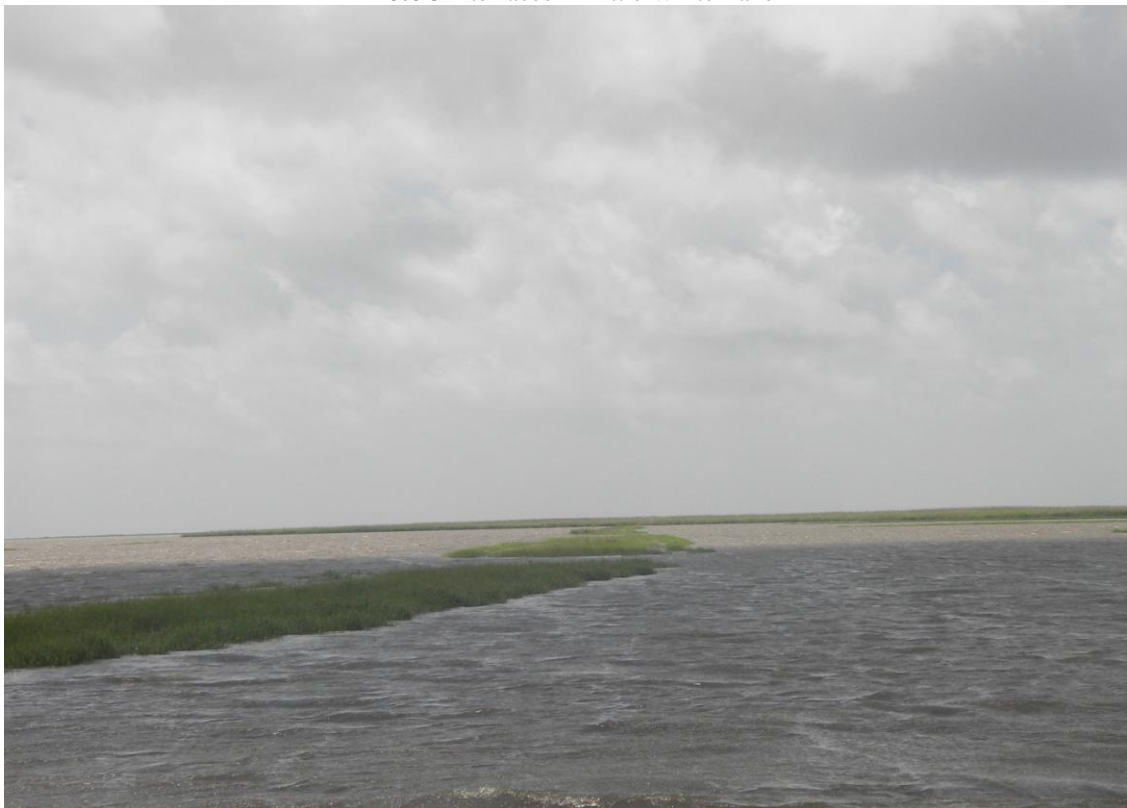
Photo 4—terraces in Little White Lake
