2011 Operations, Maintenance, and Monitoring Report

Freshwater Bayou Canal Wetland Protection

State Project Number ME-04
Priority Project List 2

June 2011
Vermilion Parish

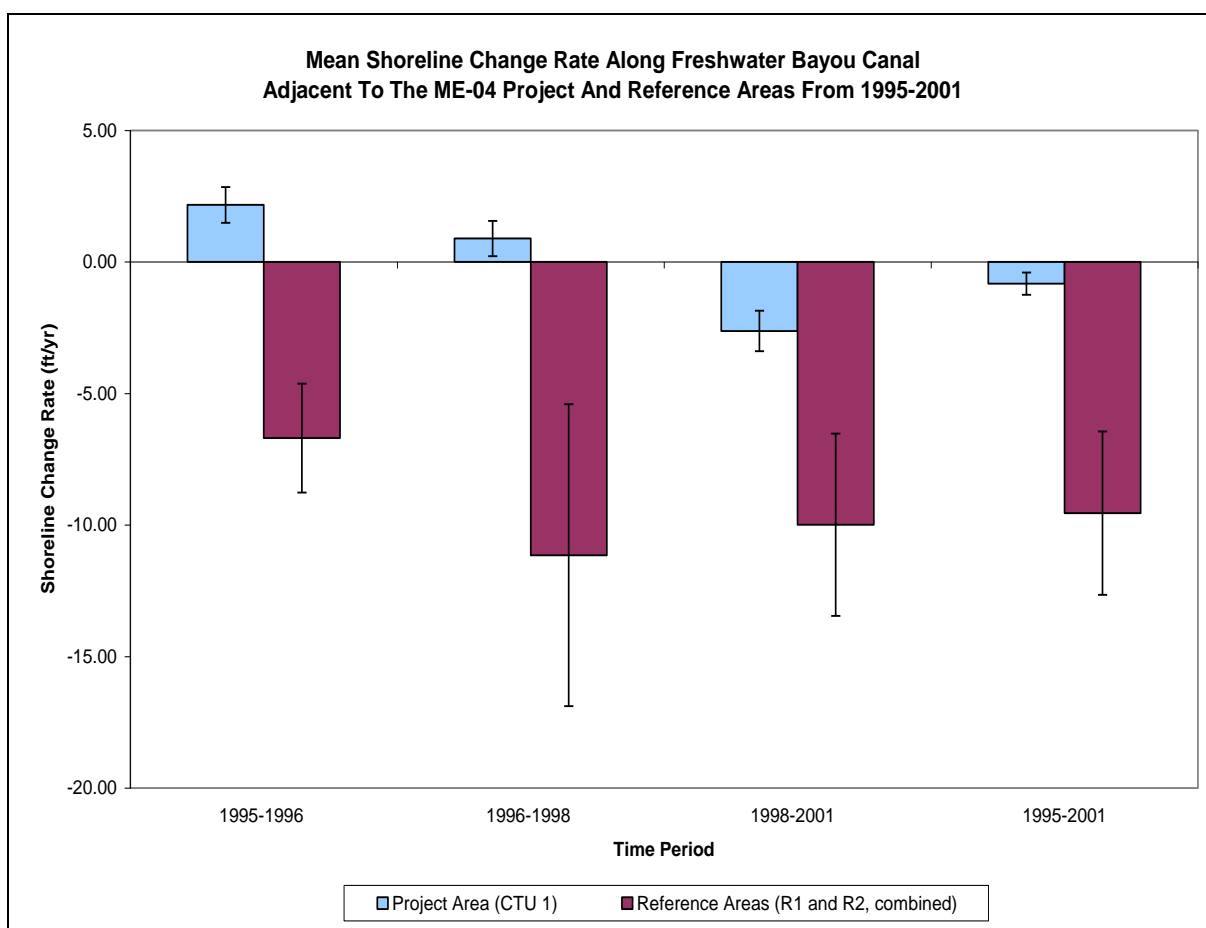
The project area shoreline prograded an average of 2.17 ft/yr (0.66 m/yr) between June 1995 and July 1996 (figure 8), and an average of 0.89 ft/yr (0.27 m/yr) between August 1996 and February 1998, but eroded an average of -2.62 ft/yr (-0.80 m/yr) between March 1998 and May 2001 (figure 8). Overall, the average shoreline change rate on the west canal bank behind the rock dike was -0.83 ft/yr (-0.25 m/yr) between June 1995 and May 2001.

Conversely, erosion was documented at all six reference area monitoring stations on each survey conducted, averaging -6.69 ft/yr (-2.04 m/yr) between April 1995 and July 1996, -11.15 ft/yr (-3.40 m/yr) between August 1996 and February 1998, and -9.99 ft/yr (-3.05 m/yr) between March 1998 and May 2001 (figure 8). Overall, the average shoreline change rate along the two reference areas on the east canal bank was -9.55 ft/yr (-3.03 m/yr) between June 1995 and May 2001.

Figure 8. Mean shoreline change rate along Freshwater Bayou Canal adjacent to the ME-04 project and reference areas from 1995-2001.

Shoreline along the west bank of FBC in the project area has benefited from the construction of the rock dike, as indicated by the significantly reduced erosion rates relative to the reference areas. However, the rate of erosion increases when the elevation of the rock material sinks below the originally constructed top elevation, as noted in 2001. Maintenance events in 2002 and 2005 lifted the rock dike back to the prescribed elevations. However, a large breach has occurred at the Transco Pipeline exposing the interior marsh of CTU 1 to the tidal effects of Vermilion Bay, which was already severely impacted by Hurricanes Rita and Ike. A maintenance event is planned to cap the existing rock dike and the breach at the Transco Pipeline will be addressed at that time.

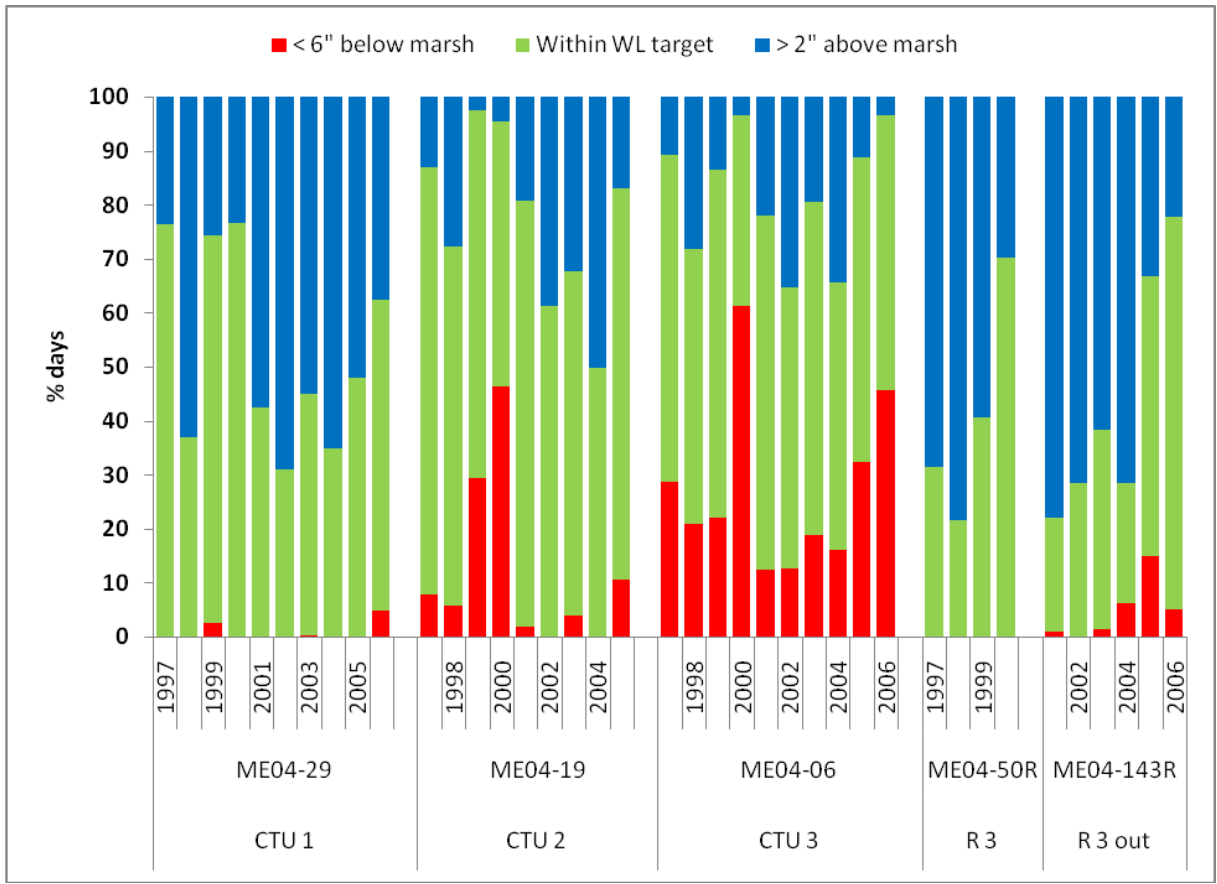
The goal to reduce water levels to within the target range of 6 in (15 cm) below to 2 in (5 cm) above marsh level was not met. Water levels in the project area were within the target range less than 50% of the year during 10 years of project-specific data collection. However, project area water levels were within the target range a greater percentage of time than the reference area (figure 9).

In general, when reference area water levels were out of the target range, they tended to be greater than 2" above the marsh surface. Project area water levels were less than 6" below marsh surface more often than reference stations. This would be expected since the reference area stations are located along major waterways and are subject to higher tidal amplitude, while the three project area stations are located in interior marsh areas influenced by water control structures. Water levels were higher during all years in the project area compared to the reference area (Vincent 2003).

Figure 9. Percentage of days per year water levels were inside and outside of target range within the project and reference areas at project-specific stations.

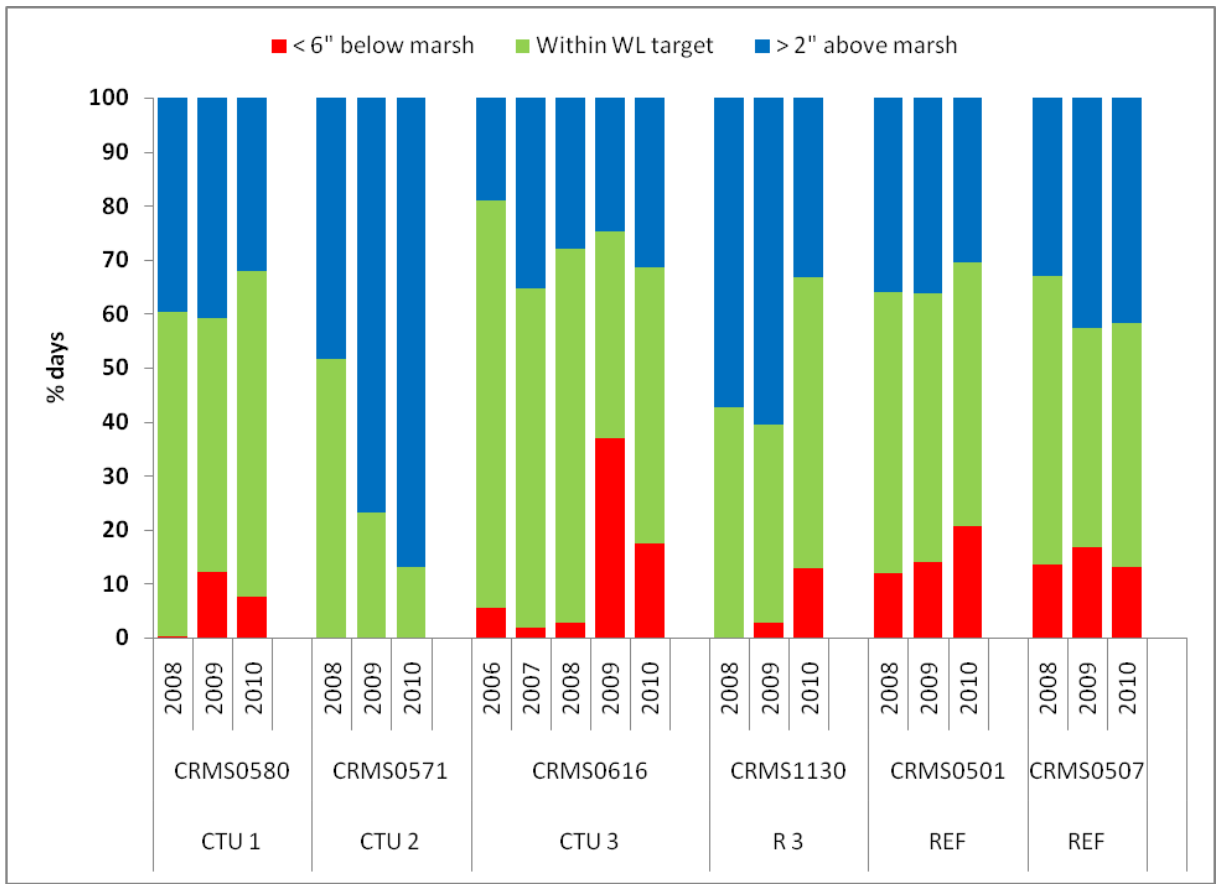
This trend continued through 2010 at the CRMS sites (Figure 10). The CRMS sites chosen as reference had nearly identical water levels to project area sites 580 and 616. Site 571 (in the northeastern part of CTU 2) had very high water levels compared to the other stations.

Figure 10. Percentage of days per year water levels were inside and outside of target range within the project and reference areas at CRMS stations.

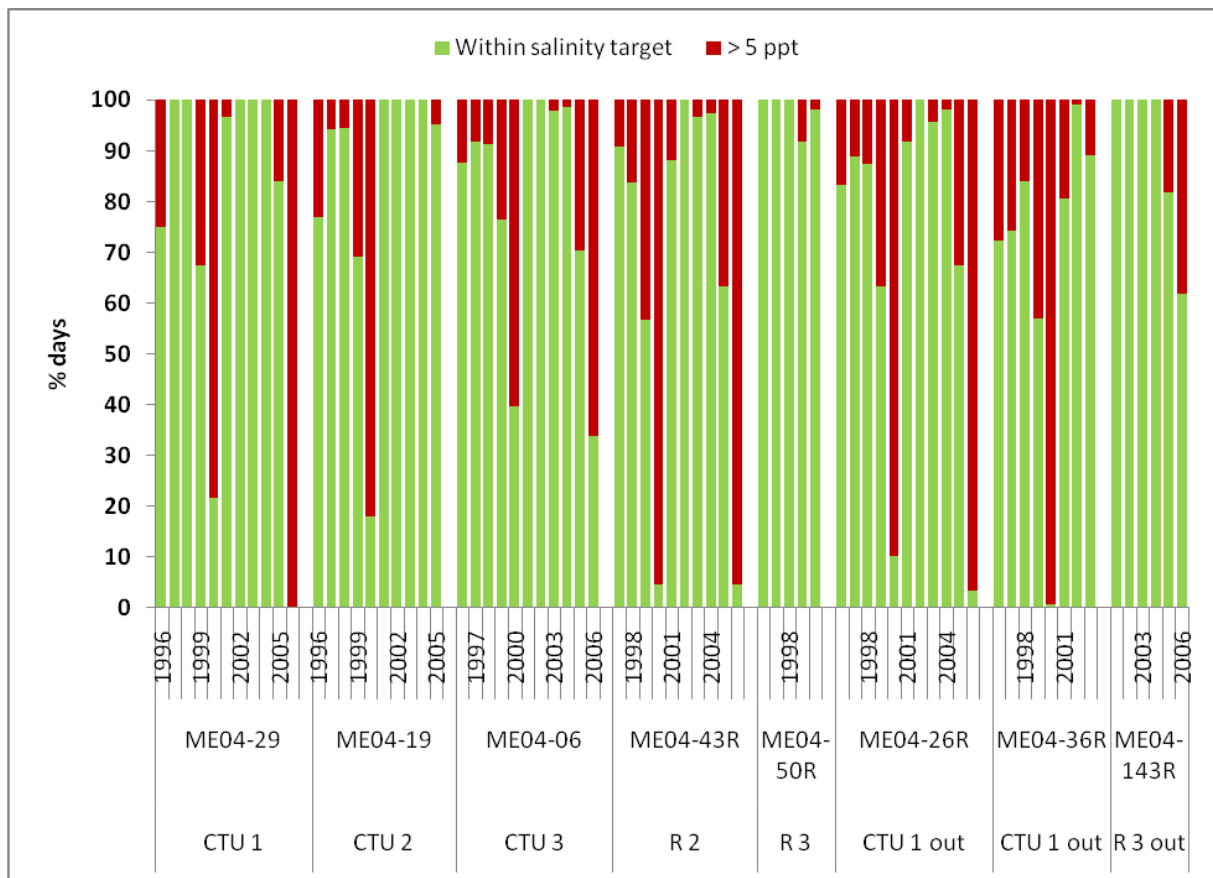
Figure 11. Percentage of time that project and reference area salinities were above the target range of 5 ppt at project-specific stations.

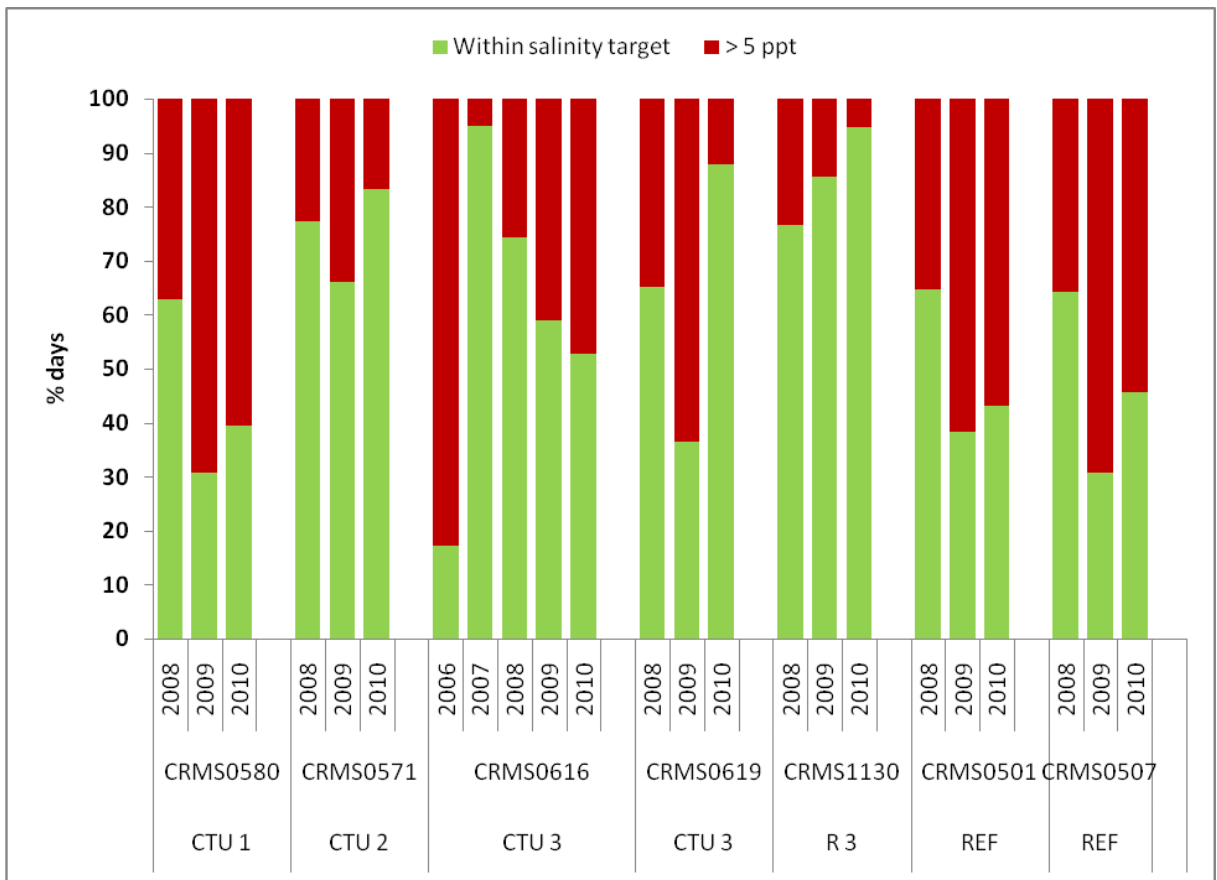
Figure 12. Percentage of time that project and reference area salinities were above the target range of 5 ppt at CRMS stations.

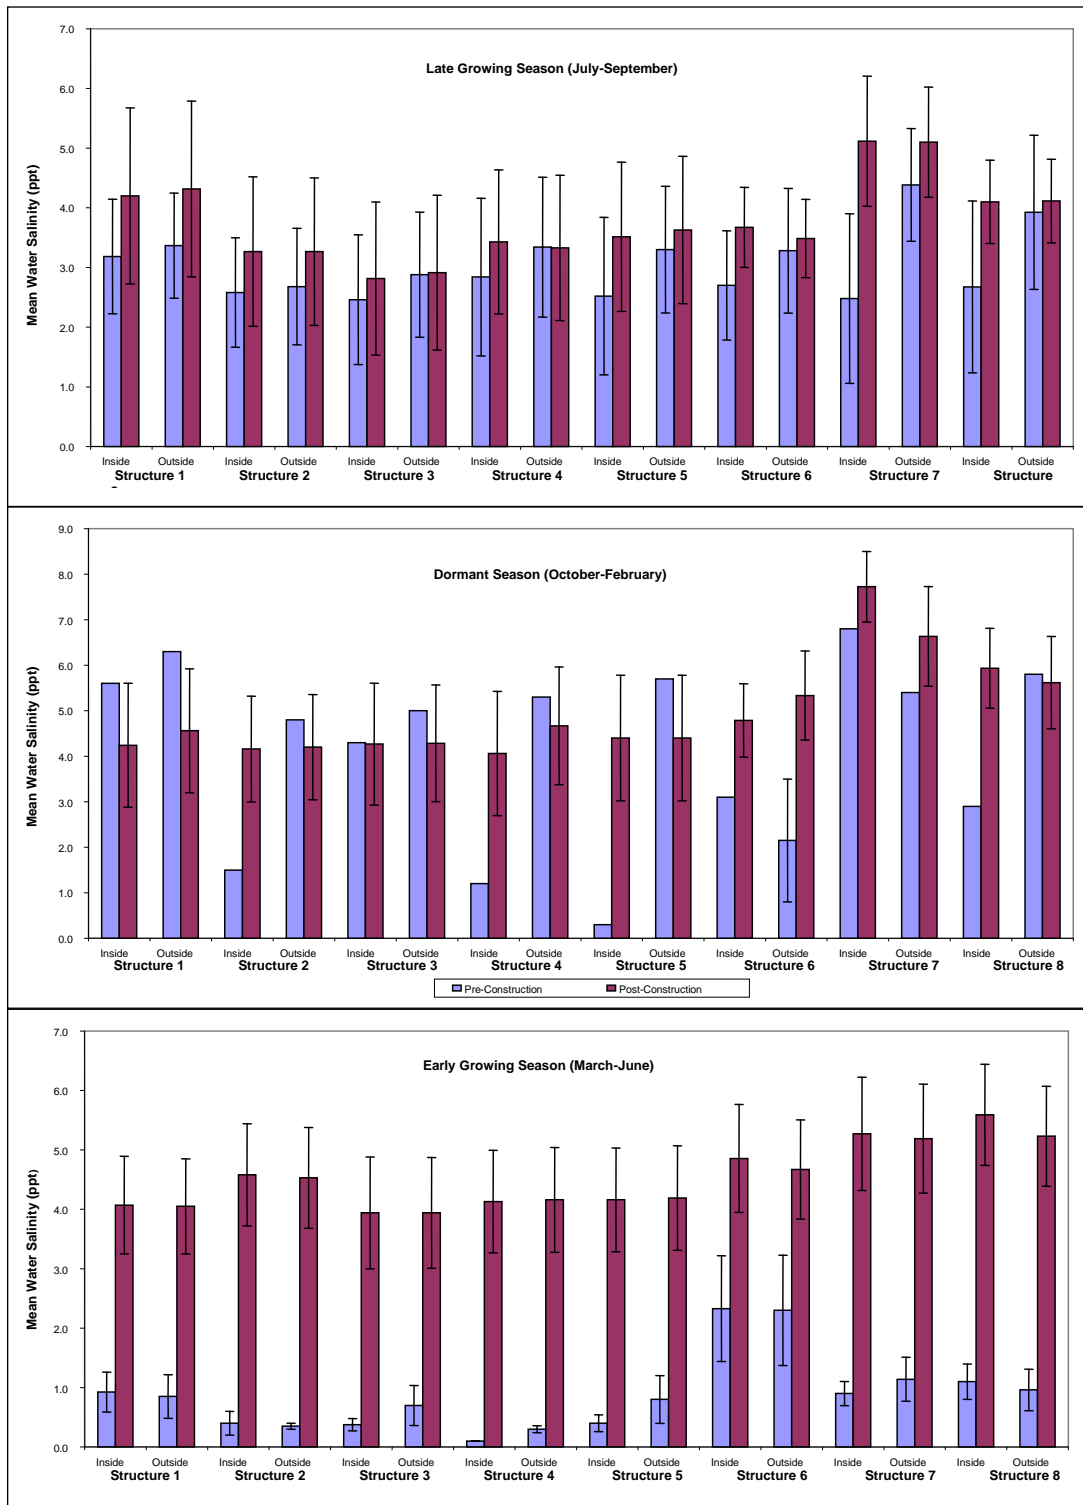
Discrete monthly water salinity readings taken at the eight CWPPRA structure sites do show that water salinity “inside” and “outside” of the structures was higher during the post-construction period than during the pre-construction period at all eight structures (figure 13).

Figure 13. Comparison of mean seasonal water salinity (ppt) inside and outside of the 8 CWPPRA structures at ME-04 during the pre-construction (March 1996-September 1998) vs. the post-construction (October 1998-May 2002) time periods. Error bars represent ± 1 standard error.

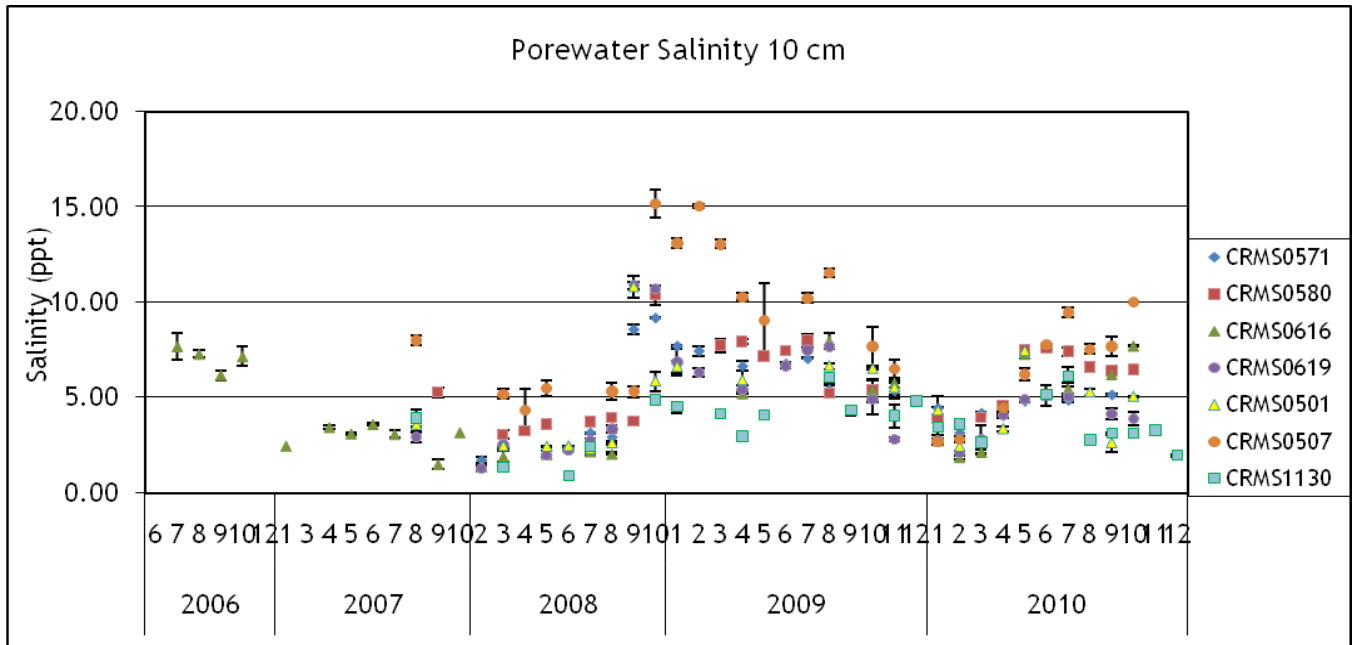
Means by month of interstitial water salinity at the CRMS sites is presented in Figures 14a and 14b. The highest salinities occurred at reference station 507, located on the east side of Freshwater Bayou, averaging around 9 ppt, while the lowest occurred at 1130 in Reference area 3, averaging under 5 ppt. Generally, interstitial salinities in the project area were below 5 ppt at the 10 cm level prior to Hurricane Ike. Since Hurricane Ike, salinities at the 10 and 30 cm levels have remained above 5 ppt except for a few months in the early part of 2010.

Figure 14a. Interstitial water salinity at 10 cm below the soil surface. Error bars, where present, represent the means of stations in that class for that month ± 1 Std Err.

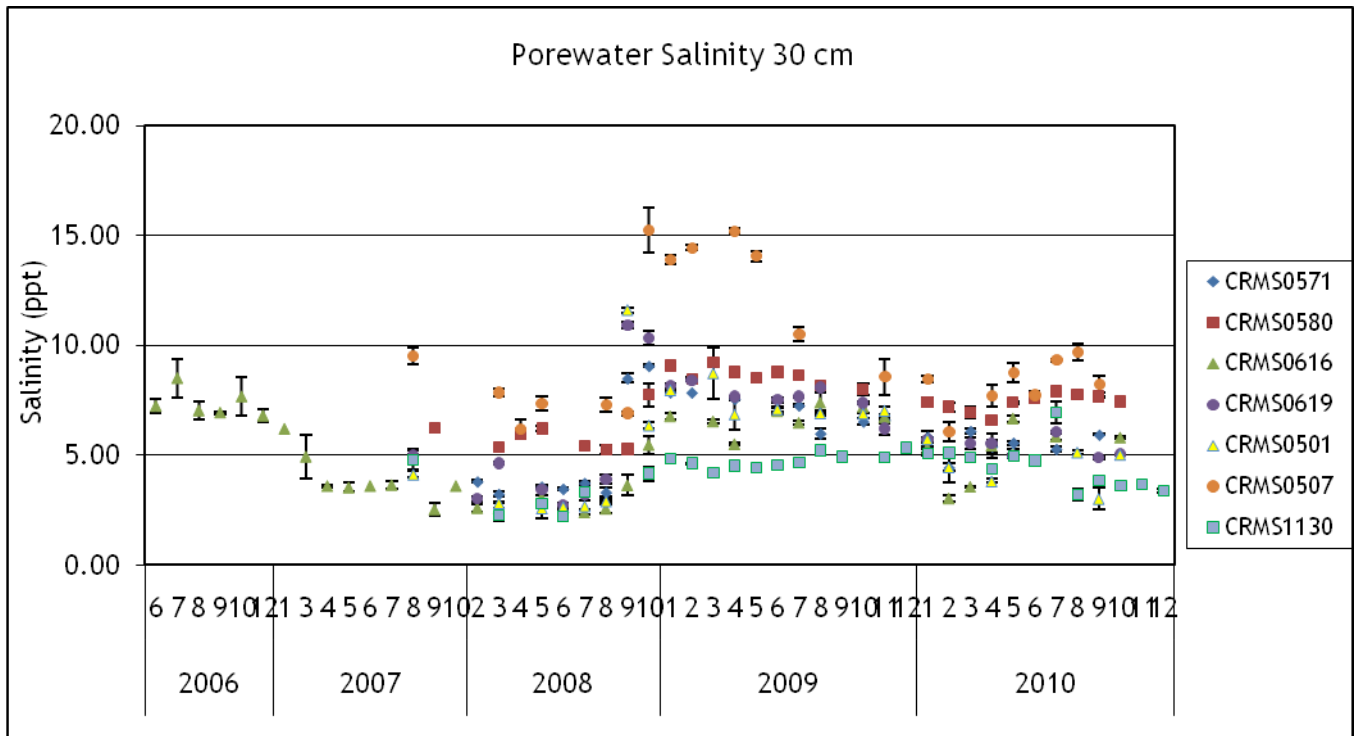
Figure 14b. Interstitial water salinity at 30 cm below the soil surface. Error bars, where present, represent the means of stations in that class for that month ± 1 Std Err.

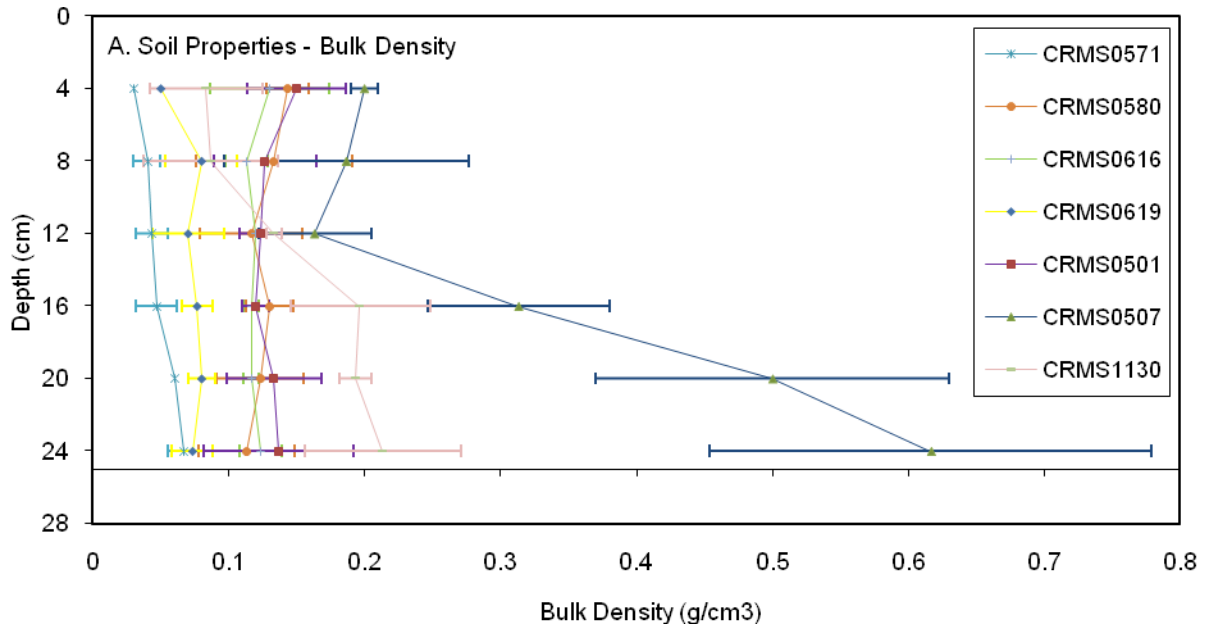
Soil cores were collected one time (within a year of site establishment) to describe soil properties (bulk density and percent organic matter). Three, 4" (10.16-cm) diameter cores were collected to a depth of 24 cm and divided into 6, 4-cm sections at the site. All cores were sampled after Hurricane Rita. Figures for mean bulk density and percent organic matter (OM%) by CRMS station are presented in Figures 18a and 18b. Bulk density profiles are similar for all stations except 571 which has higher bulk density below 16 cm. OM% was also highest at site 571. Marsh elevation change and vertical accretion data are being collected at all CRMS sites but the current estimates are preliminary and will not be presented at this time.

Figure 17a. Mean soil bulk density collected at project and reference CRMS stations. Error bars represent standard deviation.

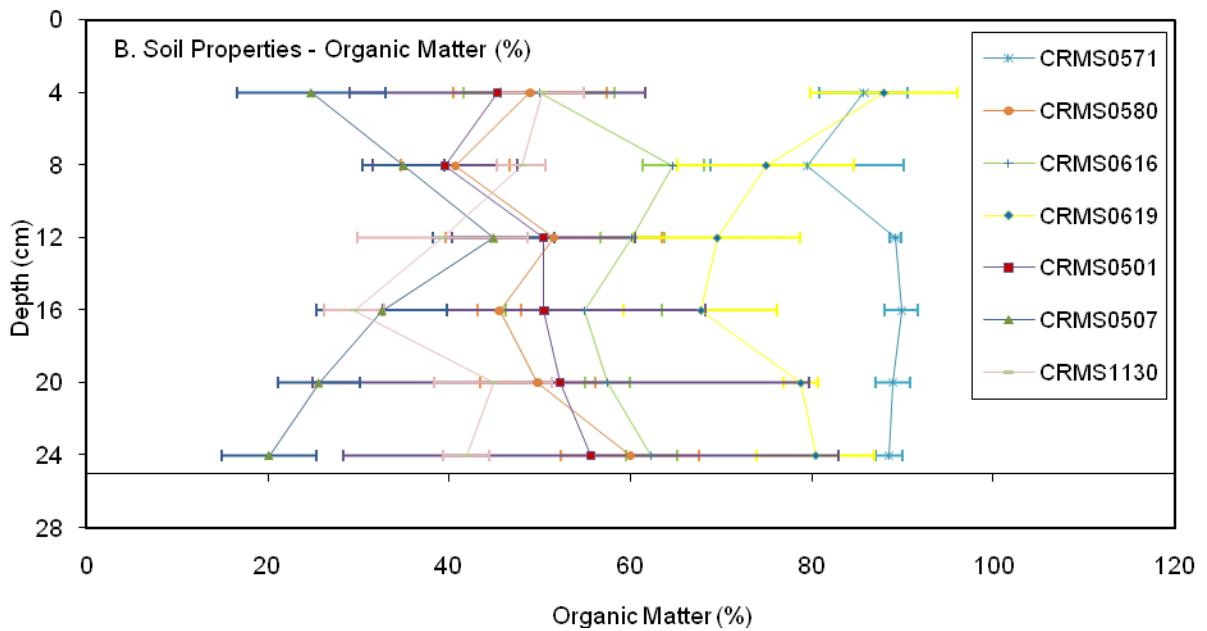
Figure 17b. Mean soil organic matter content collected at project and reference CRMS stations. Error bars represent standard deviation.

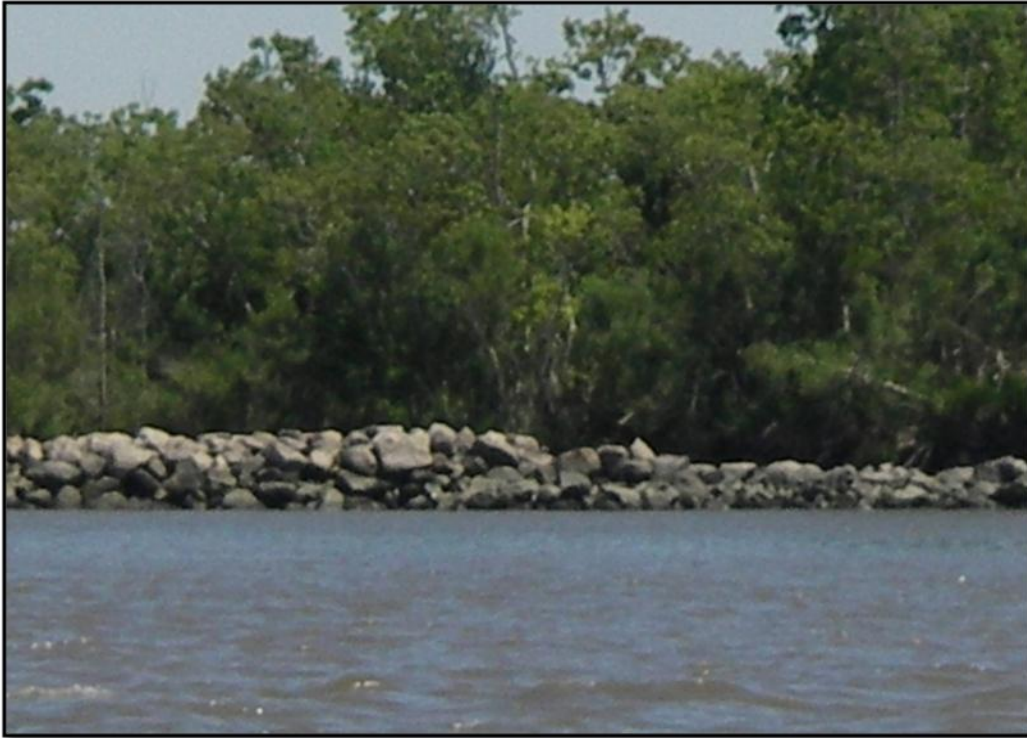
The inspection revealed the 11,420 linear feet of foreshore dike repaired in the 2005 maintenance project is in good condition. The additional 2,000 linear feet of foreshore rock dike have sections below elevation 4.0' NAVD and have recently been surveyed by NRCS personnel. An estimate will be prepared based on this survey data of what it will take to restore these sections of dike to original elevation. The funding request will be submitted to CWPPRA in 2012. (Photos: Appendix A, Photos 1 & 2)

Photo No. 1, Typical rock dike

Overall the Freshwater Bayou Wetlands Project structural components are in good condition. The 2,000 linear feet of foreshore dike mentioned above will be addressed in an upcoming maintenance event as well as the breach at the Transco Pipeline location. A funding request will be submitted to CWPPRA in 2012.

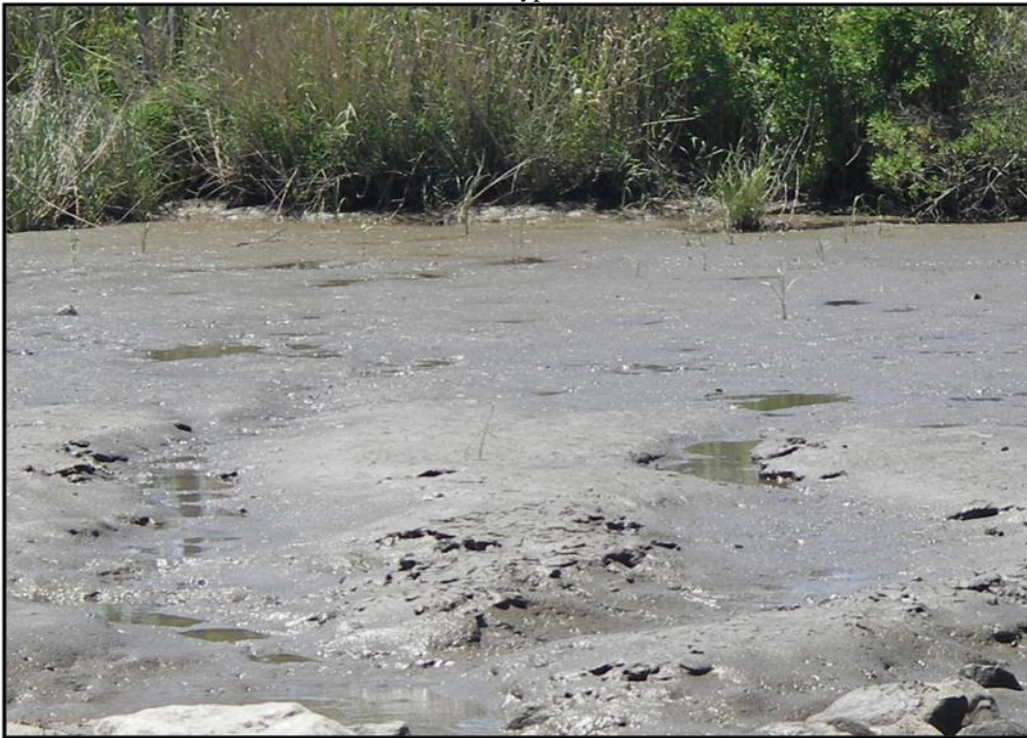
Photo No. 2, View showing accretion behind rock dike
