**2011 Operations, Maintenance,
and Monitoring Report**

Sabine Refuge Marsh Creation

State Project Number CS-28
Priority Project List 8

July 2011
Cameron Parish

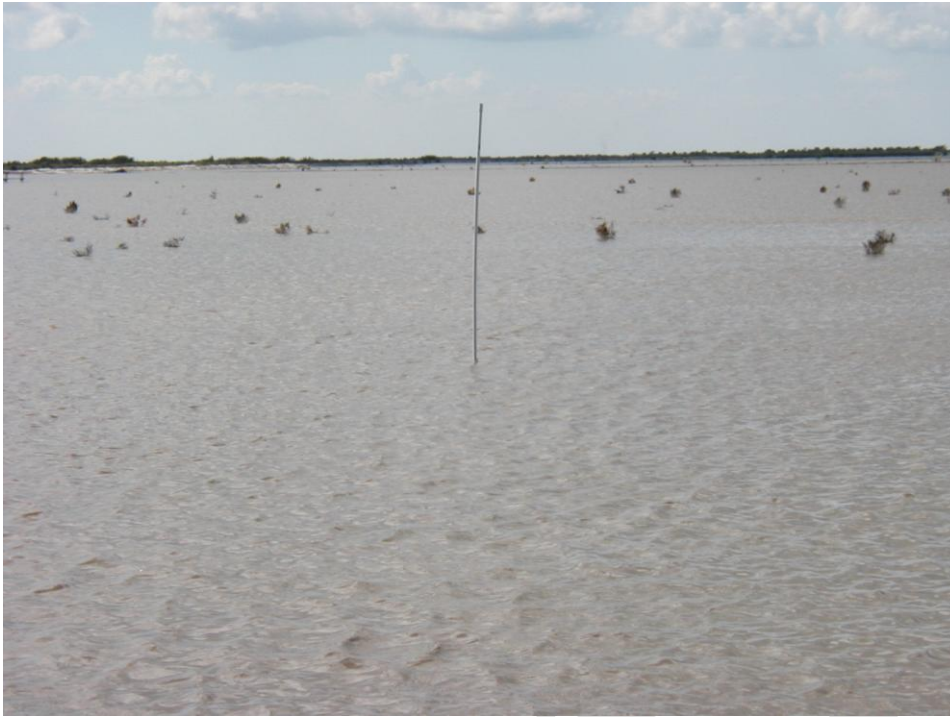
Figure 5. Photograph of vegetation station (CS28-205) in the Cycle 1 deposition area at time of establishment (September, 2002). The plants in the background are *Salicornia bigelovii*.

Vegetation stations were established in Cycle 1 post construction in 2002 while the cell was still a mudflat (figure 5). *Spartina alterniflora* was planted along the edges of Cycle 1 in 2002. By 2004, the Cycle 1 area was dominated by *Spartina alterniflora* over five feet tall (figure 6). The dredge material probably contained mineral rich clays that *S. alterniflora* was responding to. Hurricane Rita knocked back Cycle 1 vegetation significantly (figure 7). The immediate hurricane impact was much stronger in the project area than in the reference (figure 8). The Cycle 1 deposition area recovered quickly from Hurricane Rita in total cover (figure 9), height of dominant species (figure 10), and continued to slowly increase in species richness (figure 11).

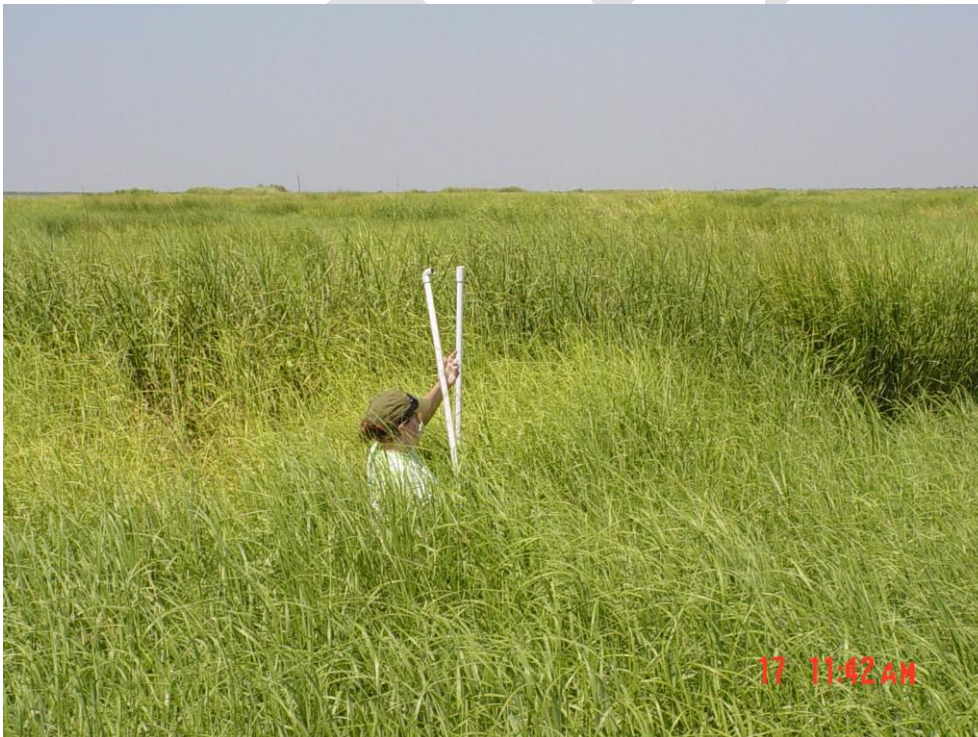
Figure 6. Photograph of vegetation station (CS28-205) in the Cycle 1 deposition area two years after construction (August, 2004).

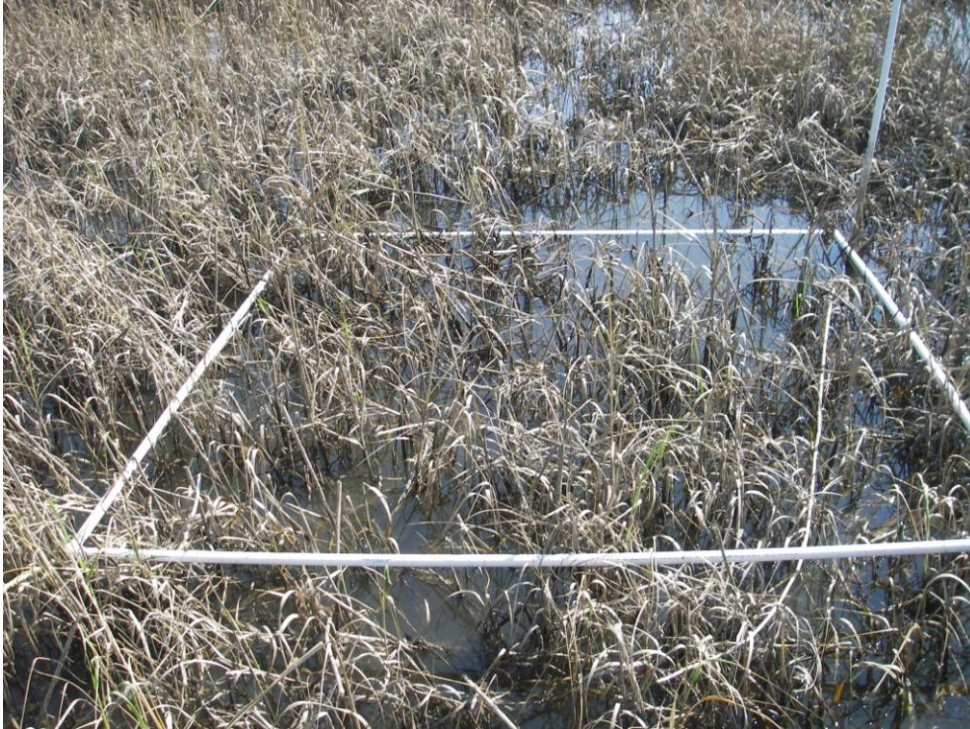
Figure 7. Photograph of vegetation station (CS28-200) in the Cycle 1 deposition area six weeks after Hurricane Rita and three years after construction (October, 2005).

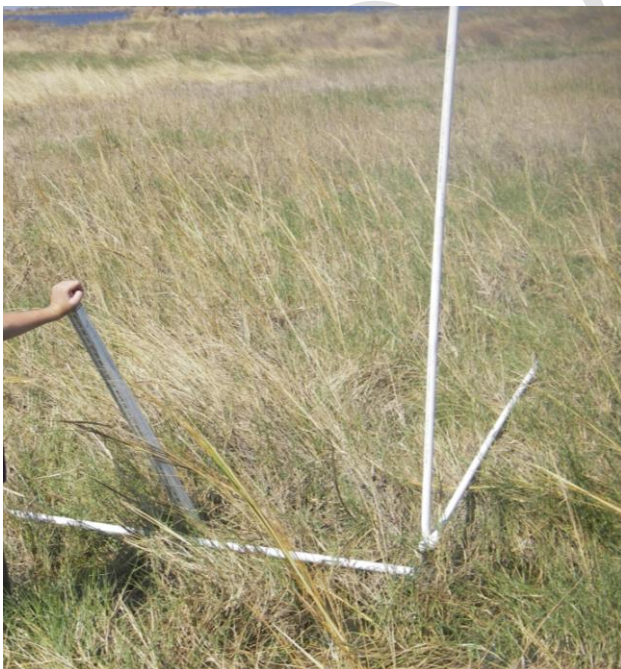
Figure 8. Photograph of vegetation station (CS28-150) in the reference area six weeks after Hurricane Rita (October, 2005).

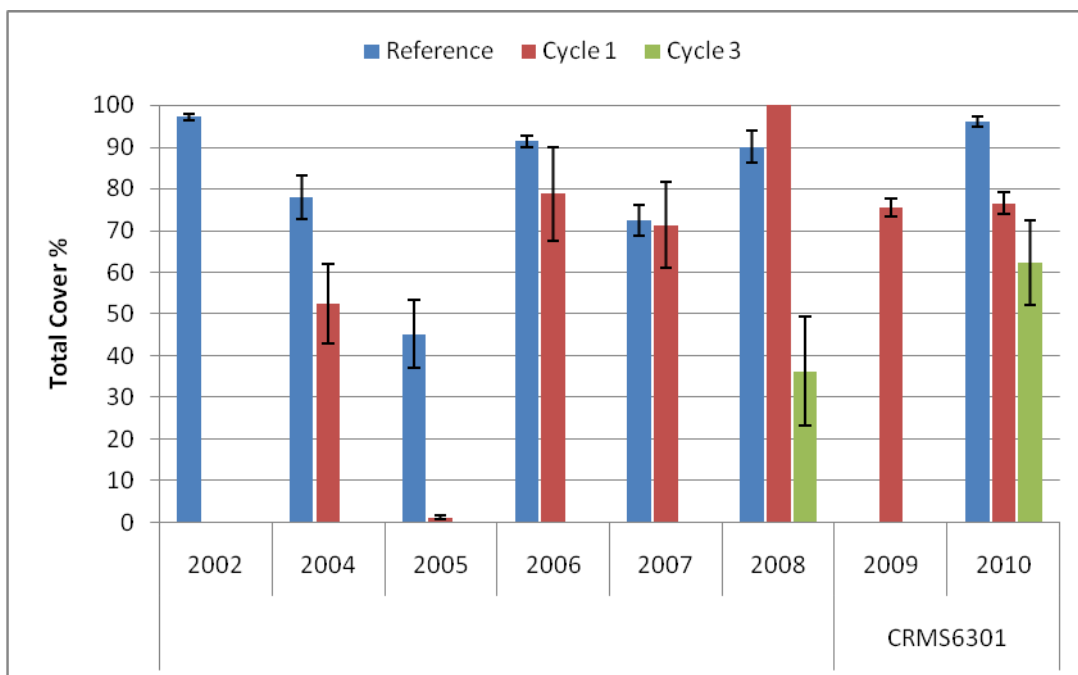
Figure 9. Total percent cover of emergent vegetation in the CS-28 project cycles and reference area. Mean \pm SE.

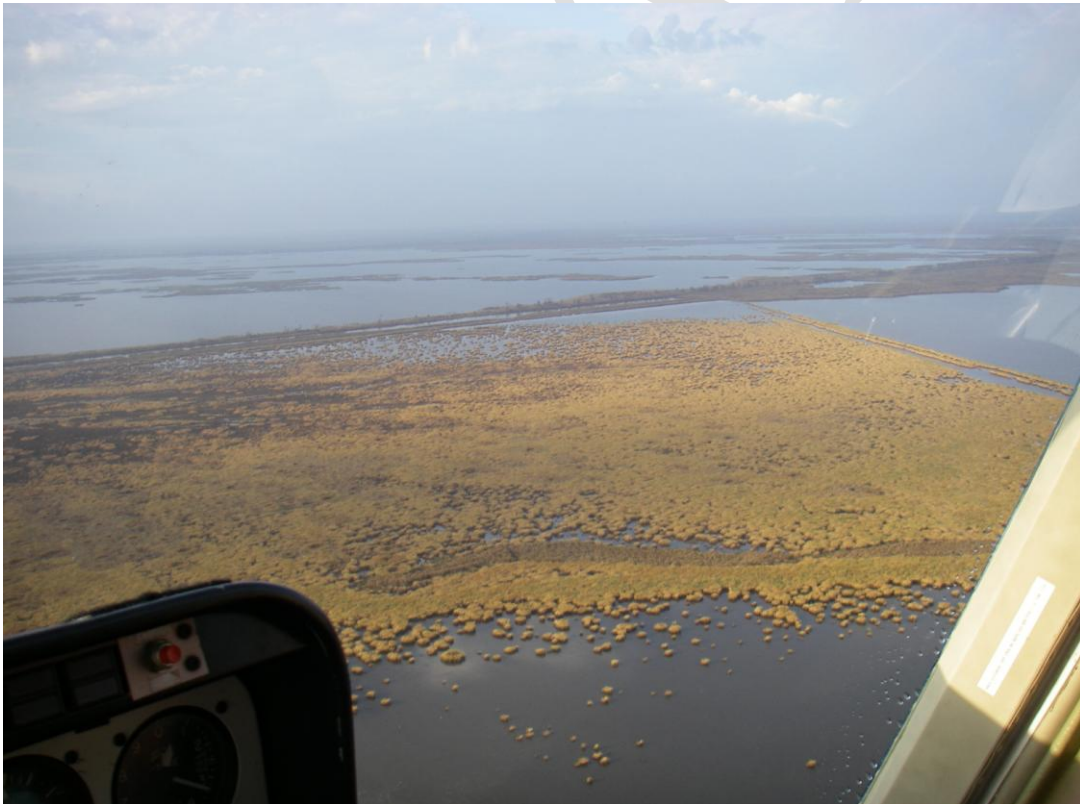
Figure 12. Cycle 3 as seen from the air in October 2008.

Cycle 3 was pumped in 2007 and had begun to vegetate prior to the first measurements in 2008 (figure 12). The species assemblage in Cycle 3 was slightly different than in Cycle 1 in the first couple of years (figure 13). Cycle 1 was essentially a monoculture of *S. alterniflora* while Cycle 2 had some stands of *Salicornia depressa*. We can assume the difference was due to the plantings (which were not installed in Cycle 3). The assumption that the cell would vegetate from seed appears to have been correct. In fact, there was as much cover in Cycle 3 after one year as there was in Cycle 1 after two years. It will be interesting to see whether the community that develops in Cycle 3 is similar to Cycle 1. It will take a long time for either area to be as diverse as the reference area although Cycle 1 did begin to see more species in 2009. The main difference between Cycle 1 and the reference area is the absence of *Spartina patens*.

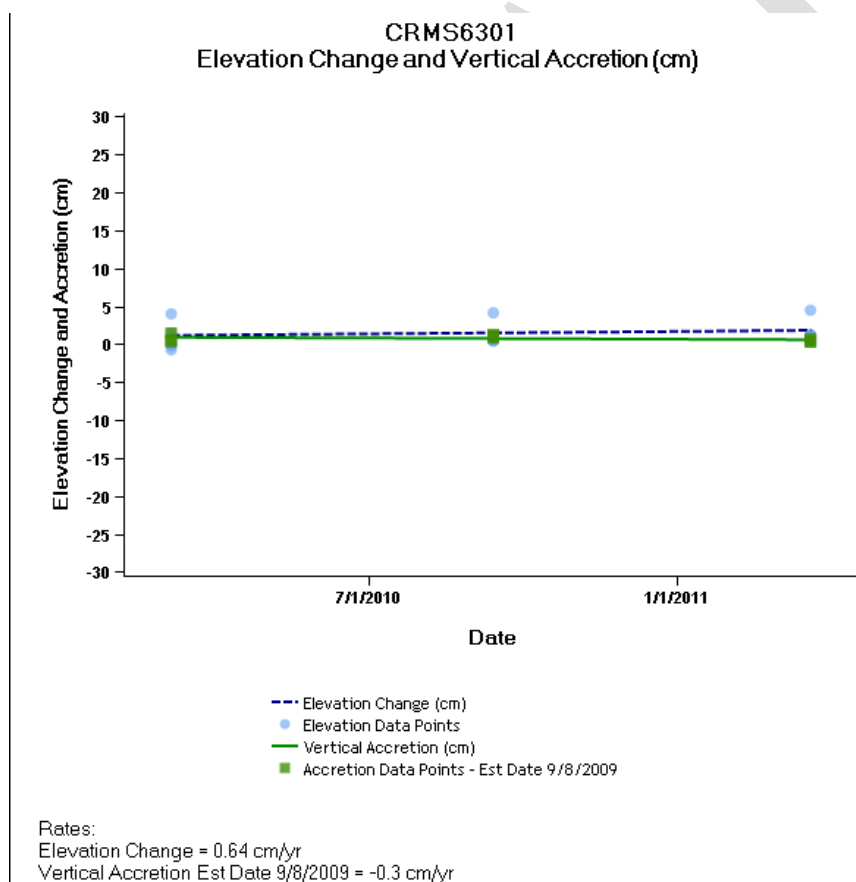
Figure 14. Very preliminary elevation change and accretion rates from CRMS6301 in the Cycle 1 dredge deposition area.

Very preliminary elevation change rates are available from CRMS6301. Elevation change and accretion rate data collected over less than five years should be used very carefully but for the purposes of this report, it appears that elevation has been holding steady or slightly increasing (<1 cm/yr) since 2009 suggesting the dredge in Cycle 1 is no longer settling (figure 14).
