**State of Louisiana
Coastal Protection and Restoration Authority**

2011 Operations, Maintenance, and Monitoring Report

Naomi Outfall Management (BA-03c) and Barataria Bay Waterway East Side Shoreline Protection (BA-26)

State Project Numbers BA-03c and BA-26
Priority Project Lists 5 and 6

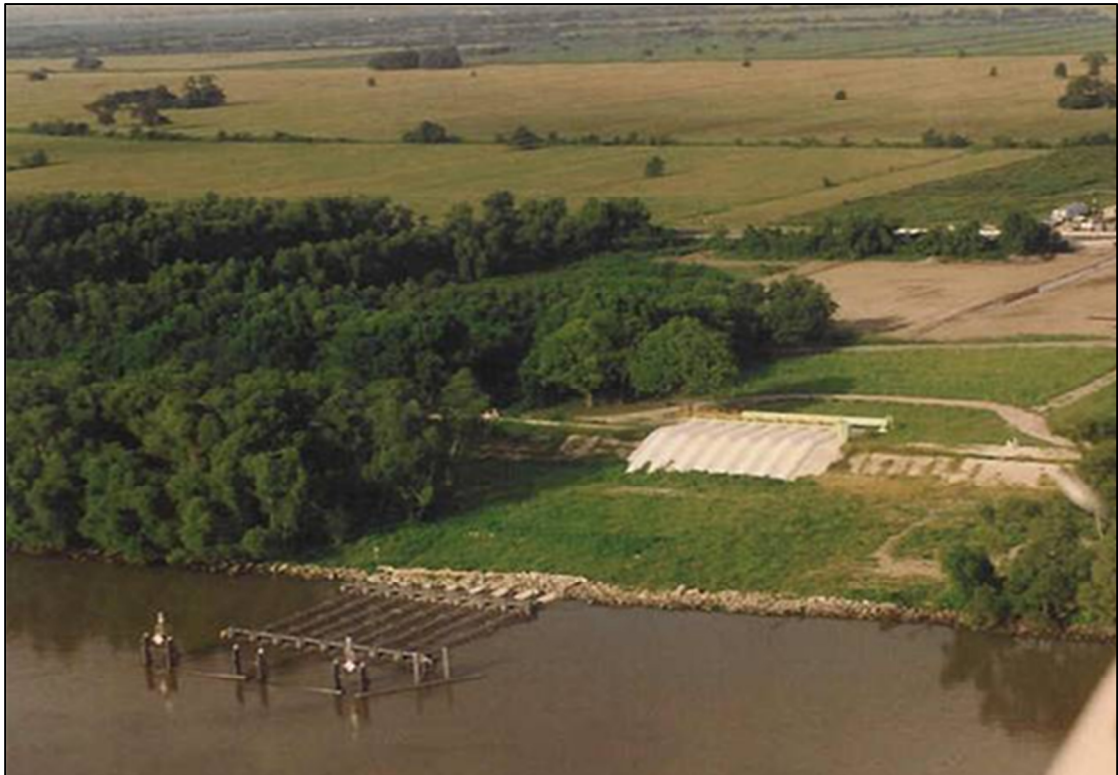
Figure 1. Naomi Siphon Diversion (BA-03). Water is siphoned from the Mississippi River, discharged into a ponding area (not visible in this photograph), and distributed through a single channel into the surrounding marshes.

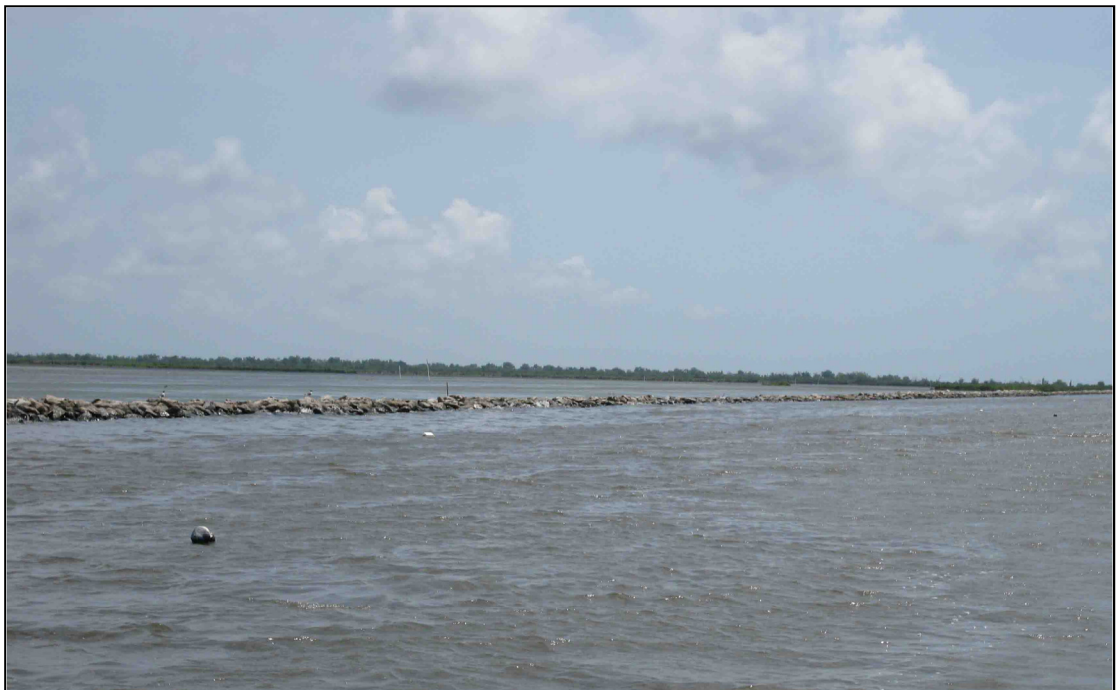
The BA-26 project includes approximately 17,100 linear feet (3.2 miles) of foreshore rock dike bank line protection and an earthen hydrologic barrier created from dredged material from the BBW placed to the east along the rock dike within the project area (Figure 3). The rock structure was constructed with an expanded clay core to reduce its overall weight. The clay material was encapsulated in geotextile bags and placed along the centerline of the dike. The dike is intended to re-establish the eastern bank of the BBW and to protect the adjacent marsh from unnatural water exchange and subsequent erosion that is exacerbated by wakes from vessel traffic.

Figure 3. Barataria Bay Waterway East Side Shoreline Protection project (BA-26).

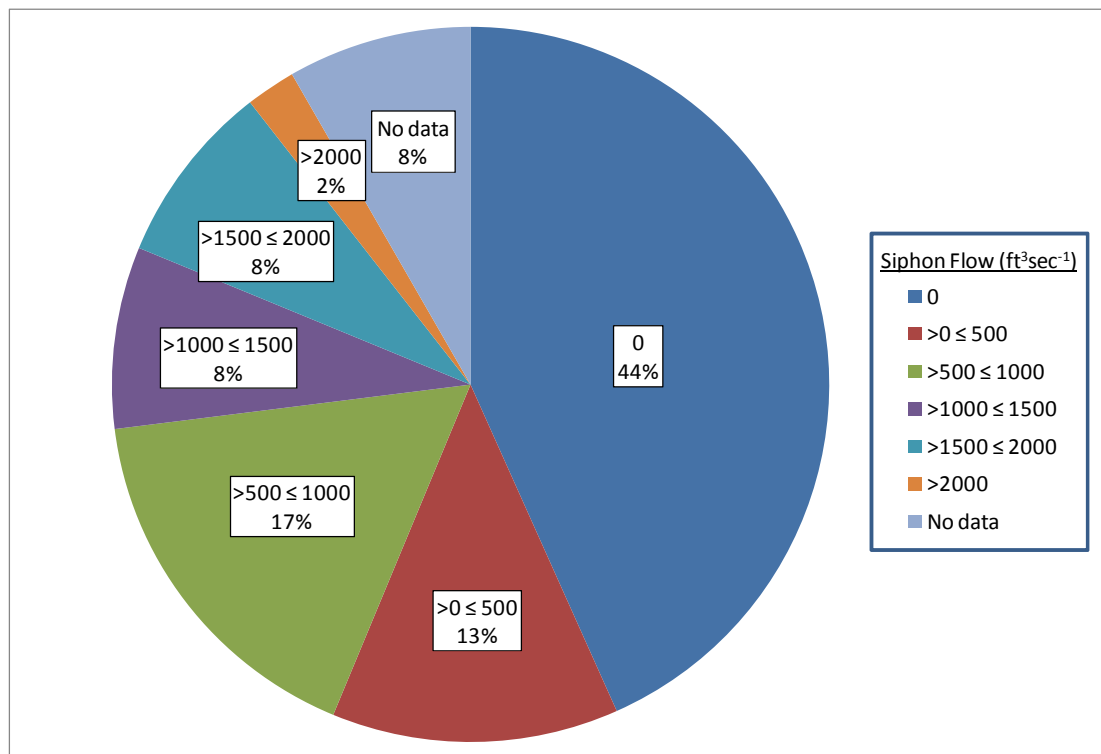
The siphons can discharge $2,144 \text{ ft}^3\text{s}^{-1}$ if all eight siphons are running and the river is at an optimum (high) river stage; however, since the start of operation in 1993, it is estimated that they ran $>1000 \text{ ft}^3\text{s}^{-1}$ only 18% of the time and above $2000 \text{ ft}^3\text{s}^{-1}$ only 2% of the time. When flowing, the siphons have most commonly operated between $500\text{--}1000 \text{ ft}^3\text{s}^{-1}$ (Figure 4). From February 1993–December 2010, the siphons were

Figure 4. Siphon flow at the Naomi siphons between February 1993–December 2010, divided into mean daily flow rates. The percent values are the percent of time the siphons were operating within the stated flow range.

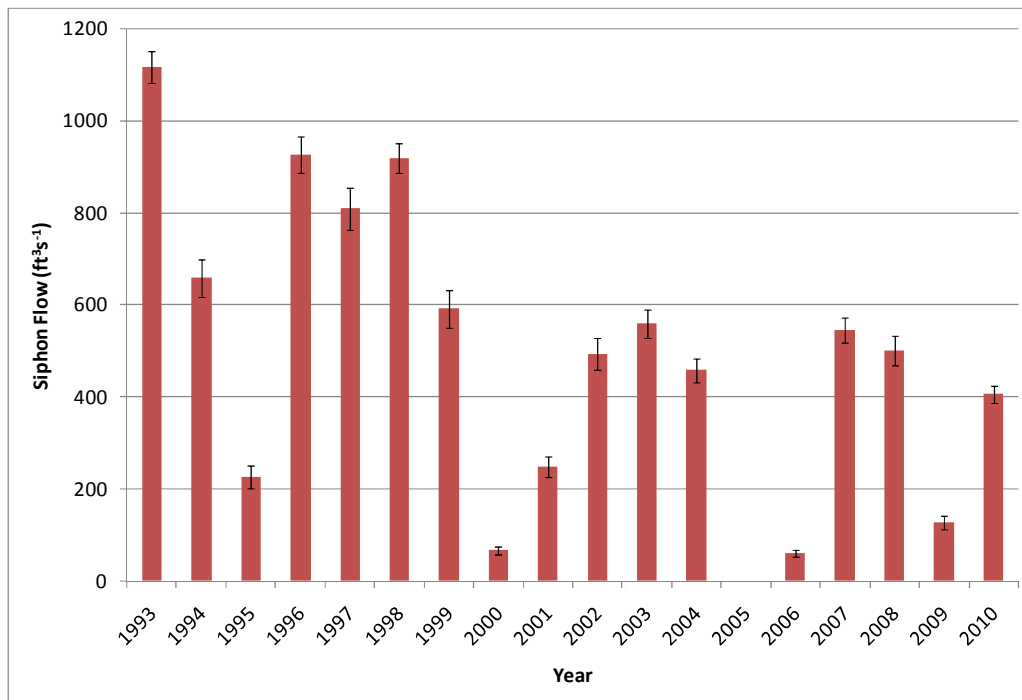
Siphon operations were examined in greater detail by calculating yearly mean siphon flow (Figure 5) and the number of days of major/minor/no flow and no data (Table 1). The maximum flow rate of the siphons is $2,144 \text{ ft}^3\text{s}^{-1}$; therefore, major flow was categorized as flow greater than or equal to half the maximum flow rate ($1072 \text{ ft}^3\text{s}^{-1}$), with minor flow being categorized as less than half the maximum flow rate. The highest annual mean flow rate was $1116 \text{ ft}^3\text{s}^{-1}$ in 1993; this year also had the highest percent of days the siphons were operating (93.7%).

Figure 5. Yearly mean siphon flow (\pm SE) for the Naomi siphons from February 1993–December 2010. Siphons were limited in operation during 1995 (operations), 2000 (drought), 2005–2006 (Hurricane Katrina) and 2009 (maintenance issues).

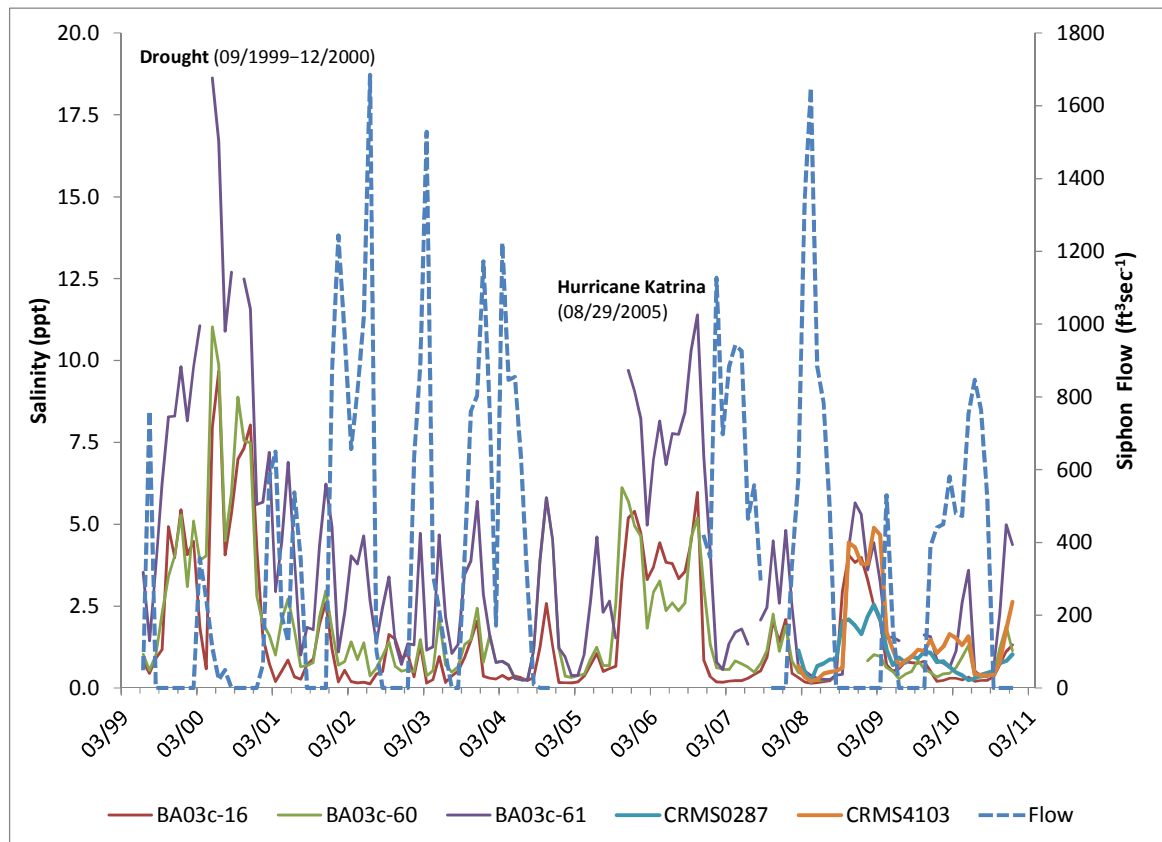
Figure 8. Mean monthly salinity and siphon flow in the BA-03c/BA-26 project area from June 1999–December 2010. CRMS data start February 2008.

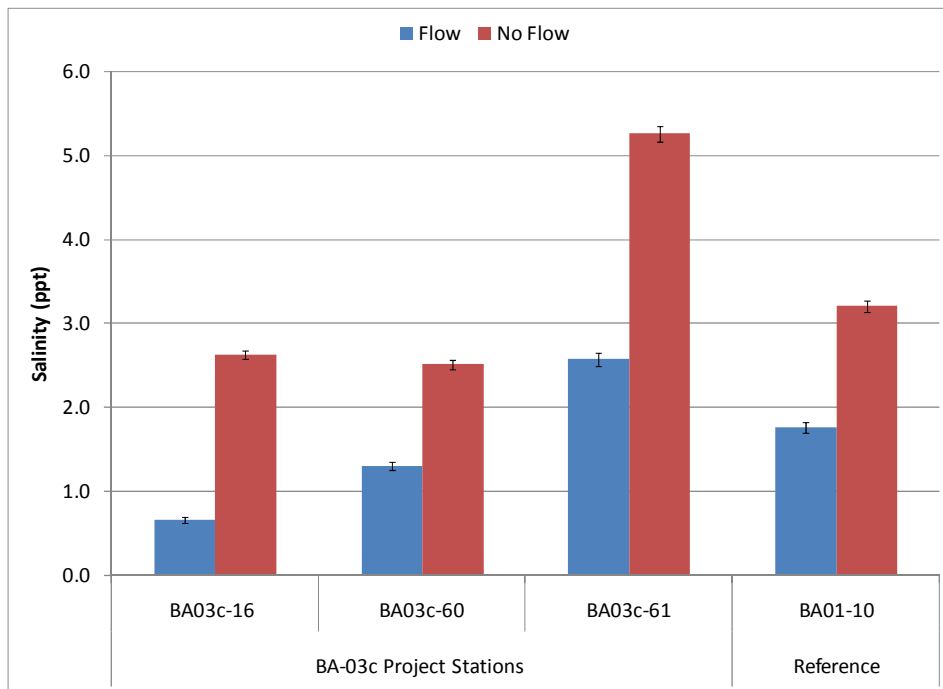
When the siphons were flowing, salinity was lower at the project stations, (Table 2A, Figure 9) CRMS stations (Table 2B, Figure 10), and reference stations. Because the same salinity trend was seen both within the project area and at reference stations, the decrease in salinity is likely a partial factor of naturally lower salinities in the region during times of siphon flow. This is explained by the co-occurrence of the siphons running during times of high river discharge, when natural freshening of the basin typically occurs. Neighboring restoration projects, such as the Davis Pond Diversion, may also influence salinity in the surrounding project area and at reference sites.

Figure 9. Mean daily salinity (\pm SE) at project and reference continuous recorder stations during flow and no flow time periods between June 1999–December 2010.

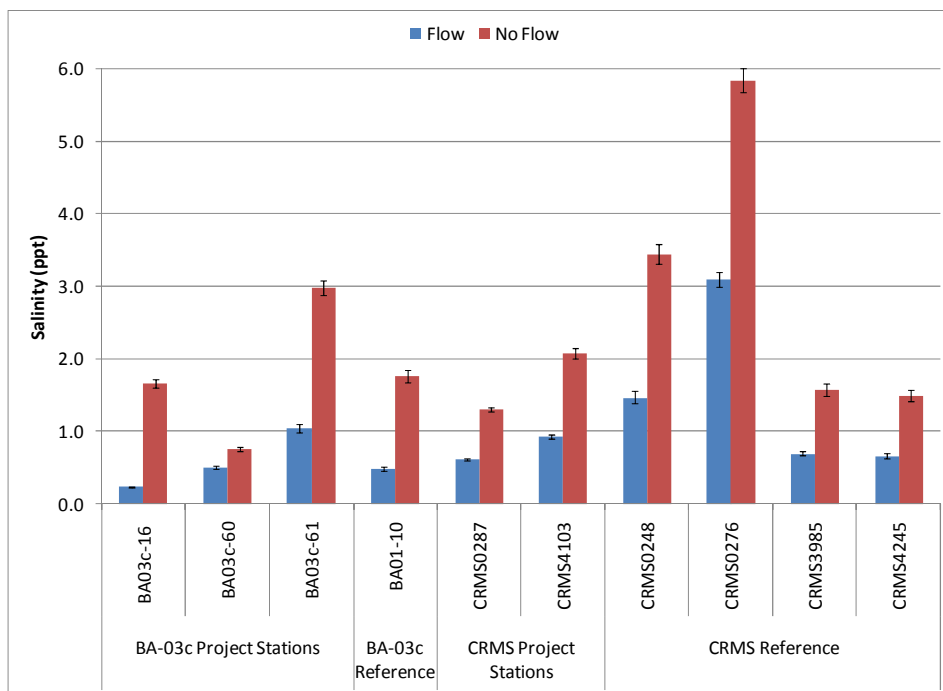
Figure 10. Mean daily salinity (\pm SE) at project, CRMS, and reference continuous recorder stations during flow and no flow time periods between May 2008–December 2010.

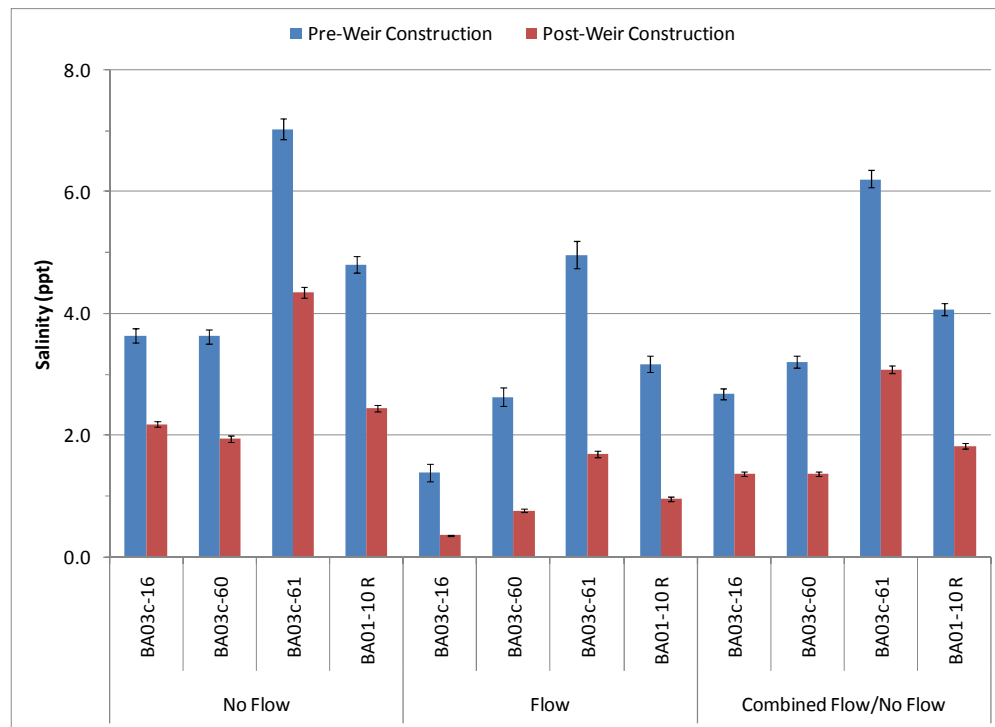
Figure 12. Mean daily salinity (\pm SE) compared pre/post weir construction during periods of flow, no flow, and combined flow/no flow, at project stations within the BA-03c/BA-26 project area and at reference station BA01-10, located on the opposite side of the weirs.

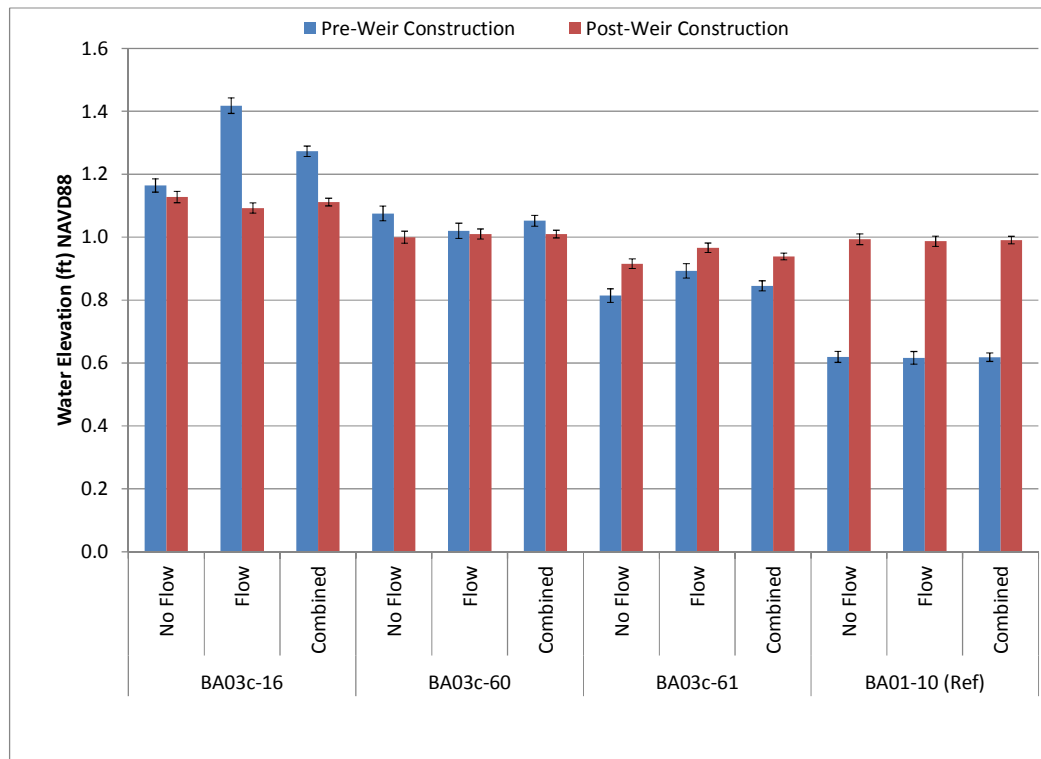
Mean daily water elevation was compared pre- and post-weir installation to detect any effects from the weirs on water elevation within the project area (Figure 15). None of the stations in the project area showed significant increases in water elevation during siphon operation after the weirs were installed ($p>0.05$). The only station that exhibited a significant increase in water elevation post-weir installation was reference site BA01-10, located on the opposite side of the weir ($p<0.05$). As stated previously, reference station BA01-10 lies just within the outer perimeter of the Davis Pond Freshwater Diversion (BA-01) project area. The diversion began operation on July 18, 2002, just three days after construction of the weirs was completed. The increase in water elevation post-weir construction at BA01-10 may partly be due to the effects of the newly introduced diversion waters.

Figure 15. Mean daily water elevation (NAVD88) (\pm SE) compared pre/post weir construction during periods of flow, no flow, and combined flow/no flow within the BA-03c/BA-26 project area and at reference station BA01-10. Pre-weir time period: June 1, 1999–August 14, 2002; post-weir time period: August 15, 2002–December 31, 2010.

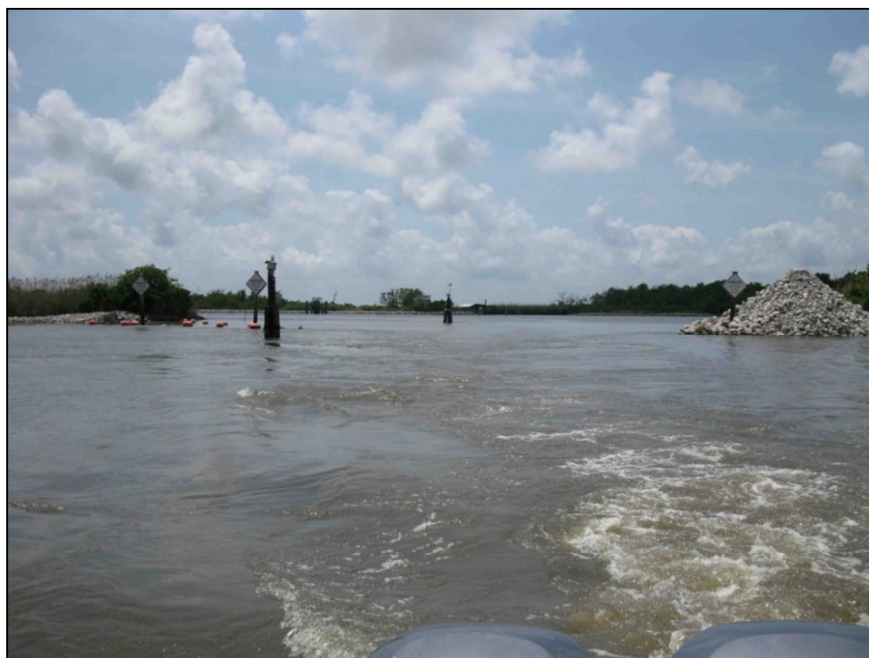
The structure has been altered to facilitate construction of the South Shore of the Pen (BA-41) project. Rock has been temporarily removed from the weir and stored within the footprint of the structure (Appendix A, Photo #1). The structure will be replaced as designed at a later date.

Photo 1. Naomi Outfall Management (BA-03c). Bayou Dupont Canal weir, looking out from the Pen.

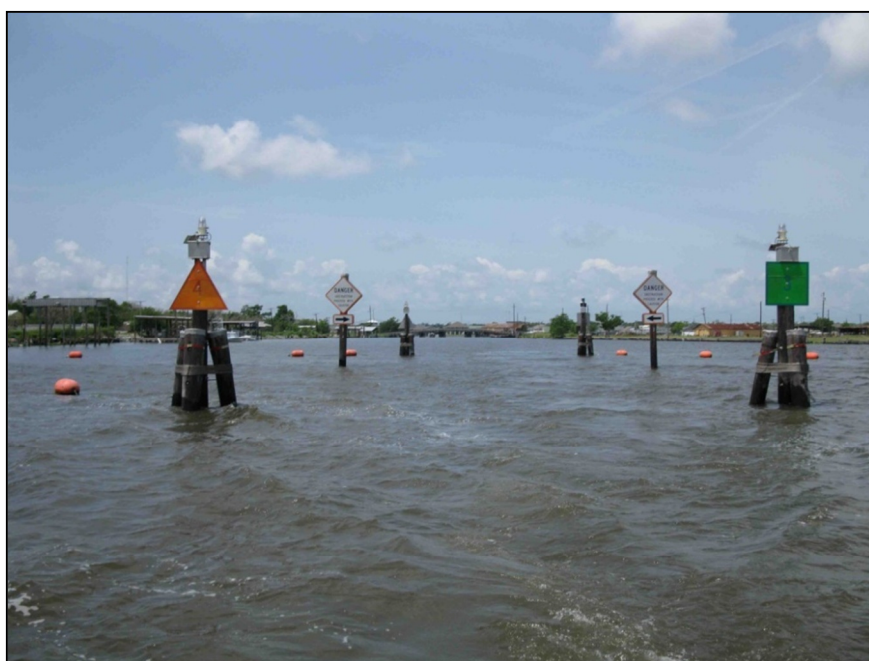
Some of the signs are losing their lettering due to weathering (Appendix A, Photo #2). The orange warning buoys on the north side came loose from the temporary repair and were repaired again before the inspection.

Photo 2. Naomi Outfall Management (BA-03c). Goose Bayou Canal weir, looking west. The weir has settled below the waterline.

After receiving the survey data from the Goose Bayou Canal Weir, it was determined that there is no need to perform maintenance to the rock structure at this time. The marker buoys still need to be repaired and will be done by CPRA this year.

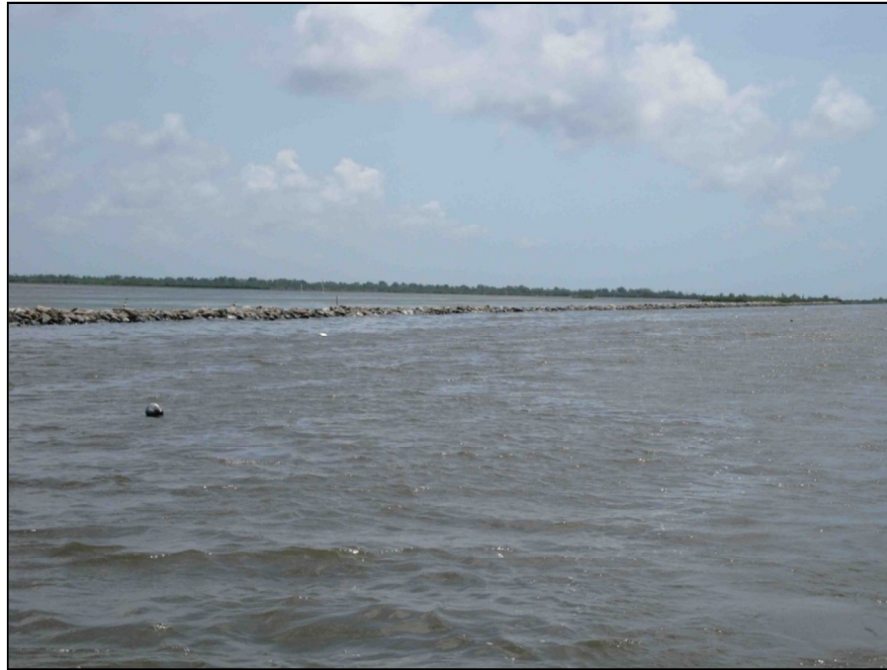
There are no noticeable damages to the rock structure since the previous inspection (Appendix A, Photo #3). More settlement has been observed in front of the marsh creation portion of the South Shore of the Pen Project (BA-41). A small gap in the rock structure was seen at approximate coordinates N29.61380°, W 090.07905°. This gap is probably the result of vandalism and should be monitored (Appendix A, Photo #4). Some accretion and vegetation was observed behind the rock structure at the north end of the project (Appendix A, Photo #5).

Photo 3. Barataria Bay Waterway East Side Shoreline Protection (BA-26).

- No immediate repairs are necessary at this time.

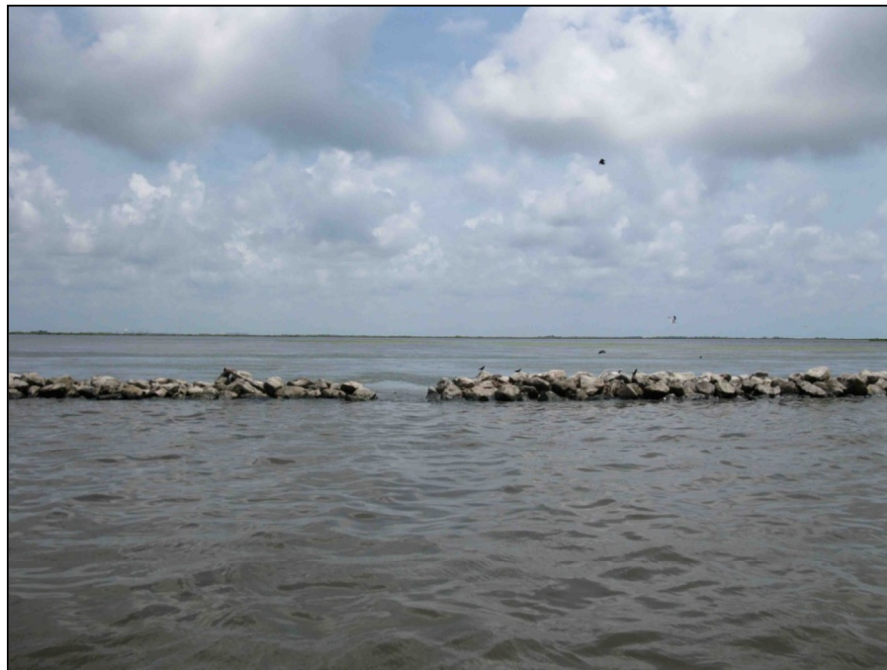
Photo 4. A gap in the rock dike for the BA-26 project.

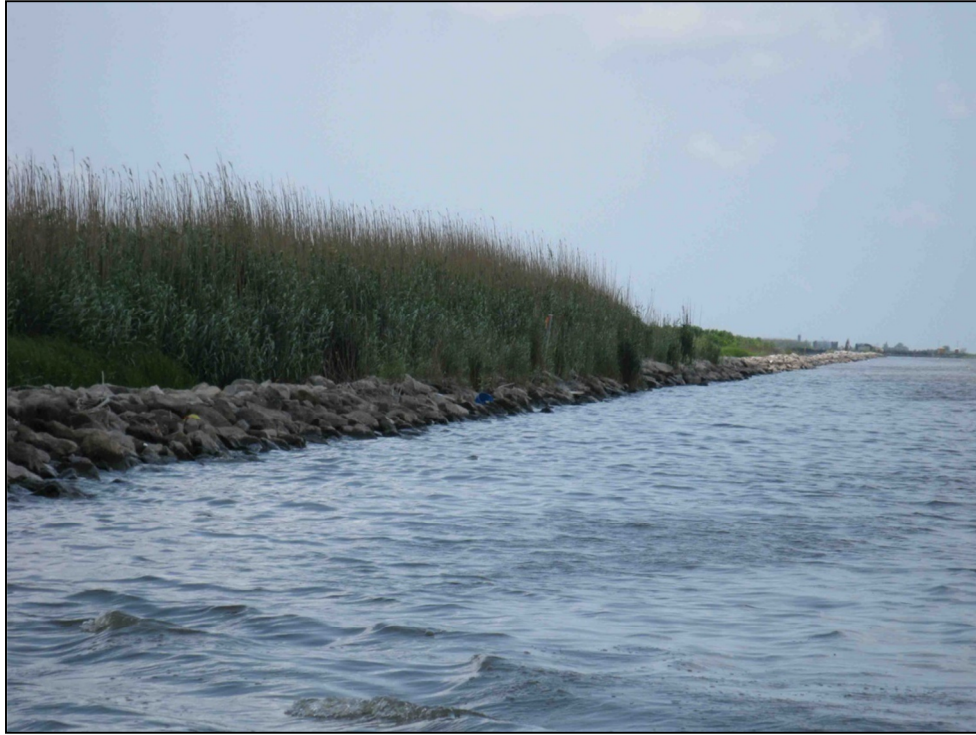
Photo 5. Evidence of accretion behind the rock wall for the BA-26 project.
