## 2012 Operations, Maintenance, and Monitoring Report

### Little Lake Shoreline Protection/Dedicated Dredging Near Round Lake (BA-37)

State Project Number BA-37  
Priority Project List 11

June 2012  
Lafourche Parish

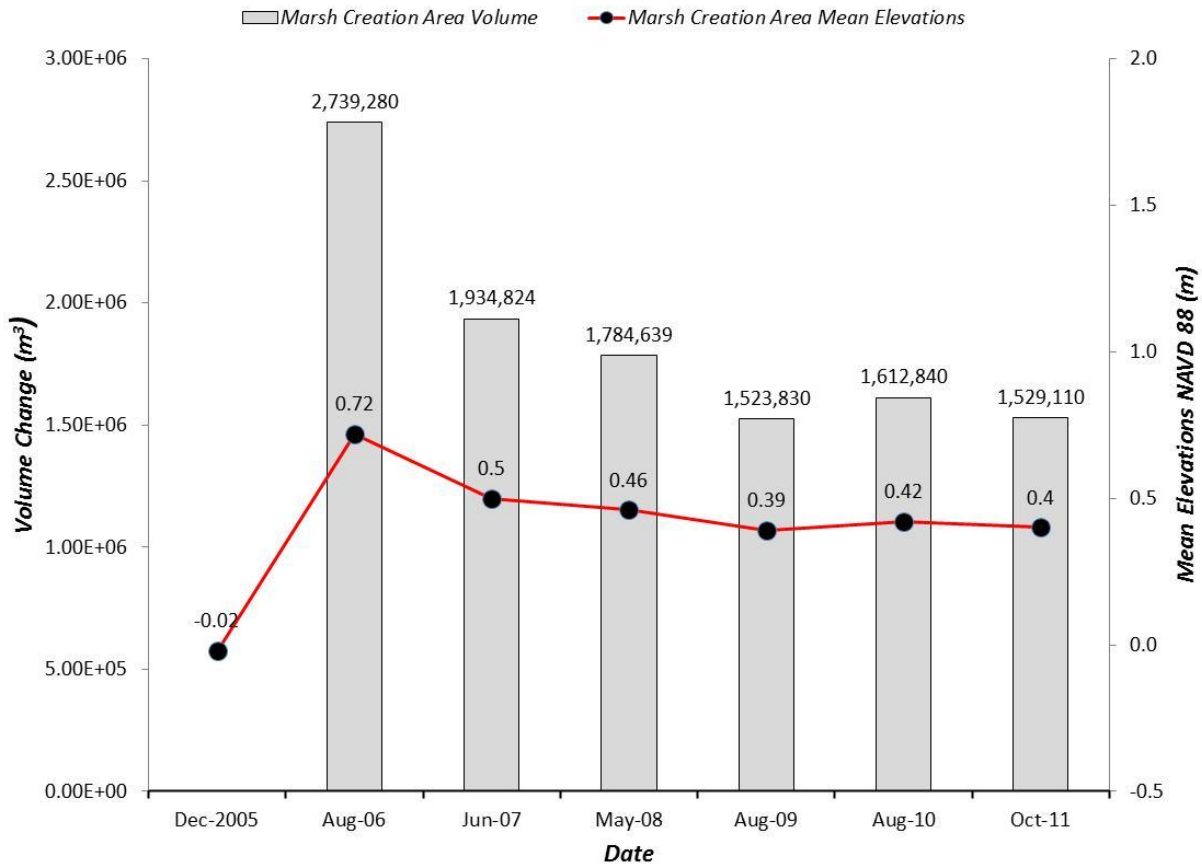
**Figure 11. Sediment volumes and mean elevations over time inside the Little Lake Shoreline Protection/Dedicated Dredging Near Round Lake (BA-37) marsh creation and nourishment area.**

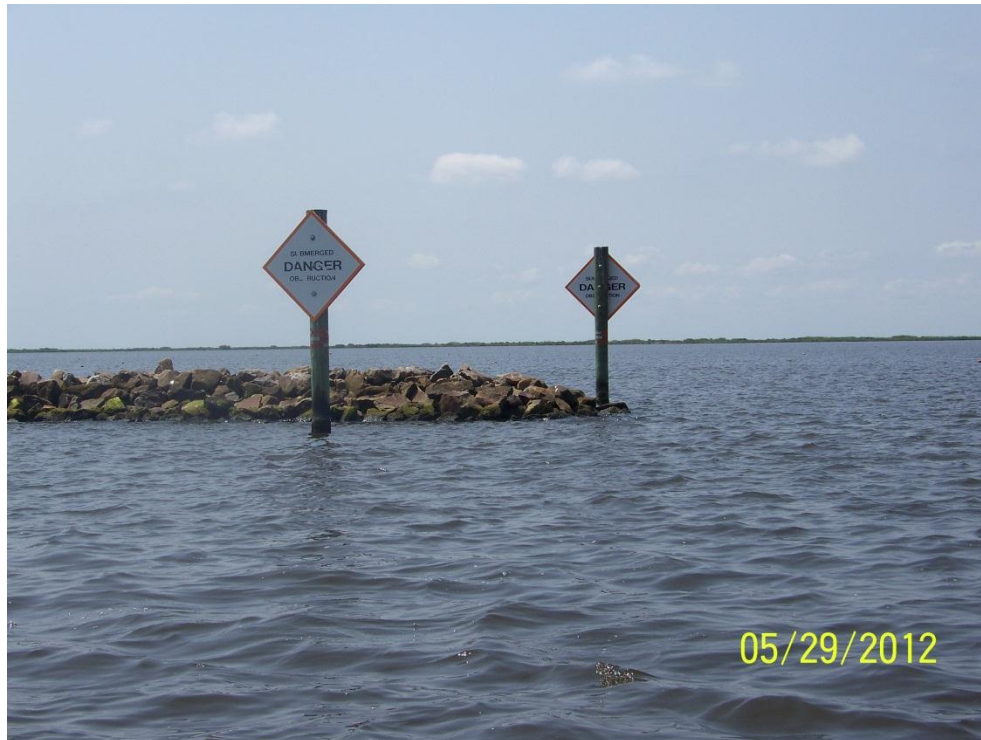
Currently, Rock Segments 1 and 2 have no marsh or vegetation along their southern edge, only open water. The fringe marsh that once separated Brusle Lake and Bay L'Ours, located along Rock Segments 1 and 2, has been eroded below the water level by Hurricane Katrina. This land loss occurred during construction of the project and the rock segments were put in place as designed and contracted. There are no recommendations for maintenance at this time; however this site will continue to be monitored to determine if the rock segments have become a hazard, and corrective actions will be conducted as needed.

Photo #1: View of the end of Rock Segment #1 closest to Benton Canal, looking south.

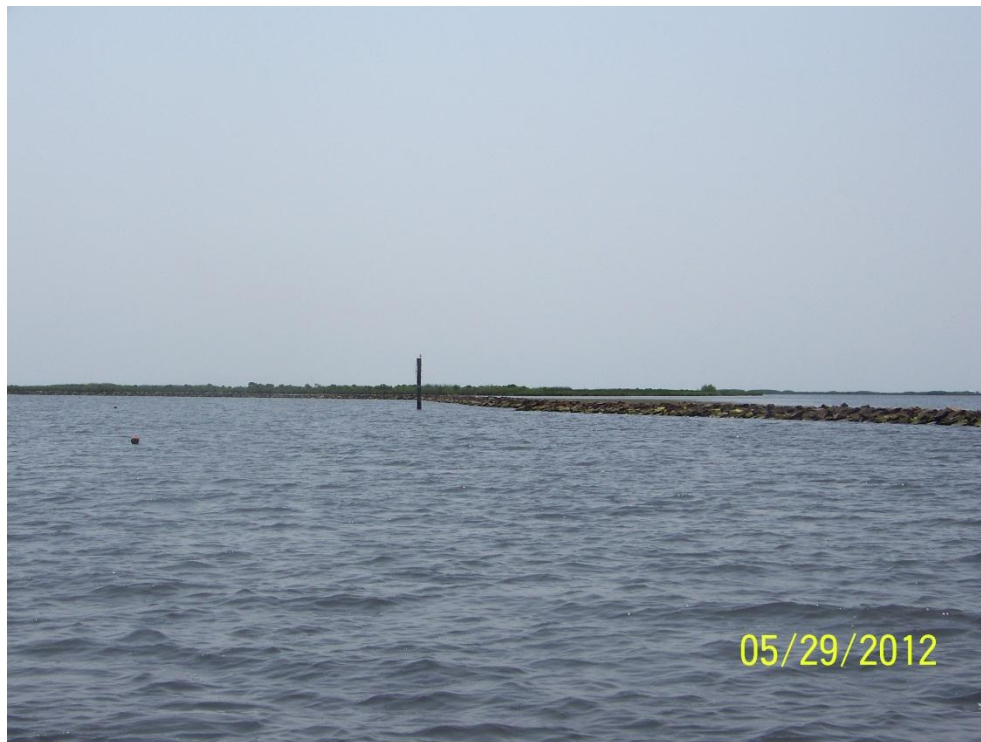
Photo #2: View along Rock Segment #1 closest to Benton Canal, looking east.

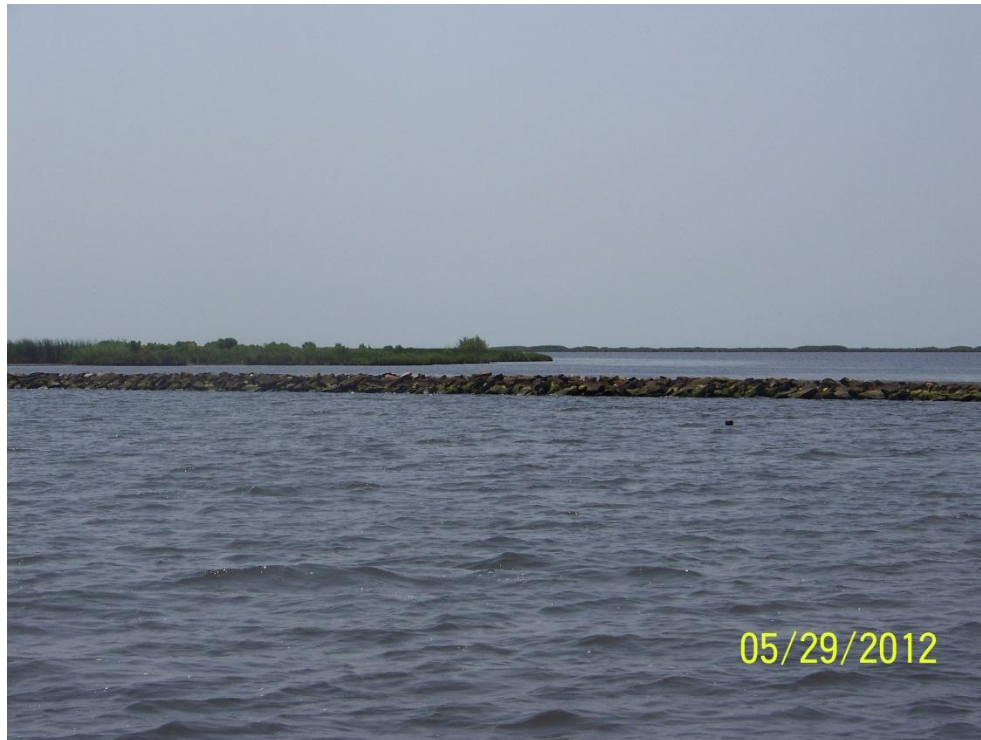
Photo #5: View along Rock Segment #2, looking southeast.

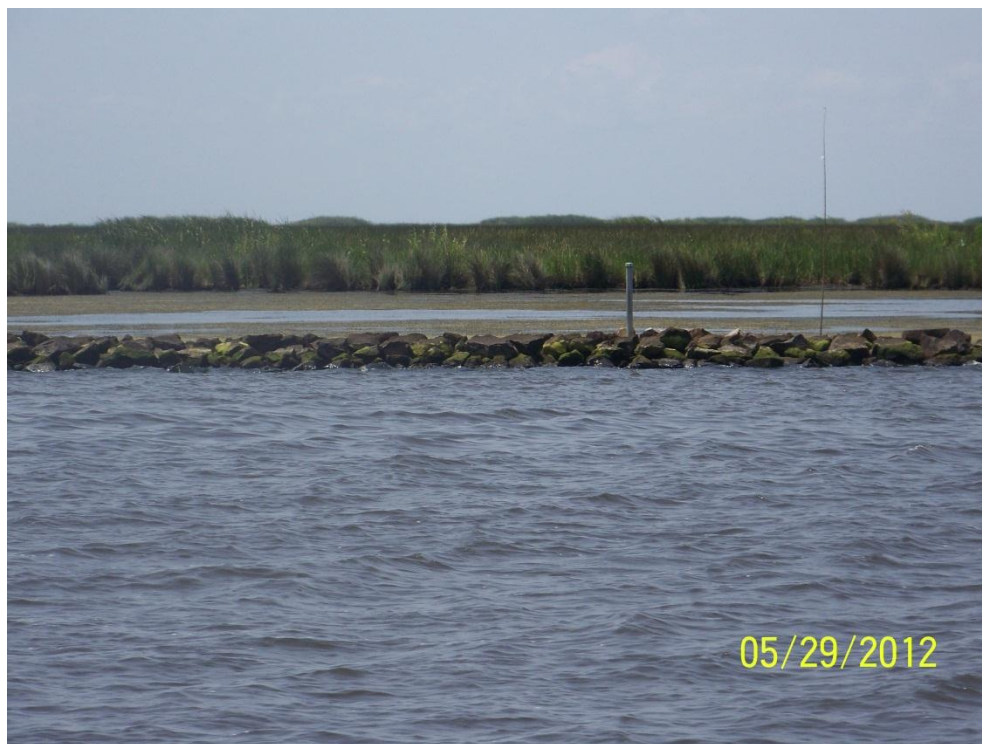
The elevation of the settlement plates were initially surveyed after construction in 2007 and then again every year until 2011. Comparing the final construction survey elevations of the settlement plates (February 2007) to the latest settlement plate survey (September 2011) shows an average settlement of 0.42 feet across the 24 segments, with the most extreme settlement being 0.70 feet. The survey conducted in 2011 (year 4) was the latest of the five surveys done since construction. The surveys will continue in years 10 and 15 of the project life to determine additional settlement of the rock dike and if a maintenance lift of the rock dike is needed.

Photo #8: View of settlement plate in Rock Segment #4, looking southeast.

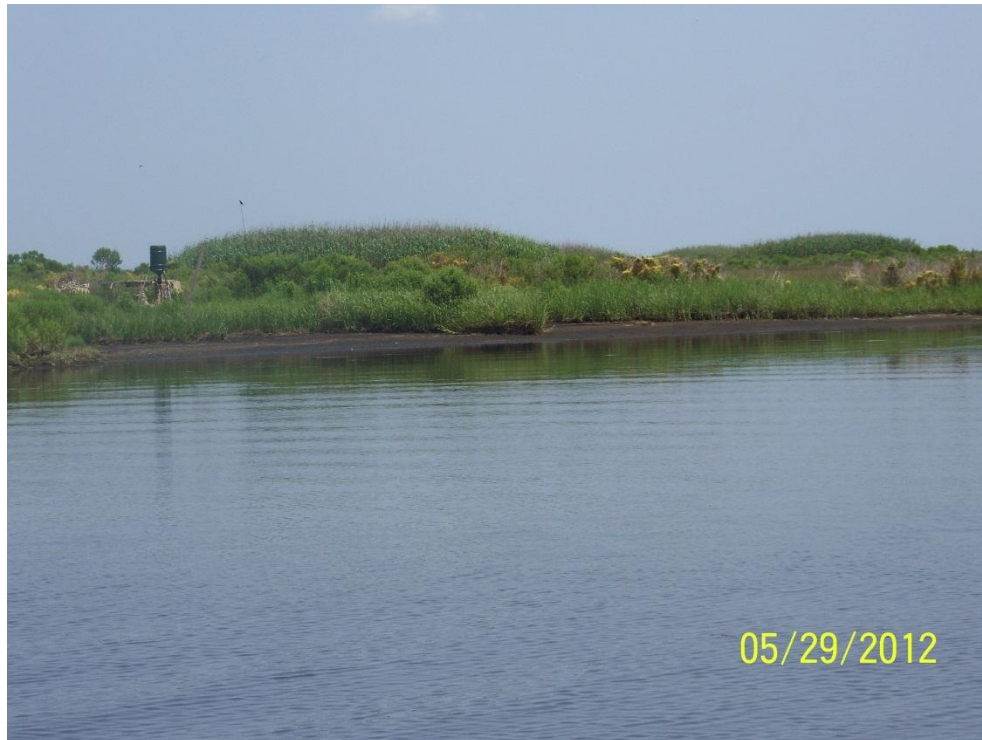
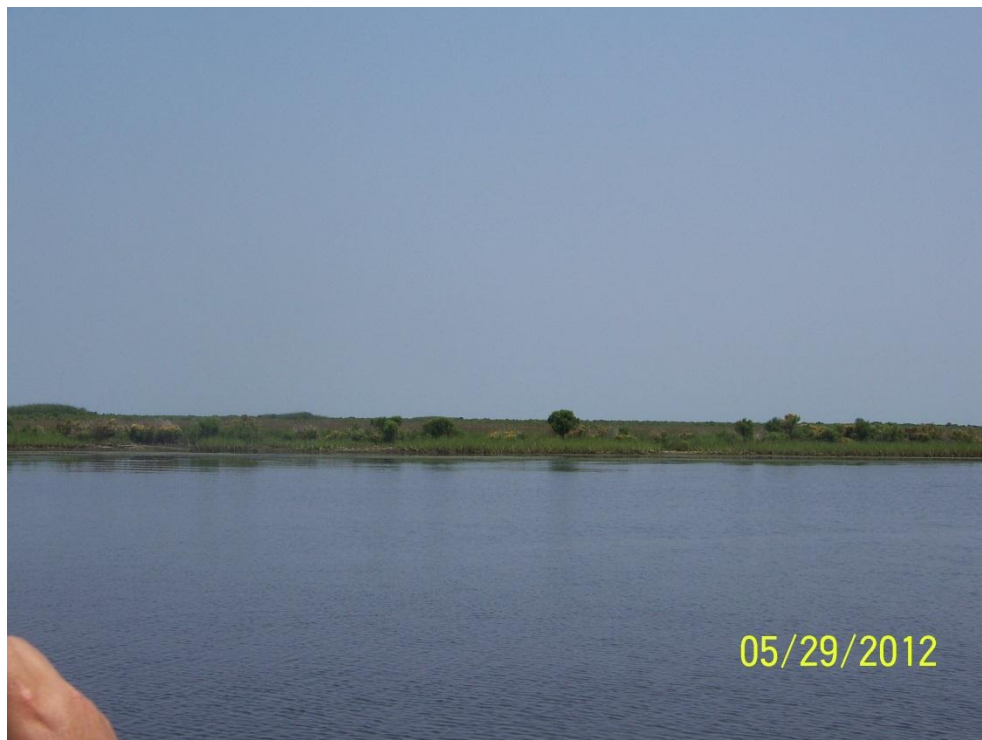
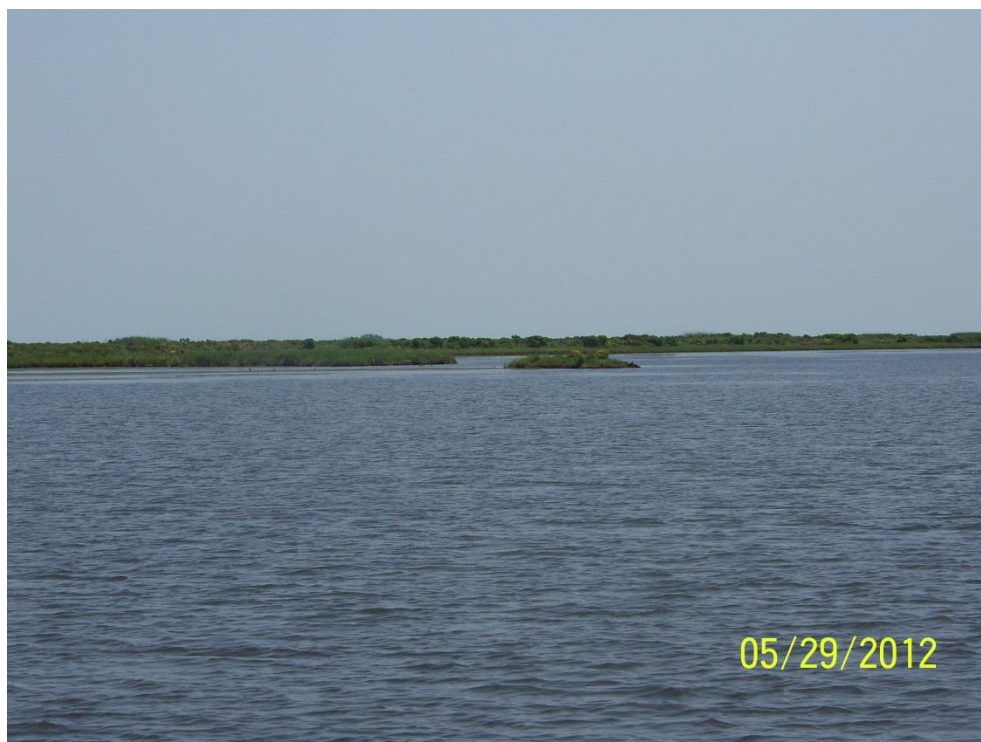
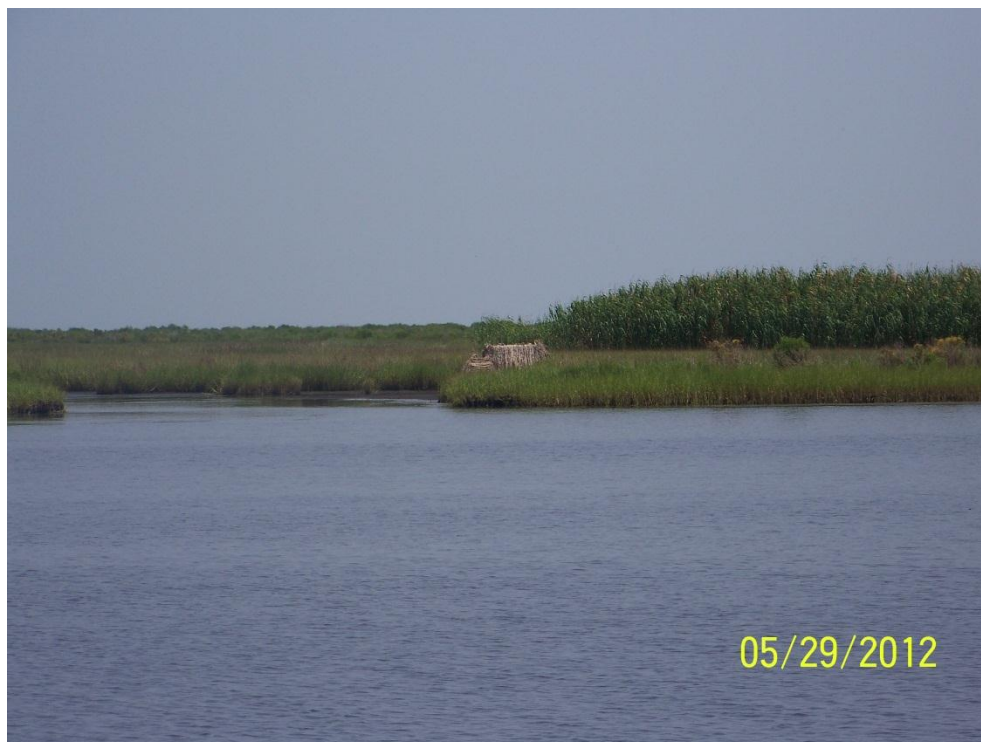
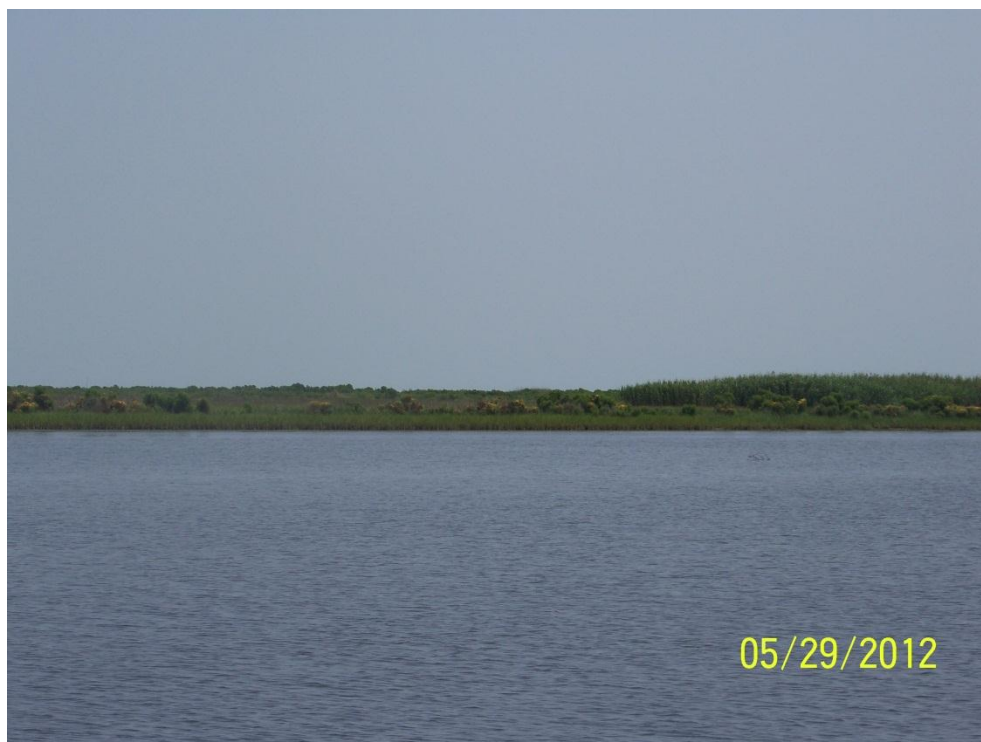
The fill material in the marsh creation area has fully vegetated. As mentioned above, marsh creation area grid point “O&M” surveys were performed in May 2008, June 2009, July 2010, and September 2011 as well as “as-built” and 9-month post-placement (May 2007) surveys. Figure 5 through Figure 10 displays the change in marsh creation elevation from the time of construction to the time of the latest available data (September 2011).

Photo #23: View of the Marsh Creation Area from the southern boundary of the containment dike, looking north.

The marsh creation area appears to be completely vegetated and the surveys indicate its elevations are approaching the average marsh elevation for the area. There are no funds allocated for the marsh creation portion of the project other than the surveying of the area grid points. We recommend that the 2011 survey be the last of the first five annual surveys as we will have five total data sets for post-construction analysis, in addition to the 10 and 15 year survey as per the O&M Plan. The survey data along with the annual visual inspections will monitor the consolidation and settlement of the fill material and the resulting elevations within the marsh creation area.

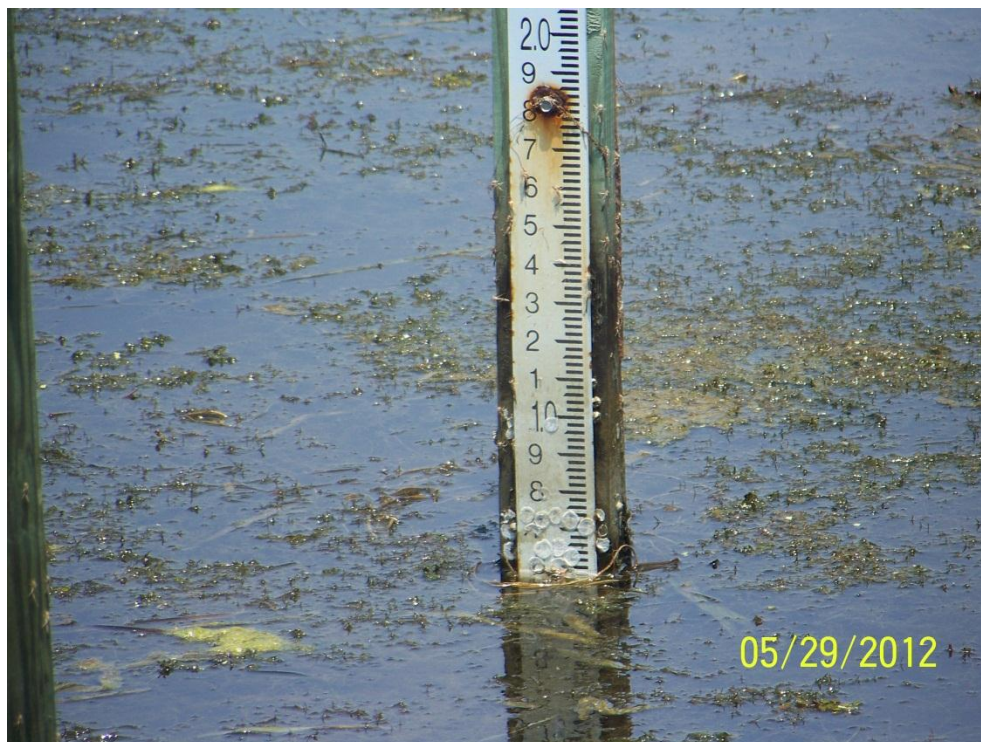
Photo #36: View of water level reading of 0.6' NAVD88 @ 1:20pm from station BA-02-57.

Install a staff gage.
