**State of Louisiana
Coastal Protection and Restoration Authority**

2012 Operations, Maintenance, and Monitoring Report

Channel Armor Gap Crevasse (MR-06)

State Project Number MR-06
Priority Project List 3

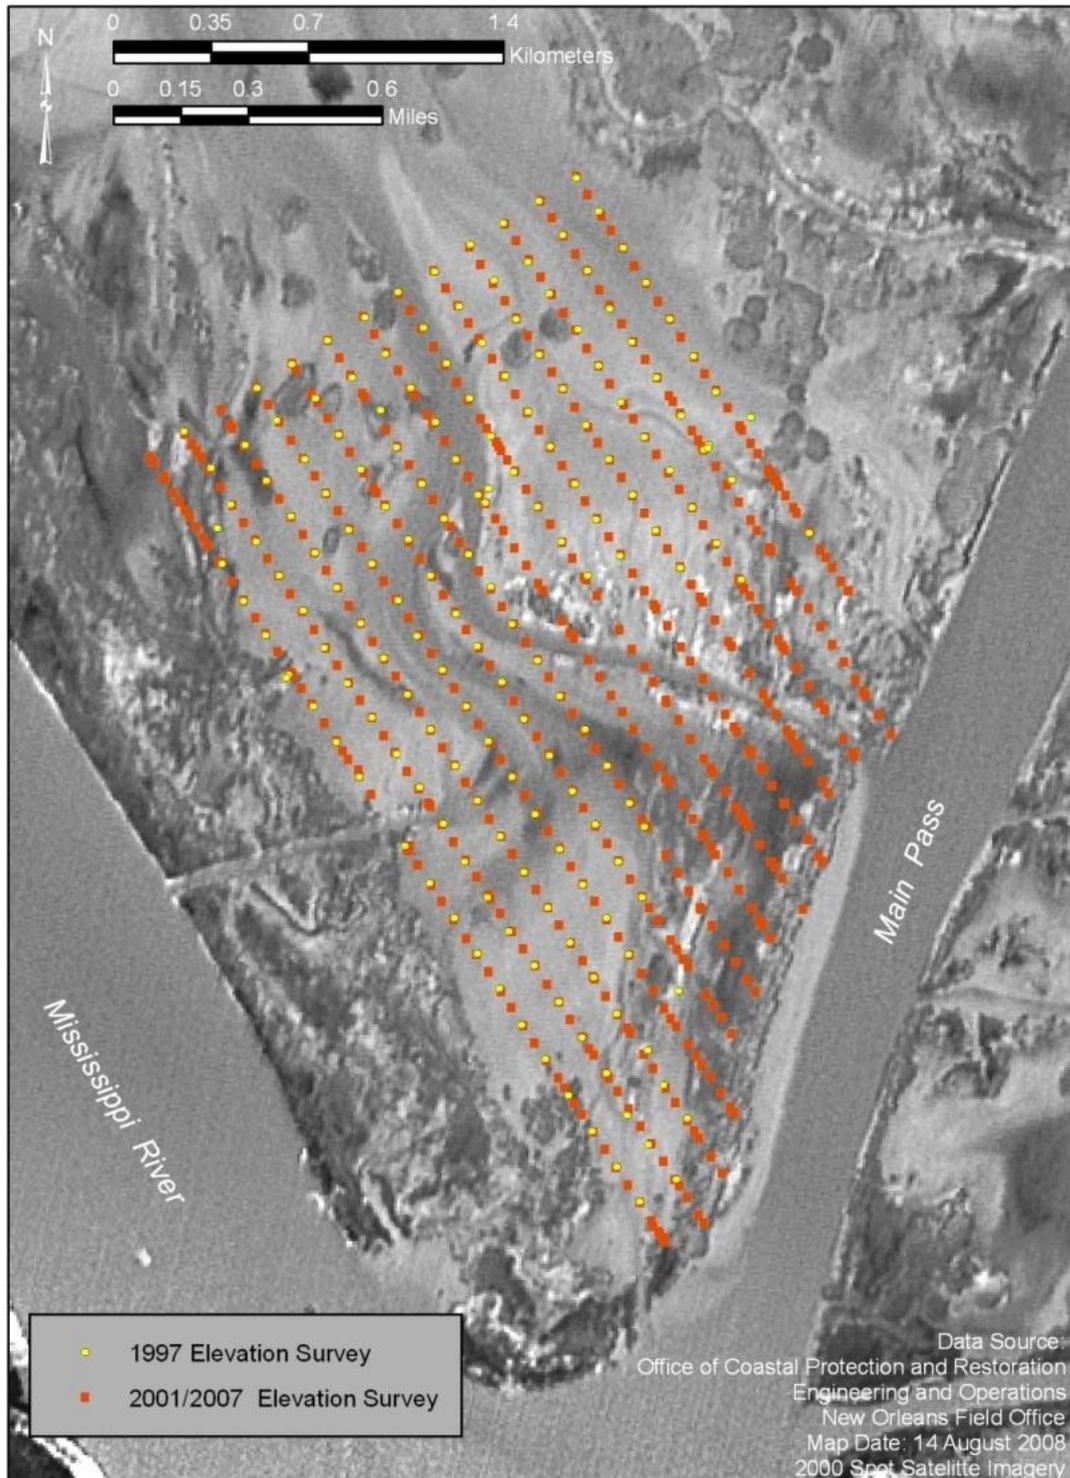
Figure 2. Schematic diagram of elevation sampling station locations in 1997 (yellow triangles) and 2001/2007 (red squares) in the Channel Armor Gap Crevasse (MR-06) project area.

In the 1997 survey, eleven transect lines were established perpendicular to the crevasse channel, 500 ft (152 m) apart, and extended the entire length of the open water areas in the receiving bay (Figure 2). Land elevations were not measured during this survey. Elevations were recorded at 500-ft intervals along each transect and at any significant change in elevation within those intervals. In the 2001 and 2007 surveys, the same transect lines were used, but elevations were recorded at 200-ft intervals and at any significant change in elevation within those intervals (Figure 2). Elevations of the entire project area (open water and land) were collected during the 2001 and 2007 surveys. However, only the immediate receiving bay was used to compare the mean elevations among all three years.

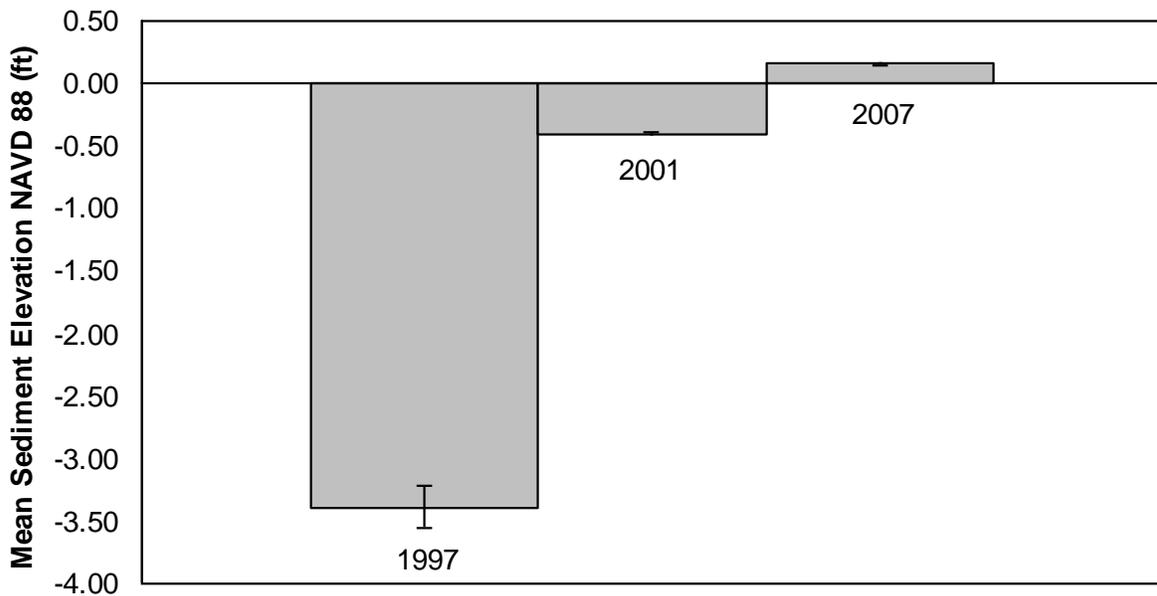
Figure 3. Mean sediment elevation (NAVD 88) (ft) in the immediate project area in 1997 (preconstruction), 2001 (post construction), and 2007 for the Channel Armor Gap Crevasse (MR-06) project.

Average elevation of the immediate receiving bay in 1997 (preconstruction) was - 3.39 NAVD 88 (ft; Figure 3 and 4). The average elevation of the receiving bay in the 2001 (post construction) elevation survey was - 0.41 NAVD 88 (ft; Figure 3 and 5) and 0.16 NAVD 88 (ft) in the 2007 elevation survey (Figure 3 and 6). There was a significant increase in elevation among all three years ($p < 0.0001$). Elevations ranged from -4.70 to -2.30 NAVD 88 (ft) in 1997, -2.10 to 0.50 NAVD 88 (ft) in 2001, and from 1.8 to 1.15 NAVD 88 (ft) in 2007. There was a greater increase in elevation from 1997 to 2001 than from 2001 to 2007, possibly a result of intense storm activity in 2005. Differences in elevation ranged from 1.2 to 4.0 NAVD 88 (ft) from 1997 to 2001 (Figure 7) and from - 0.09 to 2.0 NAVD 88 (ft) from 2001 to 2007 (Figure 8). Sediment elevations increased in most of the receiving bay between 1.64 and 4.92 NAVD 88 (ft) from 1997 to 2007 (Figure 9). The channel that had been forming in the center of the receiving bay is still evident; however, it appears to be filling in. The change in elevation across the entire project area from 1997 to 2007 is shown in Figure 10. Differences in elevation ranged from -4 to 8 NAVD 88 (ft).

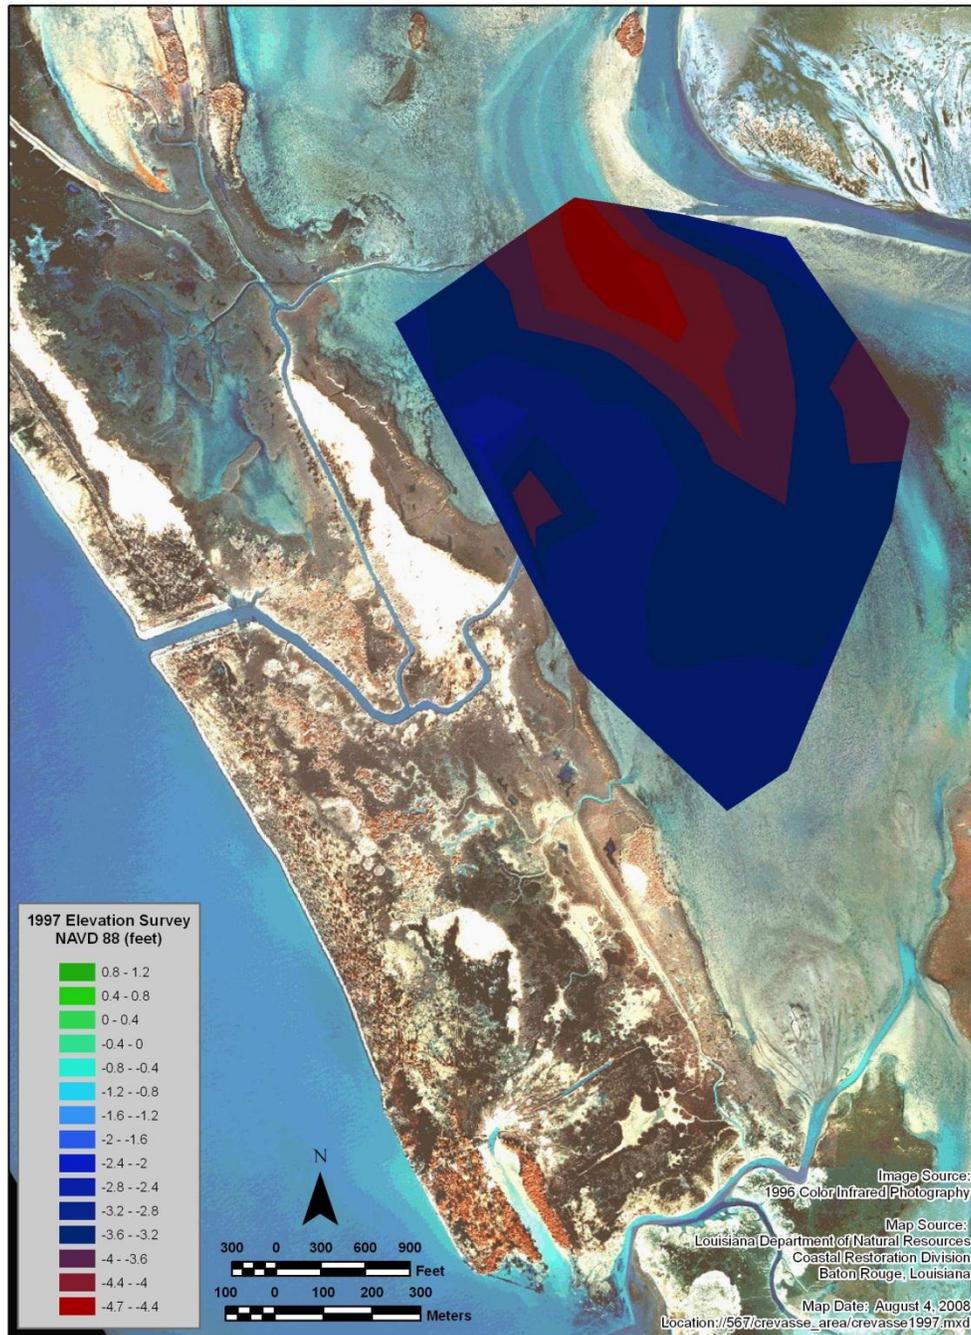
Figure 4. Preconstruction (1997) elevation (ft) within the receiving bay (Mary Bowers Pond) of the Channel Armor Gap Crevasse (MR-06) project area.

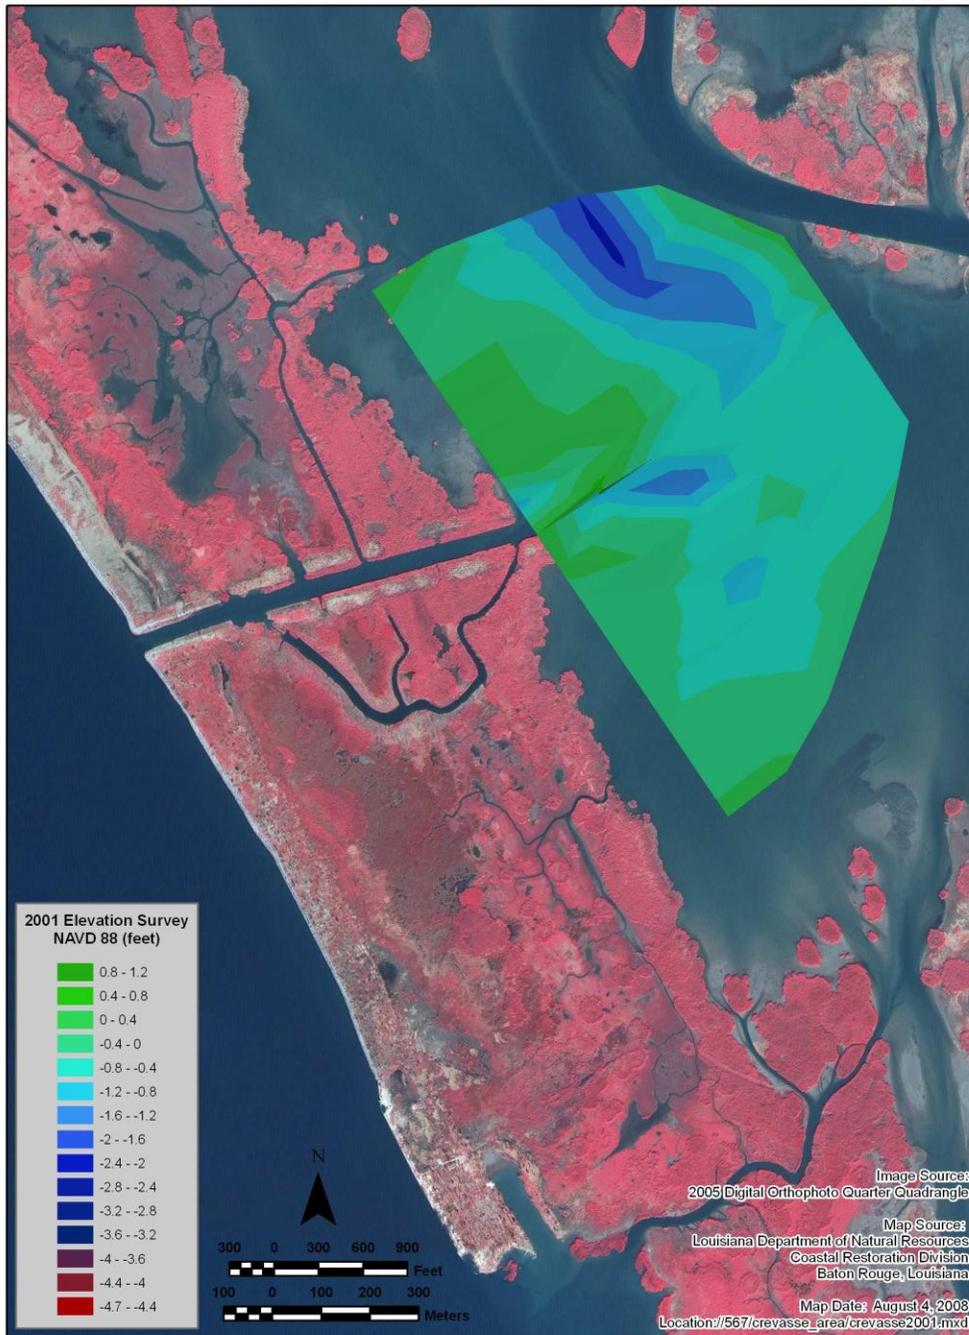
Figure 5. Post construction (2001) elevation (ft) within the receiving bay (Mary Bowers Pond) of the Channel Armor Gap Crevasse (MR-06) project area.

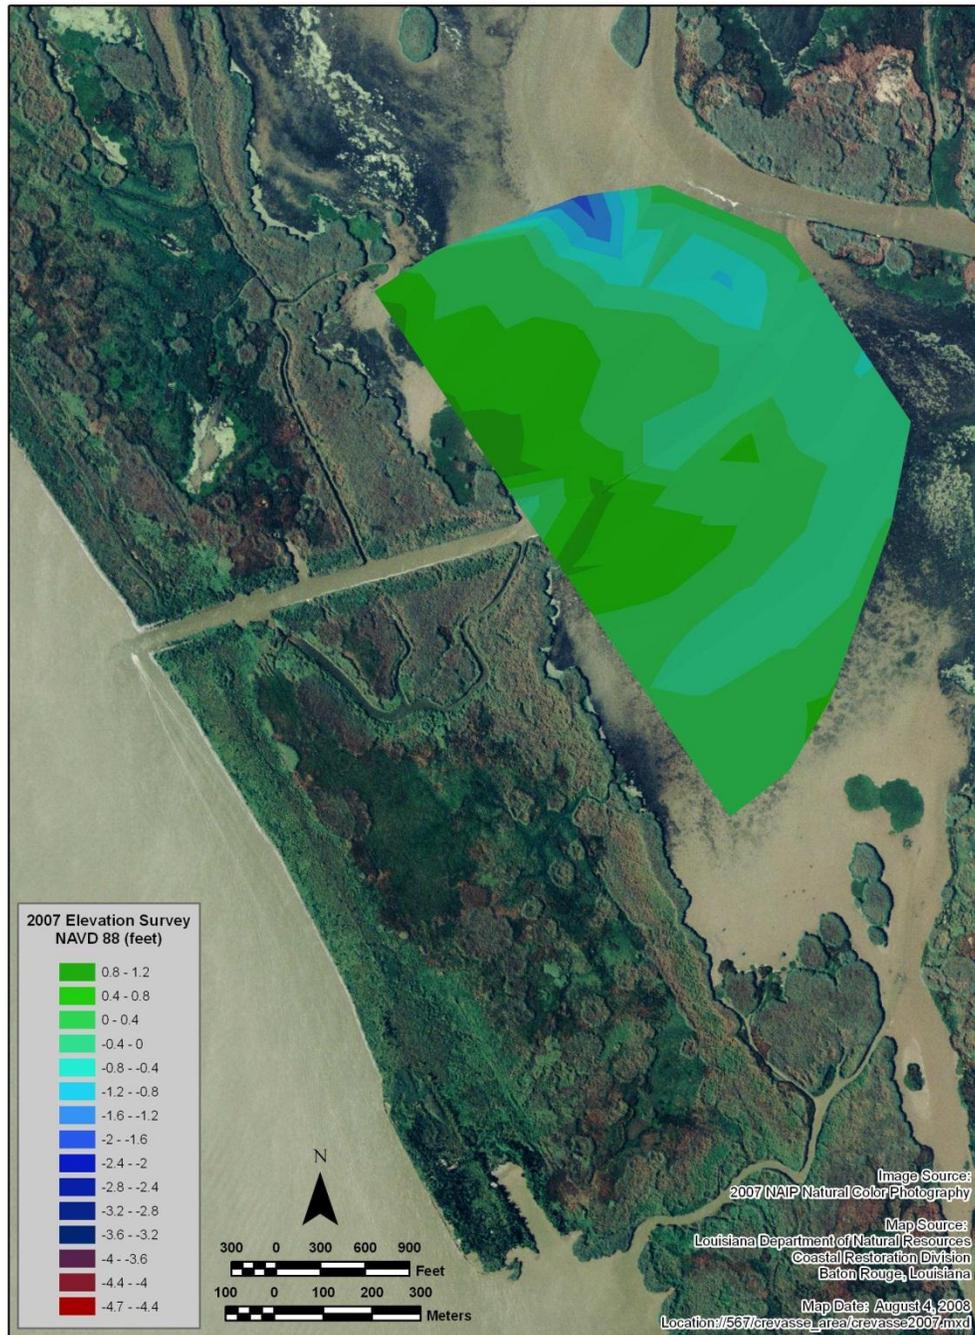
Figure 6. Post construction (2007) elevation (ft) within the receiving bay (Mary Bowers Pond) of the Channel Armor Gap Crevasse (MR-06) project area.

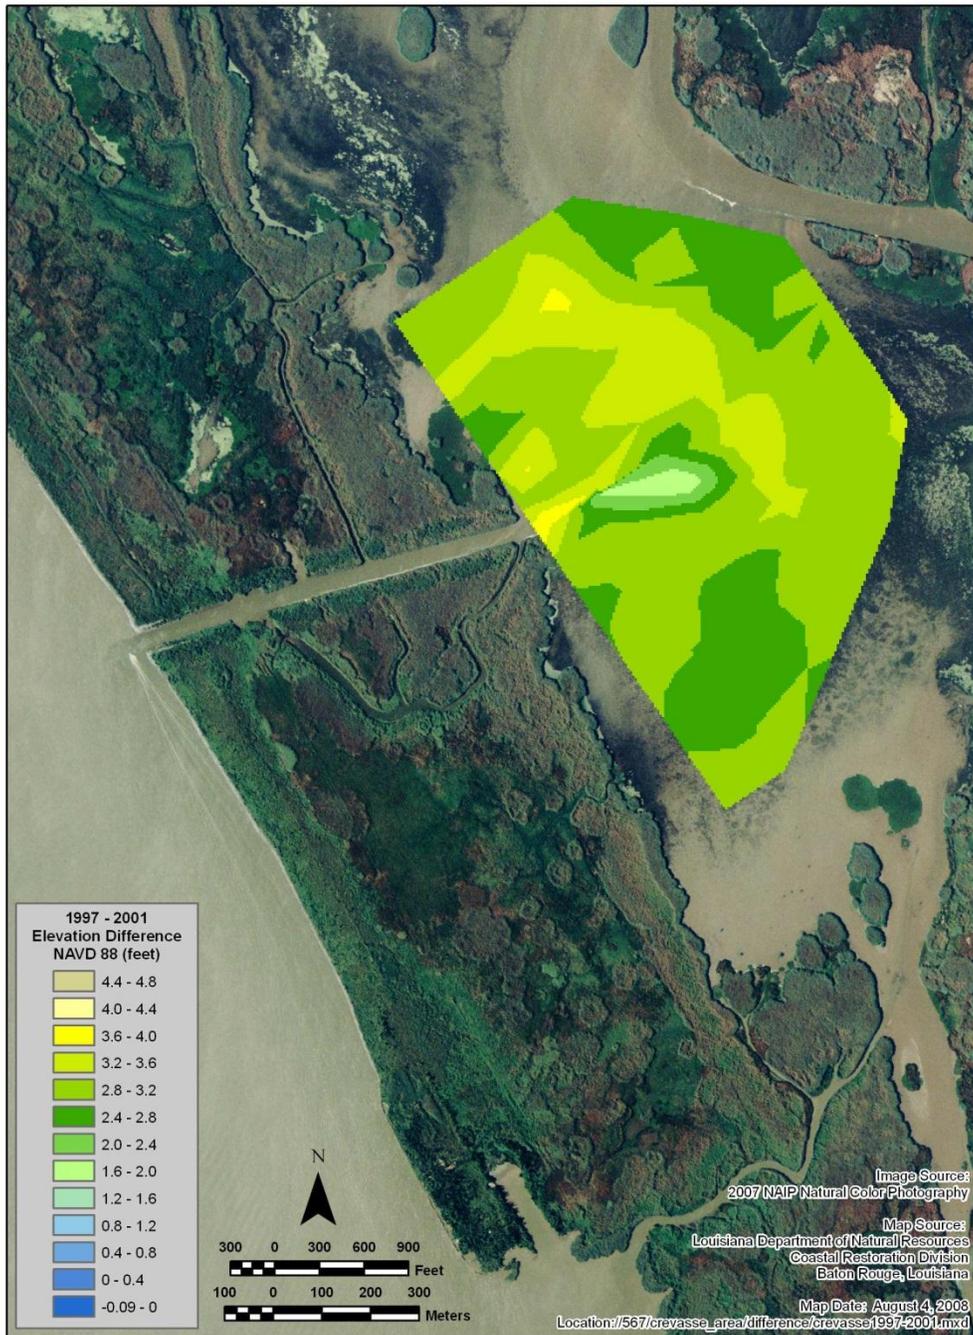
Figure 7. Sediment elevation change (ft) within the receiving basin between 1997 and 2001 in the Channel Armor Gap Crevasse (MR-06) project area.

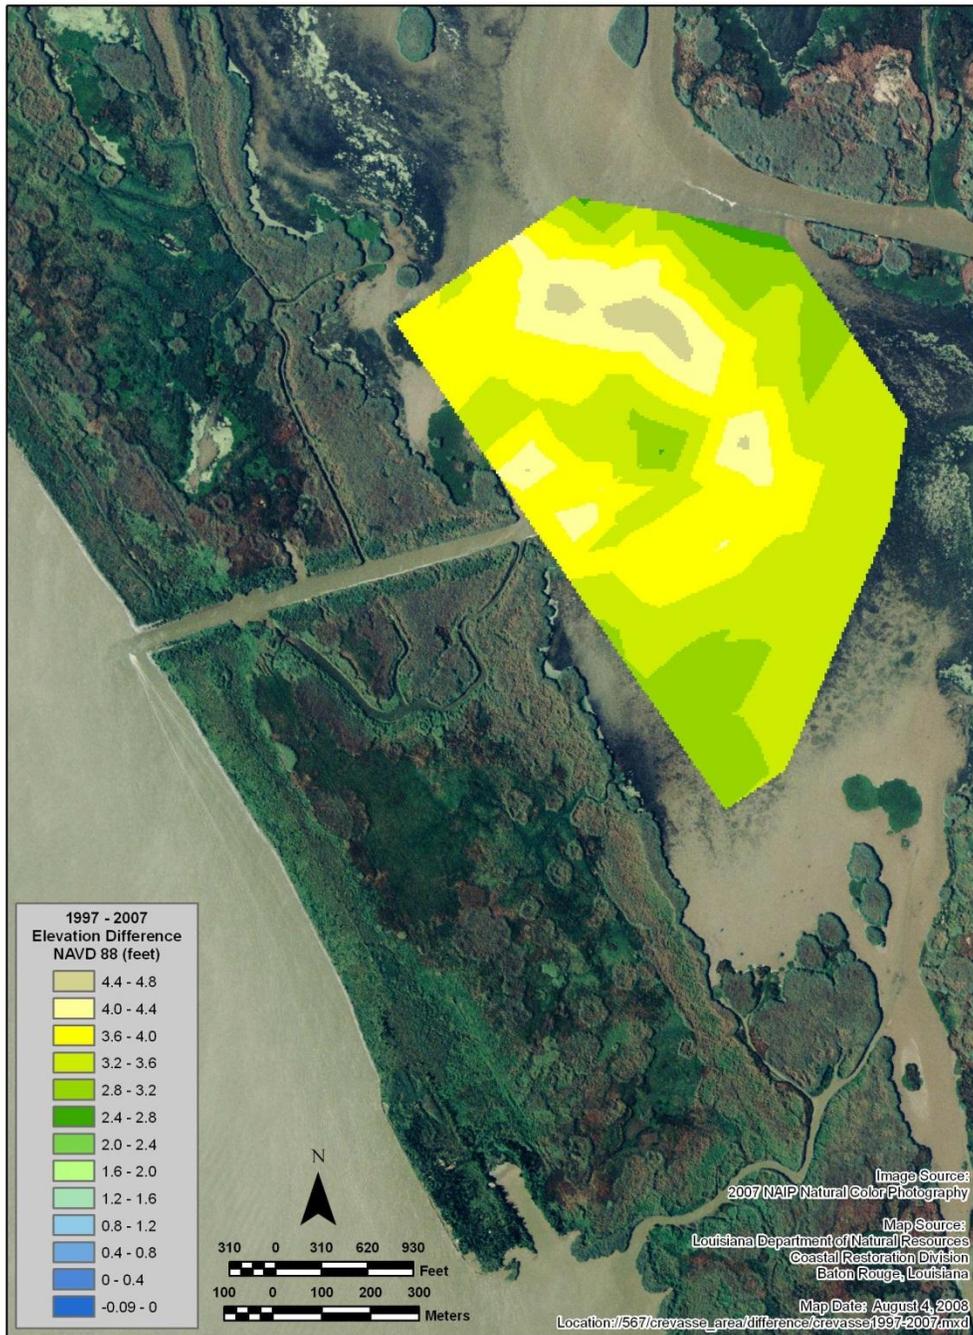
Figure 8. Sediment elevation change (ft) within the receiving basin between 1997 and 2007 in the Channel Armor Gap Crevasse (MR-06) project area.

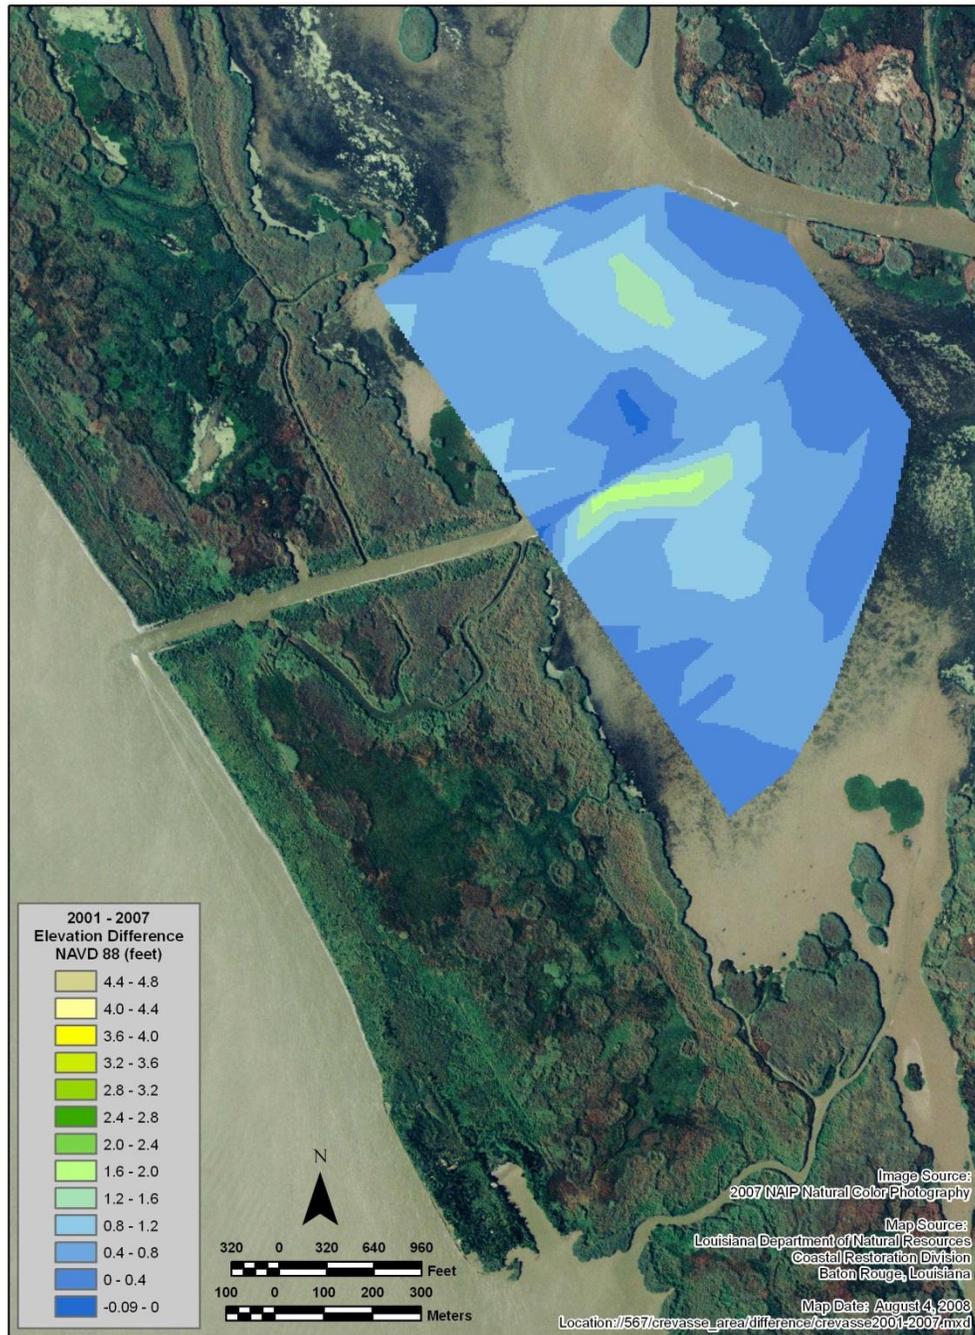
Figure 9. Sediment elevation change (ft) within the receiving basin between 2001 and 2007 in the Channel Armor Gap Crevasse (MR-06) project area.

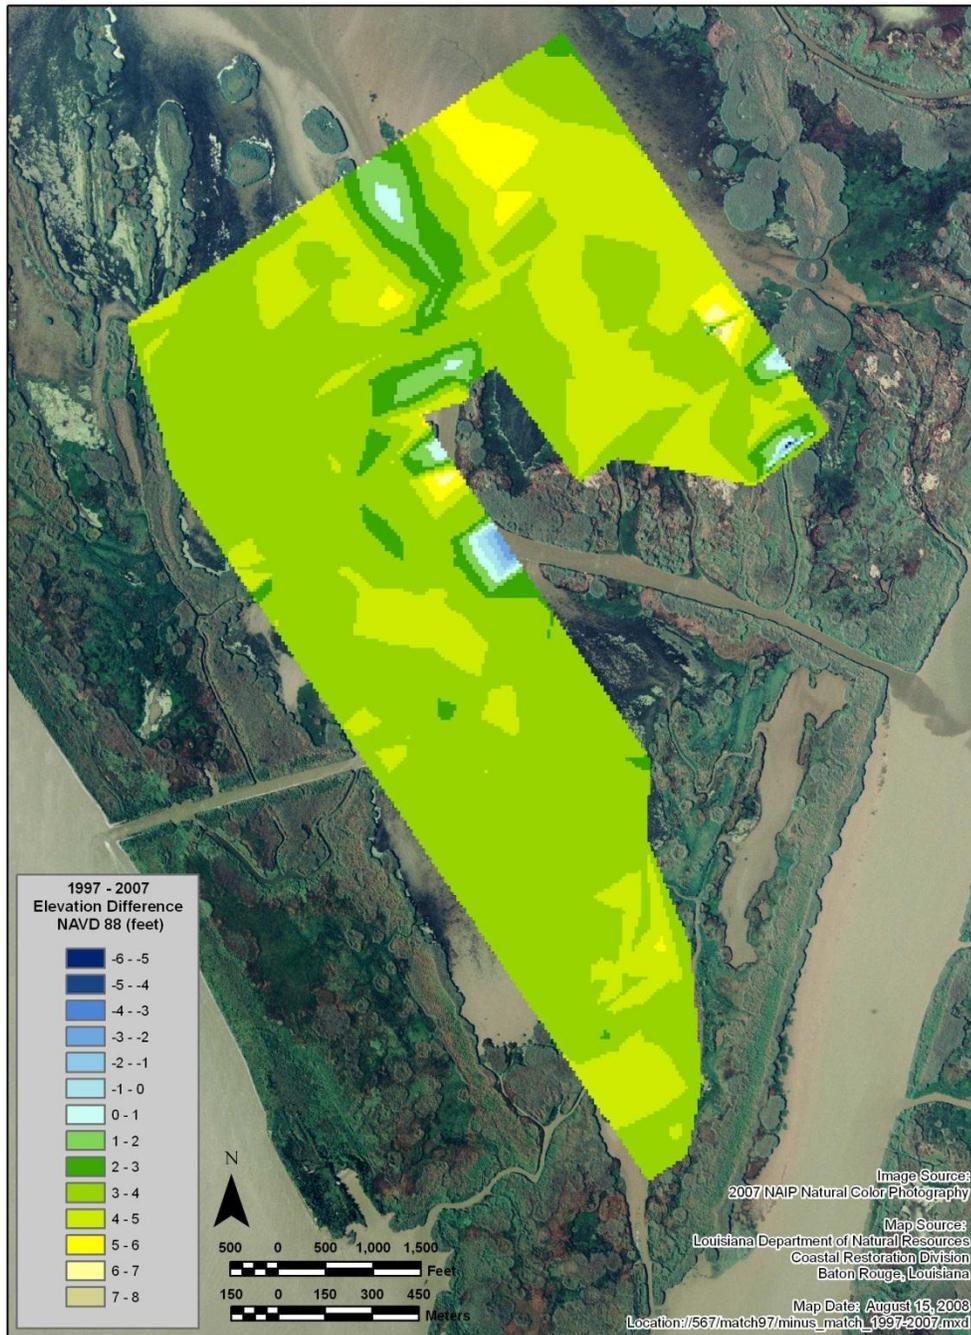
Figure 10. Sediment elevation change (ft) between 1997 and 2007 in the Channel Armor Gap Crevasse (MR-06) project area.

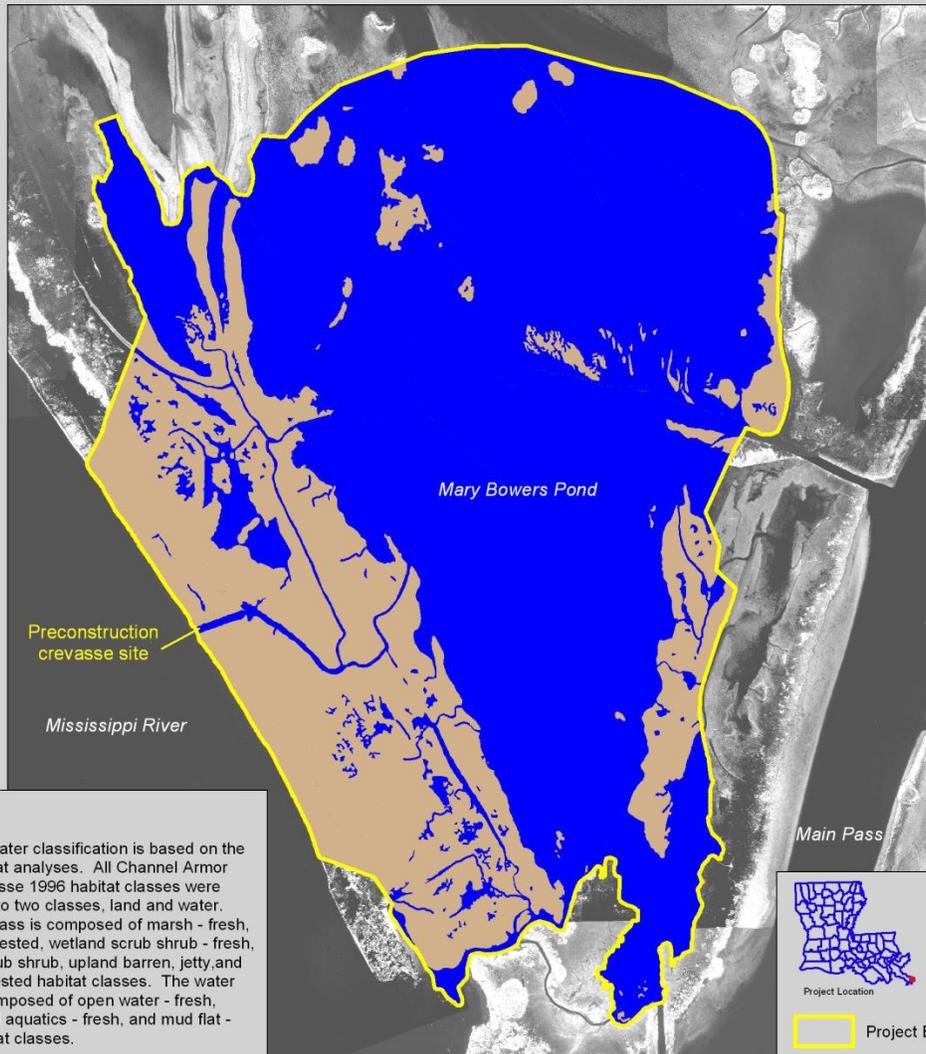
Figure 11. 1996 (preconstruction) land/water analysis of the Channel Armor Gap Crevasse (MR-06) project area.

Method:
 The land-water classification is based on the 1996 habitat analyses. All Channel Armor Gap Crevasse 1996 habitat classes were grouped into two classes, land and water. The land class is composed of marsh - fresh, wetland forested, wetland scrub shrub - fresh, upland scrub shrub, upland barren, jetty, and upland forested habitat classes. The water class is composed of open water - fresh, submerged aquatics - fresh, and mud flat - fresh habitat classes.

Class	1996 Acres
Land	474.0
Water	1091.8
Total	1565.8

Results from the 1996 preconstruction land/water analysis indicated that 474 acres (191.8 hectares) of the project area were land, and 1,091.8 acres (442 hectares) were open water, a ratio of 30% land to 70% open water (Figure 11). In the 2001 analysis, 526.4 acres (213 hectares) were land and 1,039.8 acres (420.8 hectares) were open water, increasing the ratio to 34 % land to 66 % open water (Figure 12). In the 2007 analysis, 667 acres were classified as land and 899 acres were open water, increasing the ratio to 43% land to 57% open water (Figure 13).

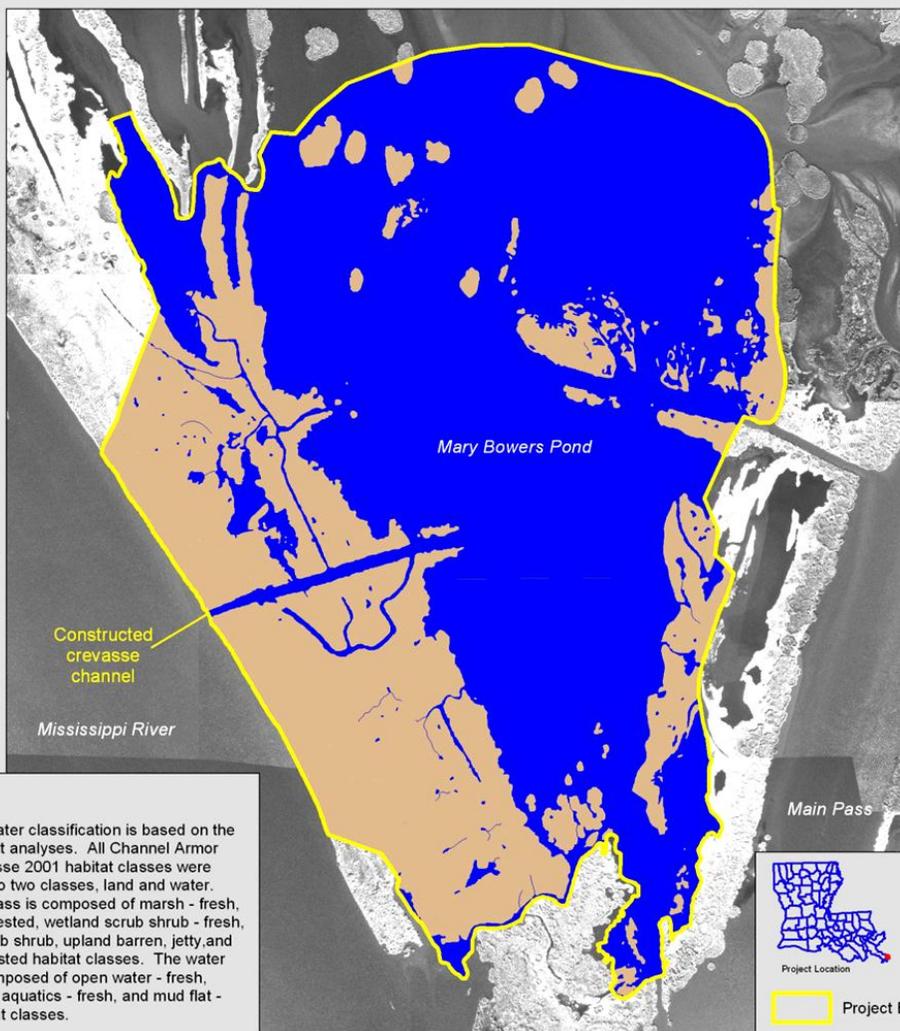
Figure 12. 2001 (post construction) land/water analysis of the Channel Armor Gap Crevasse (MR-06) project area.

Method:
The land-water classification is based on the 2001 habitat analyses. All Channel Armor Gap Crevasse 2001 habitat classes were grouped into two classes, land and water. The land class is composed of marsh - fresh, wetland forested, wetland scrub shrub - fresh, upland scrub shrub, upland barren, jetty, and upland forested habitat classes. The water class is composed of open water - fresh, submerged aquatics - fresh, and mud flat - fresh habitat classes.

Class	2001 Acres
Land	526.4
Water	1039.4
Total	1565.8

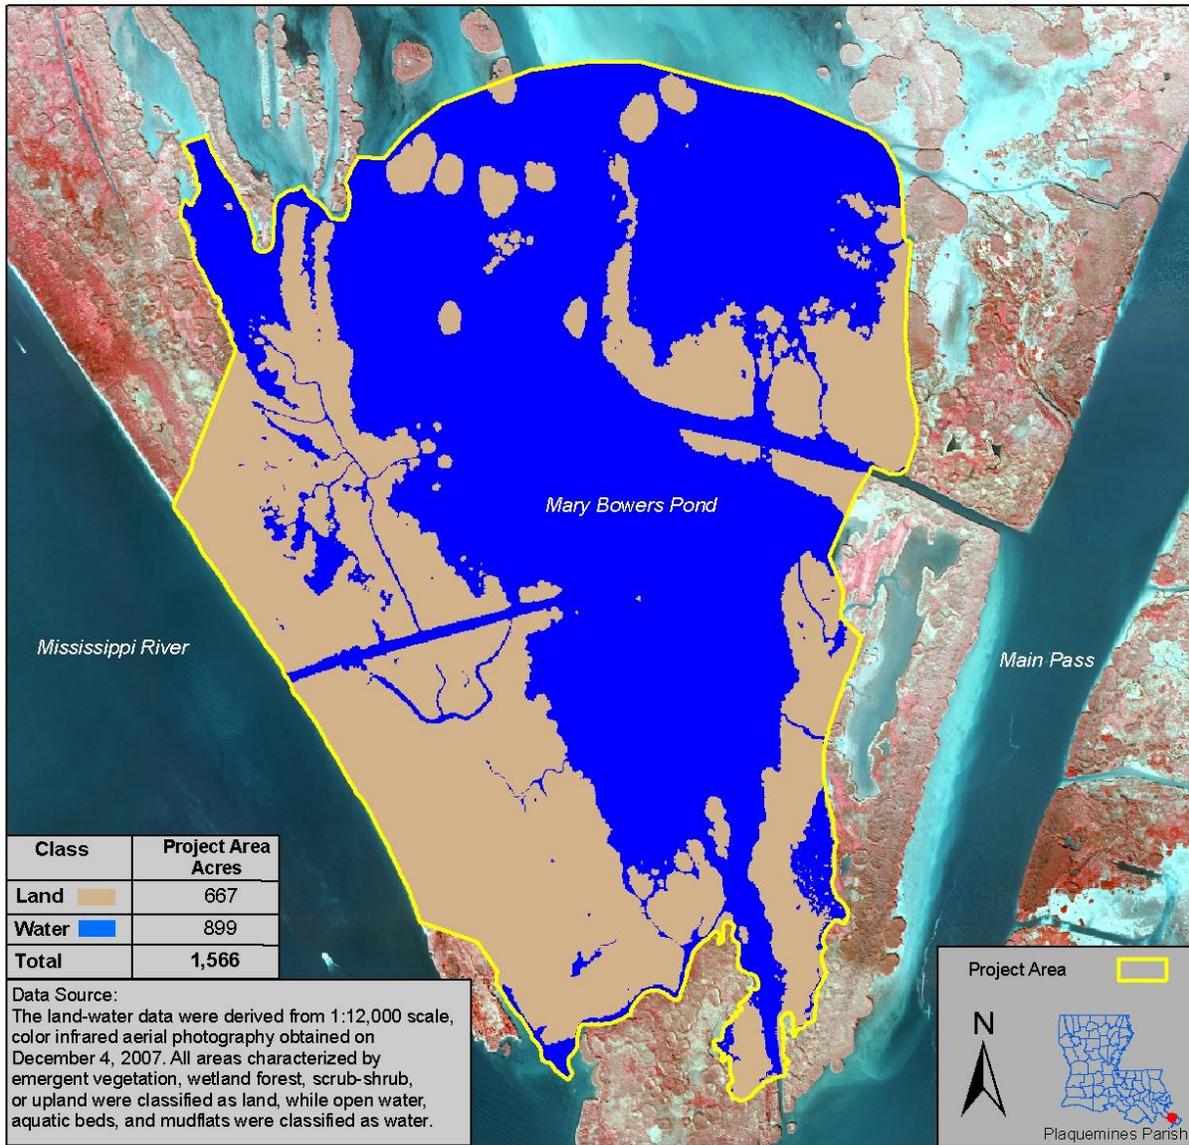
Figure 13. 2007 land/water analysis of the Channel Armor Gap Crevasse (MR-06) project area.

Since construction, the land area within the MR-06 project area has increased by 41%; a total of 193 acres. It is important to note, however that very little of this land has formed in the immediate crevasse receiving bay. The majority of the new land has formed in the vicinity of two other crevasses that feed into the project; one at the southern end and the other on the eastern side entering from Main Pass (Figure 1). The success of these two crevasses in creating new land can likely be attributed to two factors: age and location within the receiving bay. The crevasse on the eastern side of the project area was created in 1985 by the Superior and Mobile Oil Company and re-dredged in 1995 by USFWS. In the 1996 pre-construction land/water analysis for MR-06, land formation from this crevasse (12 years old at the time) was already evident. The crevasse at the southern end of the receiving bay was created in 1995 by the U.S. Army Corps of Engineers. Although only 2 years older than MR-06, this crevasse has been successful in creating land, mostly through the expansion of the marsh on the southern and eastern edges of the project area. As noted in the first progress report for MR-06 (Troutman 1999), the area adjacent to this crevasse is the shallowest in the receiving bay.

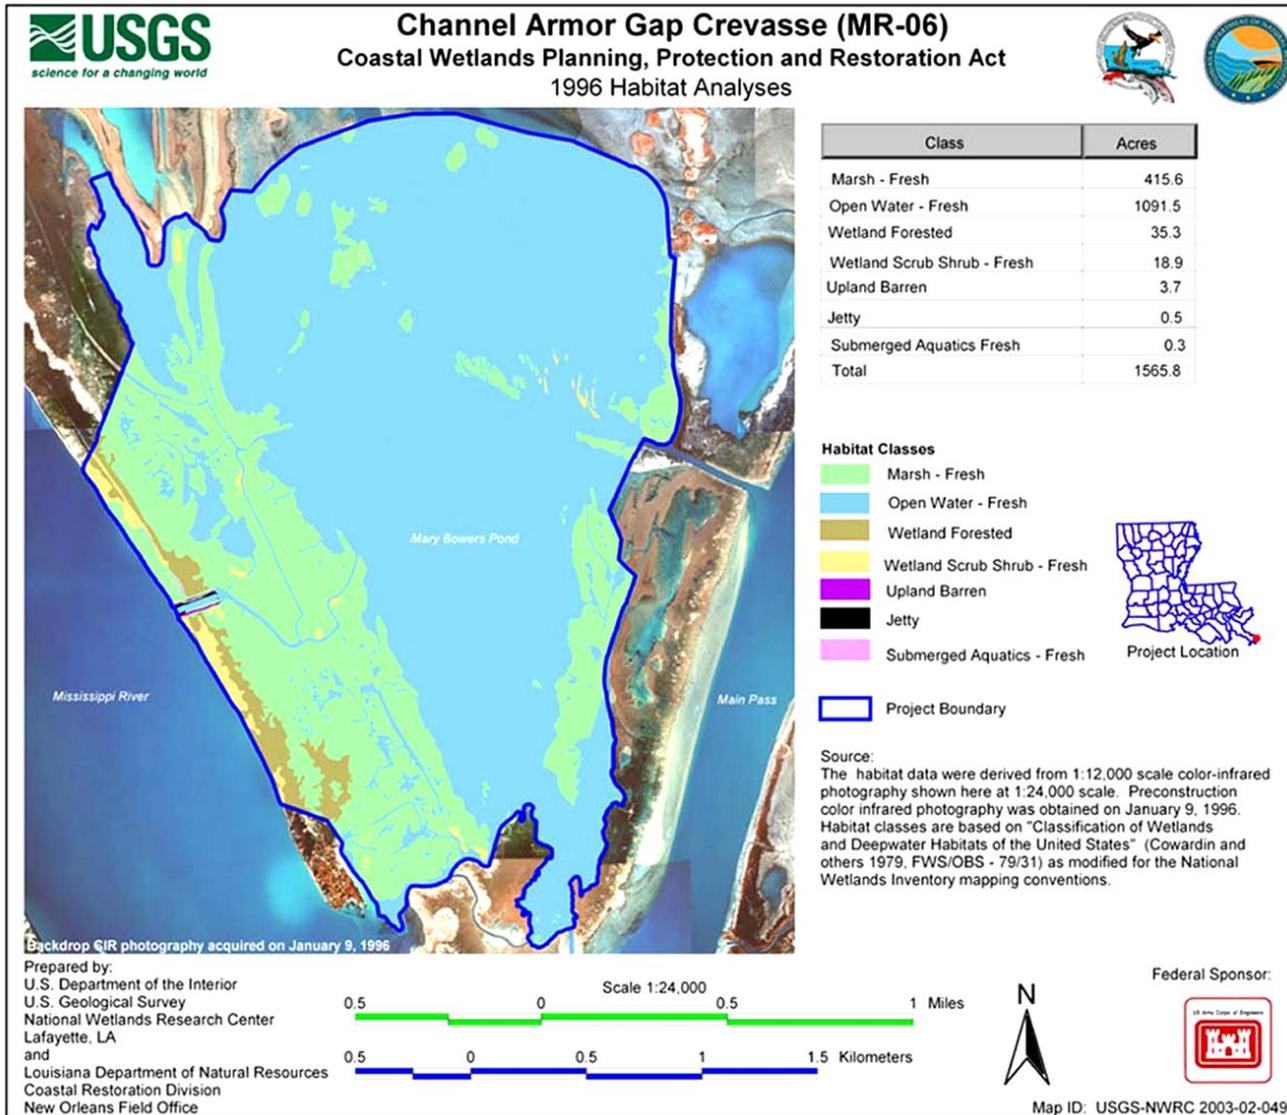
Figure 14. Preconstruction habitat analysis of the Channel Armor Gap (MR-06) project area.

Habitat analysis of the 1996 aerial photographs indicated seven habitat classes (Figure 14). Approximately two thirds of the project area consisted of fresh open water, including 0.3 acres of submerged aquatic vegetation. Fresh marsh made up the majority of the remaining acreage. Most fresh marsh was located on the western side of the project area, as were nearly all of the wetland forest and scrub-shrub habitats. Upland barren and jetty made up the remaining 4.2 acres (1.7 hectares). Habitat analysis of the 2001 aerial photographs yielded seven habitat classes (Figure 15). Most of the fresh marsh increase was adjacent to two, previously constructed, crevasses on the eastern and southern fringes of the project area. Forested wetlands decreased from 35.3 acres (14.3 hectares) to 23.7 acres (9.6 hectares), and fresh wetland scrub shrub increased from 18.9 acres (7.6 hectares) to 37.9 acres (15.3 hectares). Upland scrub shrub, jetty, and forested uplands made up the remaining 9.7 acres (3.9 hectares).

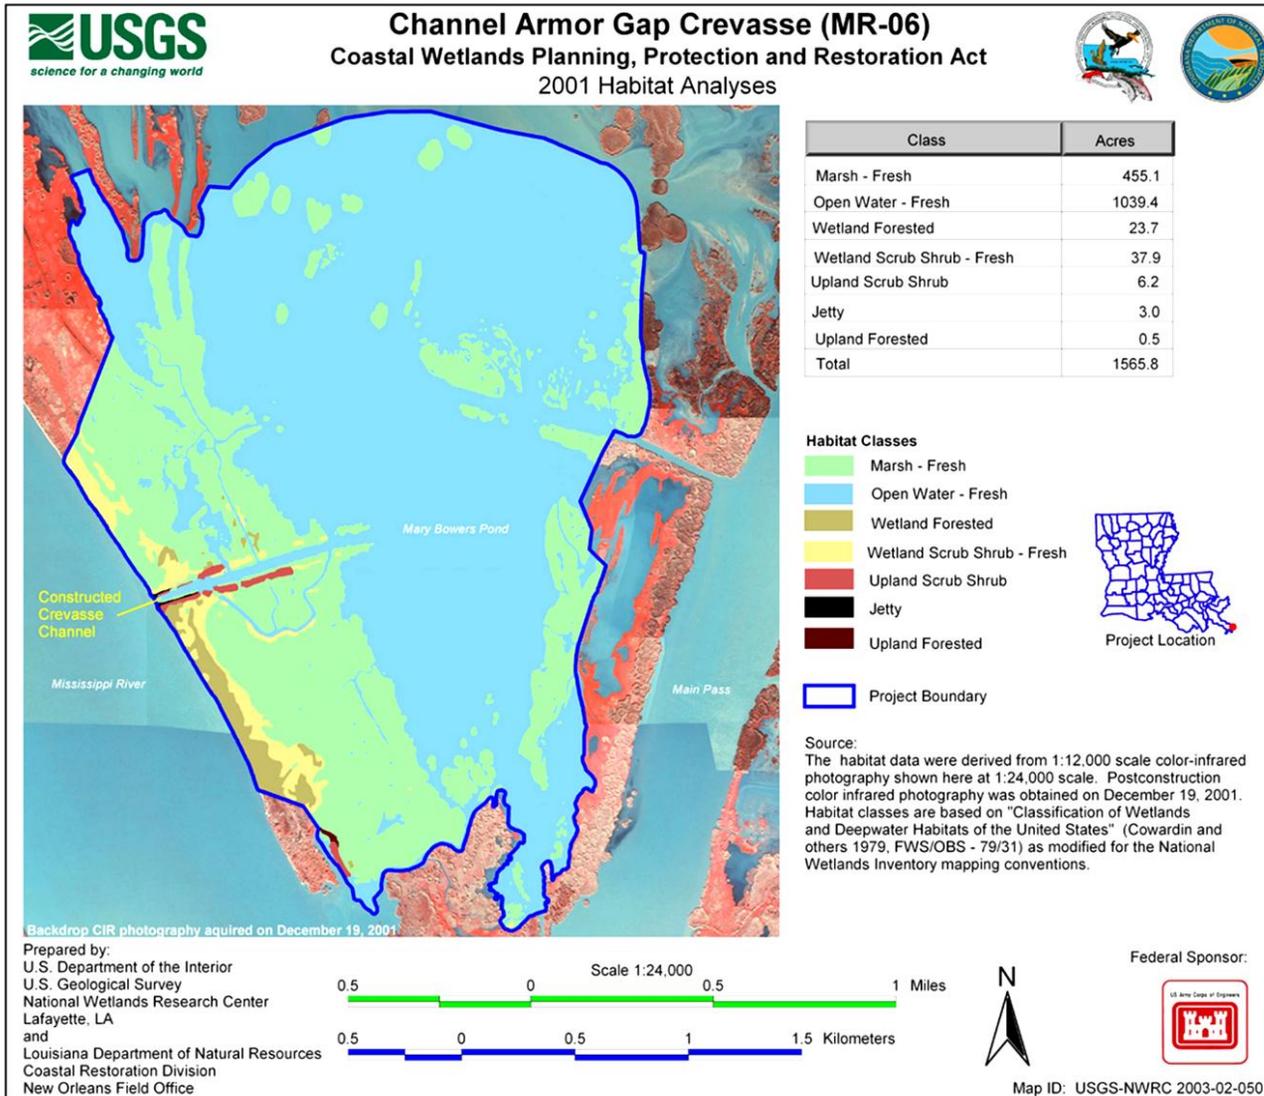
Figure 15. Post construction habitat analysis of the Channel Armor Gap (MR-06) project area.

Habitat mapping indicates that the vegetative community types remained largely unchanged in the early years following crevasse construction. The majority of the project area was fresh marsh prior to and following construction. The 2001 analysis indicated that a 6.2 ac of upland scrub shrub habitat had formed on either side of the crevasse channel, likely the result of spoil placement from crevasse

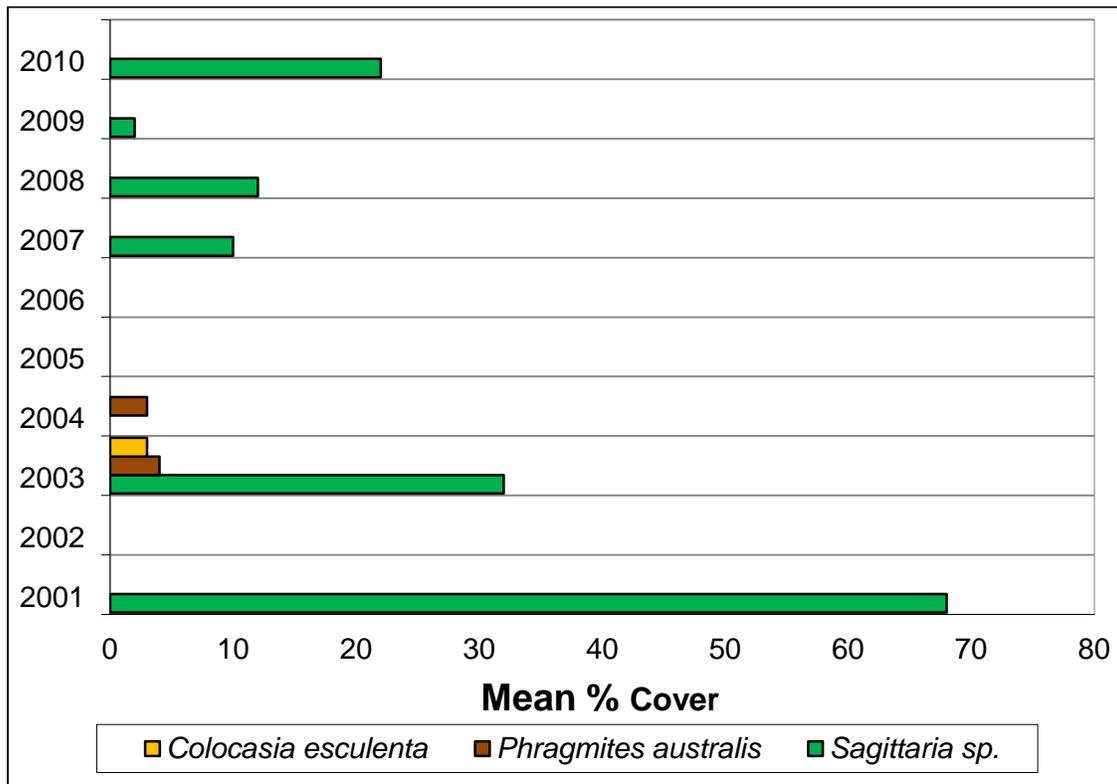
Figure 16. Mean percent cover of emergent vegetation species from 2001 to 2010 (2001 – 2002 n=2; 2003 – 2007 n=7; 2008 – 2009 n=8; 2010 n=9). No vegetation was observed in 2002, 2005, or 2006.

Vegetative cover recovered somewhat in the 2007 – 2010 surveys, although in each of these years vegetation was found in 2 or fewer plots. Mean percent cover ranged from 2% to 22% (Figure 16) across all stations. One new station was added to Transect 1 in 2008, along with another in 2010; both were located on the northern end of the transect. The only species observed during these surveys was *Sagittaria* sp.

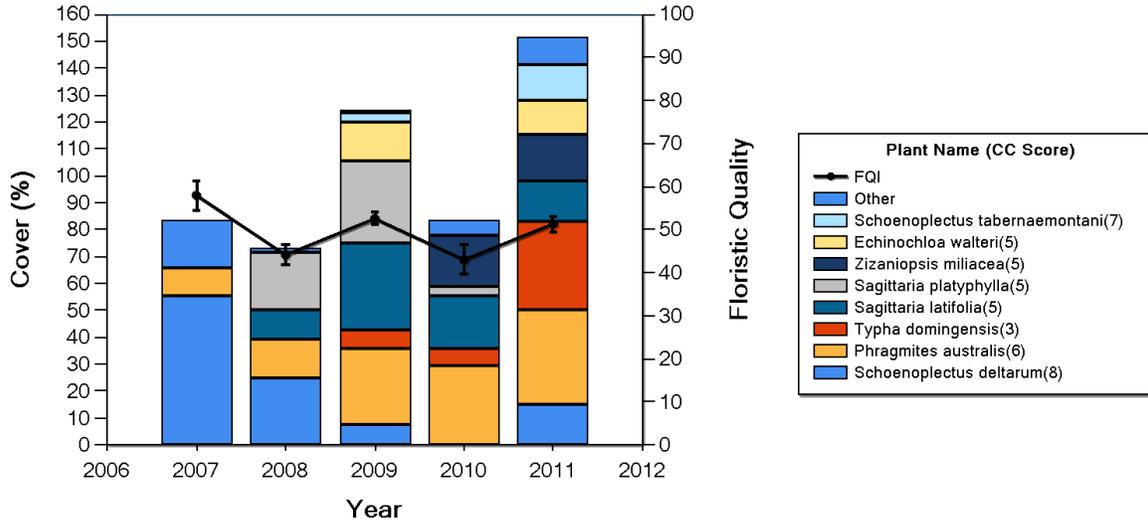
Figure 17 Mean % cover of major species and FQI score at CRMS2634 vegetation plots in years 2007 through 2011.

FQI scores at CRMS2634 remained relatively stable from 2007 to 2011, ranging from a low of 43 in 2010 to a high of 58 in 2007 (Figure 17). Total mean percent cover values showed a general upward trend for the same period, with the highest values seen in 2009 and 2011. There was also a shift in the species composition, from a community dominated by *Schoenoplectus deltarum* (delta bulrush) and *Sagittaria* sp. (bulltongue) to one dominated by *Phragmites australis* (common reed) and *Typha domingensis* (southern cattail). FQI scores for the MR-06 project area were consistently higher than other fresh marsh CRMS project and reference sites within the MRD hydrologic basin from 2007 to 2011 (Figure 18).

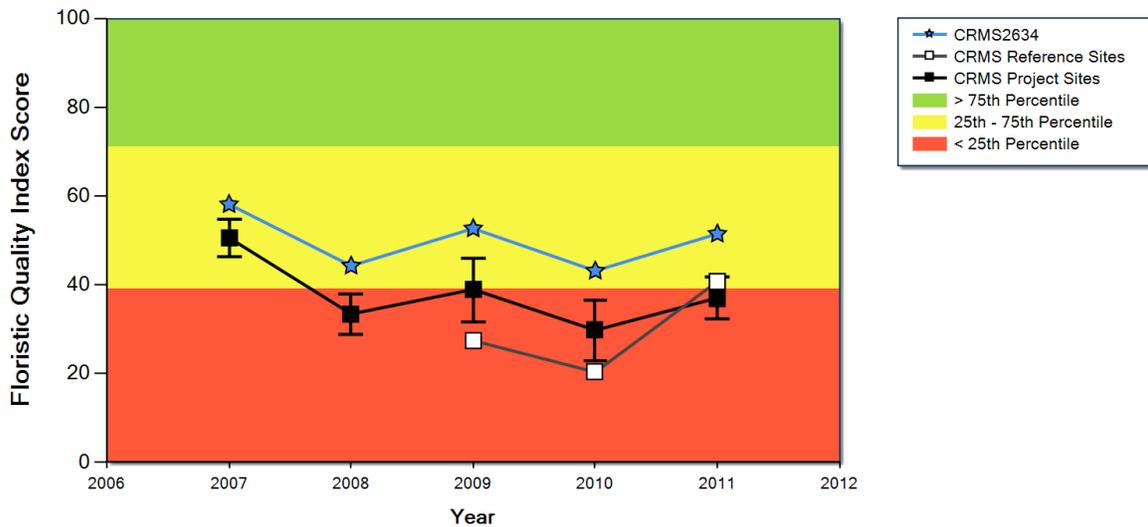
Figure 18. FQI scores of CRMS sites within the MR-06 project area (blue stars) are shown over time relative to all other fresh marsh CRMS sites within the Mississippi River Delta hydrologic basin. Black squares represent CRMS sites located within restoration projects; white squares are CRMS reference sites outside of restoration projects. Project and reference site scores are the mean (\pm SE) FQI scores by year for all sites with similar marsh types within Mississippi River Delta Basin.
