**State of Louisiana
Coastal Protection and Restoration Authority**

2012 Operations, Maintenance, and Monitoring Report

Channel Armor Gap Crevasse (MR-06)

State Project Number MR-06
Priority Project List 3

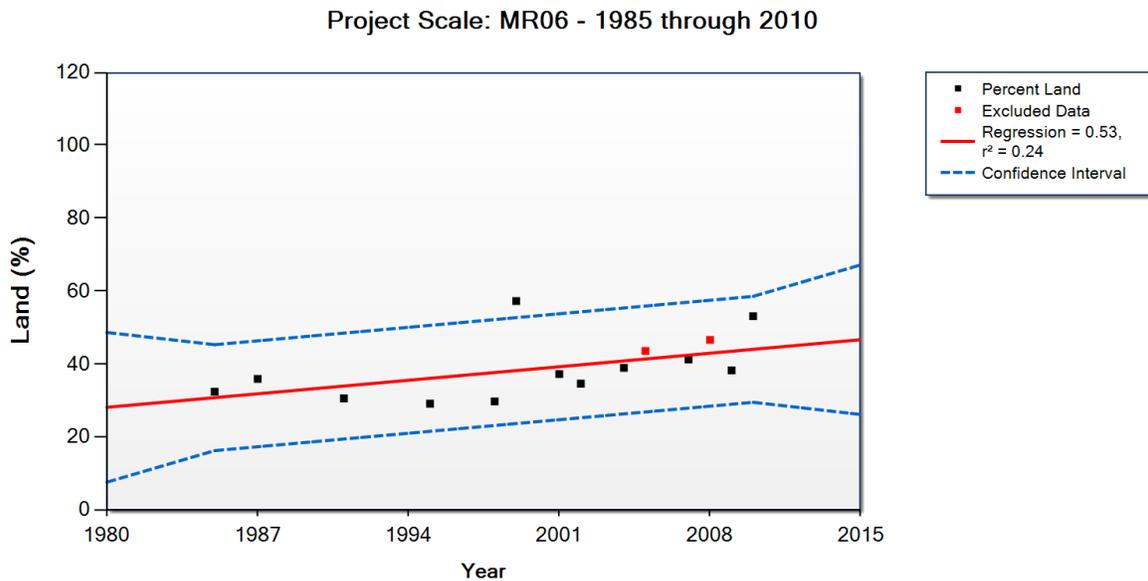
Figure 19. Project scale percent land change for MR-06. Percent land values are displayed for all cloud free TM images available for 1984 – 2010. The red line depicts the percent land trend for the entire period of record. Percent land calculated as percent land of total project area. Data points were excluded immediately following the hurricanes of 2005 and 2008 because they do not represent average conditions.

Percent land trends were calculated using Landsat Thematic Mapper (TM) data for 1985 - 2010. Linear regressions were calculated for the period of record excluding the 2005 and 2008 dates. Post-hurricane images were excluded from analysis because they do not represent average conditions and exclusion was an effort to reduce the influence of

transitory storm effects. The variability in percent land data points around the slope illustrates the influence of various sources of environmental variance or classification error. Positive slopes indicate increasing percent land or historical land gain and negative slopes indicate decreasing percent land or historical land loss (Couvillion et al., 2011). The positive slope of the regression line for MR-06 indicates that land gain is occurring in the project area (Figure 19). This is consistent with the project-specific land/water analysis. When the same data are separated into pre- and post-construction time periods a more complete picture emerges. The pre-construction percent land trend was negative (Figure 20), however this trend was reversed post-construction.

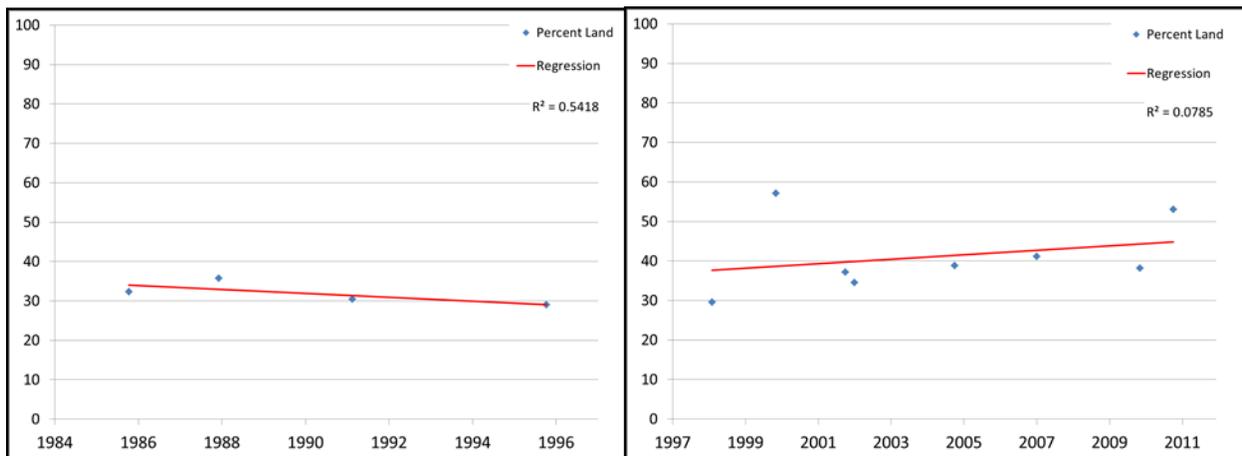
Figure 20. Pre-construction (left, N=4) and post-construction (right, N=8) percent land change for MR-06. The red line depicts the percent land trend for the period. Percent land calculated as percent land of total project area.
