## 2012 Operations, Maintenance, and Monitoring Report

### Fritchie Marsh Restoration (PO-06)

State Project Number PO-06  
Priority Project List 2

June 2012  
St. Tammany Parish

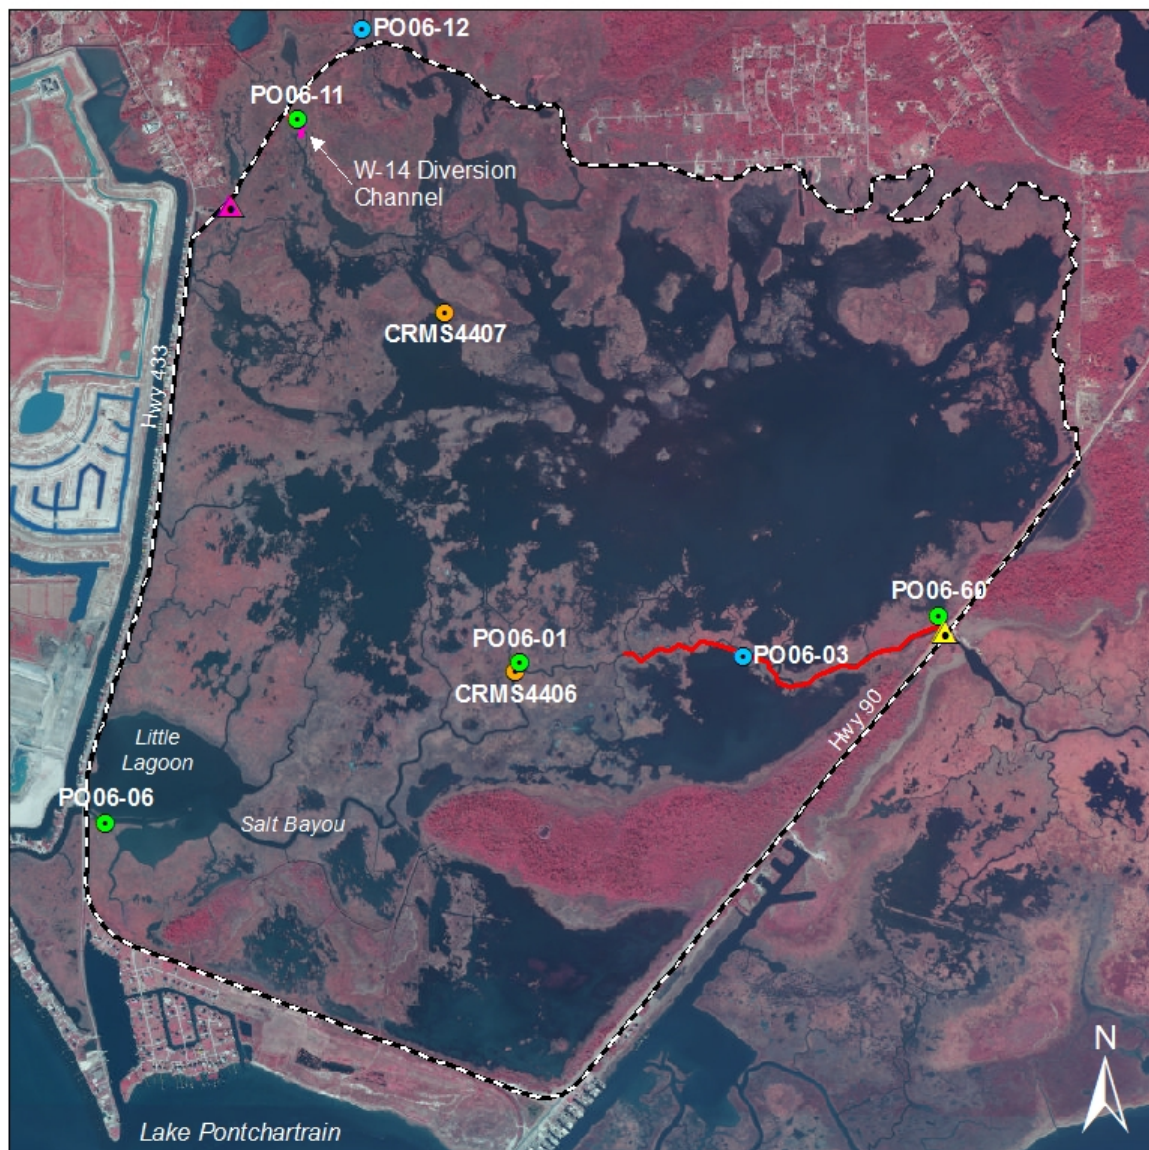
- 72" Concrete Culvert
- Steel Sheetpile Weir with Boat Bay
- PO-06 Continuous Recorder
- CRMS Continuous Recorder
- PO-06 Staff Gauge
- 5,300ft Dredging of Salt Bayou
- 400ft Dredging of W-14 Diversion Channel
- Project Boundary

**Figure 1.** Fritchie Marsh Restoration (PO-06) project boundary, construction features, continuous recorder locations, and CRMS site locations.

- Installation (jack and bore) of a 72-inch diameter by 136-foot long concrete culvert under U.S. Highway 90, rock riprap lining of the Salt Bayou channel bottom and pipe outlets, and installation of 308 linear feet of sheet piling to form a bulkhead.
- Installation of a weir in the W-14 canal. The weir consists of 108 linear feet of sheet pile with a 20-foot wide boat bay.
- Dredging of approximately 400 linear feet of the W-14 diversion channel and 5300 linear feet of the Salt Bayou channel.

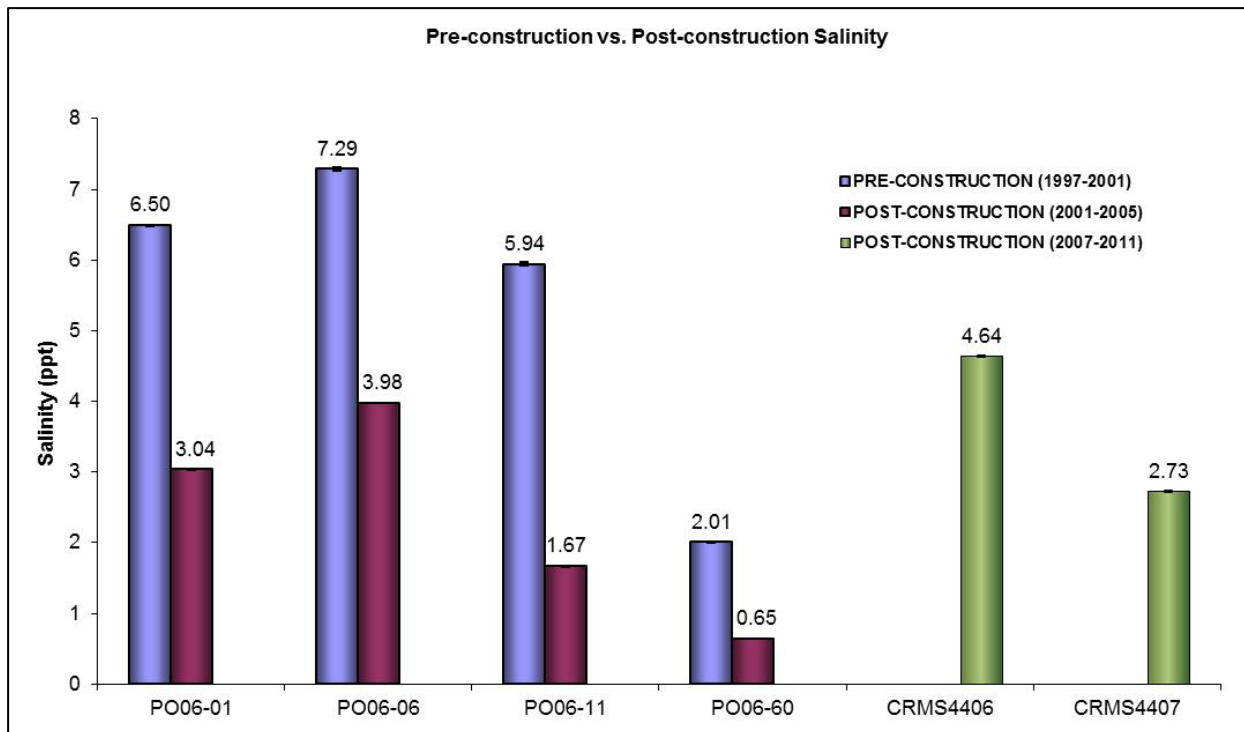
**Figure 11.** Mean weekly salinity at continuous recorder stations located in the Fritchie Marsh (PO-06) project area during pre-construction and post-construction periods.

The data show that the mean weekly salinity was lower and water level was higher at all four continuous recorder stations during the post-construction period (Figures 11 and 12). These data showed a significant interaction ( $p<0.0001$ ) between stations in both the salinity and water level analyses. The significant *period* by *location* interaction indicates that the relative magnitude of changes in salinity and water level was different between stations indicating a project effect. These effects show up graphically as lines out of parallel in Figures 13 and 14. Interpretation of these results is complicated by the record-setting drought from September 1999 to December 2000, which led to increased salinity during some of the pre-construction period (Figure 9). The statistical design controls against this kind of nuisance fluctuation only under the assumption that the four sites would respond equally to the drought. In order to test this assumption, the analysis was repeated with the drought period removed. The *period* by *location* interaction was again found to be significant ( $p<0.0001$ ) indicating that there was a significant project effect despite the occurrence of the drought.

Although salinity and water level monitoring ended at the PO-06 sites in 2005, hydrographic data collection has been ongoing at the two CRMS sites in the project area since November 2007. CRMS4406 is located mid-way along Salt Bayou in nearly the same location as former site PO06-01, while CRMS4407 is located in the northern project area nearest to former site PO06-11 (Figure 1). Mean weekly salinity at the CRMS sites from 2007 to 2011 was slightly higher than the post-construction salinity (2001 to 2005) at the PO-06 sites (PO06-01, PO06-11), but still lower than the pre-construction salinity (Figure 11). The increase in salinity in the post-construction period was lower in the northern project area (+1.1 ppt, CRMS4407 vs PO06-11) than at the Salt Bayou location (+1.6 ppt, CRMS4406 vs PO06-01). Mean weekly water level at CRMS4406 near Salt Bayou was 0.19 ft lower from 2007 to 2011 than was measured at PO06-01 from 2001 to 2005. In the northern project area, however, mean weekly water level was the same at CRMS4407 as post-construction levels at PO06-11 (0.04 ft difference) (Figure 12).

post-construction salinity at PO06-06, which was located closer to the lake (Figure 1, Figure 11). Subsequent project inspections have determined that breaches along the banks of Salt Bayou near the culvert are still allowing fresh water to enter the project area (see Section II, b), and therefore the project is still functioning as designed. In the northern project area, water level and salinity data show relatively small changes before and after Hurricane Katrina, and therefore Salt Bayou siltation does not seem to be affecting this portion of the project. In fact, the salinity increase of ~1 ppt in the post-Katrina period may be due to the location of CRMS4407 which is located further from the W-14 Canal than PO06-11. Even the salinity increase of 1.6 ppt at the Salt Bayou location is relatively small and may have little ecological impact considering the wide salinity range of an intermediate to brackish marsh. There are no plans to re-dredge Salt Bayou at this time, but water level and salinity data will continue to be monitored at the CRMS sites to determine if any action will be needed in the future.

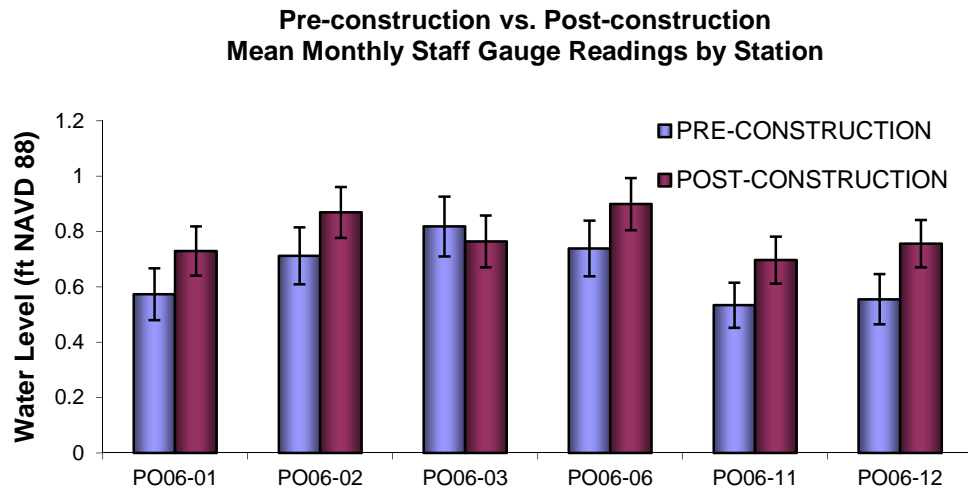
**Figure 15.** Mean of monthly staff gauge readings at the six staff gauges located in the Fritch Marsh (PO-06) project area during the pre-construction (3/98-2/01) and post-construction (3/01-6/05) periods.

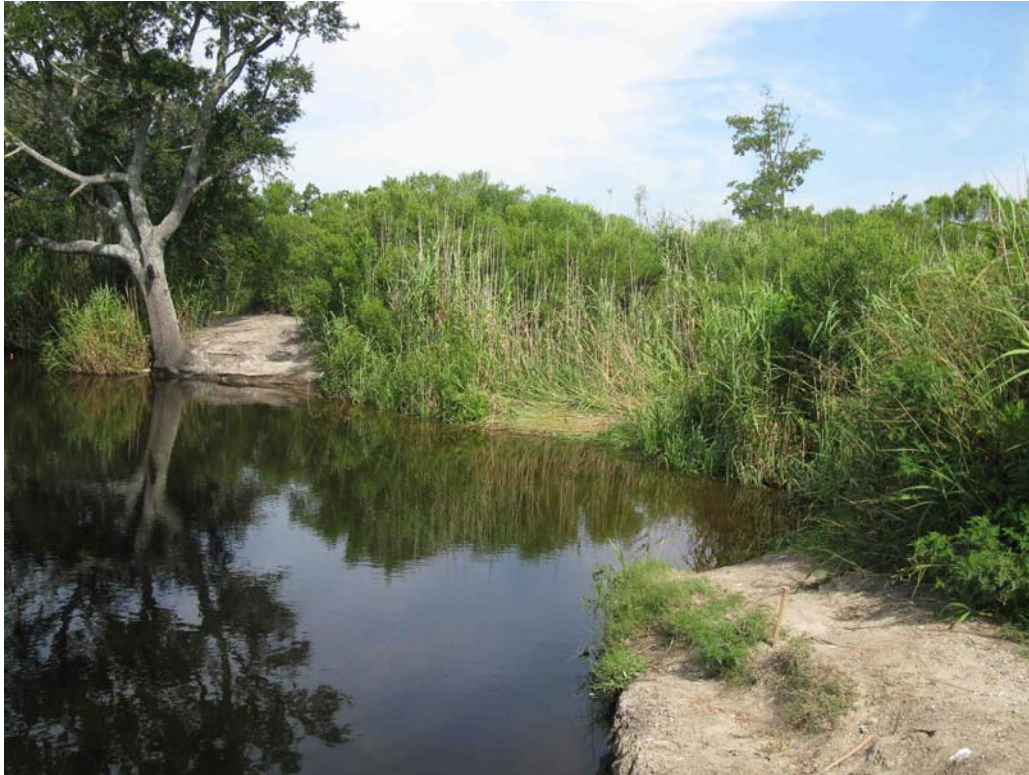
**Photo #1. Salt Bayou Bank Scour Near Culverts**

There is no change in this structure from the previous inspection. The bank scour reported in previous inspection reports is still of concern; however, it is well vegetated (Appendix A, Photos #1 and 2).

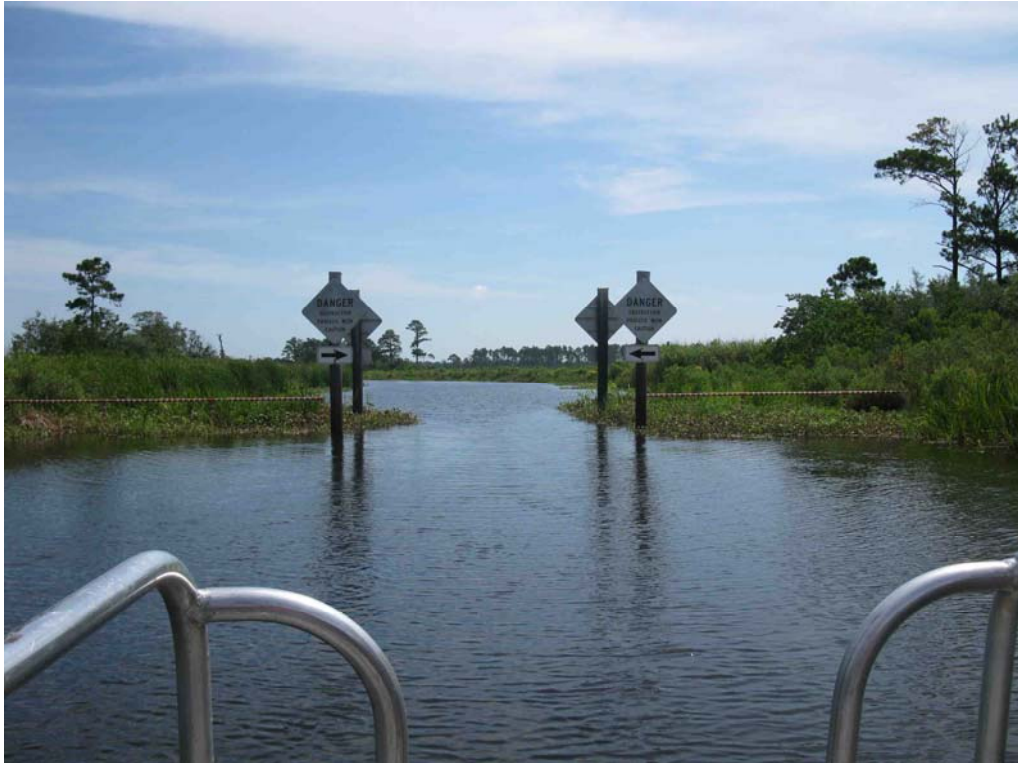
**Photo #3. W-14 Weir**

There was no visible damage to this structure and it is operating as designed (Appendix A, Photo #3).

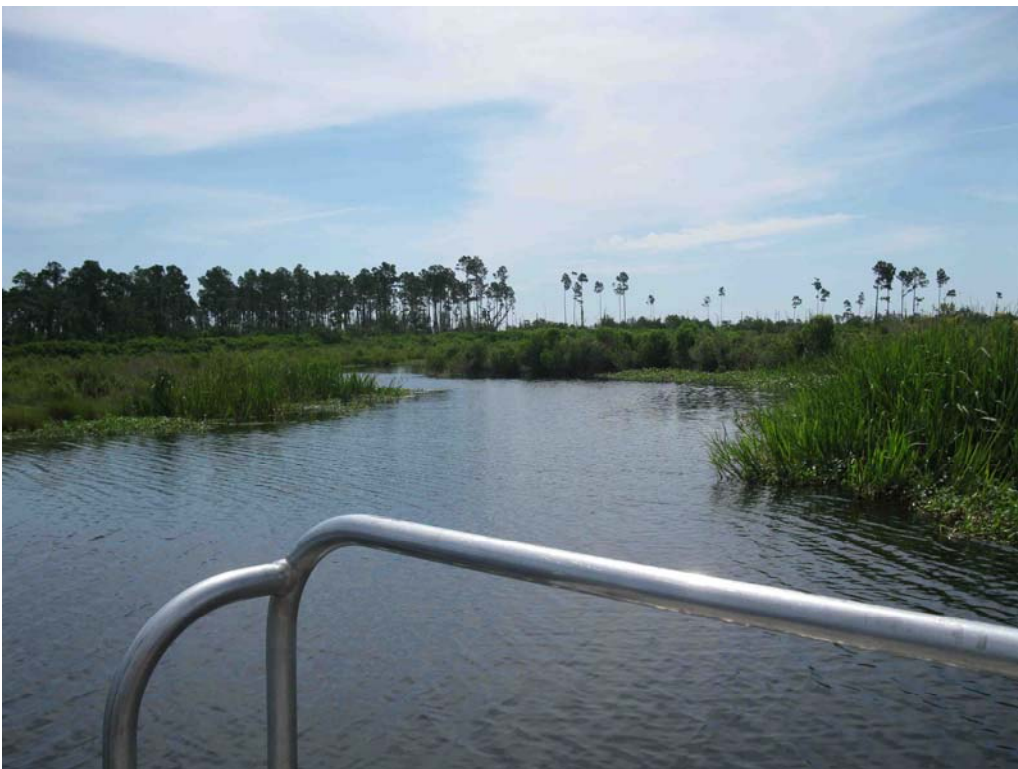
**Photo #4. W-14 Diversion Channel Beyond Dredging**

There is no visible change to this feature. It is diverting water from the north as designed (Appendix A, Photo #4).
