2011/2012 Annual Inspection Report

EAST MARSH ISLAND MARSH CREATION PROJECT (TV-21)

State Project Number TV-21 Priority Project List 14

March 13, 2012 Iberia Parish

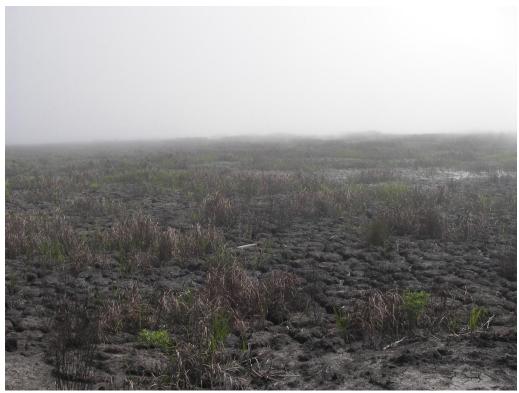
Photo No. 1, Marsh Creation Cell

The two marsh creation cells are in good condition since the project was completed in 2010. The containment dikes are stable and the natural vegetation continues to expand within the cells. It is estimated that there is seventy (70%) per cent natural vegetation cover. The one year post construction surveys have been completed by T. Baker Smith. The survey data indicates the marsh platform is settling as expected and is near the target healthy marsh elevation of +1.7 NAVD88. (Photos: Appendix B, Photo 1-5)

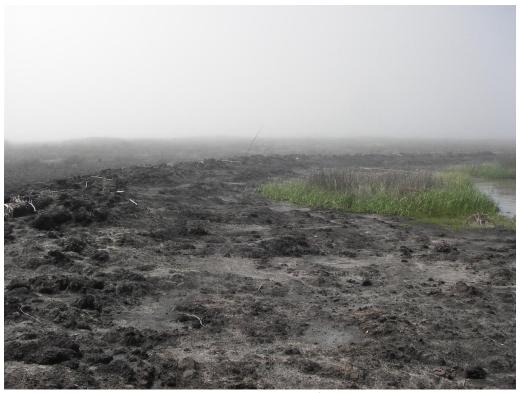
Photo No. 4, Earthen Plug at End of Pipeline Canal.

The earthen plug at the end of the North-South Pipeline Canal is holding up well with no differential settlement taking place. (Photos: Appendix B, Photo 4)
