**Coastal Protection and Restoration Authority of
Louisiana**

2012 Operations, Maintenance, and Monitoring Report

Delta Management at Fort St. Philip (BS-11)

November 12, 2012
Plaquemines Parish

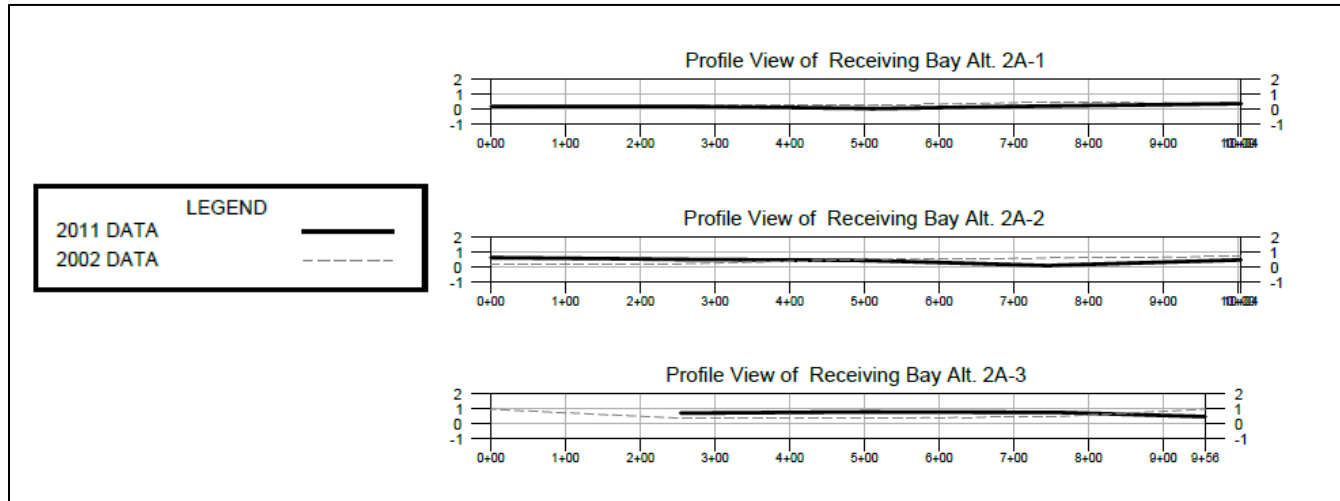
Figure 7. Profile view of elevation survey transects within the receiving bay of crevasse Alt 2A of the Delta Management at Fort St. Philip (BS-11) project.

Receiving bay Alt 2A showed a net loss of -1,176.16 cubic yards (yd³) of sediment from 2002 (pre-construction) to 2011 (year 5). The profile drawings show relatively small changes in elevation between pre-construction and year 5 (Figure 7). Elevation was highest along Transect 3 which is closest to the crevasse channel, and there was no scouring due to the crevasse channel inflow as seen in crevasse 1A. The channel survey, however, indicated a gain of 9,692.53 cubic yards (yd³) from 2006 to 2011. Infilling of the channel appears to be hindering the accumulation of sediment in the receiving bay of crevasse Alt 2A.

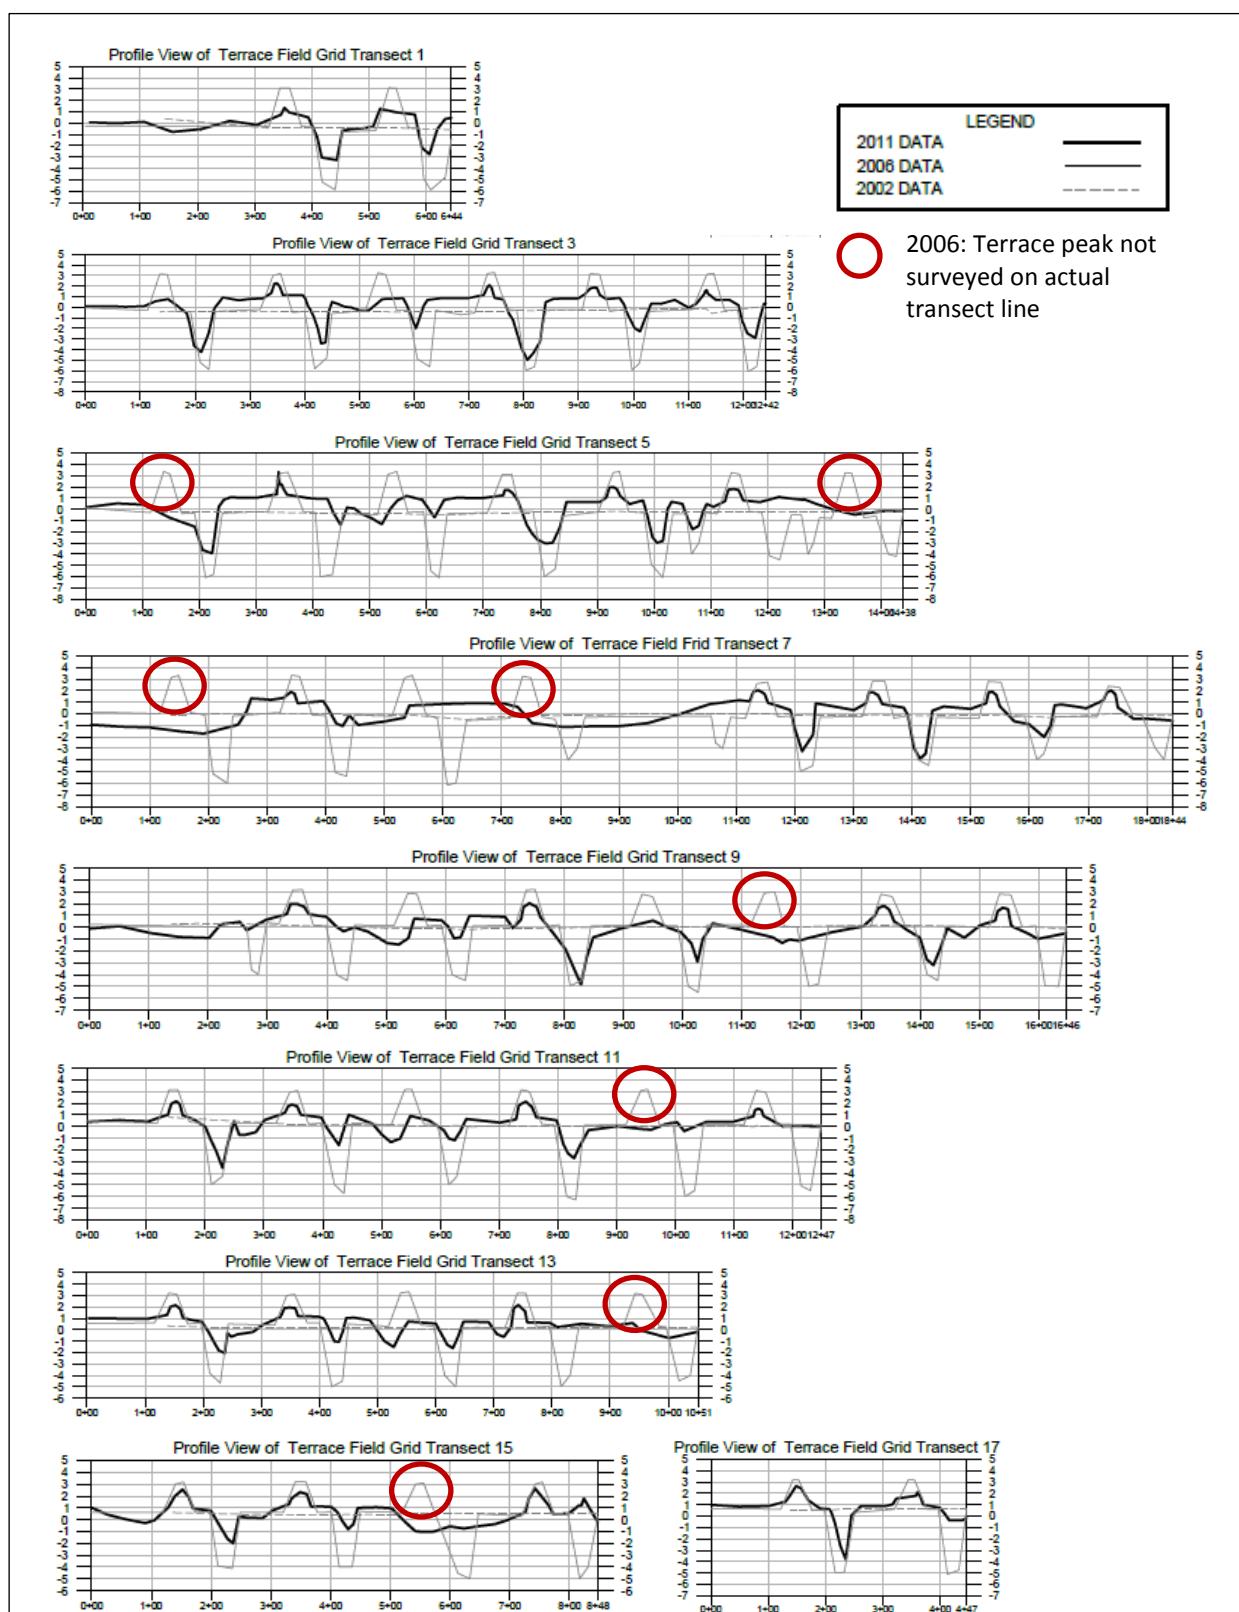
Figure 8. Profile view of surveyed transects within the terrace field of the Delta Management at Fort St. Philip project in 2002, 2006, and 2011.

The 2011 profile of the terrace field transects indicate a general ‘flattening’ of the 2006 profile, due to infilling of the borrow channels and erosion/subsidence of the terraces (Figure 8). The profile views show the terrace crowns subsiding about one foot on average from 2006 to 2011. Loss of terrace height was even greater at points along the terrace edges, where scouring and erosion occurred. Significant shoaling, however, was seen within the borrow areas around the terraces, which affirms that sediment is being retained within the terrace field.

Volumetric comparisons could not be made within the terrace field due to the highly irregular surface between the survey transects. Area calculations, however, showed that the terrace field experienced a net loss of sediment along all nine transects from 2002 to 2006 due to construction of the terraces (Figure 8, Table 2). The total net loss of sediment along all transects due to construction was 3,480.98 ft². By 2011, the terrace field experienced a net gain of 4127.66 ft² along all nine transects. Due to the anomalies in the 2006 data, both of these values may be underestimated. The comparison between the 2002 (pre-construction) and 2011 (year 5) is the most valid because it does not include the anomalous data from 2006. This comparison showed a net gain along six out of the nine transects, for a total net gain of 794.76 ft². Rough approximations of sediment volume using the average end area method of estimation show that 71,037 yd³ of sediment was gained from 2006 to 2011, while the net volume gained overall from 2002 to 2011 was 14,464 yd³. In the five years since construction, most of the gain in sediment replaced sediment lost to construction. Net sediment gain at year 5 is modest compared to pre-construction conditions; however, the terraces remain subaerial and will continue to capture material as designed.

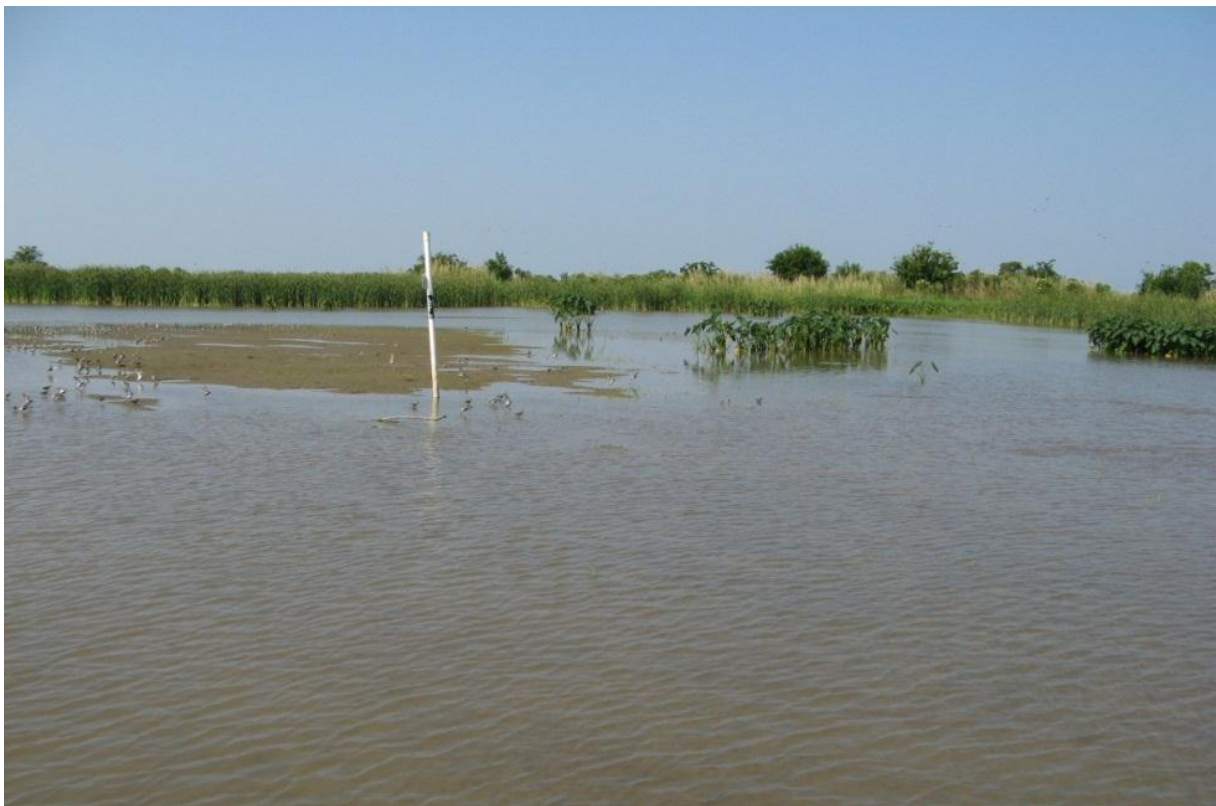
Figure 9. Colonization of *Colocasia esculenta* (elephant ear) on a mudflat located in Crevasse 1B of the Delta Management at Fort St Philip (BS-11) project.

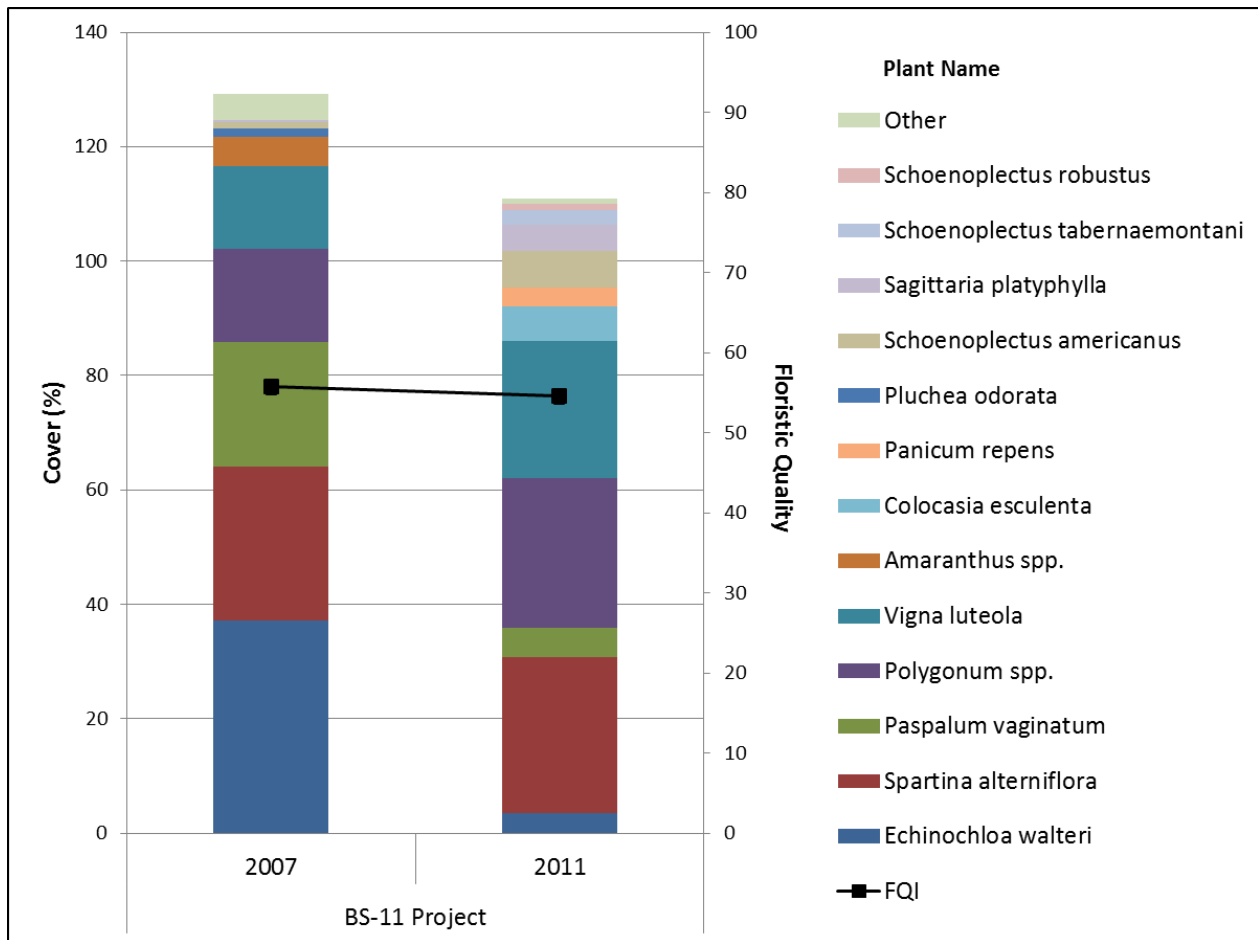
Figure 10. Mean percent cover of species within the BS-11 terrace field and the Floristic Quality Index (FQI) score for 2007 and 2011.

The dominant species in 2011 were *S. alterniflora* and *P. punctatum* (Figure 10). *S. alterniflora* was the only species found in or near every plot sampled. A large decrease in percent cover of *E. walterii*, as well as the artificially planted species, *P. vaginatum*, was observed in 2011. Alternatively, an increase in the percent coverage of *Polygonum spp.*, *V. luteola*, and *Schoenoplectus americanus* was observed in 2011. The percent coverage of *S. alterniflora* was 27% in both sampling years. Overall, the vegetation on the terraces appeared vigorous, and the changes in species composition were mostly typical of a post-disturbance (i.e., construction) event. Although some terraces have subsided, all are still supporting vegetative cover.

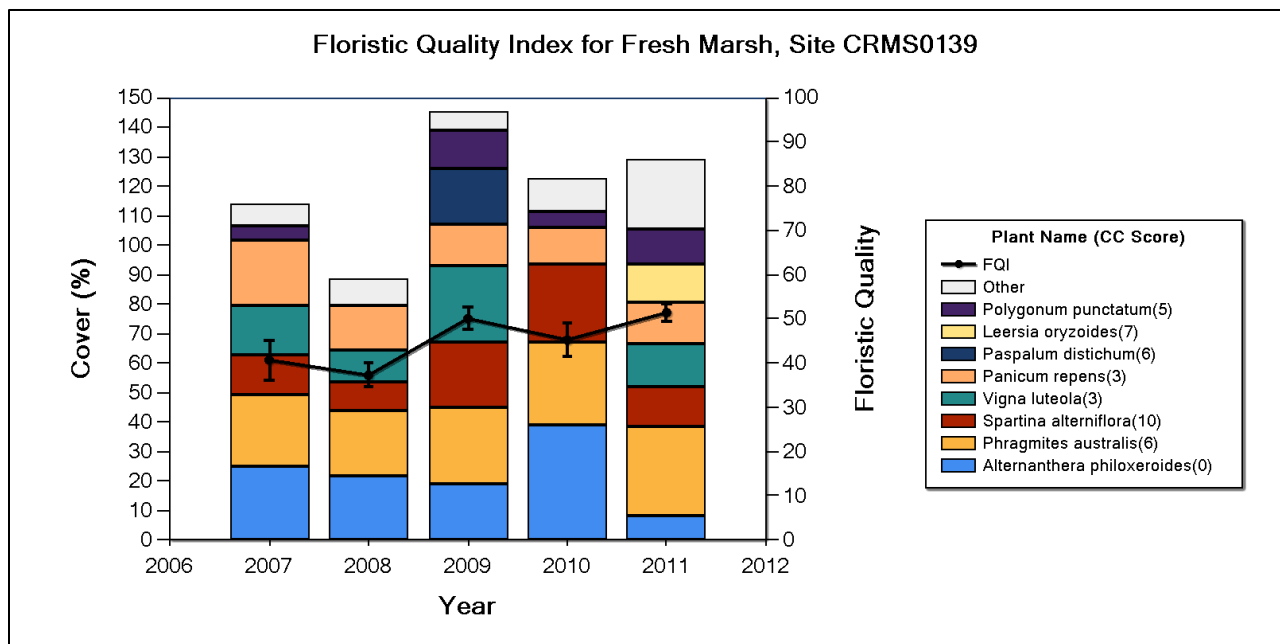
Figure 11. Mean percent cover of species and the Floristic Quality Index (FQI) score at CRMS0139 from 2007 to 2011.

One tool that has been used to assess the quality of the vegetation community at the CRMS sites is the Floristic Quality Index (FQI) (Cretini et al. 2011). The FQI is calculated by assigning each species a CC score, or coefficient of conservatism, which is scaled from 1 to 10 and reflects a species' tolerance to disturbance and habitat specificity. A modified FQI was developed by the CRMS Vegetation Analytical Team, which assembled a team of experts to assign CC scores to Louisiana's wetland plant species. The modified FQI equation takes into account not only the CC scores, but also the percent covers of species at a site, and the resulting score is scaled from 0 to 100. Mean FQI scores were calculated for the BS-11 terrace sites and CRMS139 sites for each of the sampling years. FQI scores for the BS-11 sample years were essentially the same in both sample years dropping from 56 in 2007 to 55 in 2011 (Figure 10). The FQI scores were slightly lower at CRMS0139, fluctuating between 37 and 51 from 2007 to 2011 (Figure 11). The lower FQI at the CRMS site is likely due to the greater presence of *A. philoxeroides*, which is assigned the lowest CC score of 0. Based on the FQI scores, it appears that the terraces are supporting an emergent vegetation community that is equally as stable as the surrounding natural marsh.

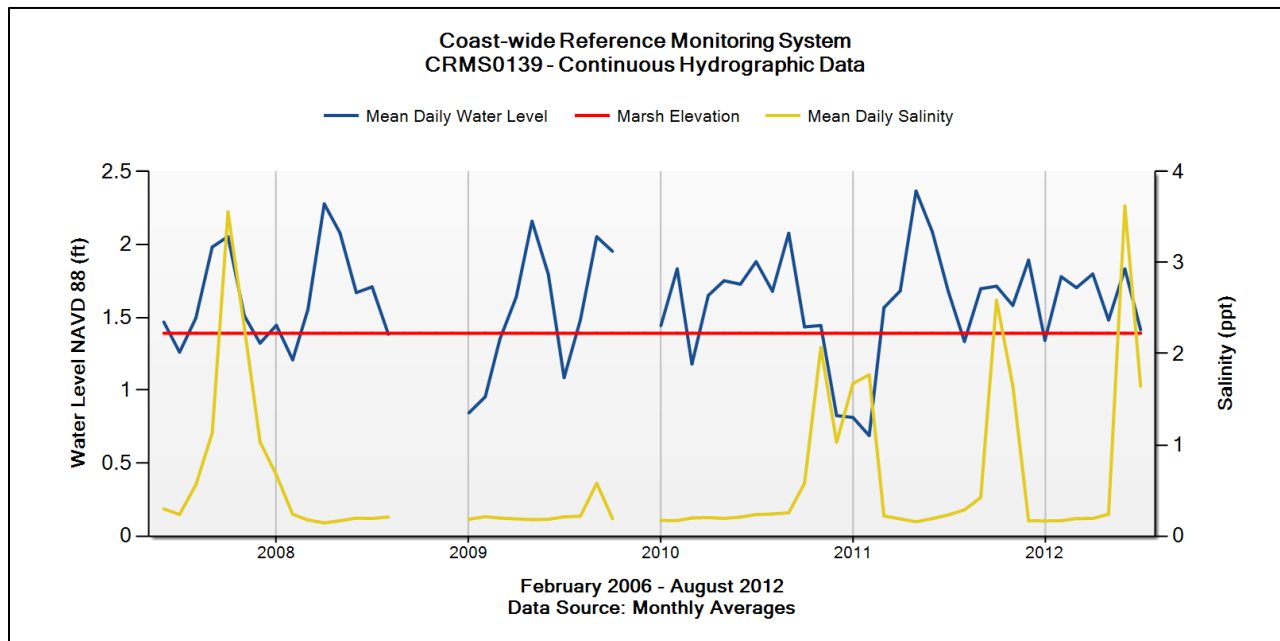
Figure 12. Monthly mean salinity (ppt) and water level (ft NAVD 88) collected at CRMS0139 from 2007 to present.

Hydrographic Data. Salinity and water level have been sampled hourly at CRMS0139 from June 2007 to present using methods described in Folsie et al. (2008, revised 2012) (Figure 12). A continuous recorder is serviced approximately once every month to clean and calibrate the recorder and to download the data. A staff gauge is installed next to the continuous recorder to compare recorded water levels to a known datum (NAVD88). During processing, the data are examined for accuracy and loaded to the CPRA database, and are available for download from the CRMS website (<http://www.lacoast.gov/crms2>). The mean salinity recorded at CRMS0139 was 0.62 ppt. Large spikes in salinity up to 19 ppt were associated with fronts and storm events but were generally brief in duration. Mean water level was 1.59 ft NAVD and ranged from 0.92 to 2.22 ft NAVD. Based on an average marsh elevation of 1.4 ft NAVD, it is estimated that the marsh at CRMS0139 is flooded 62% of the year.

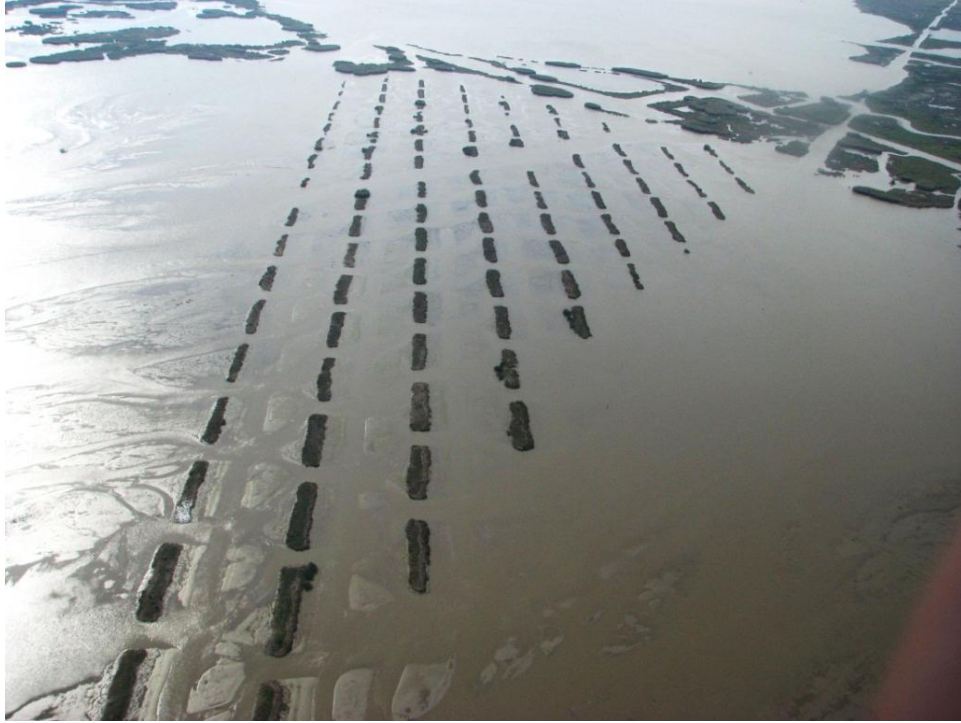
Terrace Field (12/08/2011)

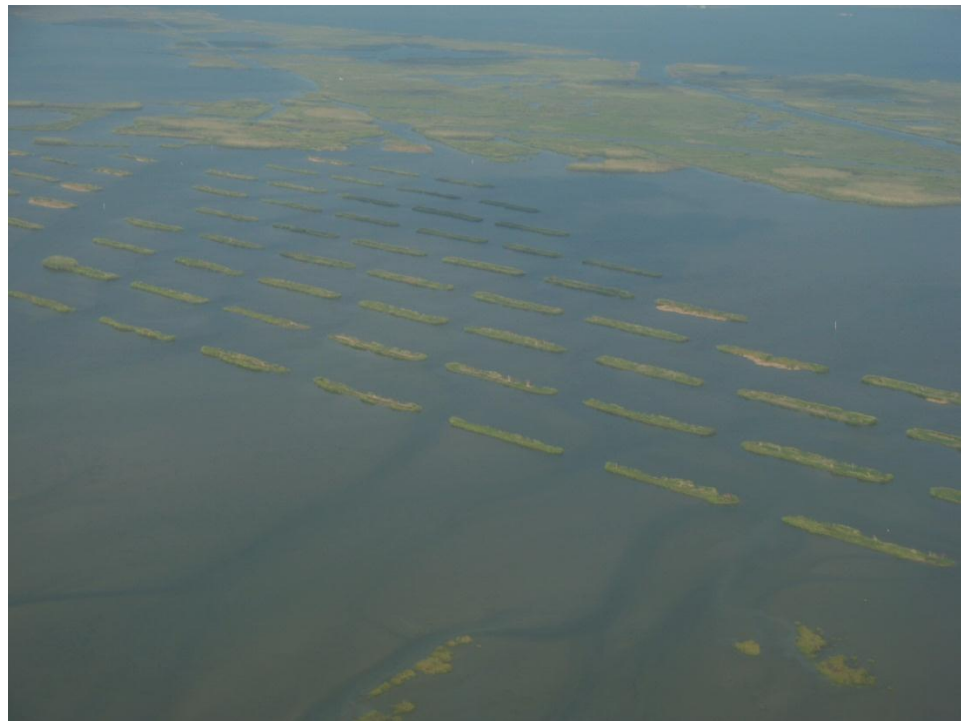
Terrace Field (9/24/2012)

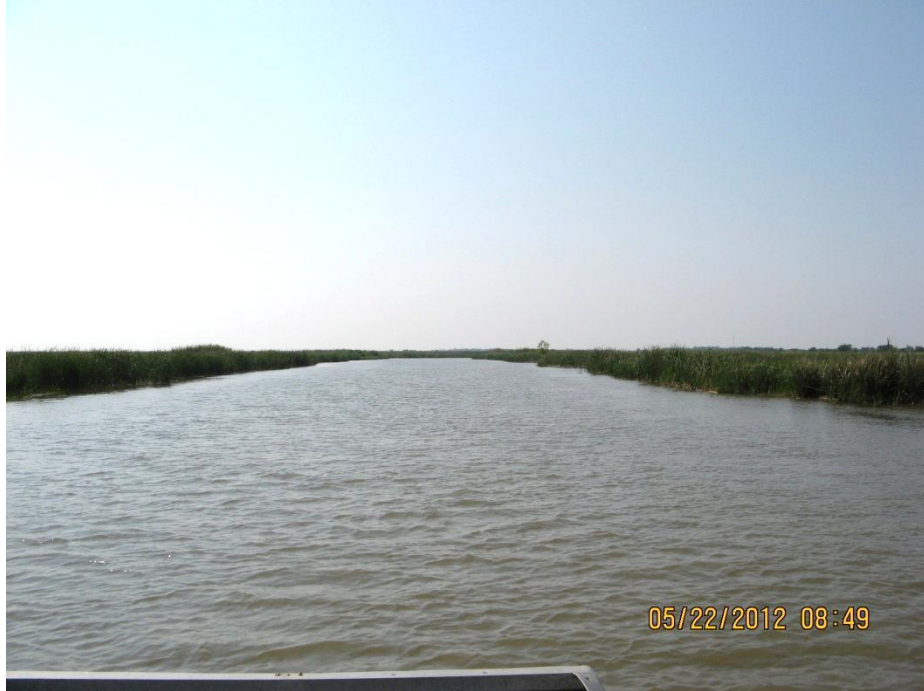
Channel 1-A exiting the Terrace Field in Bay Denesse

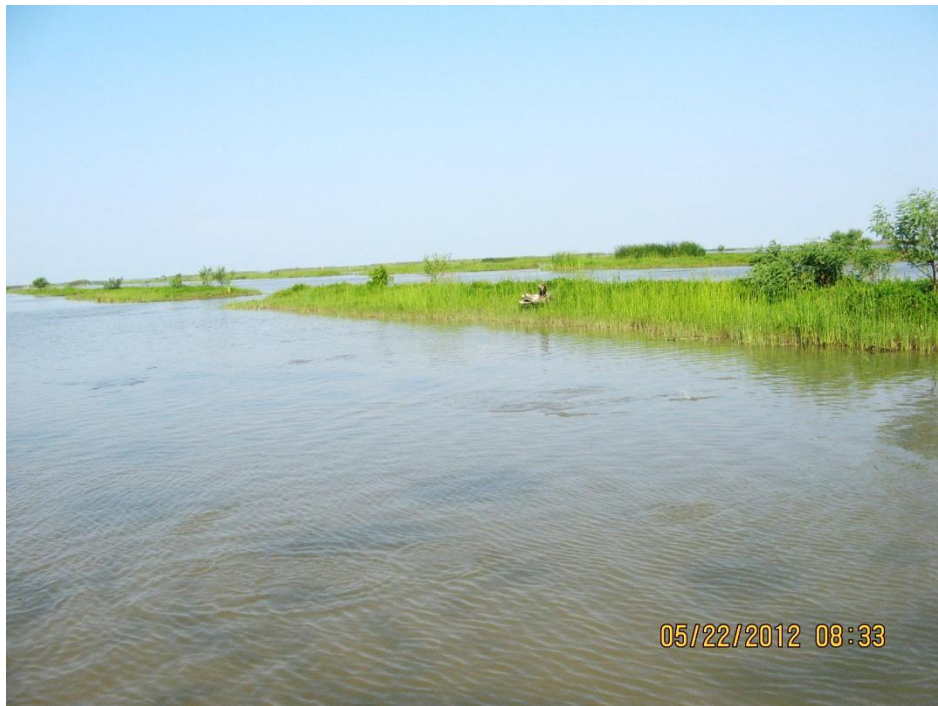
Terrace Field in Bay Denesse

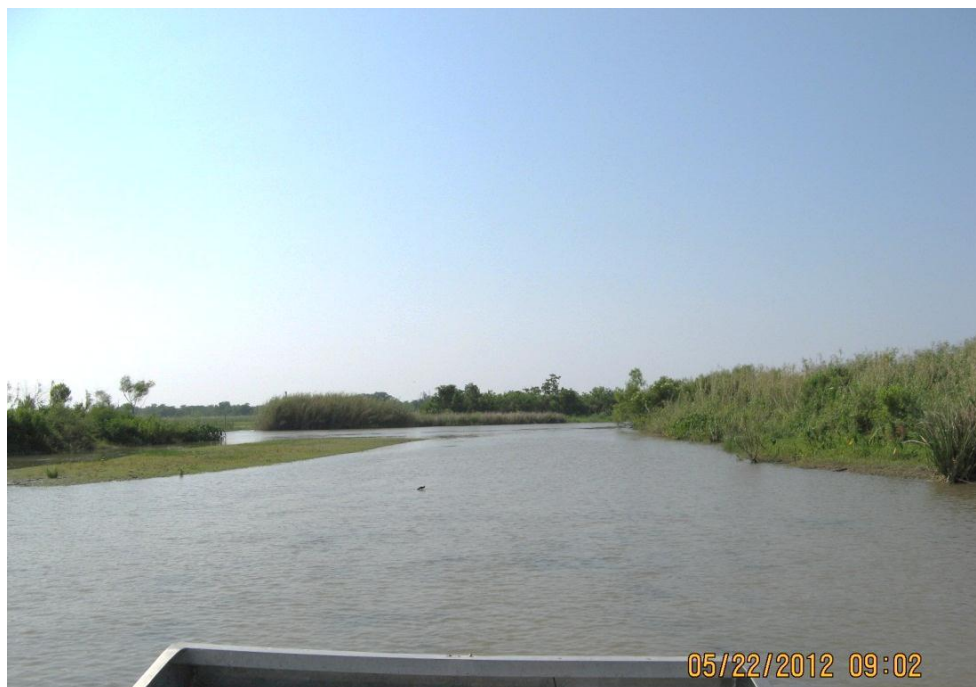
- iii. **Crevasse 1B:** Grasses have sprouted on an island formed in the crevasse after the 2011 high river event. Mudflats within the receiving bay are visible above the water surface.

Crevasse 1-B Channel shoaling

Elevation surveys from October 2011 indicate that shoaling is occurring within the crevasses. Results from this survey will be discussed in further detail in Section IV. CPRA will evaluate the deposition patterns and determine best use of the maintenance funds available. If CPRA determines crevasse clean-outs are the best alternative, they will submit a cost estimate for the first round of maintenance dredging of the crevasses.

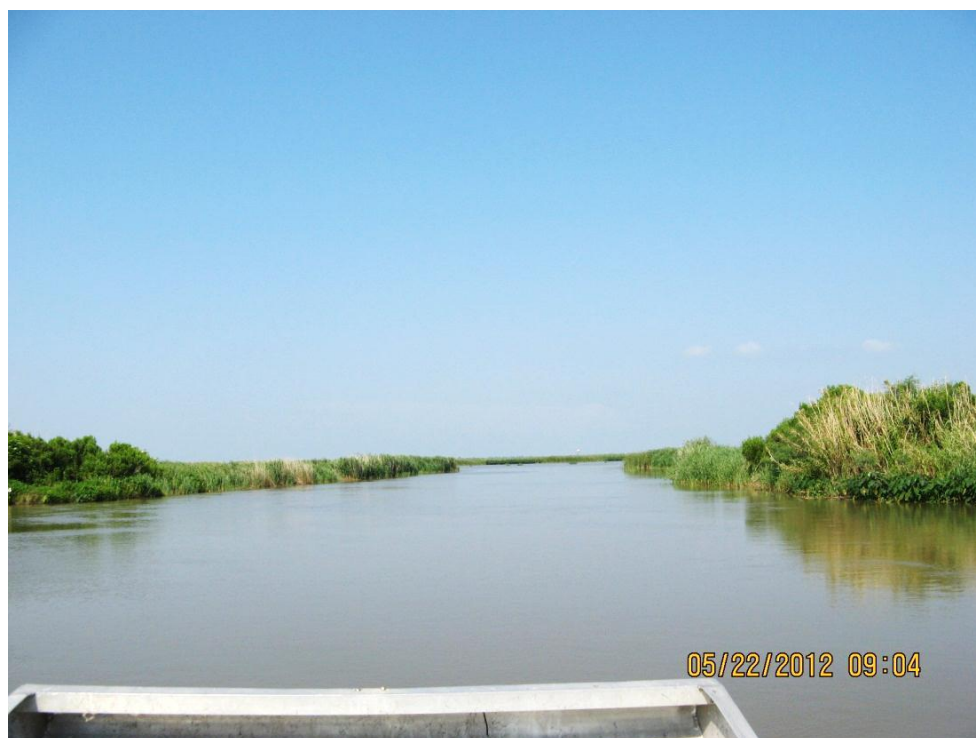
- iv. **Crevasse 1C:** The 2011 survey indicates this crevasse has begun infilling. The channel outfall shows colonization of emergent vegetation.
- v. **Crevasse Alt. 2A:** Flow is maintained within the channel. The channel has filled to 1'-3' deep.

Crevasse 1-C

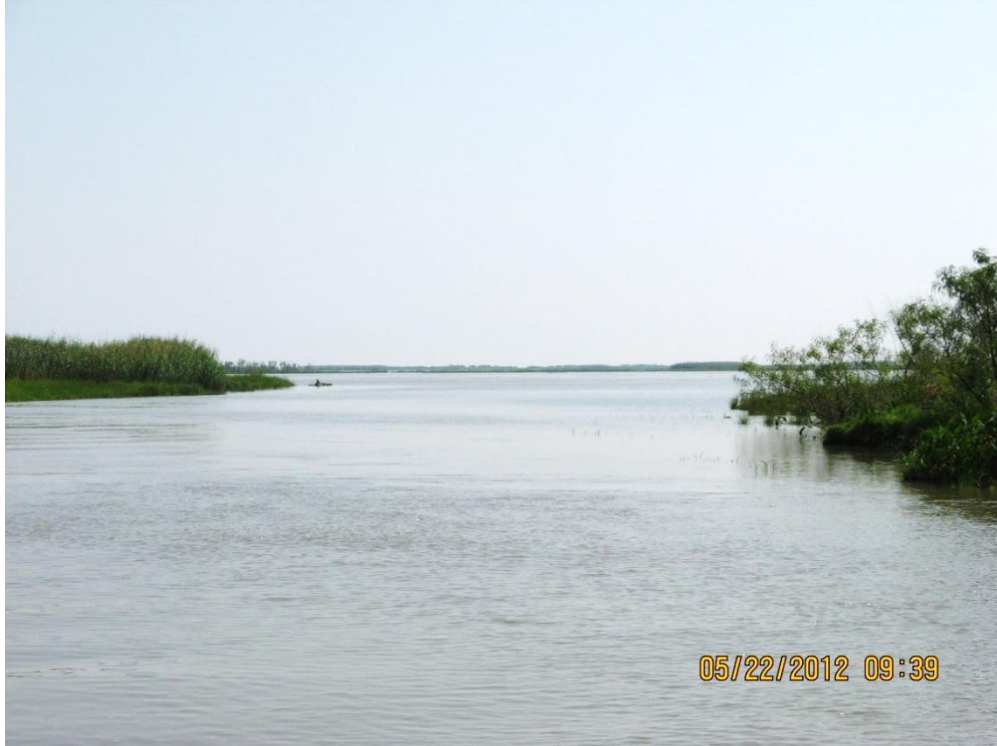
Crevasse Alt 2-A Channel with vegetated spoil bank

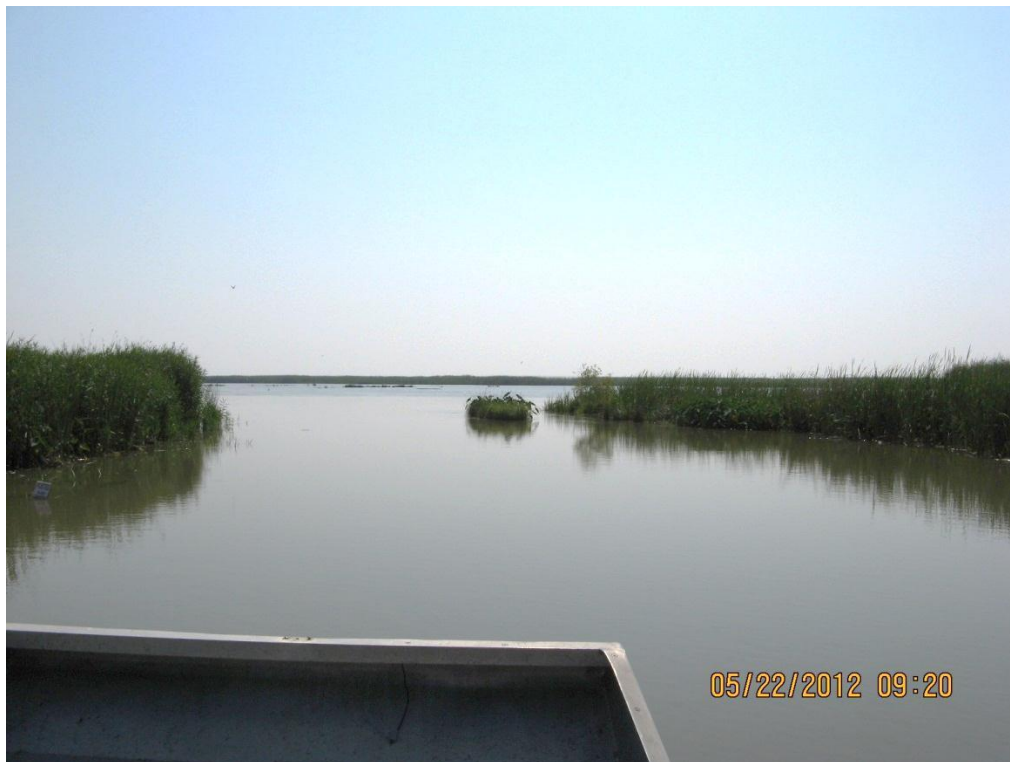
- vi. **Crevasse 2B:** Flow is maintained within the channel. Sporadic vegetated islands are emerging within the receiving bay. The channel has begun filling in; the deepest part of the channel runs along the northern bank.

Crevasse 2-B Channel outlet, spoil bank marsh growth.

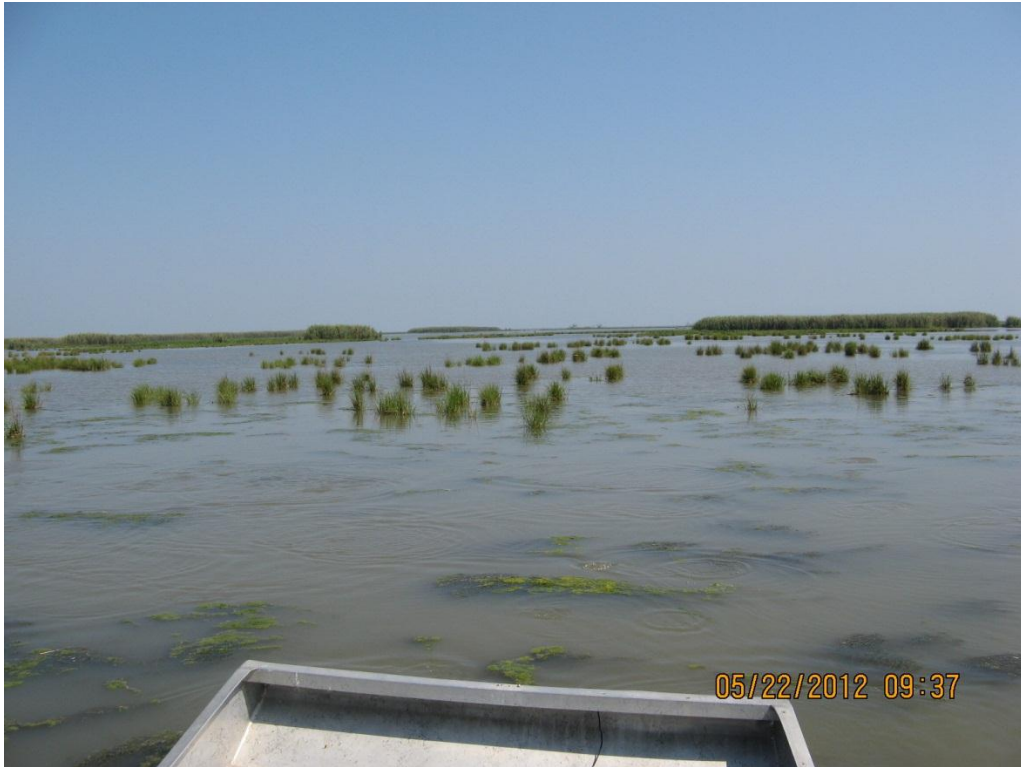
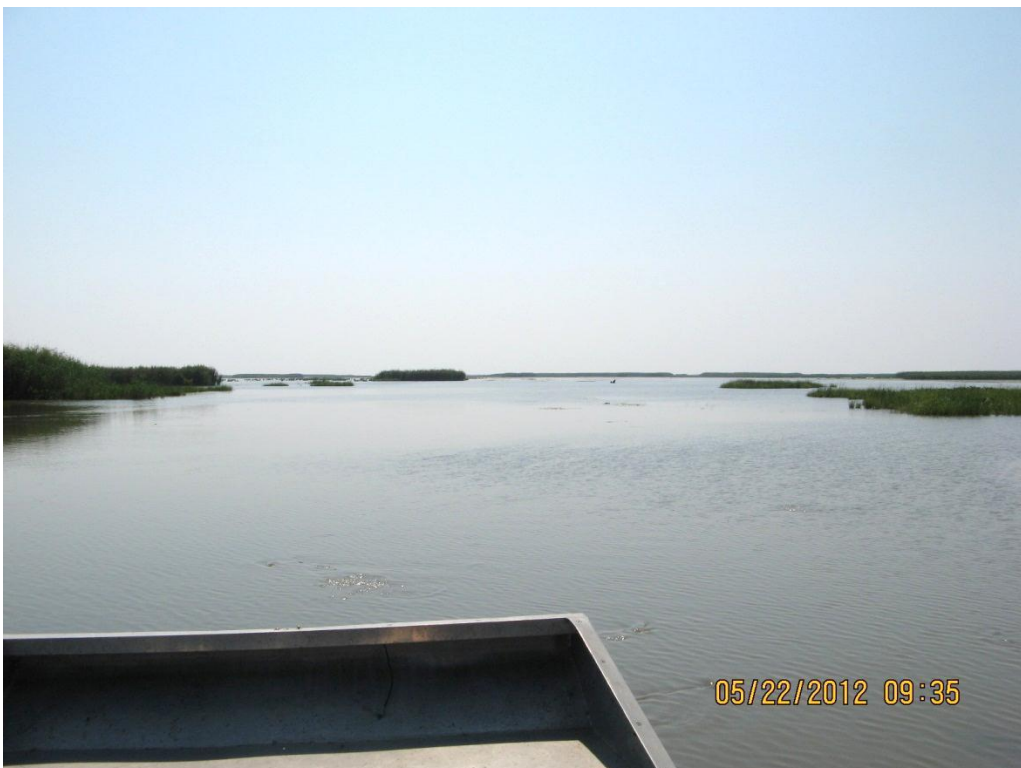
- vii. **Crevasse 2C:** The channel has begun infilling, but flow is maintained within the channel. The receiving bay floor is supporting SAV along with vegetated mudflats.

Crevasse 2-C Interior marsh growth
