**State of Louisiana
Coastal Protection and Restoration Authority
Office of Coastal Protection and Restoration**

2013 Operations, Maintenance, and Monitoring Report

Terrebonne Bay Shore Protection Demonstration (TE-45)

State Project Number TE-45
Priority Project List 10

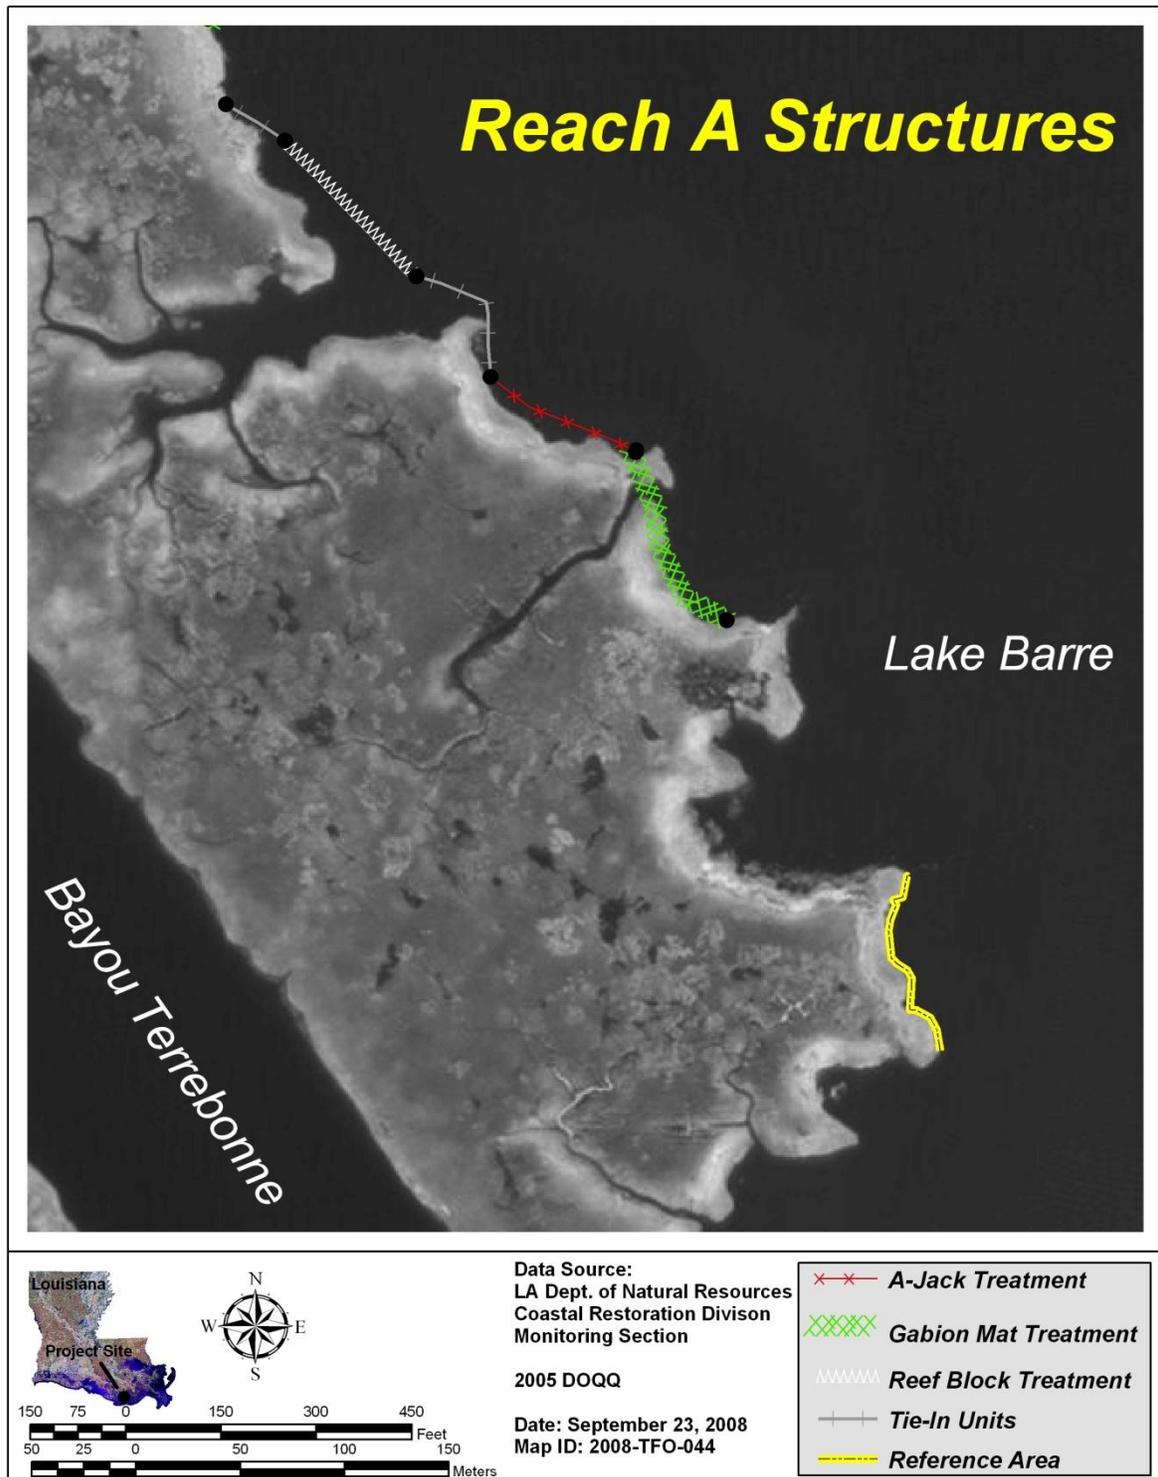
Figure 2. Location of the Reach A project features (structure treatments) at the Terrebonne Bay Shore Protection Demonstration (TE-45) project.

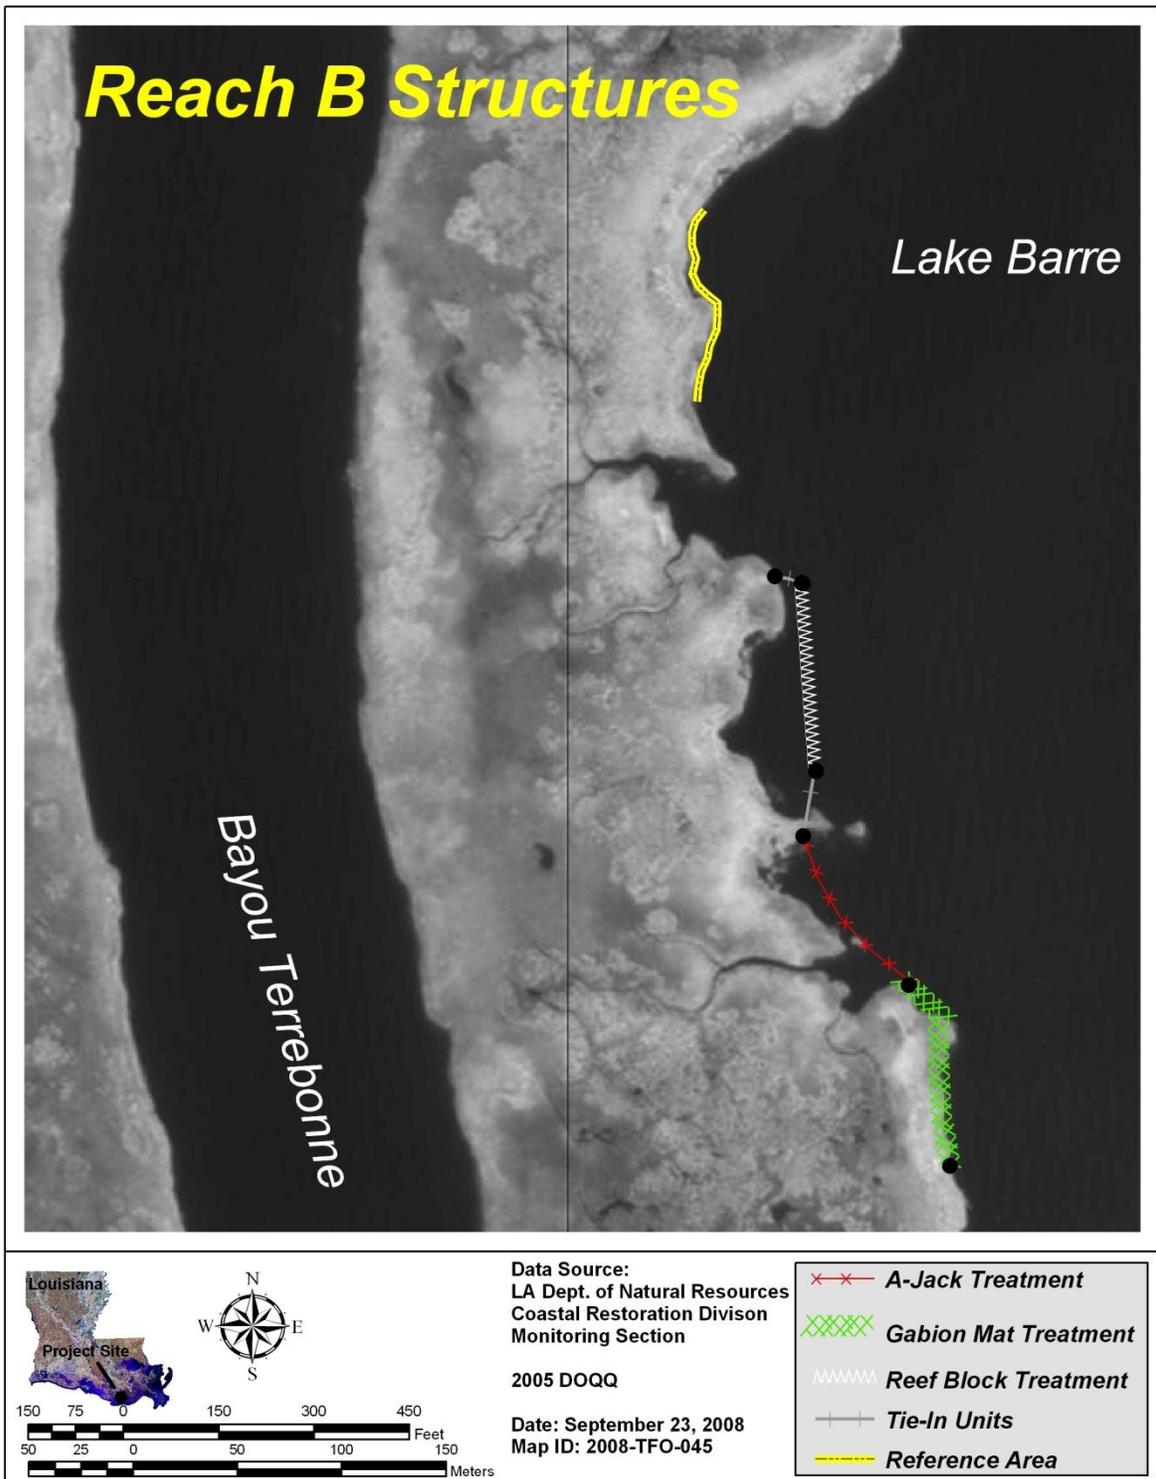
Figure 3. Location of the Reach B project features (structure treatments) at the Terrebonne Bay Shore Protection Demonstration (TE-45) project.

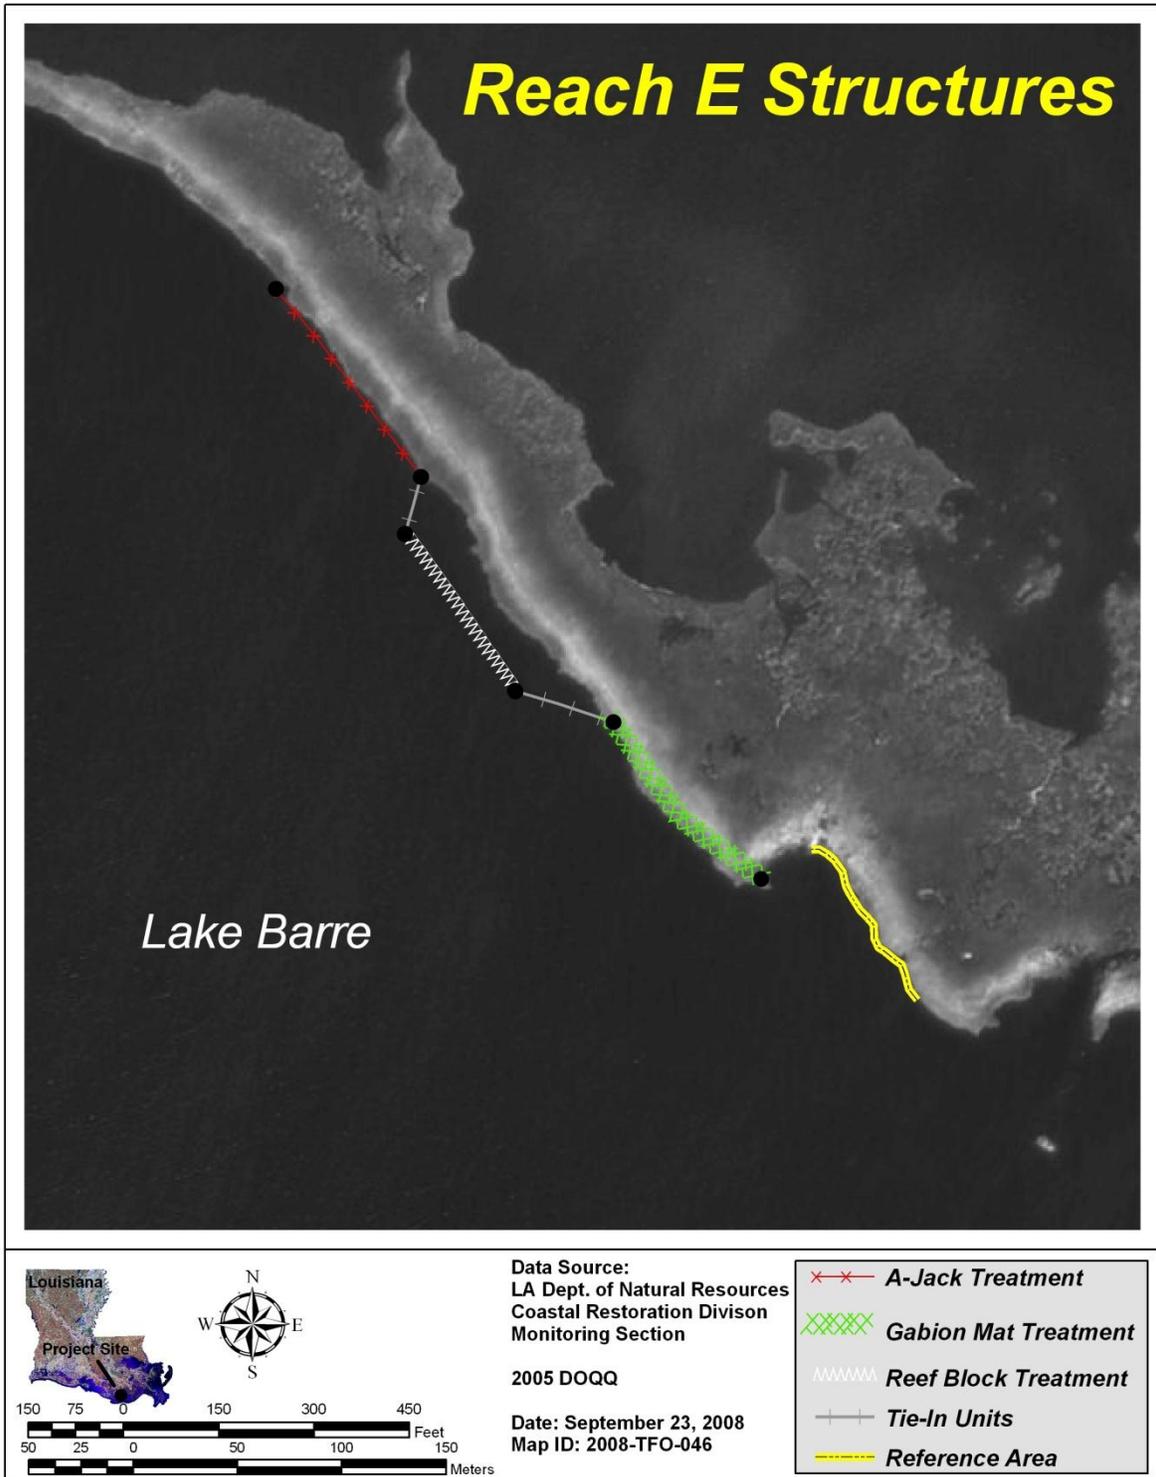
Figure 4. Location of the Reach E project features (structure treatments) at the Terrebonne Bay Shore Protection Demonstration (TE-45) project.

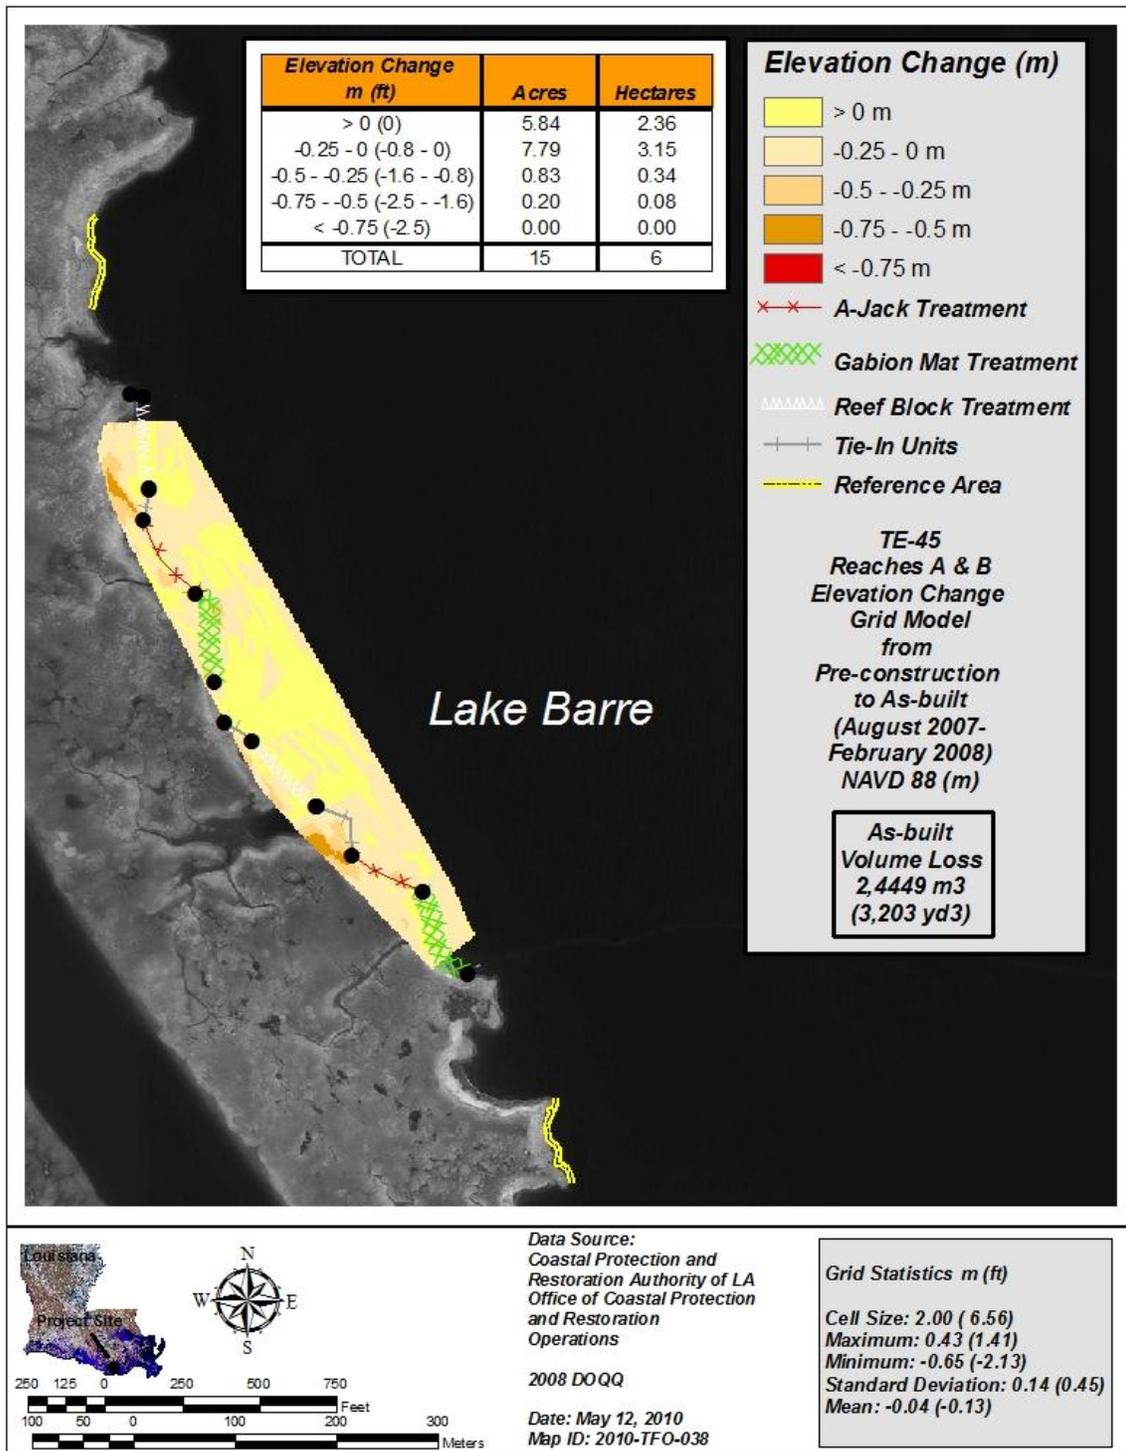
Figure 8. Elevation and volume change grid model from pre-construction (Aug 2007) to as-built (Feb 2008) for Reaches A and B at the Terrebonne Bay Shore Protection Demonstration (TE-45) project.

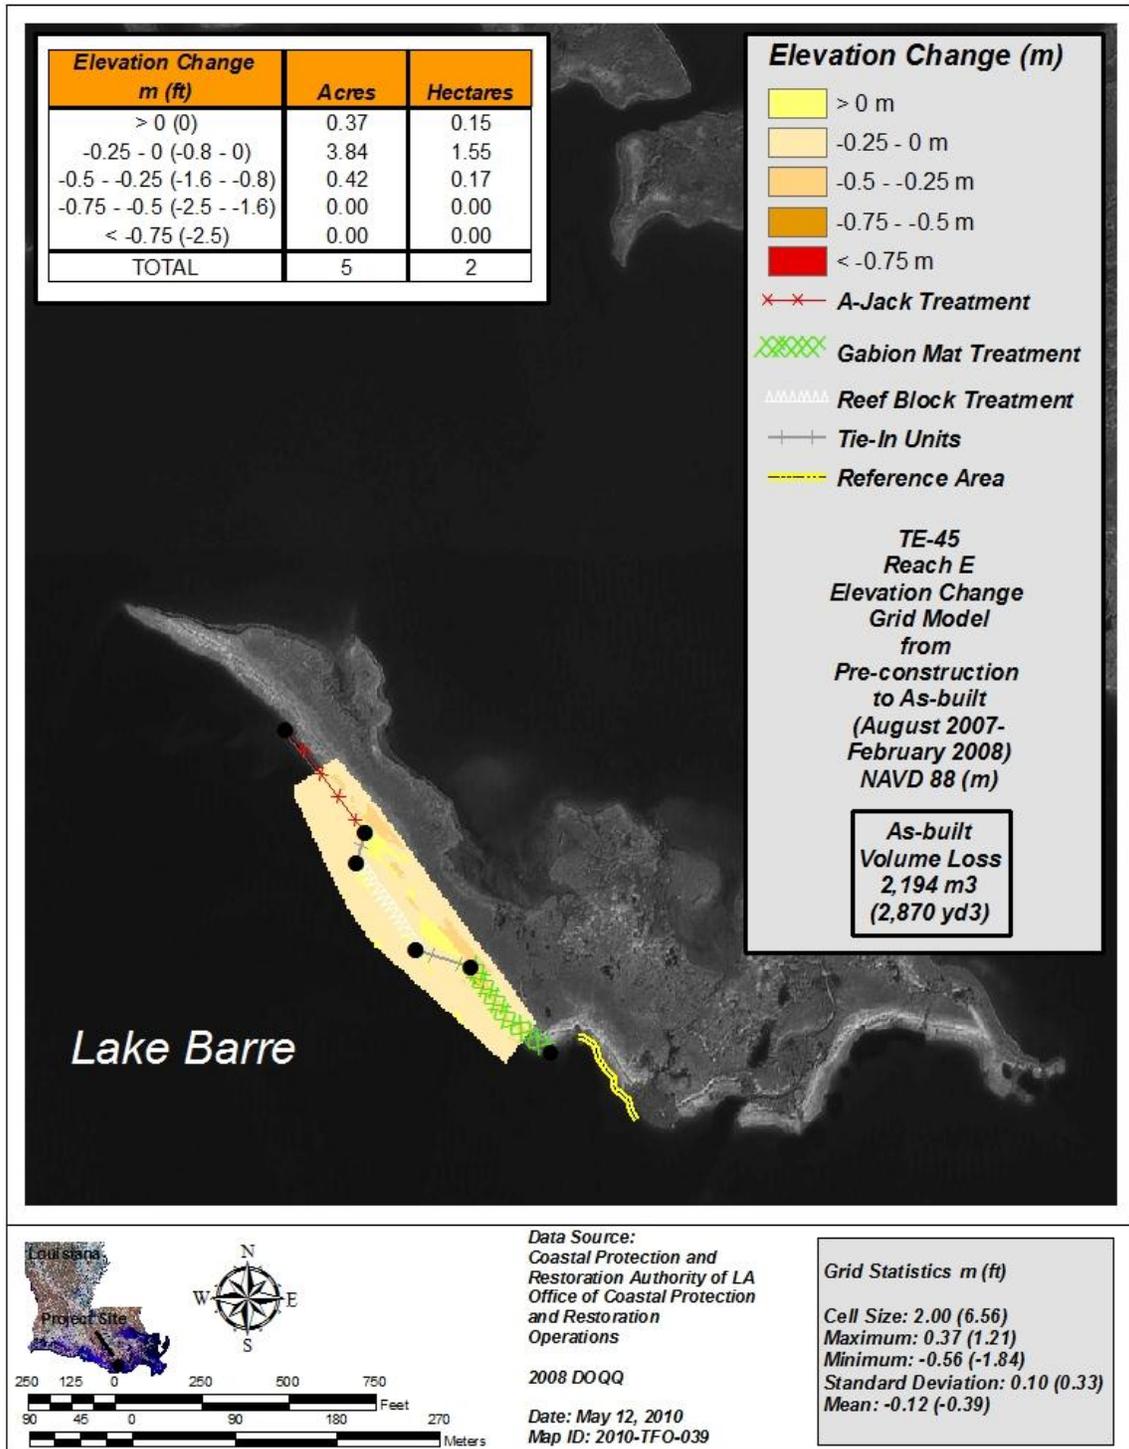
Figure 9. Elevation and volume change grid model from pre-construction (Aug 2007) to as-built (Feb 2008) for Reach E at the Terrebonne Bay Shore Protection Demonstration (TE-45) project.

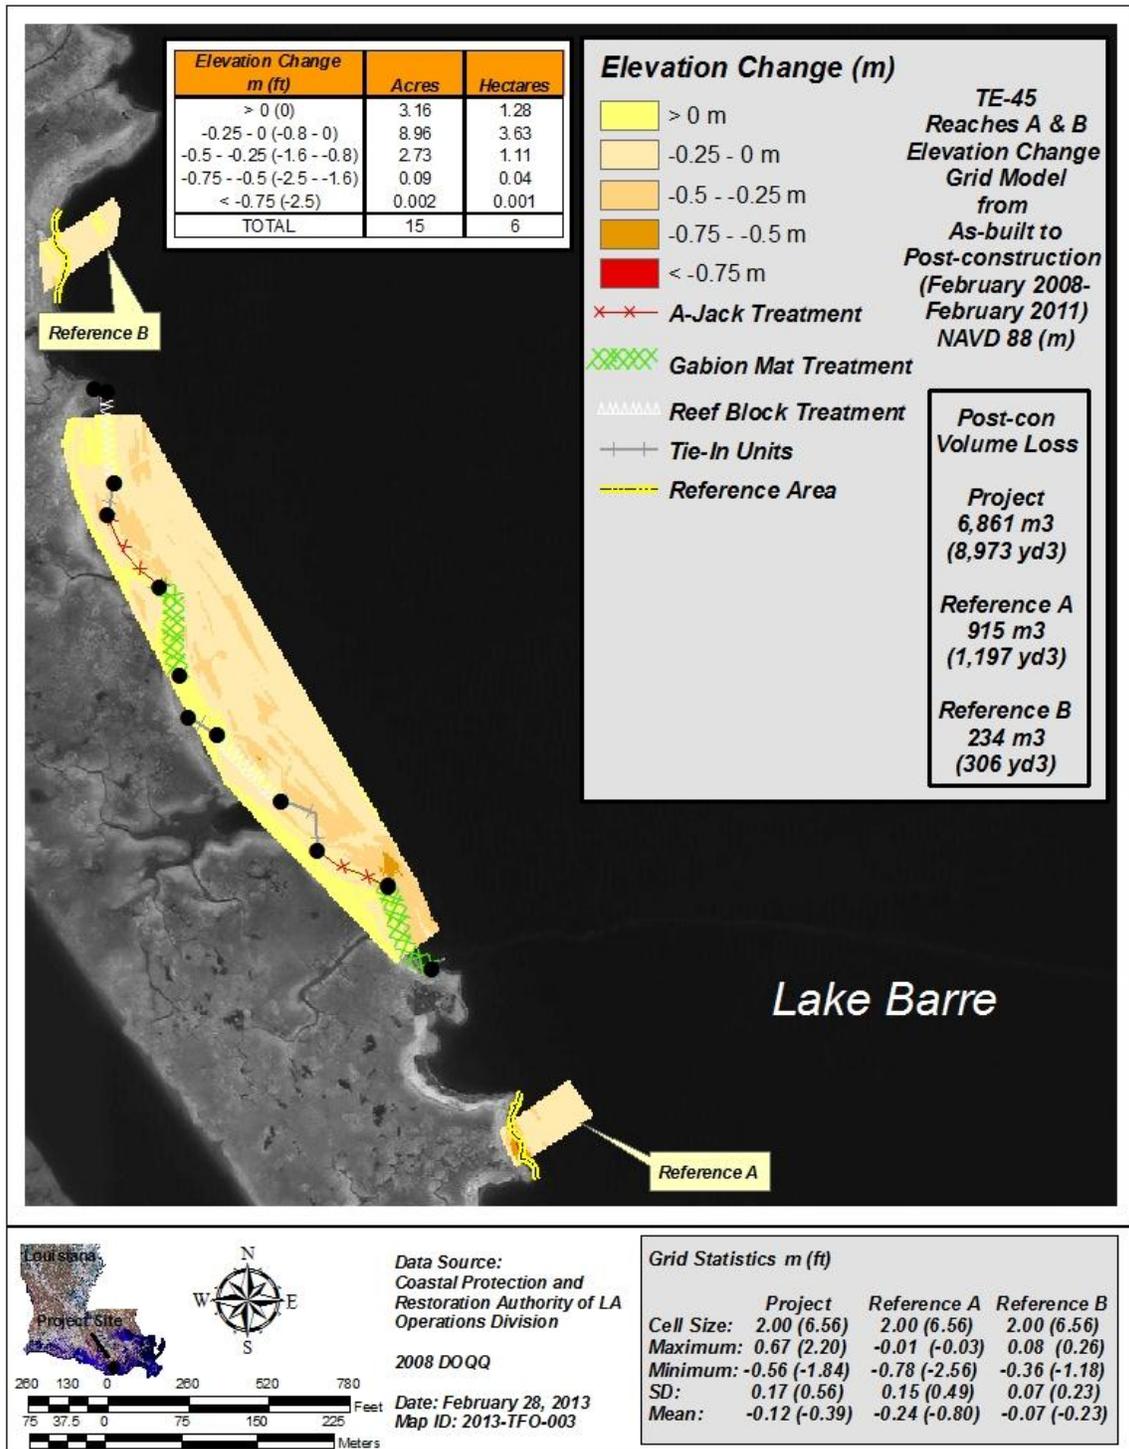
Figure 10. Elevation and volume change grid model from as-built (Feb 2008) to post-construction (Feb 2011) for Reaches A and B at the Terrebonne Bay Shore Protection Demonstration (TE-45) project.

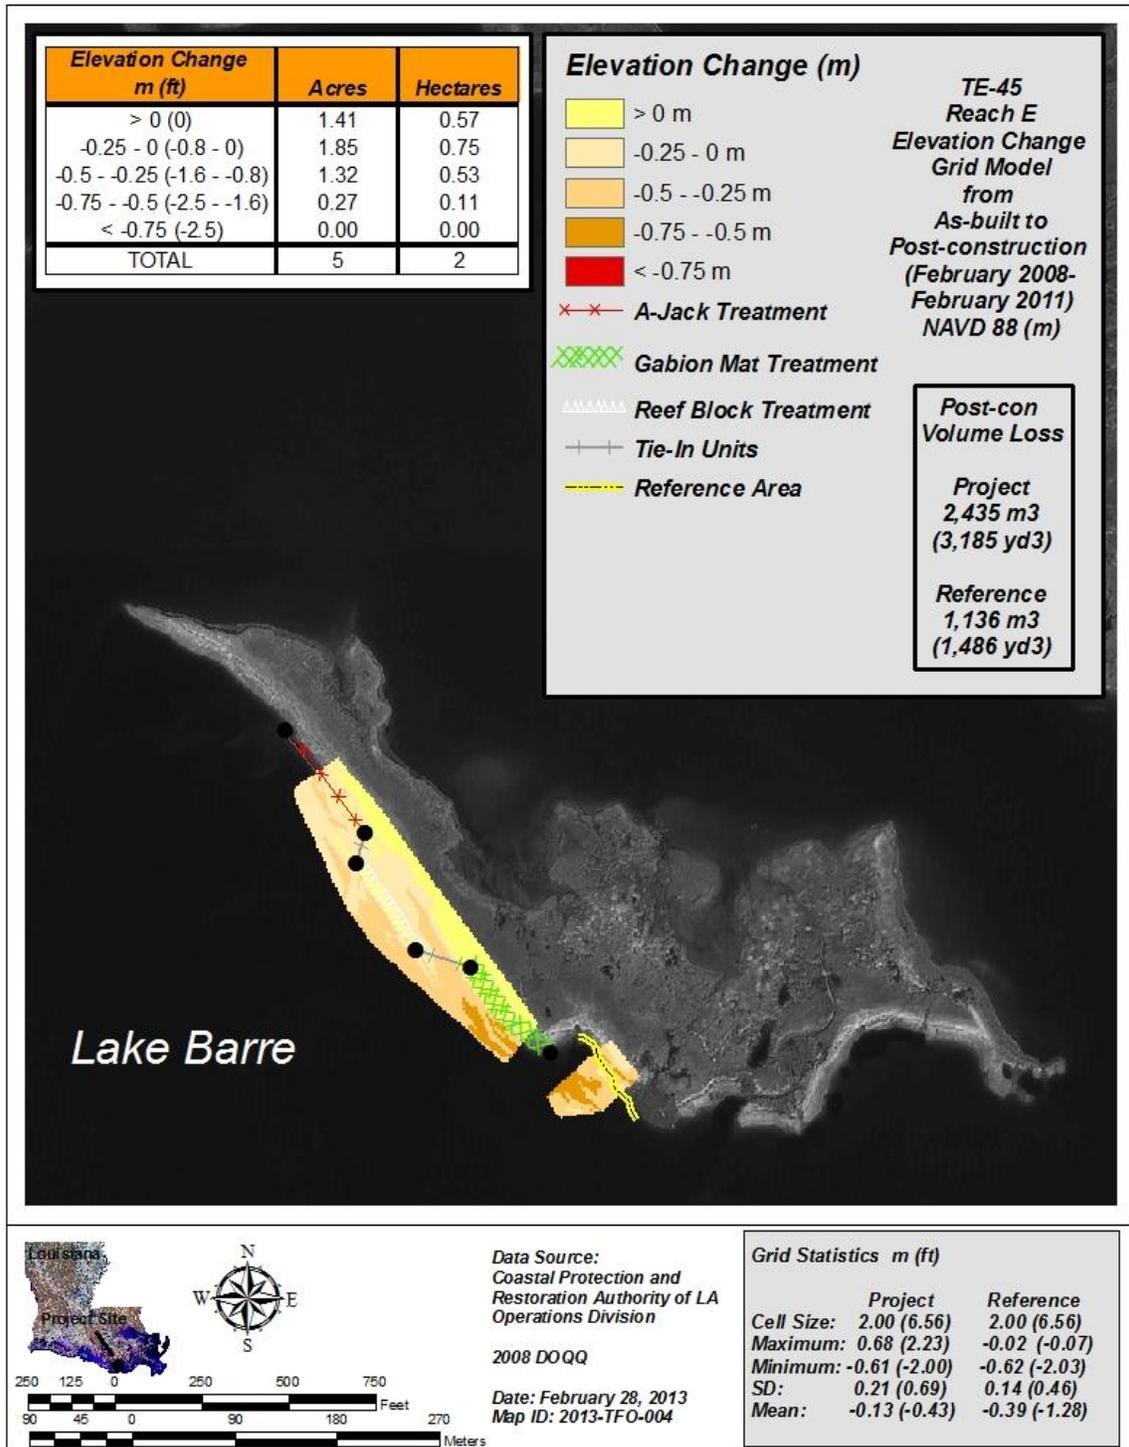
Figure 11. Elevation and volume change grid model from as-built (Feb 2008) to post-construction (Feb 2011) for Reach E at the Terrebonne Bay Shore Protection Demonstration (TE-45) project.

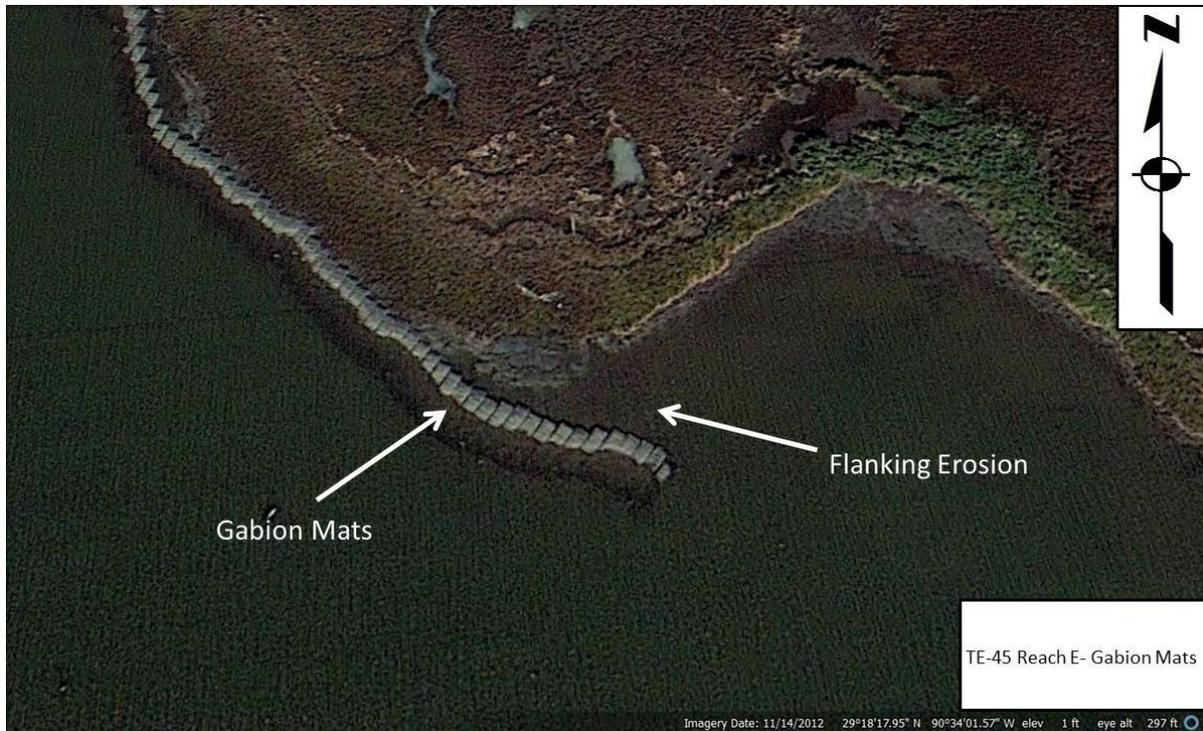
Figure 18. November 14, 2012 image depicting flanking erosion behind the Reach E Gabion Mat treatment at the Terrebonne Bay Shore Protection Demonstration (TE-45) project. Image reproduced from Google Earth.

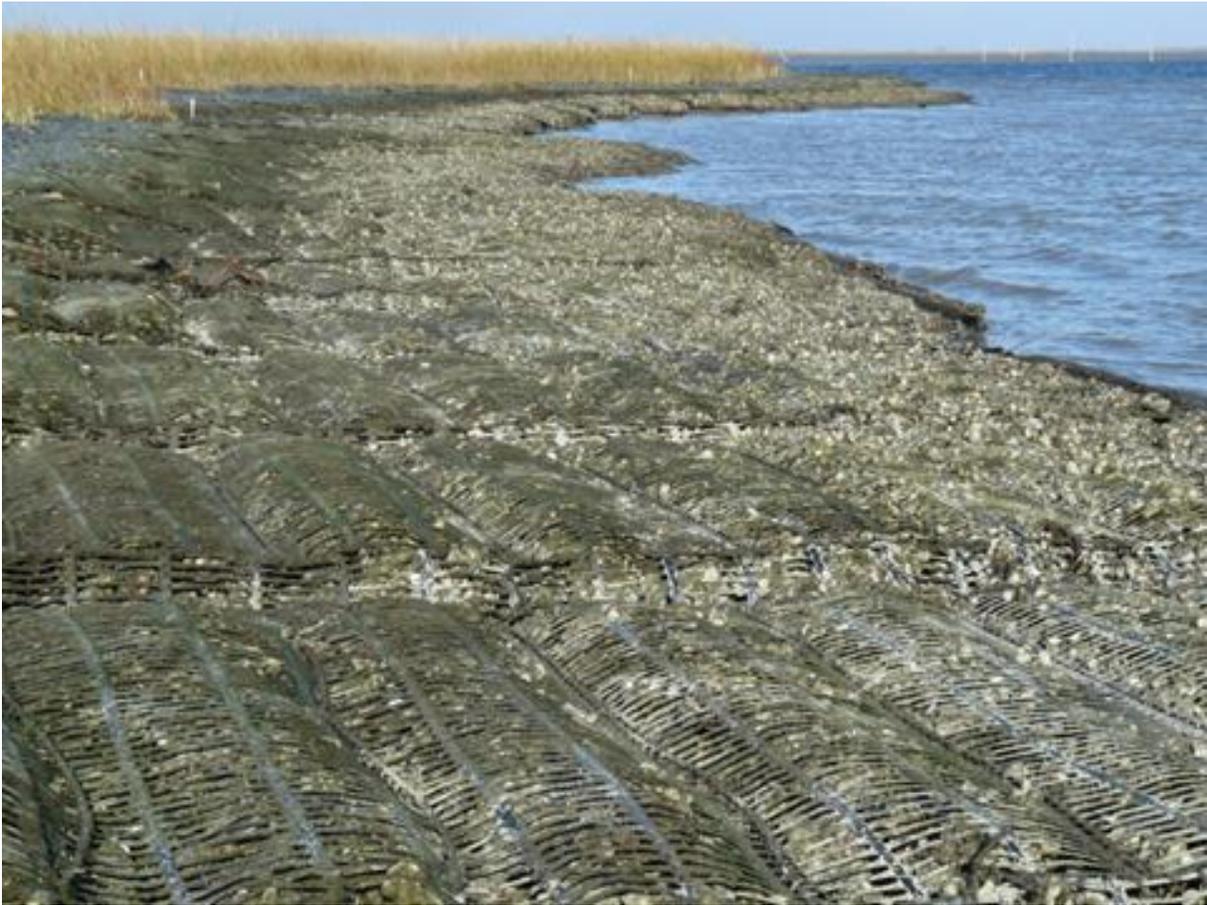
Figure 24. Reach A Gabion Mats showing oyster population gradient from top of mat (to the left in the photo) to the bottom edge of the mat. Photo taken at extreme low tide in winter.

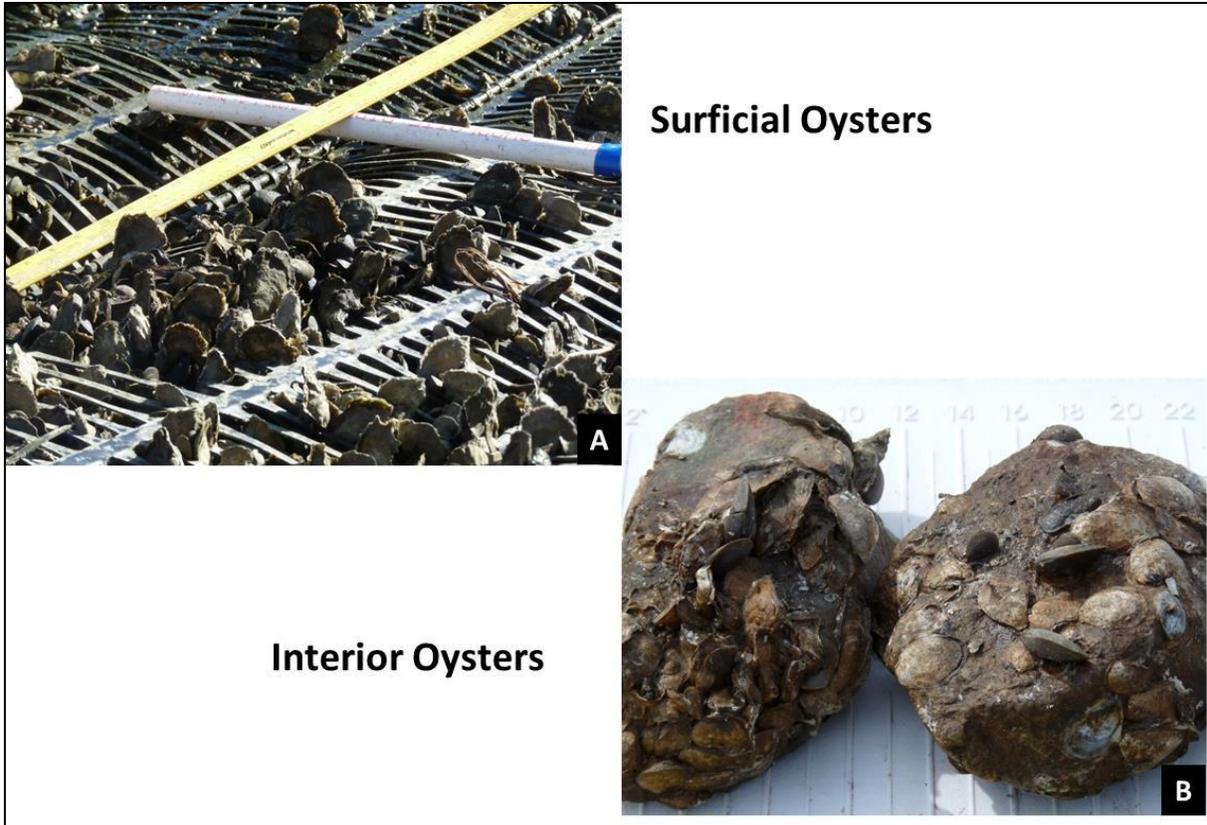
Abundance of larger-sized oysters on the Gabion Mats, and therefore ultimately reef development, are primarily surficial processes resulting in a veneer-type of development (Figure 27). The smaller-sized oysters, predominantly within the interior, have limited if any opportunity to build consolidated reef; such conditions are also typical on natural reefs which produce a veneer-type of reef existence.

Figure 27. Photos of surficial oysters (A) showing emergent and consolidated reef and small interior oysters (B) on limestone; also notice in both photos the presence of hooked mussels.

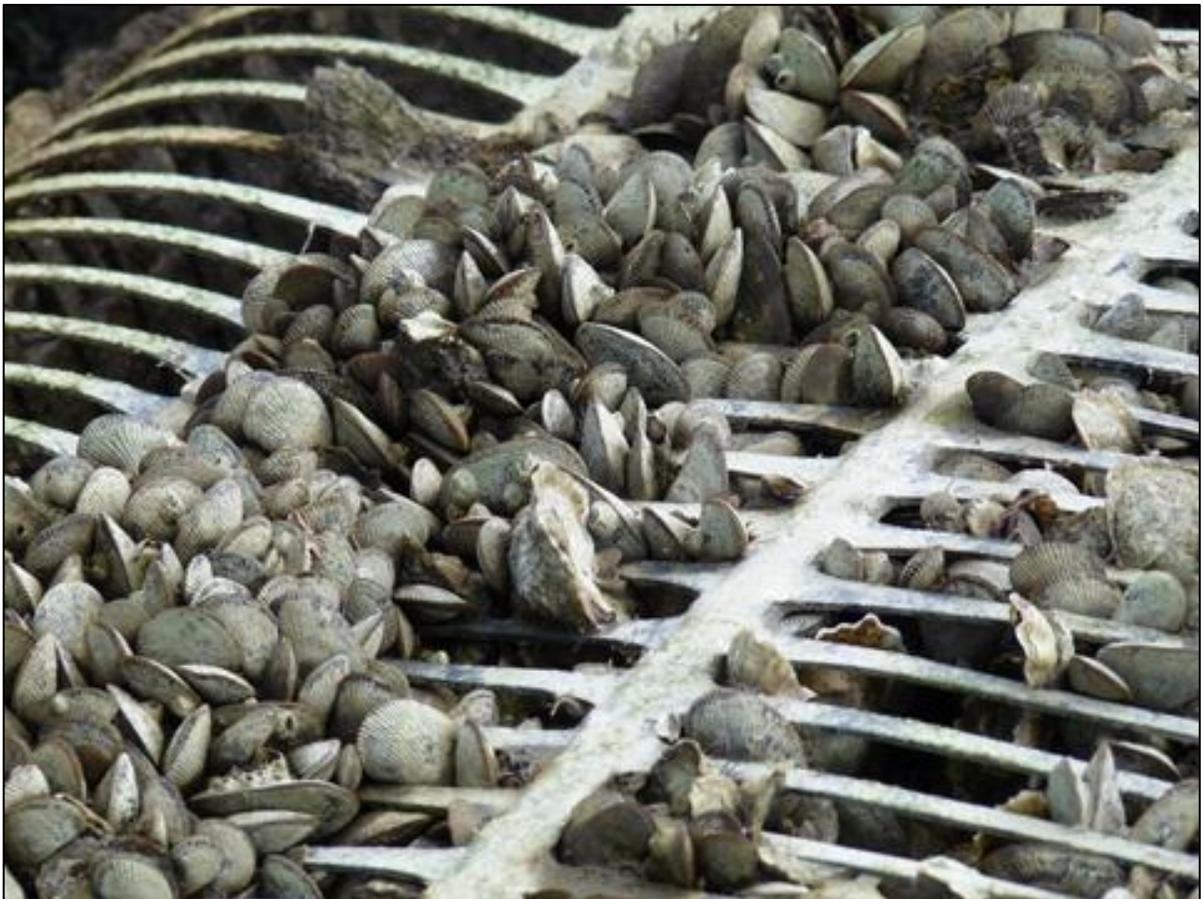
Fig 32. Photo of hooked mussels covering oysters on a Gabion Mat.

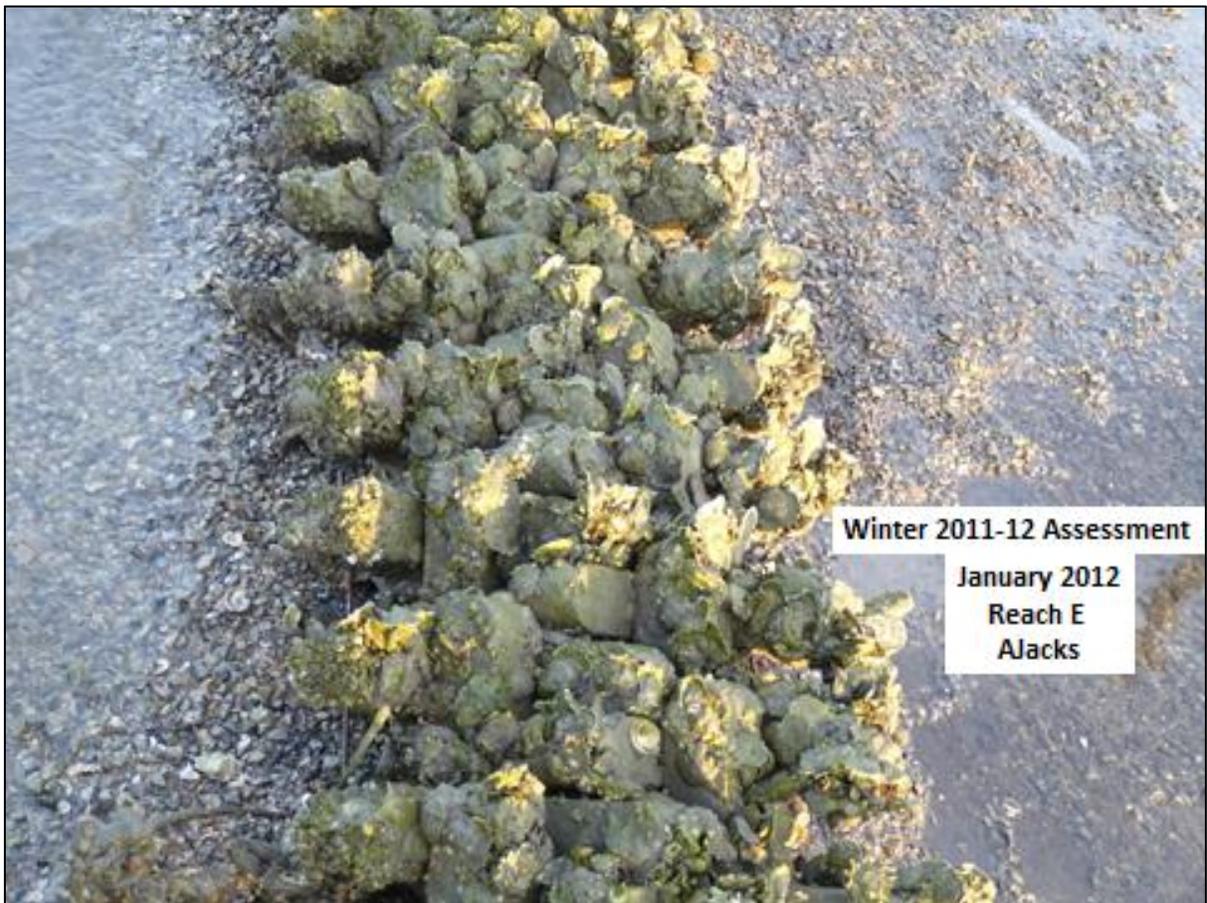
Figure 35. Photo of A-Jacks showing surficial oyster coverage and oyster reef development as well as bare areas during winter 2011-12 assessment.

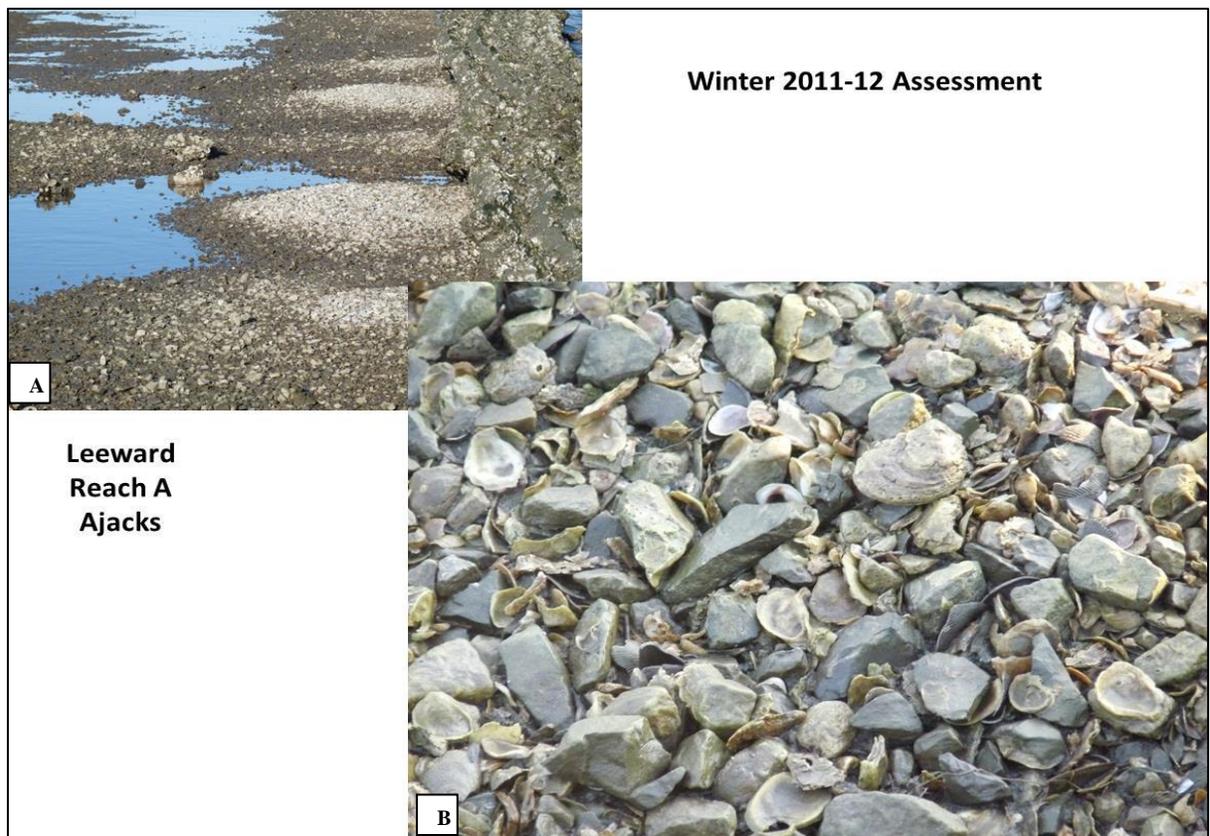
Figure 40. Photo of shell rubble and hash from self-generated A-Jacks oyster activities and shell washed up from estuary by storms and tides.

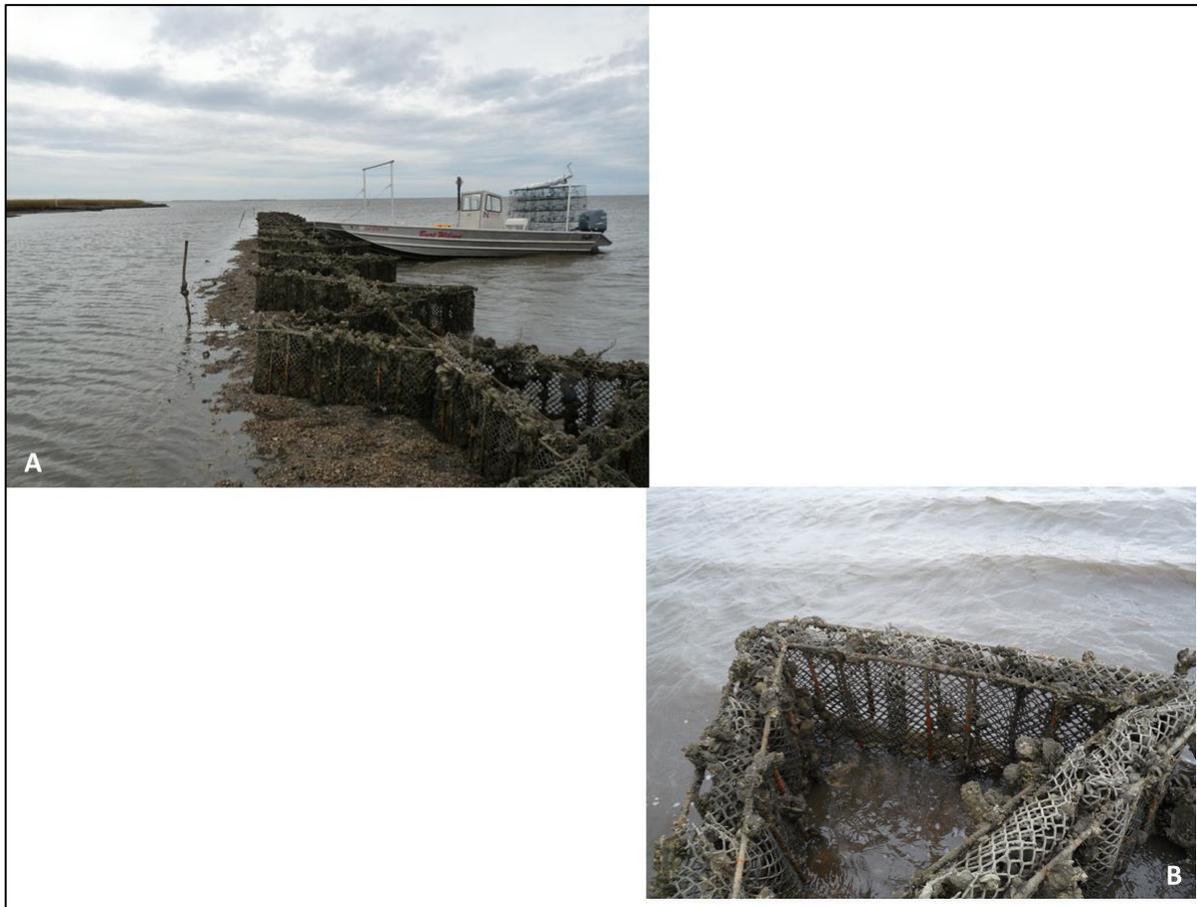
Figure 41. Photos of ReefBlks at Reach E showing void (gap) spaces where shell once existed. Winter 2011-12 assessment four years post construction.

Assessment of oyster populations on ReefBlks during winter 2011-12 focused on Reaches A and B since Reach E is considered failing with over 50% shell loss. A successful ReefBlk with no shell bags with gaps (void spaces) is shown in Figure 45. Also note the accumulation of oyster shell fragments and hash on the geotextile/limestone mat (Figure 45), which, similar to Gabon Mats and A-Jacks, contributes to additional habitat and can be washed into the marsh to further potentially slow shoreline erosion. Unique to the ReefBlks are the triangle inner areas (Figure 46) which also accumulates shell fragments and hash providing additional habitat for species.

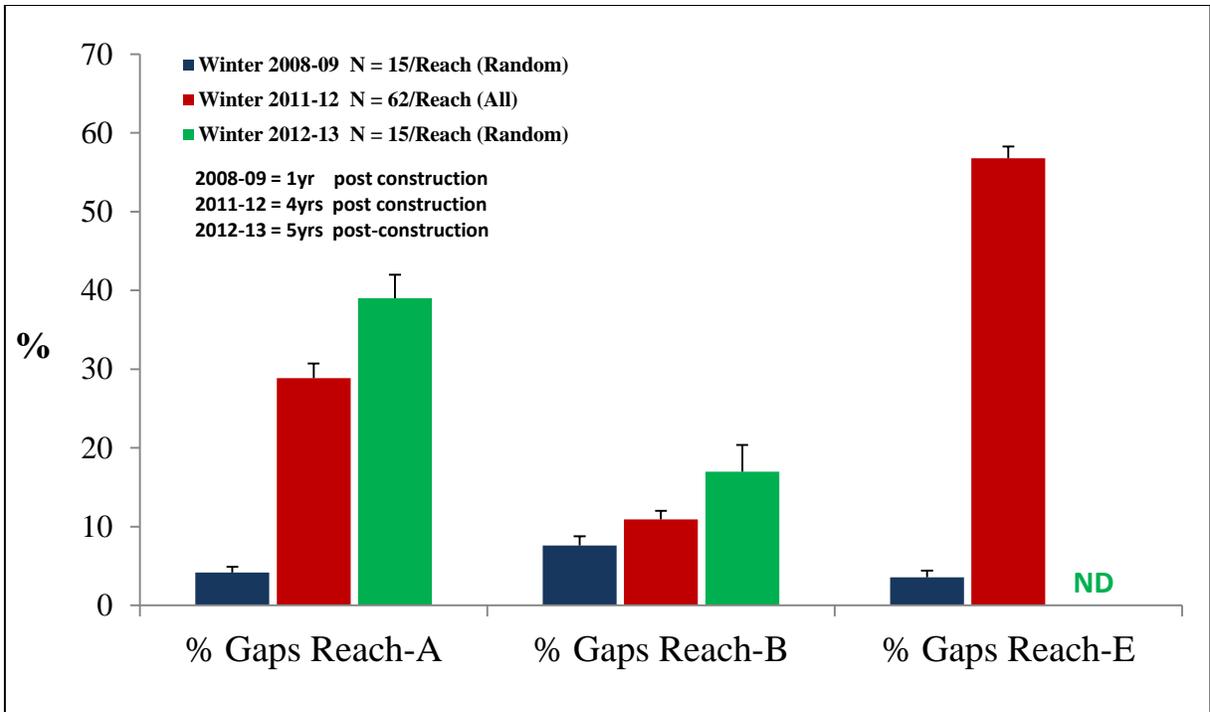
Figure 42. Mean percent (+1S.E.) void (gap) spaces in ReefBlks by Reach and year.

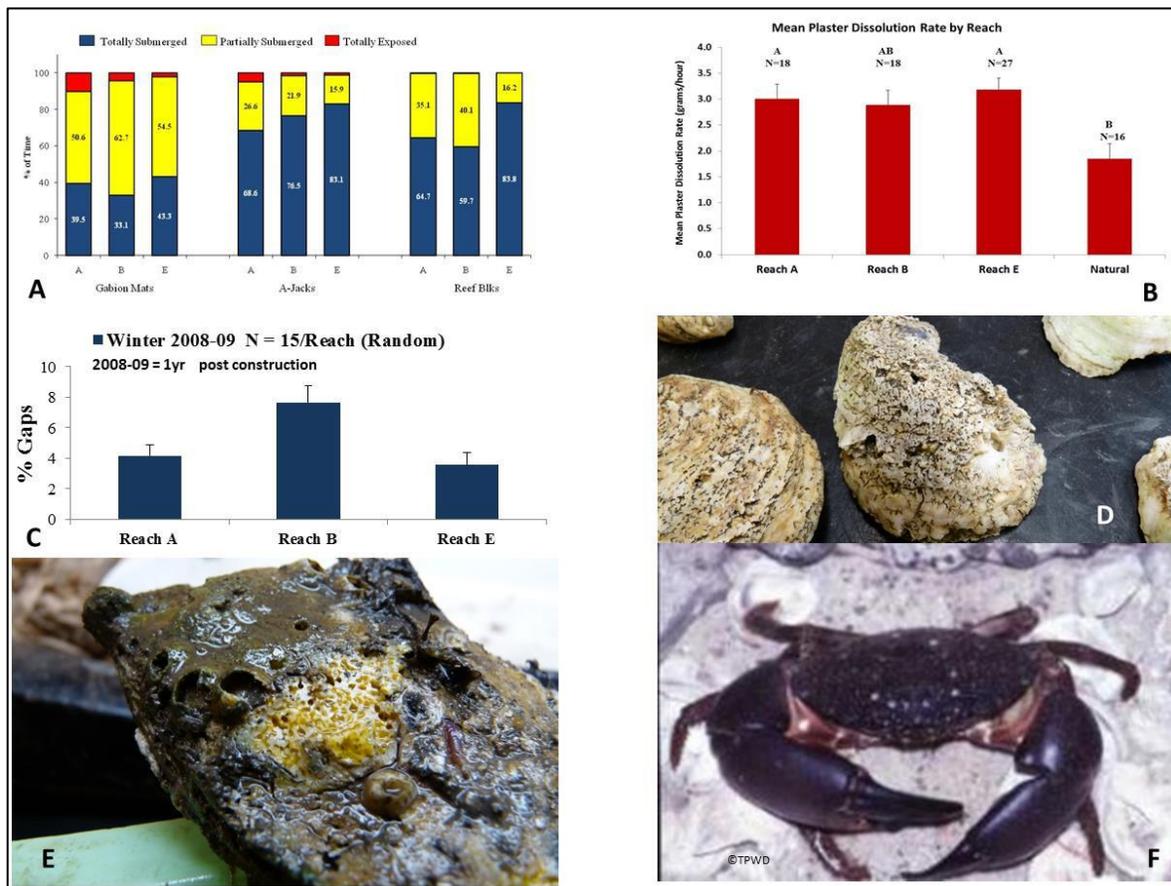
Figure 44. The Synergy of factors hypothesized for causing oyster shell disappearance in ReefBlk bags. See text narrative for explanation of interactions.

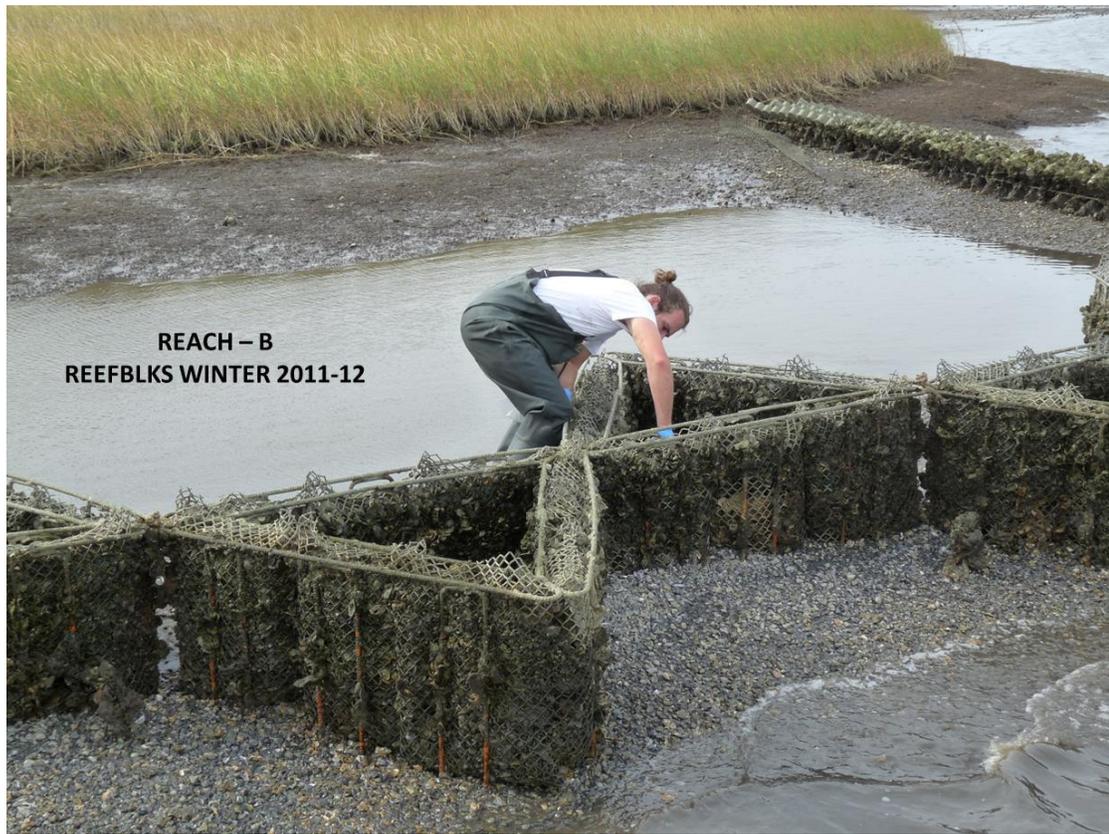
Figure 45. Photo of Reach B ReefBlks at low tide during the winter 2011-12 assessment, showing successful colonization. Also notice the shell and limestone on the bottom of the windward side. A-Jacks used to tie-in the flank of the project are seen in the background.

ReefBlk oyster densities were taken only from the middle bag of the unit's three sides. If a unit's side did not have shell to near the top of the horizontal rebar (Figure 45), i.e., not having gaps (void spaces), it was not used in the analysis for density. Oyster densities between Reaches A and B were not significantly different ($P < .05$) and had an aggregate density of 2,294 live oysters per square meter, far exceeding densities found on Gabion Mats and A-Jacks (Figure 48). ReefBlks with relatively significant
