**State of Louisiana
Coastal Protection and Restoration Authority
Office of Coastal Protection and Restoration**

2013 Operations, Maintenance, and Monitoring Report

Terrebonne Bay Shore Protection Demonstration (TE-45)

State Project Number TE-45
Priority Project List 10

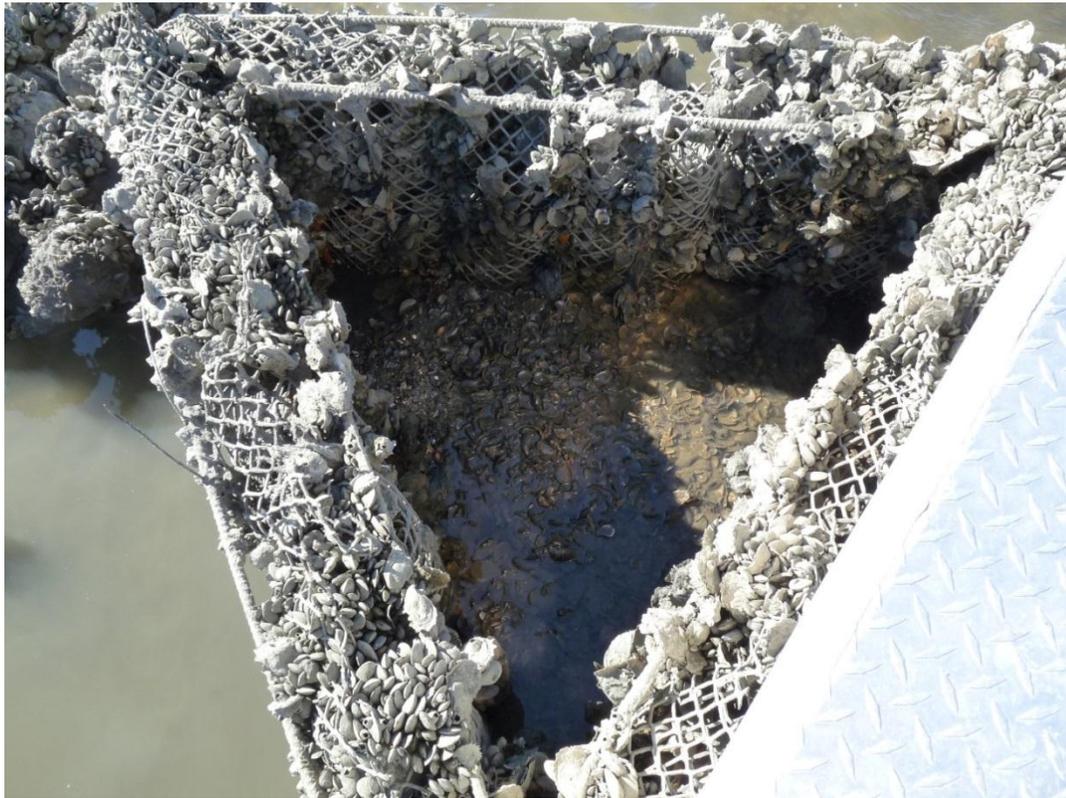
Figure 46. Photo showing oyster shell and mussel shell deposition with the ReefBlk triangle during the winter 2011-12 assessment.

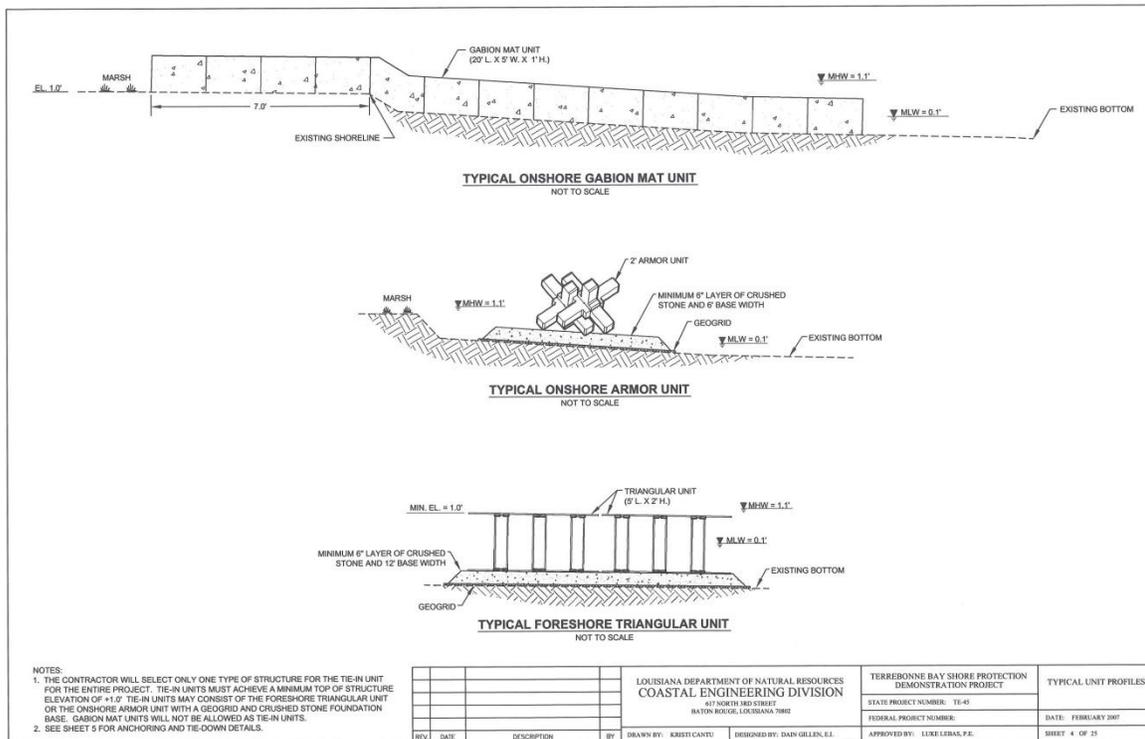
Figure A-1. Typical cross sections showing the Terrebonne Bay Shore Protection Demonstration (TE-45) project's shoreline protection structures.

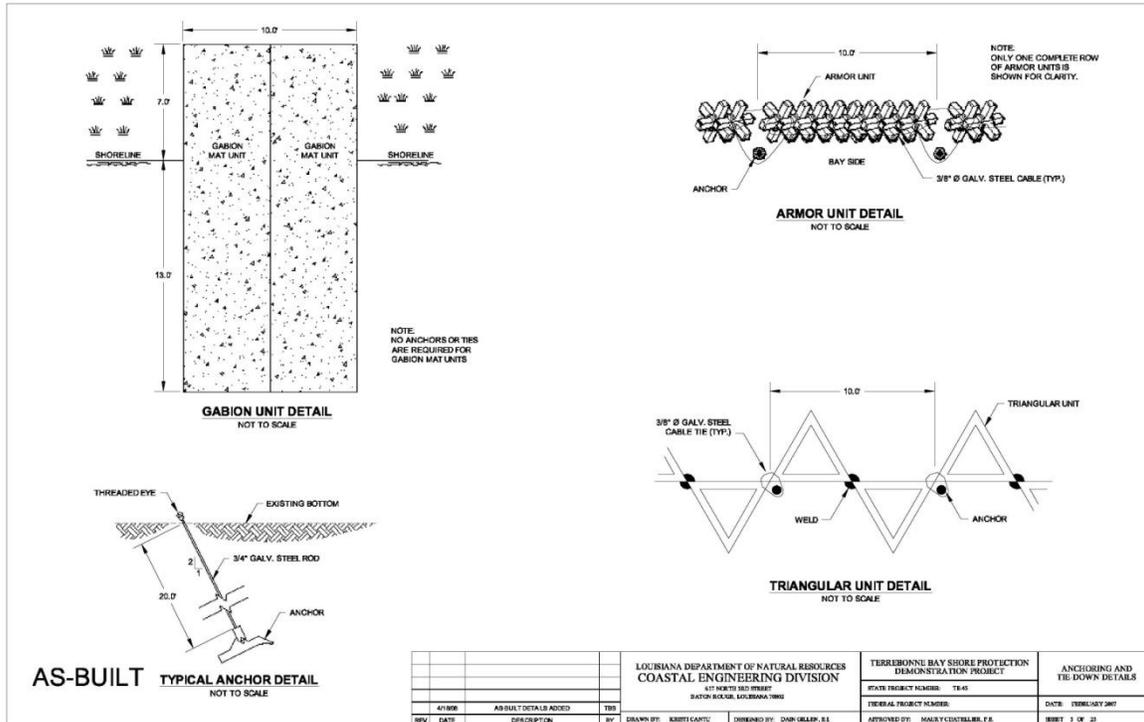
Figure A-2. Aerial view depicting the typical layout and anchoring details for the Terrebonne Bay Shore Protection Demonstration (TE-45) project's Gabion Mat, A-Jack, and ReefBlk structures.

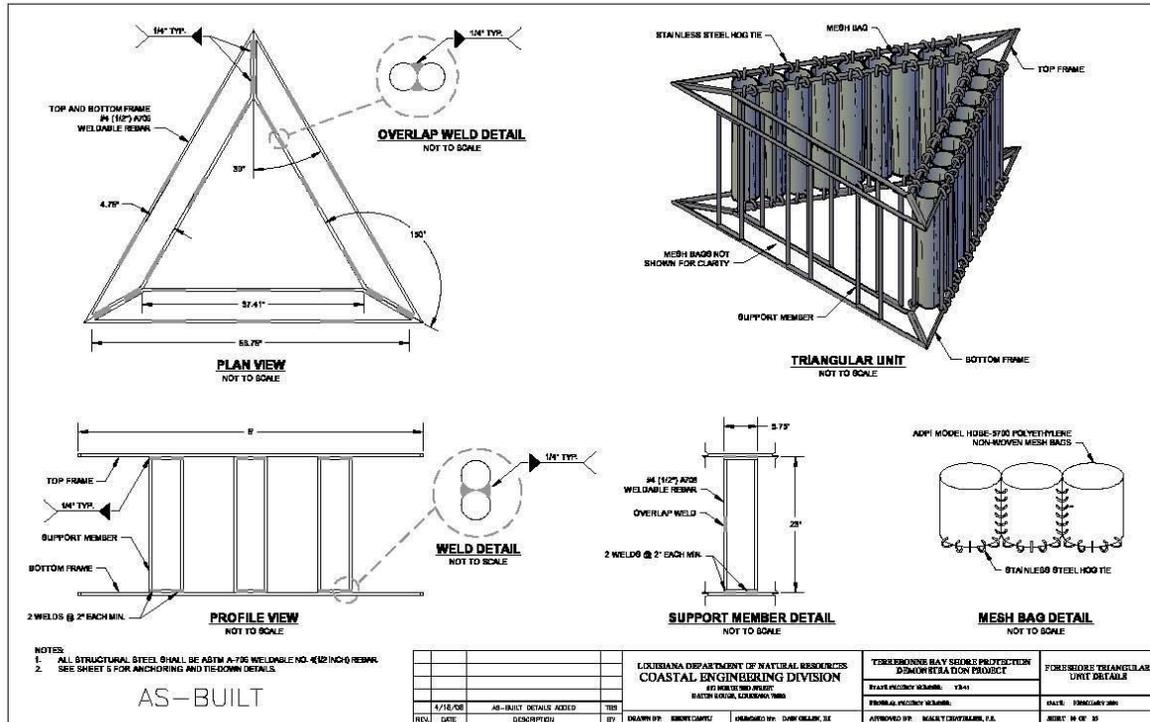
Figure A-3. Design drawings showing the Terrebonne Bay Shore Protection Demonstration (TE-45) project's ReefBlk structure.

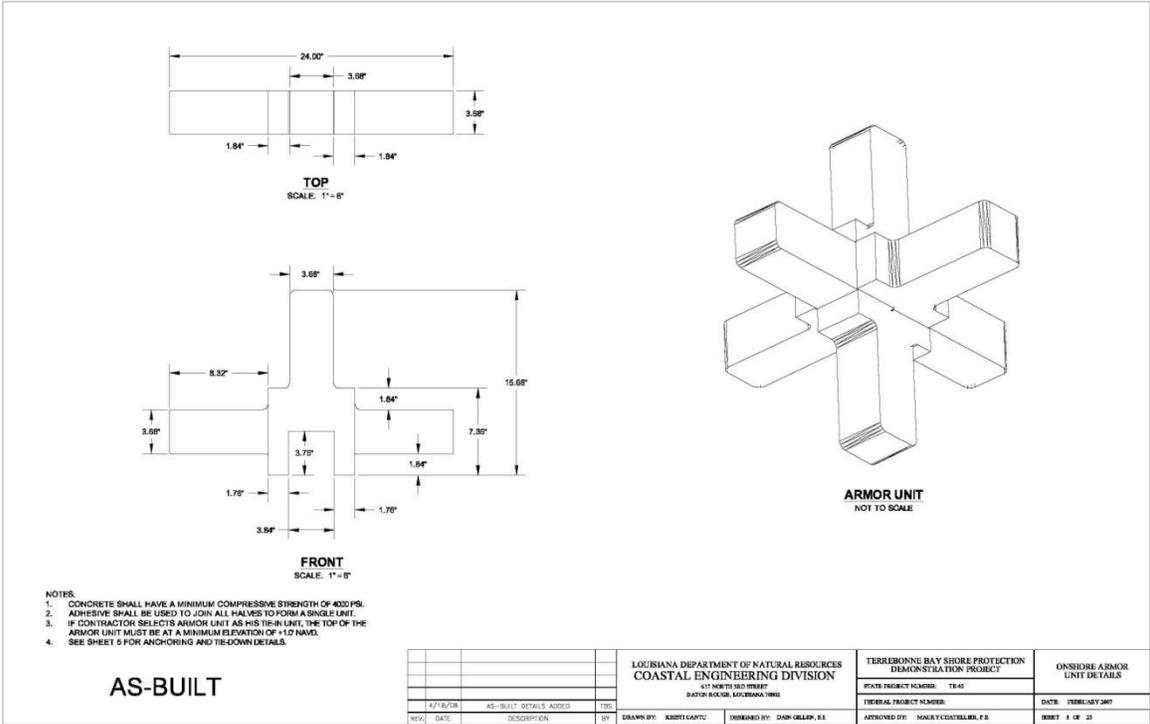
Figure A-4. Design drawings showing the Terrebonne Bay Shore Protection Demonstration (TE-45) project's A-Jack structure.

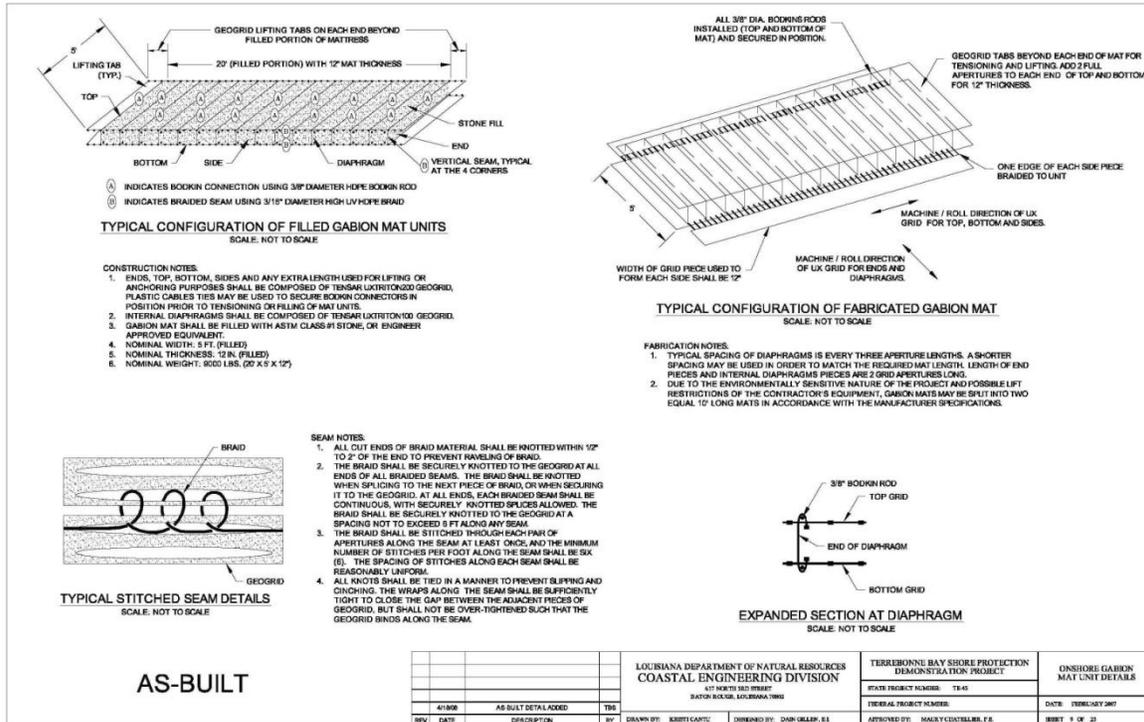
Figure A-5. Design drawings showing the Terrebonne Bay Shore Protection Demonstration (TE-45) project's Gabion Mat structure.

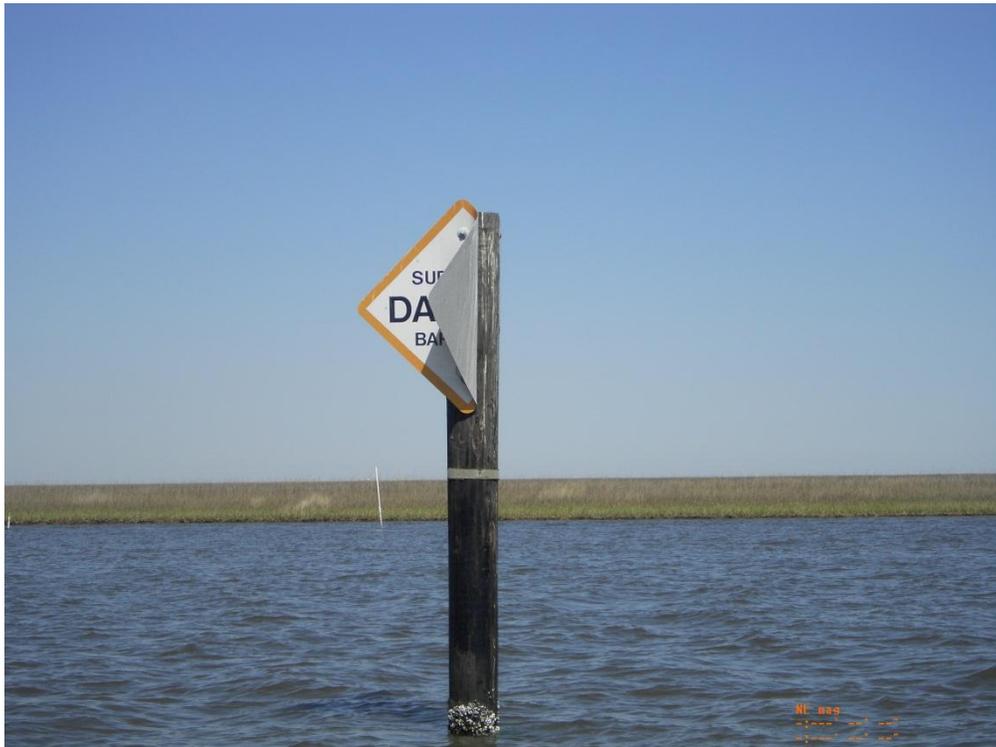
Photo 18: View of Damaged warning sign along Reach E
