**2013 Operations, Maintenance,
and Monitoring Report**

**West Lake Boudreaux Shoreline
Protections and Marsh Creation
(TE-46)**

State Project Number TE-46
Priority Project List 11

December, 2013
Terrebonne Parish

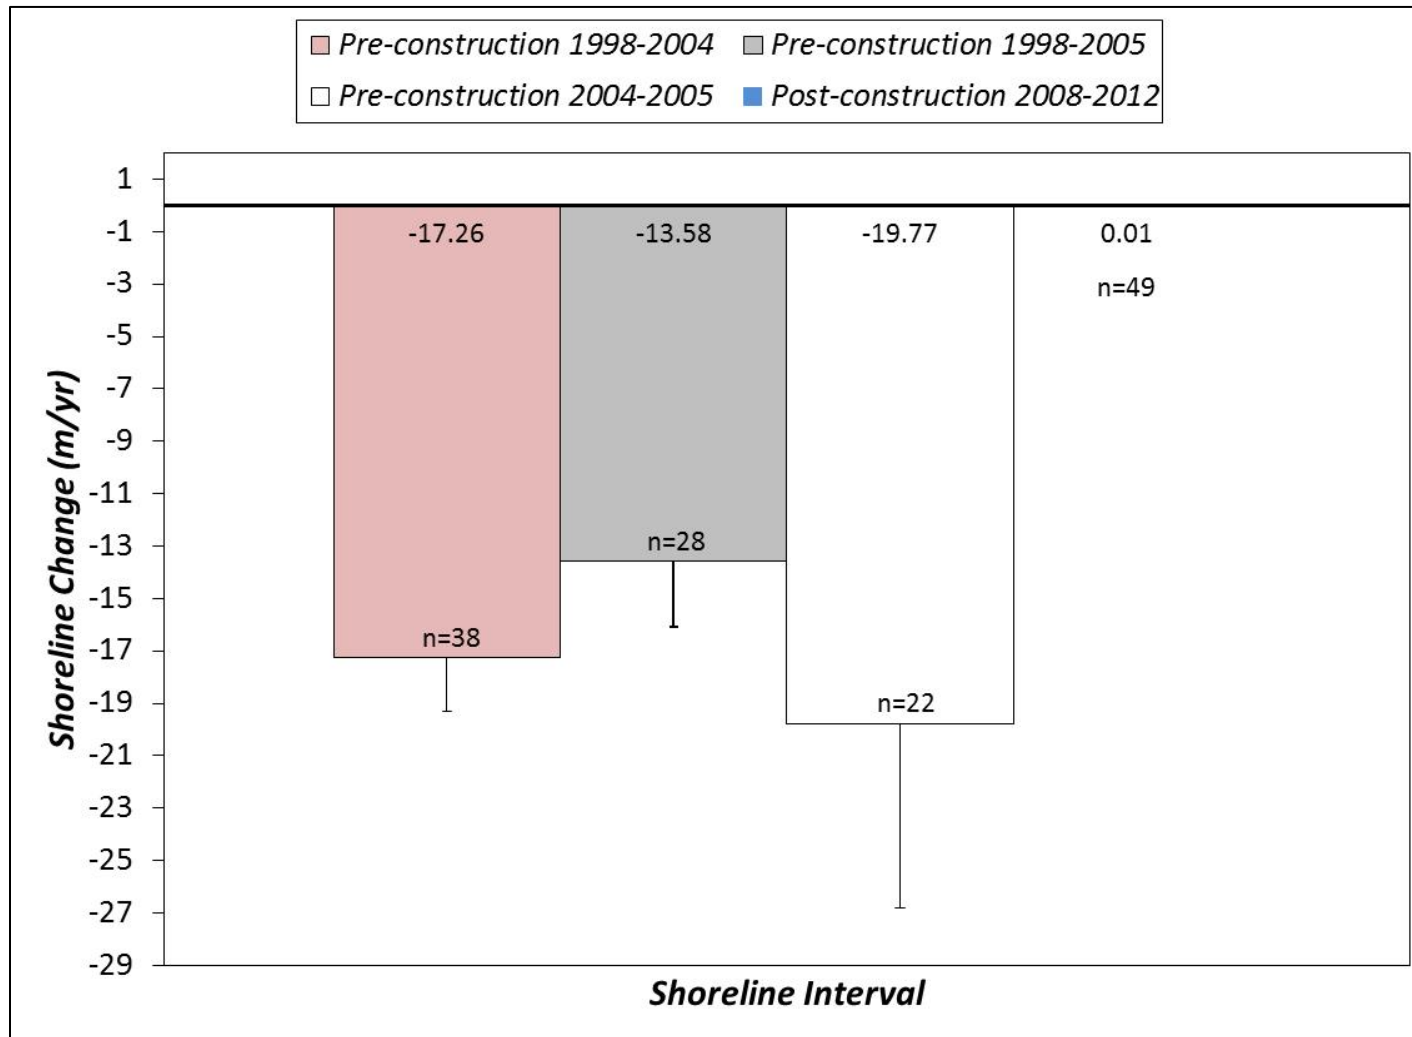
Figure 6. Shoreline change rates for the area behind the foreshore rock protection structure for various time intervals both pre-construction and post-construction.

Since construction of the foreshore rock shoreline protection structure and the marsh creation areas, the marsh edge erosion rate has declined in the project area. The average shoreline erosion rate behind the rock shoreline protection structure was 0.01 m/yr (0.03 ft/yr) from Oct 2008 to Oct 2012 (Figure 6). Actually, the post-construction interval showed minimal progradation. However following visual inspections of the aerial photographs, it became apparent that the shoreline position differences are probably the result of vegetation colonization of mudflat areas in the immediate lee of the structure. The combination of the foreshore rock shoreline protection structure, sediment additions to the marsh creation area shoreline, and the small fetch behind the rock shoreline protection structure likely facilitated the low post-construction erosion rate. This grouping of shoreline protection and marsh creation features has proven to minimize shoreline transgressions on other restoration projects (Curole and Ledet 2012). Future shoreline data will determine if these low erosion rates are sustainable.

Pre-construction data reveals that the TE-46 shoreline was transgressing at a rapid rate. The shoreline erosion rates for this 1998-2005 interval averaged -13.58 m/yr (-44.55 ft/yr) (Figure 6). During the 8 year pre-construction interval, the project area shoreline receded -105 m (-344 ft). Subsequent pre-construction analyses of the TE-46 shorelines produced erosion rates of -17.26 m/yr (-56.64 ft/yr) for the interval from 1998-2004 and -19.77 m/yr (-64.85 ft/yr) for the interval from 2004-2005 (Figure 6). Approximately, 1,200 m (3,937 ft) of the pre-project shoreline were converted to open water during 1998-2005 interval. As a result, no shoreline change data could be generated for these reaches. Figure 6 illustrates the declining population of shoreline replicates over the pre-construction intervals and indicate that the shoreline was breaking up in place at this time. Although the shoreline erosion rate was exceptionally high for the 1998-2005 interval, the erosion estimates are probably underestimated due to the loss of shoreline reaches. The large erosion values and the small number of shoreline replicates reported for the 2004-2005 interval (Figure 6) reveal that erosion and land-loss rates increased for this interval. Indeed, several narrow shoreline reaches were transformed to open water habitat during the 2004-2005 interval. Therefore, it is evident from the shoreline erosion data that the 2005 hurricane season altered and reshaped the project area shorelines (Figure 6). The passage in quick succession of Hurricane Cindy (Jul 2005), Hurricane Katrina (Aug 2005), and Hurricane Rita (Sep 2005) in close proximity to the project area probably eroded large sections of shoreline. Therefore, the 2005 hurricanes hastened the shoreline retreat in the pre-construction project area and intensified the land-loss and fragmentation of the Lake Boudreaux shorelines.

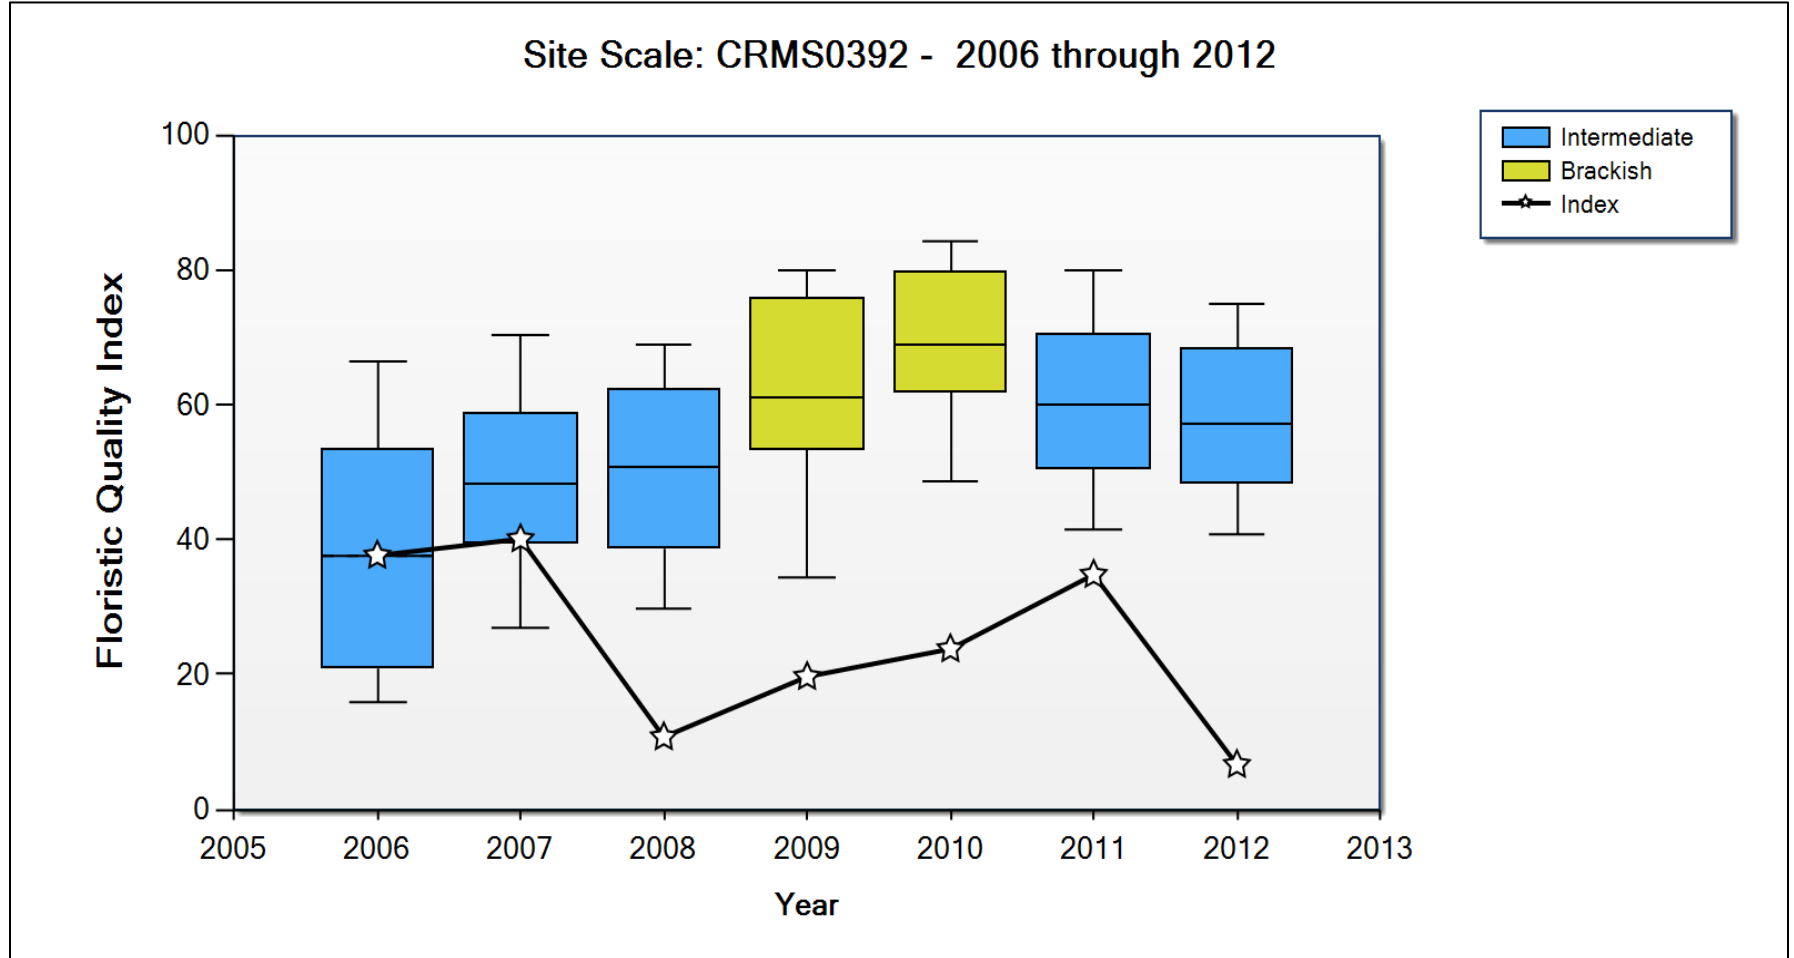
Figure 16. A time series of FQI scores for CRMS0392 relative to a box plot of scores for all the CRMS sites within the same marsh type each year. Marsh type classifications for each year are based on species composition data for that year at the specific CRMS site.

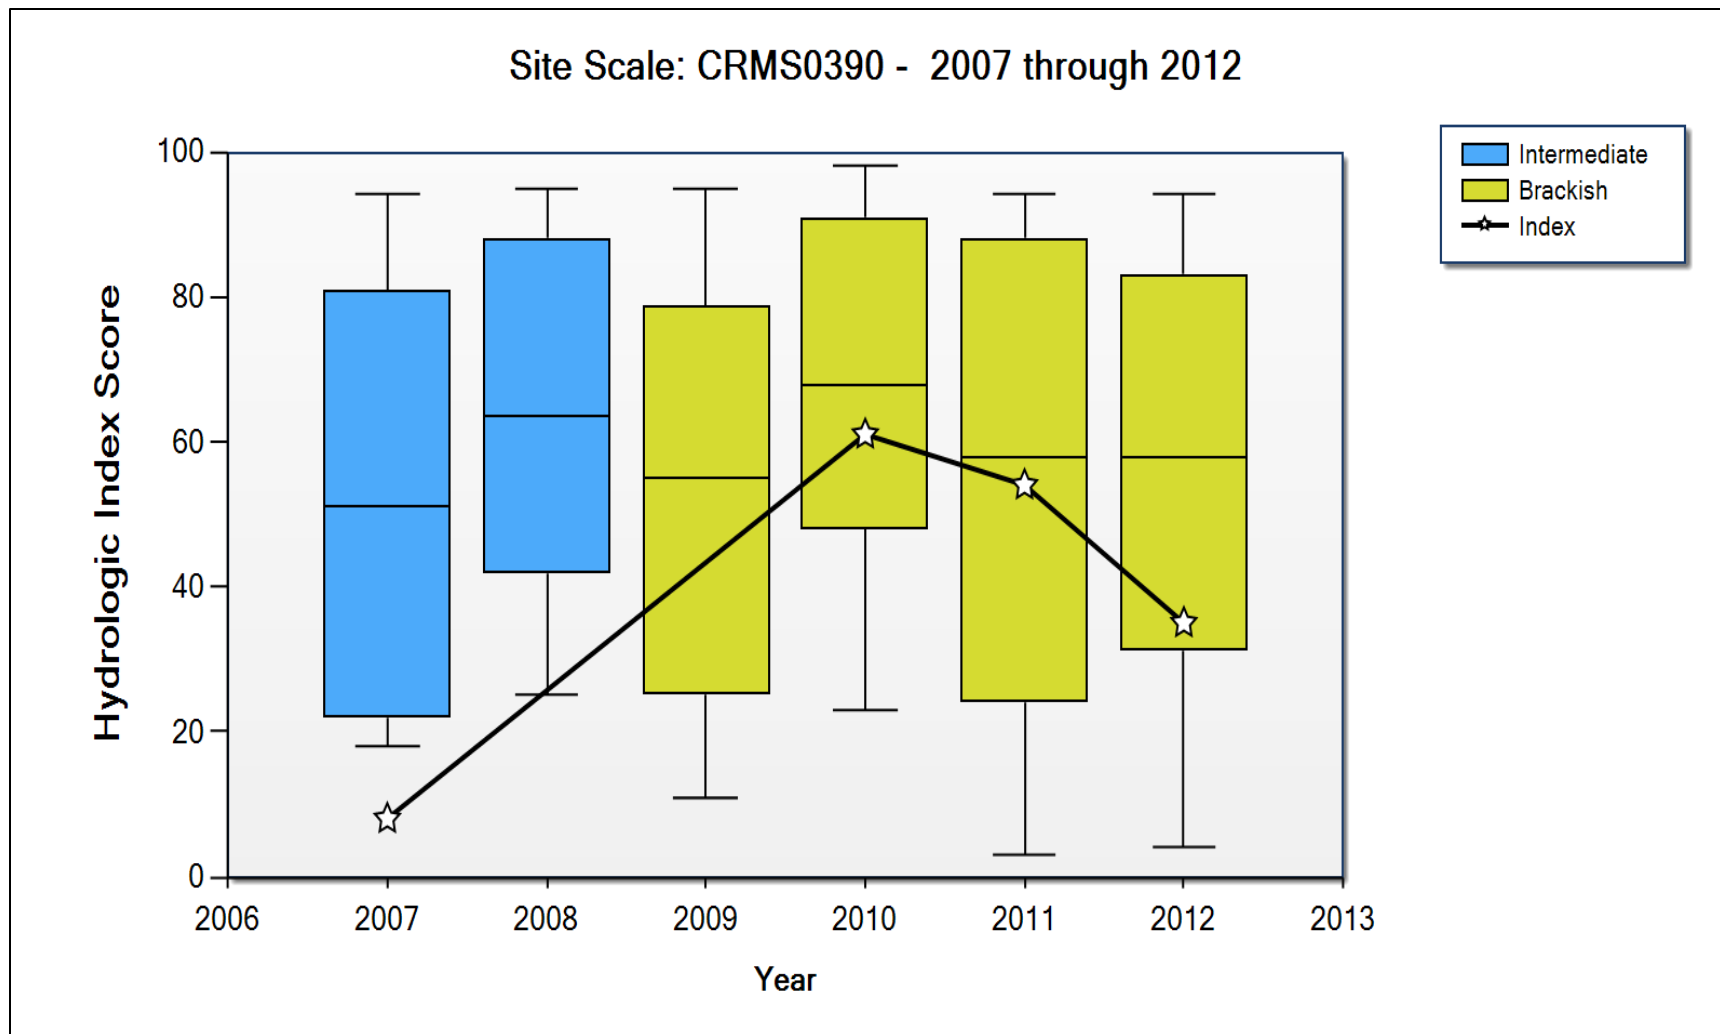
Figure 20. A time series of Hydrologic Index scores for CRMS0390 relative to the boxplot of the scores for all the sites within the same marsh type each year. The HI score for CRMS0390 is not shown for 2006, 2008, and 2009 because the data set for those water years did not meet the data completeness threshold of >70%.

The Hydrologic Index (HI) score was developed by CRMS analytical teams based upon parameters collected at CRMS sites from 2006 through 2009 across the Louisiana coast from which they developed a baseline distribution. The index was designed to help better understand the condition of coastal wetlands at various time and spatial scales. A site was classified as good if its score was greater than 75% of all CRMS site scores calculated during this baseline period, fair if it fell within the 25% to 75% range, and poor if it did not exceed 25%. The HI score is calculated by year, and requires greater than 70% data completeness for a particular year in order to obtain a score. HI scores indicate if the project area hydrologic conditions have provided a healthy environment for the marsh vegetation to thrive. The HI scores for the CRMS reference sites are presented in Figures 19 and 20. The box plots indicate a comparison of the HI scores from 2006 through 2012 to scores from all the Louisiana coastal zone CRMS sites within the same marsh type. Due to the lack of data completeness for water years 2006, 2008, and 2009 for CRMS0390, comparisons to all other CRMS sites was not available (Figure 20). Interestingly the box plot indicates the change in marsh classification from intermediate to brackish as time progresses. The CRMS0390 HI scores are all lower than the comparative sites. The HI scores for CRMS0392 are not shown for water years 2006 and 2007 because the data sets did not meet the data completeness threshold (Figure 21). Marsh classifications changed from intermediate to brackish to intermediate throughout the data series. HI scores for CRMS0392 were all lower than the comparative CRMS sites, particularly for years 2008, 2011, and 2012.

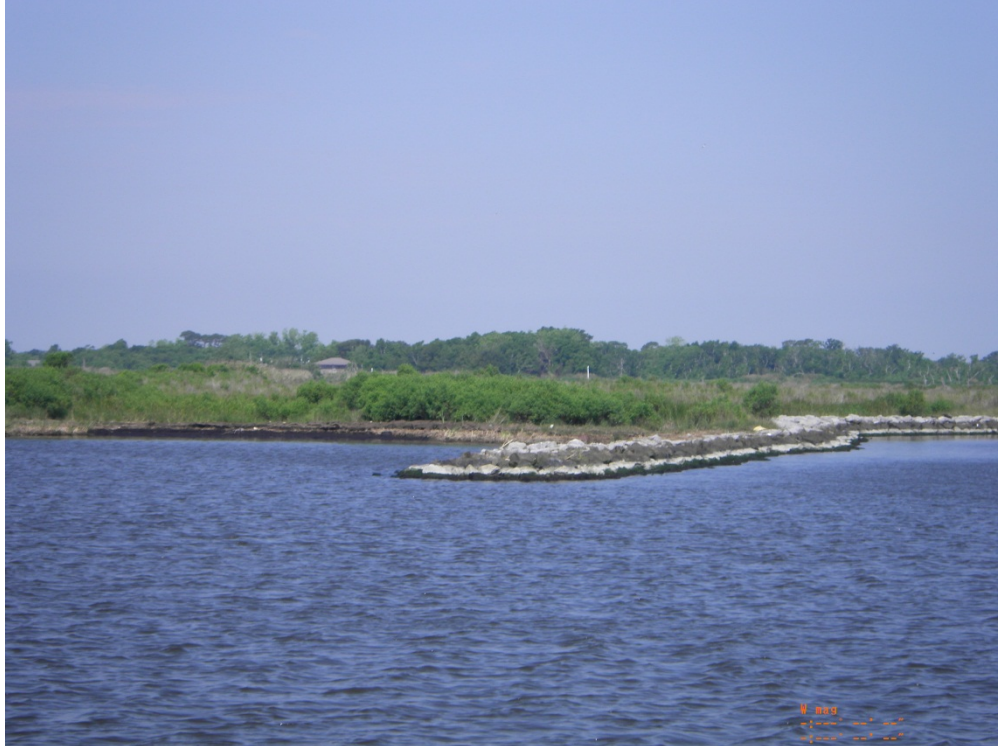
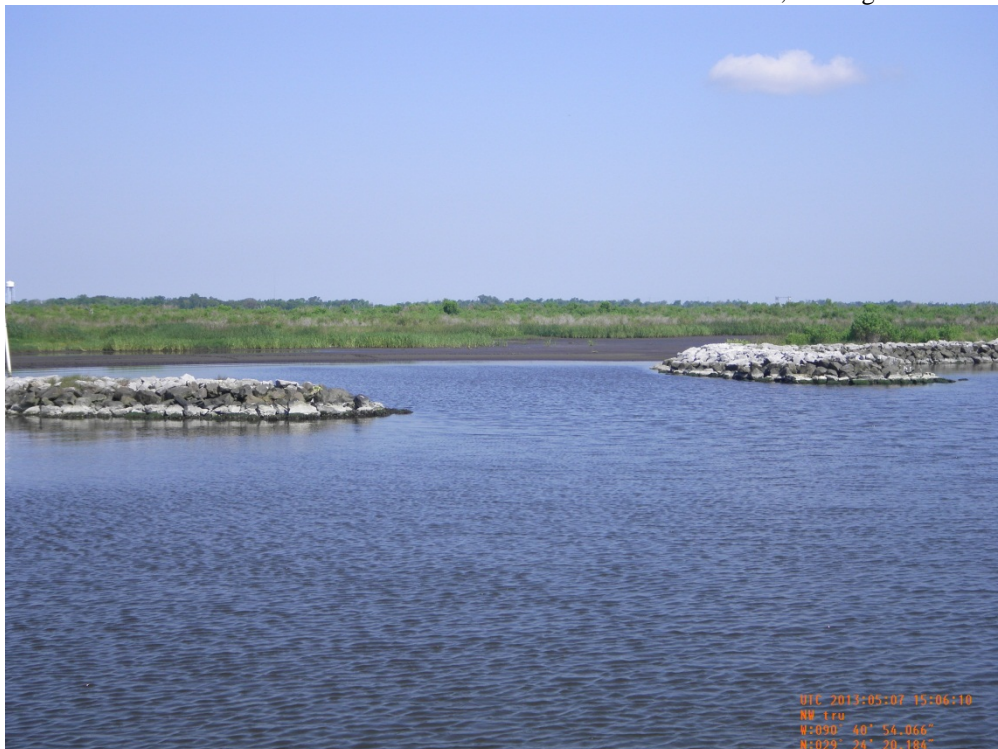
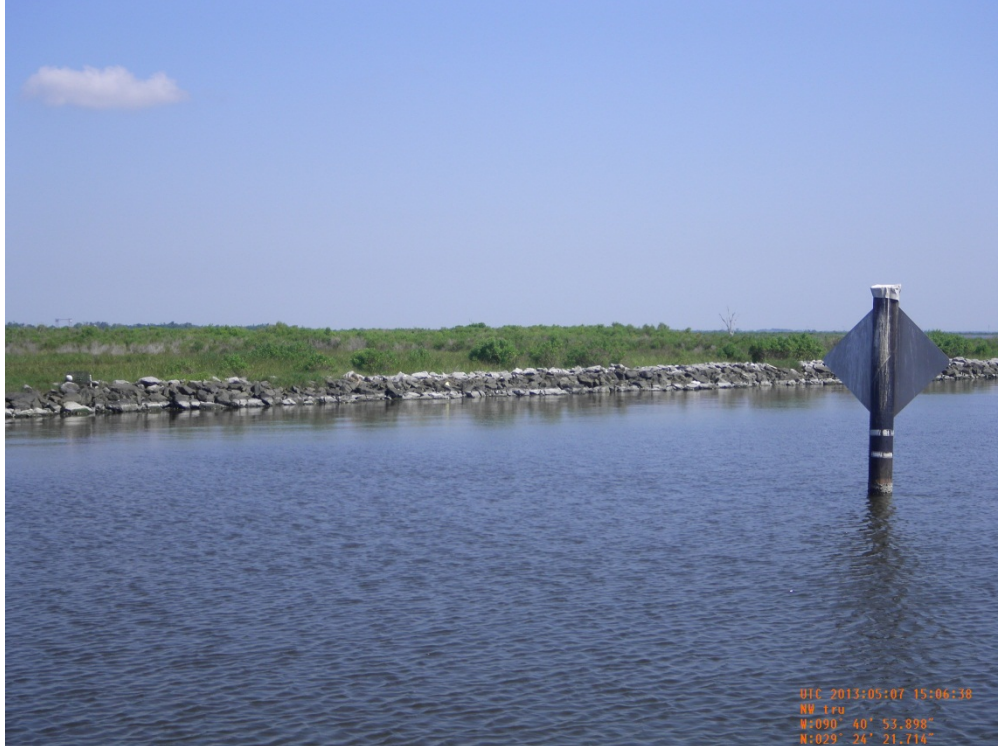
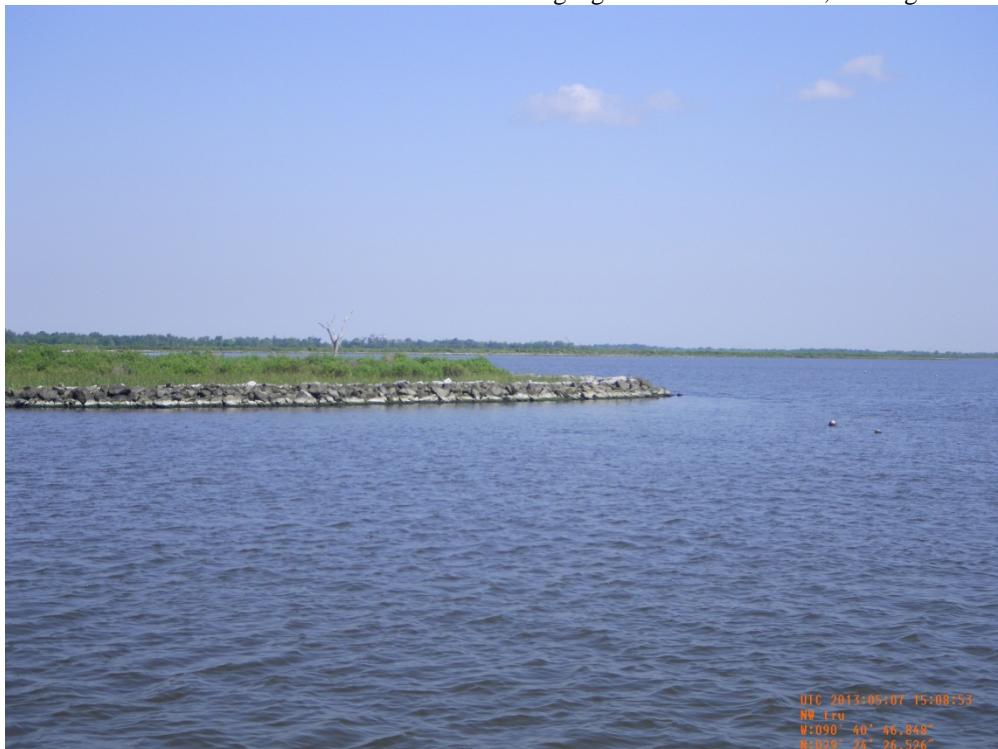
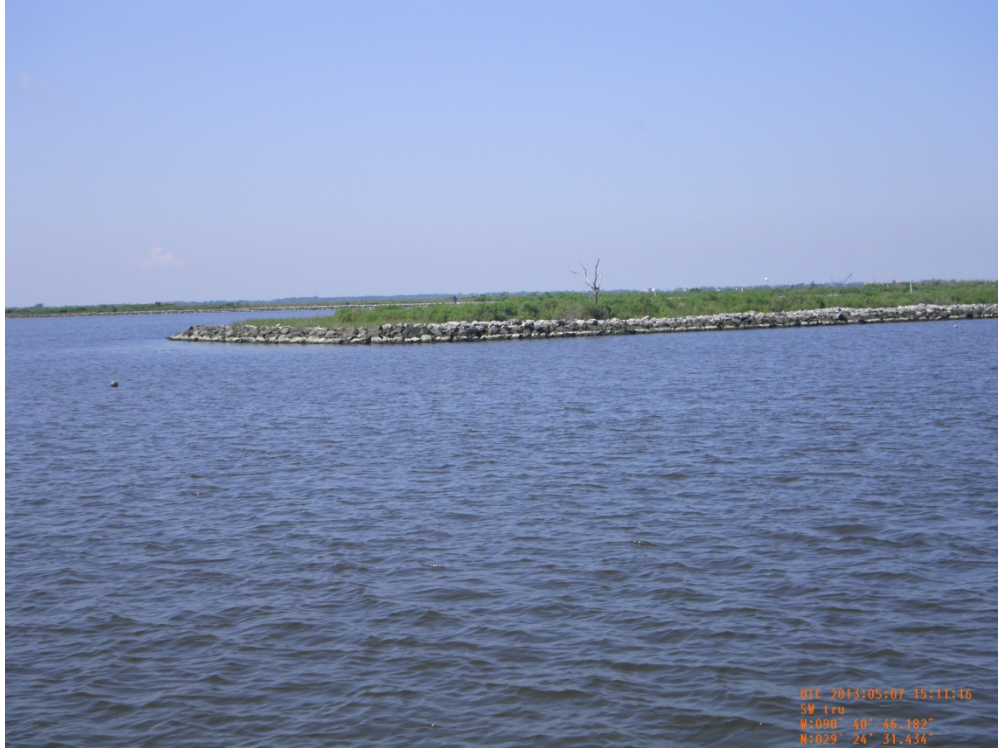
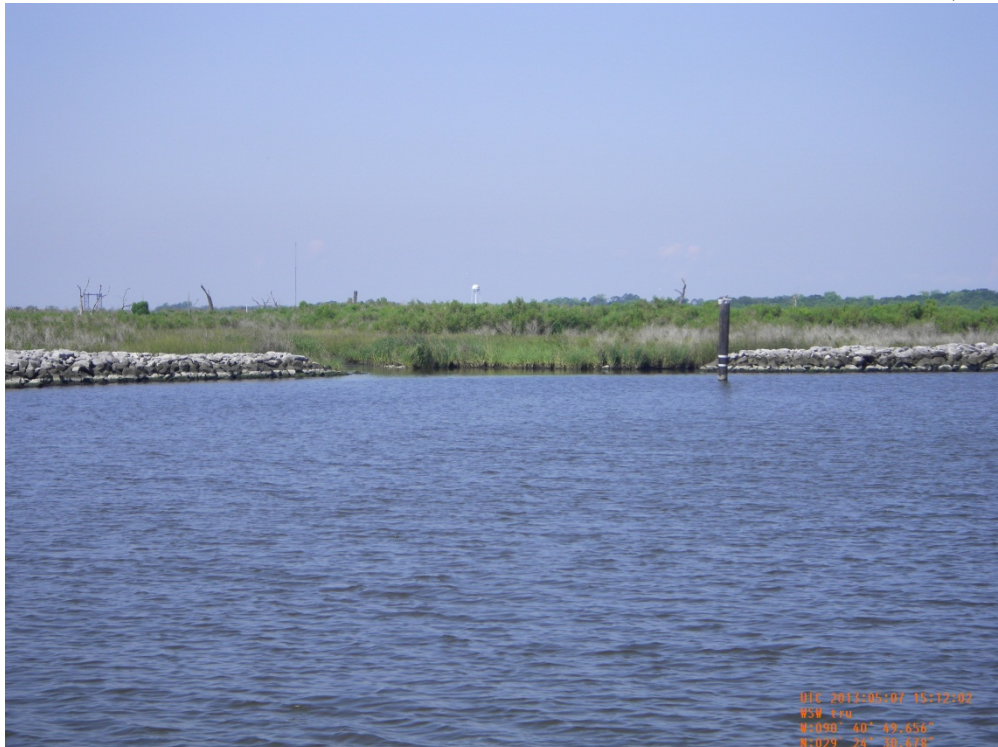
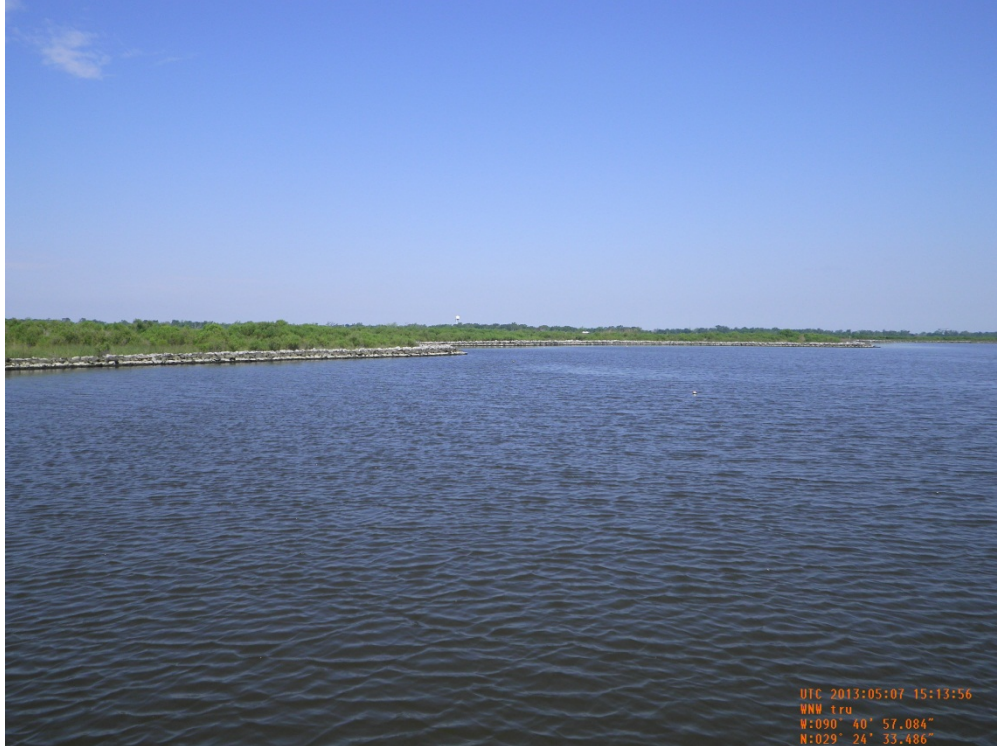
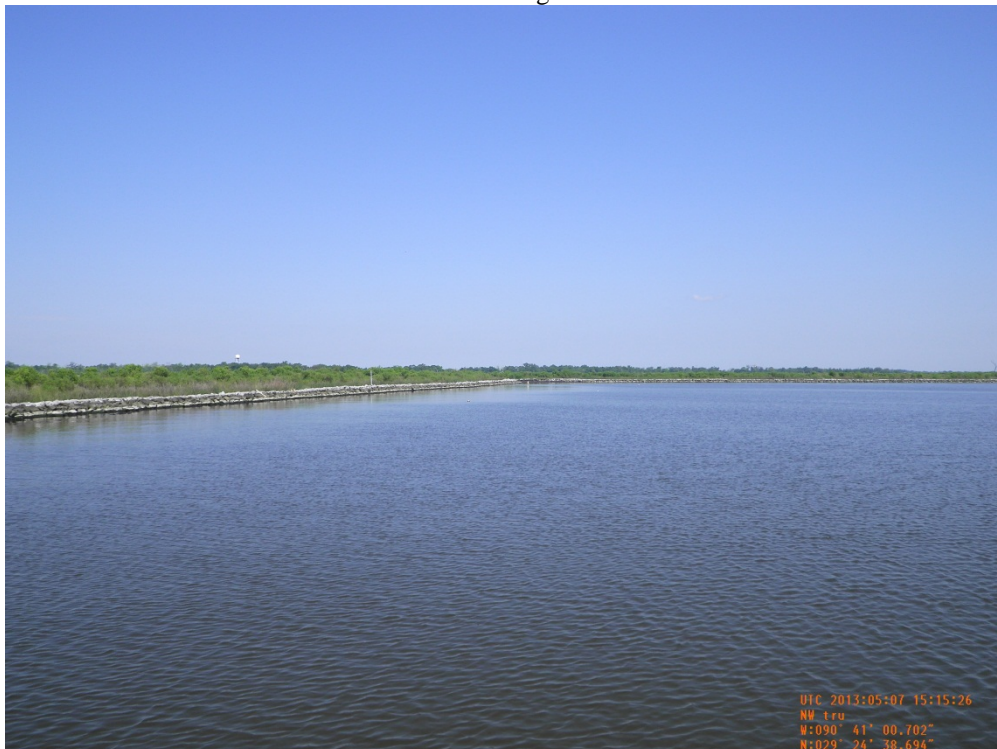
The southern segment of the rock dike appeared to be in good condition. There are no signs of settlement along the rock dike; the elevation is consistent throughout the entire length of the structure. All of the warning signs along this segment are visible and appear to be in good condition. On the southern end of the structure, the adjacent marsh shoreline has eroded significantly since the time of construction. This has caused the southern end of the rock dike to protrude approximately 150 feet into the lake. It may be prudent to add a navigational warning sign in this area to indicate this hazard, but due to the large cost involved with installing a single sign the warning sign should be included in the next maintenance event. There are no recommendations for maintenance at this time, but this area will continue to be monitored on future inspections to determine if any corrective actions need to be made. (See Appendix A, Photos 1 through 8)

Photo 1: View of the southernmost end of the foreshore rock dike, looking west

Photo 2: View of access corridor for Gulf South pipeline in foreshore rock dike, looking west

Photo 3: View of foreshore rock dike and warning sign for access corridor, looking north

Photo 4: View of the foreshore rock dike near the south end of the marsh creation southern section, looking north

Photo 5: View of the foreshore rock dike near the south end of the marsh creation southern section, looking south

Photo 6: View of the fish dip near the south end of the marsh creation southern section, looking south

Photo 7: View of the foreshore rock dike along the southern section of marsh creation

Photo 8: View of the foreshore rock dike along the southern section of marsh creation

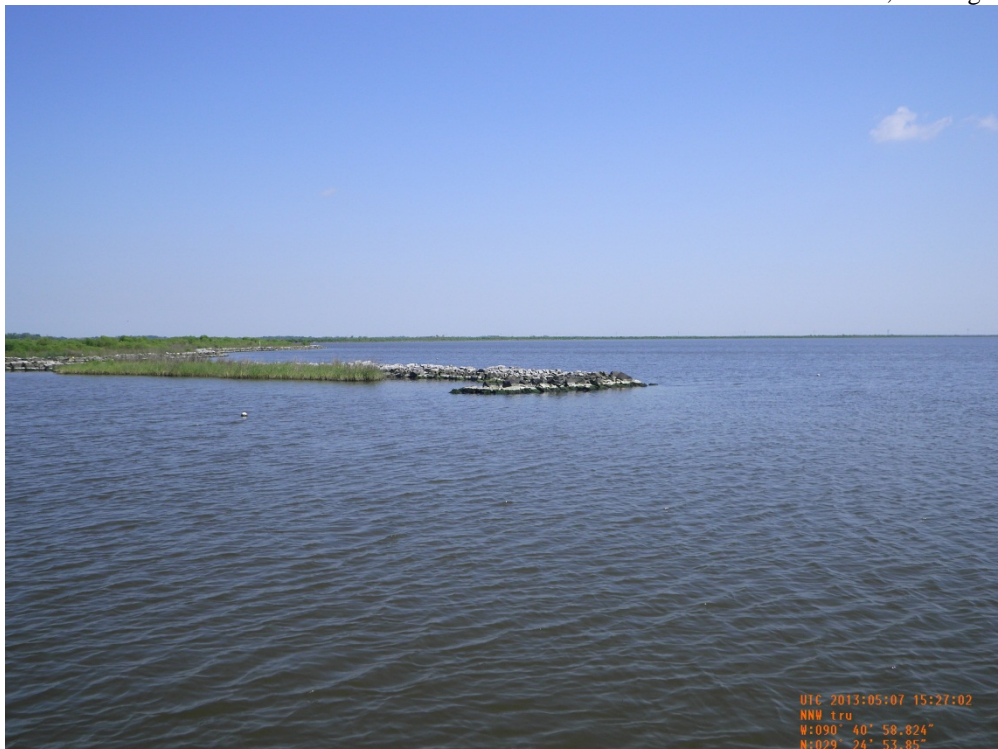
The central segment of the foreshore rock dike also appeared to be in good condition. There are no signs of settlement along the rock dike; the elevation is consistent throughout the entire length of the structure. There are no recommendations for maintenance at this time. (See Appendix A, Photo 10)

Photo 10: View of the south end of the central section foreshore rock dike, looking north

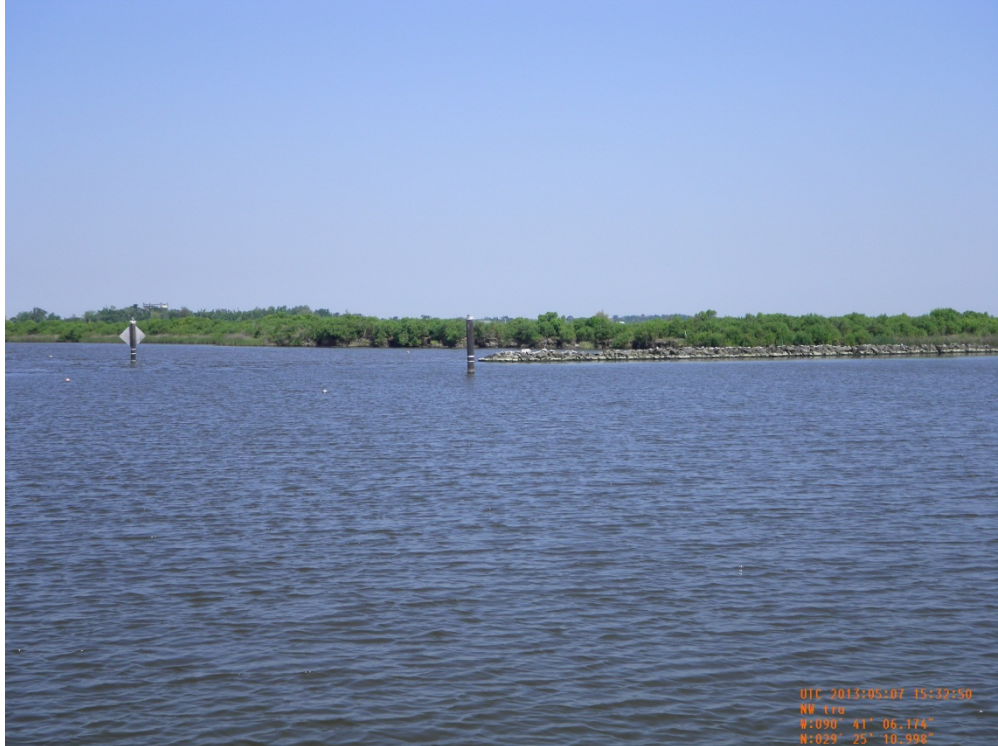
The choke down section of the foreshore rock dike could not be observed during the annual inspection as it is submerged under the waterline. The warning sign on the Lake Boudreaux side of the choke down section is missing. The timber piling support is still in its location and in good condition, but the sign itself is no longer there. It is recommended that this sign be

Photo 11: View of the choke down section in the foreshore rock dike, looking west

replaced to notify boaters coming from the lake of the navigational hazard posed by the choke down section. (See Appendix A, Photos 11 through 12)

All project features are in good shape. It is recommended that the missing warning sign on the lake side of the choke down section be replaced as it is the only indicator of the submerged structure for vessels traveling in that direction.

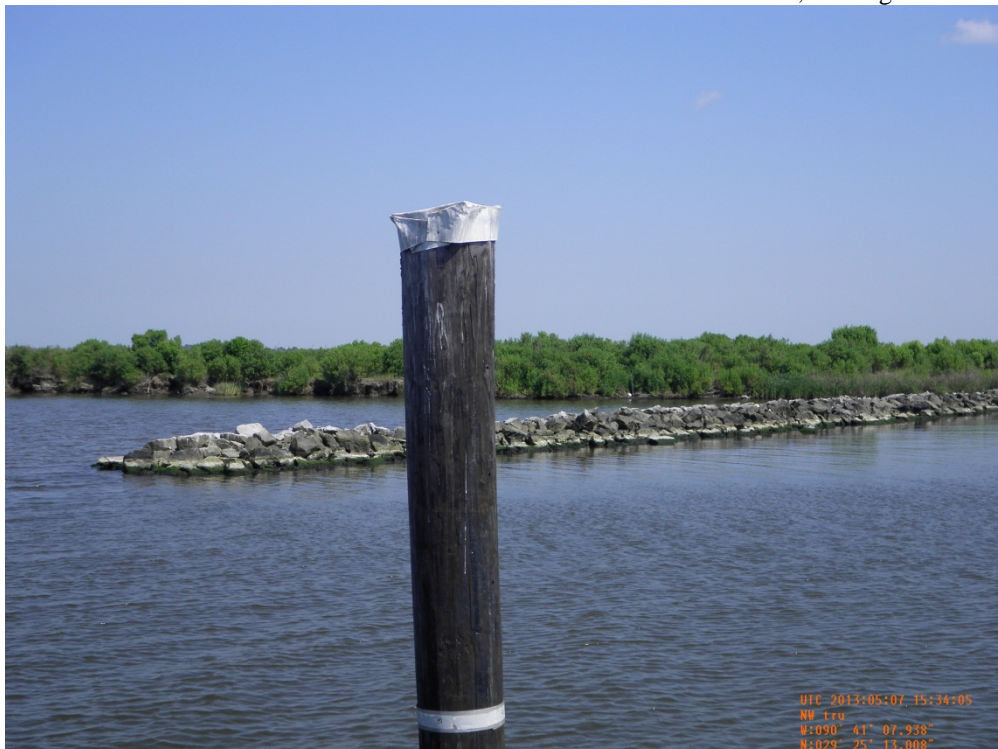
Photo 12: The warning sign on the lake side of the choke down section is missing from its support.

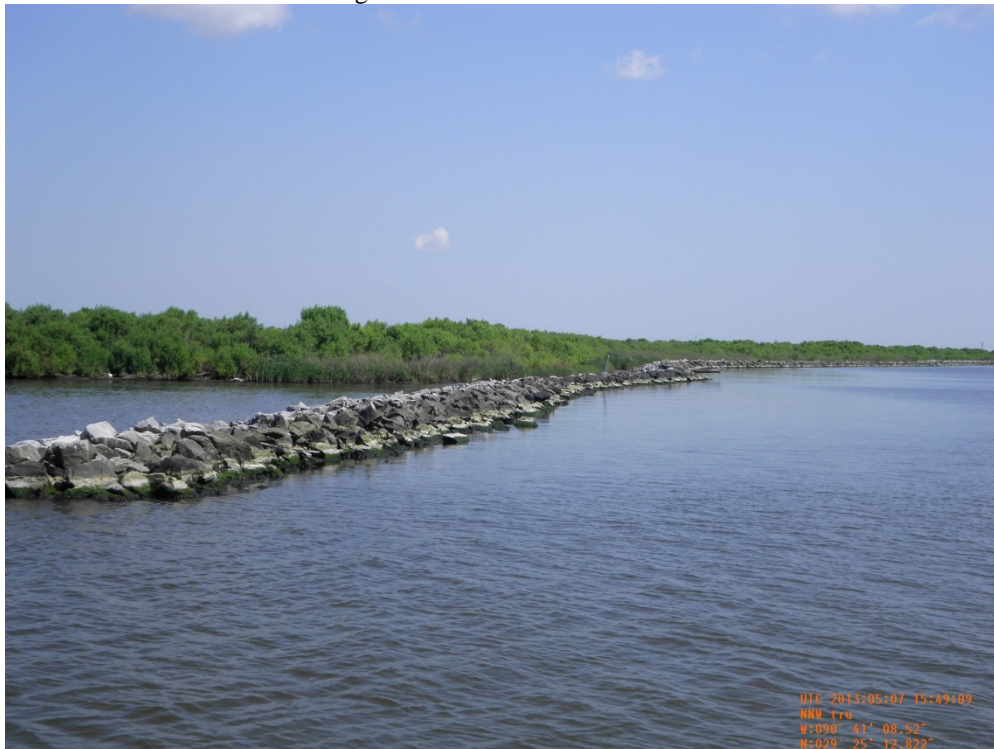
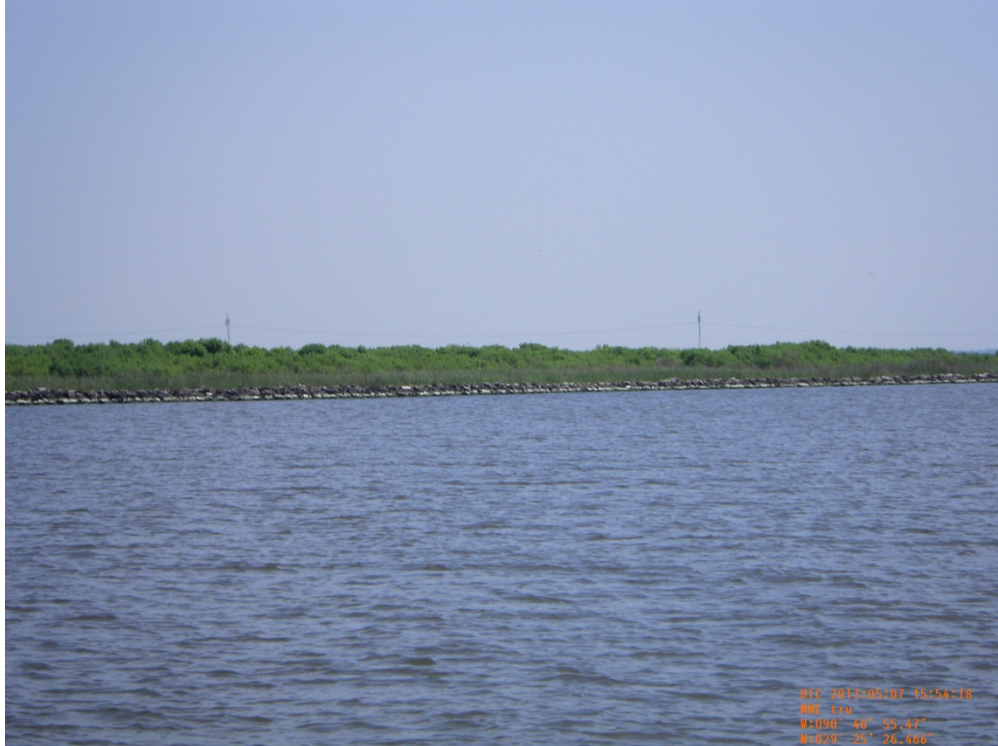
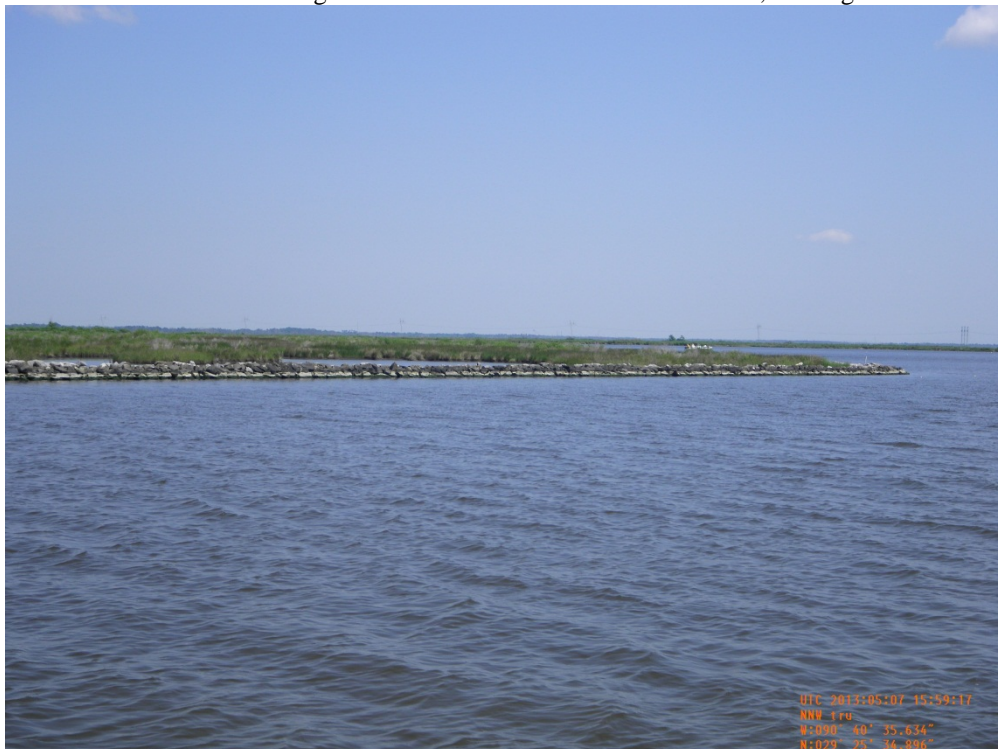
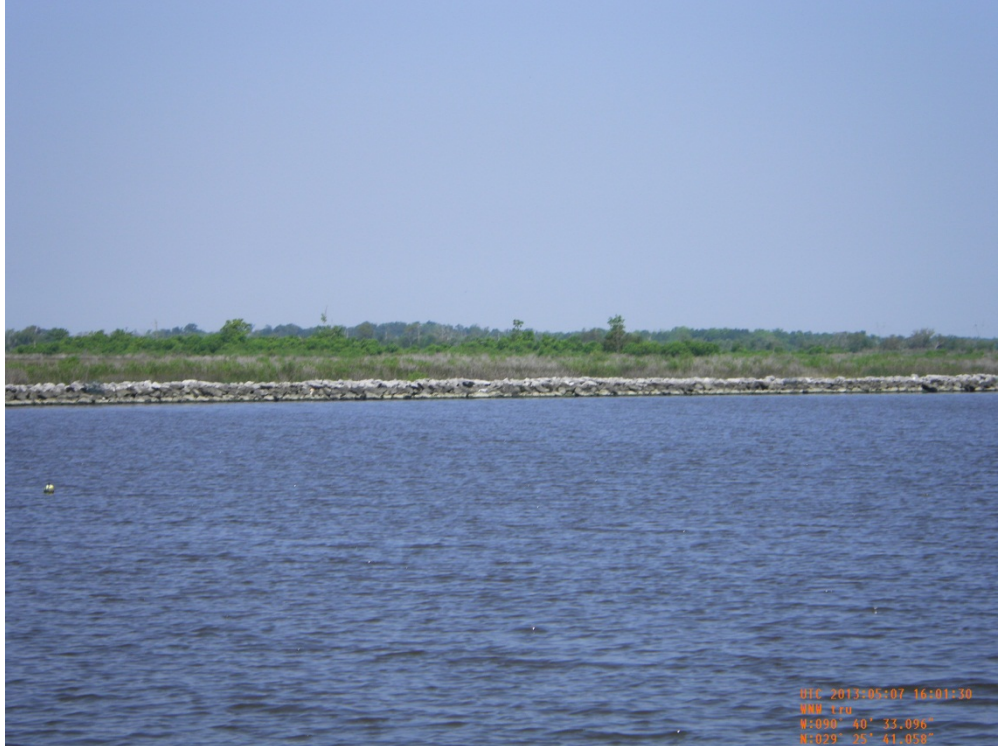
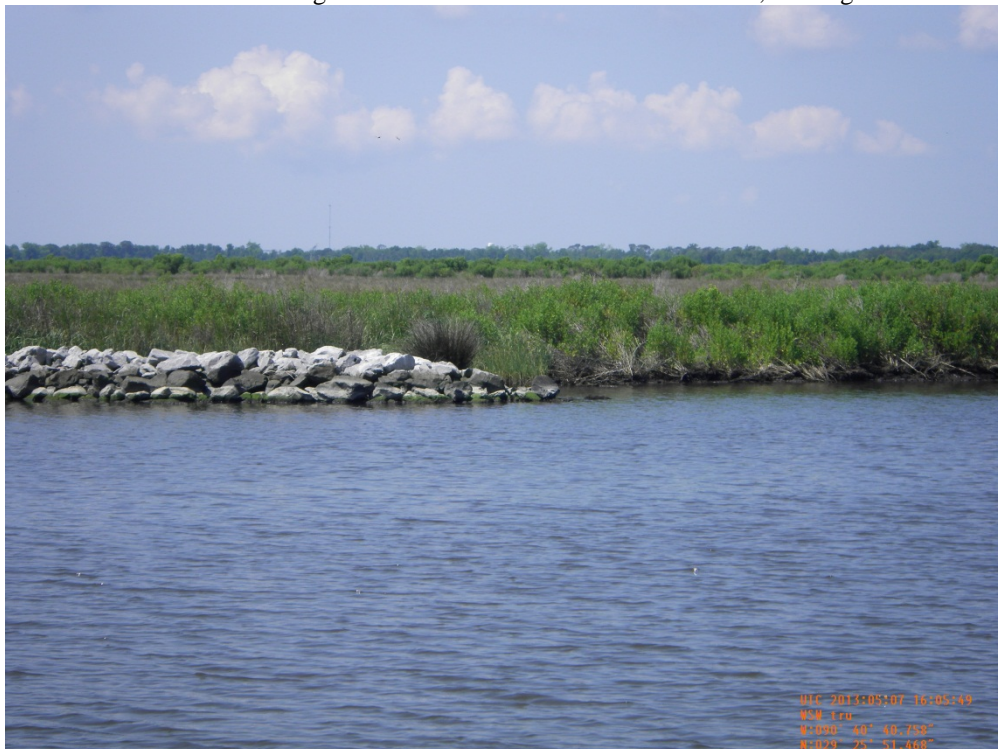
The northern segment of the rock dike appeared to be in good condition. There are no signs of settlement along the rock dike; the elevation is consistent throughout the entire length of the

structure. There is some evidence of erosional shadowing on the north end of this segment, measuring approximately 70 feet wide and 20 feet deep. This erosion of such a small area does not impede the function of the structure; however this area has been identified and will continue to be monitored on future inspections. There are no recommendations for maintenance at this time. (See Appendix A, Photos 14 through 18)

Photo 14: View along the foreshore rock dike northern section, looking north

Photo 15: View along the foreshore rock dike northern section, looking north

Photo 16: View along the foreshore rock dike northern section, looking north

Photo 17: View along the foreshore rock dike northern section, looking south

Photo 18: View of the northernmost end of the foreshore rock dike, looking south
